**2023 ANNUAL ENGINEERING
INSPECTION REPORT**

**PLUM POINT ENERGY STATION
CLASS 3N LANDFILL**

**PERMIT NO. 0303-S3N-R1
AFIN: 47-00461**

JANUARY 19, 2024

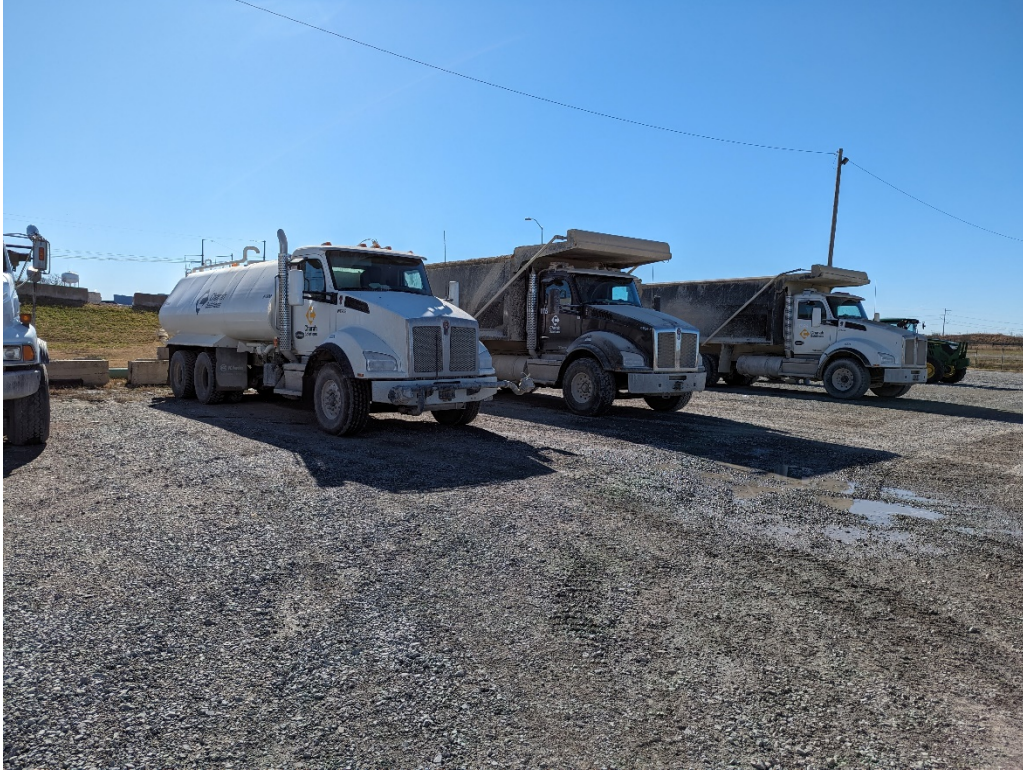
Photo 1. Water truck staged in shop parking lot.

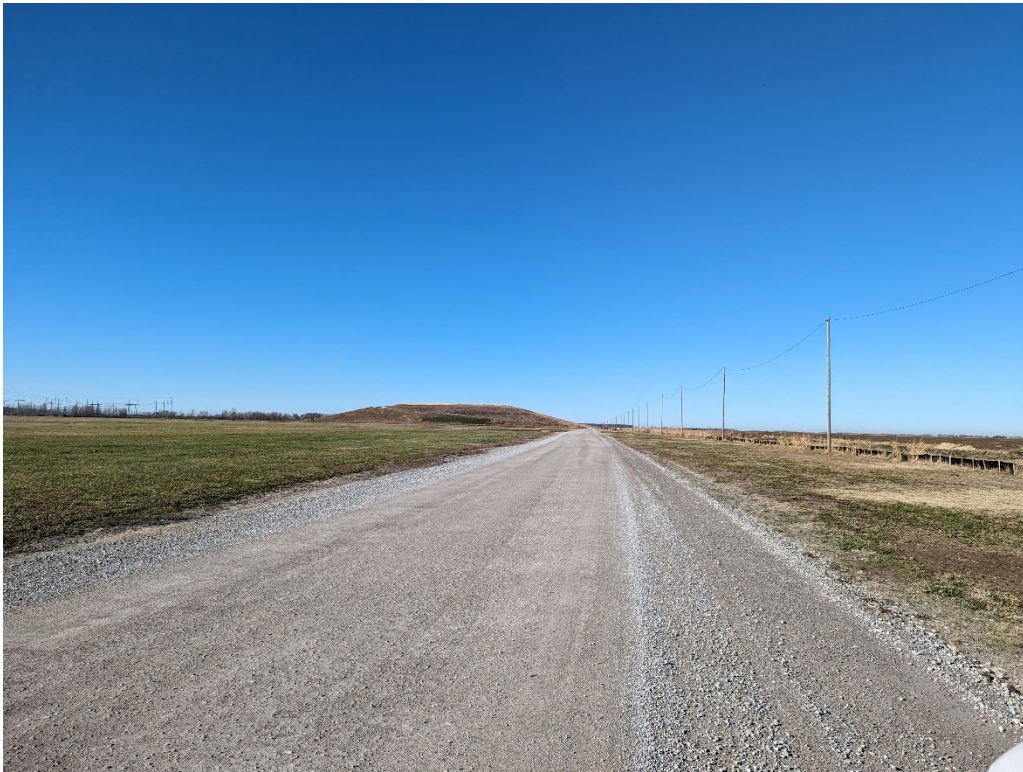
Photo 2. Haul road to landfill looking West.

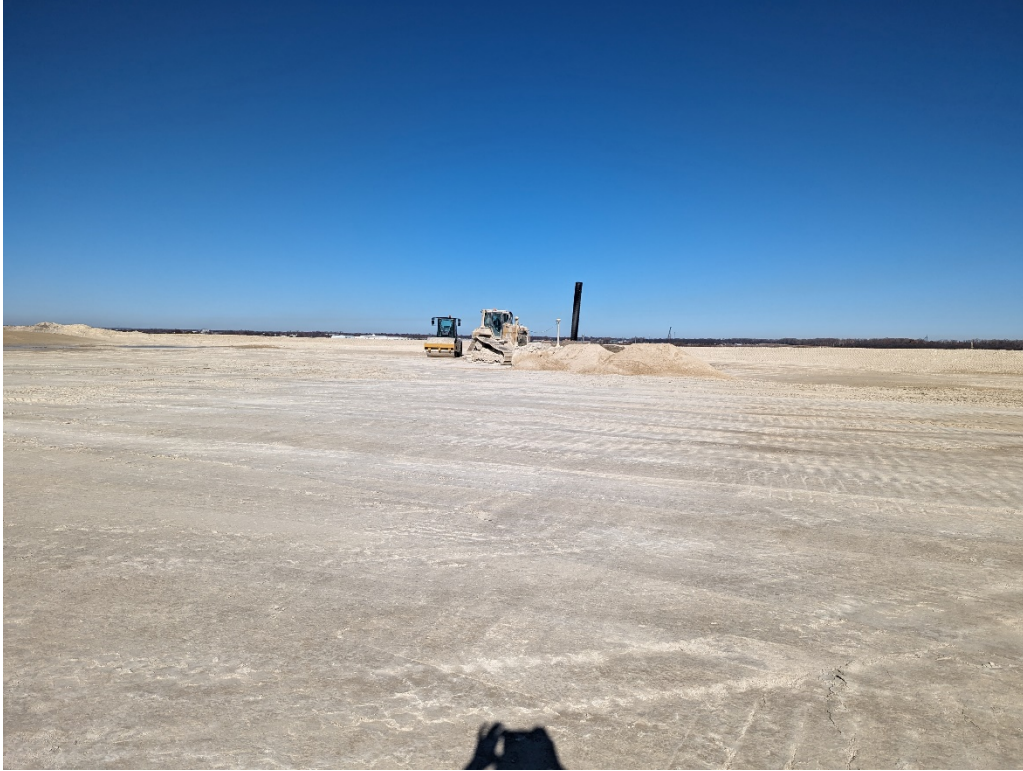
Fly ash is transported to the landfill using end-dump trucks with tarps. The ash is mixed with water in the pug mill at an appropriate rate to minimize fugitive dust problems during truck loading and dumping, but not create excess free liquids. Water is applied, when necessary, for dust suppression on roads and the landfill using a water truck. At the time of the annual inspection, waste disposal activities were halted for lunch. Additionally, wet conditions due to recent rains prior to the inspection prevented the need for water truck operation. Previous observations of disposal activities showed little dust, which was confined to the immediate active area.

Photo 3. Active working face, fly ash looking North (Cell 3).

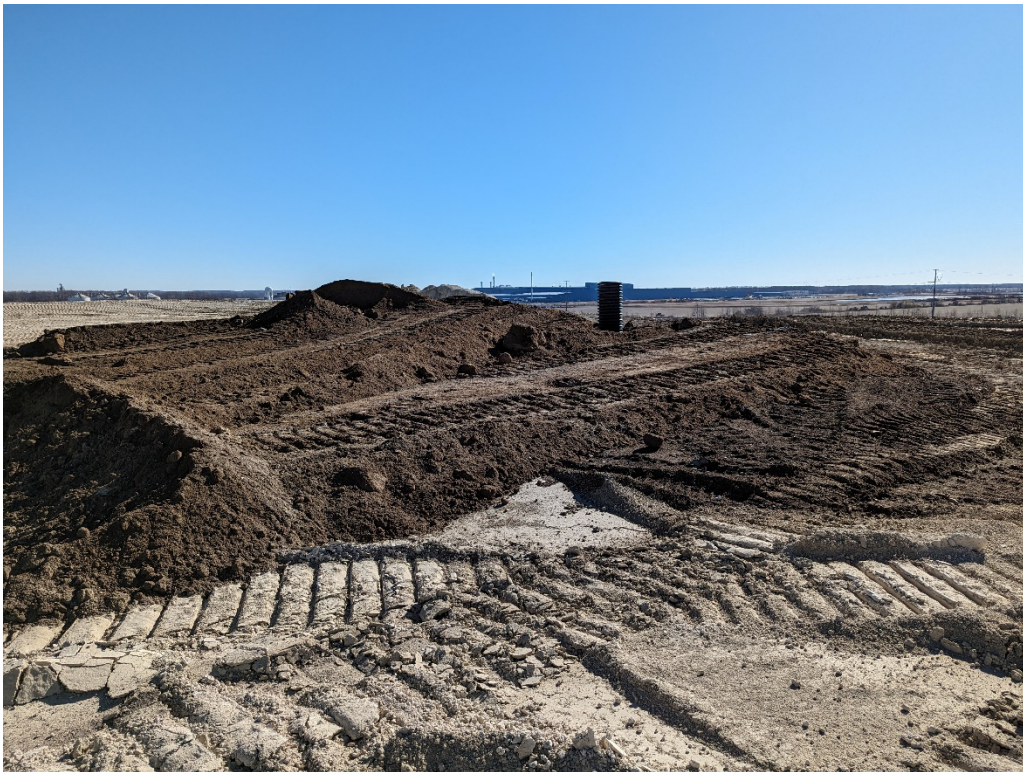
Photo 4. Active working face, bottom ash with chimney drains looking Southeast (Cell 3).

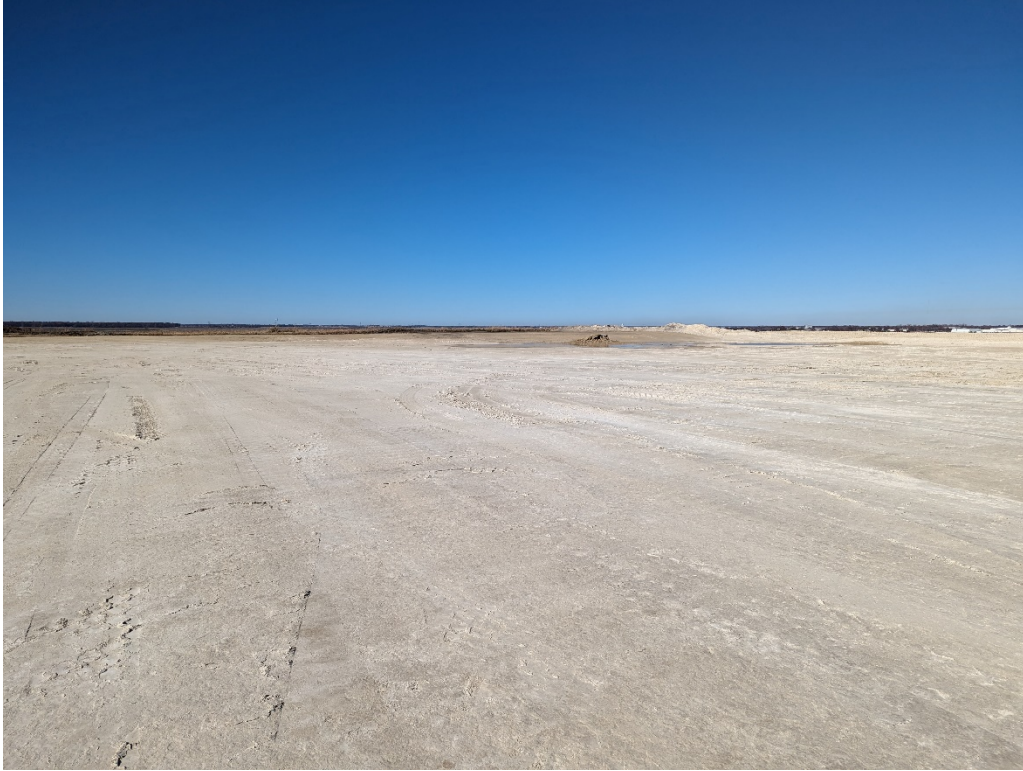
Both active cells remain open. Interim cover soil has been placed on the completed slopes of Cells 1 and 3, as noted above.

Photo 5. Open disposal area, Cells 1 and 3.

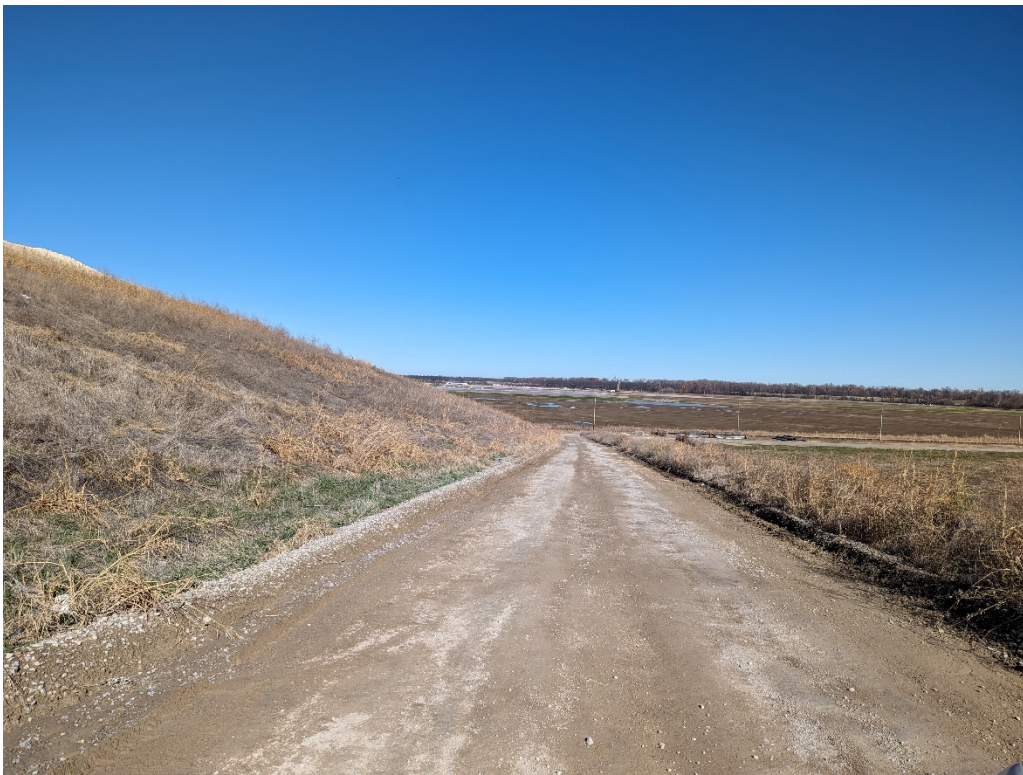
Photo 6. Cell 3 East slope intermediate cover and haul road.

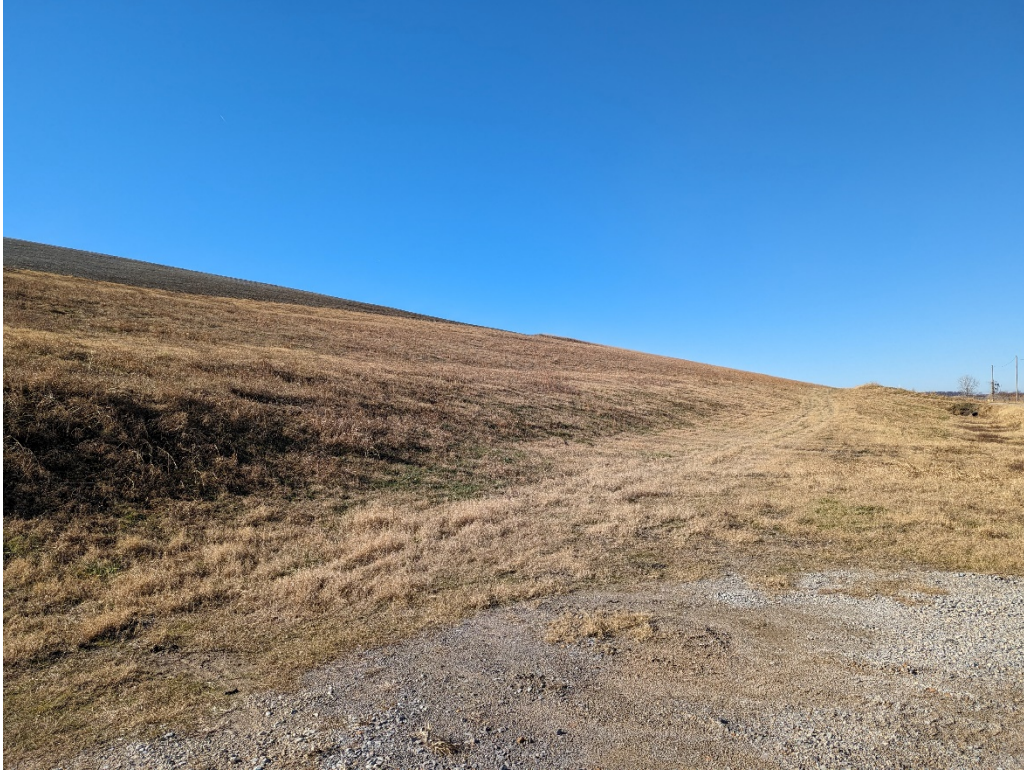
No tension cracks or other features that indicate a potential slope failure were observed during the site inspection. In addition, no active seeps were noted on the exterior slopes.

Photo 7. Typical side slope intermediate cover and vegetation.
