# **2015 ANNUAL ENGINEERING INSPECTION REPORT**

## **PLUM POINT ENERGY STATION CLASS 3N LANDFILL**

**PERMIT NO. 0303-S3N  
AFIN: 47-00461**

**JANUARY 15, 2016**

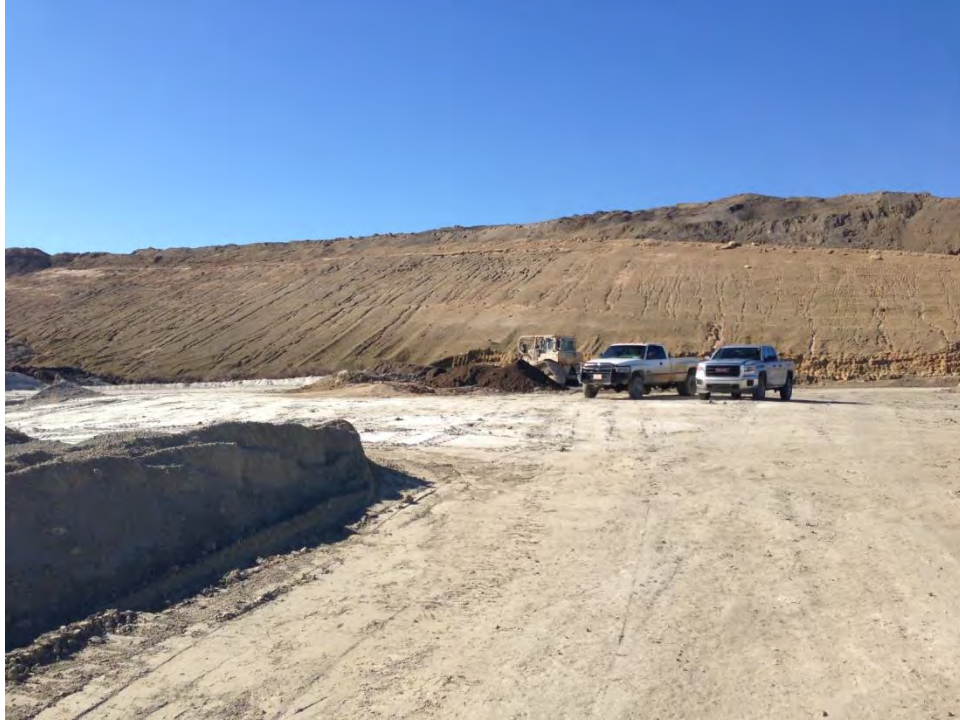
Photo 1: Cell 3 disposal area, Cell 1 from east

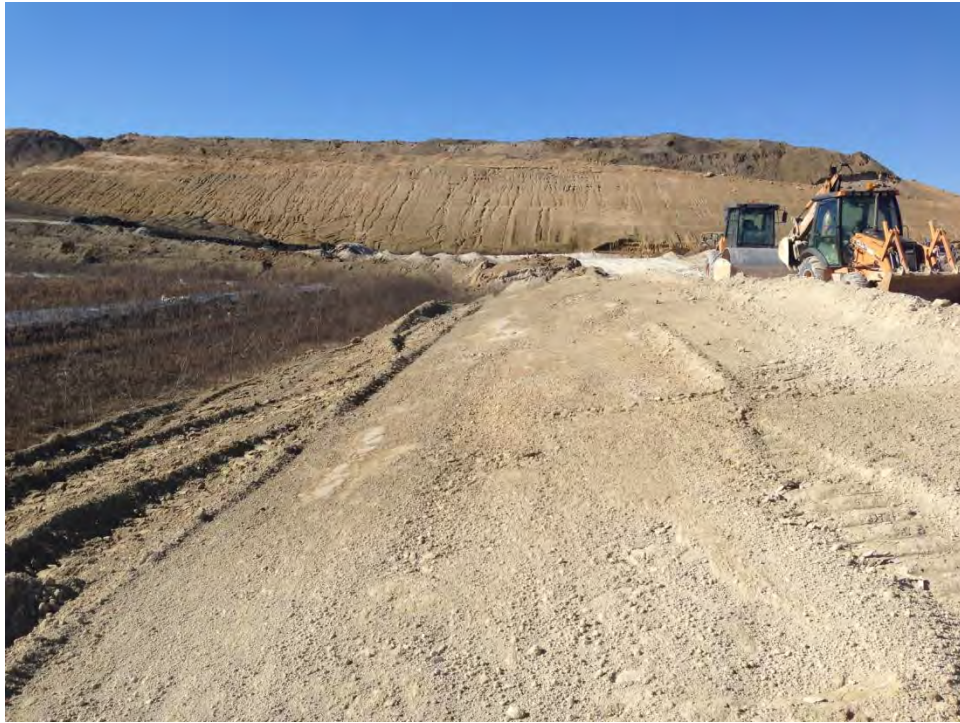
Photo 2: Cell 3 active disposal area, Cell 1 from east

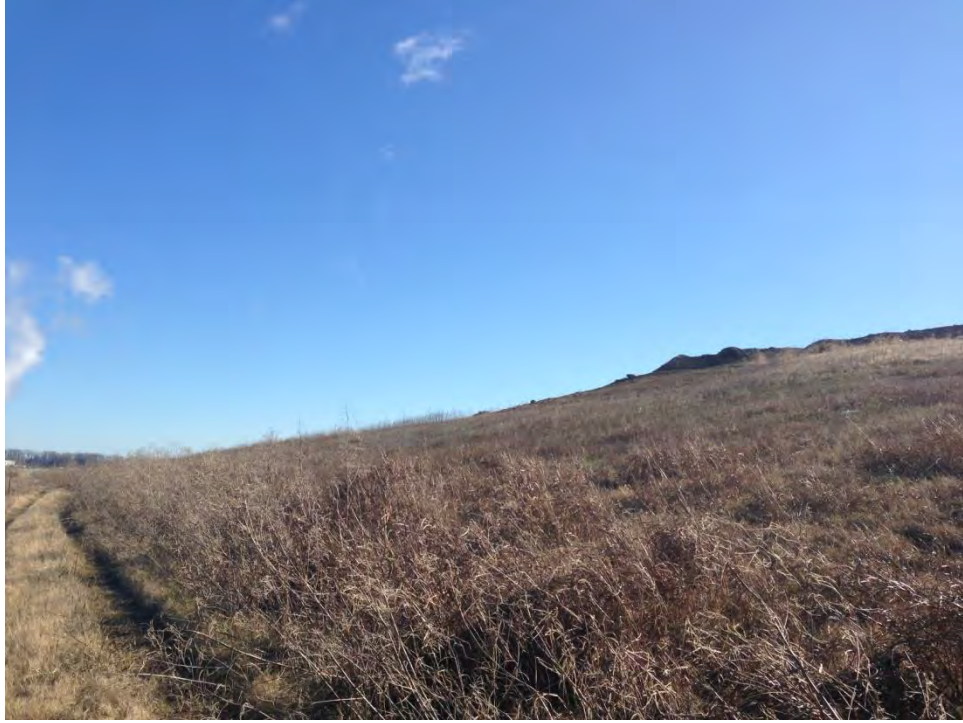
No tension cracks, seeps, or other features that indicate a potential slope failure were observed during the site inspection. In addition, no active seeps were noted on the exterior slopes.

Photo 6: Side slope of landfill, typical of north and west sides of Cell 1

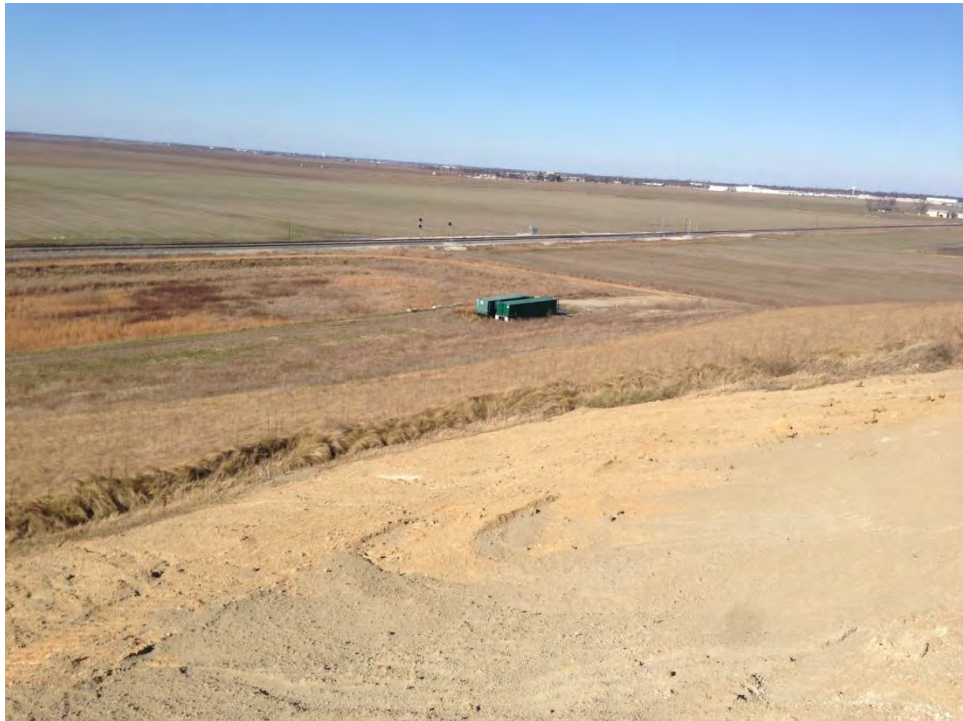
The elevated disposal area in Cell 1 is surrounded by berms for safety and to reduce effects of wind, as described in Section 4.7, below. It appears that some sections of these berms have been raised as the level of ash in the active areas rises. This has created steeper slopes near the top of the side slopes of the landfill. These were noted to the landfill manager who will regrade the affected upper slopes as soon as weather conditions allow. Charah also plans to place interim cover on these slopes, once graded.

Photo 7: Upper section of Cell 1 west slope, above interim cover

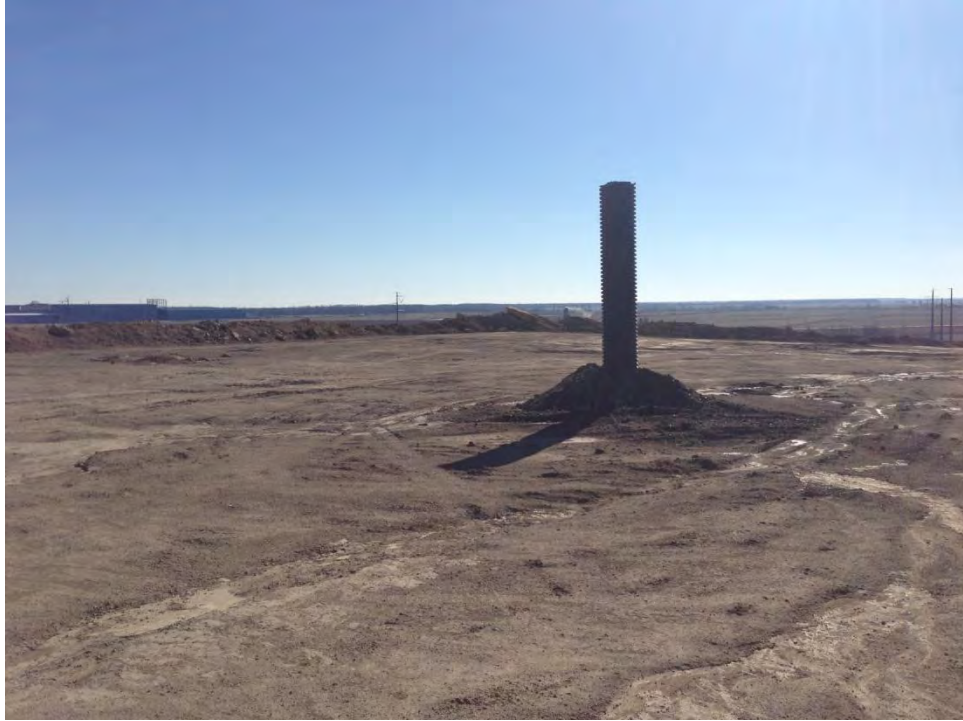
Photo 8: Top of Cell 1, edge berms and chimney drain

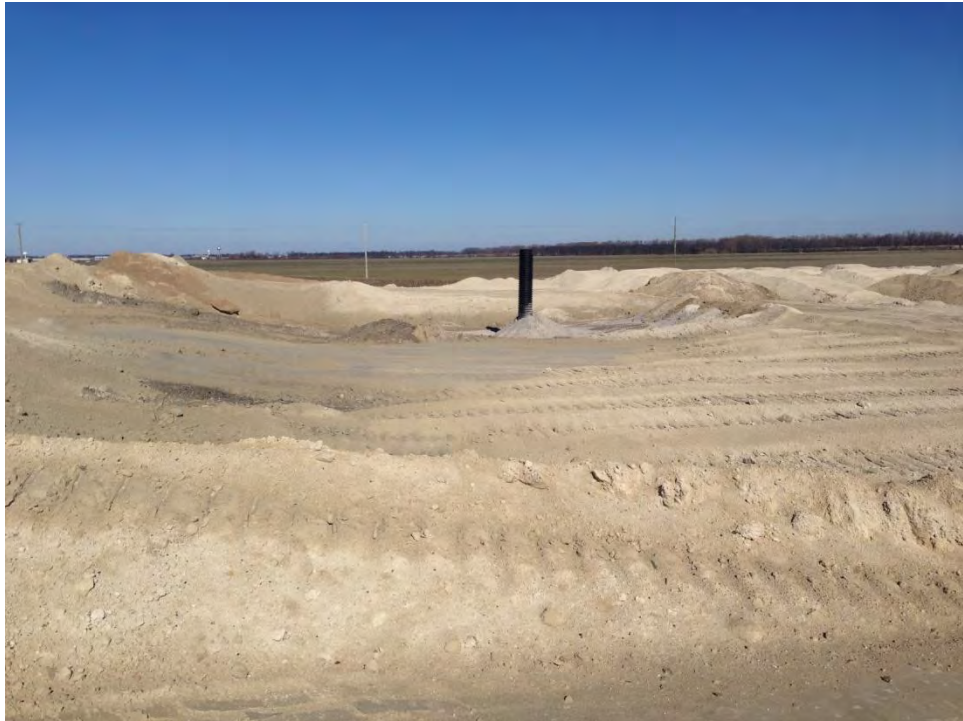
Photo 9: Cell 3 northwest chimney drain

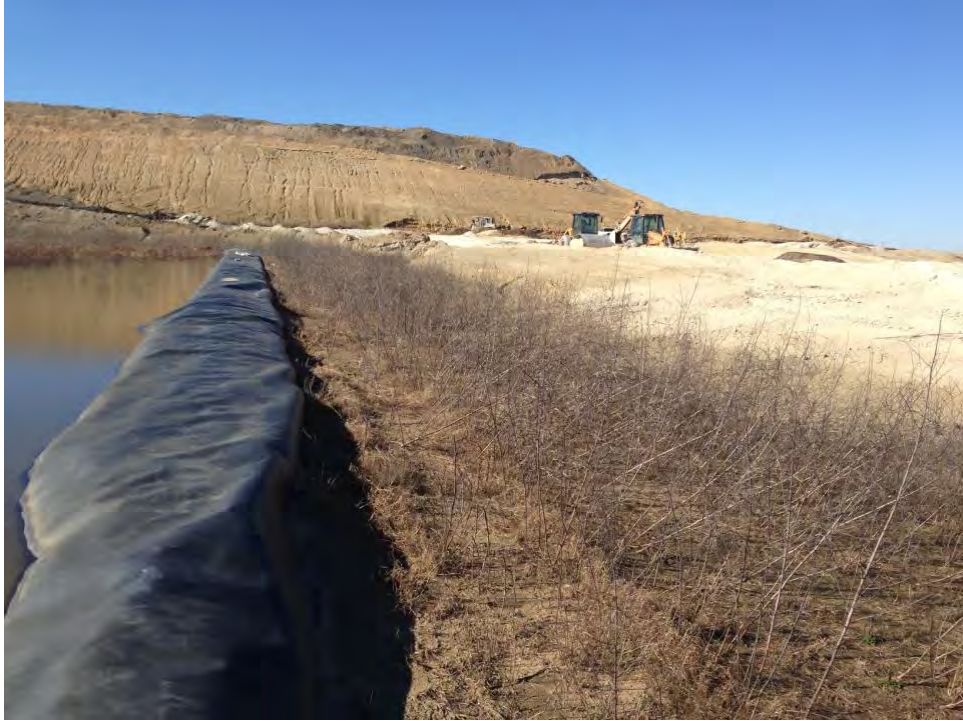
Photo 10: Cell 3 stormwater separation berm, from east

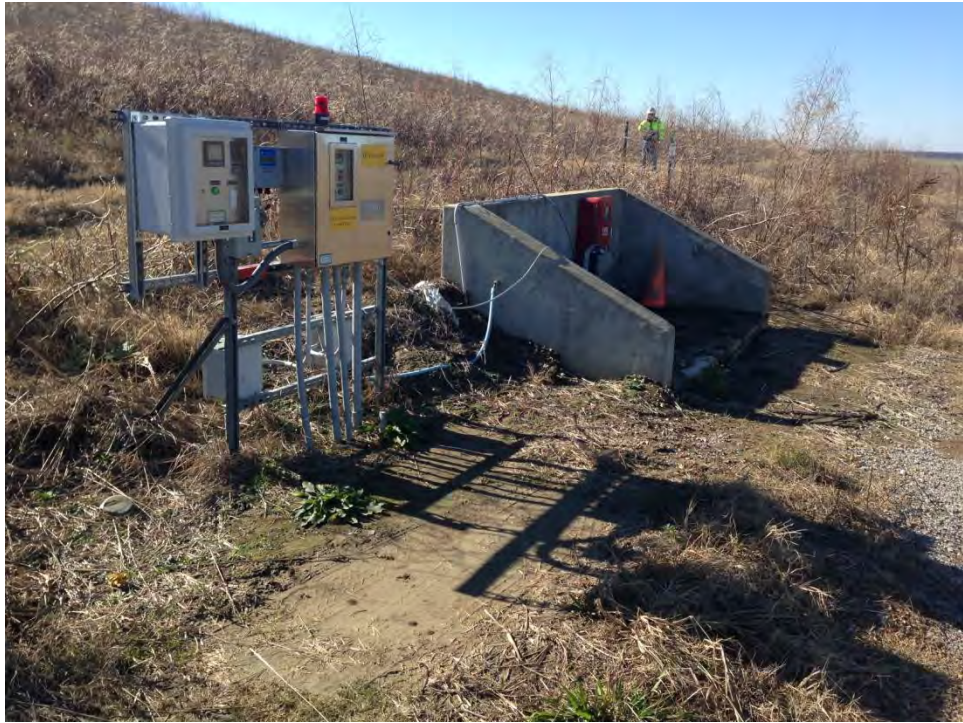
Photo 11: Typical leachate pumping system, Cell 1

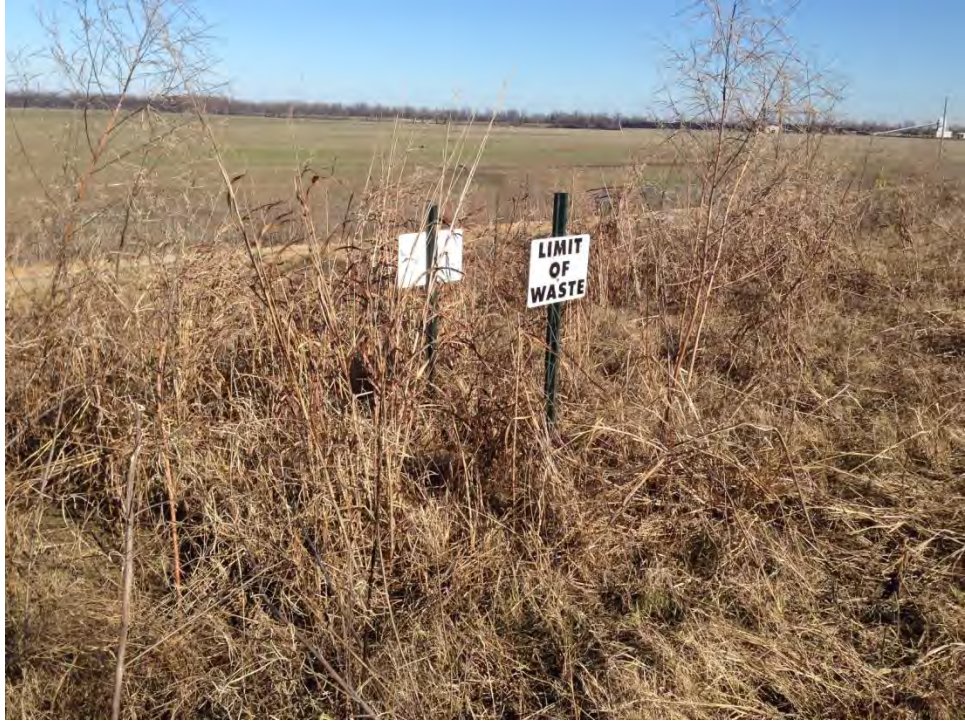
Photo 3: Typical 'Limit of Waste' and 'Edge of Liner' signage

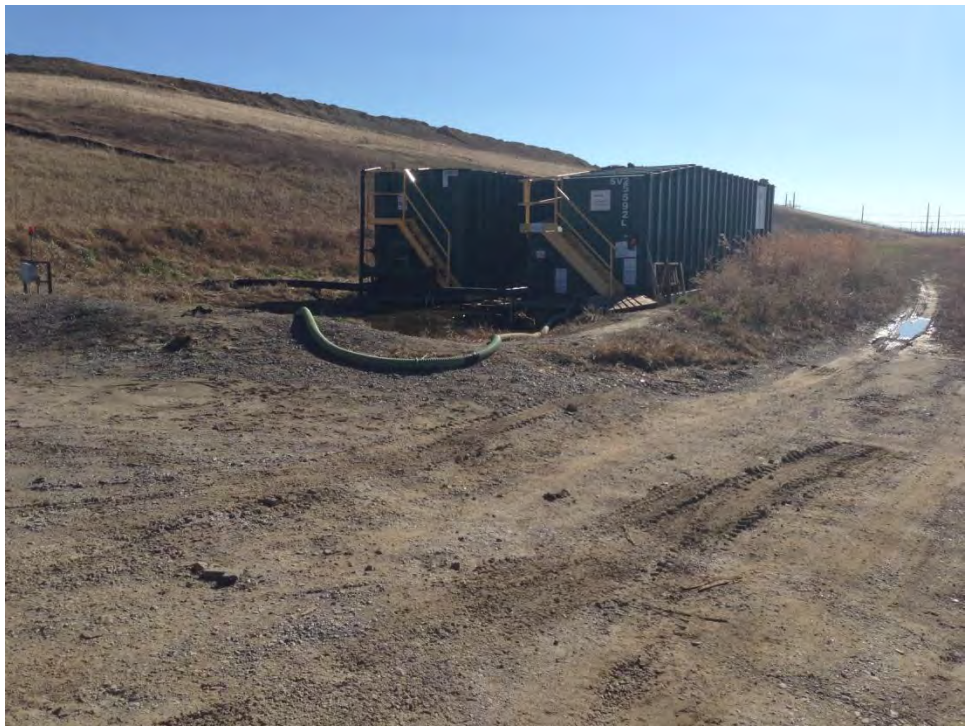
Photo 4: Leachate storage tanks
