2021 ANNUAL ENGINEERING INSPECTION REPORT

PLUM POINT ENERGY STATION CLASS 3N LANDFILL

**PERMIT NO. 0303-S3N
AFIN: 47-00461**

FTN No. R14590-2796-001

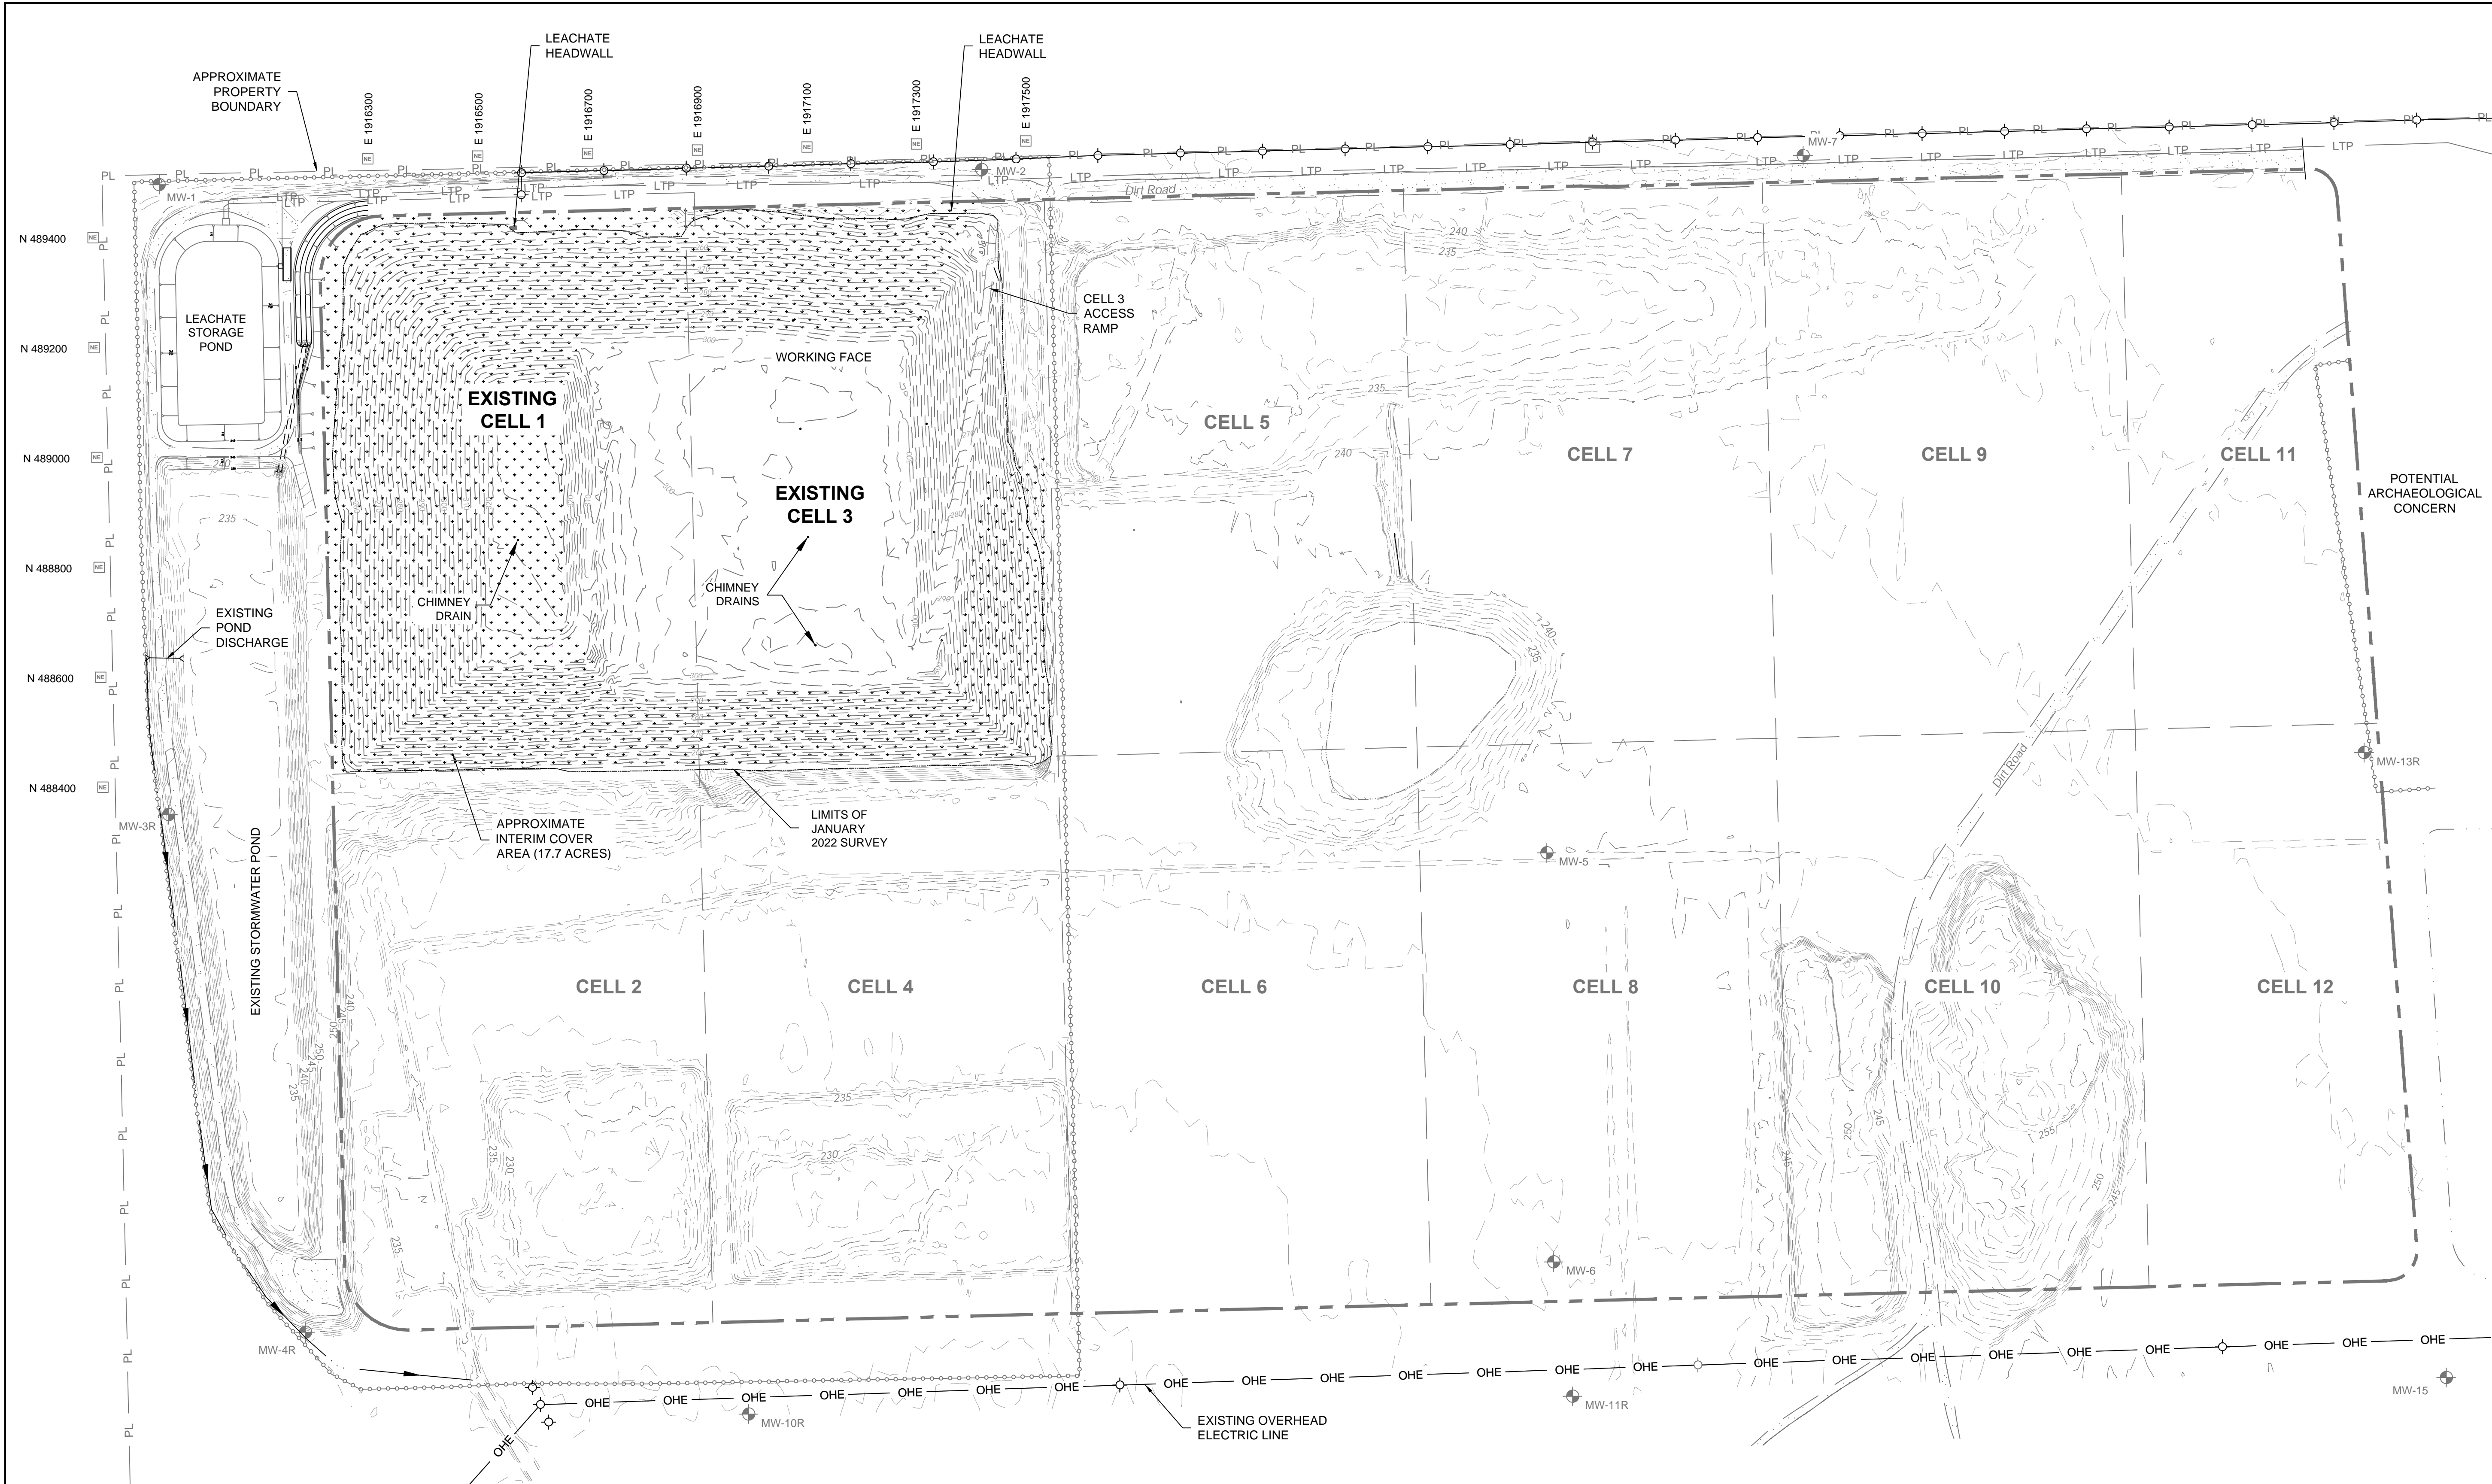
FIGURE 2
EXISTING CONDITIONS

As noted, no final cover system has been installed on Waste Cells 1 and 3. Figure 3 presents contours for the currently permitted final cover system.

Both active cells remain open. Interim cover soil has been placed, as noted, on all of Cell 1 except for the east slope into Cell 3 and on Cell 3 as noted above.

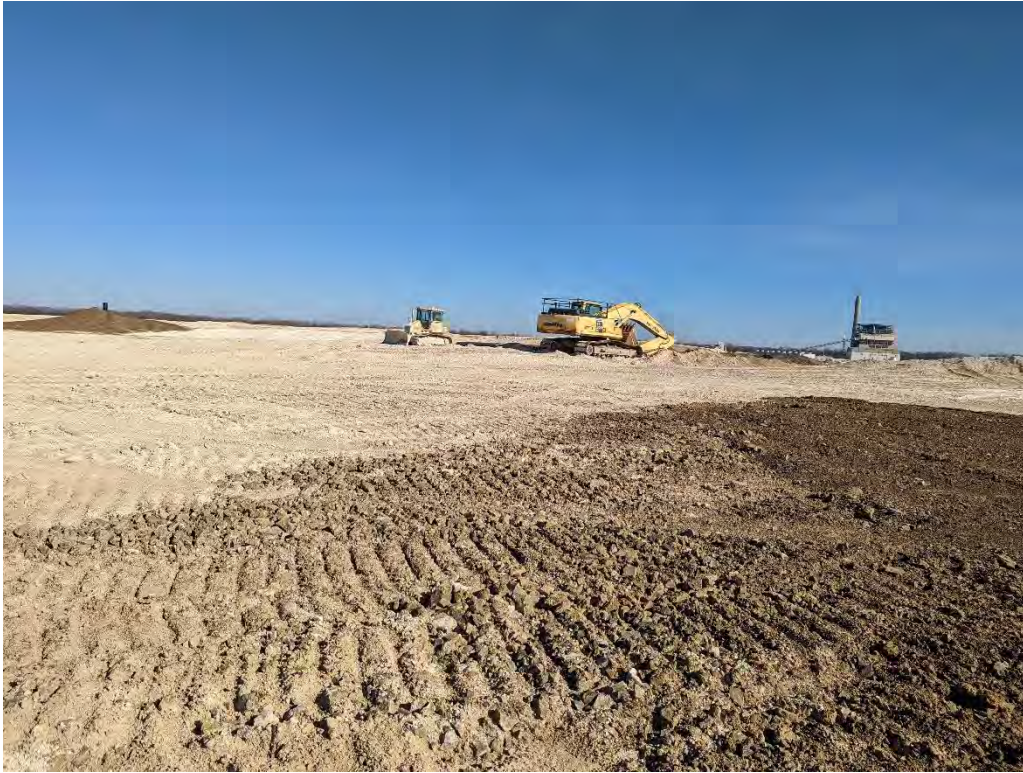
Photo 1. Active working area (Cell 3)

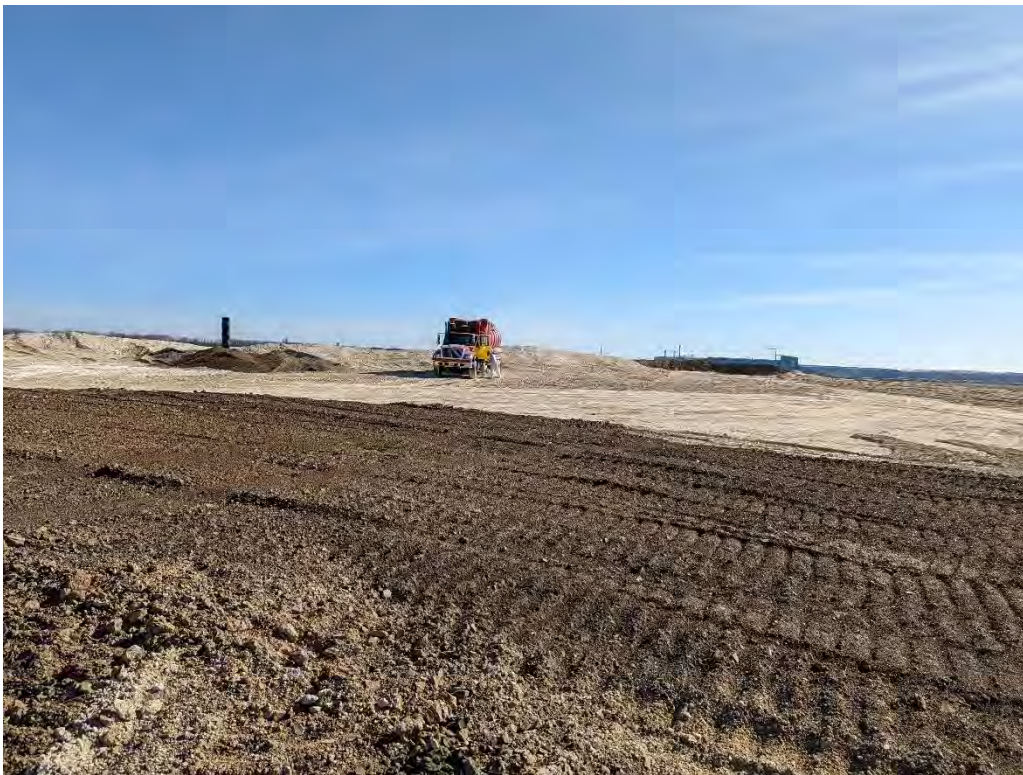
Photo 2. Water truck prepared to water active area (Cell 3).

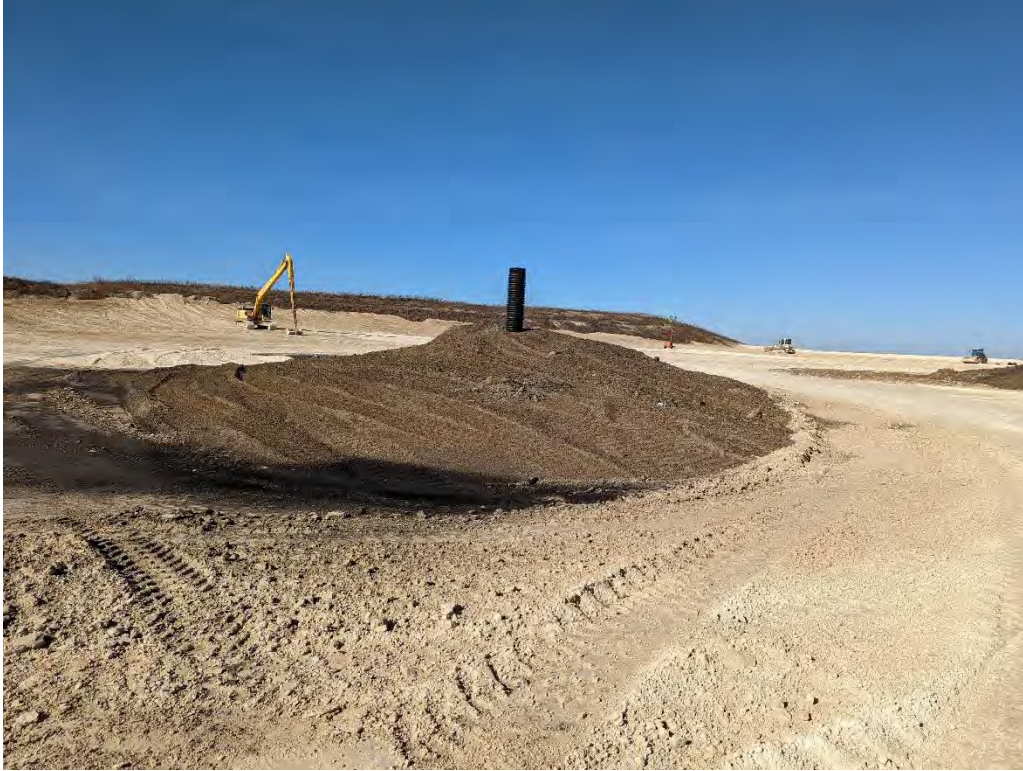
Photo 3. Active working face with chimney drain in foreground. (Cell 3).

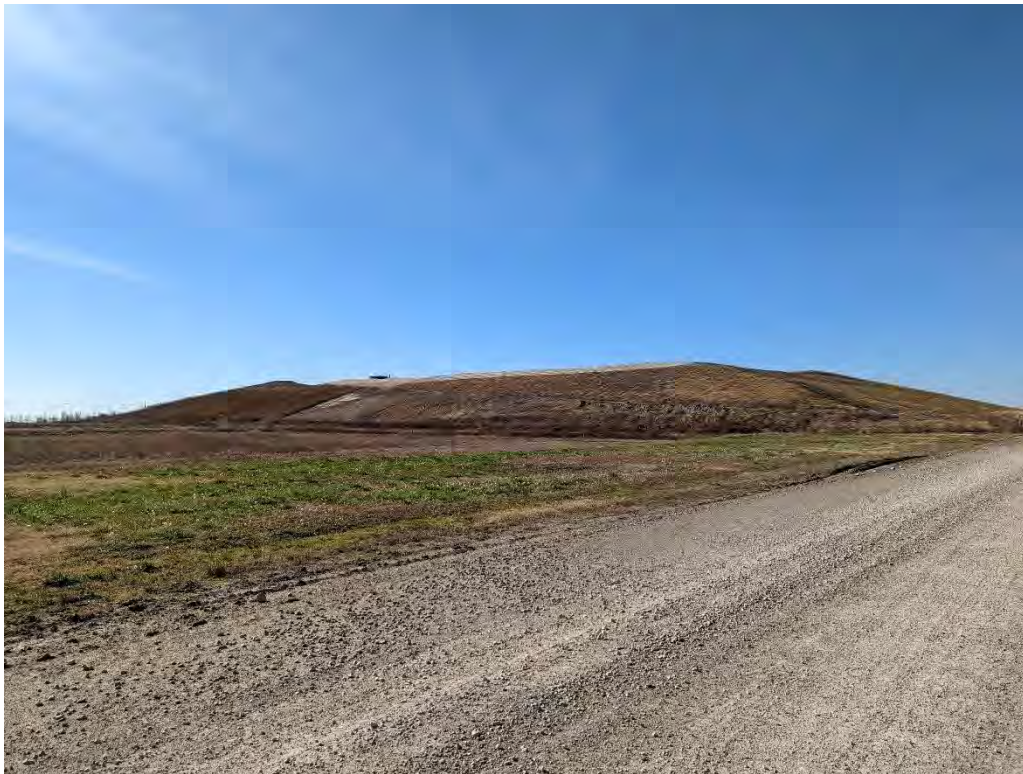
Photo 4. Haul road to landfill from East.

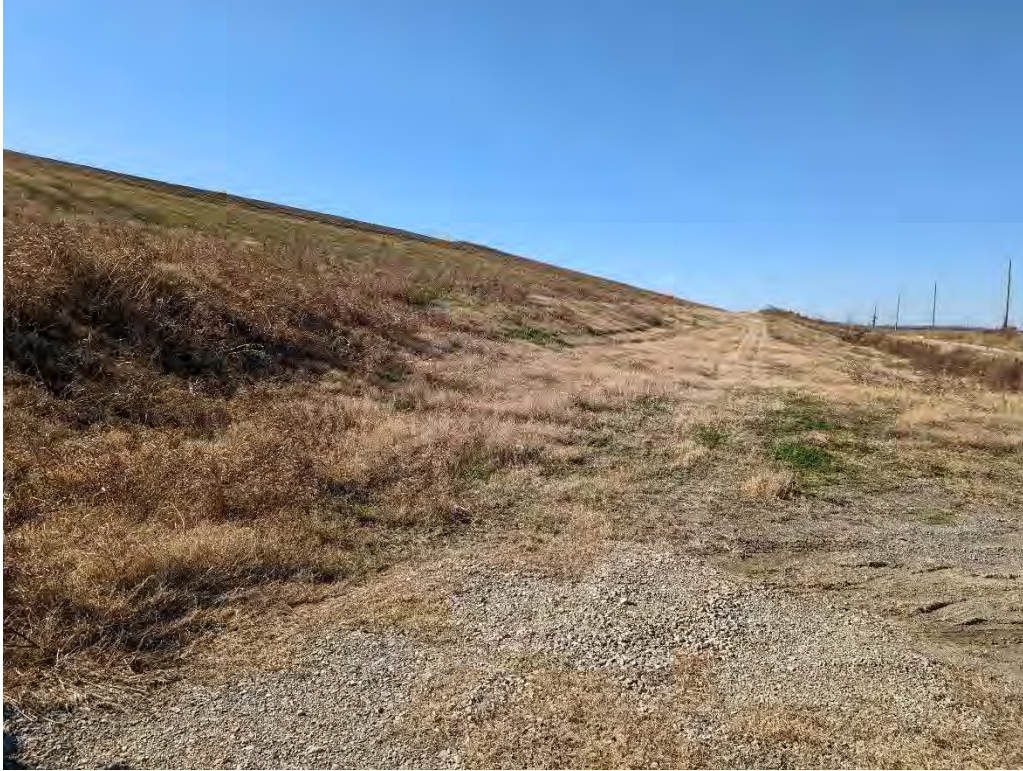
Photo 5. Cell 3 north slope interim cover.

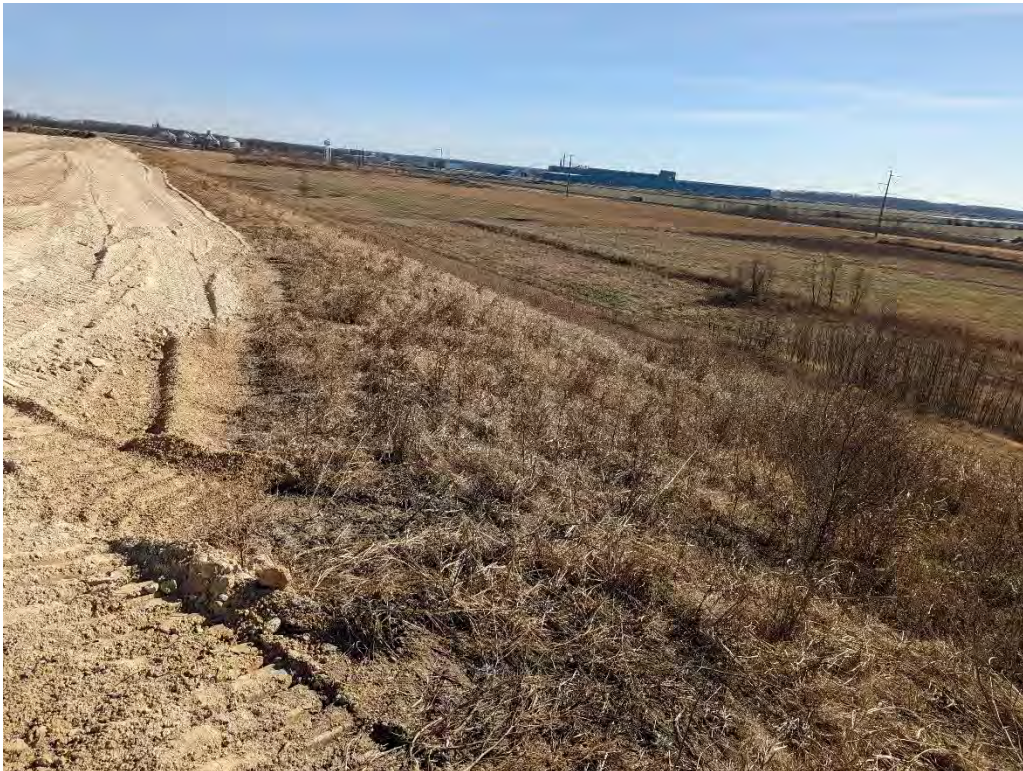
Photo 6. Cell 3 south slope interim cover.

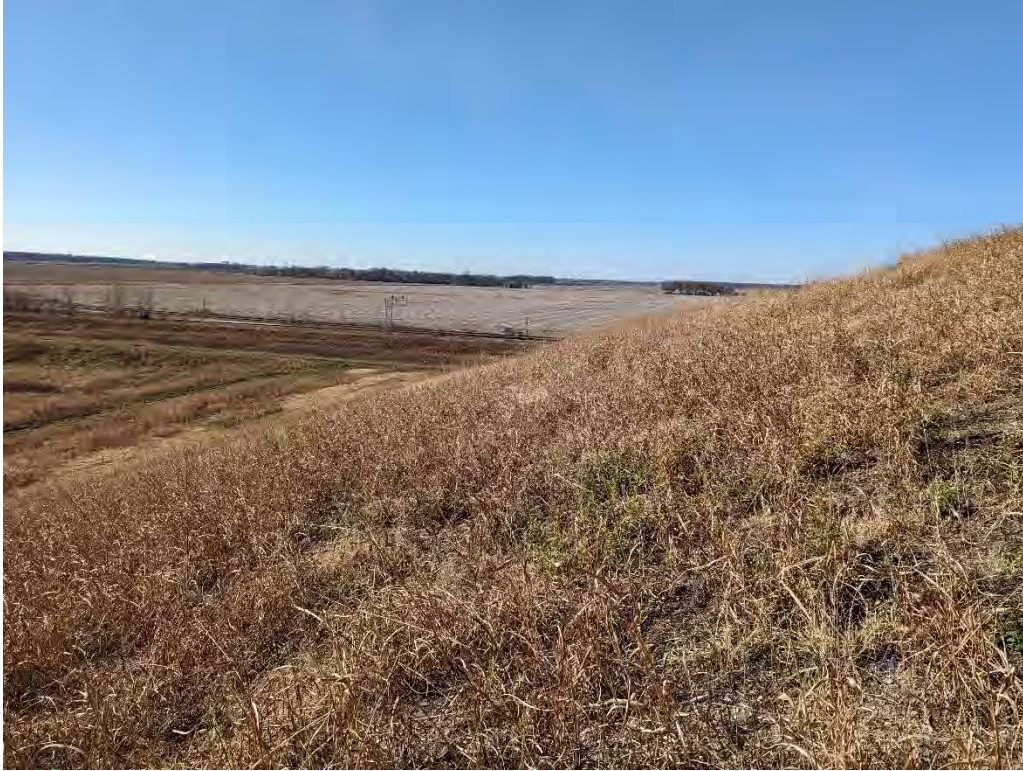
Photo 7. Cell 1 looking Southwest

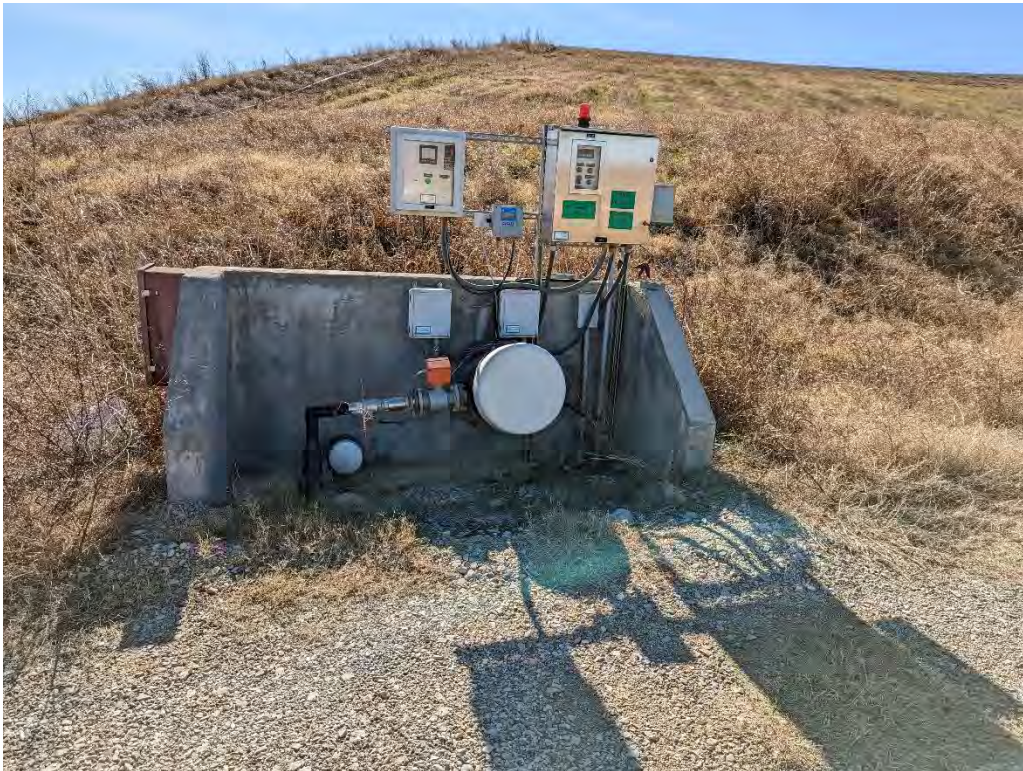
Photo 8. Typical Leachate Collection and Monitoring System

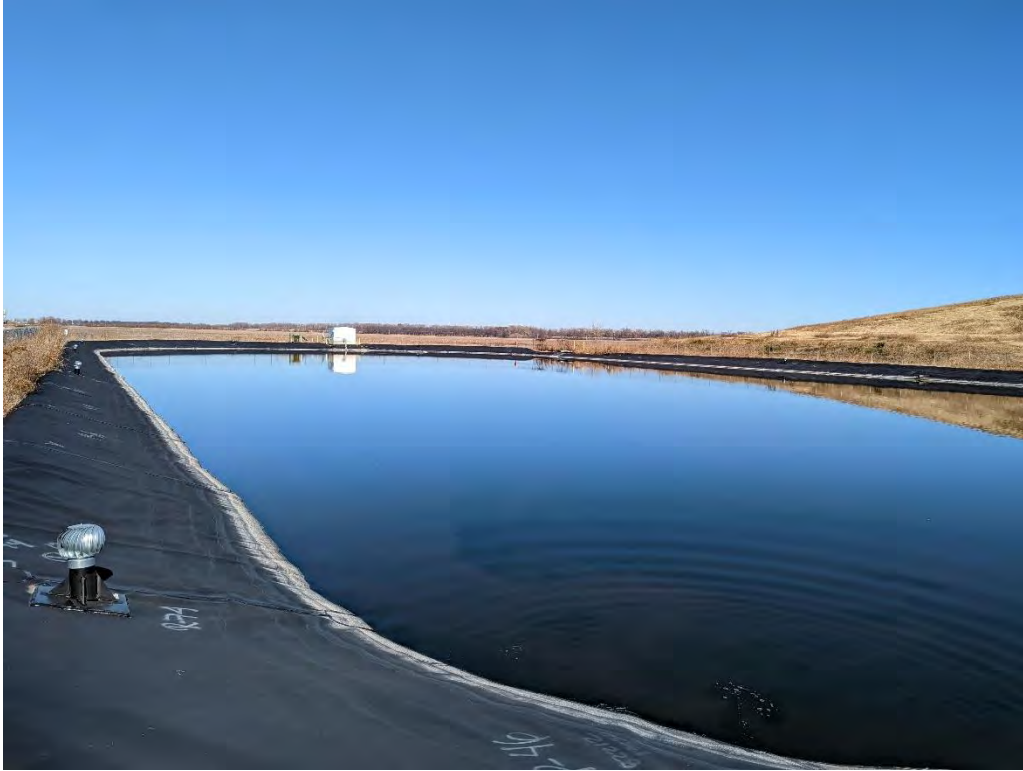
Photo 9. Leachate Pond from southwest

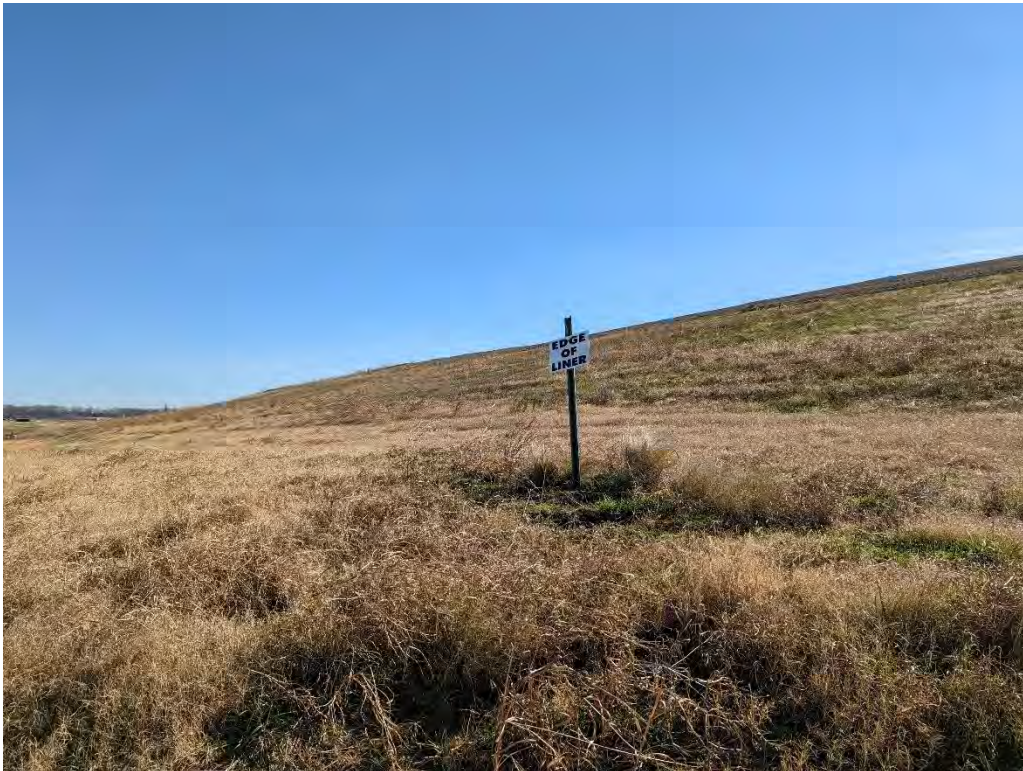
Photo 10. Side slope interim cover with edge of liner sign in foreground
