# **2025 ANNUAL ENGINEERING INSPECTION REPORT**

## **PLUM POINT ENERGY STATION CLASS 3N LANDFILL**

**PERMIT NO. 0303-S3N-R2  
AFIN: 47-00461**

Olsson Project No. 025-06500

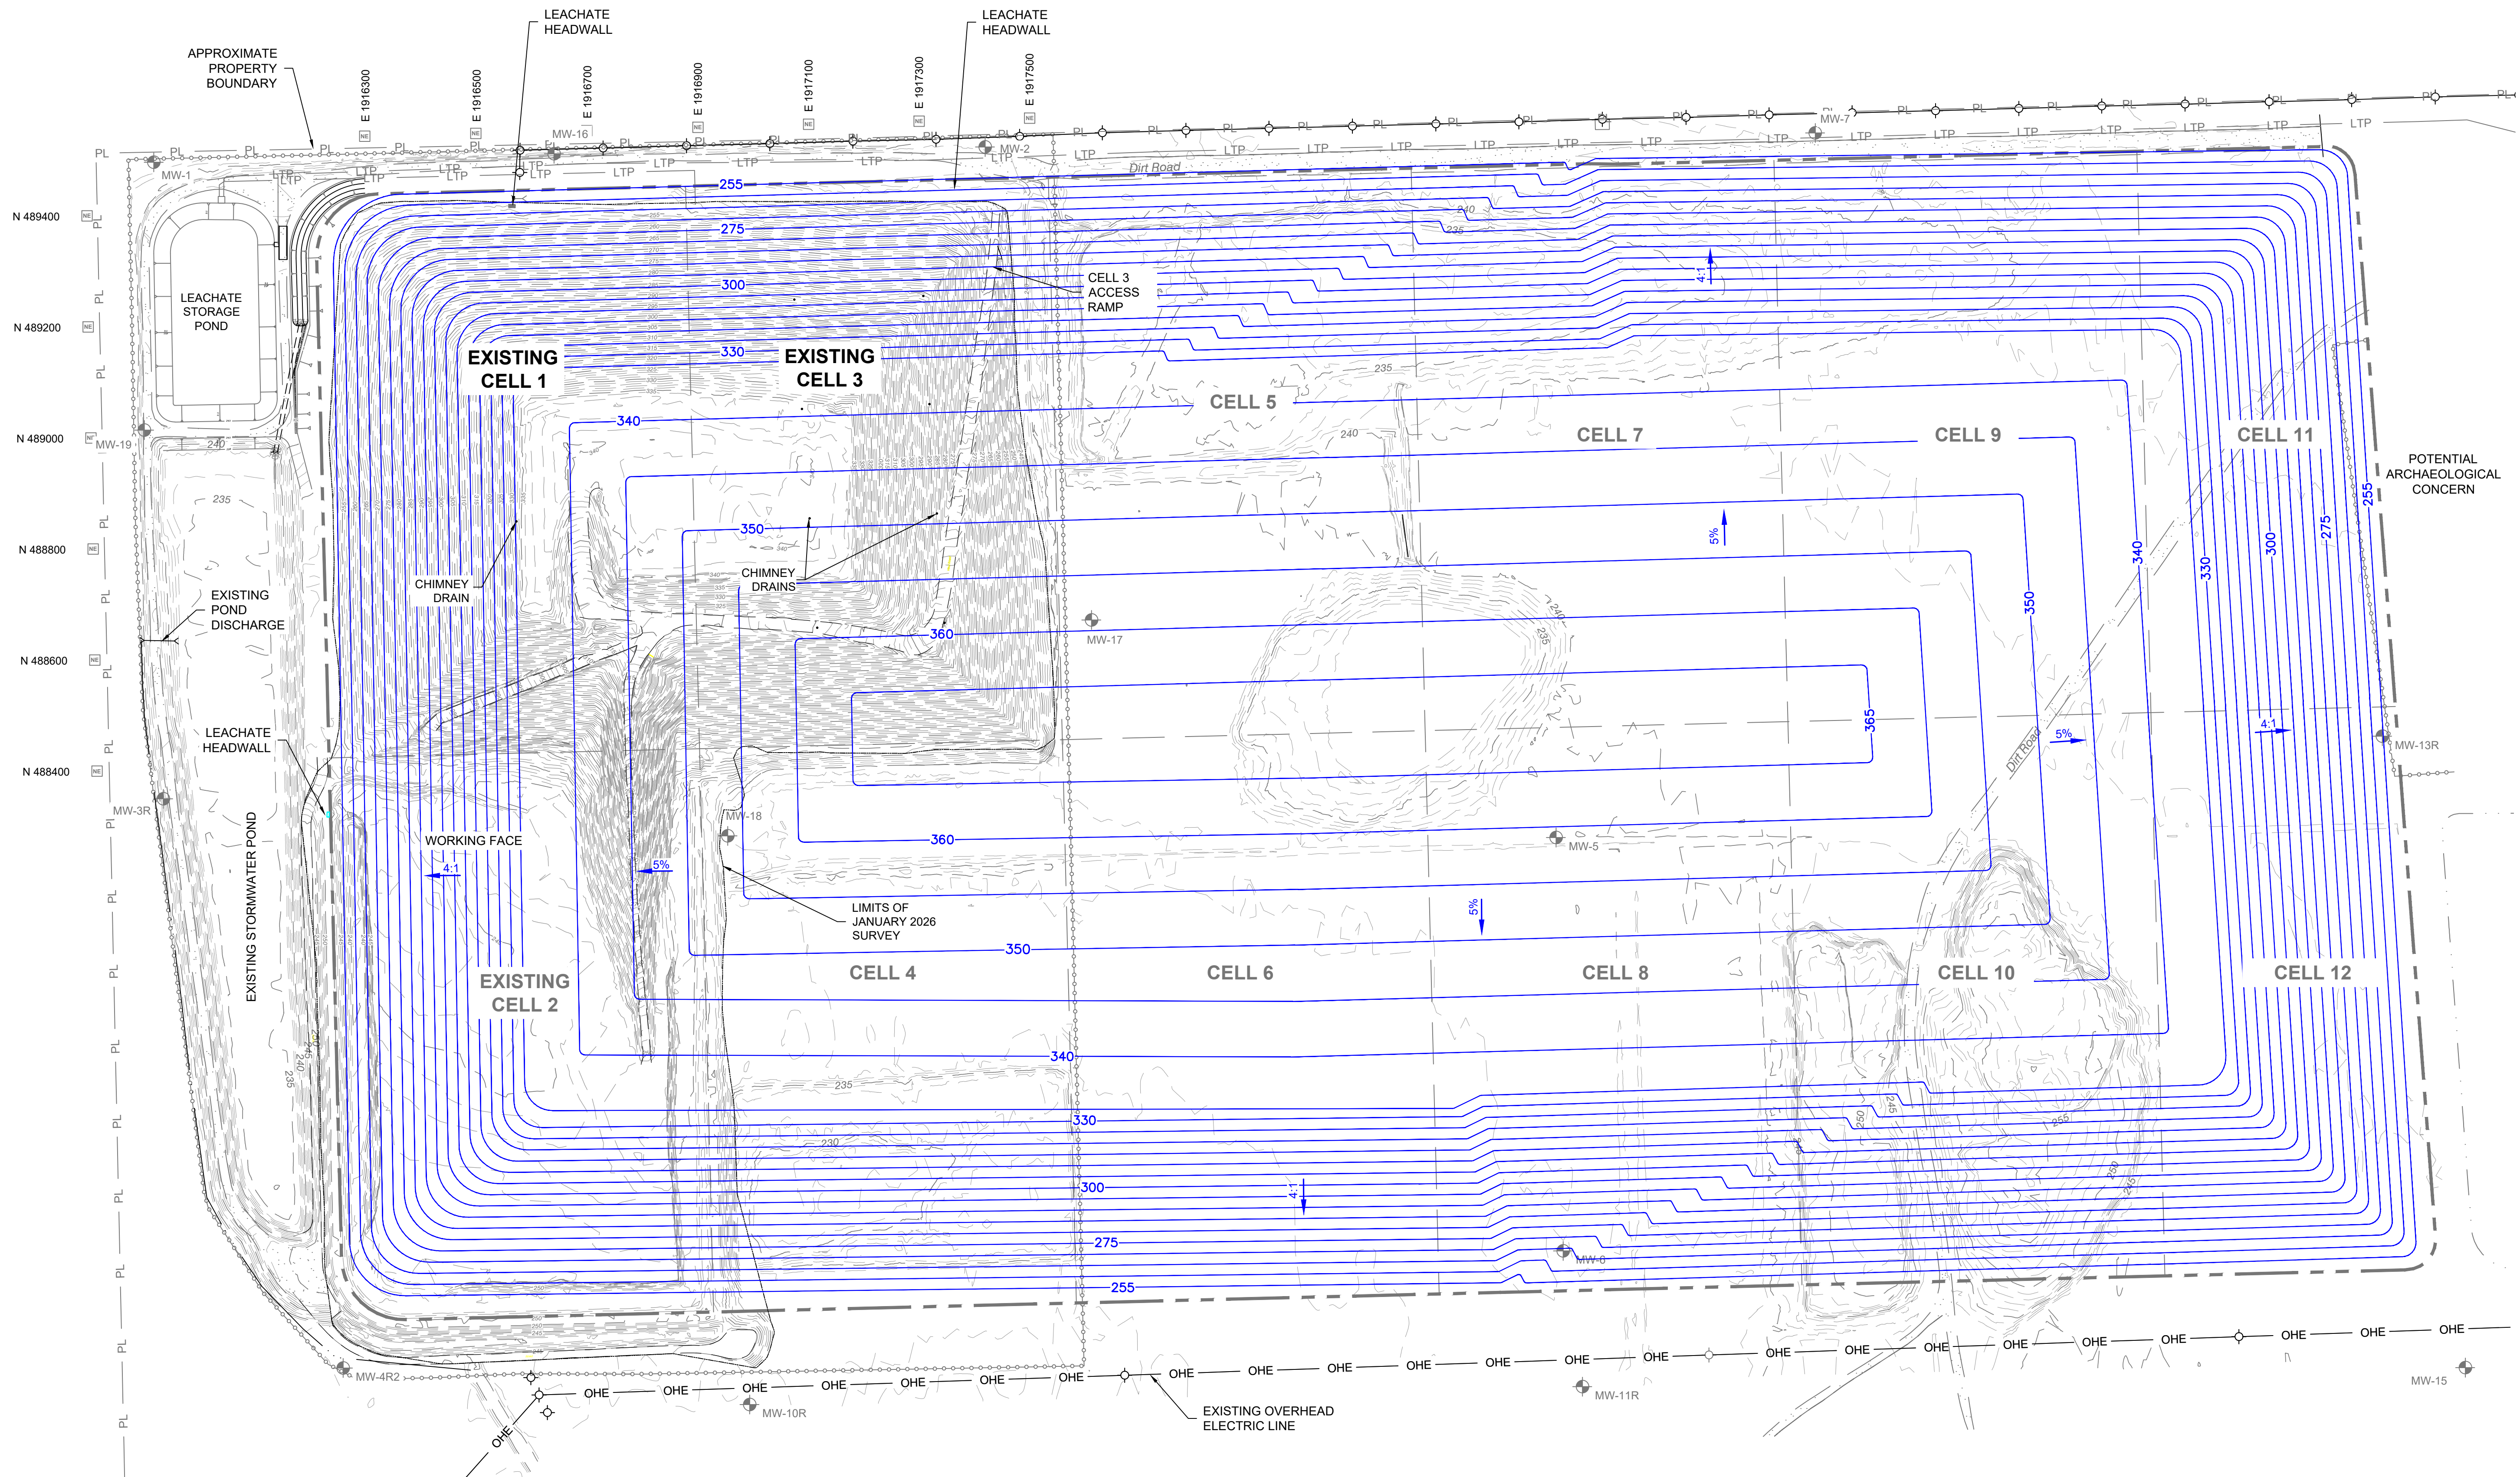
As noted, no final cover system has been installed on Cells 1, 2 or 3. Figure 3 presents contours for the currently permitted final cover system.

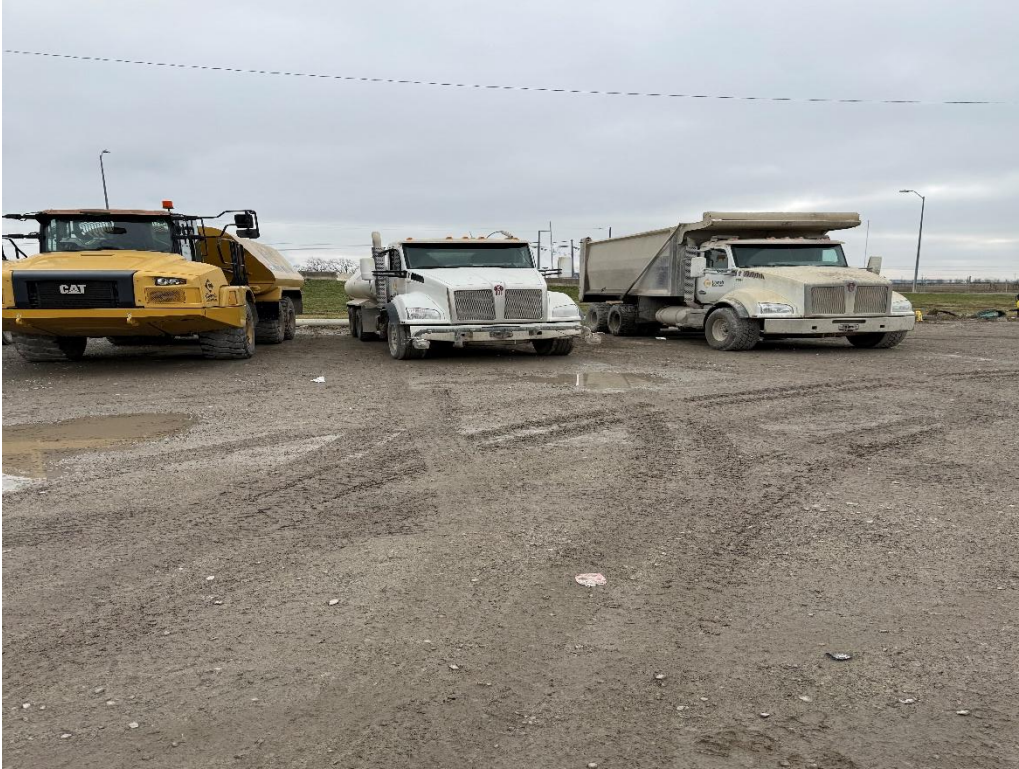
Photo 1. Water truck staged in shop parking lot.

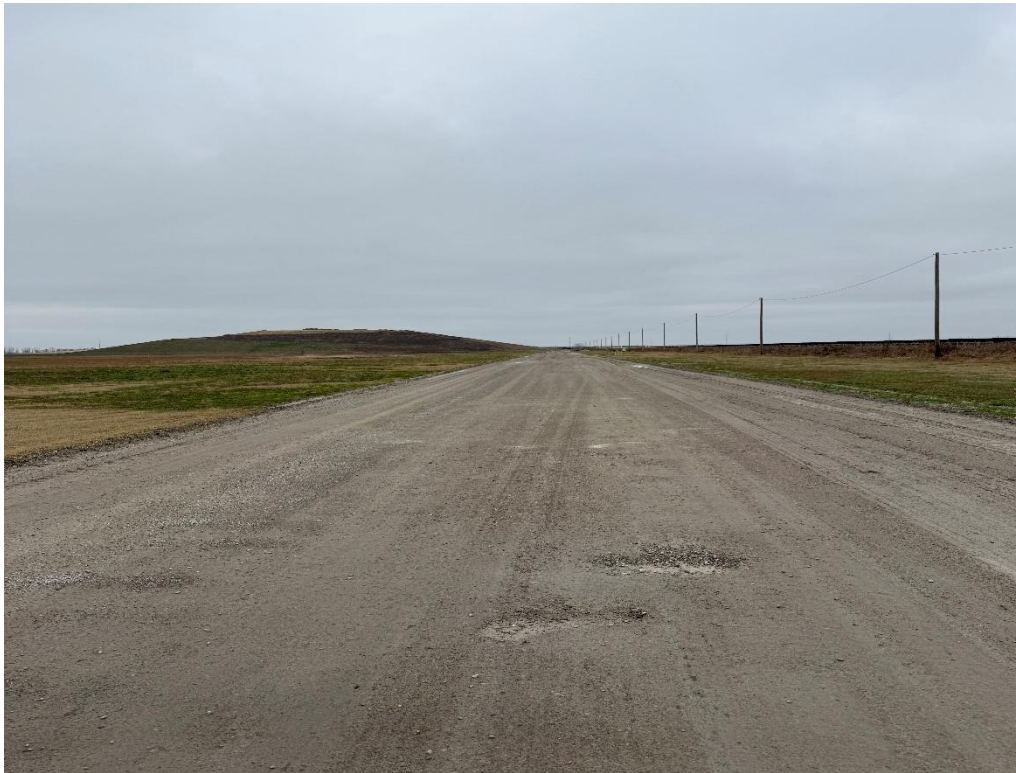
Photo 2. Main haul road to landfill looking West with landfill in the

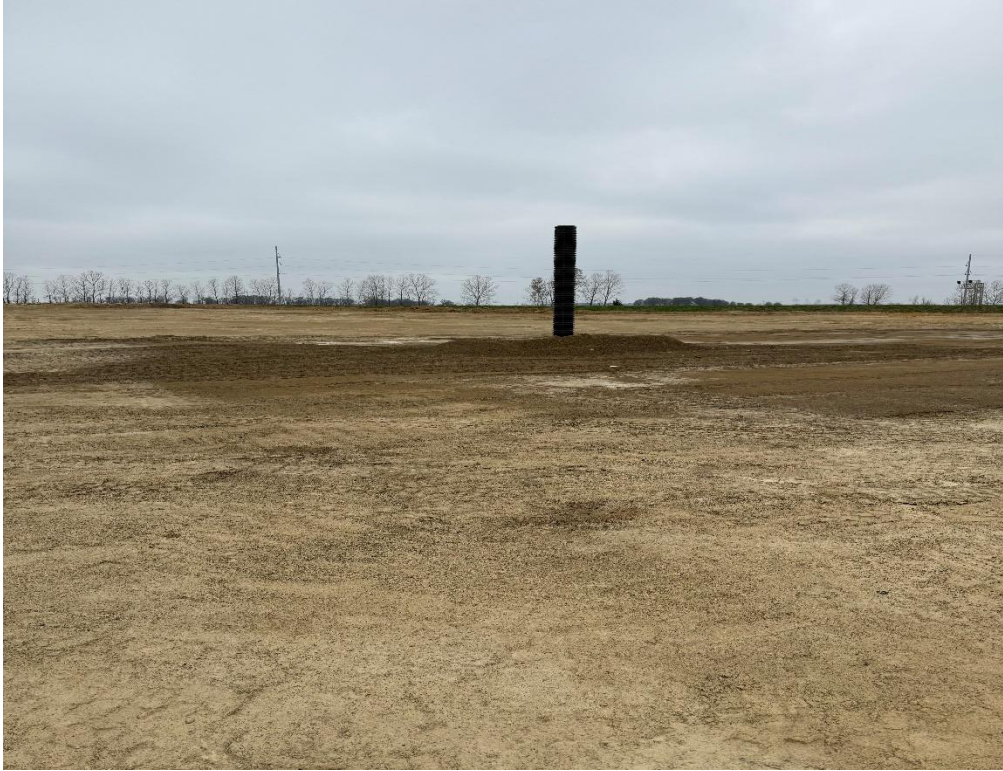
Photo 3. Active working face, bottom ash with chimney drain looking West (Cell 2).

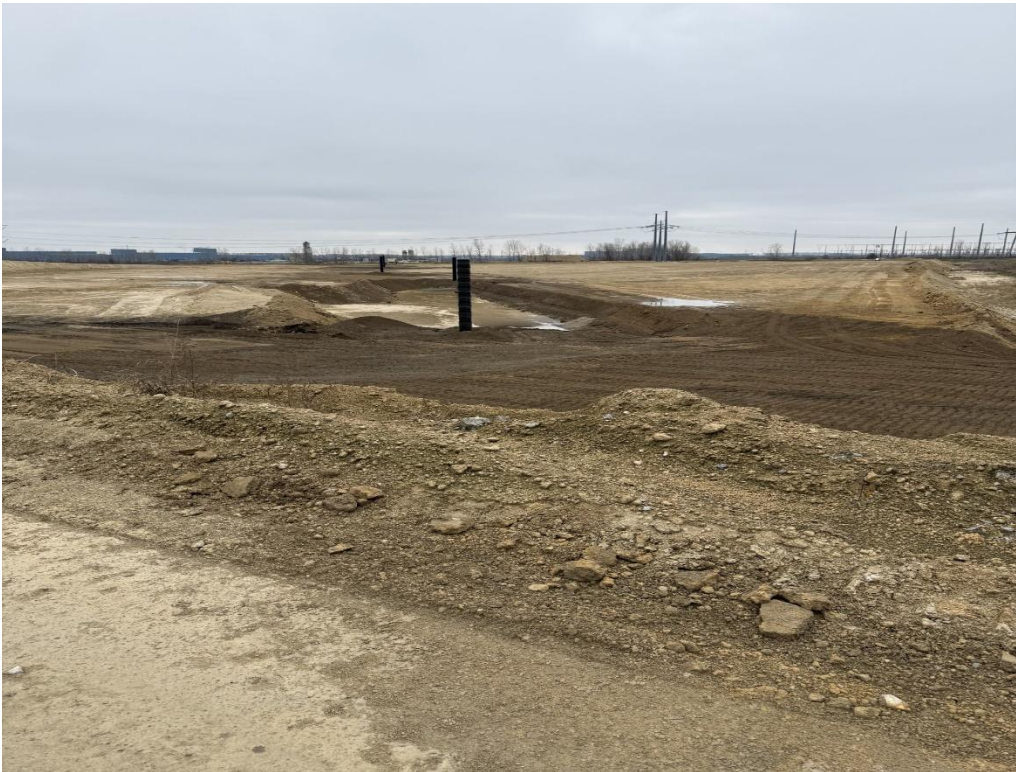
Photo 4. Open disposal area, Cell 2.

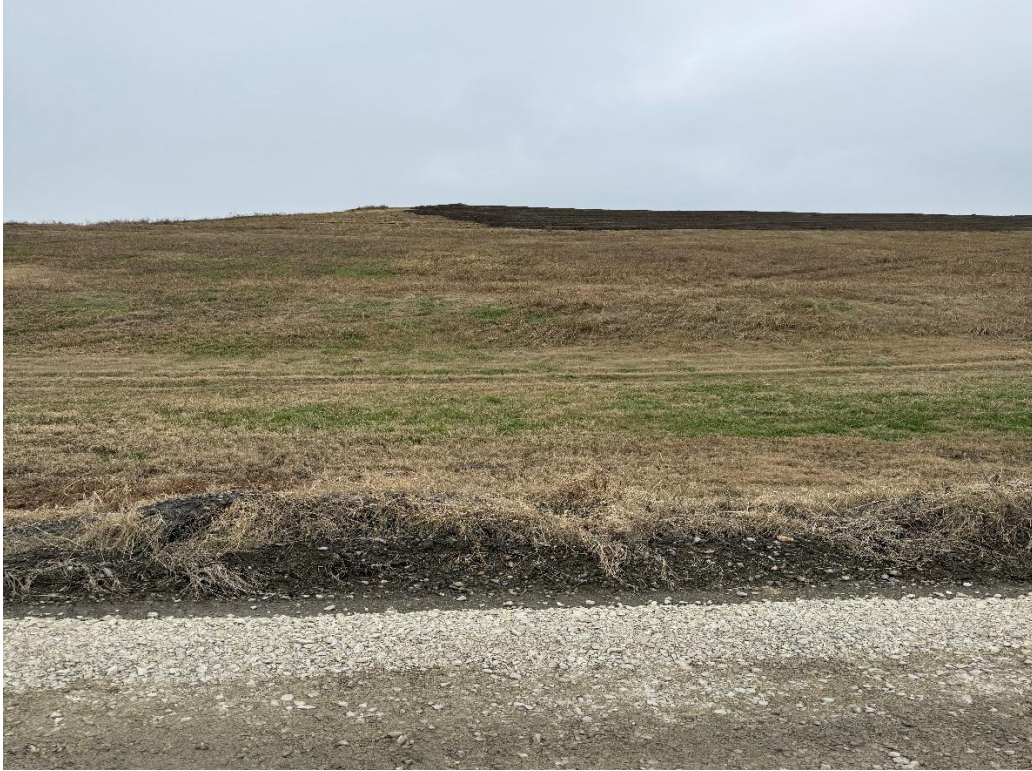
Photo 5. Typical perimeter side slope intermediate cover and vegetation.
