**NRG TEXAS POWER LLC
W. A. PARISH GENERATING STATION, UNITS 5, 6, 7, & 8**

**ANNUAL INSPECTION OF CCR LANDFILL CELLS
SUPPORTING DOCUMENT**

S&L Project No.: 12661-073

Date: January 12, 2018

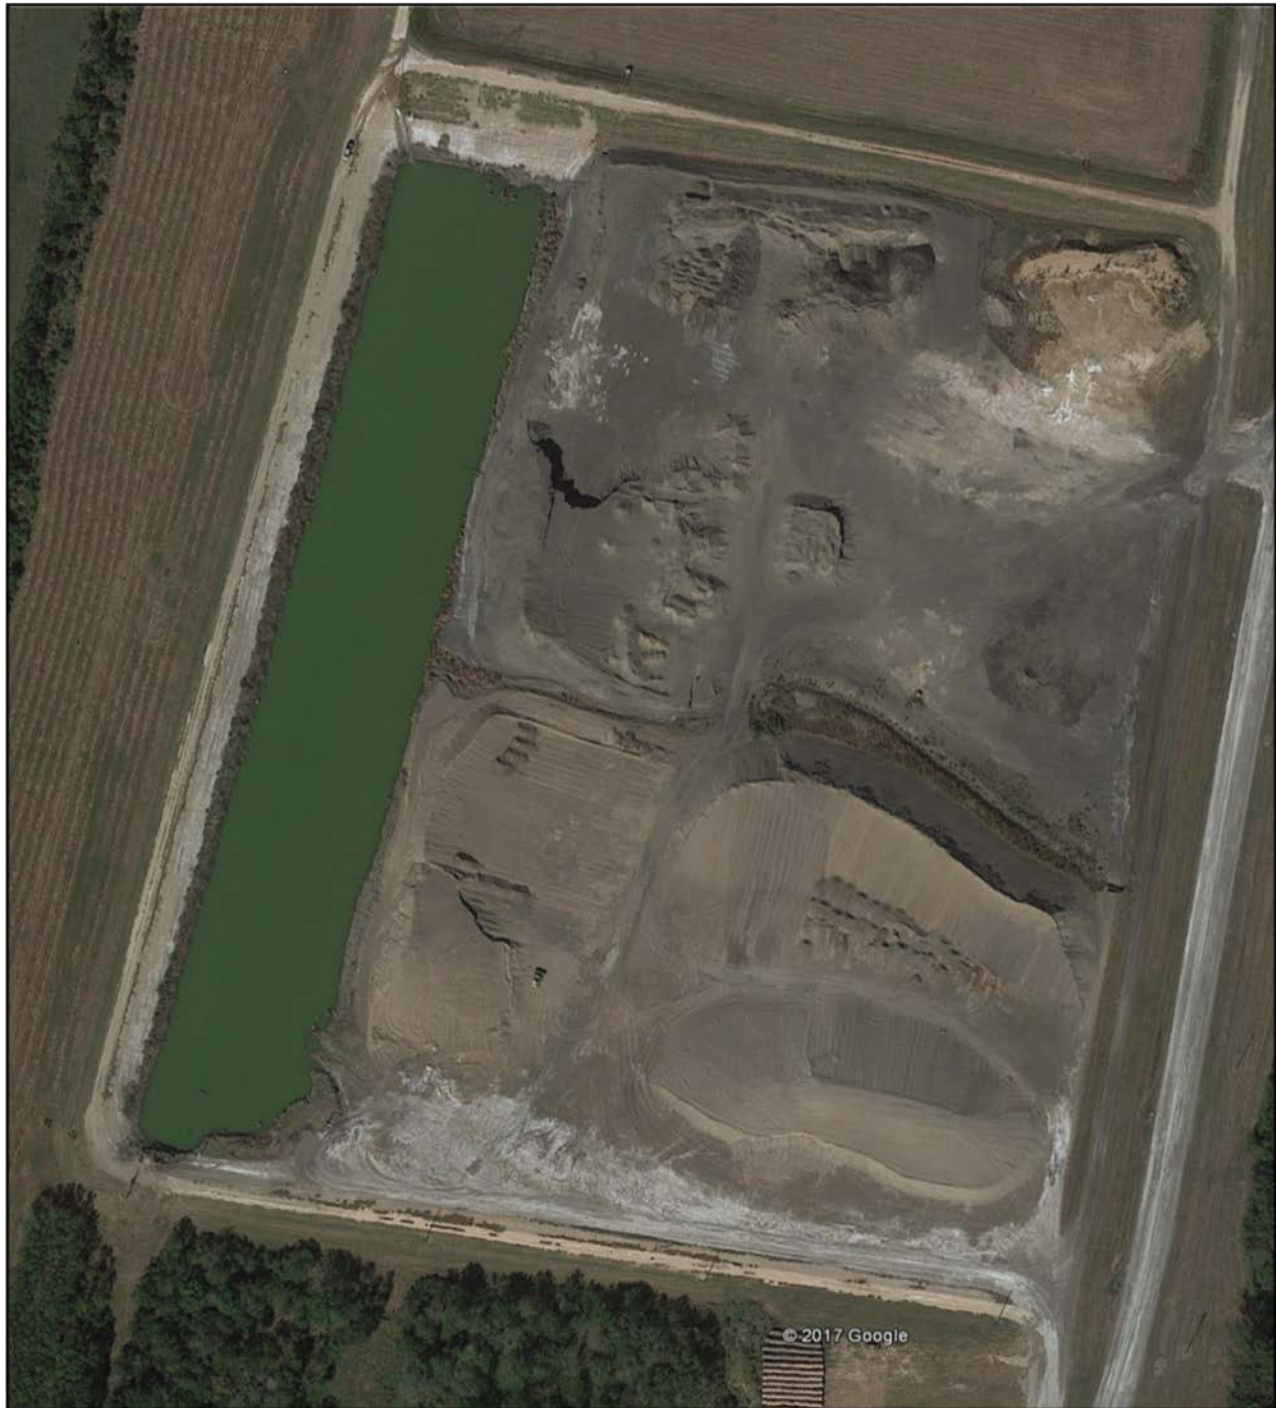
Photograph P-1 – From Google Earth Pro, dated October 28, 2017.
Downloaded December 26, 2017.
Landfill Cell 3: Aerial view of landfill cell and
storm water runoff pond inside western edge of cell.

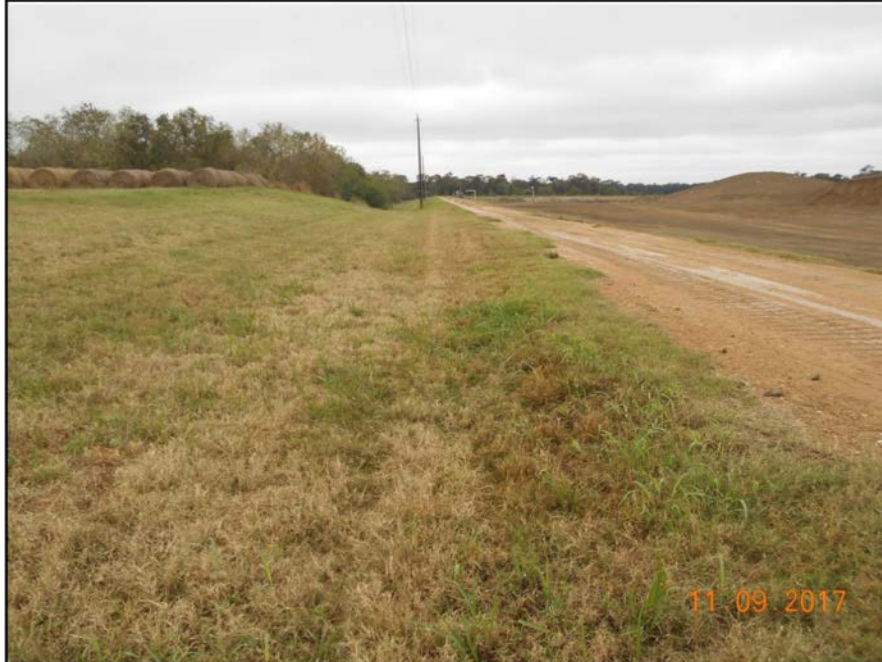
Photograph P-2 – Taken November 9, 2017 by David E. Nielson
Landfill Cell 3: Looking west along the crest and outside slope of the south landfill berm.
Note the well-established vegetation.

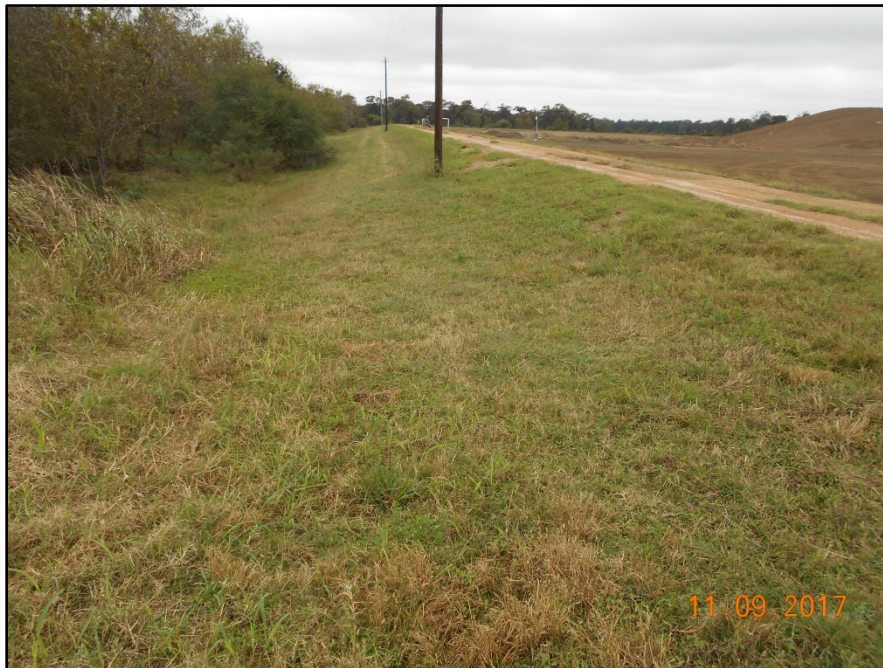
Photograph P-3 – Taken November 9, 2017 by David E. Nielson
Landfill Cell 3: Looking west along the crest and outside slope of the south landfill berm
Note the good vegetation.

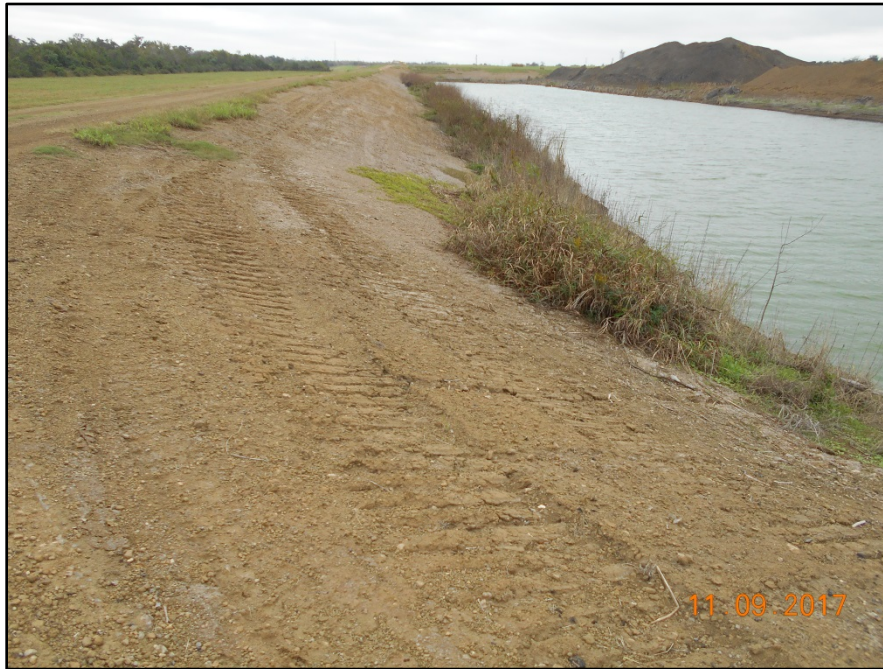
Photograph P-4 – Taken November 9, 2017 by David E. Nielson
Landfill Cell 3: Looking north along the west berm adjacent to the incised storm water pond in Cell 3.

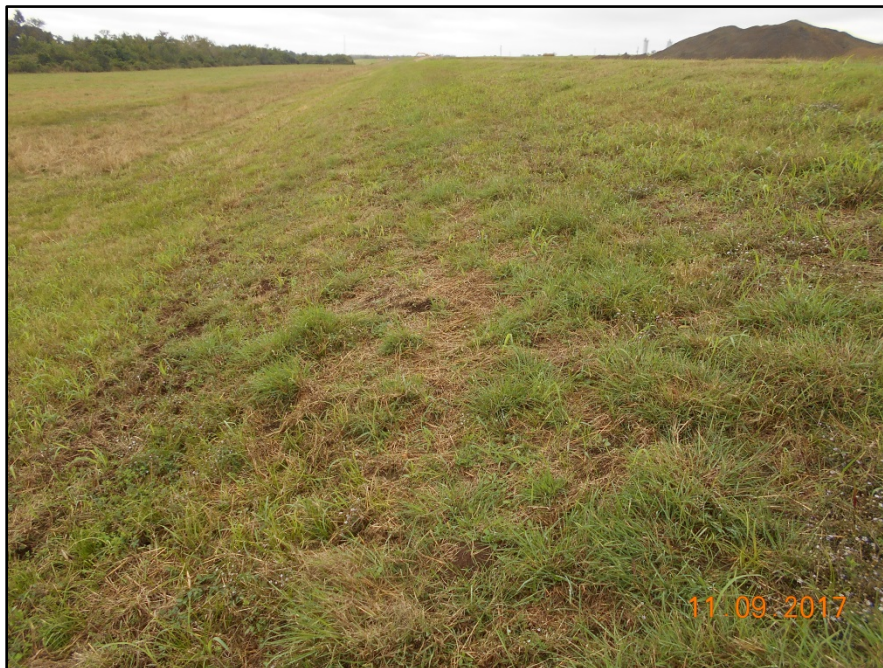
Photograph P-5 – Taken November 9, 2017 by David E. Nielson
Landfill Cell 3: Looking north along the outside slope of the western berm of landfill cell in vicinity of incised storm water pond.

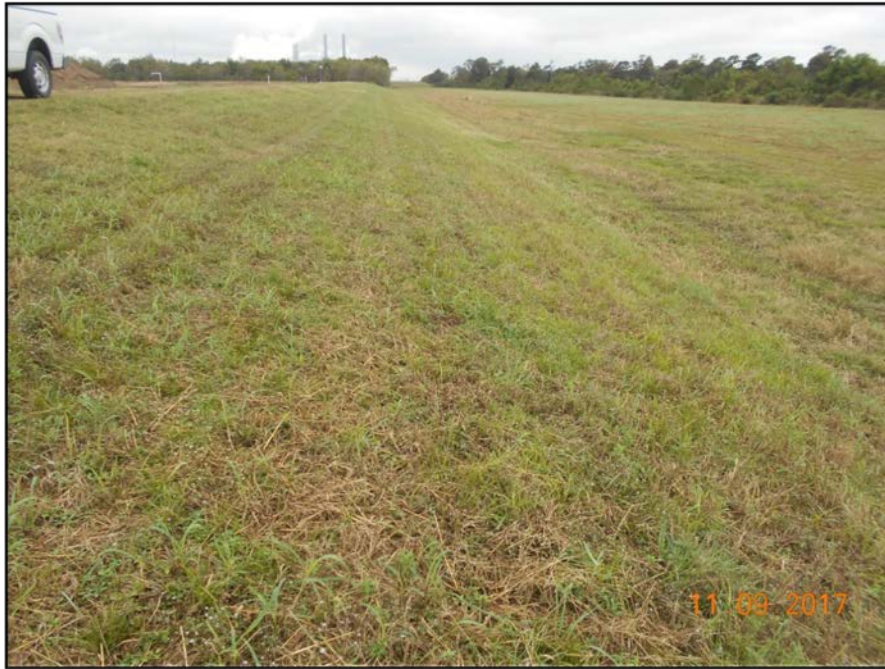
Photograph P-6 – Taken November 9, 2017 by David E. Nielson
Landfill Cell 3: Looking south along outside slope of western berm of landfill in vicinity of the incised storm water pond.
Note good vegetation.

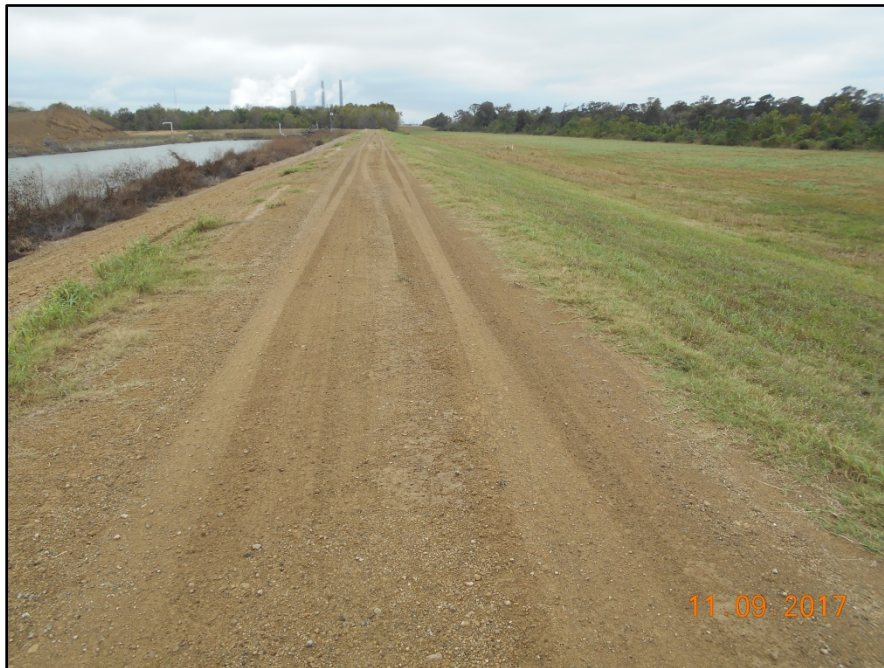
Photograph P-7 – Taken November 9, 2017 by David E. Nielson
Landfill Cell 3: Looking south along crest of the western berm of the landfill cell in vicinity of incised storm water pond.

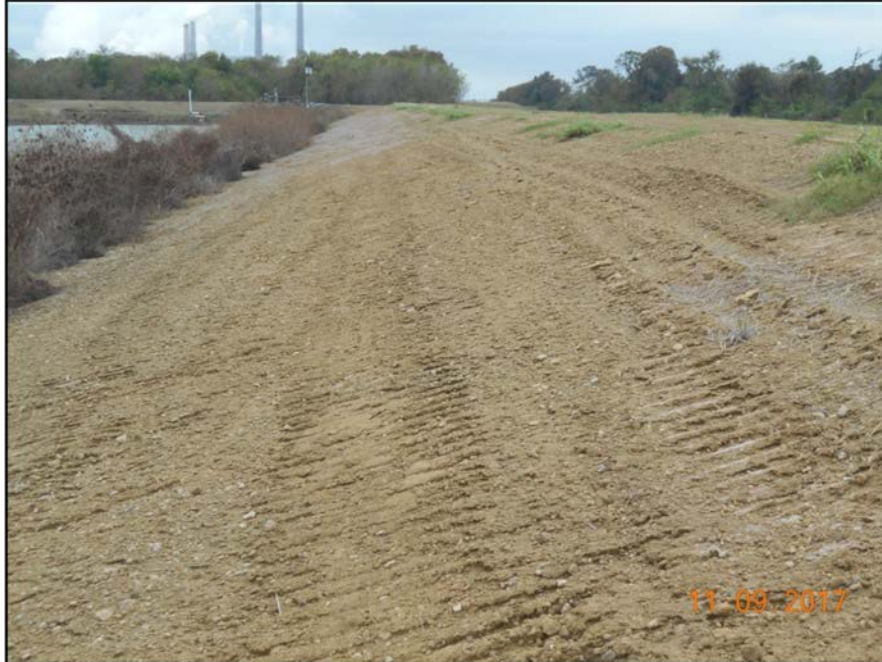
Photograph P-8 – Taken November 9, 2017 by David E. Nielson
Landfill Cell 3: Looking south along inside slope of western berm of landfill cell in vicinity of incised storm water pond. Note this area that does not support vegetation is surfaced with stabilized material to control erosion. Also see Photograph 50.

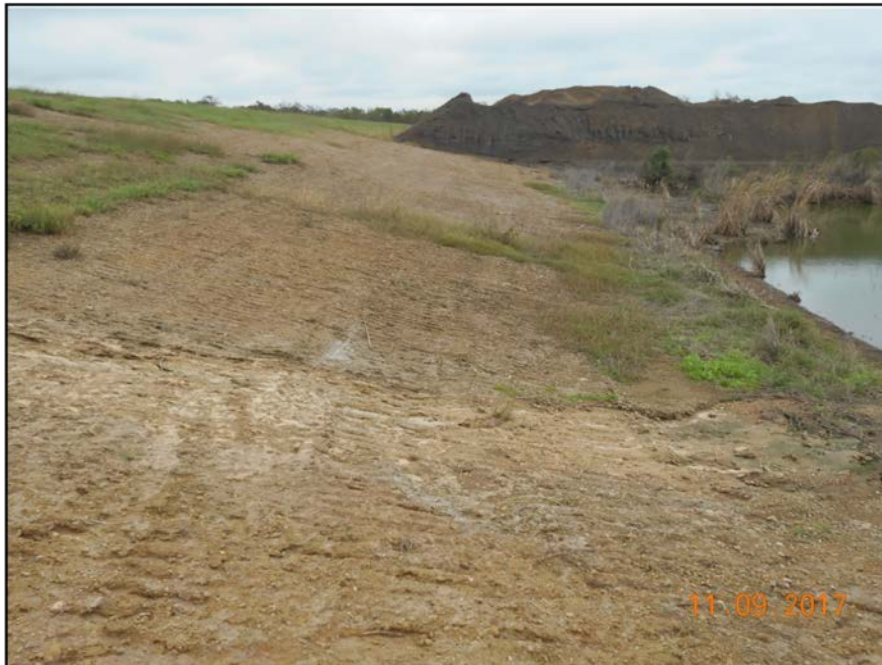
Photograph P-9 – Taken November 9, 2017 by David E. Nielson
Landfill Cell 3: Looking east along inside slope of northern edge of pond, and at the interface of the ash storage area and the storm water pond, which is incised.

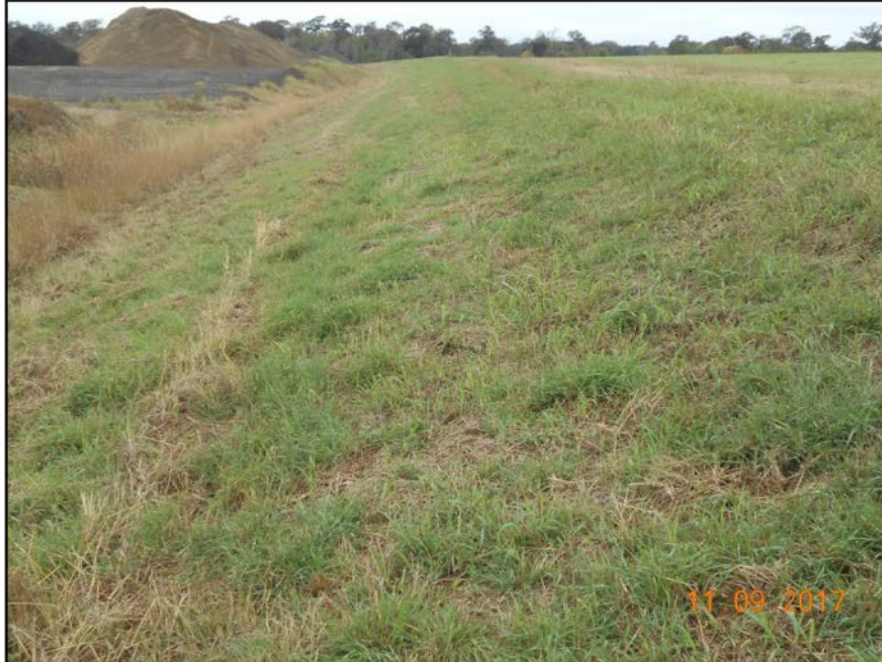
Photograph P-10 – Taken November 9, 2017 by David E. Nielson
Landfill Cell 3: Looking west along inside slope of northern berm of the landfill.
Note the good vegetation.

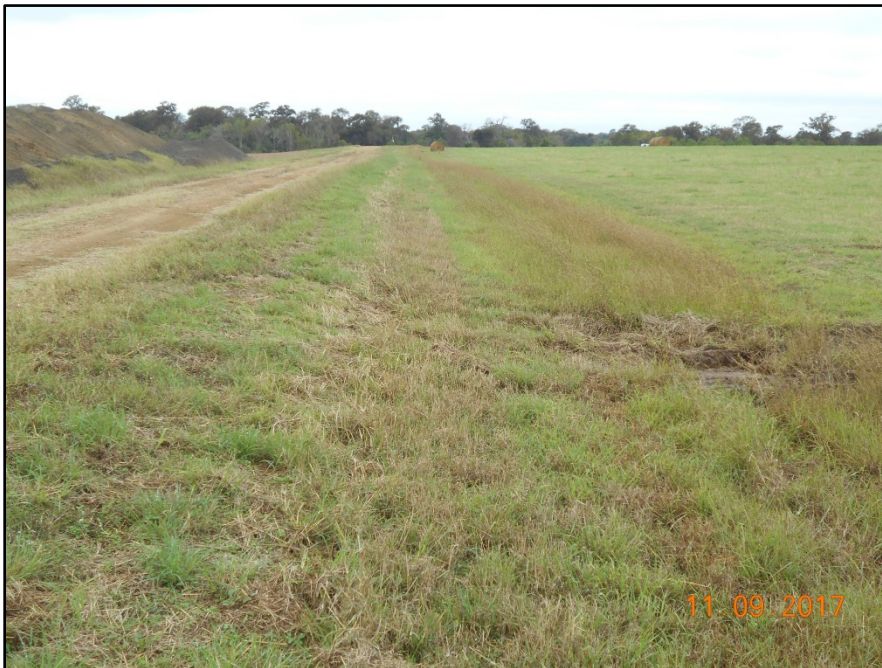
Photograph P-11 – Taken November 9, 2017 by David E. Nielson
Landfill Cell 3: Looking west along the outside slope of the northern landfill berm.

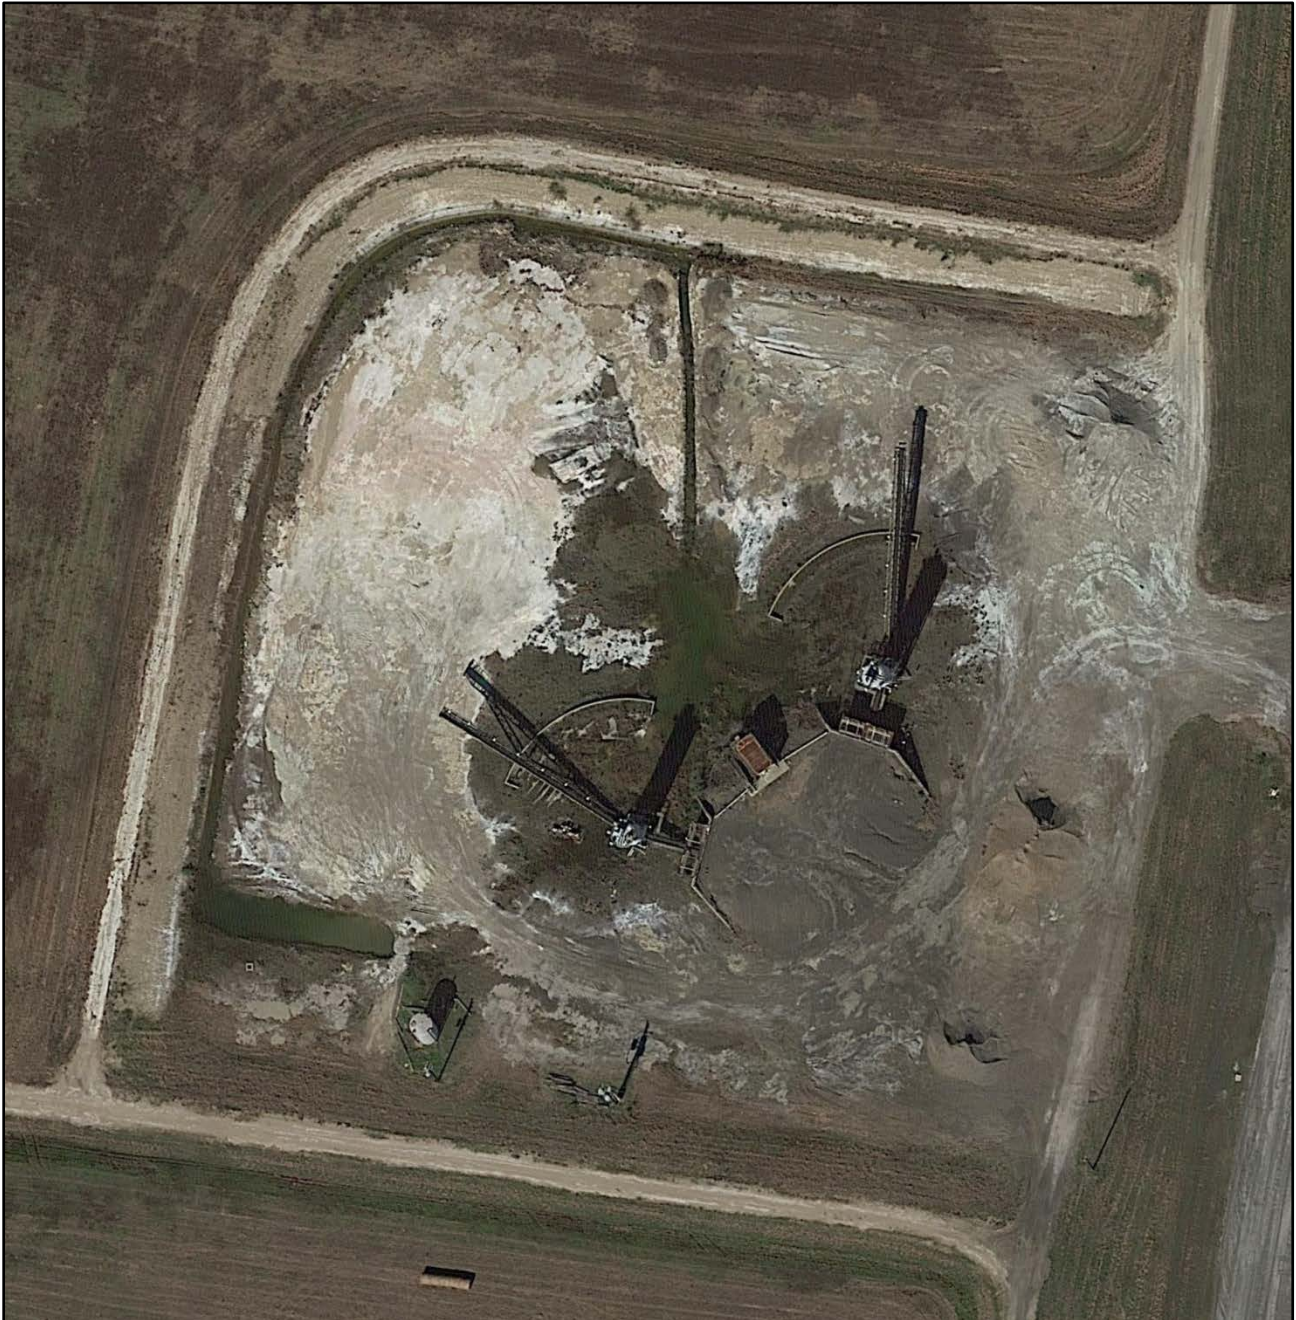
Photograph P-12 – From Google Earth Pro, dated October 28, 2017.
Downloaded December 26, 2017.

Landfill Cell 2A: Aerial view of open area of cell,
which contains a pugmill to stabilize CCR materials for disposal in other cells.
The closed portions of Cell 2A are north and west of the active area.

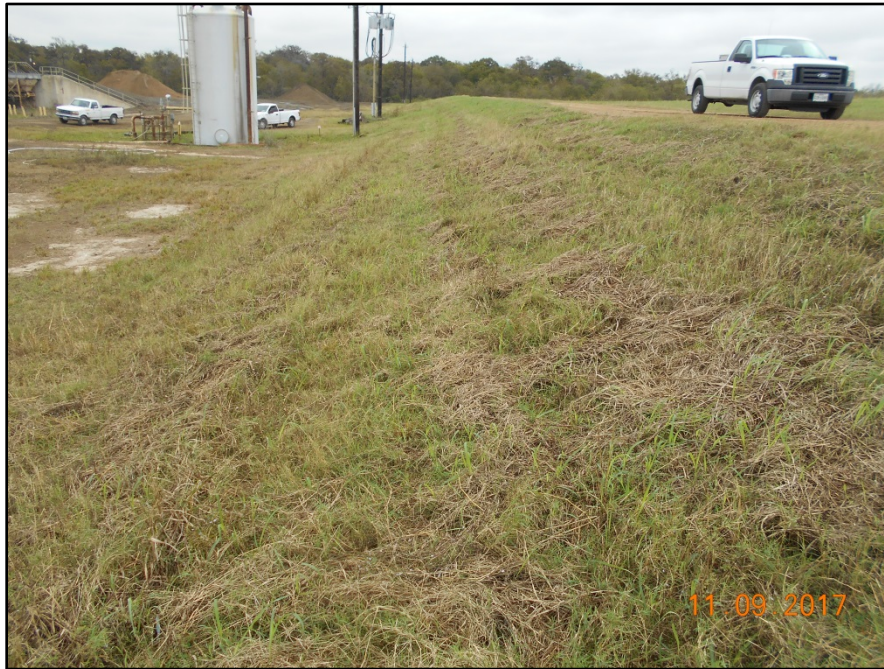
Photograph P-13 – Taken November 9, 2017 by David E. Nielson
Landfill Cell 2A: Looking east along the inside slope of the southern berm.
This berm abuts closed Cell 1B, which is higher in elevation.
Note well established grass and uniformity of slope.

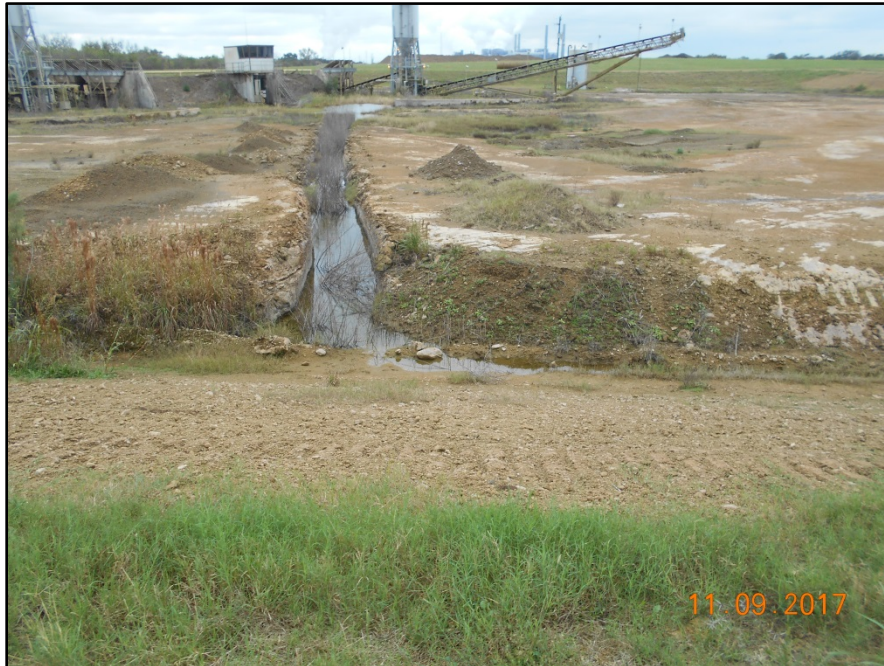
Photograph P-21 – Taken November 9, 2017 by David E. Nielson
Landfill Cell 2A: Looking south into the active portion of Cell 2A along a vertical wall ditch cut in the stabilized material that has cured in place. These vertical walls demonstrate the long-term properties of these stabilized CCR materials.

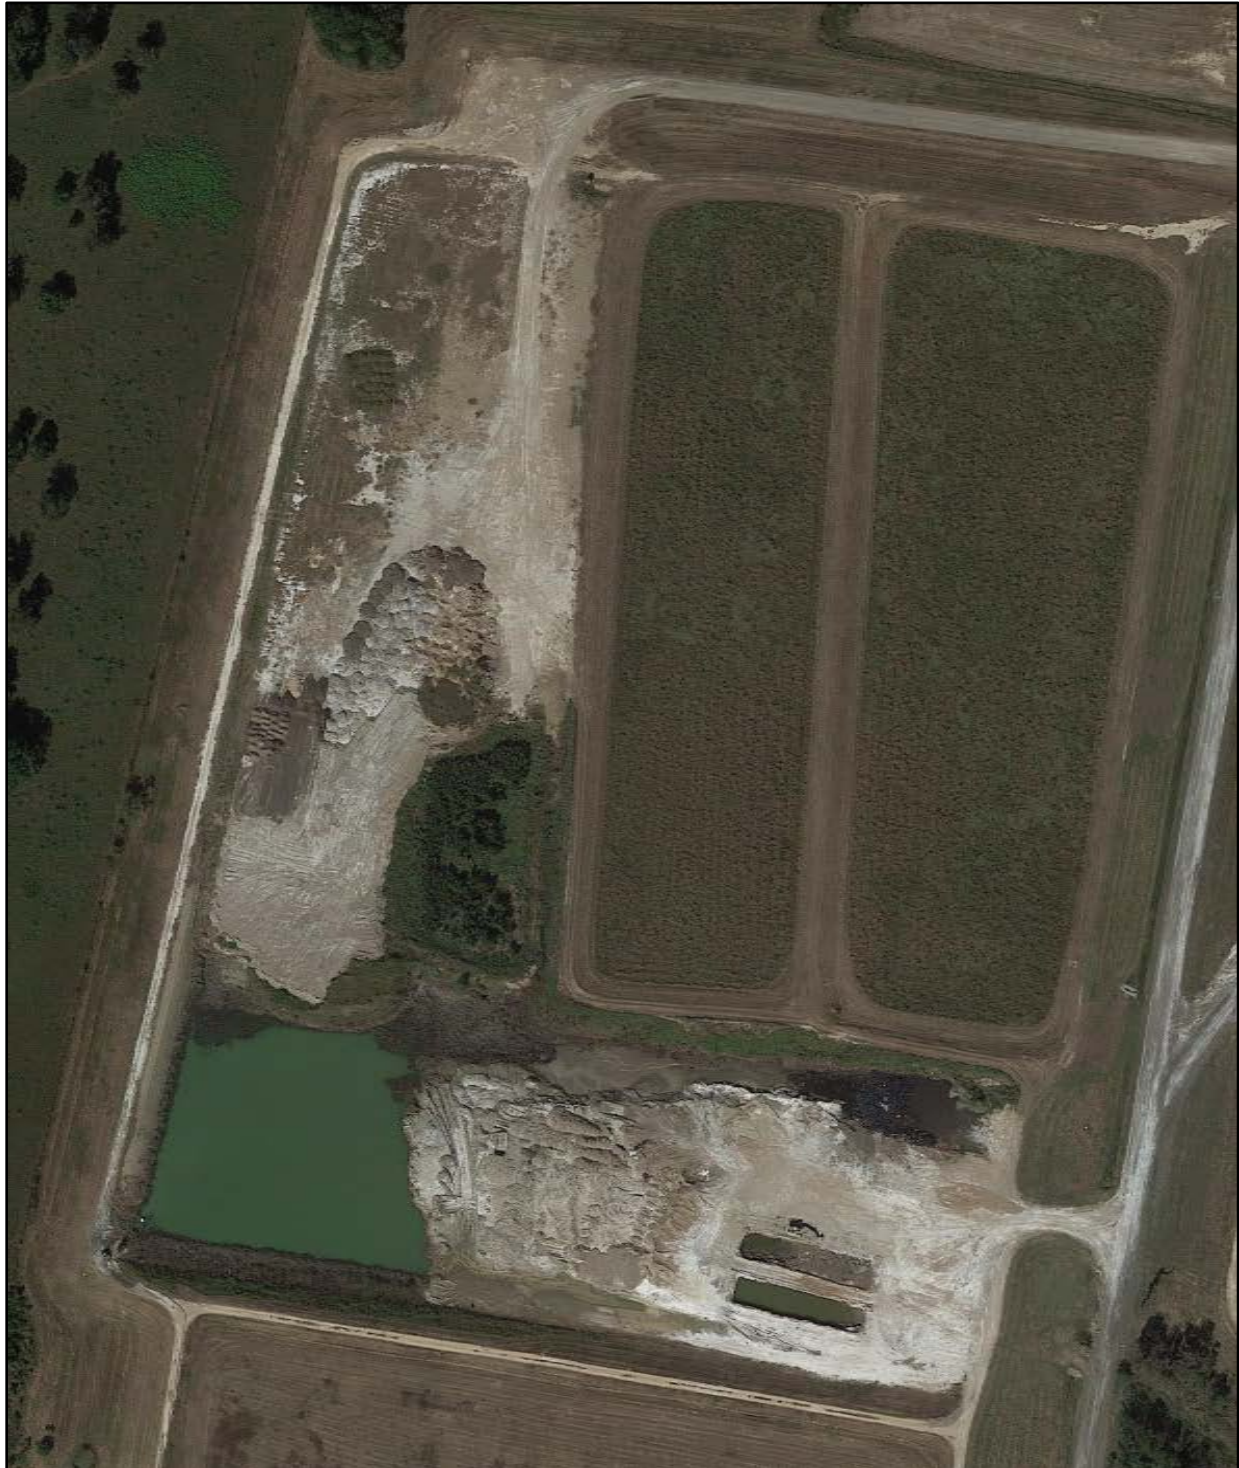
Photograph P-23 – From Google Earth Pro, dated October 28, 2017.

Landfill Cell 1C: Aerial view of landfill cell and storm water runoff pond inside the cell.
Note closed cells north and east of active cell area.

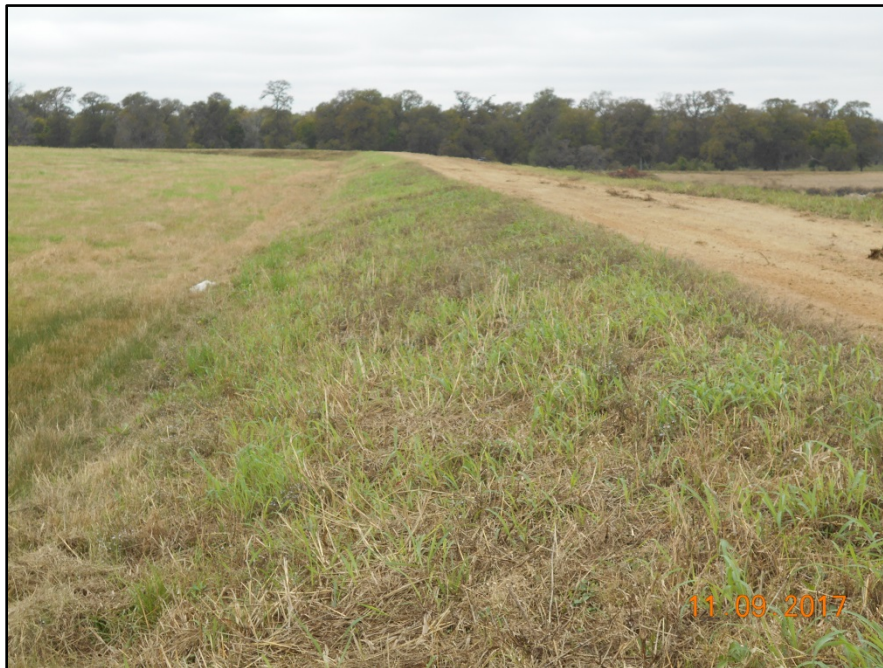
The outside slopes of the perimeter berms are shown in Photographs P-25, P-28, P-31, and P-33. These slopes typically exhibited good alignment and grades. No significant adverse conditions were identified for the outside slopes of the perimeter berm.

Photograph P-25 – Taken November 9, 2017 by David E. Nielson
Landfill Cell 1C: Looking west along the outside slope of the southern berm
of the landfill cell.

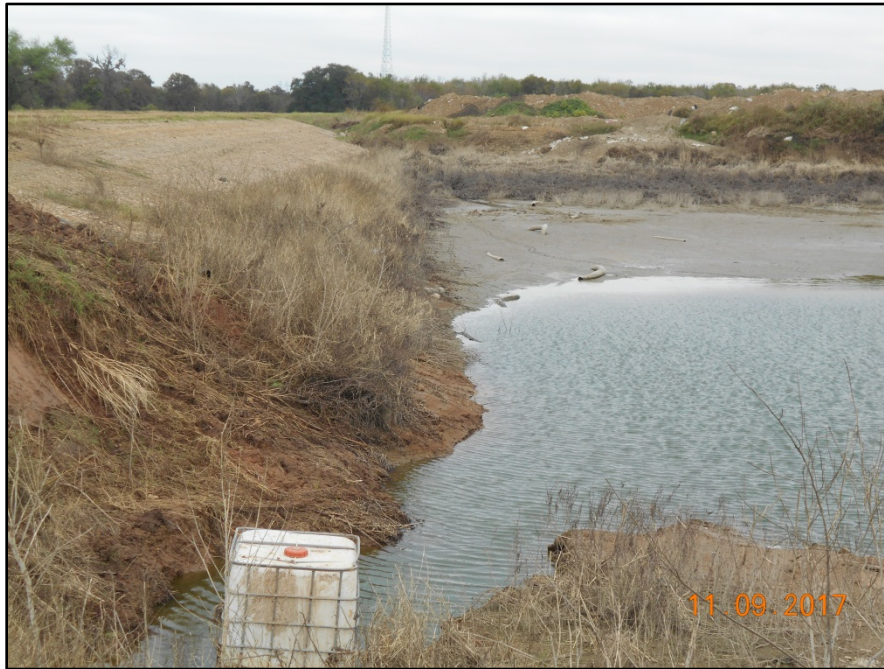
The inside slopes of the perimeter berms are shown in Photographs P-26, and P-27. These slopes typically exhibited good alignment, grades and vegetation or erosion resistant stabilized CCR material. No adverse conditions were identified for the inside slopes of the perimeter berms.

Photograph P-26 – Taken November 9, 2017 by David E. Nielson
Landfill Cell 1C: Looking north along the inside slope of the western landfill berm at the incised storm water pond.

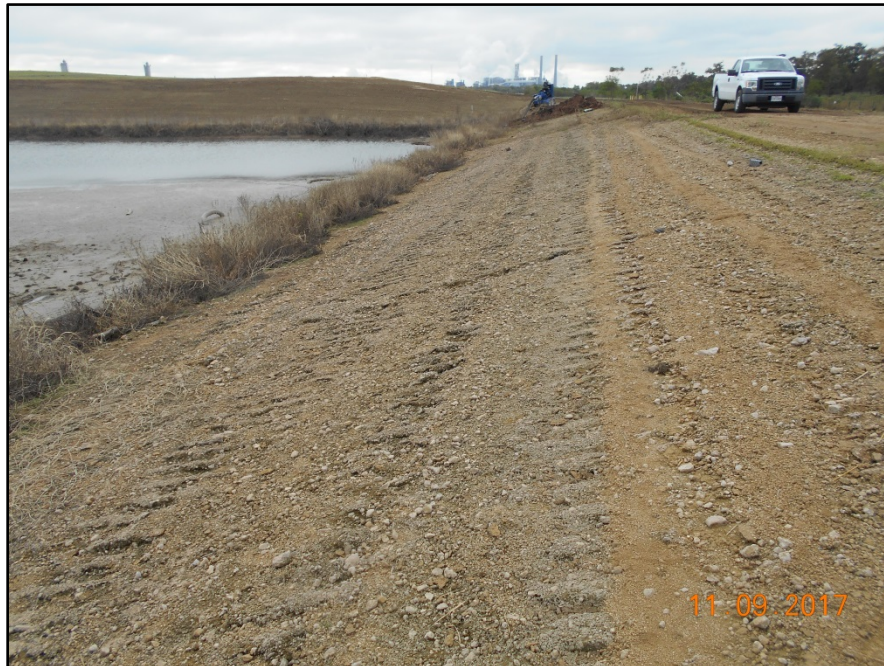
Photograph P-27 – Taken November 9, 2017 by David E. Nielson
Landfill Cell 1C: Looking south along the inside slope of the western landfill cell berm.

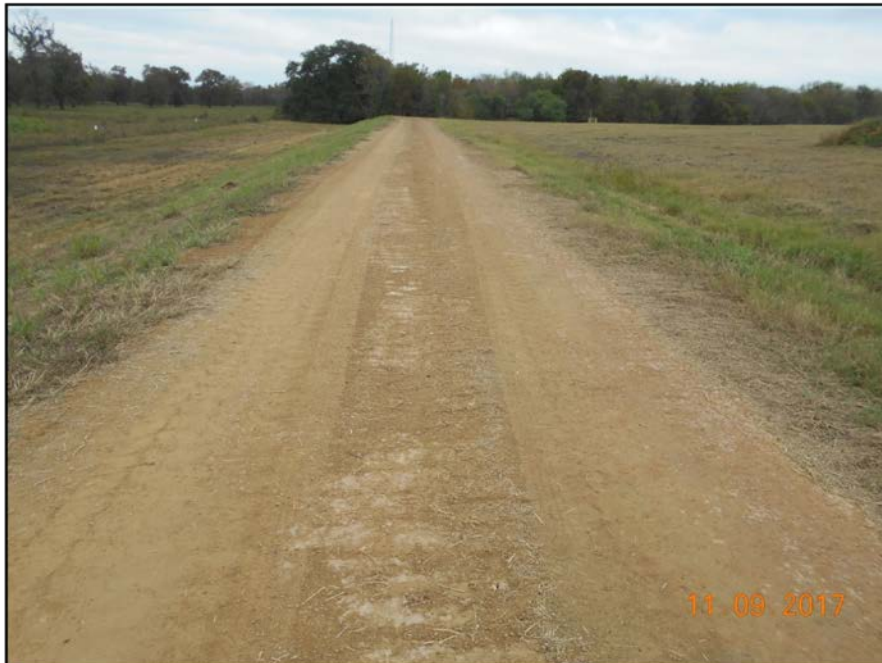
Photograph P-29 – Taken November 9, 2017 by David E. Nielson
Landfill Cell 1C: Looking north along the crest of the western berm.
Note good vegetation control and road condition.

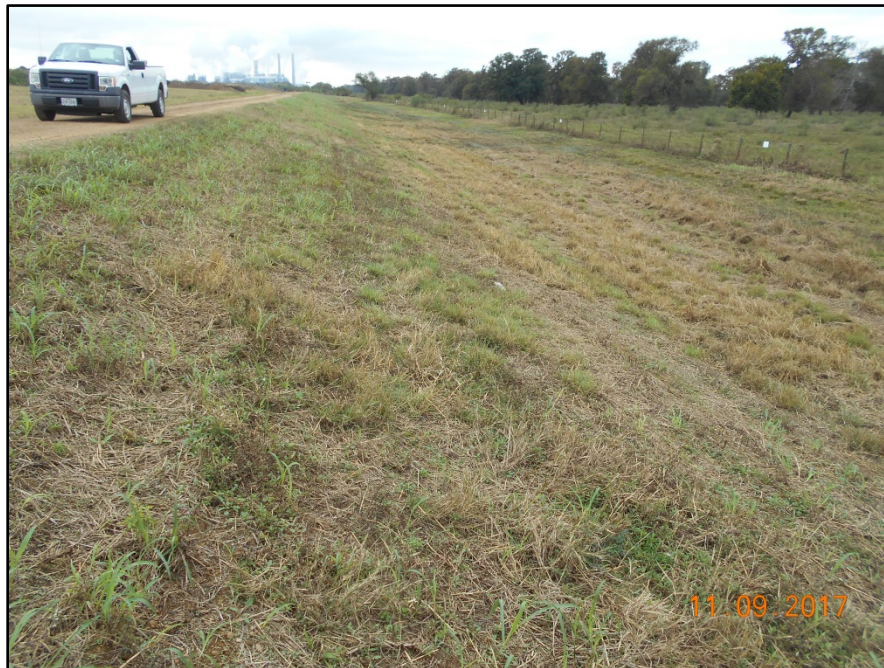
Photograph P-31 – Taken November 9, 2017 by David E. Nielson
Landfill Cell 1C: Looking south along the outside slope of the western berm.
Note good vegetation control.

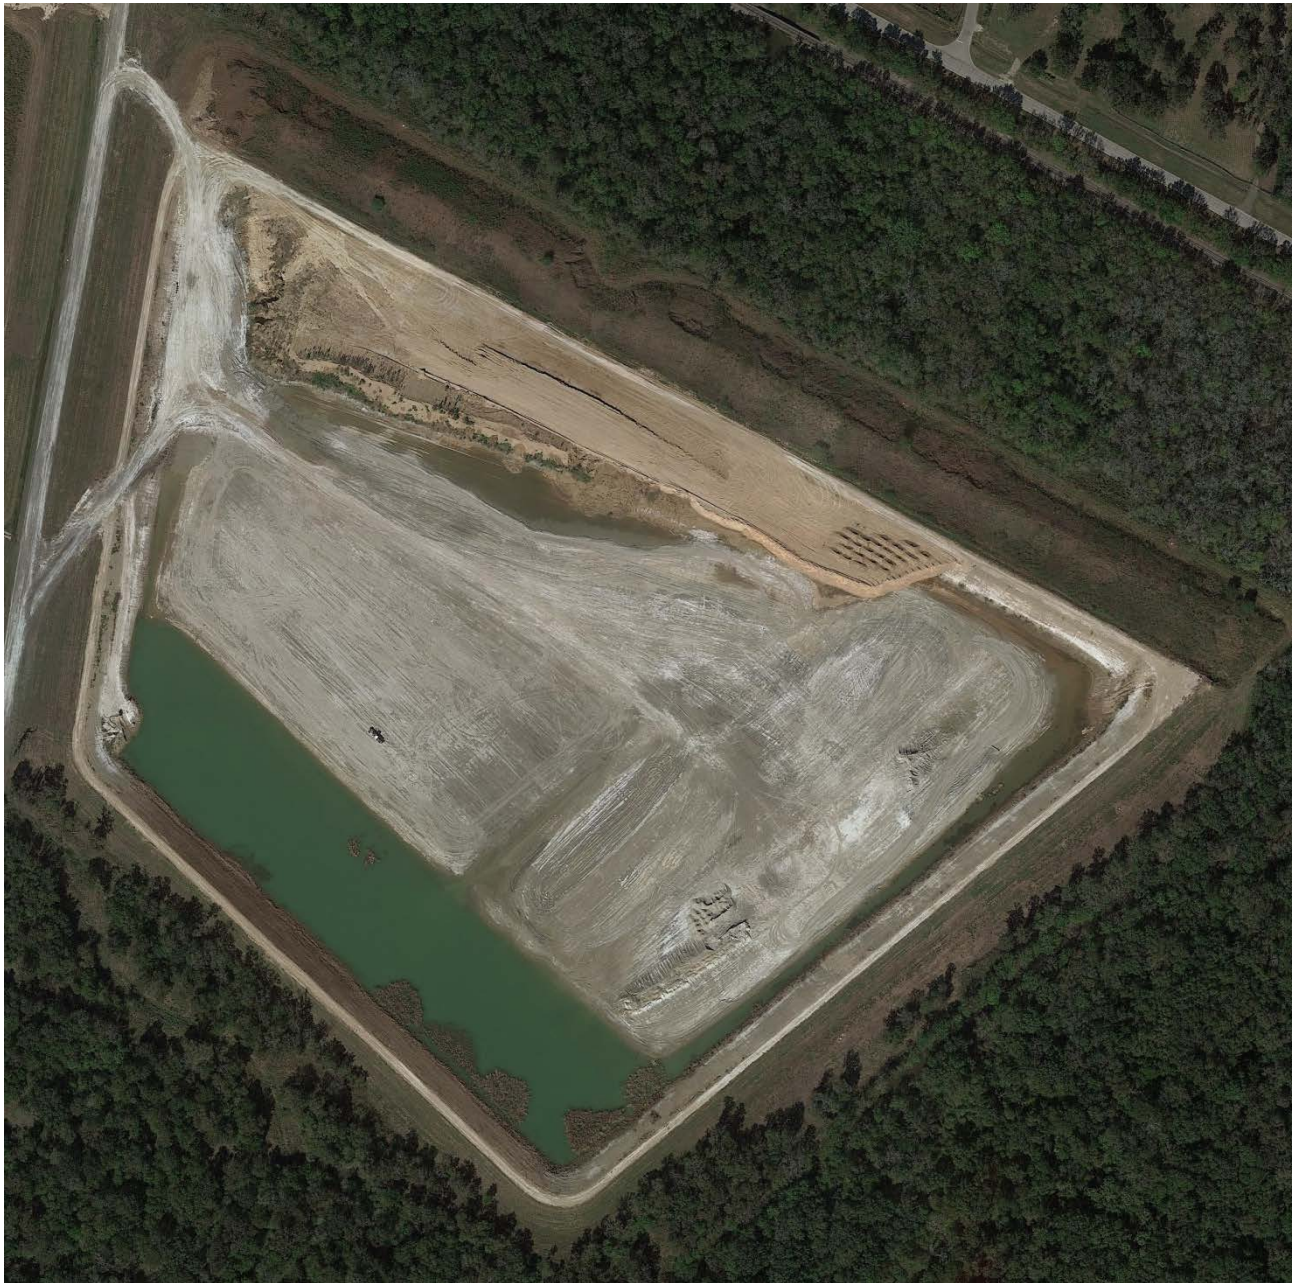
Photograph P-34 – From Google Earth Pro, dated October 28, 2017.
Downloaded December 26, 2017.
Landfill Cell 2B: Aerial view of landfill cell and storm water runoff pond inside the cell.

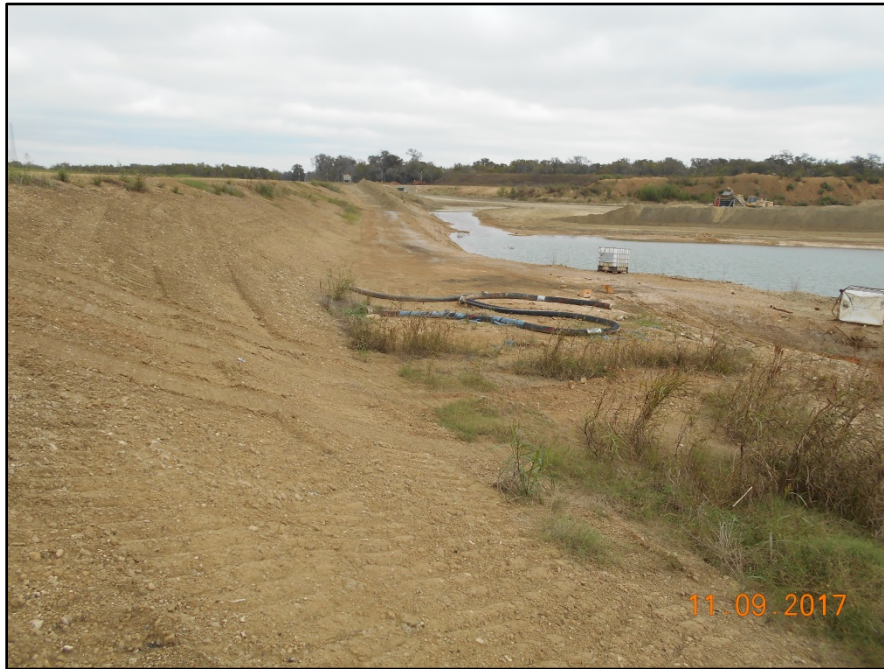
Photograph P-35 – Taken November 9, 2017 by David E. Nielson
Landfill Cell 2B: Looking north along the inside slope of the western berm
at the area where a mobile pump is placed to remove storm water collected in incised storm
water pond located within the cell. Note the slope has been regraded with stabilized material to
reduce future erosion. See Photograph 50.

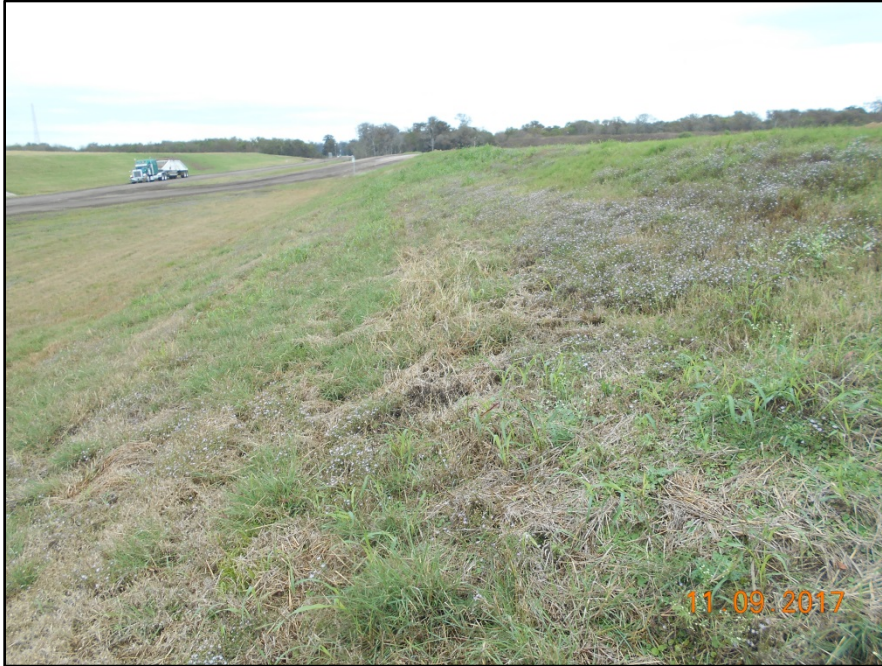
The outside slopes of the perimeter berms are shown in Photographs P-37, P-42, P-44, P-47, and P-52. These slopes typically exhibited good alignment, grades and vegetation. There were no observed indications of instability of the outside slopes of the perimeter berms and dikes.

Photograph P-37 – Taken November 9, 2017 by David E. Nielson
Landfill Cell 2B: Looking north along outside slope of western berm.
Note good vegetation cover and uniform slope.

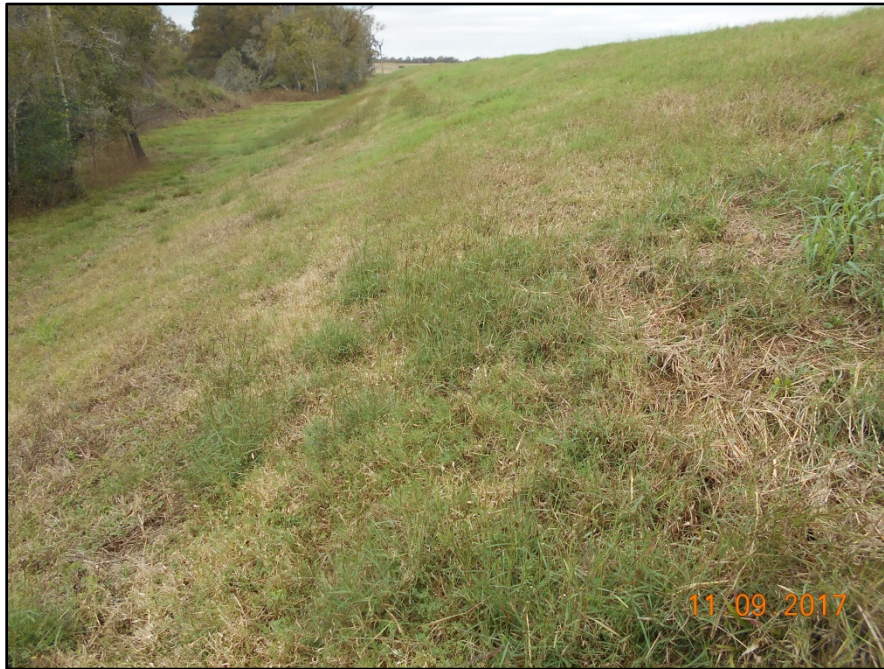
Photograph P-47 – Taken November 9, 2017 by David E. Nielson
Landfill Cell 2B: Looking west along the outside slope of the southern landfill berm.
Note good vegetation.

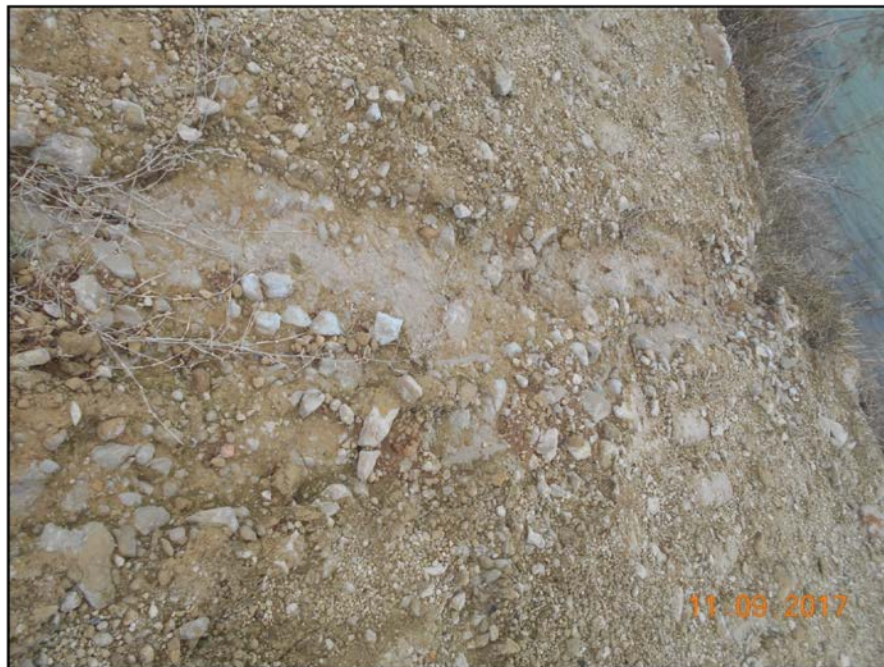
Photograph P-50 – Taken November 9, 2017 by David E. Nielson
Landfill Cell 2B: Looking down at inside slope of landfill berm. Close up view of stabilized material that has stopped apparent erosion.
