2018 Annual Inspection of CCR Landfill Cells

W.A. Parish Electric Generating Station
Thompsons, Texas

January 2019

NRG Texas Power LLC

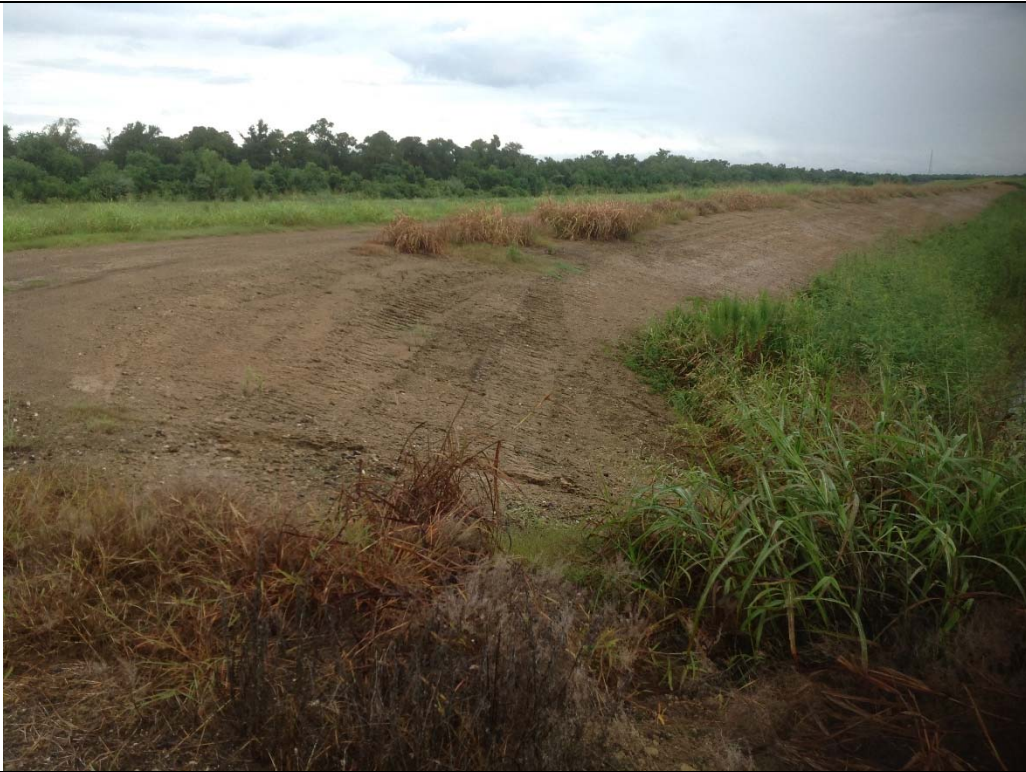
In general, the exterior slopes of the berms are well vegetated and demonstrate good alignment and slope grade. In general, the interior slopes of the berms and the berm crest are surfaced with stabilized CCR material that resists erosion.

The crest of the berms around Cell 3 are free of rutting and misalignment.

Landfill Cell 3 was found to be in good condition as observed without indications of risk of catastrophic or operational failure. The repairs made since the prior annual inspection have improved the condition of the landfill containment dikes and berms, which are considered to be in excellent condition.

Photograph P-1 Taken September 11, 2018 by Jason Leik, P.E. (During Location Restriction Inspection)
Landfill Cell 3 – Looking north along west crest and inside slope of west berm of landfill.

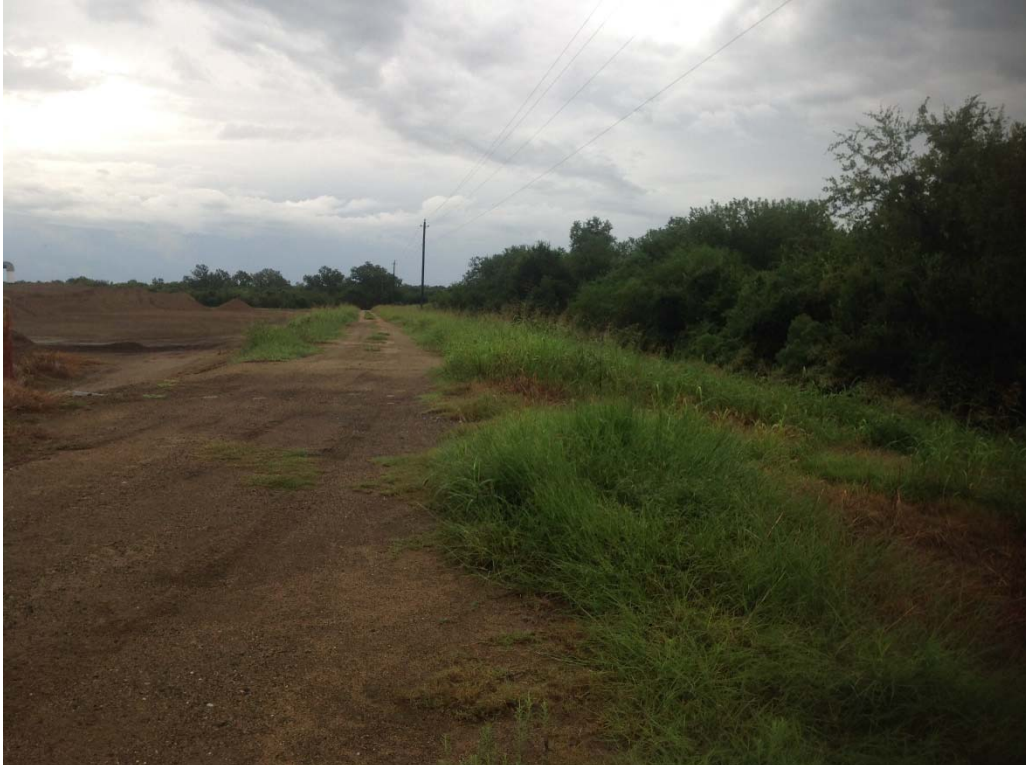
At the time of the inspection, the water level in the storm water pond was lower than the ground surface outside the western and southern berms of the pond. Thus, lateral pressure from the retained water on the landfill berms was minimal.

Photograph P-2 Taken September 11, 2018 by Jason Leik, P.E. (During Location Restriction Inspection)
Landfill Cell 3 – Looking east along southern berm of landfill Cell 3.

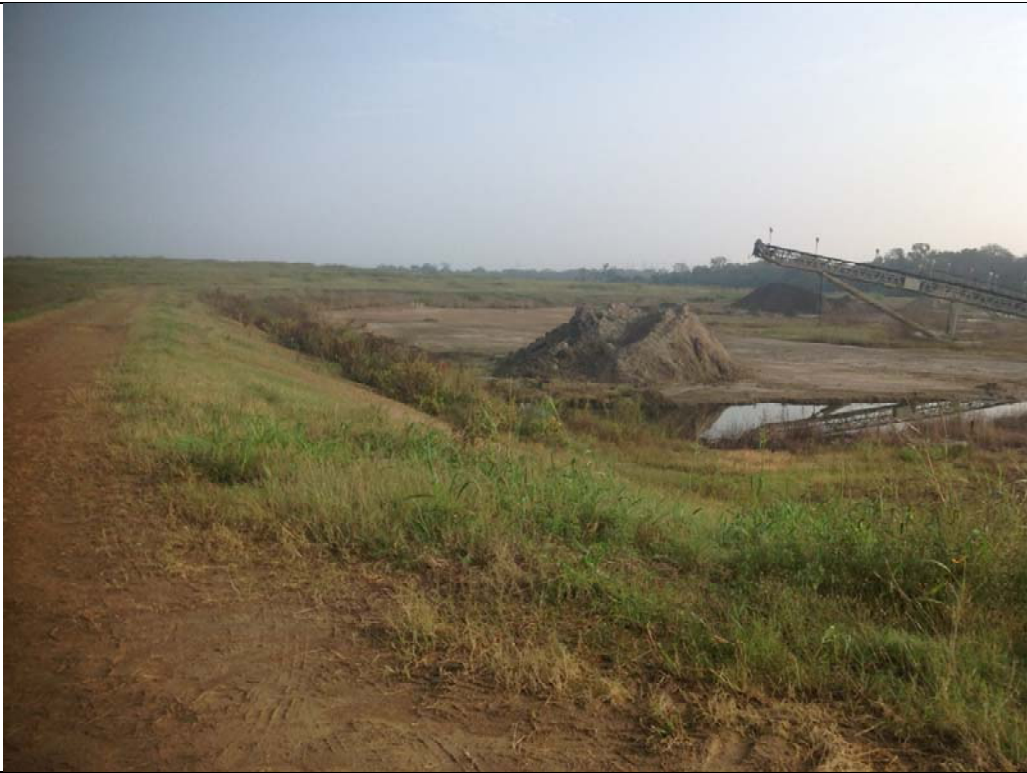
In general, the exterior slopes of the berms are well vegetated and demonstrate good alignment and slope grade. Portions of the interior slopes were well vegetated and other areas of the interior slopes of the berms and the berm crest are surfaced with stabilized CCR material that resists erosion.

Landfill Cell 2A was found to be in excellent condition as observed, without indications of risk of catastrophic or operational failure.

Photograph P-3 Taken November 7, 2018 by Jason Leik, P.E.
Landfill Cell 2a Pugmill – Looking north along west crest and inside slope of west berm of landfill. Pugmill loading conveyor visible on right

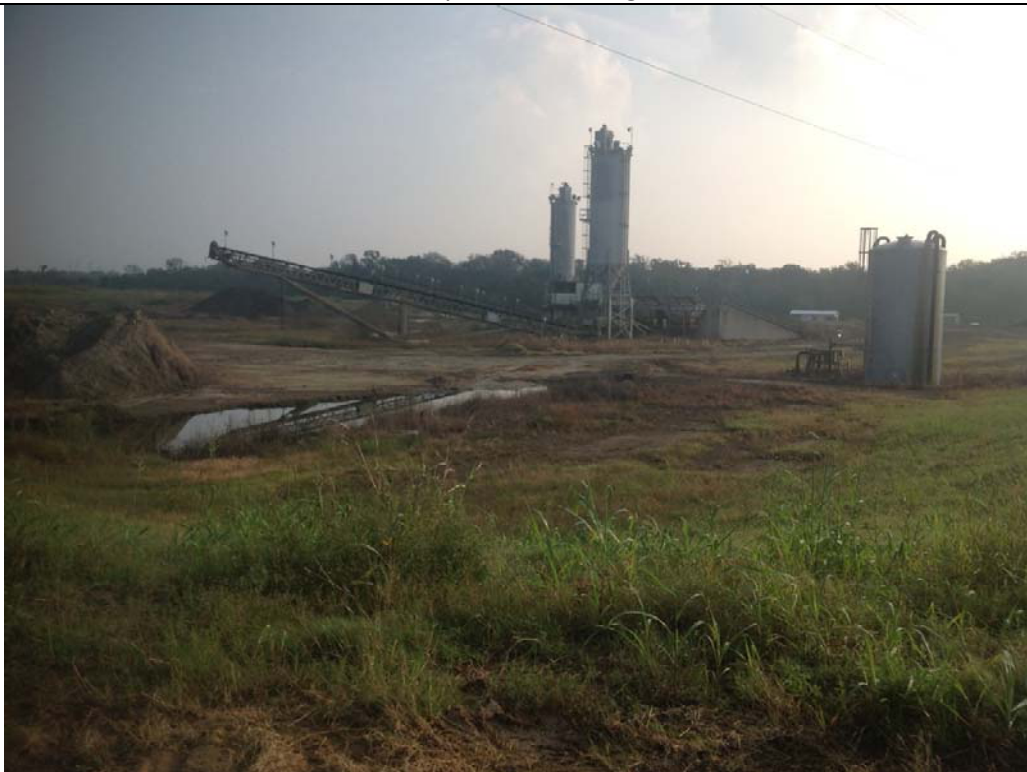
At the time of the inspection, Landfill Cell 2A was not used to store or dispose of significant quantities of CCR material. Moreover, mixing ash products for stabilization was not in progress during the inspection. Since the cell did not contain significant CCR materials and since it appears the CCR contained within Cell

2A is stable and rigid as shown in Photograph P-4, the lateral loads on the perimeter berms are considered to be minimal.

Photograph P-4 Taken November 7, 2018 by Jason Leik, P.E.
Landfill Cell 2a Pugmill – Looking northeast into center of landfill Cell 2a Pugmill.

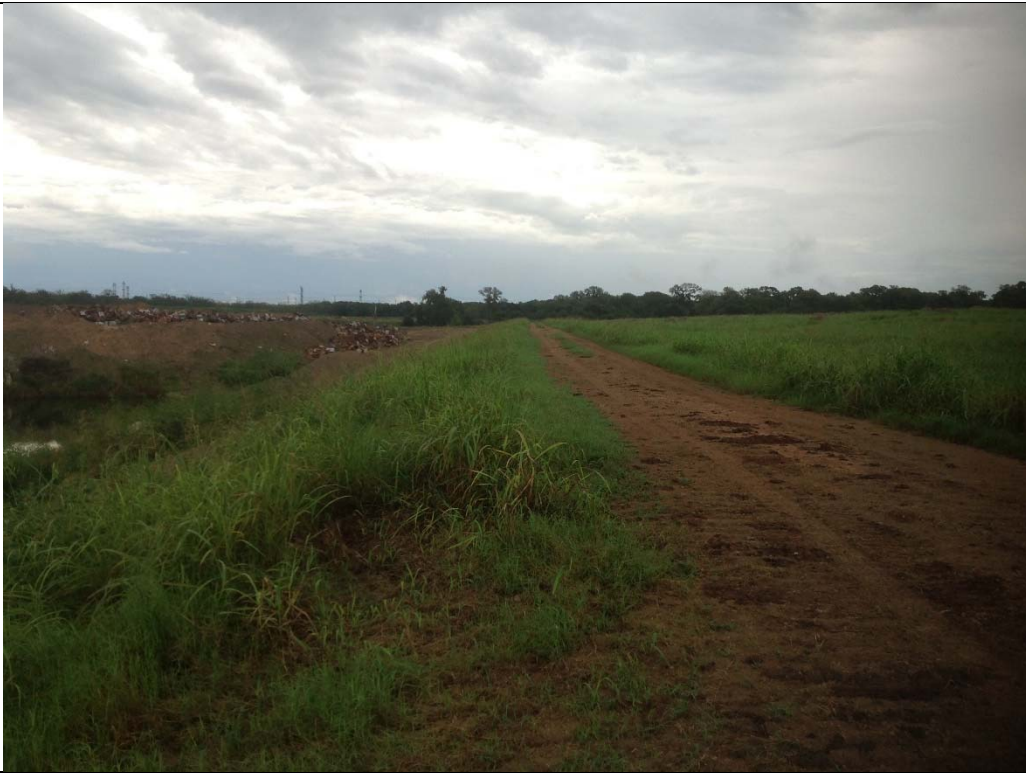
The interior slopes of Cell 1C typically exhibited good alignment, grades and vegetation or erosion resistant stabilized CCR material. No adverse conditions were identified for the inside slopes of the perimeter berms.

The crest of the berms around Cell 1C are generally free of rutting and misalignment as shown in Photos P-5 and P-6. Photograph P-6 shows that the berm along the southeast portion of the cell was recently improved.

Photograph P-5 Taken September 11, 2018 by Jason Leik, P.E. (During Location Restriction Inspection)
Landfill Cell 1C – Looking east along crest and inside slope of south berm of landfill.

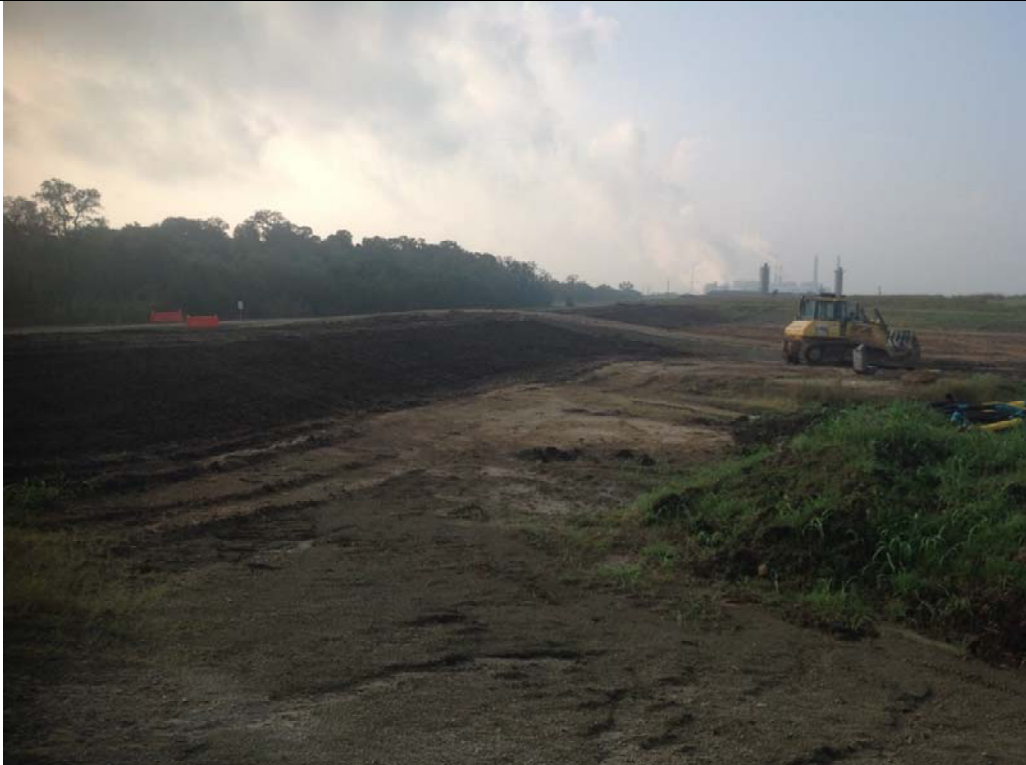
Landfill Cell 1C was found to be in good condition as observed, without indications of risk of catastrophic or operational failure and is considered to be in excellent condition.

Photograph P-6 Taken November 7, 2018 by Jason Leik, P.E.
Landfill Cell 1C – Looking south at inside slope of newly improved eastern berm.

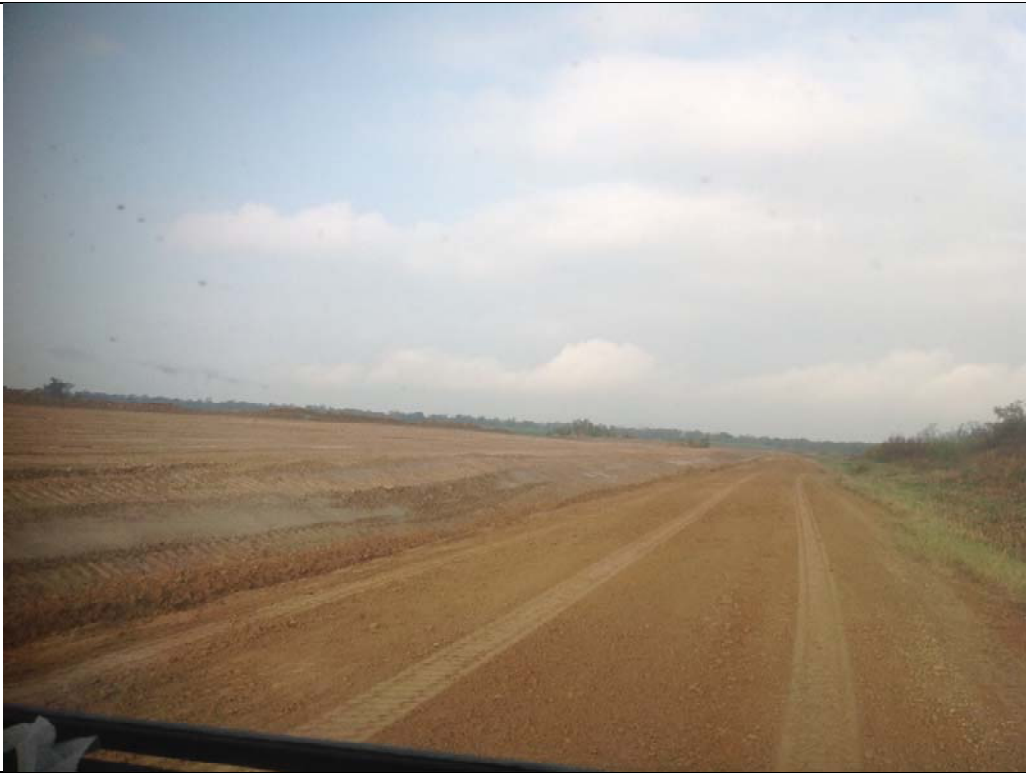
The crest of the berms and dikes around Cell 2B are generally free of rutting and misalignment as shown on Photograph P-7. The berm crest and roadway surface are well maintained and considered to be in good to excellent condition.

Photograph P-7 Taken November 7, 2018 by Jason Leik, P.E.
Landfill Cell 2B – Looking west along crest of north berm. CCR material placed on left.

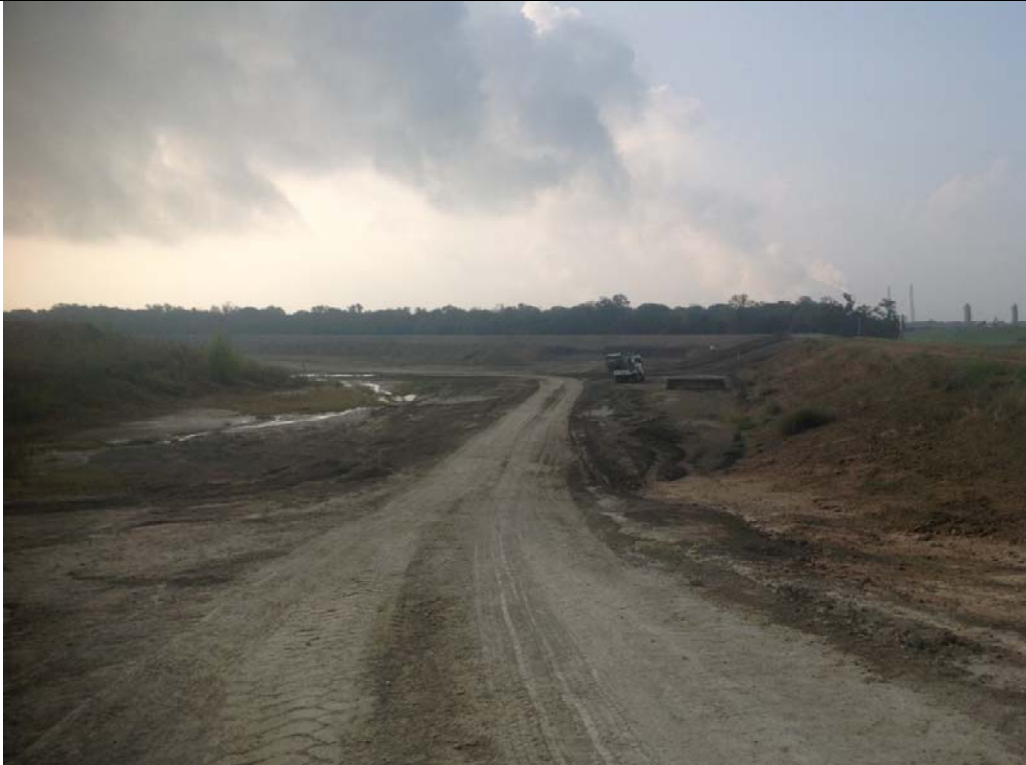
The inside slopes of the perimeter dikes and berms around Cell 2B as well as the berm crest are surfaced with stabilized CCR material to prevent erosion. In general, these slopes were well graded and uniform in slope.

Landfill Cell 2B was found to be in excellent condition as observed, without indications of risk of imminent catastrophic or operational failure.

Photograph P-8 Taken November 7, 2018 by Jason Leik, P.E.
Landfill Cell 2B – Looking south into interior of Cell 2B from top of north berm. West and south berms visible.
