2020 Annual Inspection of CCR Unit

**W. A. Parish Electric Generating Station
Thompsons, Texas**

January 2021

NRG Texas Power LLC

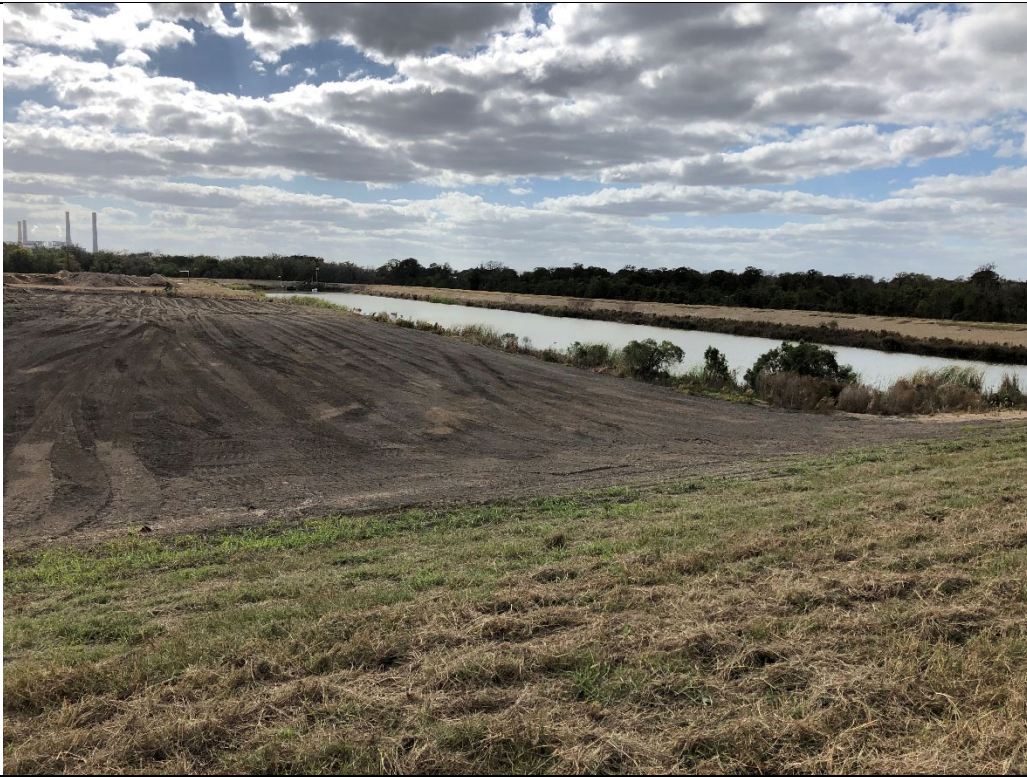
In general, the exterior slopes of the perimeter berms were well vegetated and demonstrated good alignment and slope grade. The crests of the berms around Cell 3 were free of rutting and misalignment.

Cell 3 was observed to be in good condition without indications of risk of catastrophic or operational failure. The Cell 3 perimeter berms were observed to be in excellent condition.

Photograph P-1: View looking south-southwest of Cell 3 from top of north berm. Bottom ash material is visible to the left; the Cell 3 contact water pond to the right. The interior slopes and crest roads of the berms have been stabilized with a cemented mixture of bottom ash and fly ash. The remainder of the berms are well vegetated.

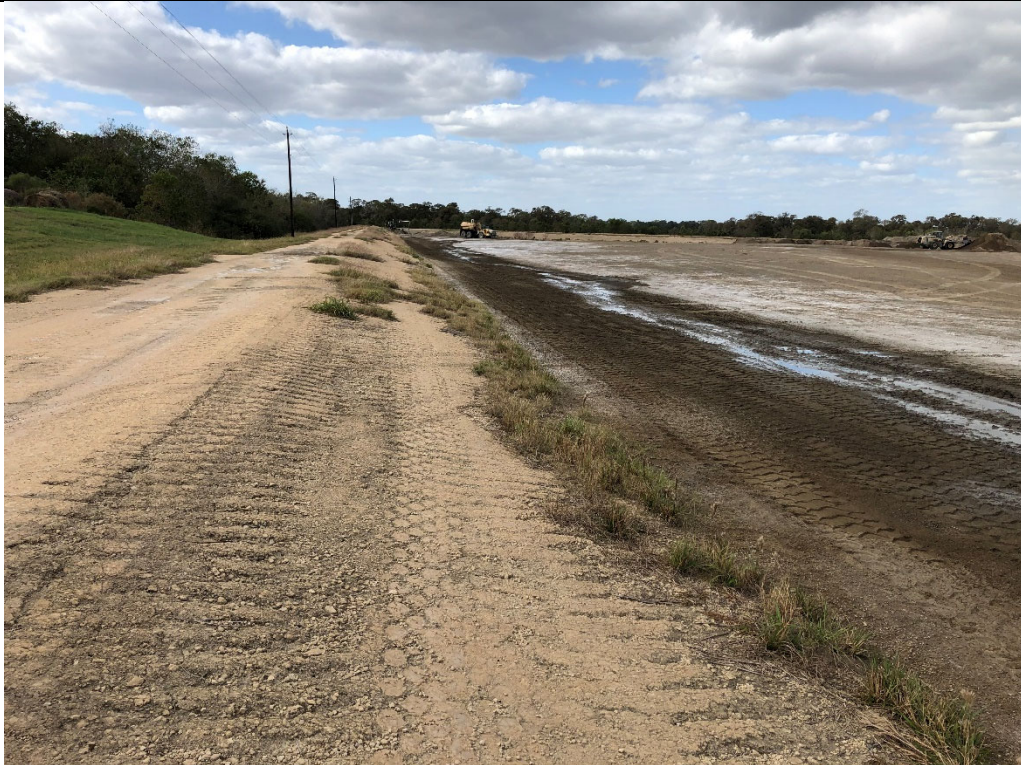
Photograph P-2: View looking west of Cell 3's south berm. The crest road was well maintained, exterior slopes well vegetated without erosion issues, and interior slope improved with stabilized CCR material.

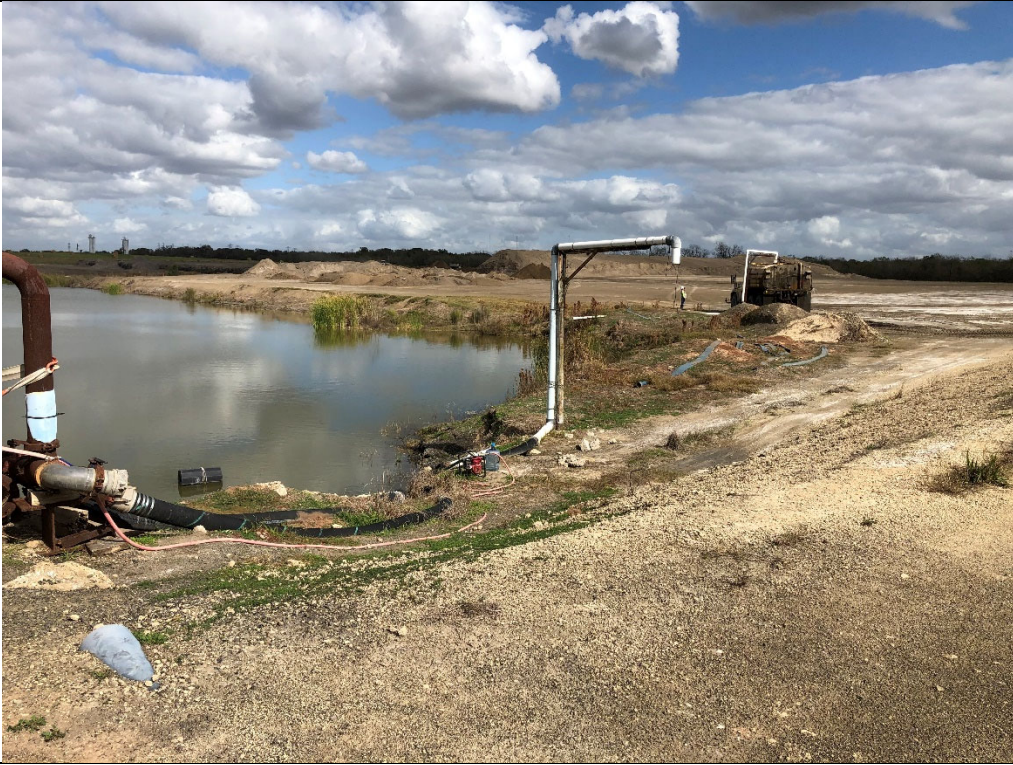
At the time of the inspection, the water level in the stormwater pond was at approximately the same elevation as the ground surface outside the western and southern berms of Cell 3. Thus, lateral pressure from the water in the stormwater pond on the landfill berms appeared to be minimal.

Photograph P-3: View looking northeast of Cell 3 Coal Combustion Residual (CCR) waste pile and of location where water from Cell 3's contact water pond is transferred to trucks.

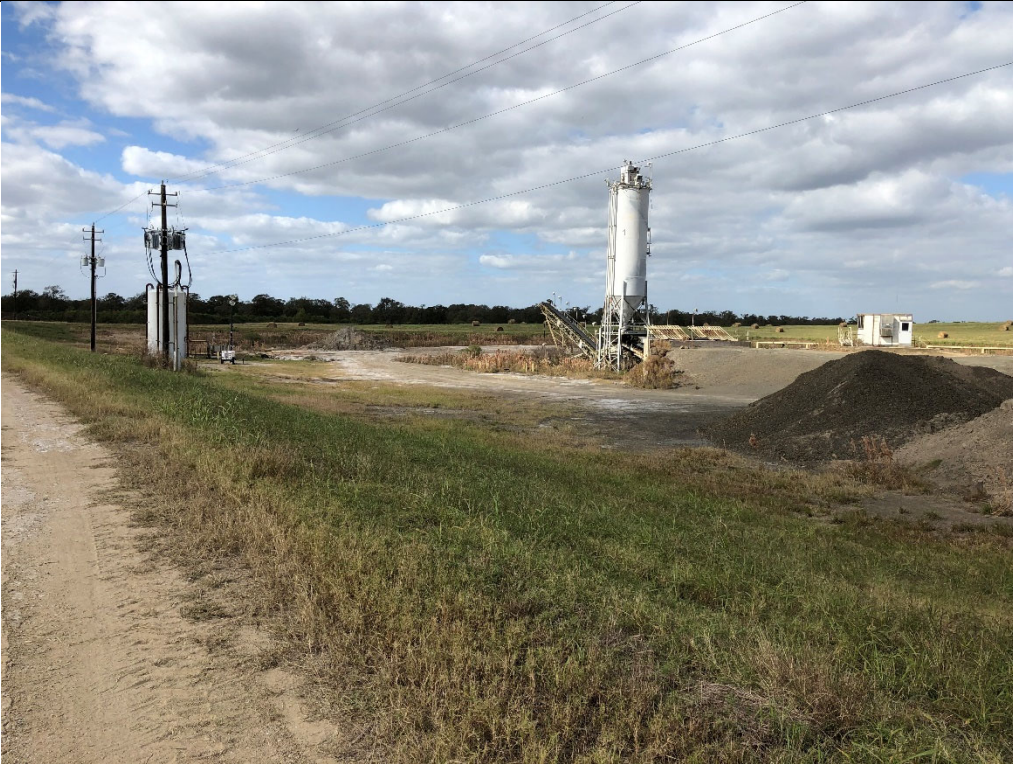
In general, the exterior slopes of the perimeter berms are well vegetated and demonstrate good alignment and slope grade. The surfaces of portions of the interior slopes were either well vegetated or stabilized with CCR. The berm crests were also stabilized with CCR.

Cell 2A was observed to be in good condition without indications of risk of catastrophic or operational failure. The Cell 2A perimeter berms were observed to be in good condition.

Photograph P-4: View looking west along the south berm of Cell 2A (the Pugmill Area).

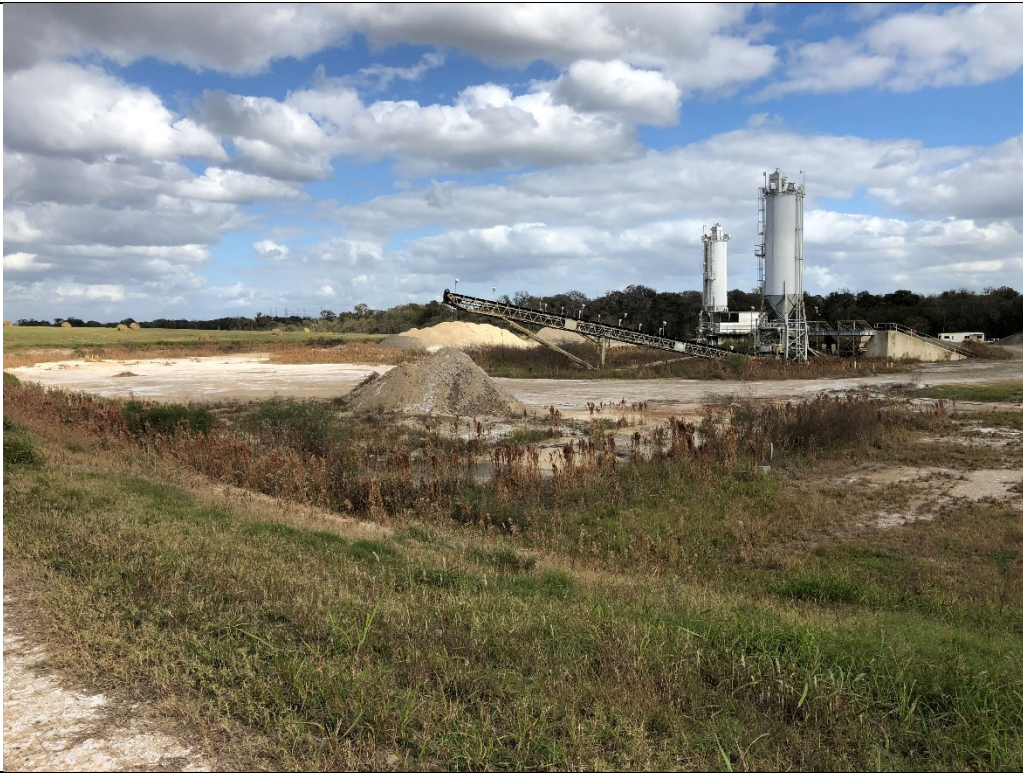
The location of Cell 2A is depicted on Figure 1 and Photographs P-4, P-5, and P-6. At the time of the inspection, Landfill Cell 2A was not used to store or dispose of significant quantities of CCR. Mixing CCR for stabilization was not in progress during the inspection, but TRC observed CCR stockpiled in Cell 2A. Based on the location of the stockpiles and the nature of the material stored there, the lateral loads on the perimeter berms appeared to be minimal.

Photograph P-5: View looking northeast of Cell 2A, the Pugmill Area. Pugmill equipment and mixed CCR material are visible in this photograph.

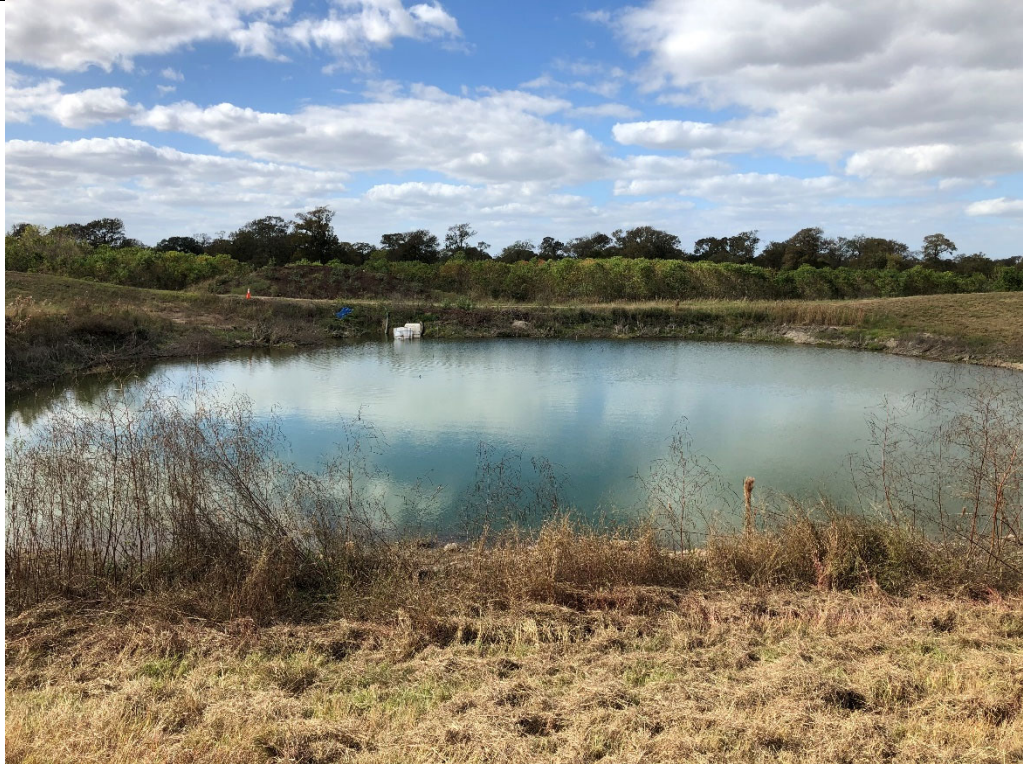
At the time of the inspection, the water level in the stormwater pond appeared to be lower than the elevation of the ground surface outside the western berm of Cell 2A. Thus, lateral pressure from the water in the stormwater pond on the landfill berms appeared to be minimal.

Photograph P-6: View looking west across the contact water pond in Cell 2A. Slopes were either stabilized or well vegetated.

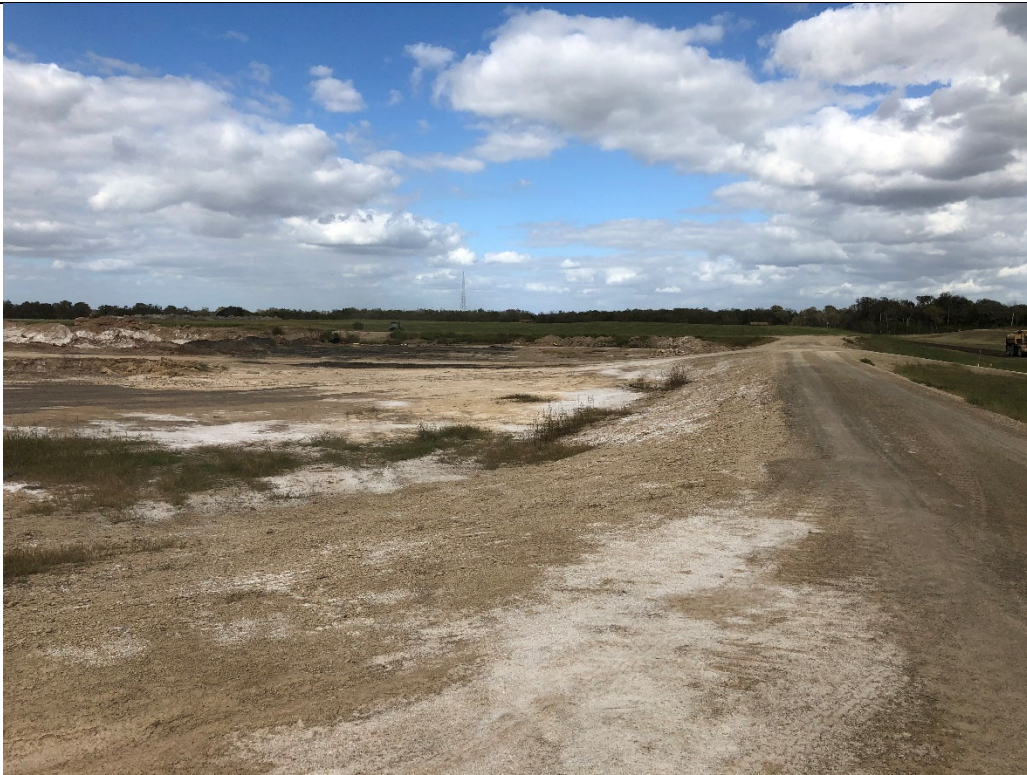
In general, the exterior slopes of the perimeter berms are well vegetated and demonstrate good alignment and slope grade. No significant adverse conditions were identified for the outside slopes of the perimeter berms. The crests of the perimeter berms were generally free of rutting and misalignment as shown on Photographs P-7 through P-9.

Photograph P-7: View looking north along the eastern berm of Cell 1C. Slopes were either stabilized (interior) or well vegetated (exterior). Crest road was stabilized with no significant rutting.

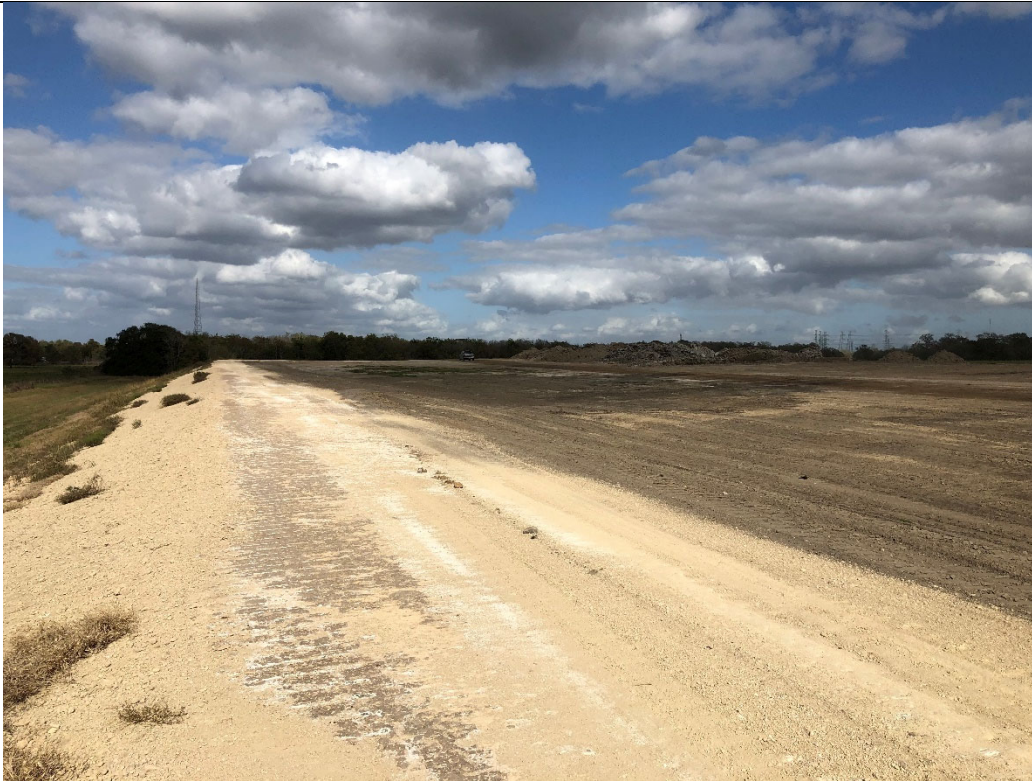
Photograph P-8: View looking north of the western berm of Cell 1C. This portion of the landfill is full – CCR waste material is visible to the right of the berm road.

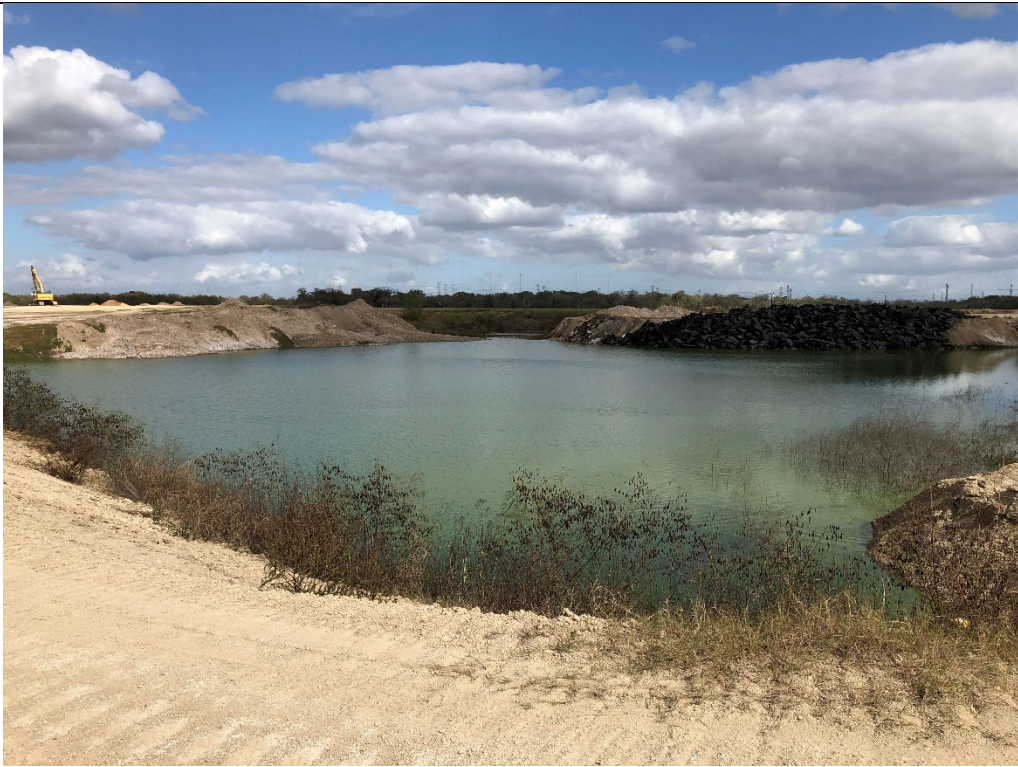
At the time of the inspection, the water level in the stormwater pond was at approximately the same elevation as the ground surface outside the western berm of Cell 1C. Thus, lateral pressure from the water in the stormwater pond on the landfill berms appeared to be minimal.

The interior slopes of Cell 1C exhibited good alignment, grades, and vegetation or erosion resistant stabilized CCR. No adverse conditions were identified for the inner slopes of the perimeter berms. During the September 9, 2020 weekly inspection performed by NRG, a small portion of the southwest

inner slope had sloughed after heavy rainfall. This area was repaired and resurfaced with stabilized CCR. This area was observed to be in good condition during TRC's visual inspection.

Photograph P-9: View looking northeast of the contact water pond in Cell 1C. Picture was taken from berm at southwest corner of Cell 1C.

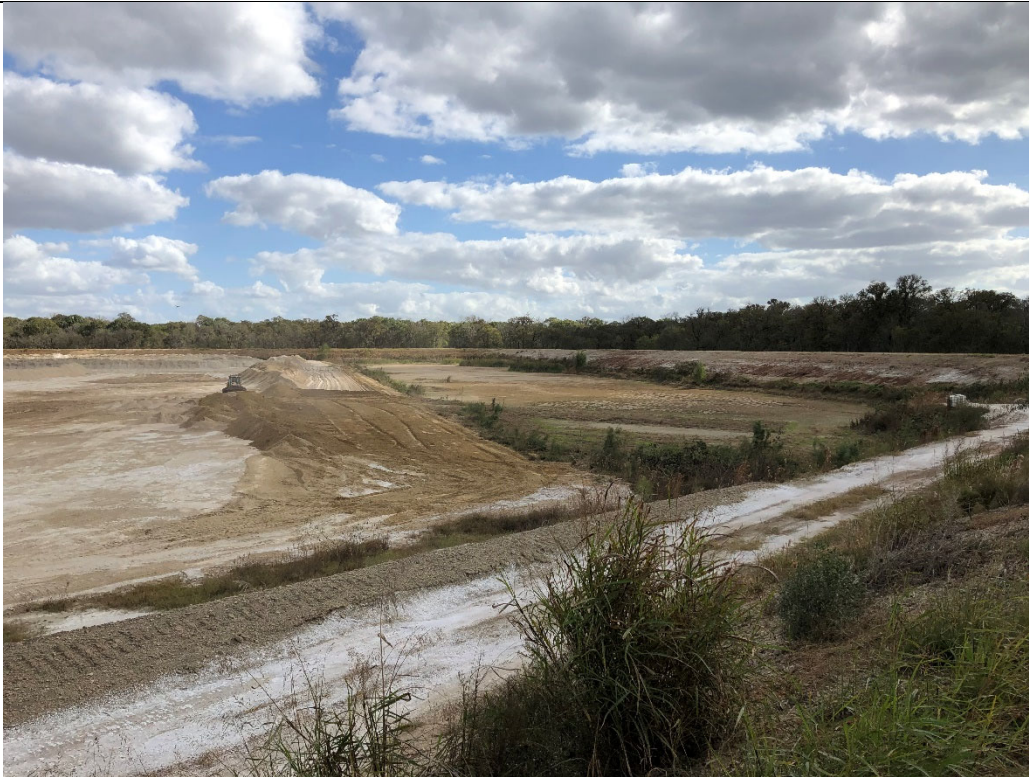
The location of Cell 2B is depicted on Figure 1 and Photographs P-10, P-11, and P-12. During the November 19, 2020 inspection, the stormwater pond was dry. During the December 2, 2020 inspection, the water level in the stormwater pond was lower than the elevation of the ground surface outside the western, southern, and eastern perimeter berms of Cell 2B. Thus, lateral pressure from the water in the stormwater pond on the landfill berms appeared to be minimal.

Photograph P-10: View looking east over an entry road of Cell 2B from western berm. This photograph shows the fly ash storage area on the left and center of the photograph. The dry contact water pond is visible on the right side of the photograph.

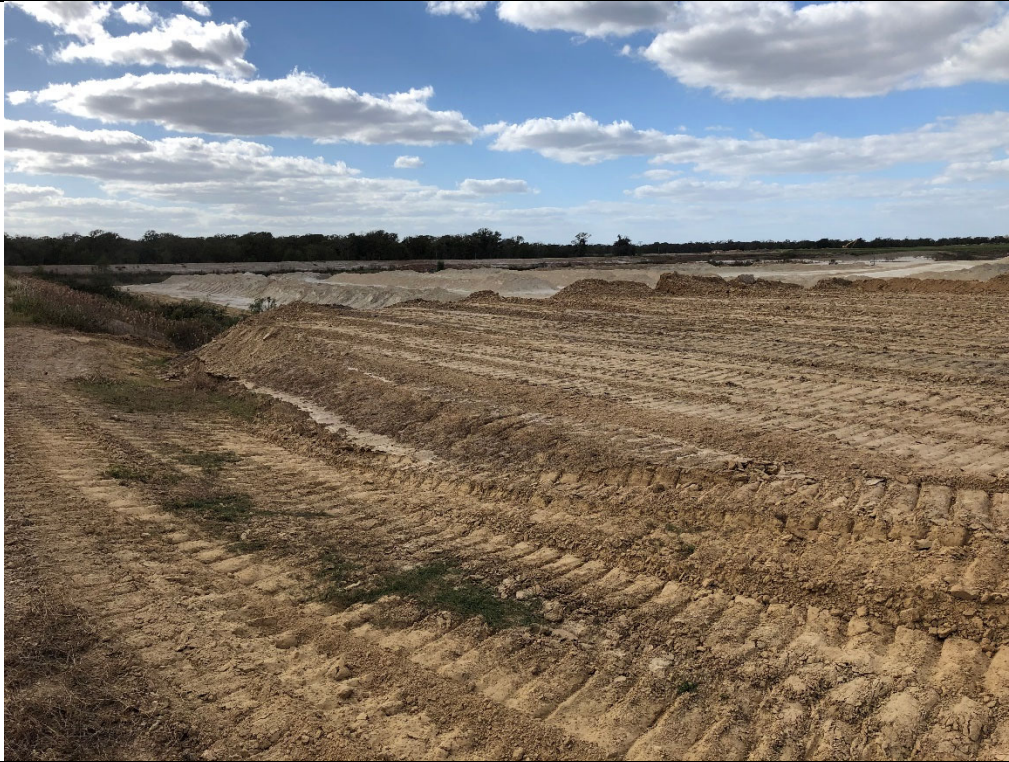
Photograph P-11: View looking southwest of Flue Gas Desulfurization (FGD) waste interred on north side of Cell 2B. This photograph was taken from the northeast corner of the landfill. The fly ash storage area is visible in the center background (beyond the FGD waste).

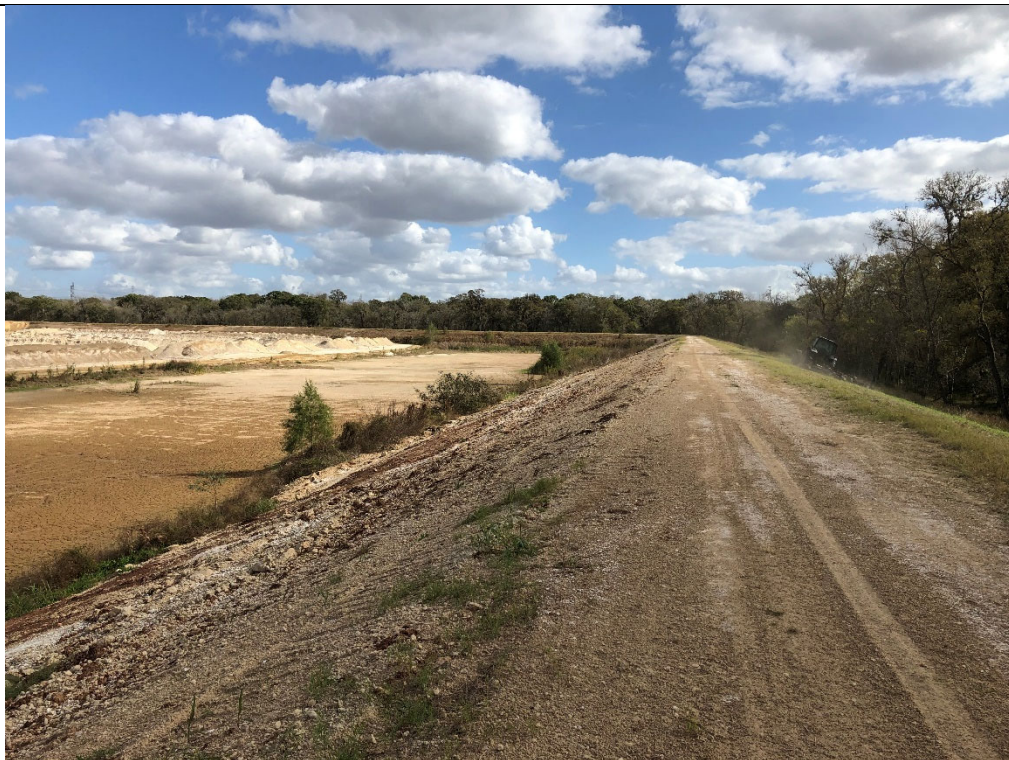
The crests of the berms around Cell 2B were generally free of rutting and misalignment. The berm crest and roadway surface were well maintained and were in good condition.

The surfaces of the majority of the inside slopes of the perimeter berms around Cell 2B as well as the berm crests were surfaced with stabilized CCR to prevent erosion. In general, these slopes were well graded and uniform in slope. The portion of the interior slope that was not surfaced with stabilized CCR was a recently repaired section of the perimeter berm. During the September 23, 2020 weekly inspection performed by NRG, a section of the inner slope of the southern perimeter berm that was over 100 feet in length had sloughed. The area was repaired and regraded, with the repairs being substantially complete by the October 7, 2020 weekly inspection. This area was observed to be in good condition during TRC's visual inspection.

Photograph P-12: View looking east of Cell 2B's southern berm. The section of the interior slope of the southern berm that was recently repaired is visible on in this photograph (left foreground). The contact water pond is visible in the left background. The crest road and vegetated exterior slope are visible in the center and right sides of the photograph.
