# **2022 Annual Inspection of CCR Unit**

**W. A. Parish Electric Generating Station  
Thompsons, Texas**

**January 2023**

**NRG Texas Power LLC**

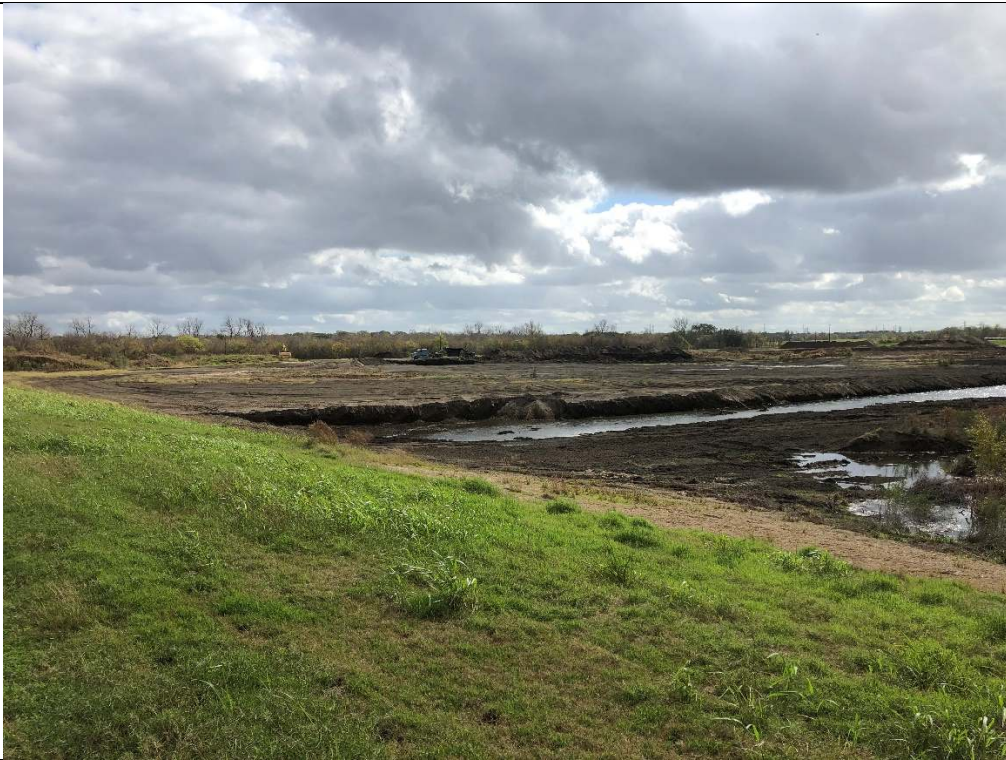
Photograph P-1: View looking southeast of Cell 3 from top of north berm. The darker bottom ash material is visible in this photograph, as is the area where the bottom ash is being excavated from the landfill and sold as road base. The Cell 3 storm water pond is visible to the right. The interior slopes and crest roads of the berms are either vegetated (slopes) or have been stabilized with a cemented fly ash mixture.

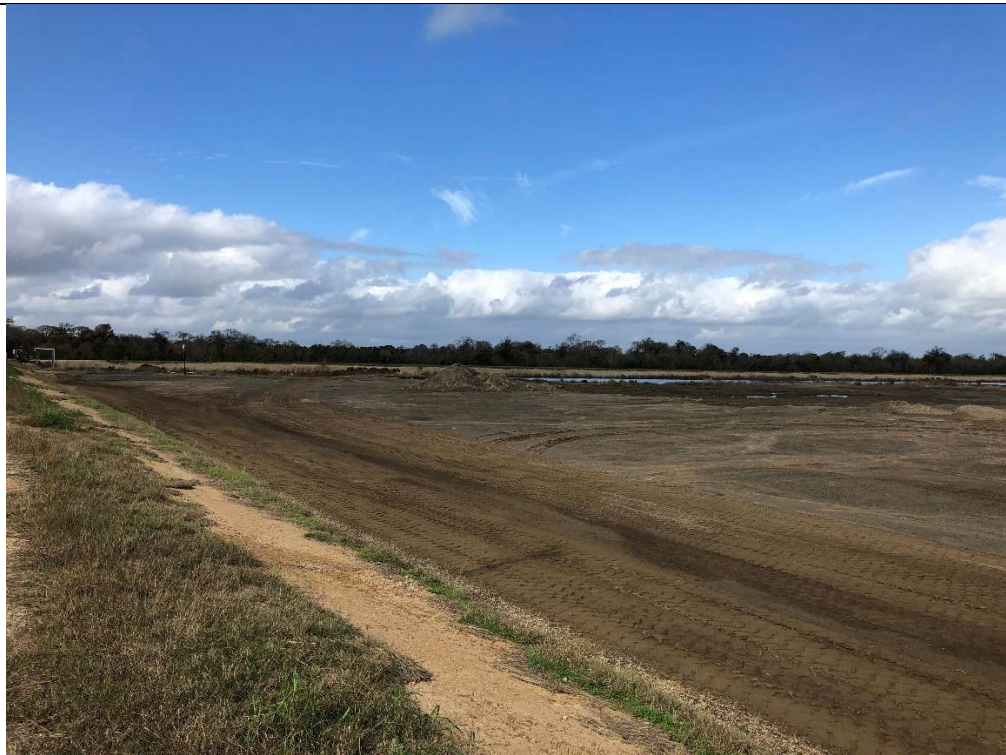
In general, the exterior slopes of the perimeter berms were well vegetated and demonstrated good alignment and slope grade. The crests of the berms around Cell 3 were free of rutting and misalignment.

Photograph P-2: View looking west-northwest from Cell 3's south berm. The crest road was well maintained, exterior slopes well vegetated without erosion issues, and interior slope either improved with stabilized CCR material or vegetated.

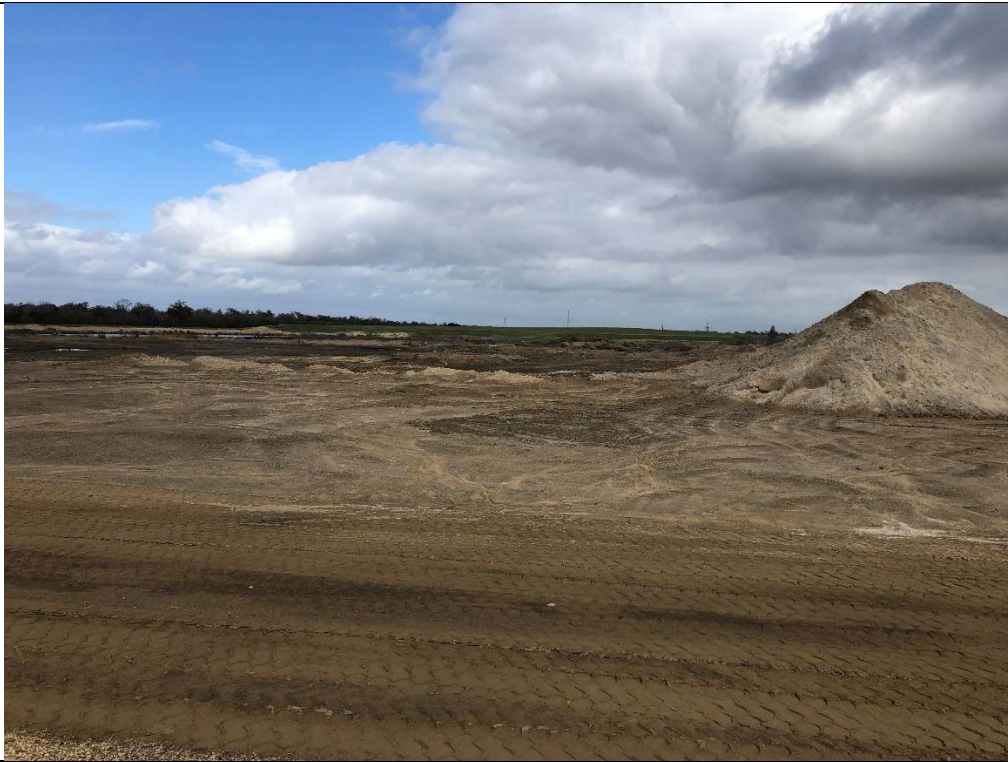
Photograph P-3: View looking north of interior of Cell 3 landfill and Cell 3 Coal Combustion Residual (CCR) waste piles.

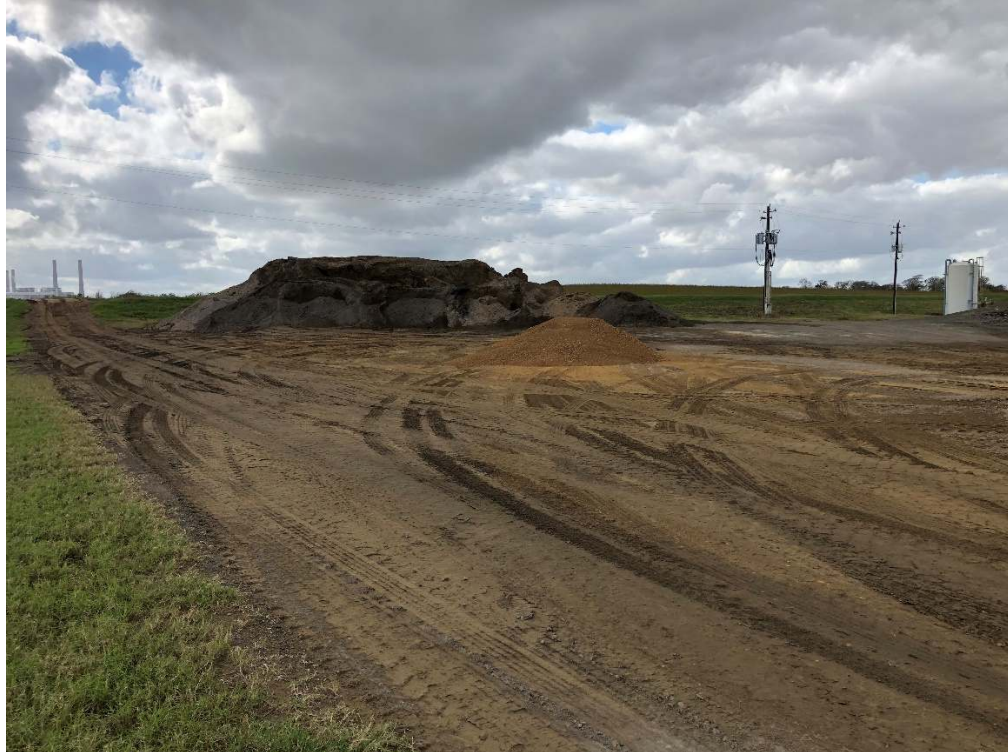
Photograph P-4: View looking southwest along the eastern edge of Cell 2A (the Pugmill Area). Stockpiled, salable CCR material is visible in the background of this photograph.

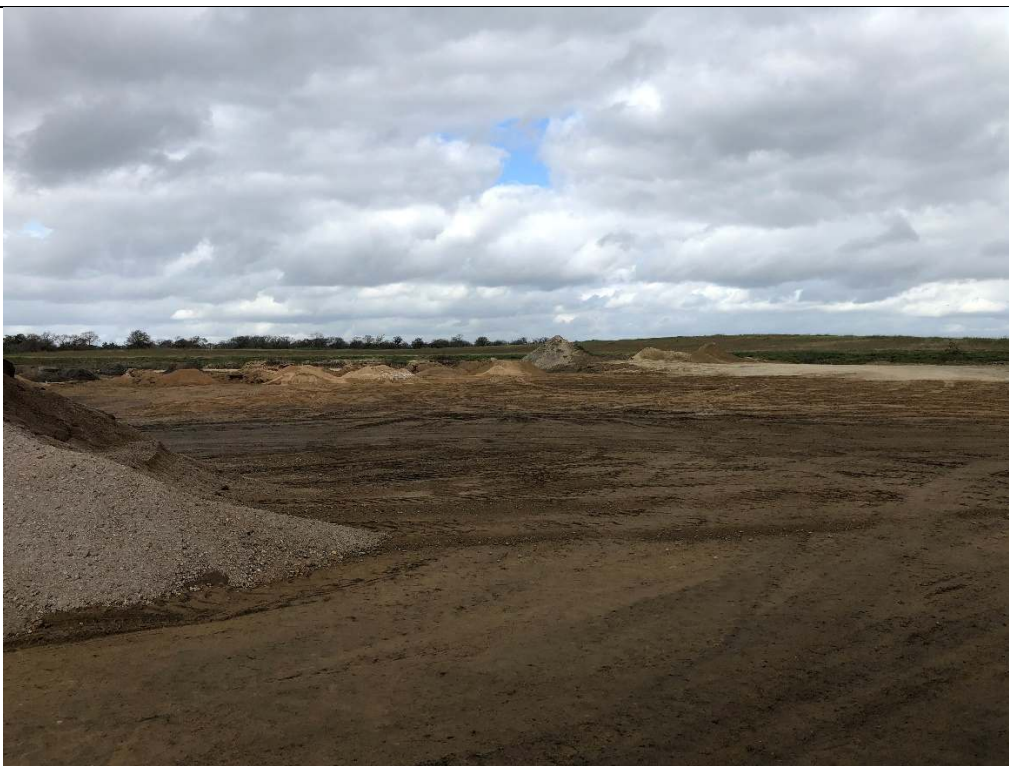
Photograph P-5: View looking northwest from the eastern edge of Cell 2A. Stockpiles of salable CCR material are visible in this photograph.

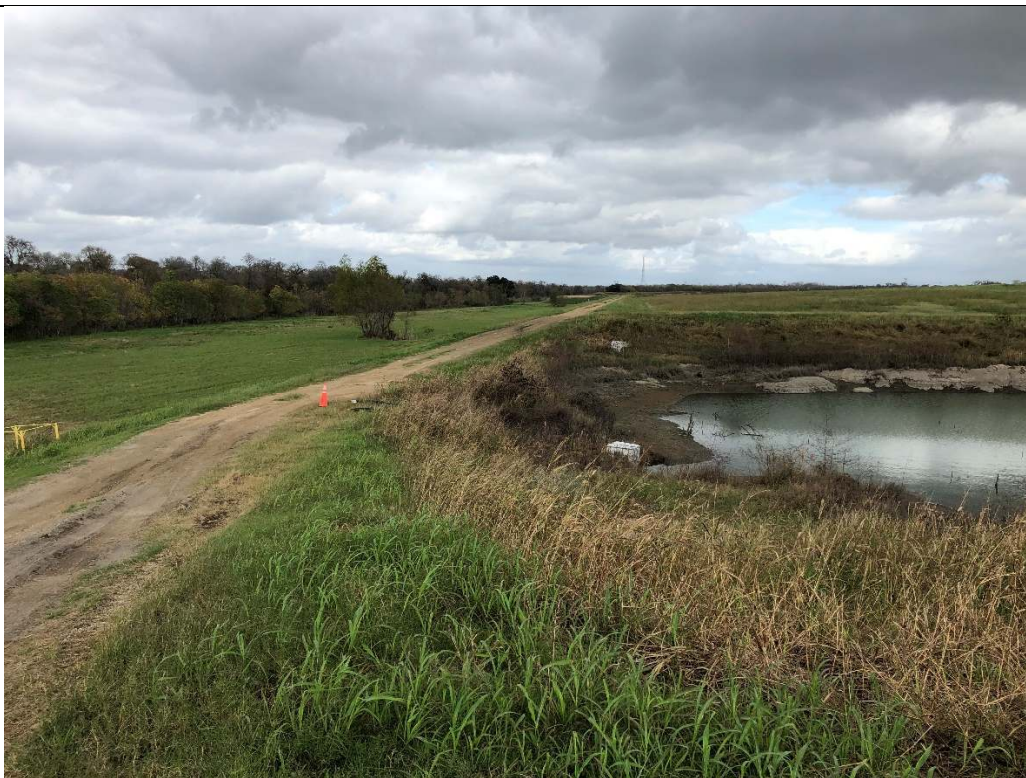
Photograph P-6: View looking north across the contact water pond in Cell 2A. Slopes were either stabilized or well vegetated.

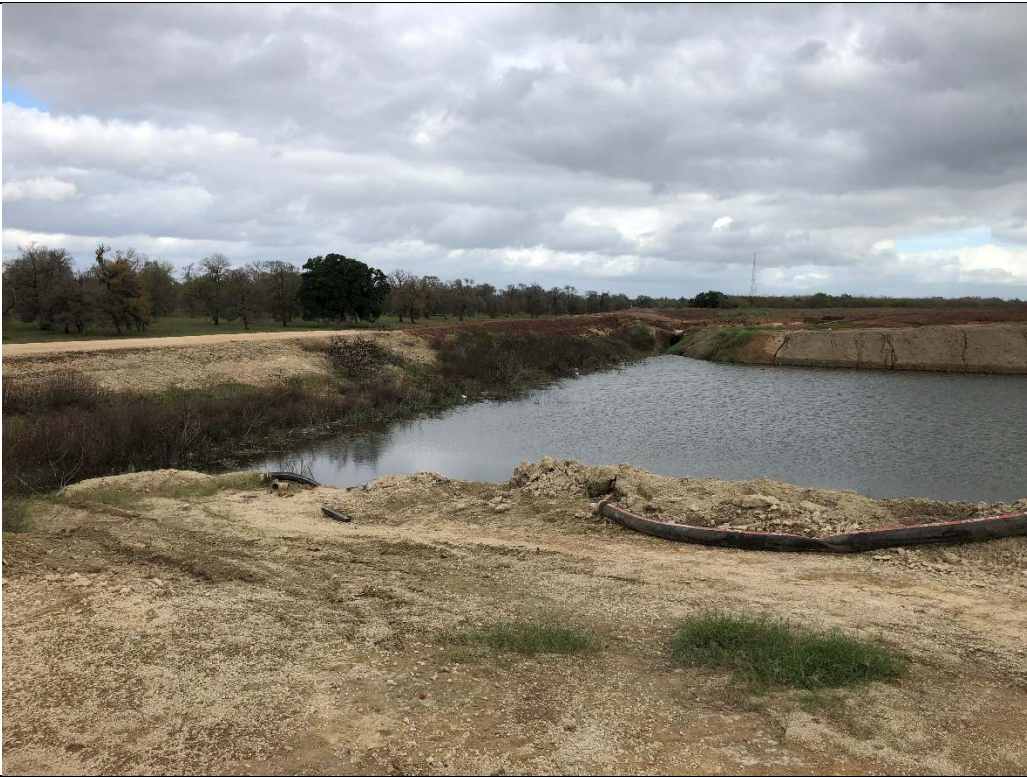
the perimeter berms. The crests of the perimeter berms were generally free of rutting and misalignment as shown on Photographs P-7 through P-9.

Photograph P-7: View looking north across the contact water pond in Cell 1C. This view is towards the area that was recently closed (located just to the north of the pond). Slopes were well stabilized.

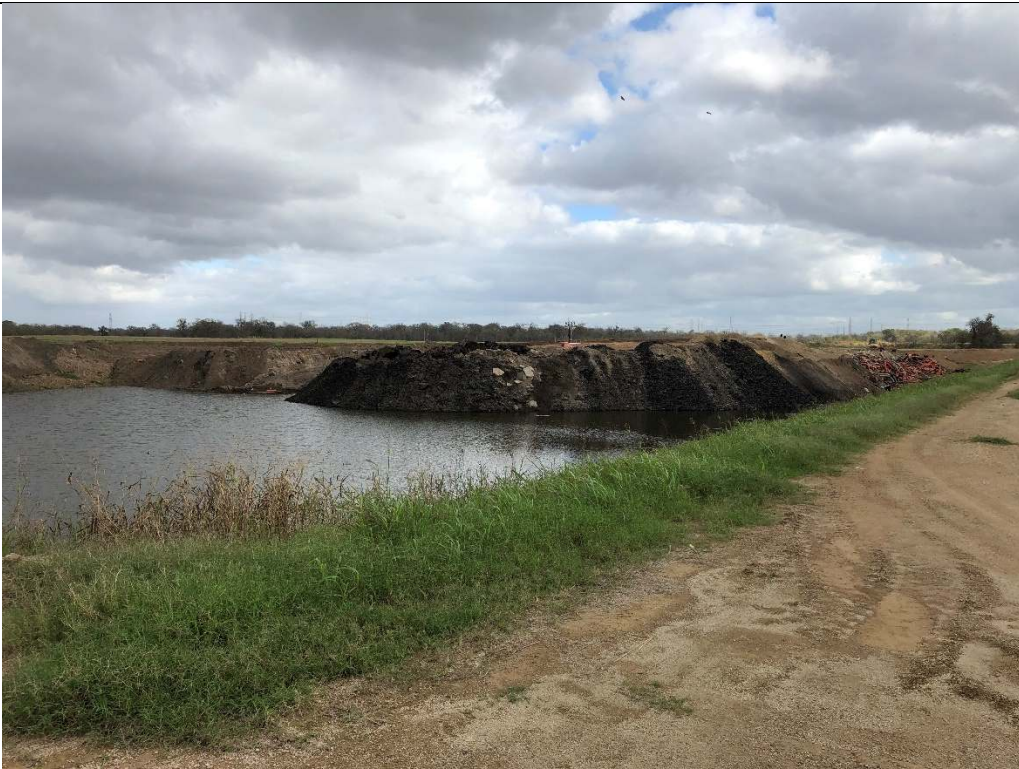
Photograph P-8: View looking northeast from the berm at the southwest corner of Cell 1C. The Cell 1C storm water pond is visible on the left side of this photograph, while waste piles are visible in the background.

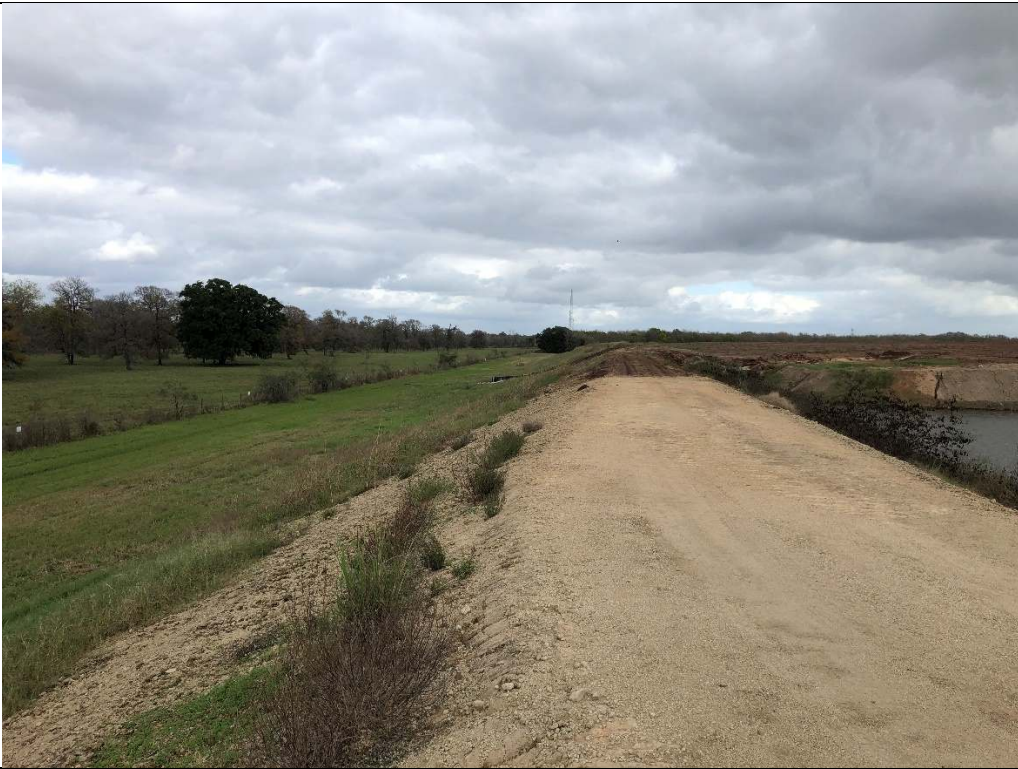
Photograph P-9: View looking north along the western berm of Cell 1C. Picture was taken from berm at southwest corner of Cell 1C. Outside of a recently repaired section (where a stormwater culvert was installed across the road) the crest road was stabilized. No significant rutting was observed.

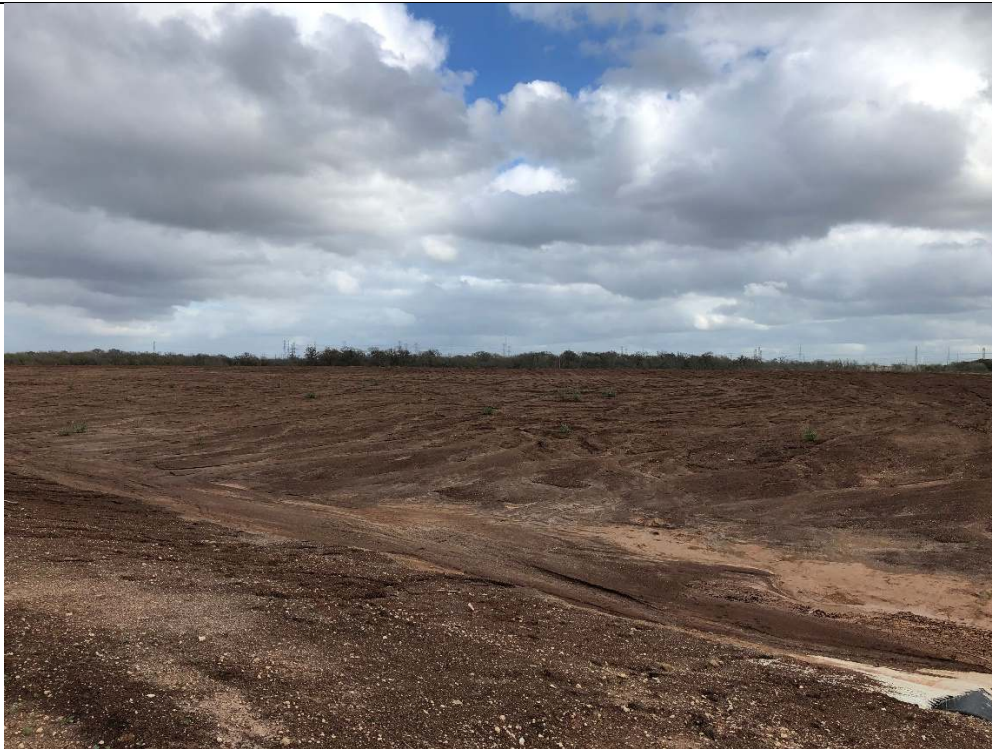
Photograph P-10: View looking east across recently closed portion of Cell 1C. Exposed topsoil (the uppermost layer of the cover system) is visible here.

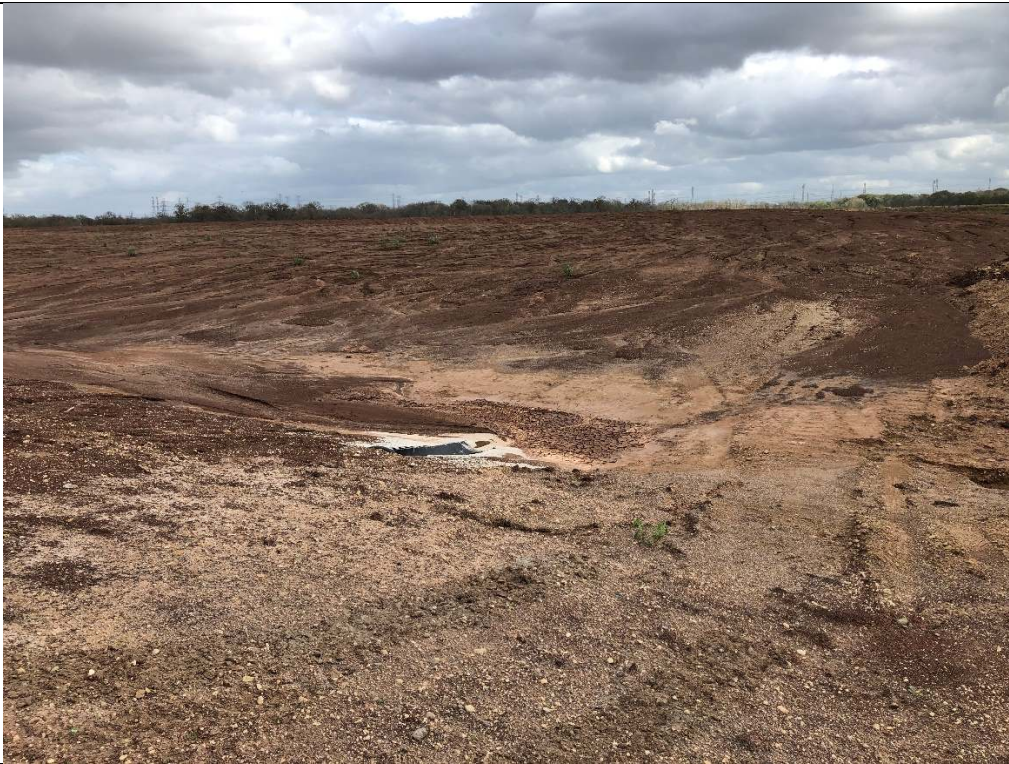
Photograph P-11: View looking east across recently closed portion of Cell 1C. The inlet of a stormwater culvert directing stormwater flow from the top of the recently closed portion of the landfill is visible. This culvert passes under the crest road.

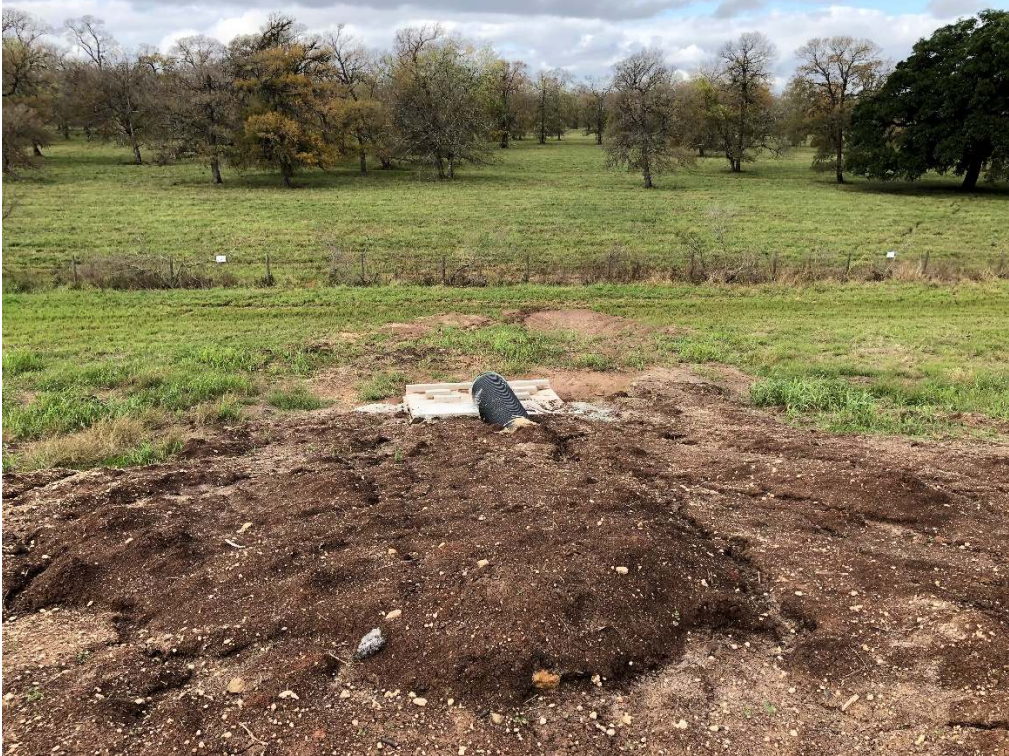
Photograph P-12: View looking west of the new stormwater culvert's outlet structure.

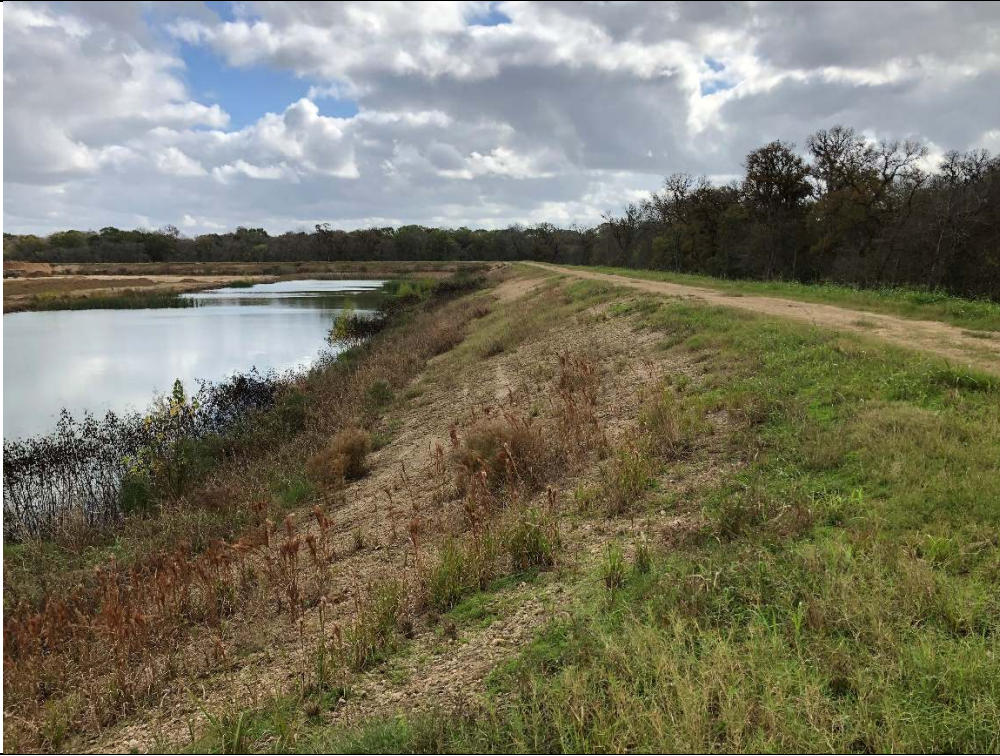
Minor sloughing of the interior slope of the southern berm was observed in 2022. This slough has been repaired, and the interior slope recompacted and resurfaced. The interior slope is not excessively steep (it appears to be a 3:1 or 4:1 slope), and it does not appear that the minor slough could create a situation of catastrophic or operational failure. This minor sloughing is an ongoing maintenance issue.

Photograph P-13: View looking southeast of Cell 2B's southern berm from southwest corner of landfill. The Cell 2B stormwater pond is visible to the left.

To prevent minor sloughing repaired areas should be improved with compacted clay material. In addition, the stabilized CCR surface on interior slopes should be replaced, repaired, and/or maintained, particularly in areas where it was removed as part of a slough repair or other maintenance activity. If this is impracticable, it is suggested that the internal slopes, particularly repaired portions of internal slopes, be well vegetated with grass as soon as possible after the repair is complete.

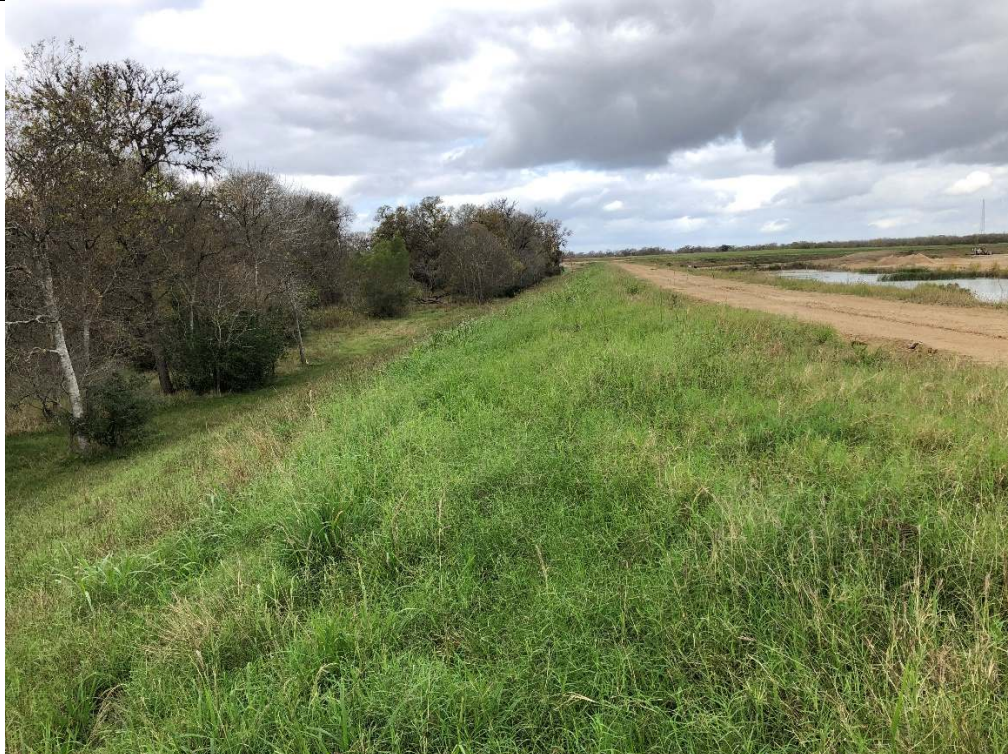
Photograph P-14: View looking northwest of the exterior slope of Cell 2B's southern berm. The exterior slope is well vegetated.

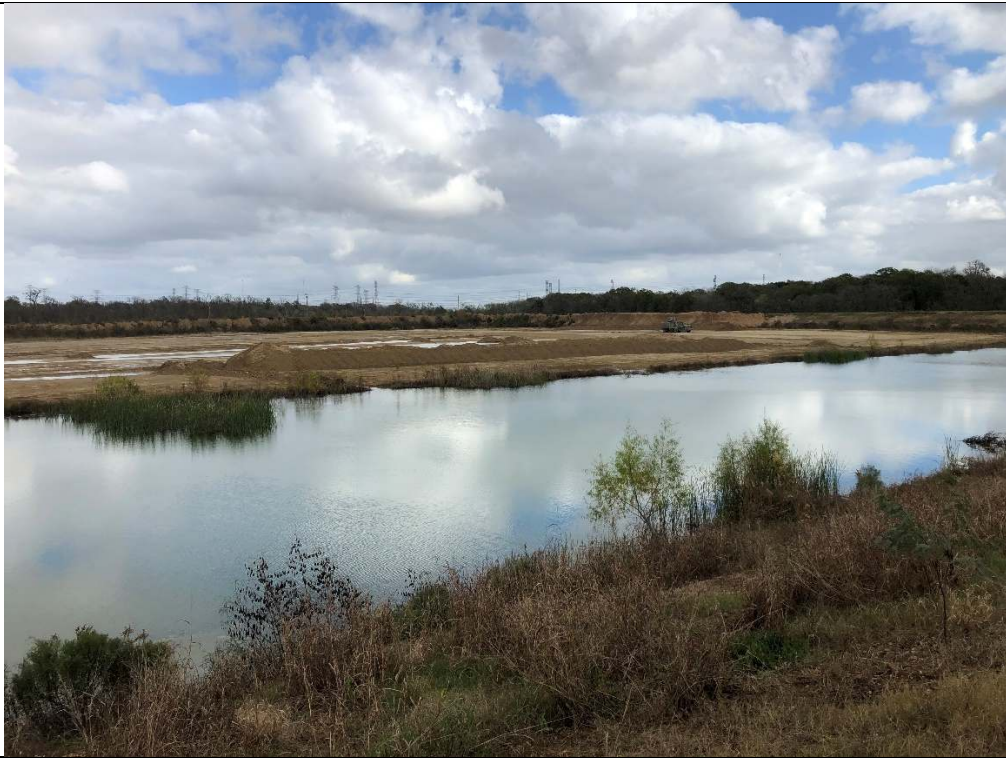
Photograph P-15: View looking northeast from southern berm across storm water pond at waste stored in Cell 2B. Stockpiled fly ash is visible in the center of the photograph, while CCR waste from the Flue Gas Desulfurization (FGD) system is visible beyond the fly ash.

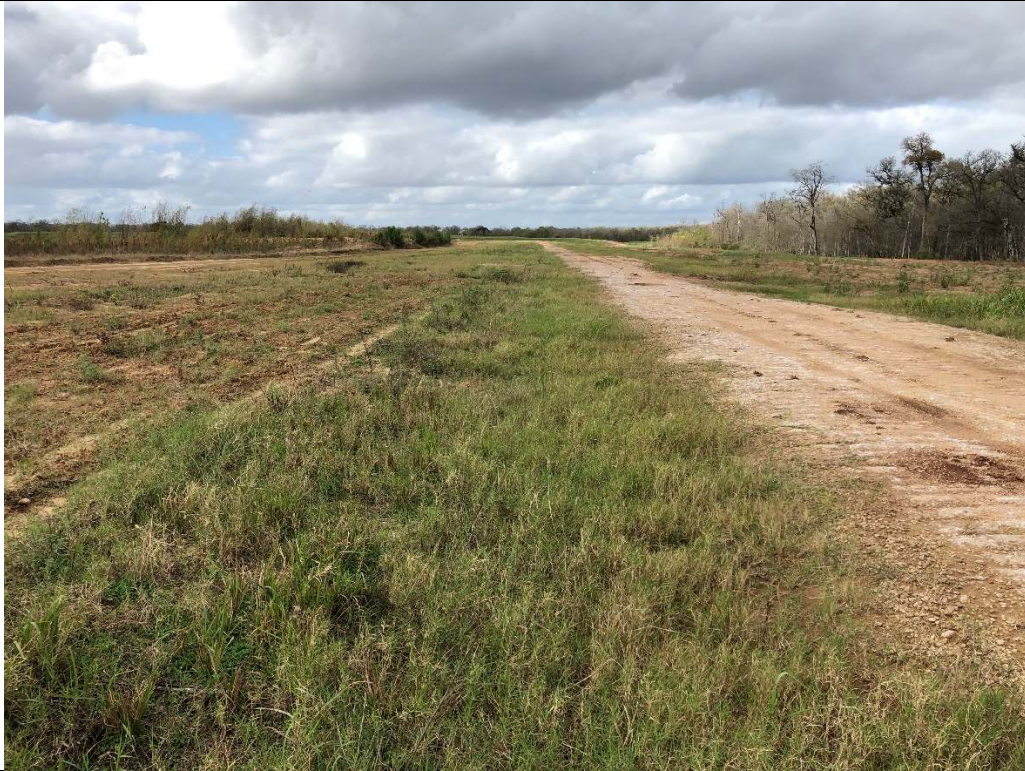
Photograph P-16: View looking west-northwest from northern Cell 2B berm. The crest road is visible to the right, FGD system waste is visible to the left.
