2023 Annual Inspection of CCR Unit

**W. A. Parish Electric Generating Station
Thompsons, Texas**

January 2024

NRG Texas Power LLC

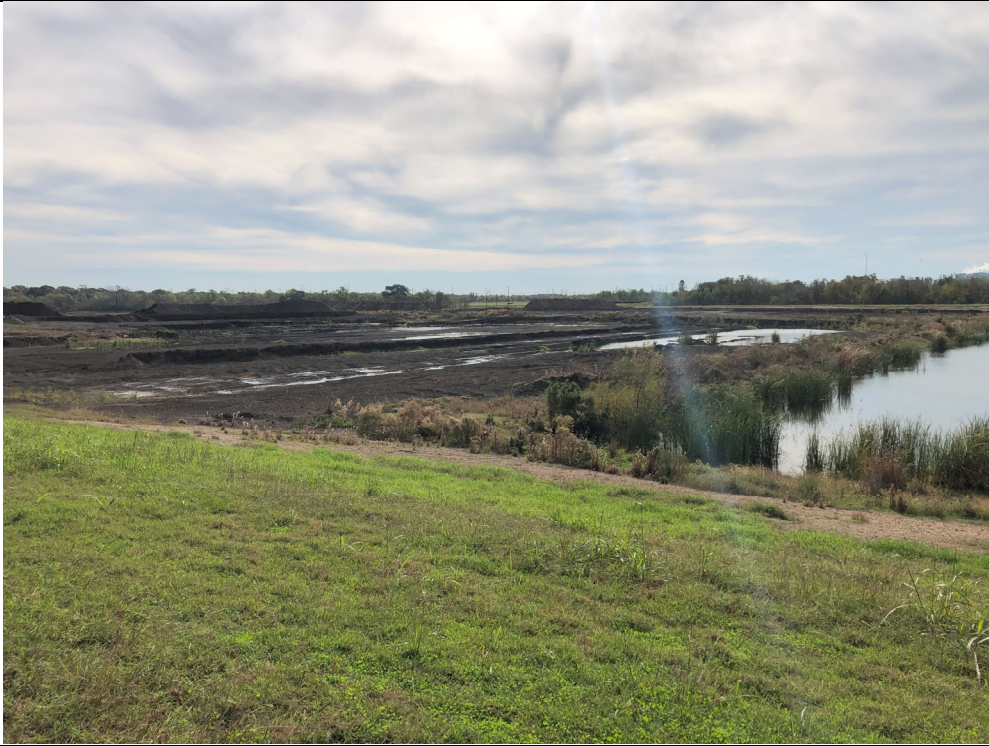
Photograph P-1: View looking southeast of Cell 3 from top of north berm. The darker bottom ash material is visible in this photograph, as is the area where the bottom ash is being excavated from the landfill and sold as road base. The Cell 3 storm water pond is visible to the right. The interior slopes and crest roads of the berms are either vegetated (slopes) or have been stabilized with a cemented fly ash mixture.

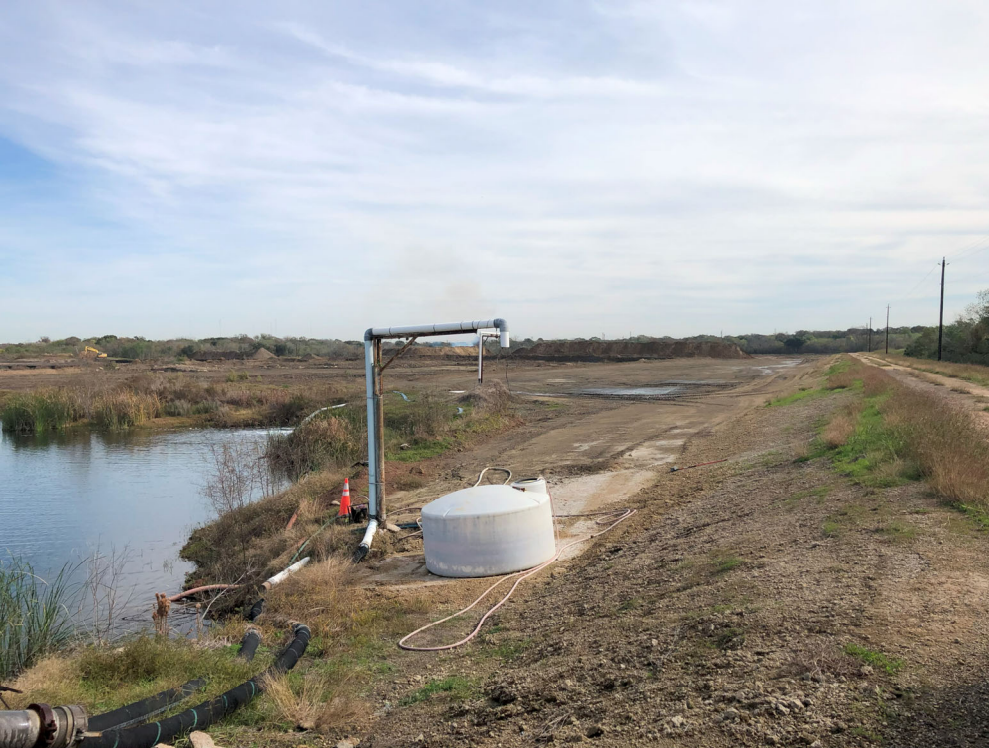
Photograph P-2: View looking east from Cell 3's southwest interior corner. The crest road was well maintained, exterior slopes well vegetated without erosion issues, and interior slope either improved with stabilized CCR material or vegetated.

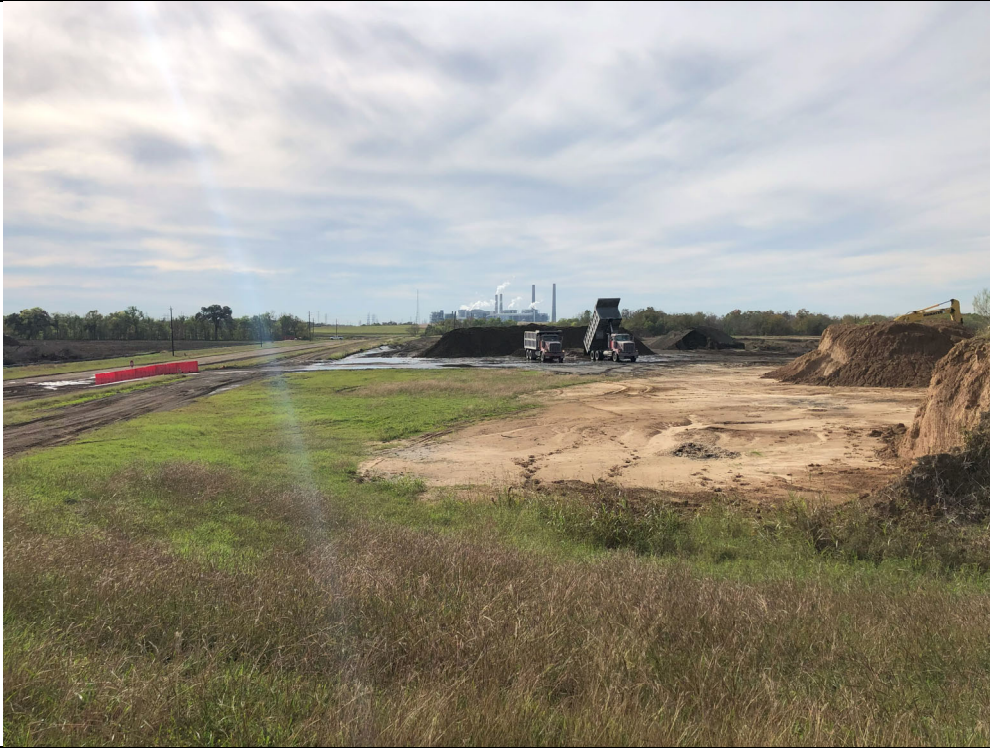
Photograph P-3: View looking south of the Cell 3 landfill and Cell 3 Coal Combustion Residual (CCR) waste piles.

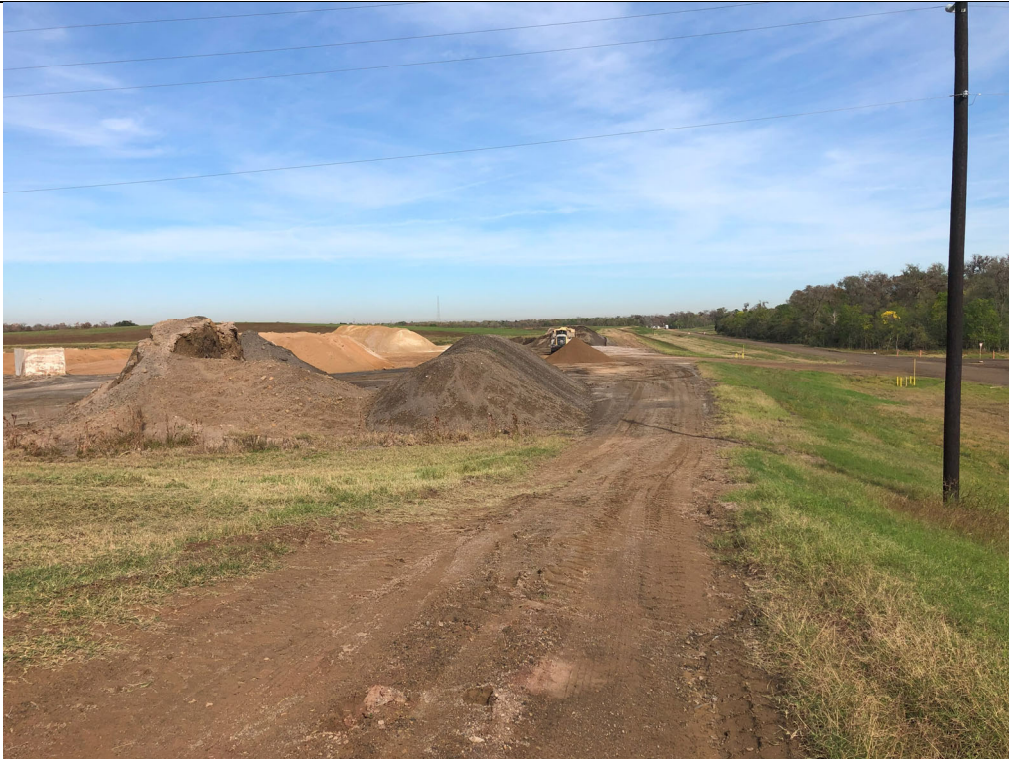
Photograph P-4: View looking north along the eastern edge of Cell 2A (the Pugmill Area). Stockpiled, salable CCR material is visible in this photograph.

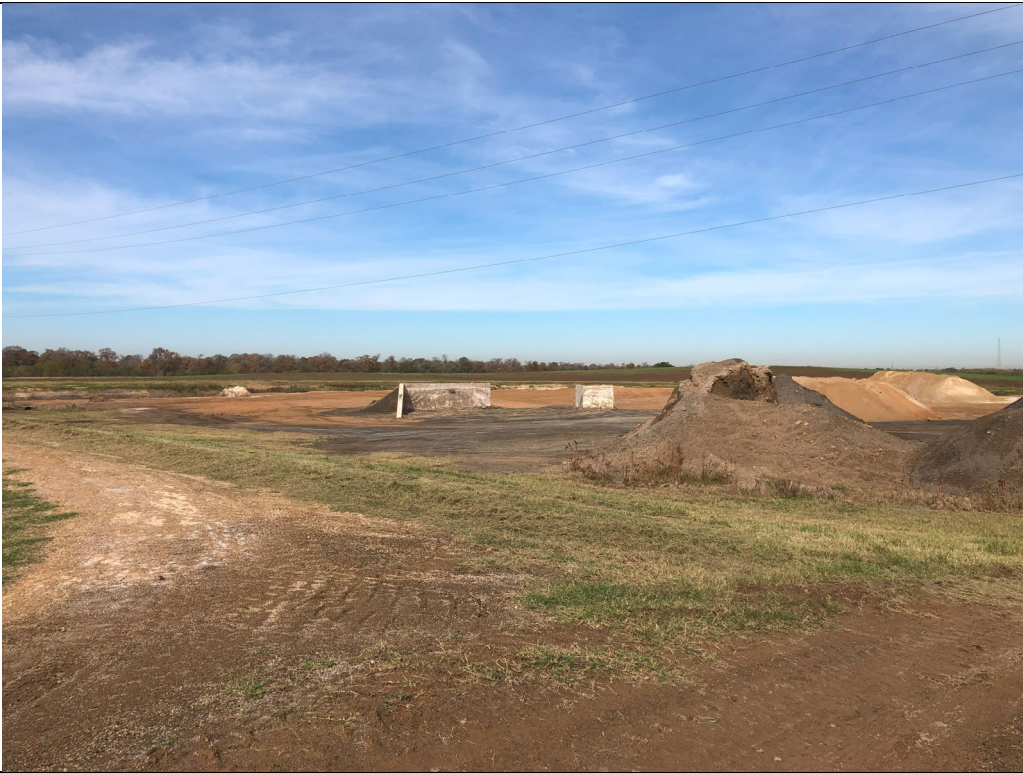
Photograph P-5: View looking northwest from the eastern edge of Cell 2A. Stockpiles of salable CCR material are visible in this photograph.

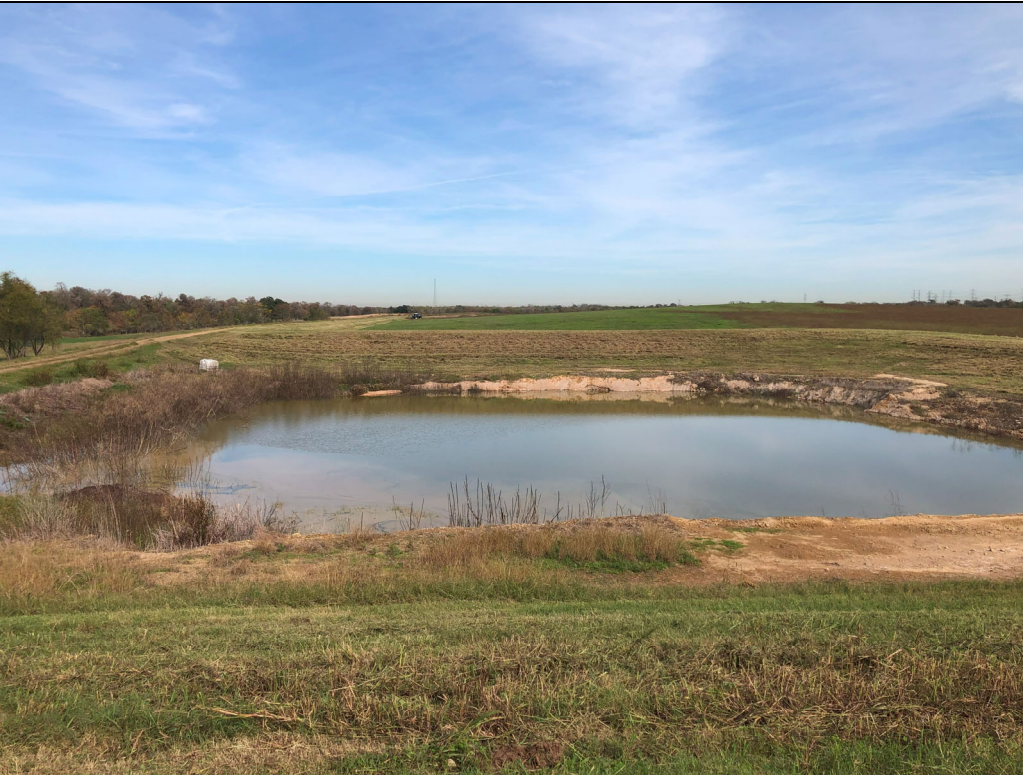
Photograph P-6: View looking north across the contact water pond in Cell 2A. Slopes were either stabilized or well vegetated.

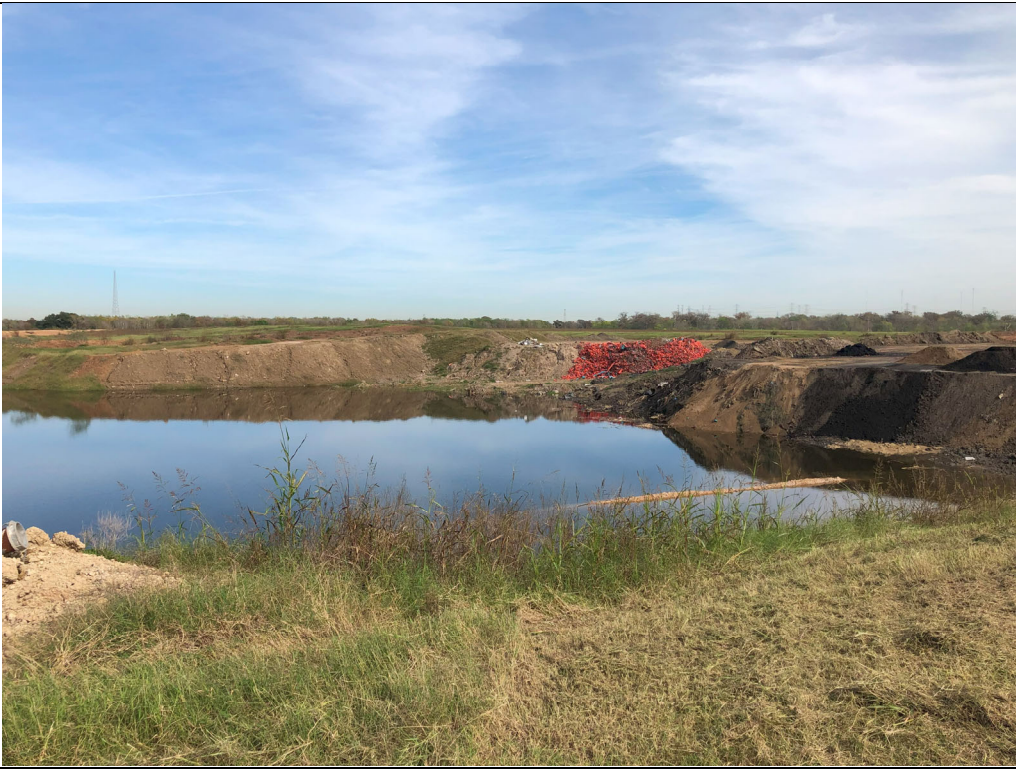
Photograph P-7: View looking north across the contact water pond in Cell 1C. This view is towards the area that was recently closed (located just to the north of the pond and left background of this photograph).

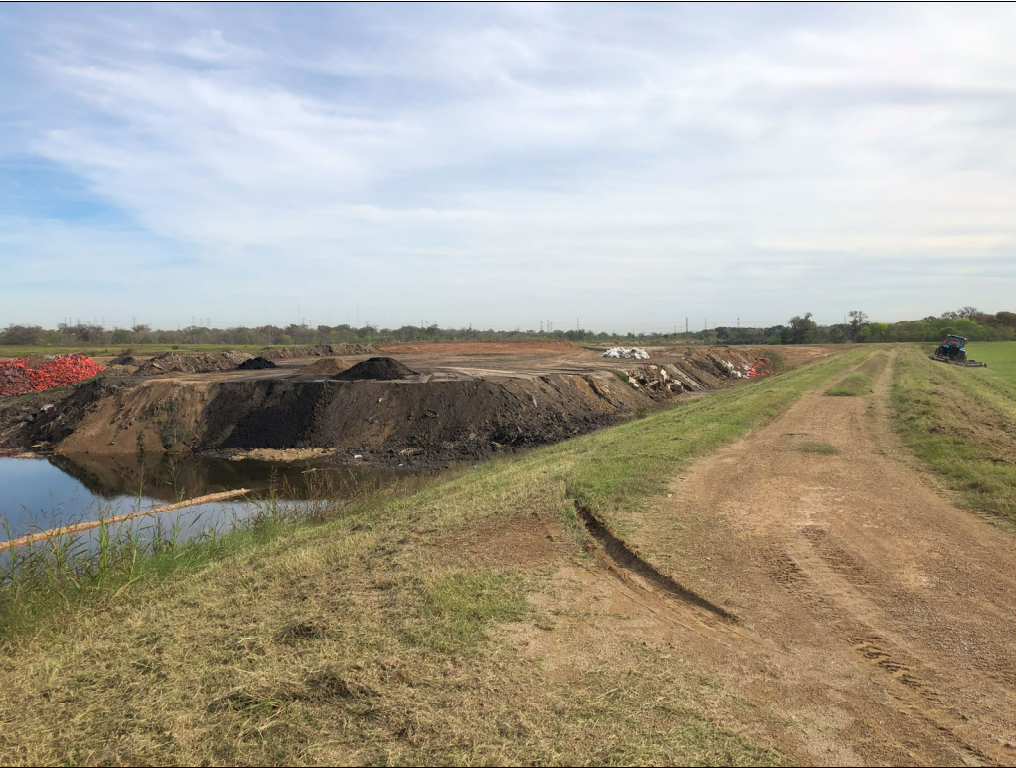
the perimeter berms. The crests of the perimeter berms were generally free of rutting and misalignment as shown on Photographs P-8 through P-10.

Photograph P-8: View looking northeast from the berm at the southwest corner of Cell 1C. The Cell 1C storm water pond is visible on the left side of this photograph, while waste piles are visible in the background.

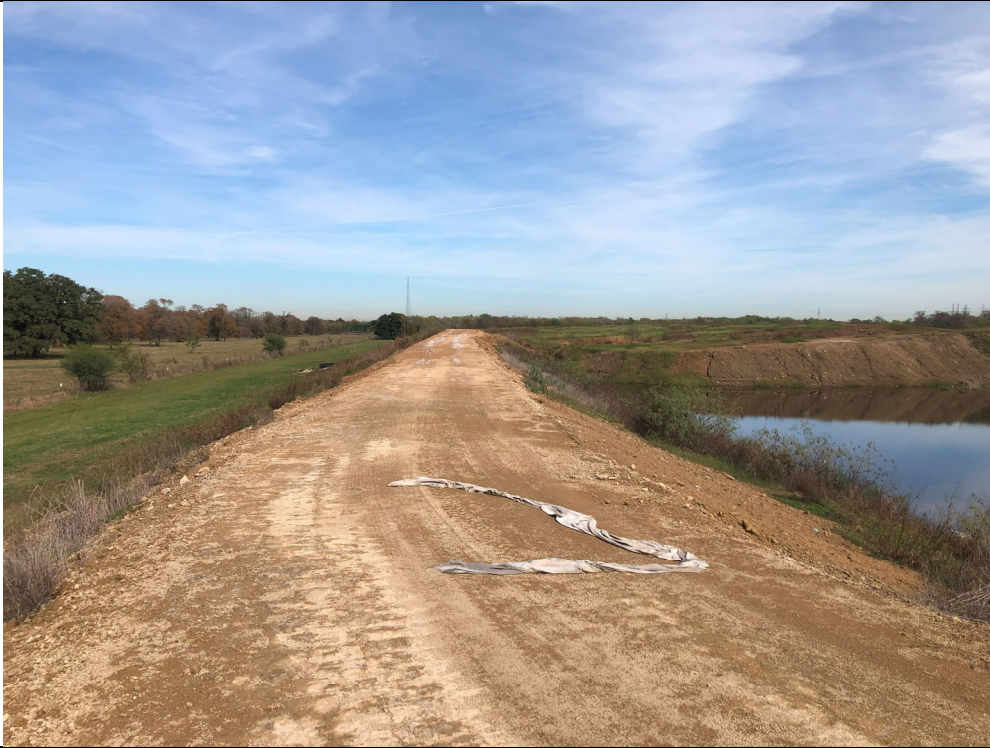
Photograph P-9: View looking north along the western berm of Cell 1C. Picture was taken from berm at southwest corner of Cell 1C. No significant rutting was observed.

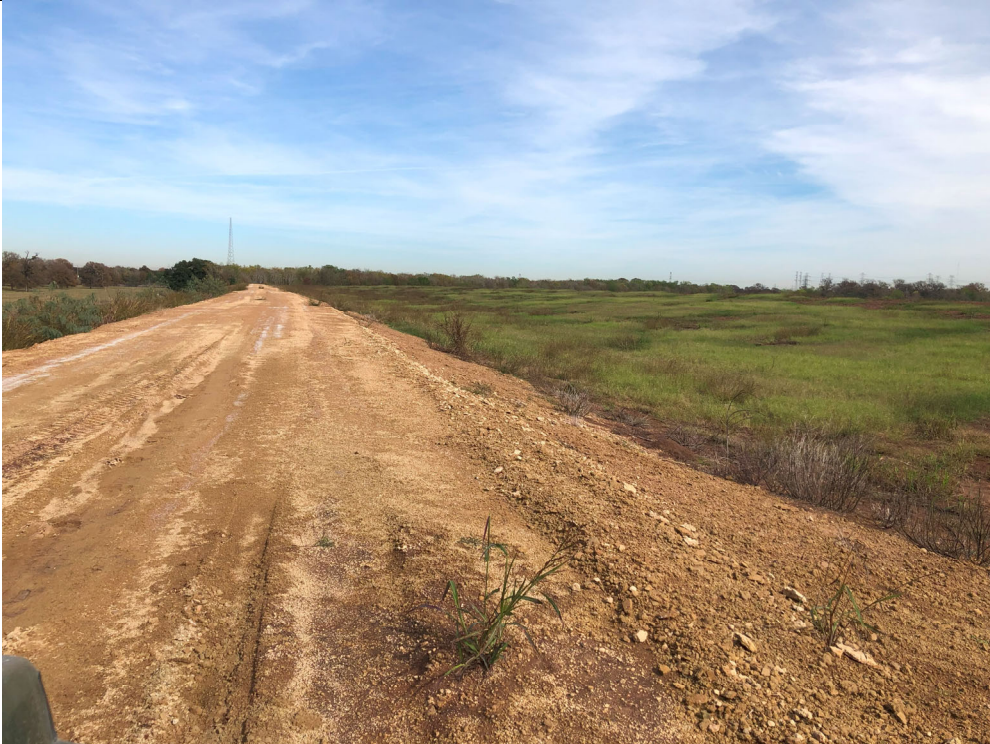
The interior slopes of Cell 1C exhibited good alignment, grades, and vegetation or erosion resistant stabilized material. No adverse conditions were identified for the inner slopes of the perimeter berms. An 11-acre portion of the landfill located along the western berm was closed in 2022. Photograph P-10 shows grass has been established on the topsoil portion of the cover system.

Photograph P-10: View looking north along the west perimeter road adjacent to Cell 1C. The portion of Cell 1C that was closed in 2022 is visible to the right.

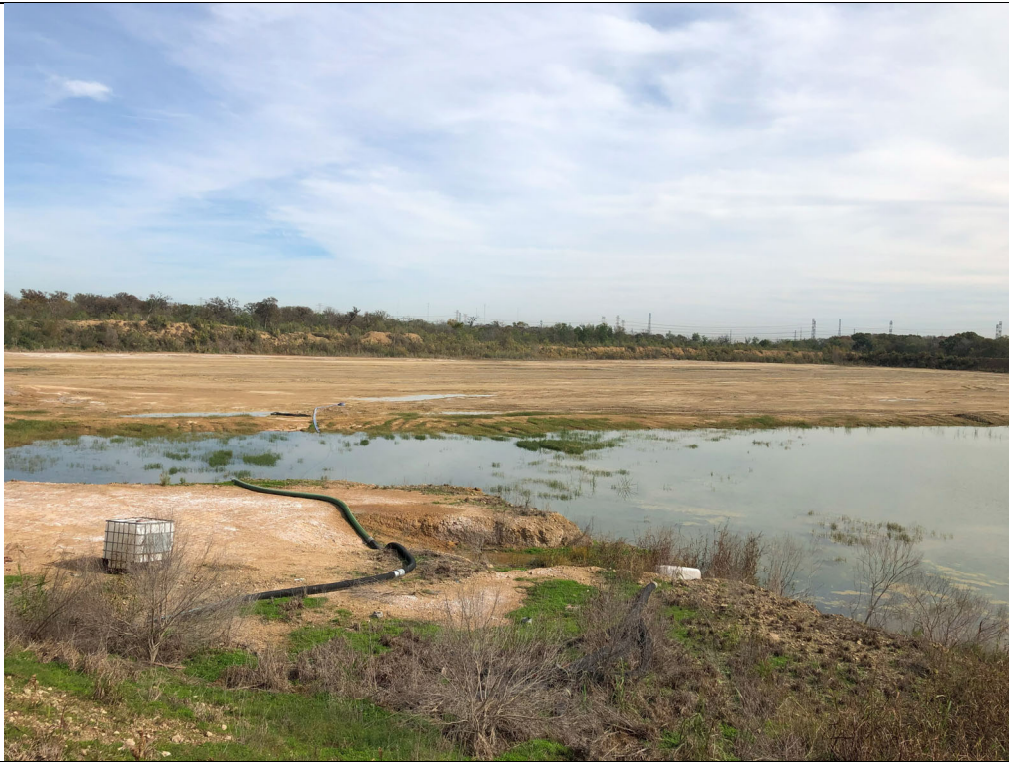
Photograph P-11: View looking northeast Cell 2B. The Cell 2B stormwater pond is visible in the foreground, the fly ash storage and loading area is visible in the middle background, and the Flue Gas Desulfurization (FGD) waste is visible in the far background.

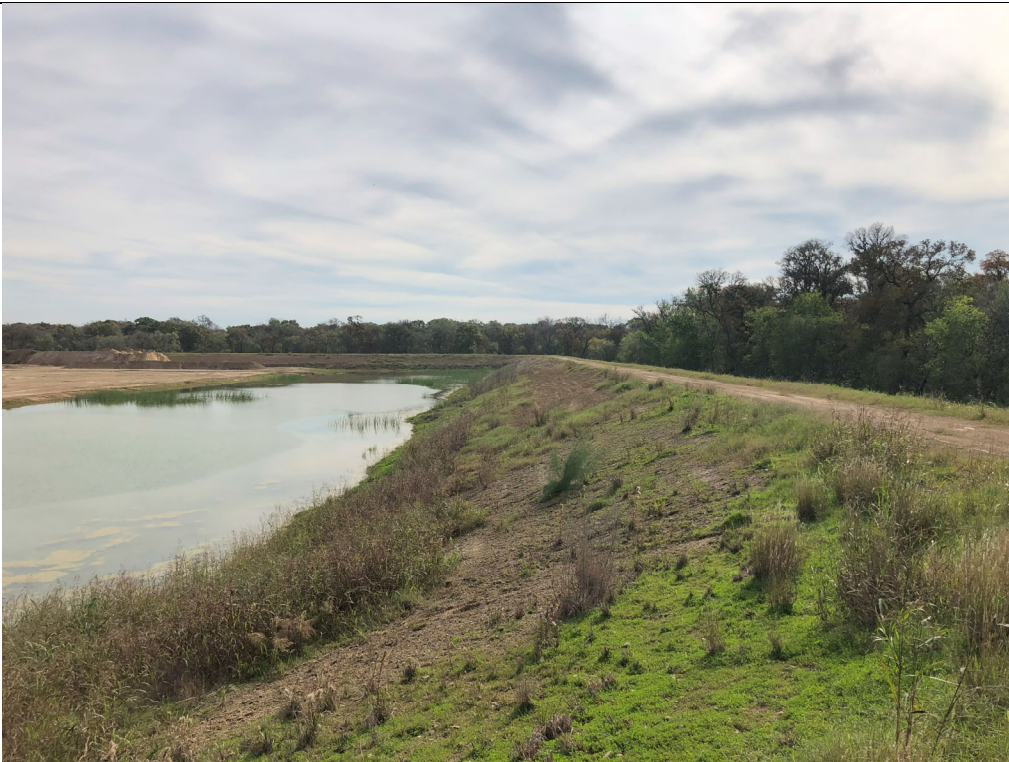
Minor sloughing of the interior slope of the southern berm was observed in 2022 and during the first half of 2023. The minor sloughing has been repaired, and the interior slope recompacted and resurfaced. The interior slope is not excessively steep (it appears to be a 3:1 or 4:1 slope), and it does not appear that the minor slough could create a situation of catastrophic or operational failure. This minor sloughing is an ongoing maintenance issue.

Photograph P-12: View looking southeast of Cell 2B's southern berm from southwest corner of landfill. The Cell 2B stormwater pond is visible to the left.

To prevent minor sloughing repaired areas should be improved with compacted clay material. In addition, the stabilized CCR surface on interior slopes should be replaced, repaired, and/or maintained, particularly in areas where it was removed as part of a slough repair or other maintenance activity. If this is impracticable, it is suggested that the internal slopes, particularly repaired portions of internal slopes, be well vegetated with grass as soon as possible after the repair is complete.

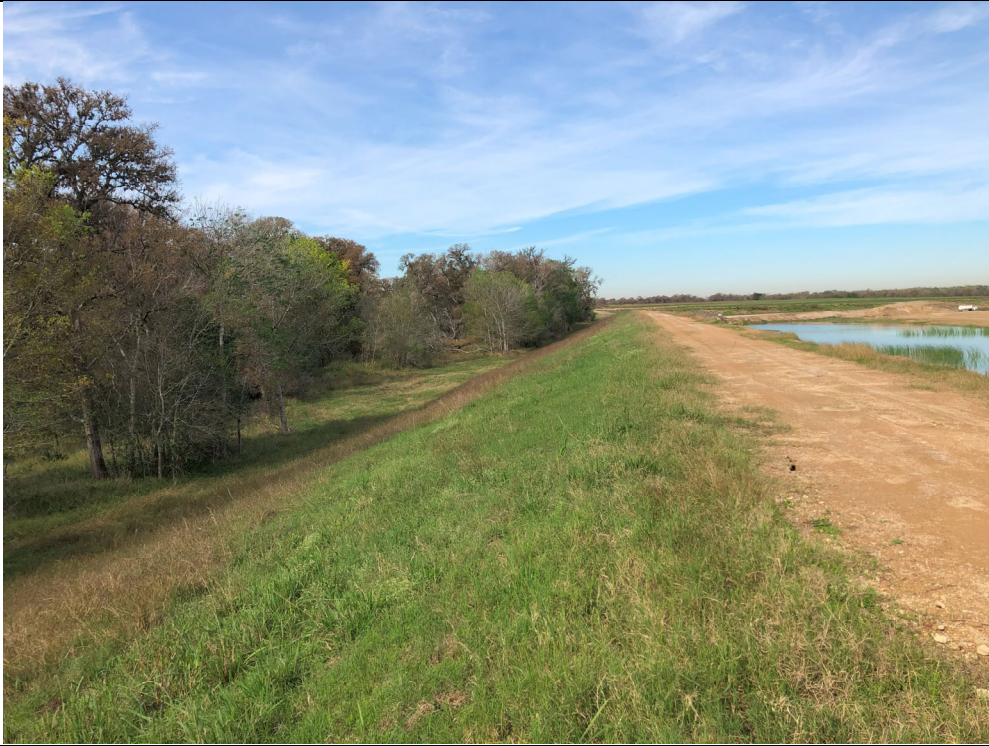
Photograph P-13: View looking northwest of the exterior slope of Cell 2B's southern berm. The exterior slope is well vegetated.

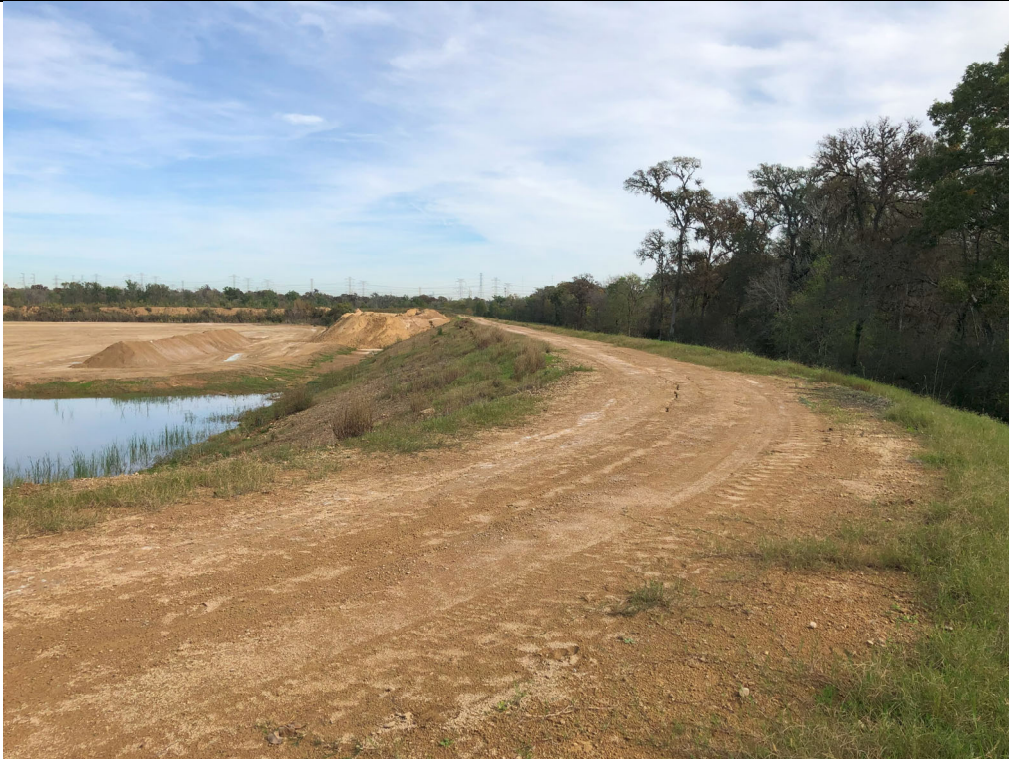
Photograph P-14: View looking northwest from the southeast corner of Cell 2B. The crest road is visible to the right, FGD system waste is visible to the left.
