**NRG TEXAS POWER, LLC
WA PARISH STATION, UNITS 5, 6, 7, & 8**

ANNUAL INSPECTION OF CCR IMPOUNDMENTS AND LANDFILL

S&L Report No.: SL-013202

Date: January 18, 2016

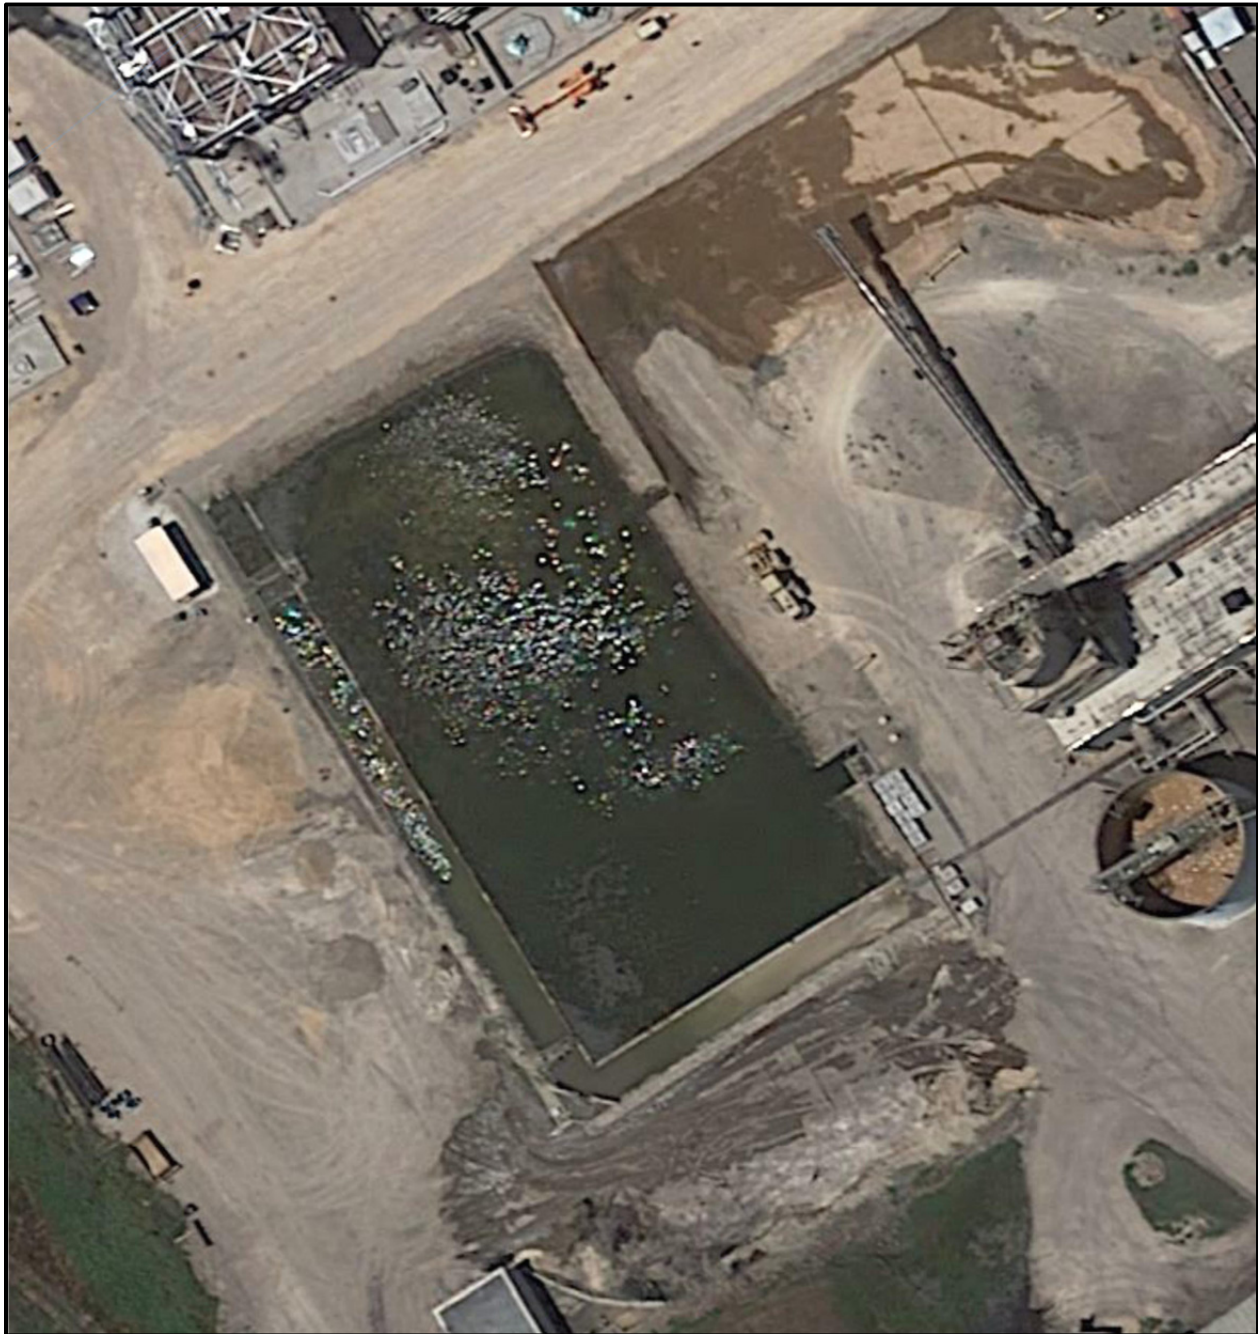
The location and general arrangement of the FGD Emergency Pond are depicted on Figures 1 and 2 and also Photograph P-1, which were all obtained from Google Earth Pro®. This Google Earth Pro image appears to accurately represent the general configuration and conditions observed at the FGD Emergency Pond by S&L on December 1, 2015, with the exception that the water level in the pond was higher in Photograph P-1 than it was at the time of the inspection.

Photograph P-1 – From Google Earth Pro, dated July 2015. Downloaded January 11, 2016.
FGD Emergency Pond (E-Pond): Aerial view of incised FGD Emergency Pond.
Also shown is the gypsum dewatering slab and stack out area
(east of pond, where front end loader is located).

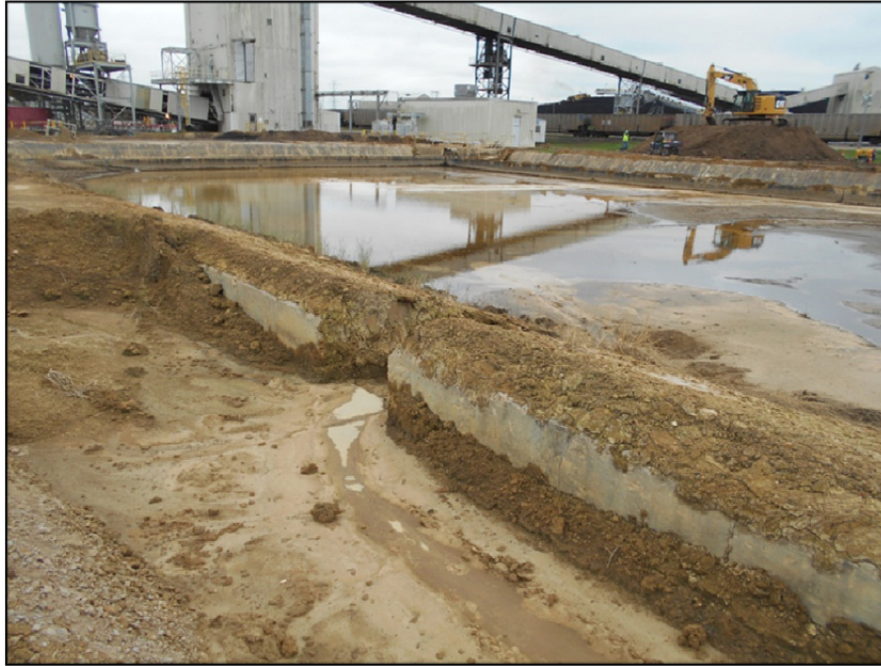
It should be noted that the soil stockpile in the background of Photographs P-2 and P-3 are of soil associated with the ongoing carbon capture construction work, and not CCR material excavated from the FGD Emergency Pond.

Photograph P-2 – Taken December 1, 2015 by David E. Nielson
FGD Emergency Pond: Looking south at the southern and western banks, which are incised.
This verifies that the Federal CCR Rule regarding inspections is not applicable to
the FGD Emergency Pond.

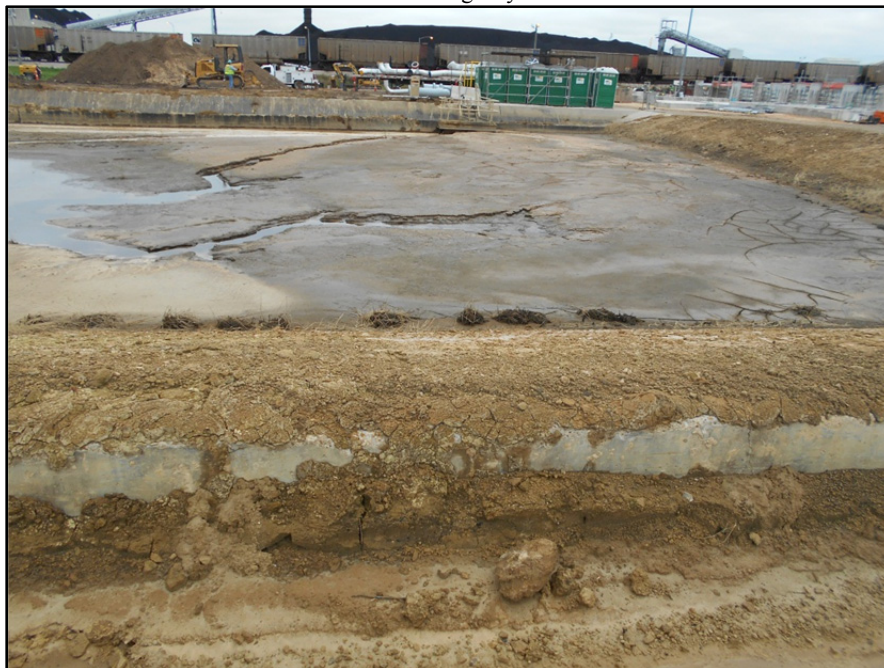
Photograph P-3 – Taken December 1, 2015 by David E. Nielson
FGD Emergency Pond: Looking southwest at the western bank, which is incised.
The dark horizontal line on the concrete wall in the background, as well as the level of the top
of sediment in the right hand portion of the pond indicate the operating water level of the pond,
which is well below the surrounding land surface (incised).

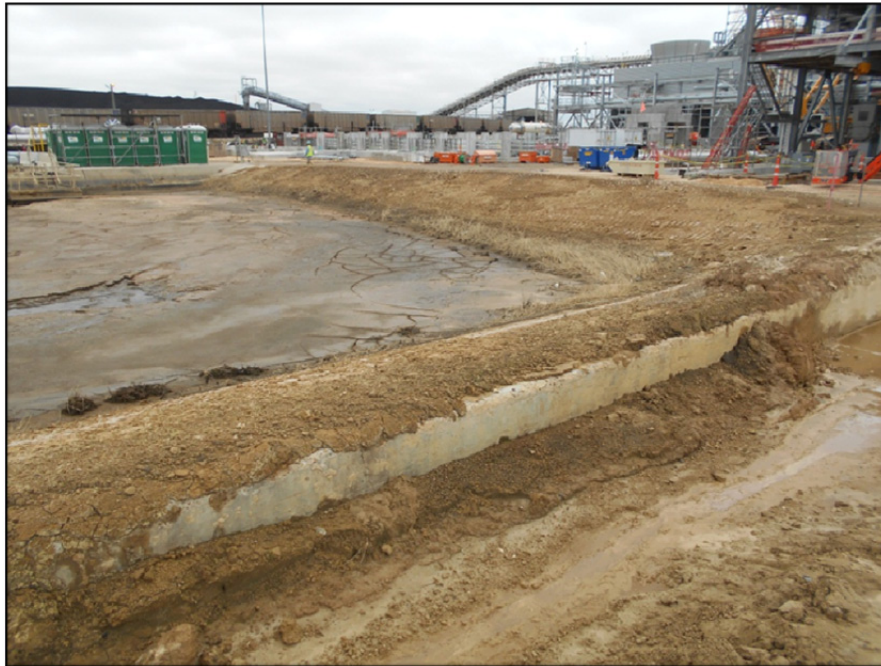
Photograph P-4 – Taken December 1, 2015 by David E. Nielson
FGD Emergency Pond: Looking west at the northern end of FGD Emergency Pond,
which is incised.

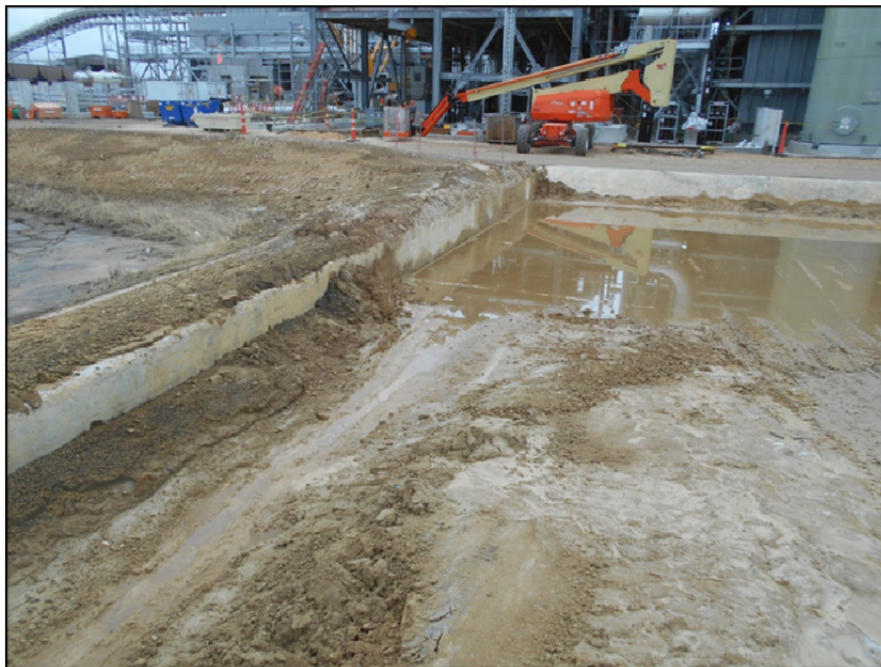
Photograph P-5 – Taken December 1, 2015 by David E. Nielson
FGD Emergency Pond: Looking northwest at the junction of the northeast corner of FGD
Emergency Pond and the adjacent depressed drainage slab, which is an incised area where
excavated CCR materials are allowed to dry. This verifies that the Federal CCR Rule regarding
inspections does not apply to the FGD Emergency Pond.

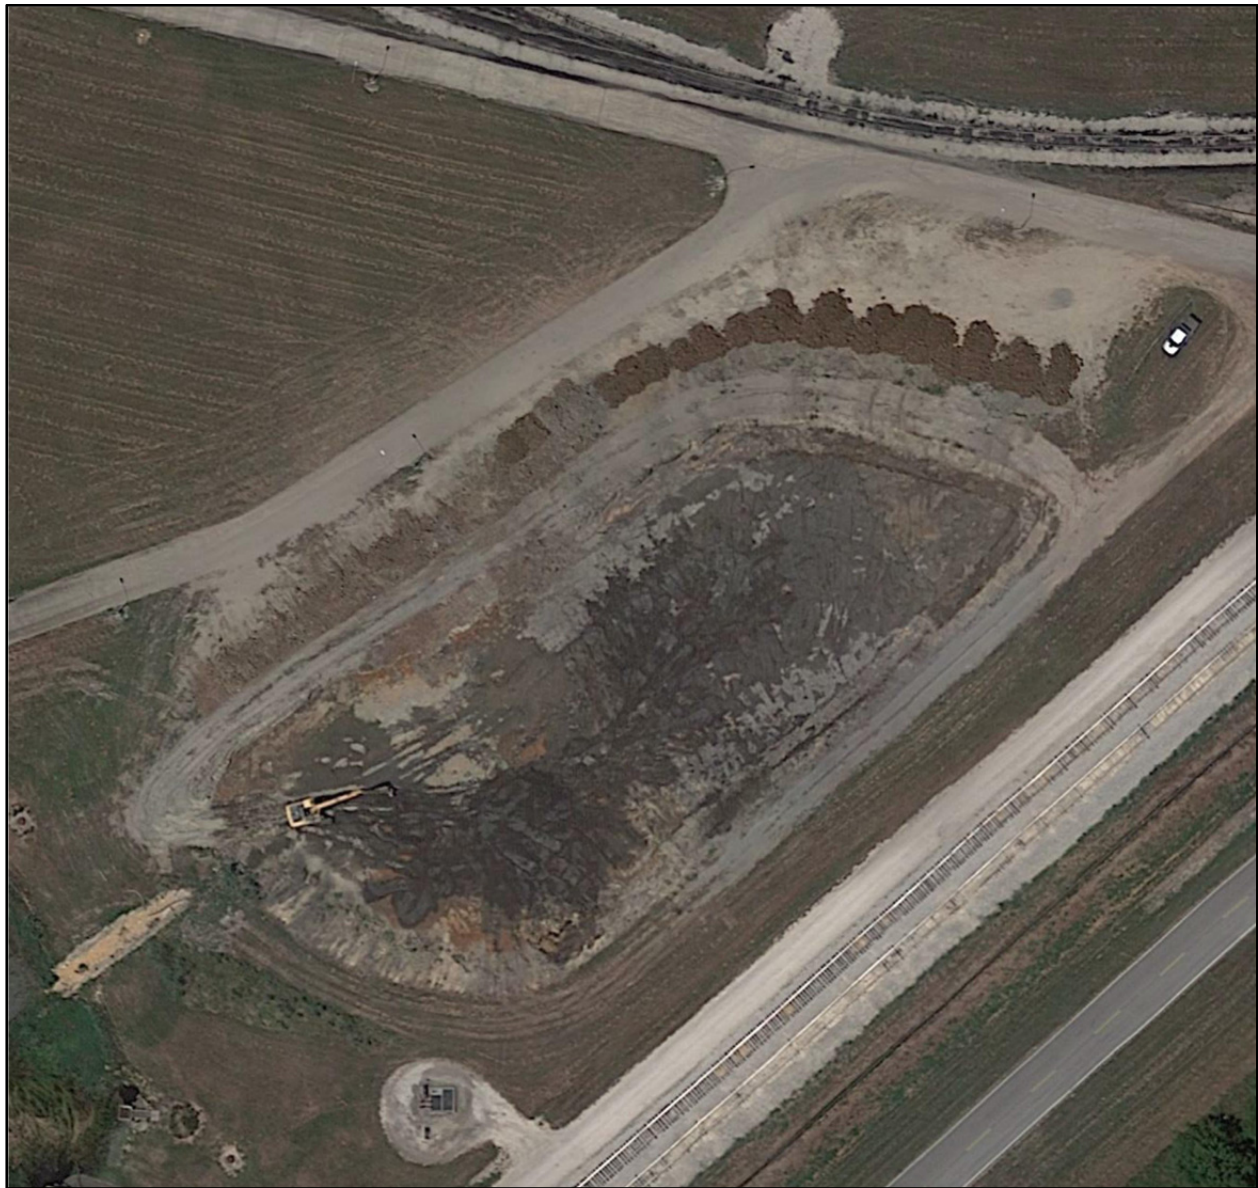
Photograph P-6 – From Google Earth Pro, dated July 2015. Downloaded January 8, 2016.
Air Preheater Pond: Aerial view of Air Preheater Pond. Note pond dredging is underway at the time of the photograph. Also note the overflow channel from the western portion of the pond into the coal yard runoff pond to the west.

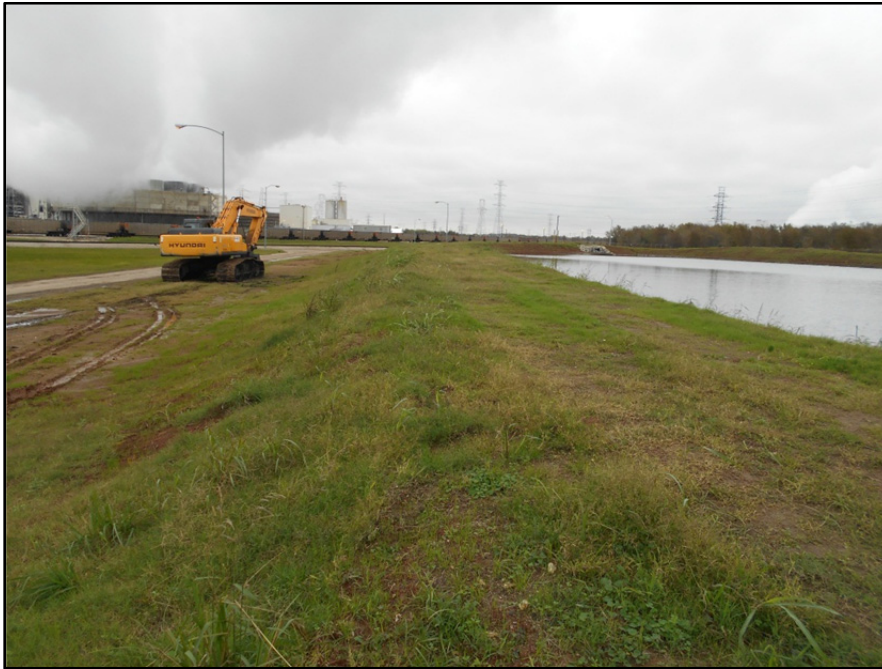
The dikes are shown in Photographs P-7, P-8 and P-9. The dikes were found to be in good condition with generally good vegetation, good slope alignment and appropriate grades.

Photograph P-7 – Taken December 1, 2015 by David E. Nielson
Air Preheater Pond: Looking northwest along exterior slope and crest of western dike.
Note minor vegetation deficiencies as the recent seeding of grass becomes established.
The grass vegetation has become well established since Photograph P-6 was taken.

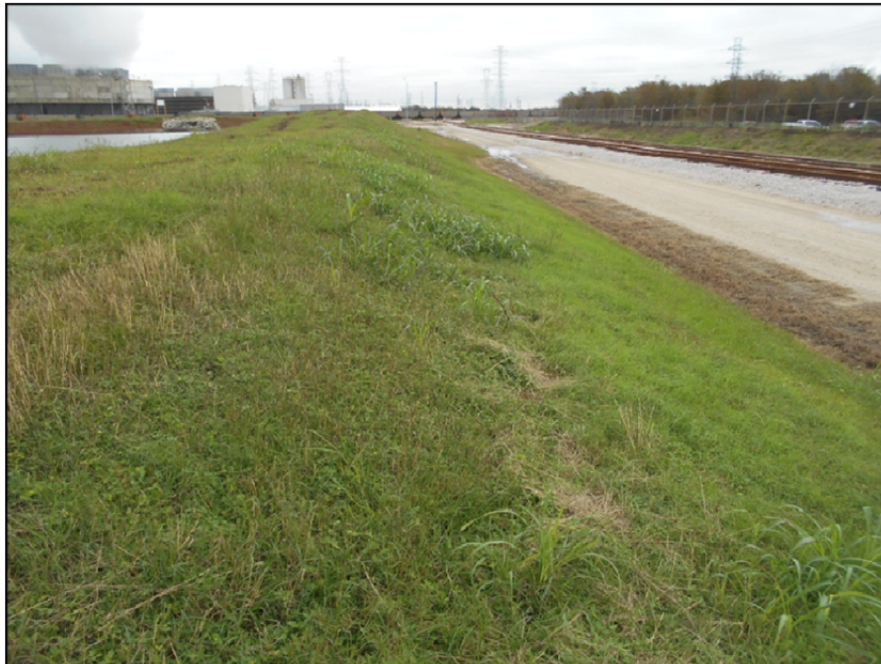
Photograph P-8 – Taken December 1, 2015 by David E. Nielson
Air Preheater Pond: Looking northwest along the exterior slope of the eastern dike.
Note good vegetation.

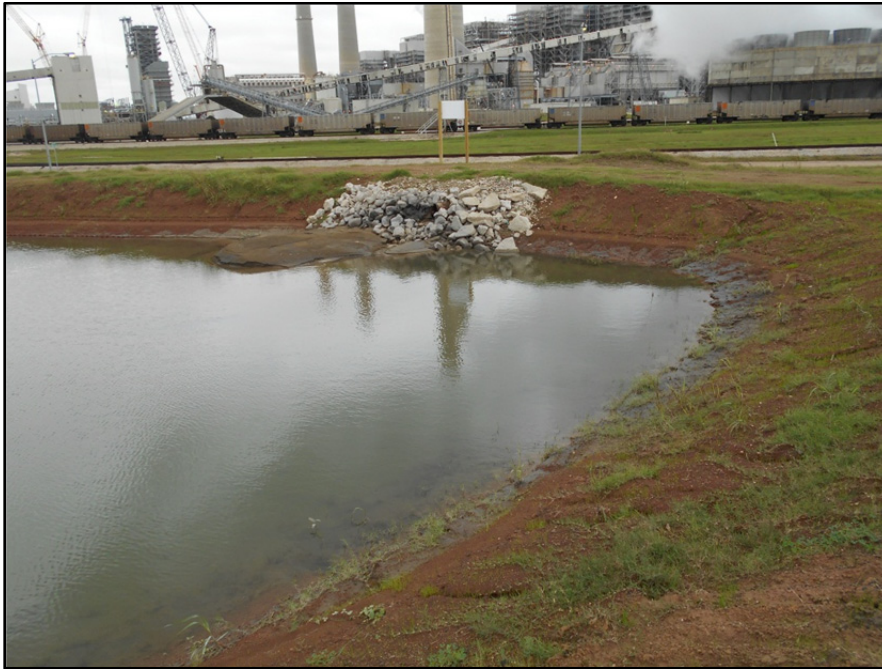
Photograph P-9 – Taken December 1, 2015 by David E. Nielson
Air Preheater Pond: Looking north at northern inside slope of dike.
Note the well armored area around the inlet pipe discharge into the pond that was not evident in Photograph P-6. The back of the required impoundment identification marker is shown beyond the riprap inlet. Also note the poor vegetative cover.

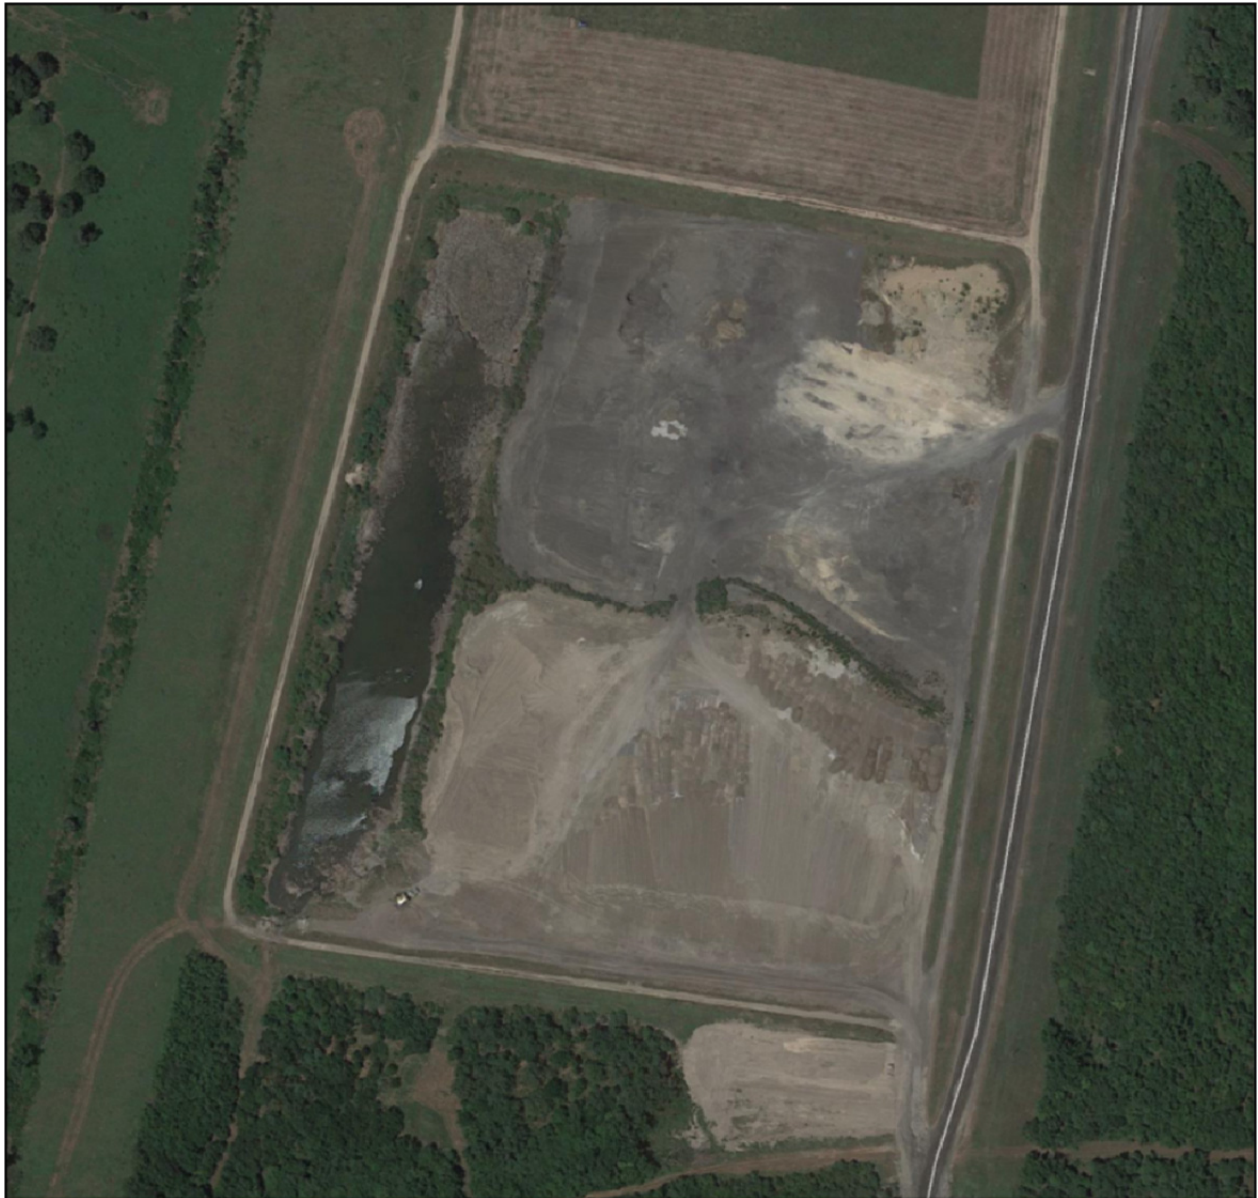
The location and general arrangement of Landfill Cell 3 are depicted on Figure 1 and also Photograph P-10, both of which were obtained from Google Earth Pro®. Photograph P-10 appears to accurately represent the conditions observed at Landfill Cell 3 by S&L on December 1, 2015, with the exception that accumulated CCR material shown by Google Earth in the northern end of the stormwater pond inside Cell 3 has been dredged.

Photograph P-10 – From Google Earth Pro, dated July 2015. Downloaded January 8, 2016.
Landfill Cell 3: Aerial view of Landfill Cell 3 and
stormwater runoff pond inside western edge of Cell 3.

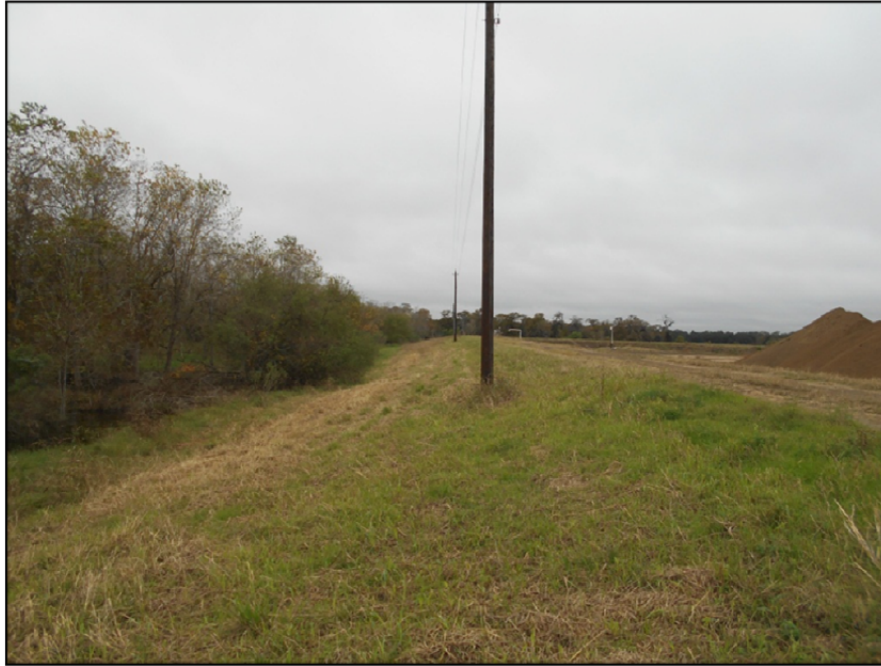
Photograph P-11 – Taken December 1, 2015 by David E. Nielson
Landfill Cell 3: Looking west along the outside slope of the south slope of landfill berm.
Note good vegetation.

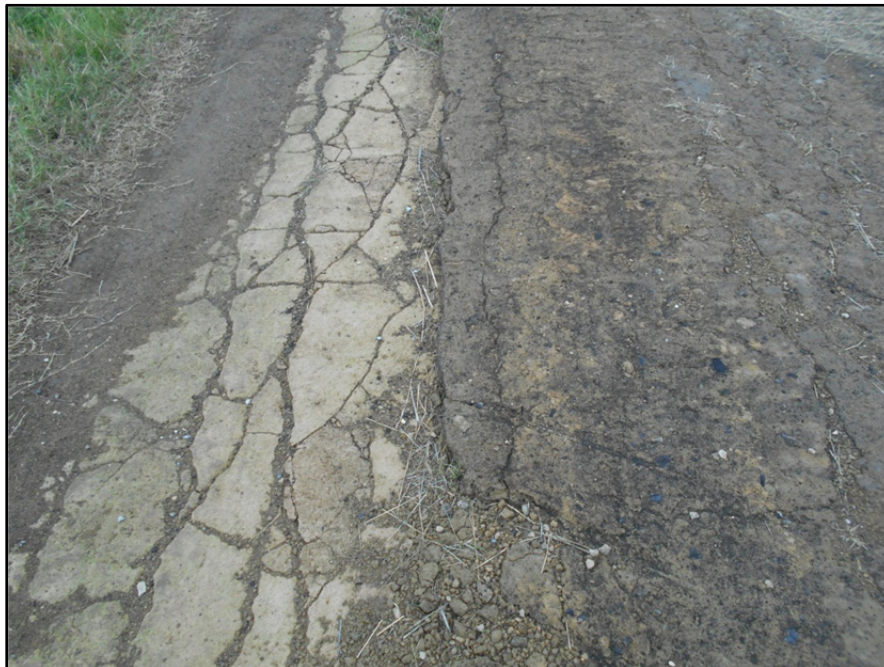
The access road on the perimeter berms/dikes is surfaced with a stabilized material that has experienced shrinkage and has cracked as shown on Photograph P-12. See Section 7.4 for a more thorough discussion of this condition. This condition does not require repairs.

Photograph P-12 – Taken December 1, 2015 by David E. Nielson
Landfill Cell 3: Looking west at the roadway along the crest of the landfill cell berm.
Note the hard surfacing on this and other berm roads was a stabilized product that exhibited significant shrinkage cracks. These cracks are not indicative of berm instability.

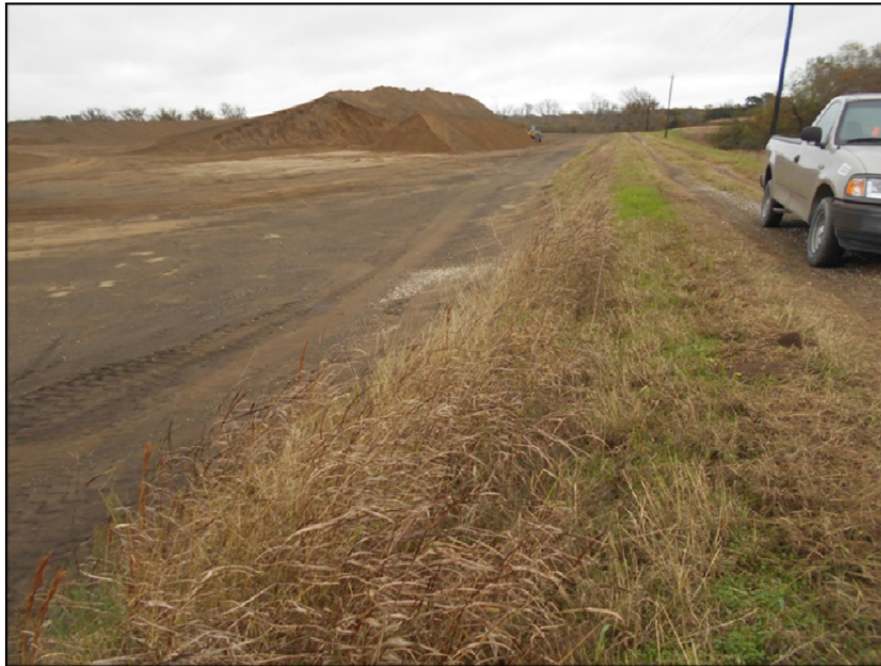
Photograph P-13 – Taken December 1, 2015 by David E. Nielson
Landfill Cell 3: Looking east along the inside slope of the south berm.

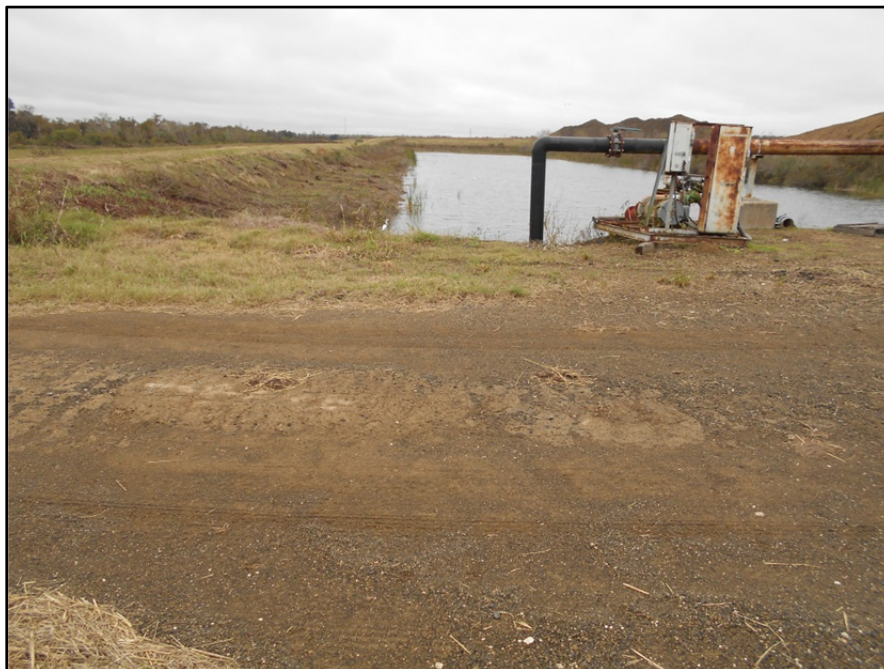
Photograph P-14 – Taken December 1, 2015 by David E. Nielson
Landfill Cell 3: Looking north along the west dike of the stormwater pond in Cell 3 (also western extent of Cell 3) and the pump, which pumps water from the stormwater pond back to plant operations. Note some benching of the west dike of the pond. This appears to be the result of prior dredging activities to remove CCR material from the pond.

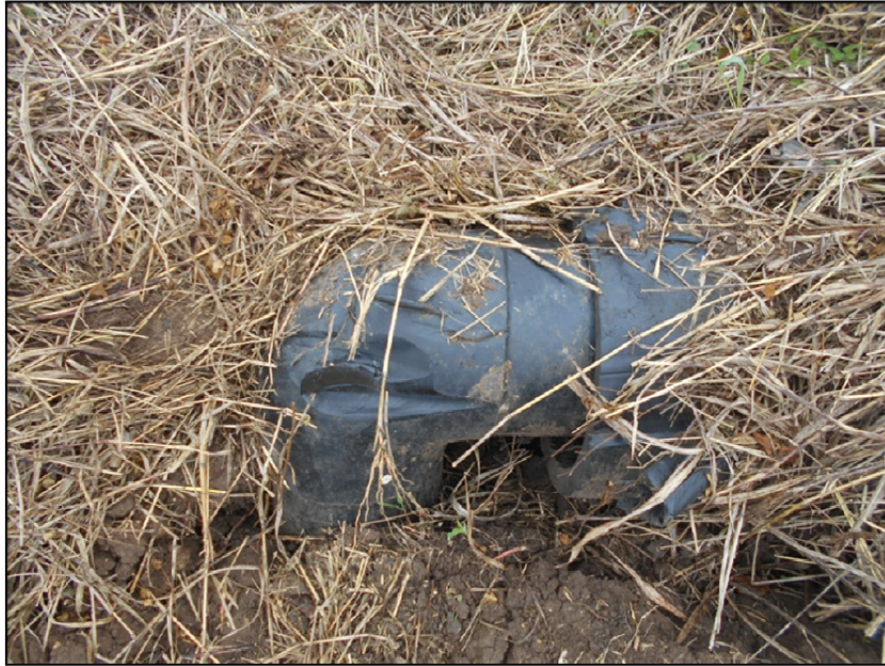
The stormwater pond discharge is pumped to the west in an HDPE pipeline. An exposed pipe elbow in this pipeline was observed on the outside slope of the western dike of the stormwater pond. Specifically, this fitting is located west of the pump station as shown in Photograph P-14 in line with the valve control shown in Photograph P-16. This exposed fitting has experienced significant damage as shown in Photograph P-15, likely as a result of recent mowing. This fitting should be evaluated by engineering or maintenance staff qualified to evaluate its operational functionality. If the integrity of the fitting is in question, it should be replaced. To prevent further damage to this fitting, bollards could be placed around the fitting or additional fill could be placed to bury the fitting.

Photograph P-15 – Taken December 1, 2015 by David E. Nielson
Landfill Cell 3: Looking at an exposed elbow of the discharge line from the stormwater pond. Note the damaged fitting appears to be from mowing equipment. This exposed fitting should be protected with bollards or buried after determination if it should be replaced.

9.3 CELL 3 REPAIR & PROTECTION OF DAMAGED PIPE ELBOW

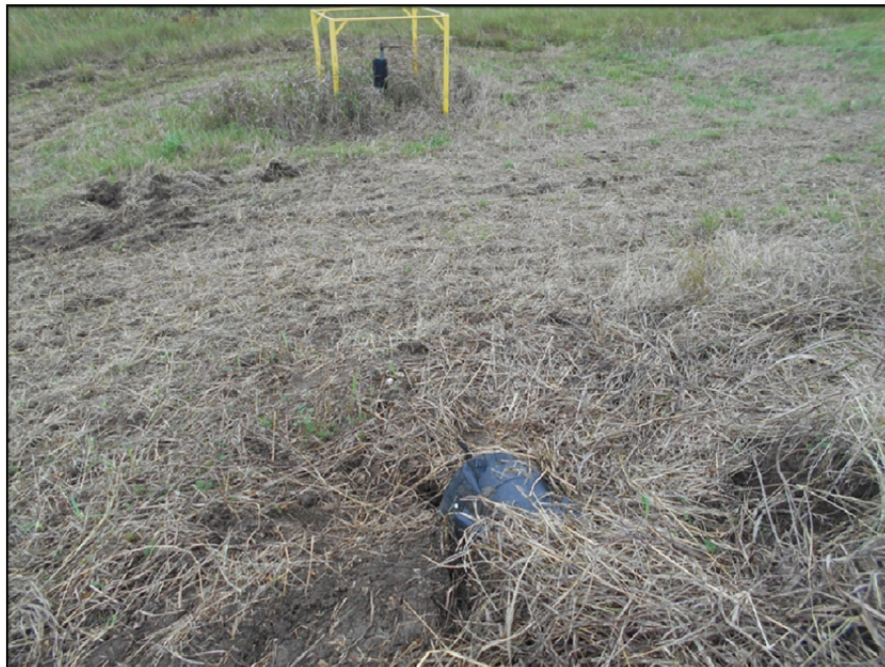
Photograph P-16 – Taken December 1, 2015 by David E. Nielson
Landfill Cell 3: Looking west from the southwest corner of the landfill cell at the damaged fitting on the discharge pipe and valve control in the background.

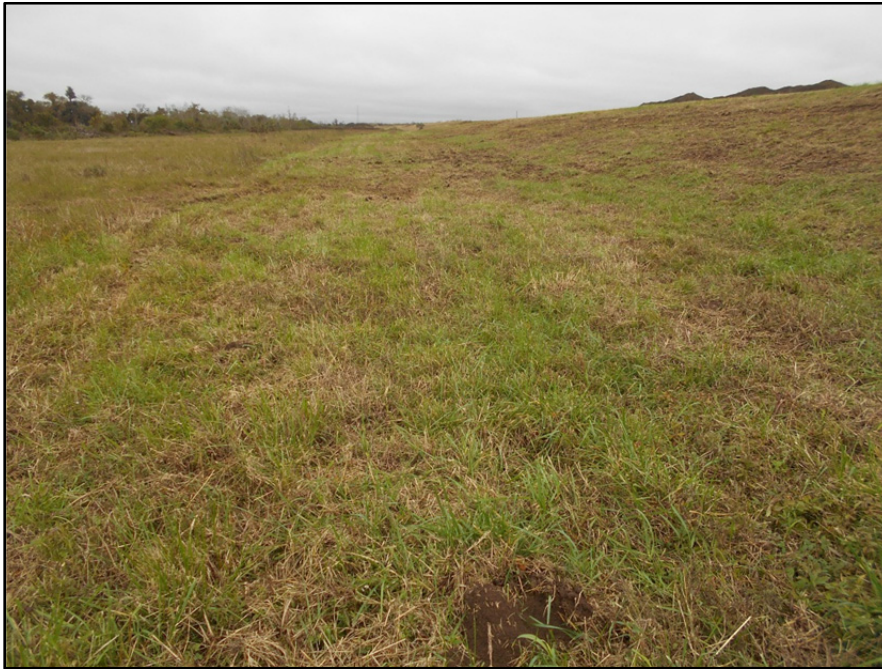
Photograph P-17 – Taken December 1, 2015 by David E. Nielson
Landfill Cell 3: Looking north along outside slope of western dike of the stormwater pond.
No instability or erosion was observed.

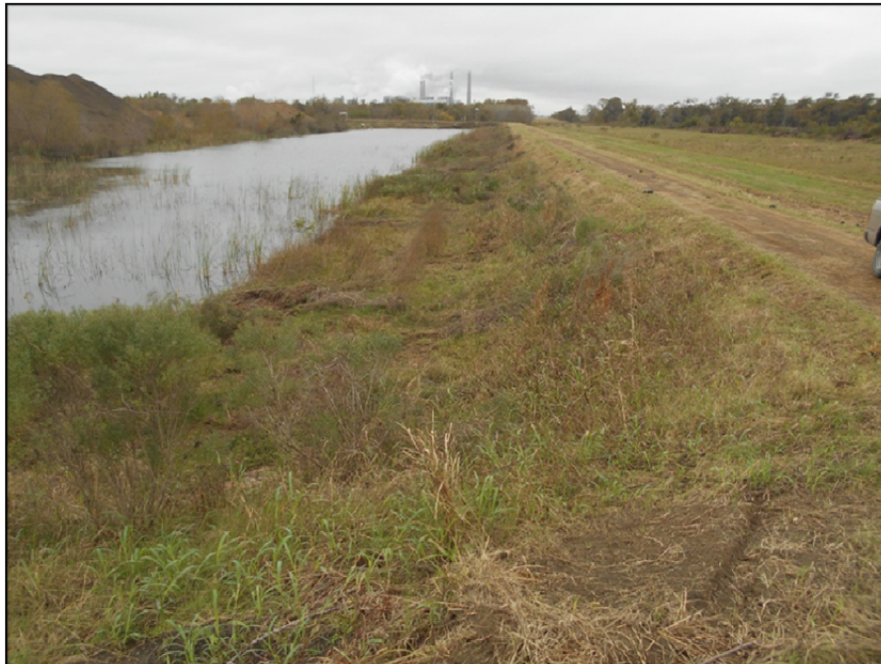
Photograph P-18 – Taken December 1, 2015 by David E. Nielson
Landfill Cell 3: Looking south along inside slope of western dike of the stormwater pond.
Benching appears to be a result of pond cleaning activities, not dike instability or wave erosion.

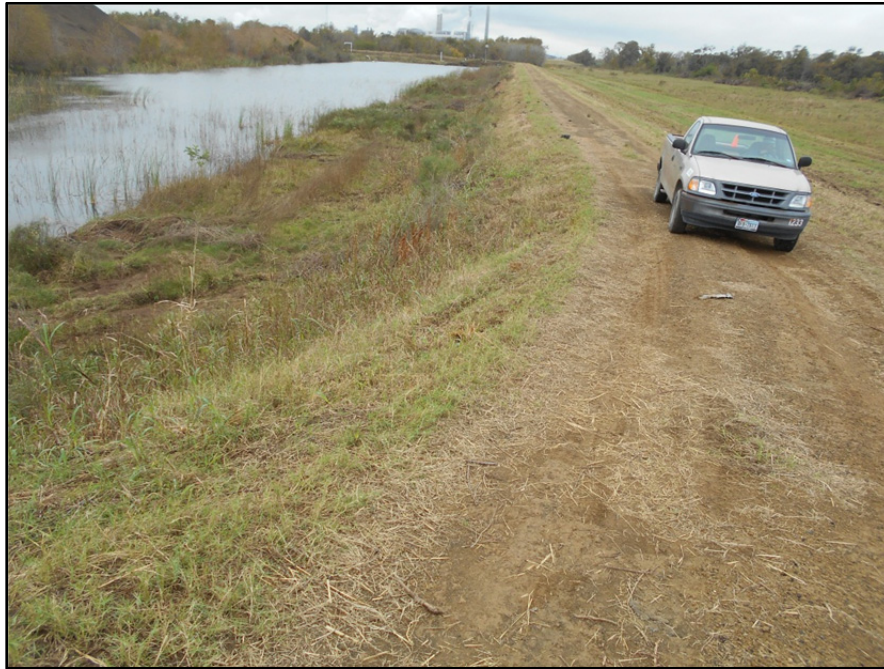
Photograph P-19 – Taken December 1, 2015 by David E. Nielson
Landfill Cell 3: Looking south at inside slope of west dike
of the stormwater pond and dike crest.
Note it appears that significantly less CCR material is stored in the pond
than is shown in Photograph P-10.

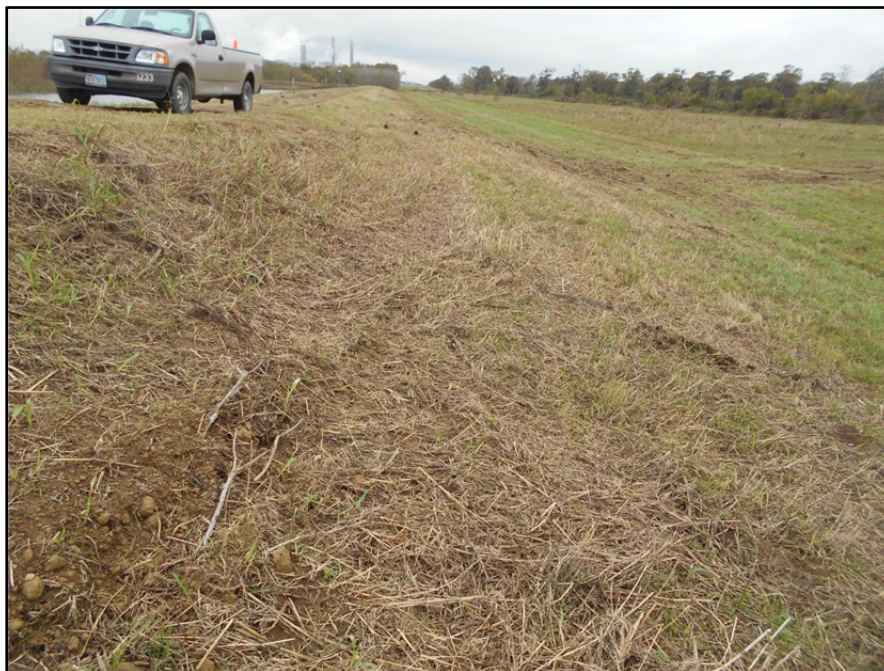
Photograph P-20 – Taken December 1, 2015 by David E. Nielson
Landfill Cell 3: Looking south at outside slope of western dike of stormwater pond.

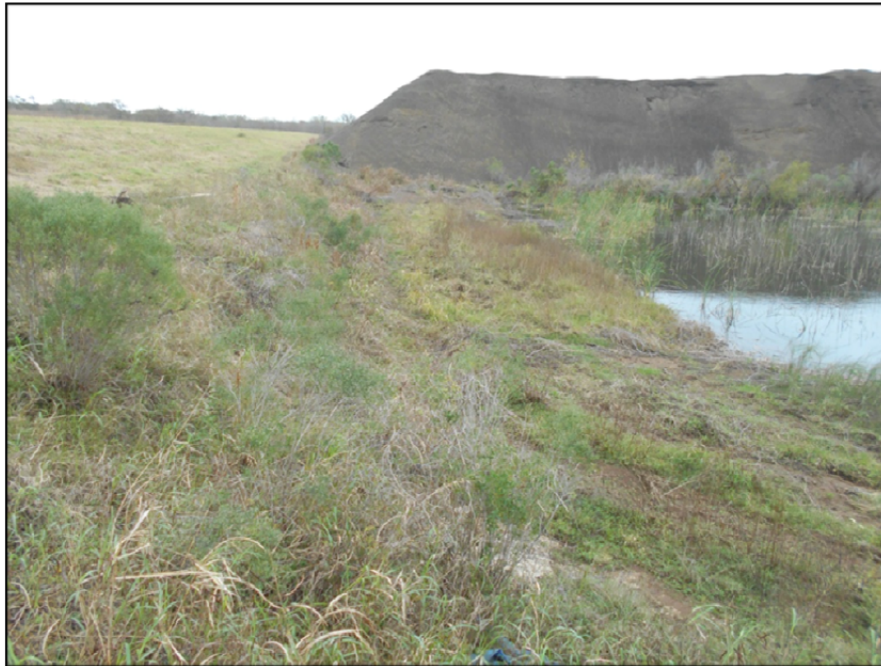
Photograph P-21 – Taken December 1, 2015 by David E. Nielson
Landfill Cell 3: Looking east along inside slope of northern edge of pond, and at the interface of the ash storage area and the stormwater pond, which is incised relative to the closed landfill cell to the north.

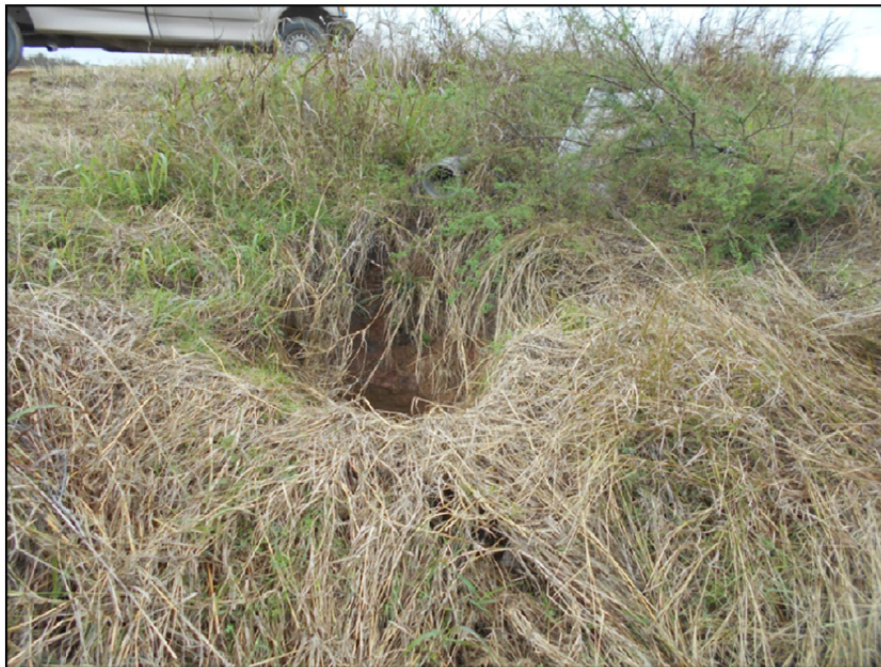
An erosional void was observed on the inside slope of north dike at the discharge for a pipe entering the pond as shown in Photograph P-22. In this area the loose and disturbed material should be removed and the erosional void filled with compacted clay soil. A splash pad or other erosion control measures could be constructed to prevent future erosion.

Photograph P-22 – Taken December 1, 2015 by David E. Nielson
Landfill Cell 3: Looking north at discharge from stormwater pipe inlet into stormwater pond. Note the absence of a splash pad and the occurrence of erosion. The vegetation should be removed, the erosional void backfilled and a splash pad or other erosion control measure may be installed.

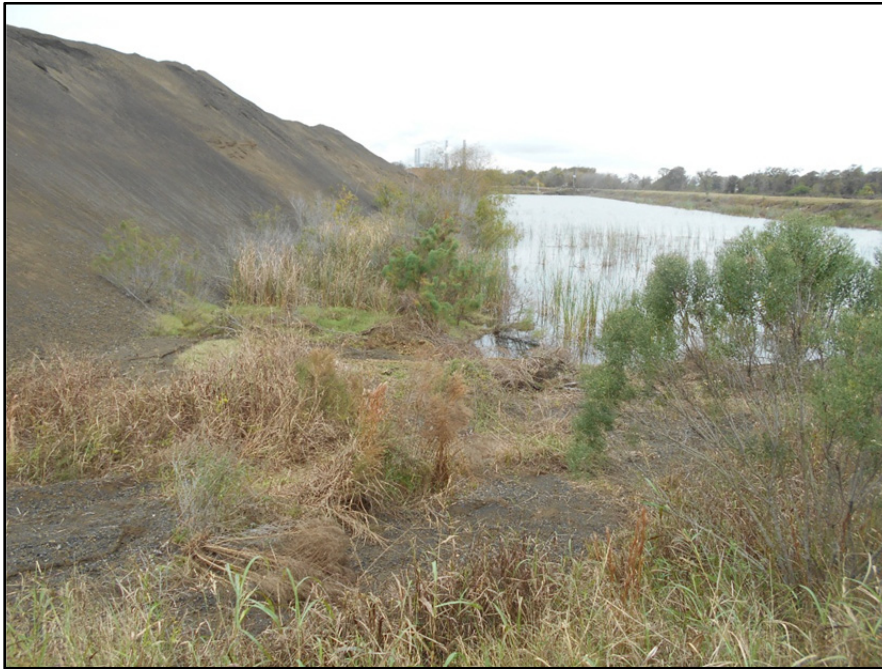
Photograph P-23 – Taken December 1, 2015 by David E. Nielson
Landfill Cell 3: Looking south at inside slope of eastern boundary
of stormwater pond and active landfill area.

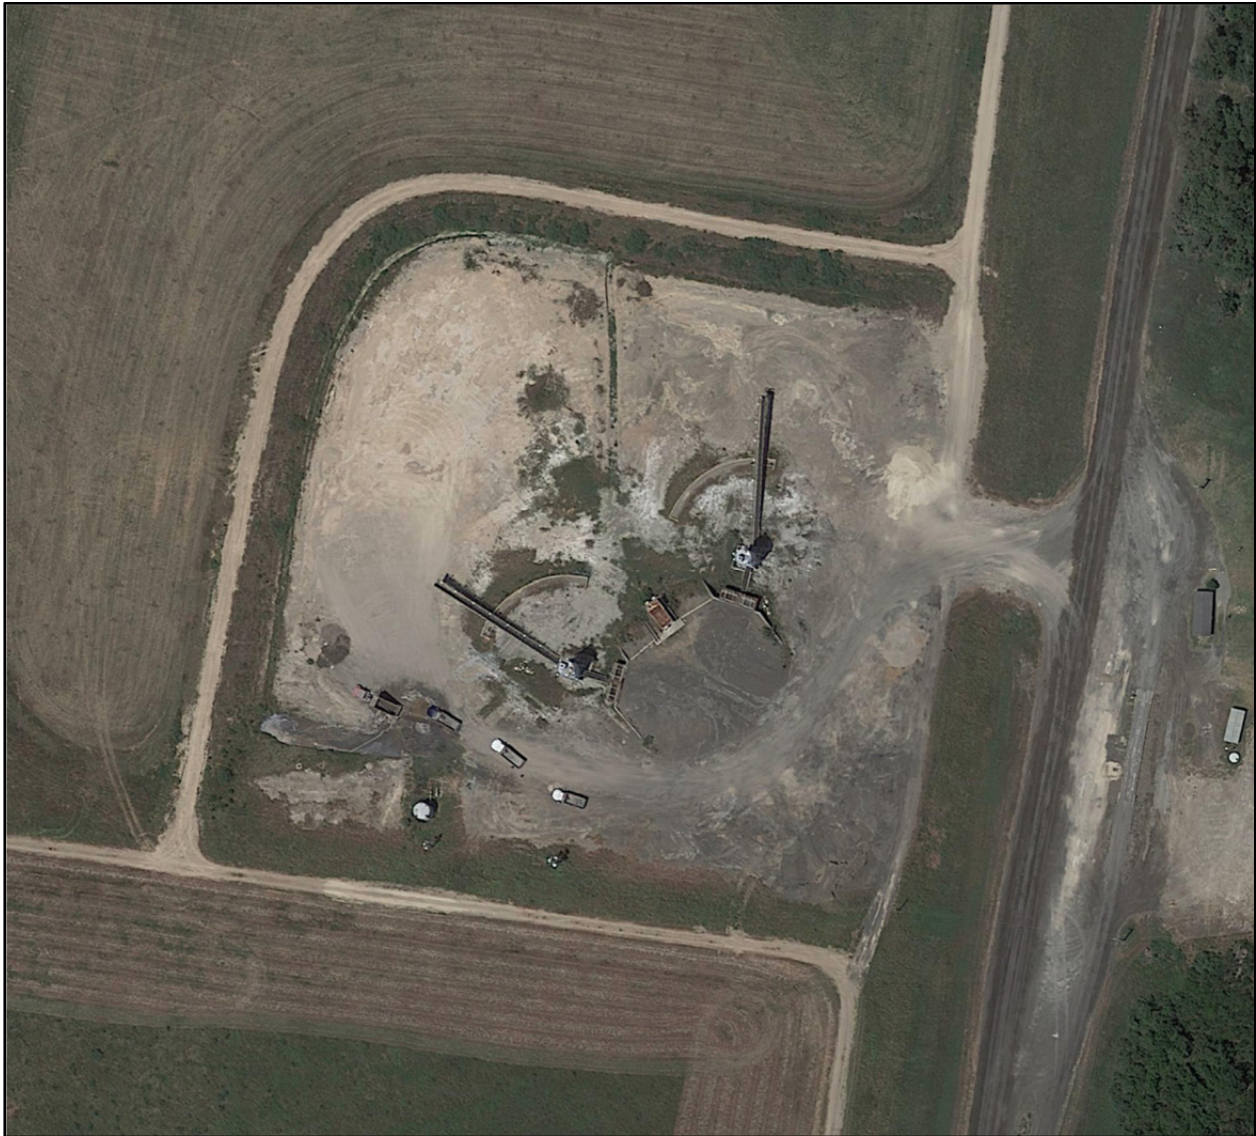
The location and general arrangement of Landfill Cell 2A are depicted on Figure 1 and also Photograph P-24, which were both obtained from Google Earth Pro®. Photograph P-24 appears to accurately represent the condition of the berms observed at Landfill Cell 2A by S&L on December 1, 2015.

Photograph P-24 – From Google Earth Pro, dated July 2015. Downloaded January 11, 2016.
Landfill Cell 2A: Aerial view of open area of Cell 2A,
which contains a pugmill to stabilize CCR materials for disposal in other cells.
The closed portions of Cell 2A are north and west of the active area.

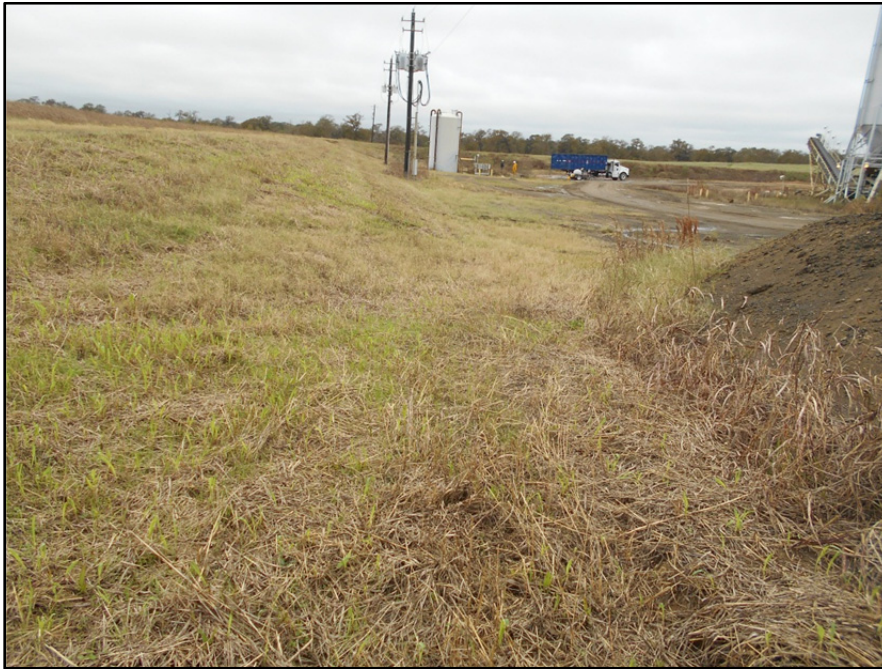
Photograph P-25 – Taken December 1, 2015 by David E. Nielson
Landfill Cell 2A: Looking west along the inside slope of the southern berm.
This berm abuts closed Cell 1B, which is higher in elevation.
Note well established grass and uniformity of slope.

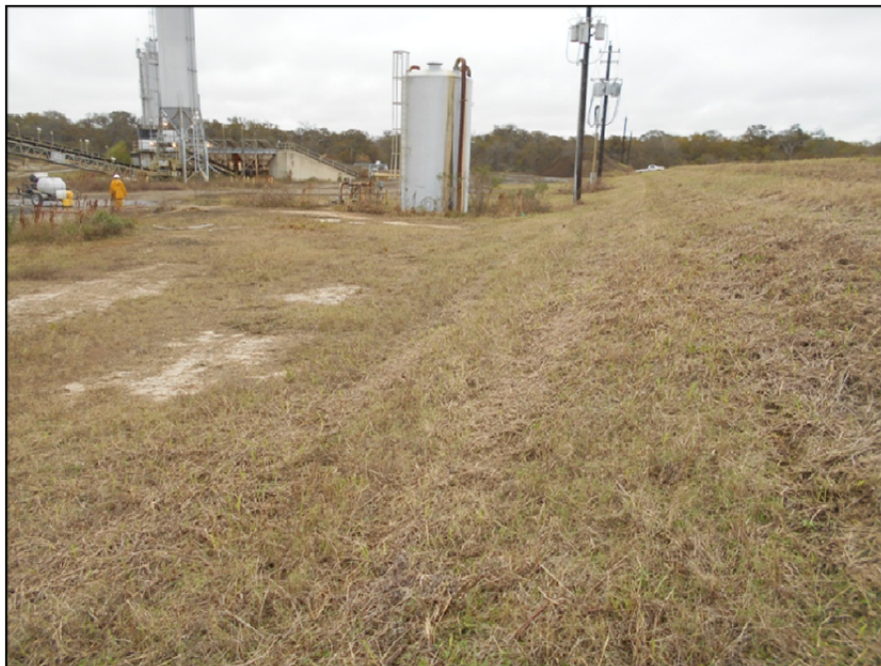
Photograph P-26 – Taken December 1, 2015 by David E. Nielson
Landfill Cell 2A: Looking east along the inside slope of southern dike.
Note large water tank in center of photograph is water storage for pugmill operations
(inside cell in photograph background).

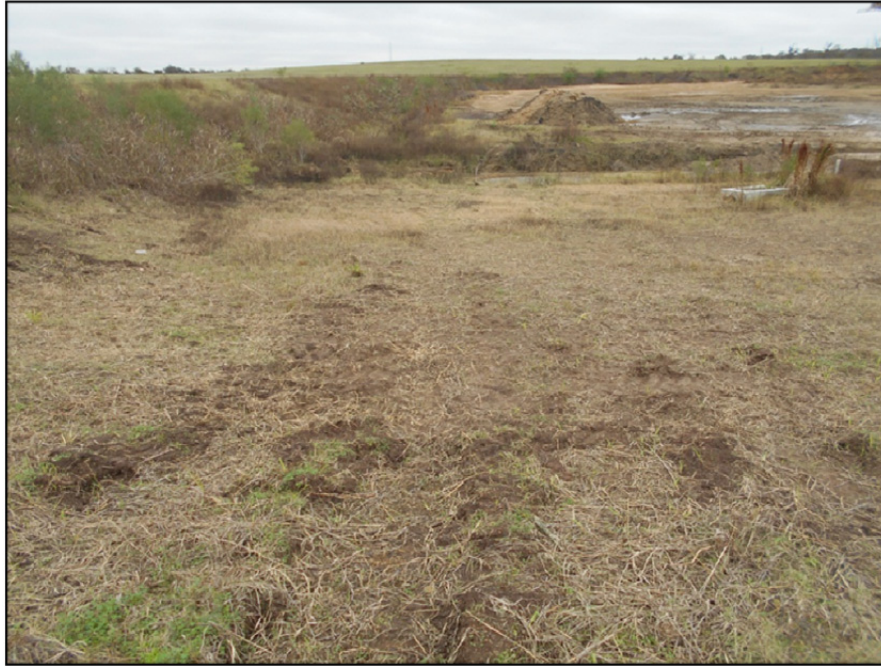
Photograph P-27 – Taken December 1, 2015 by David E. Nielson
Landfill Cell 2A: Looking north along toe of inside slope of western berm.
