**NRG TEXAS POWER, LLC
WA PARISH STATION, UNITS 5, 6, 7, & 8**

ANNUAL INSPECTION OF CCR IMPOUNDMENTS AND LANDFILL

S&L Report No.: SL-013202

Date: January 18, 2016

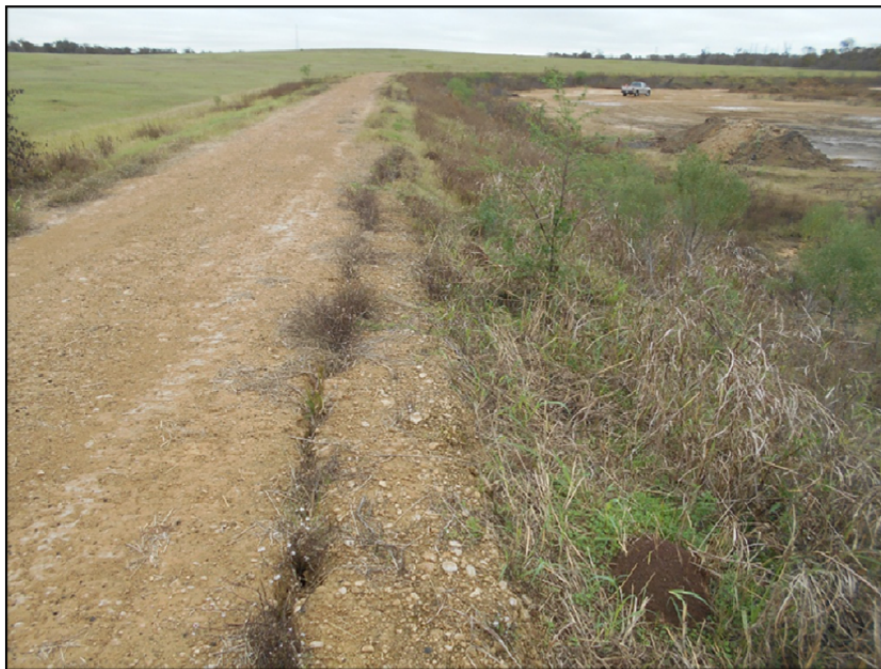
The crest of the berms around Cell 2A are free of rutting and misalignment as shown in Photographs P-28, P-29, P-30, P-37, and P-39. However, cracks in the surface material on the perimeter road are evident. The perimeter road has been surfaced with a stabilized product similar to the other landfill cells. Photograph P-31 shows a typical crack, while Photograph P-32 is of a wider crack that was probed to a depth of 12 inches as shown in Photograph P-33. These cracks are not considered to indicate movement of the berm. Instead, the cracks are likely a result of shrinkage of the stabilized material. To reduce the stormwater infiltration and the resultant potential of softening or weakening of the berm core, consideration should be given to filling these cracks with fine sand to fine gravel sized particles.

Photograph P-28 – Taken December 1, 2015 by David E. Nielson
Landfill Cell 2A: Looking north along the crest of the western berm.
Note closed sections of Cell 2A in background.
Also note longitudinal crack in crest roadway surfacing.

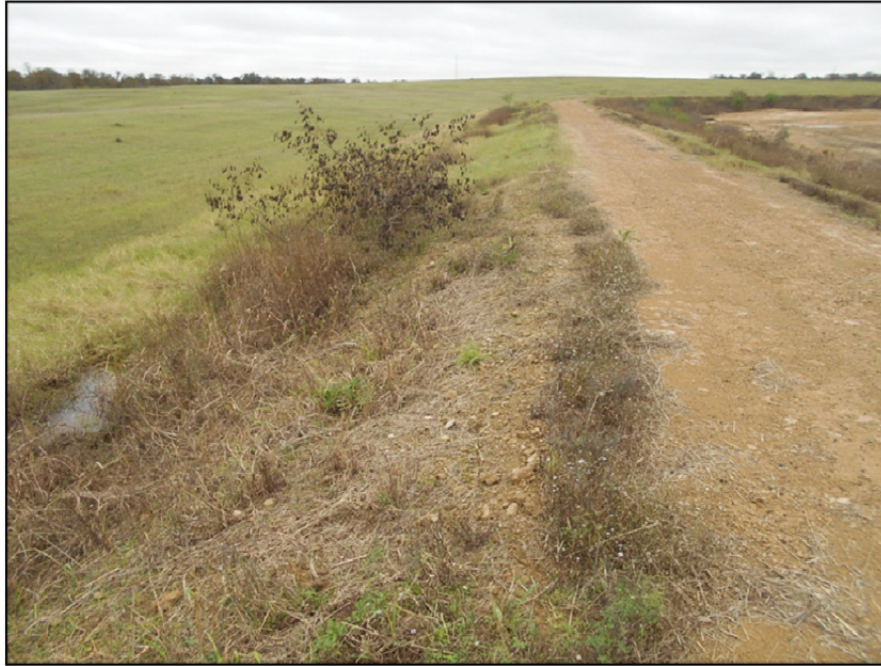
The outside slopes of the perimeter berms are shown in Photographs P-29, P-34, P-36, and P-40. These slopes typically exhibited good alignment, grades and vegetation. Several areas of taller vegetation were noted (see Photograph P-29) that should be mowed to aid in the establishment of a grass protective layer. Photograph P-29 also documented some standing water at the toe of the outside slope. This water is the result of precipitation preceding the inspection. No significant adverse conditions were identified for the outside slopes of the perimeter berm.

Photograph P-29 – Taken December 1, 2015 by David E. Nielson
Landfill Cell 2A: Looking north along the outside slope and crest of the western berm.
Note the standing water is from precipitation prior to the inspection not seepage.

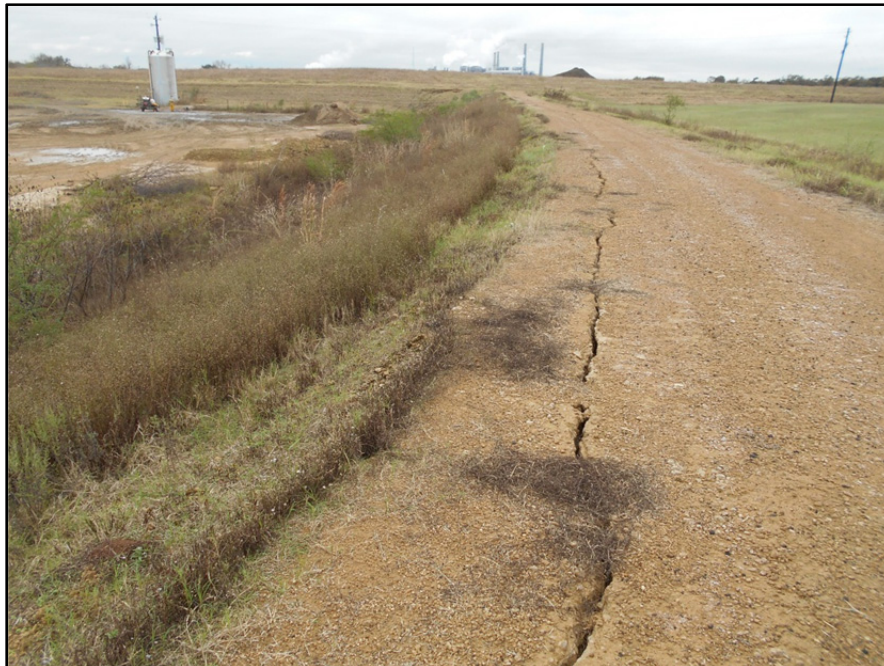
Photograph P-30 – Taken December 1, 2015 by David E. Nielson
Landfill Cell 2A: Looking south along the inside slope and crest of western berm.
Note significant crack in roadway surfacing. Cracks are also shown on
Photographs P-31, P-32 and P-33. These cracks are not considered to be
from shrinkage of the stabilized material not berm instability.

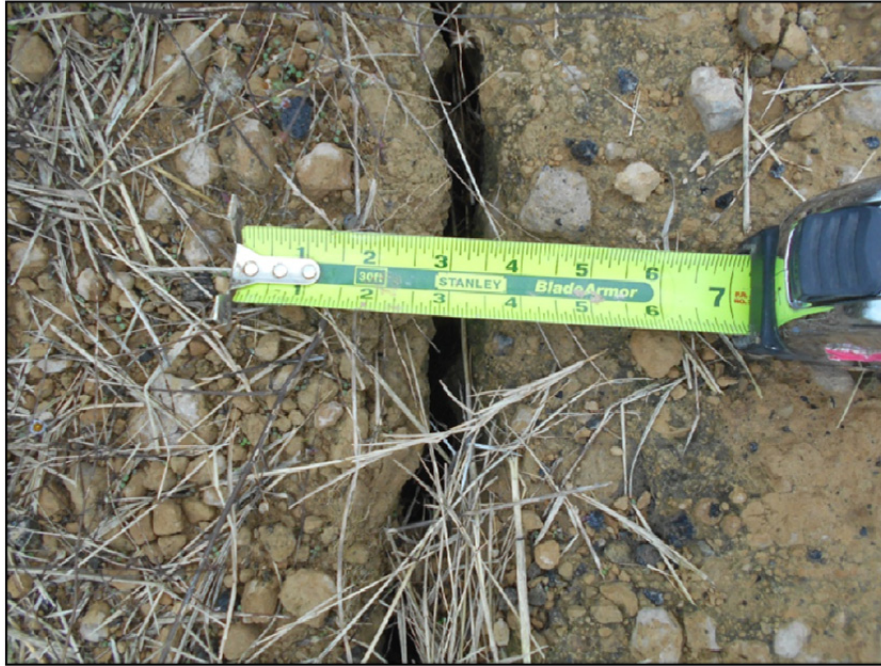
Photograph P-31 – Taken December 1, 2015 by David E. Nielson
Landfill Cell 2A: Looking at typical crack in stabilized roadway surfacing.

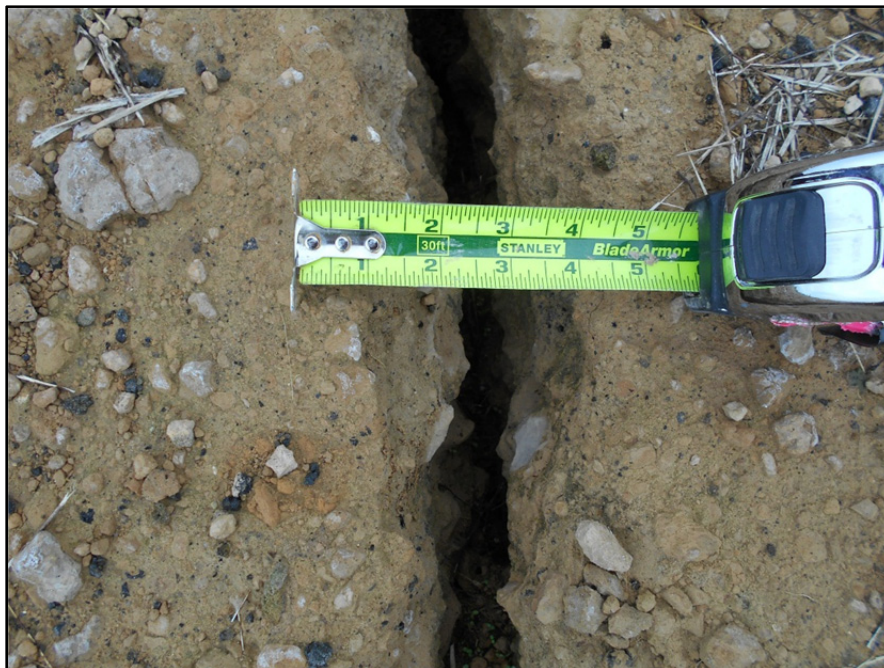
Photograph P-32 – Taken December 1, 2015 by David E. Nielson
Landfill Cell 2A: Looking at wider than typical crack in stabilized roadway surfacing.

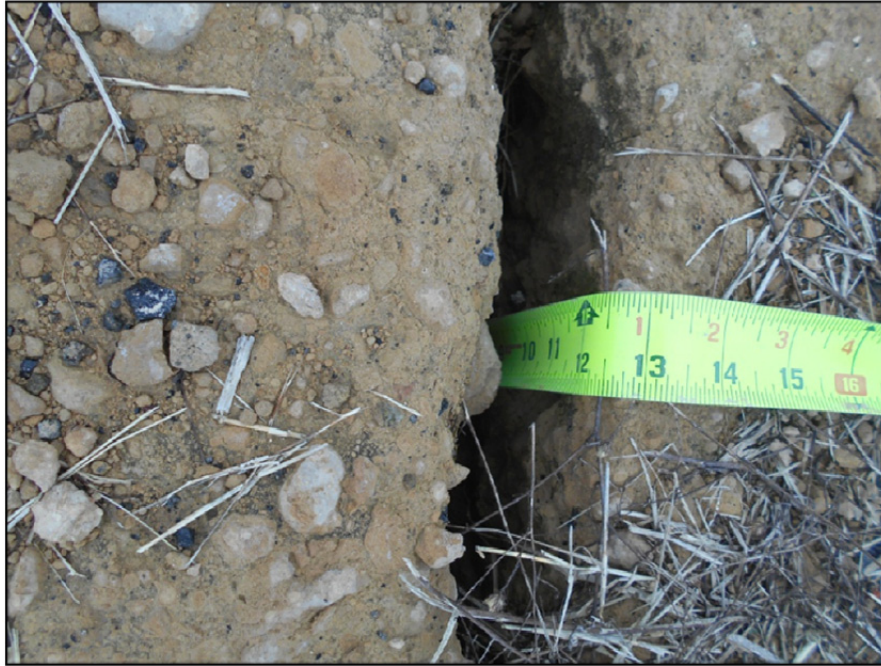
Photograph P-33 – Taken December 1, 2015 by David E. Nielson
Landfill Cell 2A: Looking at wider than typical crack in stabilized roadway surfacing. The crack extended 1 foot below the roadway surface.

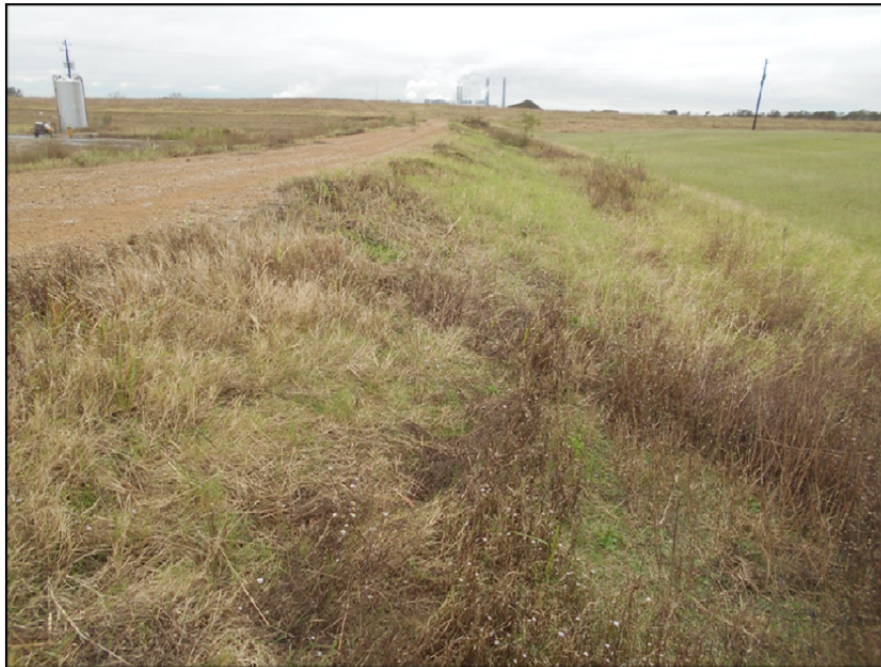
Photograph P-34 – Taken December 1, 2015 by David E. Nielson
Landfill Cell 2A: Looking south along the outside face of the western berm.

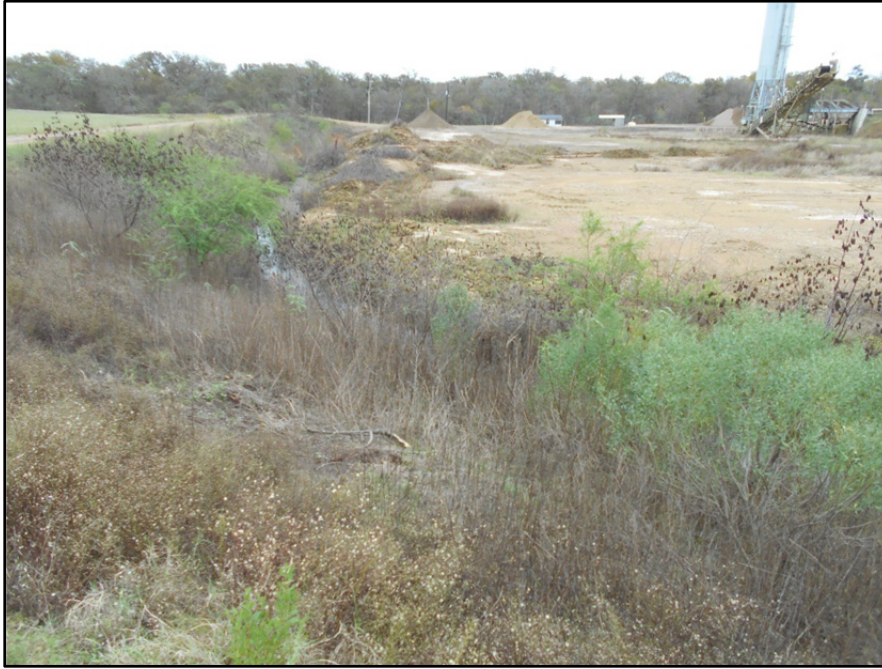
Photograph P-35 – Taken December 1, 2015 by David E. Nielson
Landfill Cell 2A: Looking east along the inside slope of northern berm.
Note small trees that should be removed.

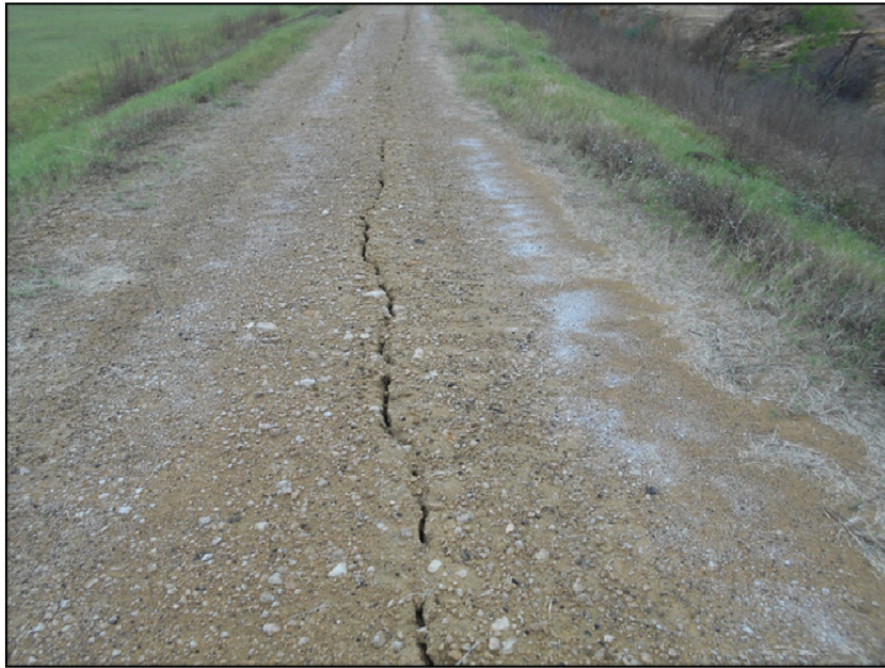
Photograph P-37 – Taken December 1, 2015 by David E. Nielson
Landfill Cell 2A: Looking west along the northern dike crest. Note shrinkage crack in the road surfacing material.

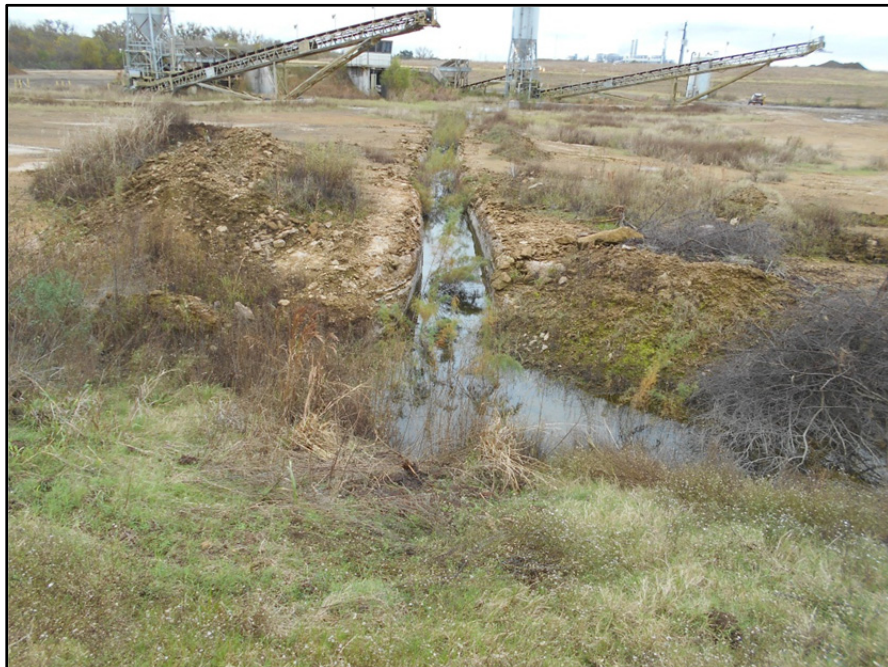
Photograph P-38 – Taken December 1, 2015 by David E. Nielson
Landfill Cell 2A: Looking south into the active portion of Cell 2A along a vertical wall ditch cut in the stabilized material that has cured in place. These vertical walls demonstrate the long-term properties of the stabilized CCR materials.

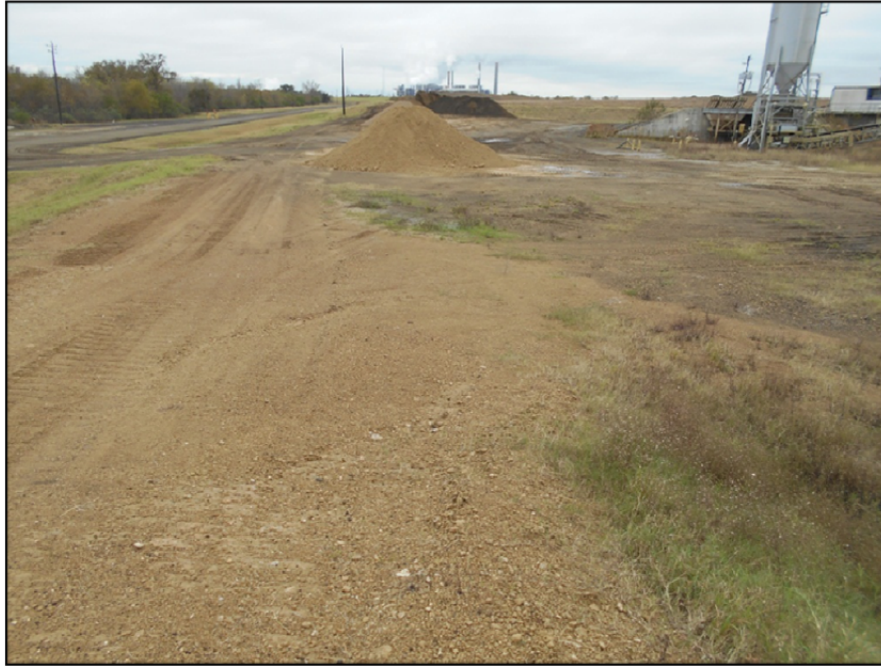
Photograph P-39 – Taken December 1, 2015 by David E. Nielson
Landfill Cell 2A: Looking south along the crest of the eastern berm.

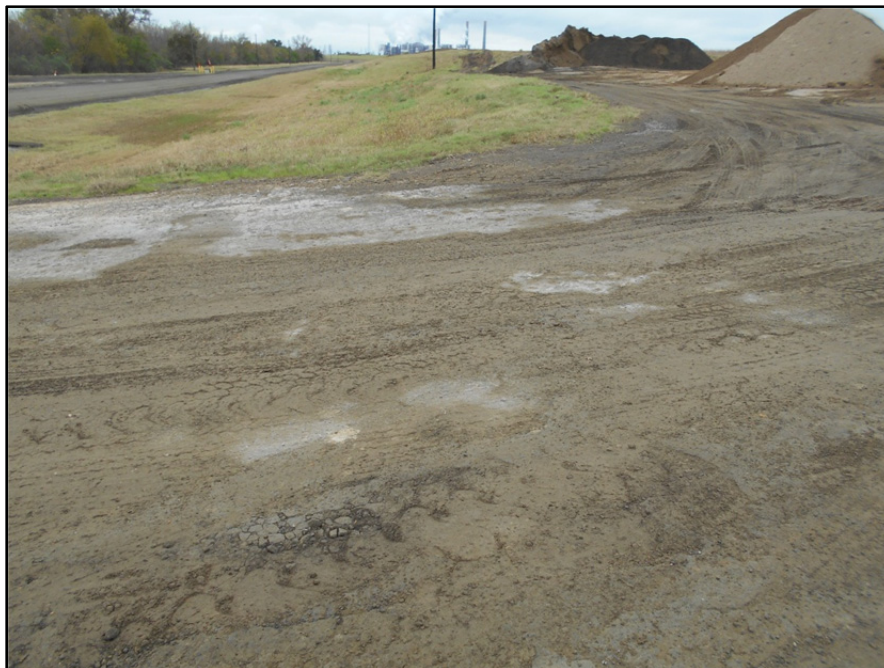
Photograph P-40 – Taken December 1, 2015 by David E. Nielson
Landfill Cell 2A: Looking south at outside slope of the eastern berm.

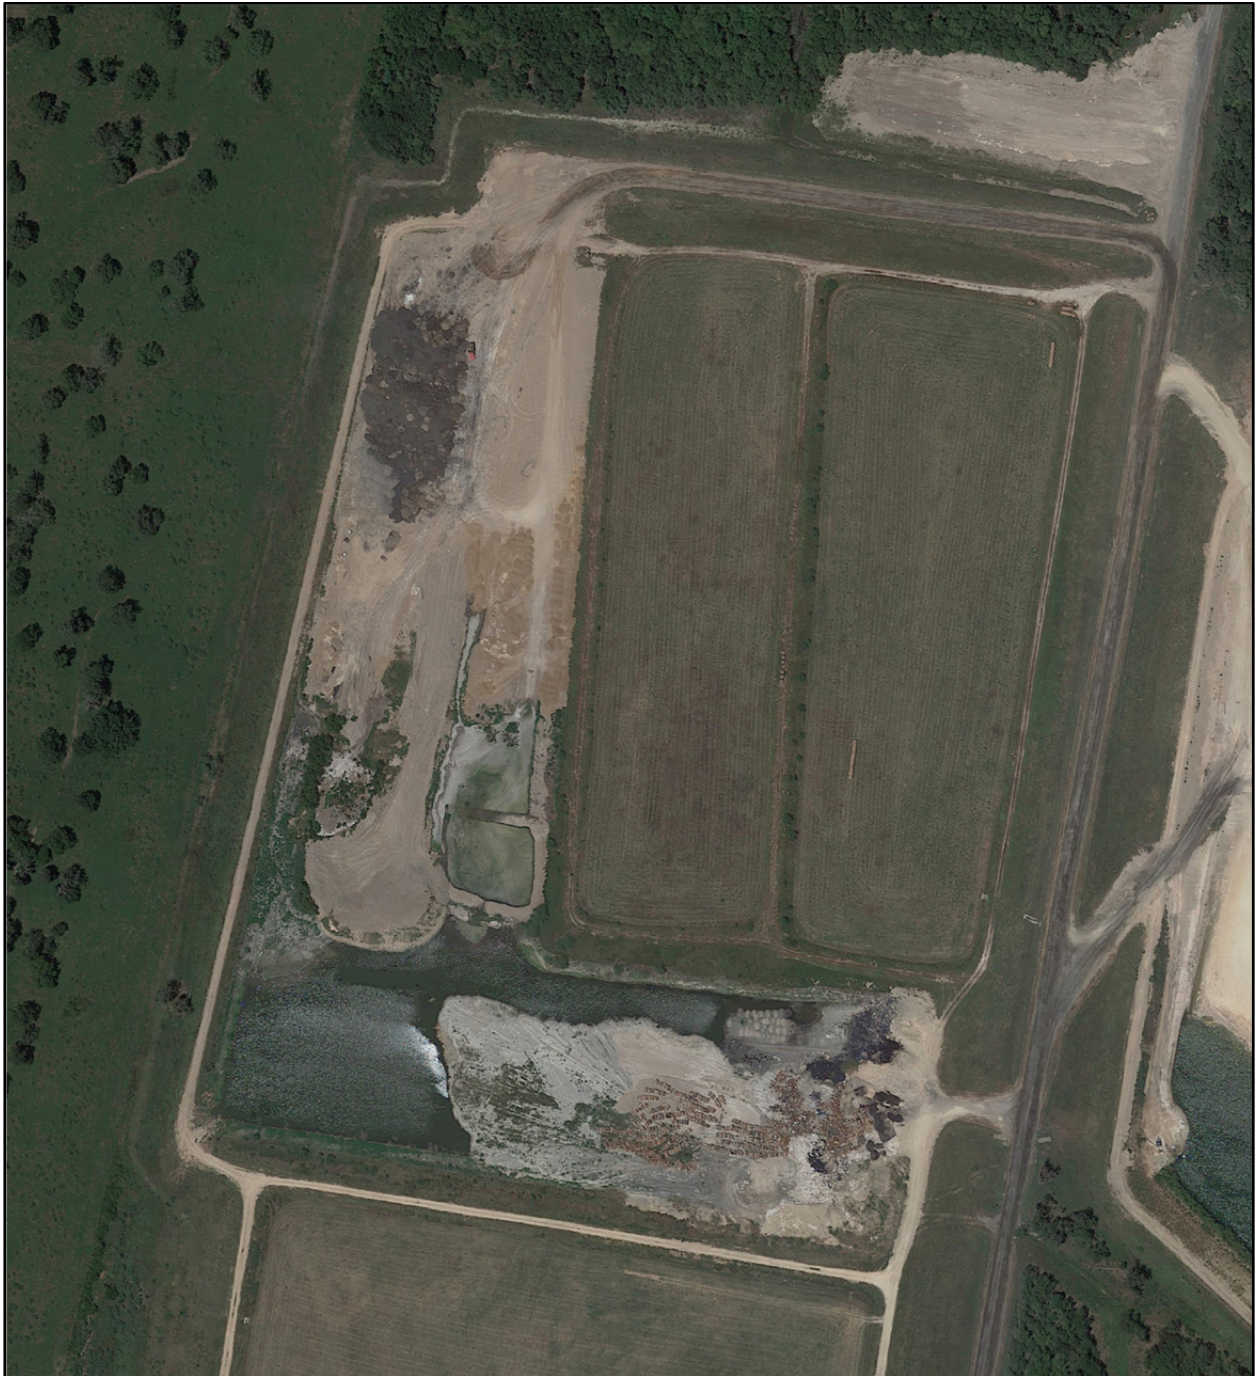
The location and general arrangement of the Landfill Cell 1C are depicted on Figure 1 and also Photograph P-41, which were both obtained from Google Earth Pro®. Photograph P-41 appears to accurately represent the condition of the berms and dikes observed at the Landfill Cell 1C by S&L on December 1, 2015.

Photograph P-41 – From Google Earth Pro, dated July 2015. Downloaded January 11, 2016.
Landfill Cell 1C: Aerial view of Landfill Cell 1C and stormwater runoff pond inside the cell.

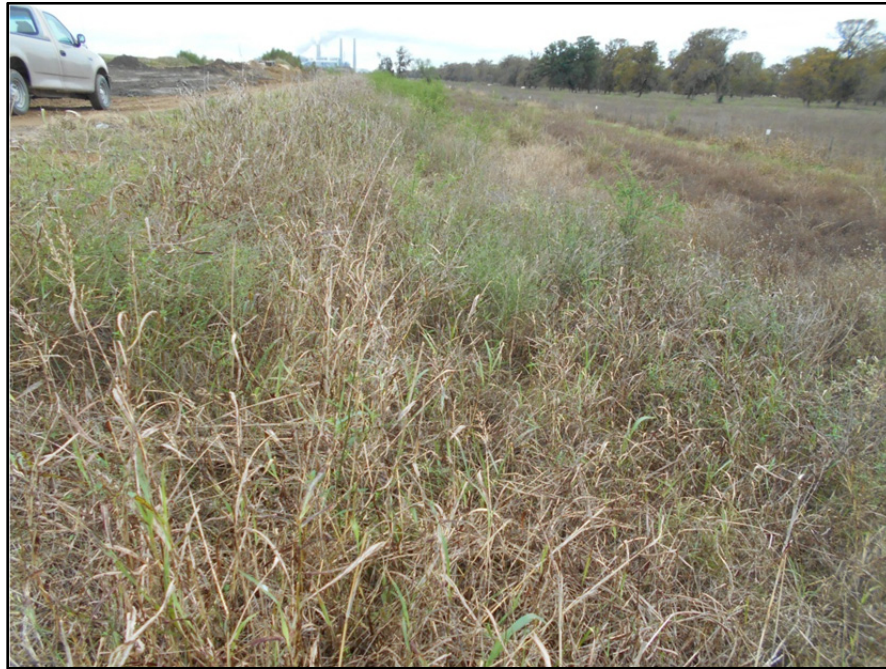
The outside slopes of the perimeter berms and dikes are shown in Photographs P-42, and P-43. These slopes typically exhibited good alignment and grades. However, significant vegetation was present that warrants mowing. No significant adverse conditions were identified for the outside slopes of the perimeter berm.

Photograph P-42 – Taken December 1, 2015 by David E. Nielson
Landfill Cell 1C: Looking south along the outside slope of the western berm.
Note vegetation control is warranted.

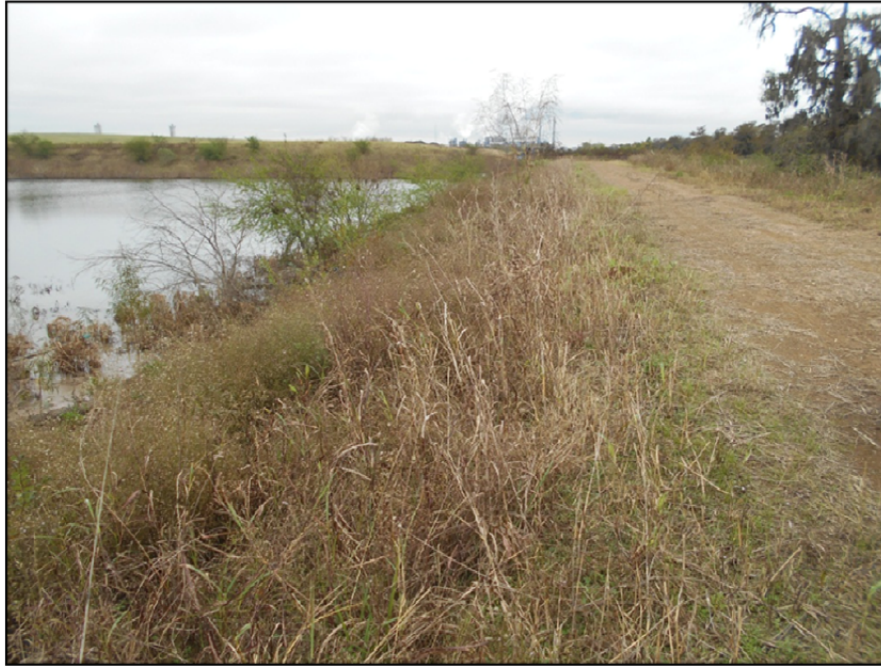
The inside slopes of the perimeter dikes on the west and south sides of the stormwater pond contained inside Cell 1C are shown in Photographs P-44 through P-47. These slopes typically exhibited good alignment and grades. However, significant woody and grass vegetation is present that should be mowed to aid in the establishment of a grass protective layer. No adverse stability or erosion conditions were identified for the inside slopes of the perimeter dikes around the stormwater pond.

Photograph P-44 – Taken December 1, 2015 by David E. Nielson
Landfill Cell 1C: Looking south along inside slope of western dike of stormwater pond.
Note small trees that should be removed.

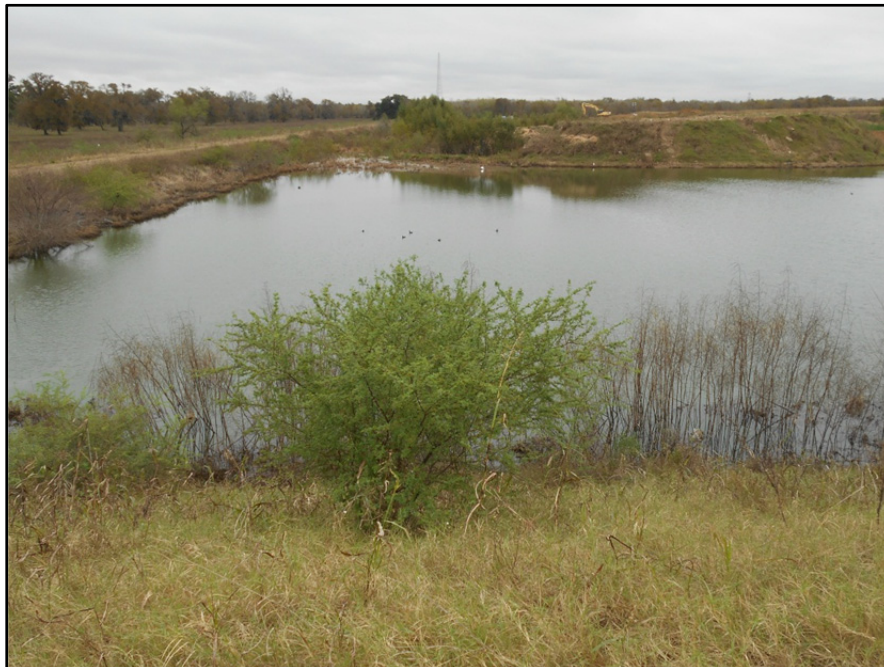
Photograph P-45 – Taken December 1, 2015 by David E. Nielson
Landfill Cell 1C: Looking north along the inside slope of the western dike.
Note small trees that should be removed.

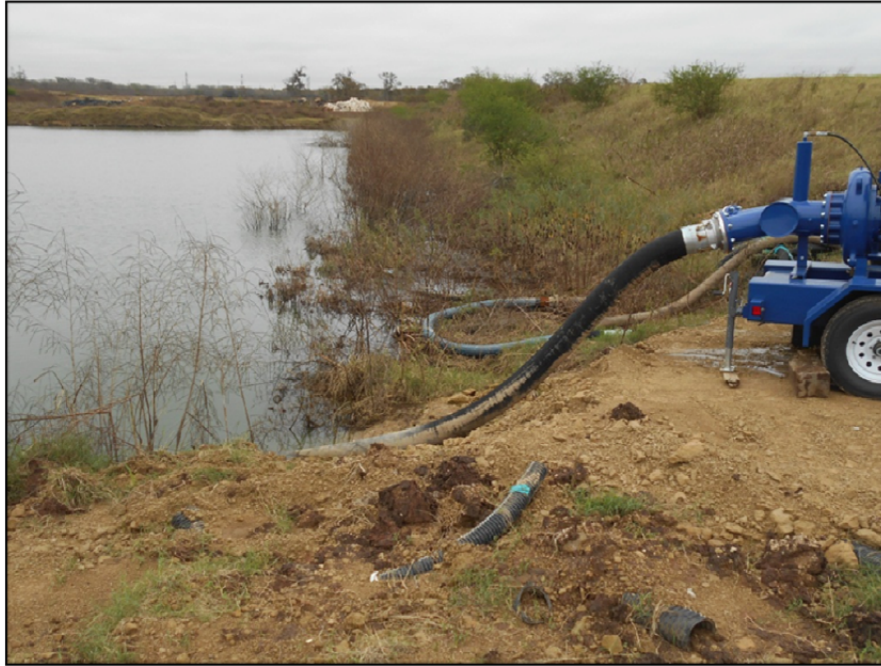
Photograph P-46 – Taken December 1, 2015 by David E. Nielson
Landfill Cell 1C: Looking east along the inside slope of the southern dike
of the stormwater pond.
Note vegetation control is warranted.

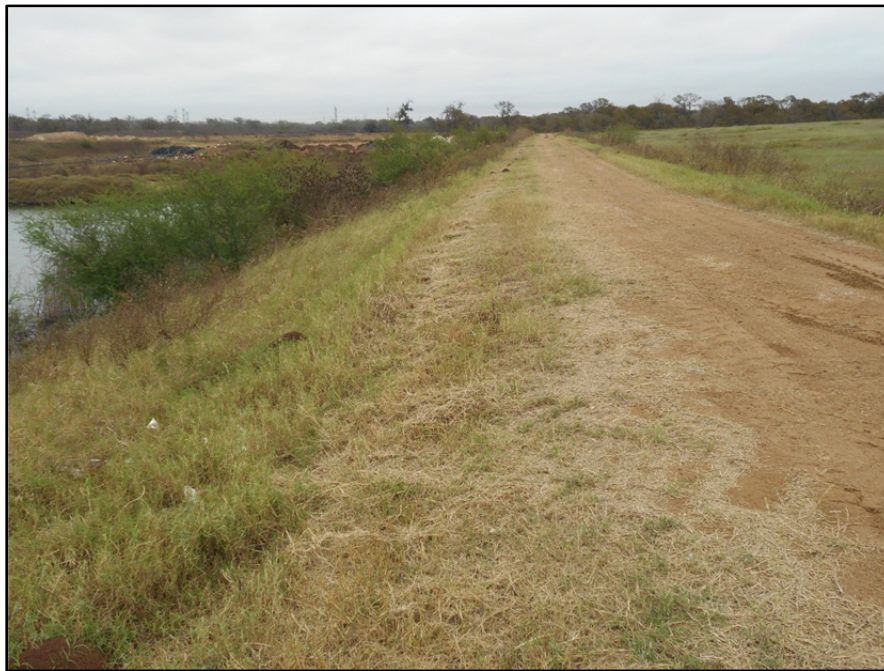
Photograph P-47 – Taken December 1, 2015 by David E. Nielson
Landfill Cell 1C: Landfill Cell 1C: Looking east along the crest of the southern dike
of the stormwater pond and then the western berm of the landfill.

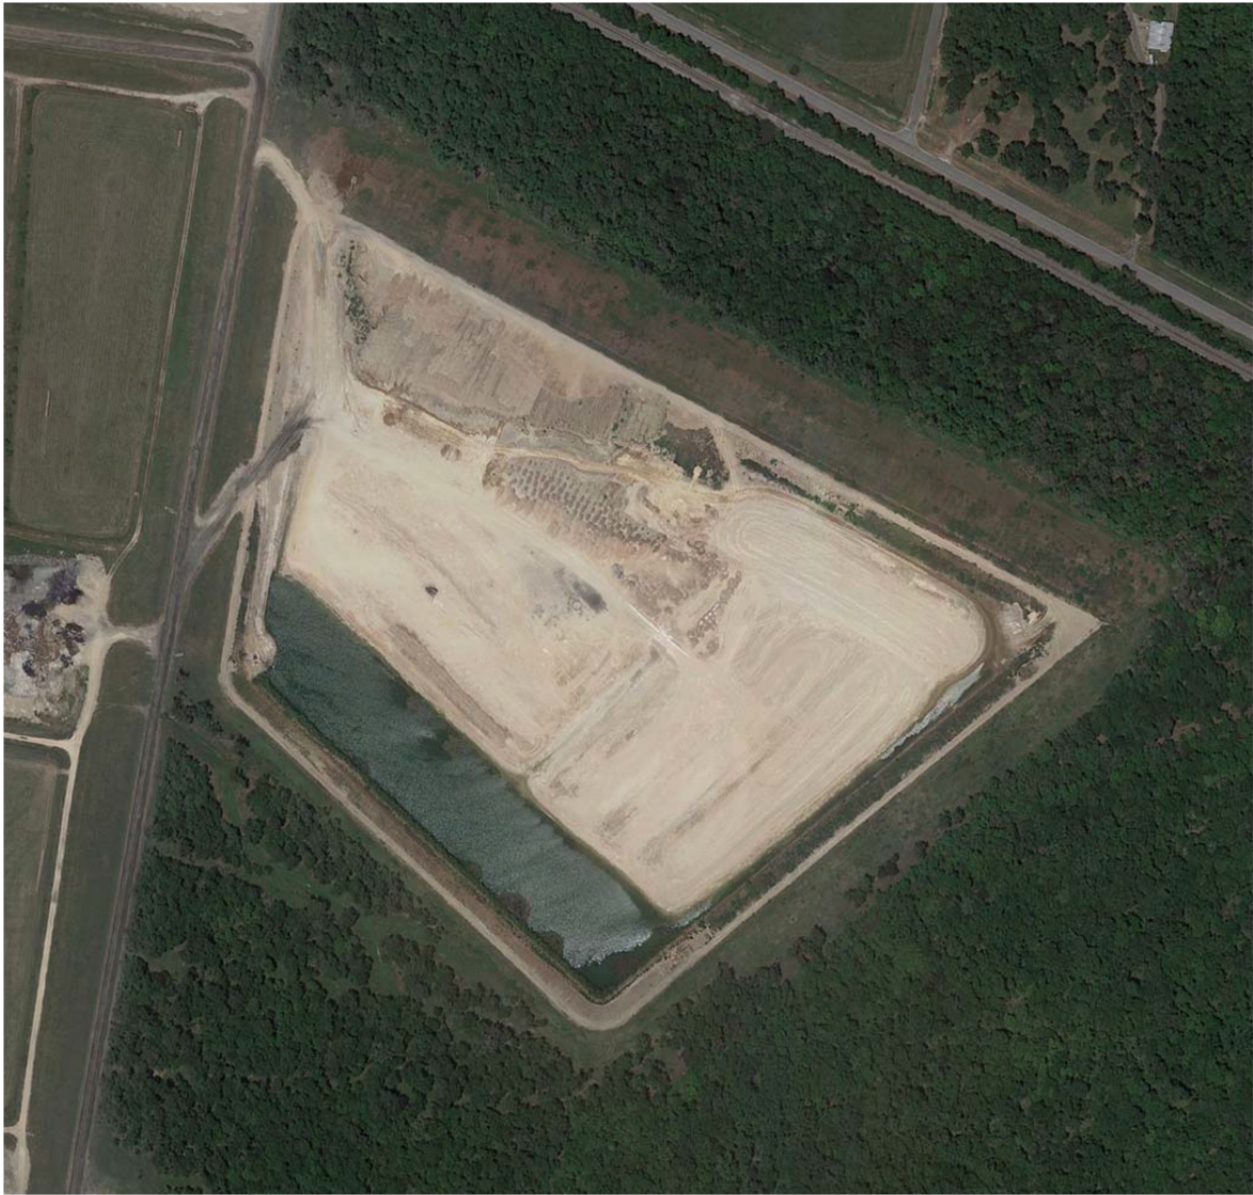
Photograph P-48 – From Google Earth Pro, dated July 2015. Downloaded January 11, 2016.
Landfill Cell 2B: Aerial view of Landfill Cell 2B and stormwater runoff pond inside the cell.

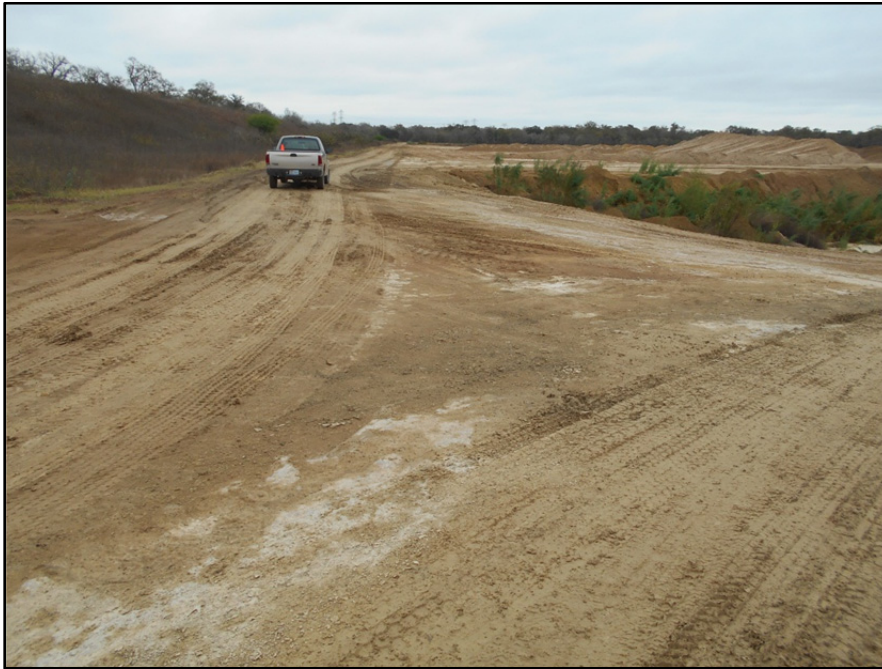
Photograph P-49 – Taken December 1, 2015 by David E. Nielson
Landfill Cell 2B: Looking east along the crest of the northern berm.
Note significant soil stockpile north of the berm crest.

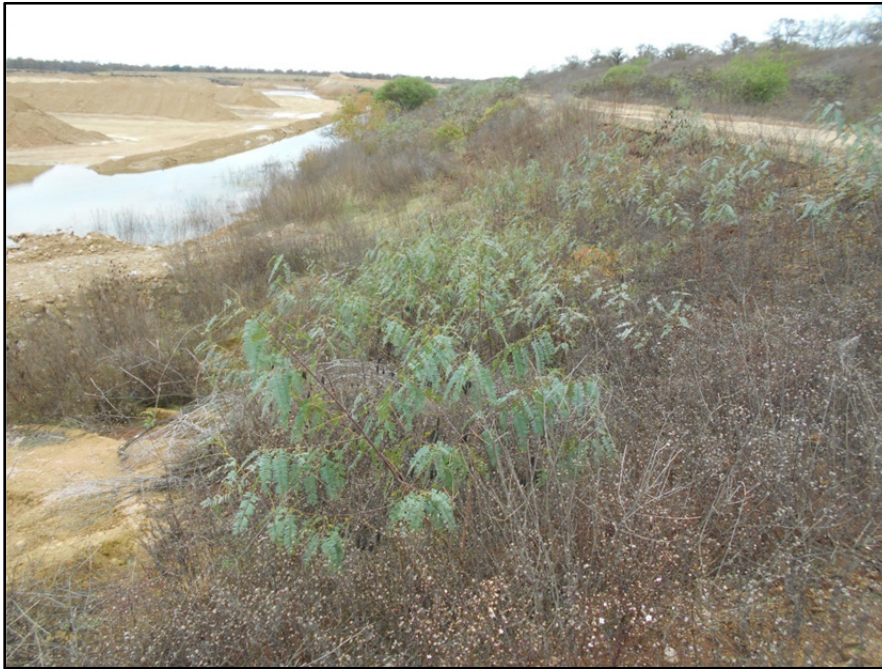
Photograph P-51 – Taken December 1, 2015 by David E. Nielson
Landfill Cell 2B: Looking west along the inside slope of the northern berm. Note accumulation of stormwater.

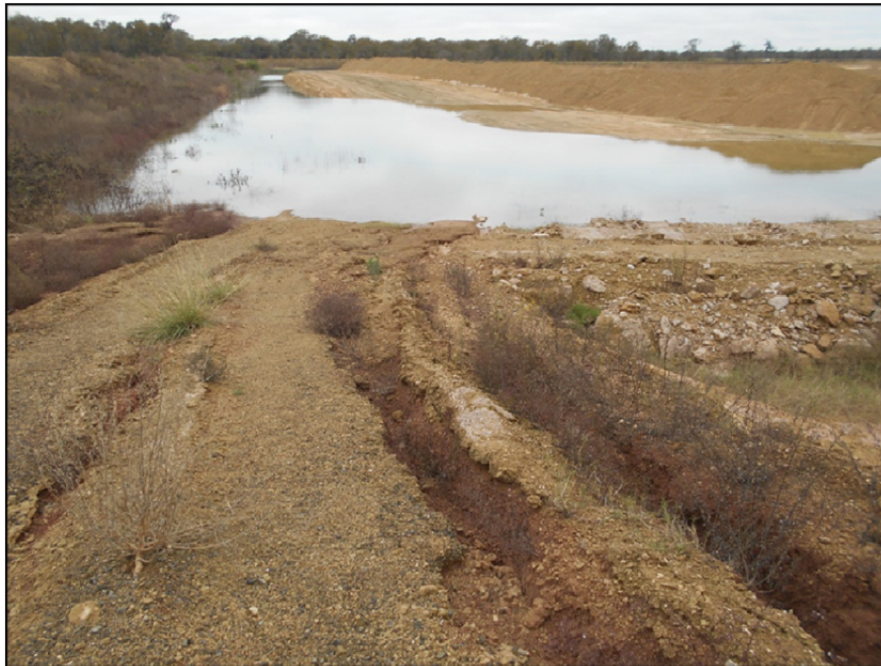
Photograph P-52 – Taken December 1, 2015 by David E. Nielson
Landfill Cell 2B: Looking south along the inside slope and toe of slope of the eastern dike/berm.

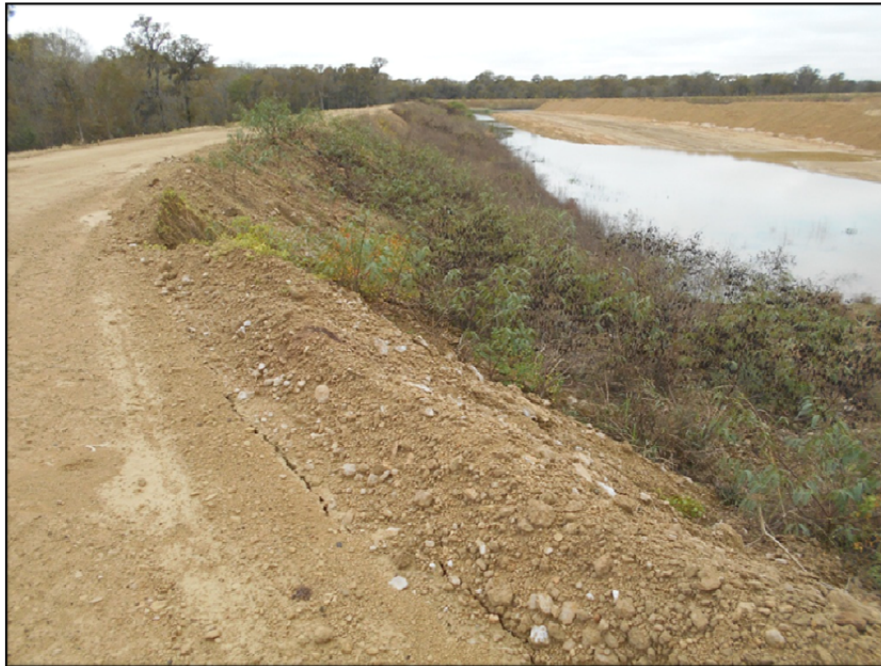
Photograph P-53 – Taken December 1, 2015 by David E. Nielson
Landfill Cell 2B: Looking south along the inside slope of the eastern berm. Note crack formation along edge of the road and the steepness of some slope sections.

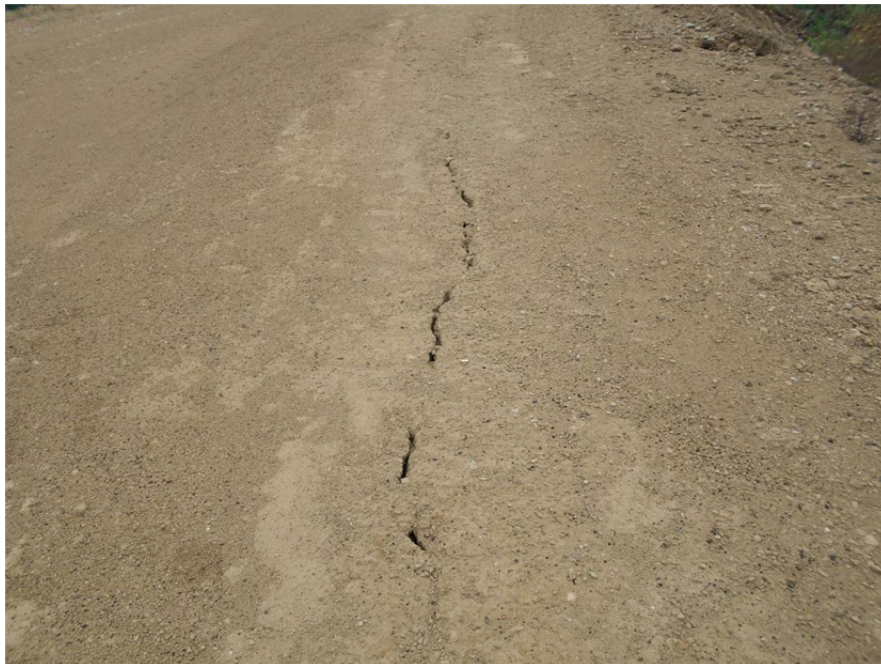
Photograph P-54 – Taken December 1, 2015 by David E. Nielson
Landfill Cell 2B: Looking south along the road on the crest of the eastern berm. Note shrinkage crack in roadway surface material has been partially filled. See Photographs P-30 through P-33 and P-37 for other photographs of this type of crack. This is considered to be shrinkage of the stabilized road surface and not evidence of berm instability.

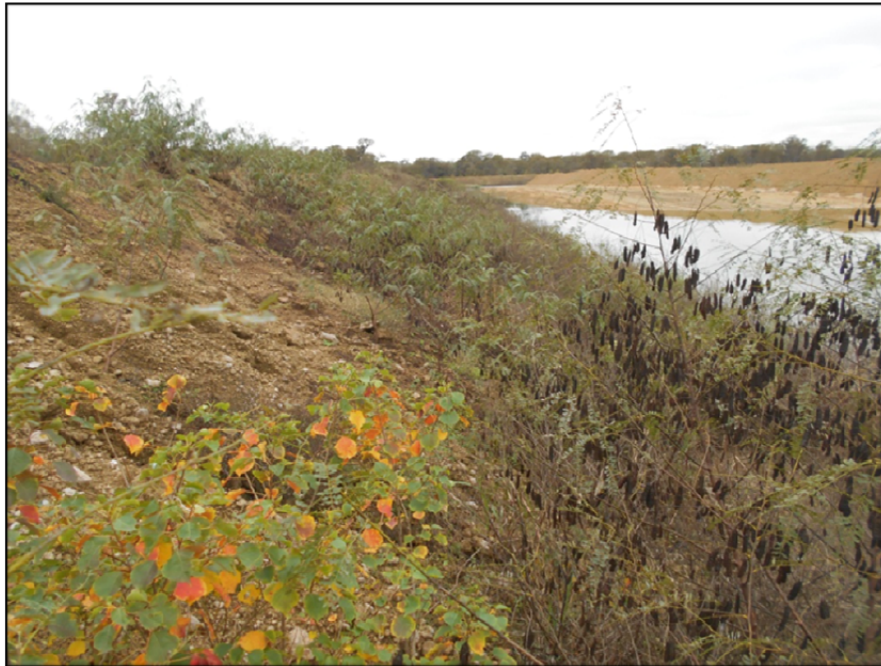
Photograph P-55 – Taken December 1, 2015 by David E. Nielson
Landfill Cell 2B: Looking south along the inside slope of the eastern berm.
Note vegetation irregularities and erosion.

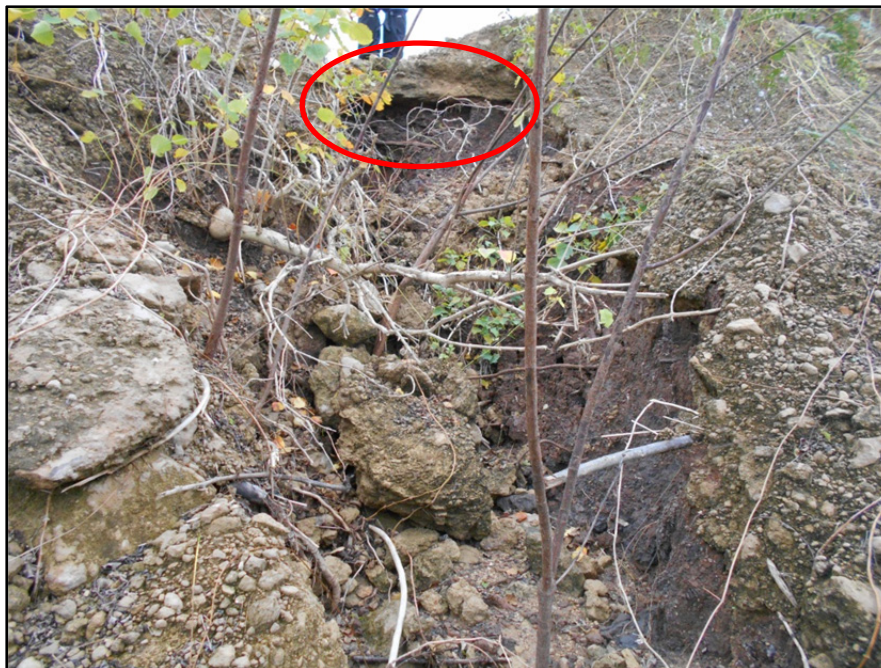
Photograph P-56 – Taken December 1, 2015 by David E. Nielson
Landfill Cell 2B: Looking up at significant erosion of the inside slope of the eastern berm. Note the stabilized road surface has been undermined (circled in red). The disturbed soils should be removed, the erosional void should be backfilled and adequate erosion control measures should be implemented. In the interim, traffic should not be allowed near the edge of the roadway.

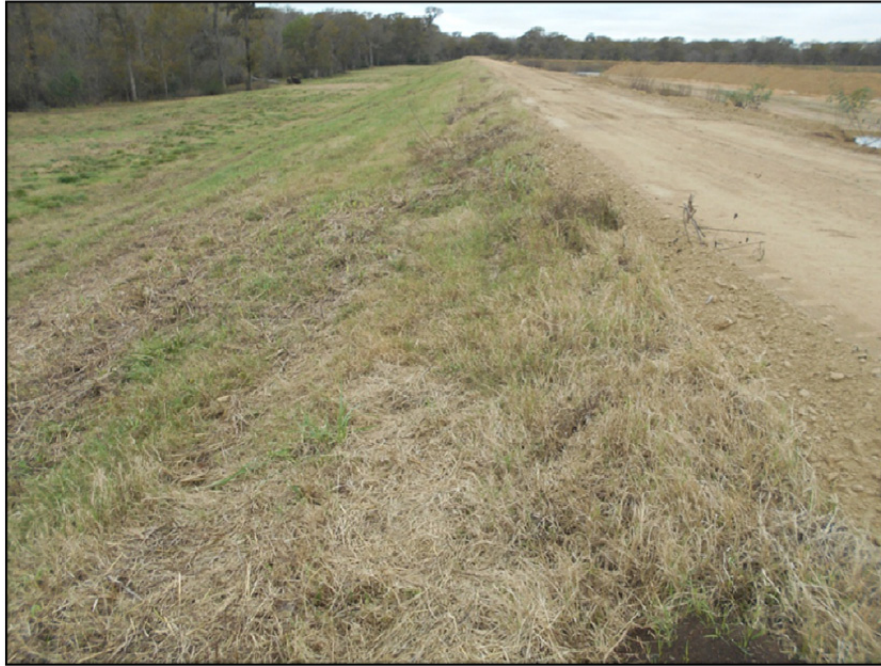
Photograph P-57 – Taken December 1, 2015 by David E. Nielson
Landfill Cell 2B: Looking south along the crest of the
outside slope of the eastern berm.

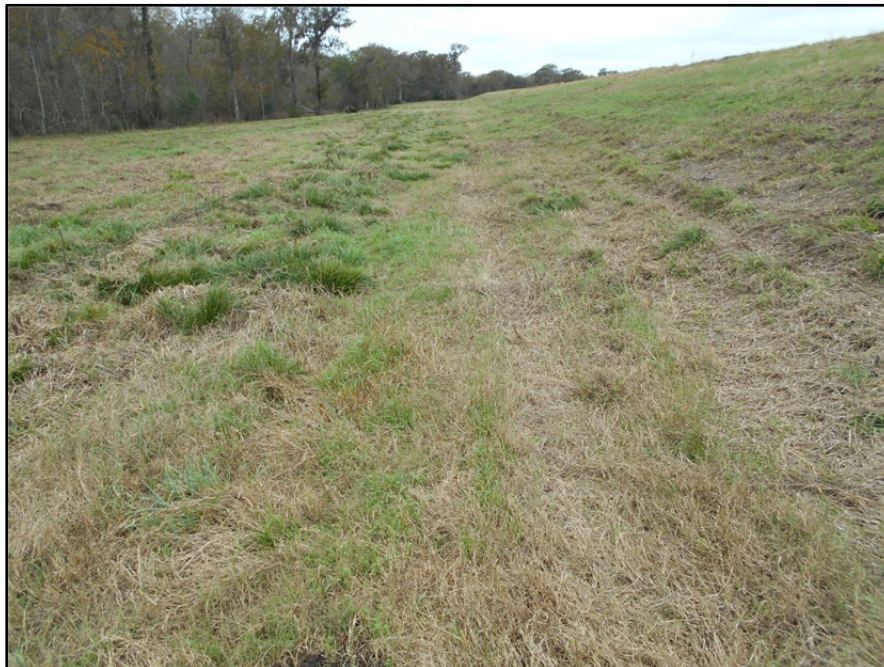
Photograph P-58 – Taken December 1, 2015 by David E. Nielson
Landfill Cell 2B: Looking south along the toe of the
outside slope of the eastern berm.

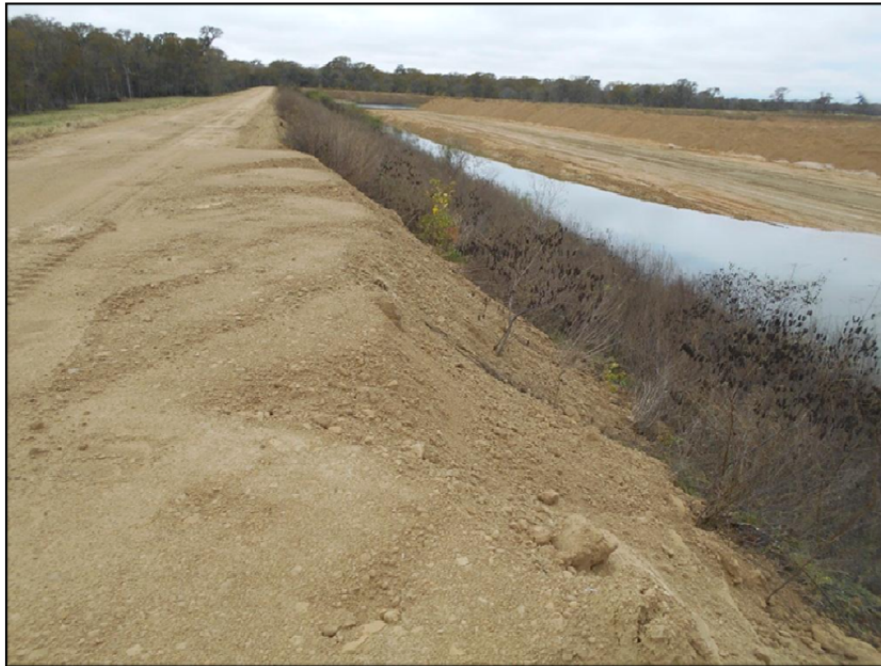
Photograph P-59 – Taken December 1, 2015 by David E. Nielson
Landfill Cell 2B: Looking south along the inside slope of the eastern berm.
Note the evidence of recent maintenance activities to protect the
edge of the roadway and mitigate steep inside slopes.

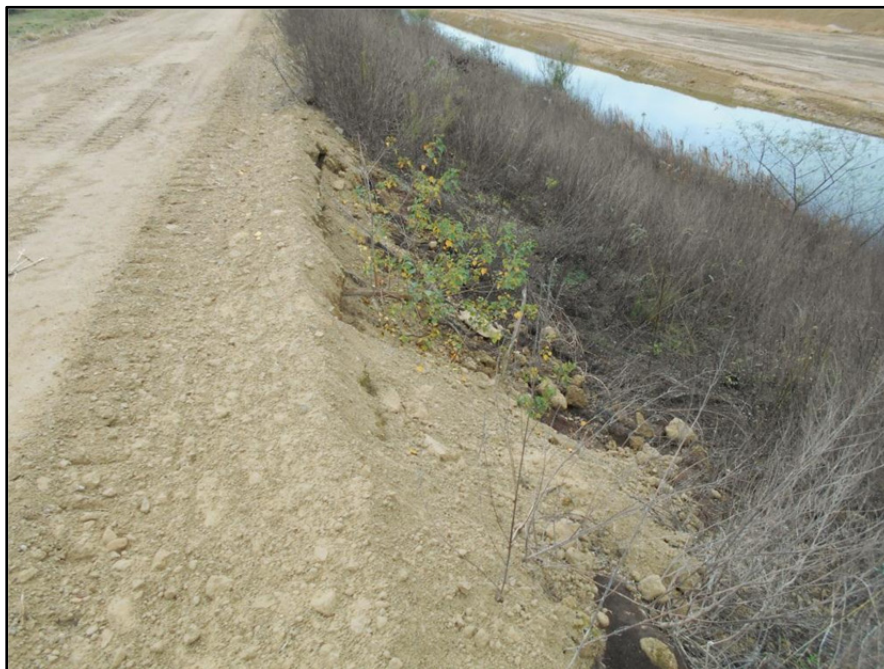
Photograph P-60 – Taken December 1, 2015 by David E. Nielson
Landfill Cell 2B: Looking south along the inside slope of the eastern berm.
Note the evidence of recent maintenance activities to protect the edge of the road.

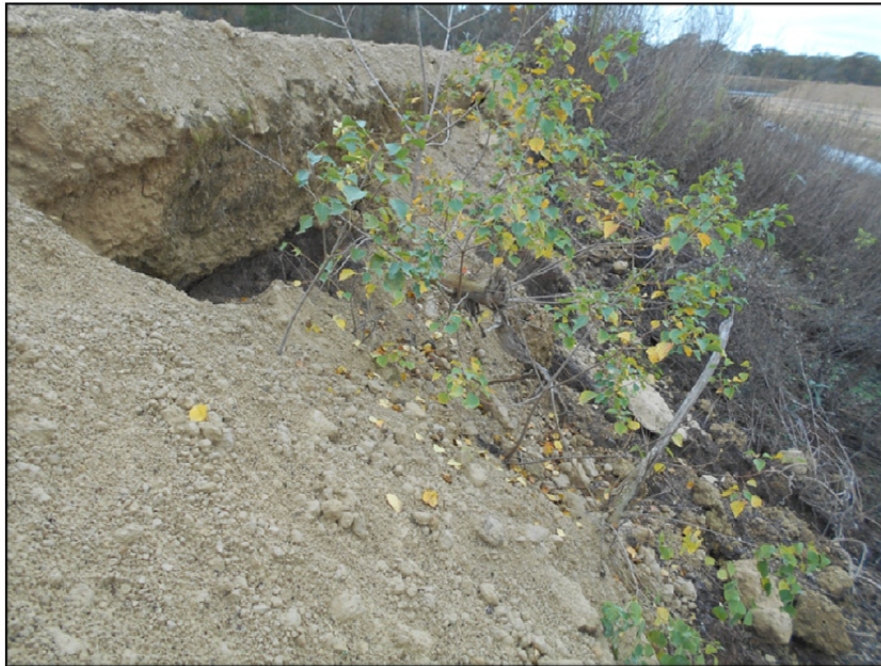
Photograph P-61 – Taken December 1, 2015 by David E. Nielson
Landfill Cell 2B: Looking south along the inside slope of the eastern berm.
Note undermining of the stabilized roadway and the steep nature of the inside slope.
