**NRG TEXAS POWER, LLC
WA PARISH STATION, UNITS 5, 6, 7, & 8**

ANNUAL INSPECTION OF CCR IMPOUNDMENTS AND LANDFILL

S&L Report No.: SL-013202

Date: January 18, 2016

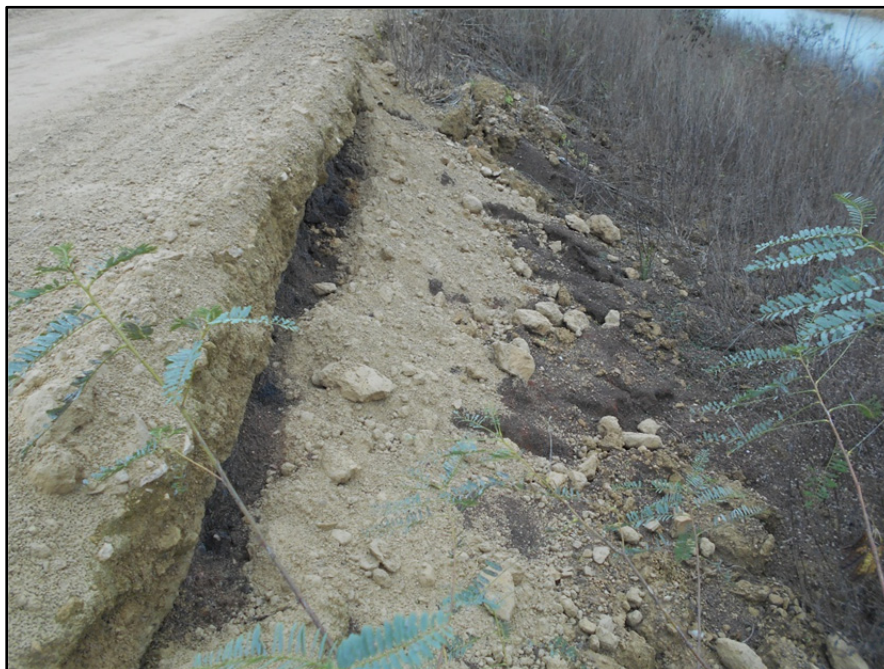
Photograph P-62 – Taken December 1, 2015 by David E. Nielson
Landfill Cell 2B: Looking south along the inside slope of the eastern berm.
Note sharp drop off at edge of road.
This area should be protected from traffic near the edge of the road.
