2021 Annual Inspection of CCR Unit

**W. A. Parish Electric Generating Station
Thompsons, Texas**

January 2022

NRG Texas Power LLC

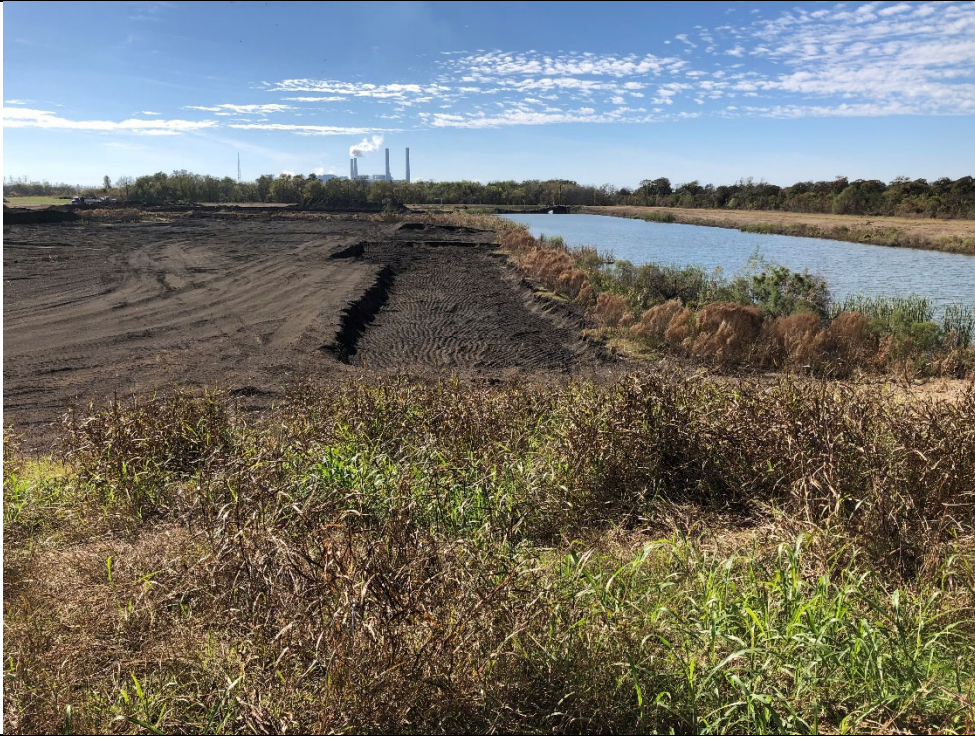
Photograph P-1: View looking south-southwest of Cell 3 from top of north berm. Bottom ash material is visible to the left; the area where bottom ash is being excavated from the landfill is visible in the center of the photograph, and the Cell 3 storm water pond is visible to the right. The interior slopes and crest roads of the berms have been stabilized with a cemented fly ash mixture. The remainder of the berms are well vegetated.

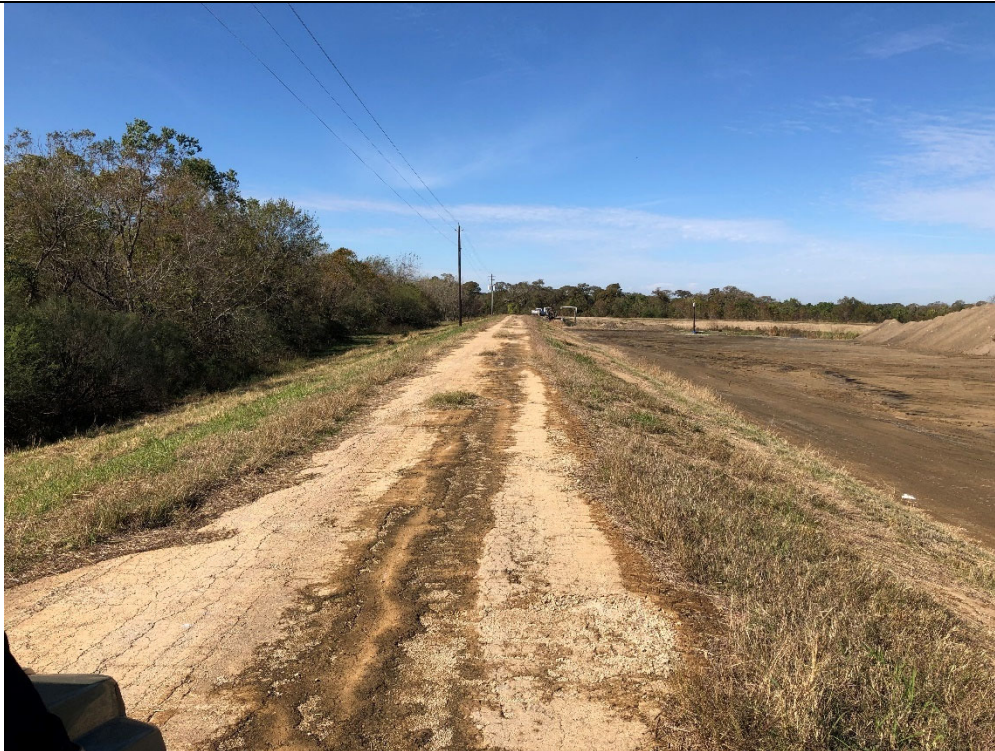
In general, the exterior slopes of the perimeter berms were well vegetated and demonstrated good alignment and slope grade. The crests of the berms around Cell 3 were free of rutting and misalignment.

Photograph P-2: View looking west of Cell 3's south berm. The crest road was well maintained, exterior slopes well vegetated without erosion issues, and interior slope either improved with stabilized CCR material or vegetated.

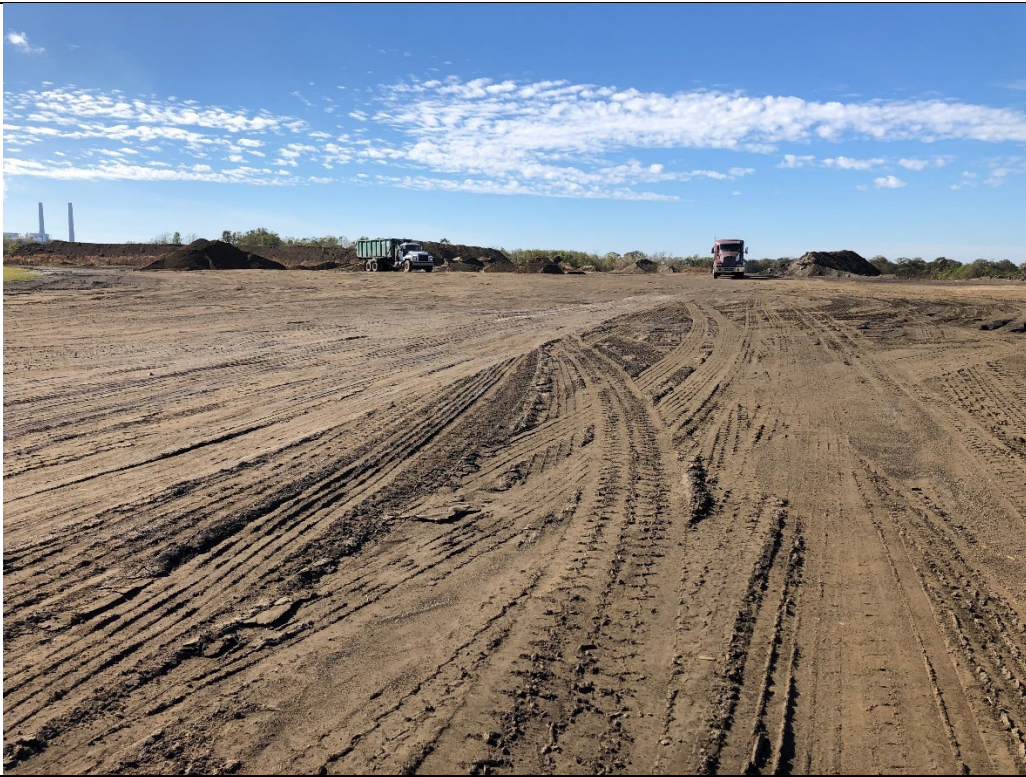
Photograph P-3: View looking west of interior of Cell 3 landfill and Cell 3 Coal Combustion Residual (CCR) waste piles. Trucks waiting to be loaded with salable bottom ash are visible in this photograph.

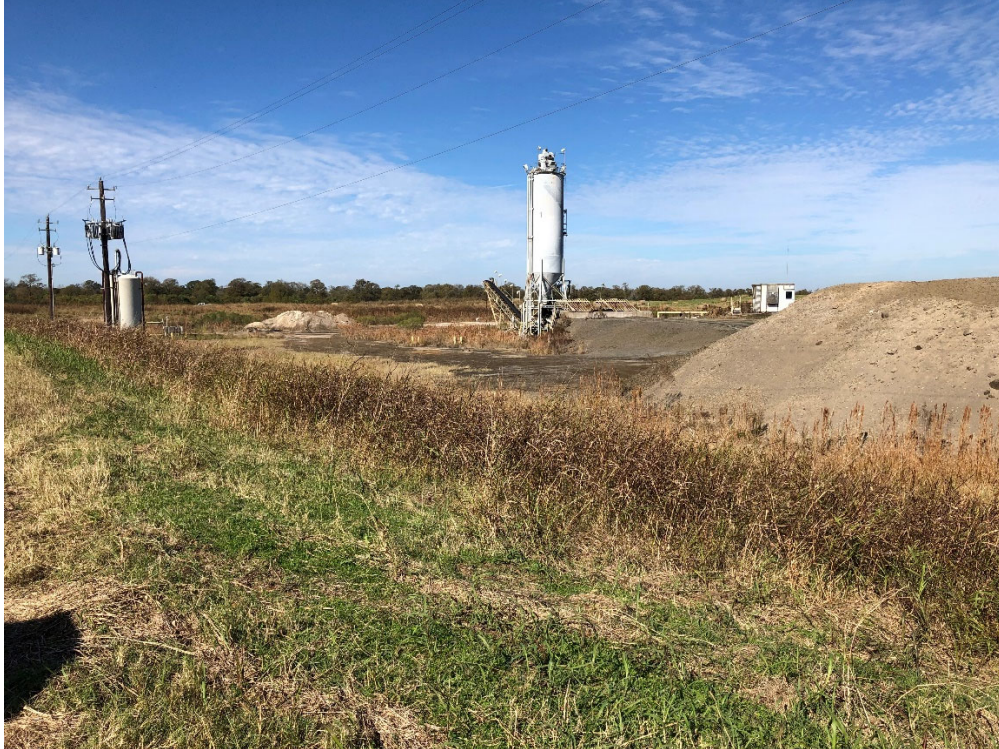
Photograph P-4: View looking west along the south berm of Cell 2A (the Pugmill Area). Stockpiled, salable CCR material is visible on the right side of this photograph.

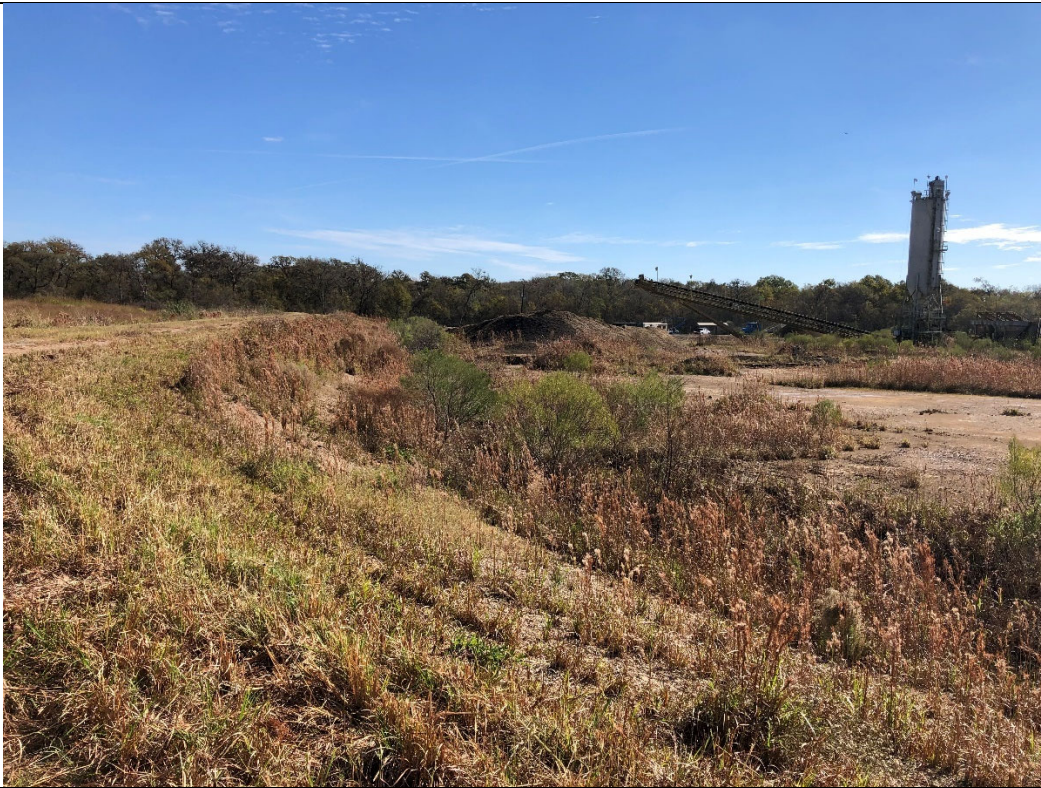
Photograph P-5: View looking east along the northern berm of Cell 2A, the Pugmill Area. Pugmill equipment and mixed CCR material are visible in this photograph.

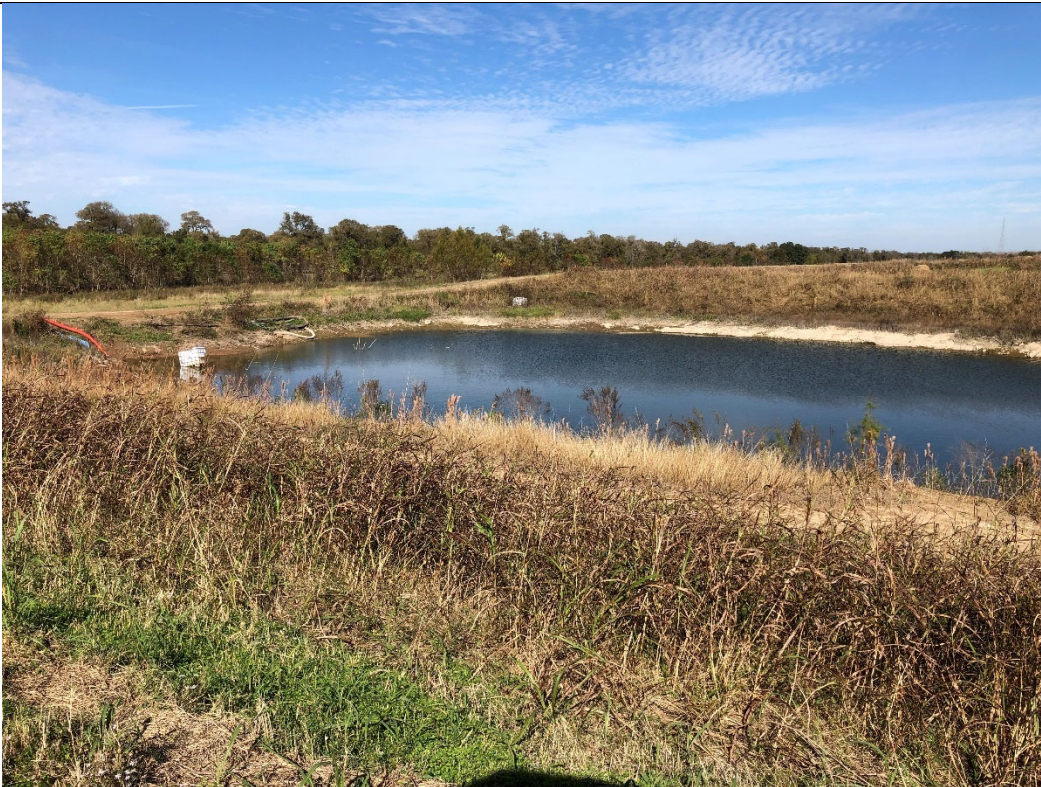
Photograph P-6: View looking north across the contact water pond in Cell 2A. Slopes were either stabilized or well vegetated.

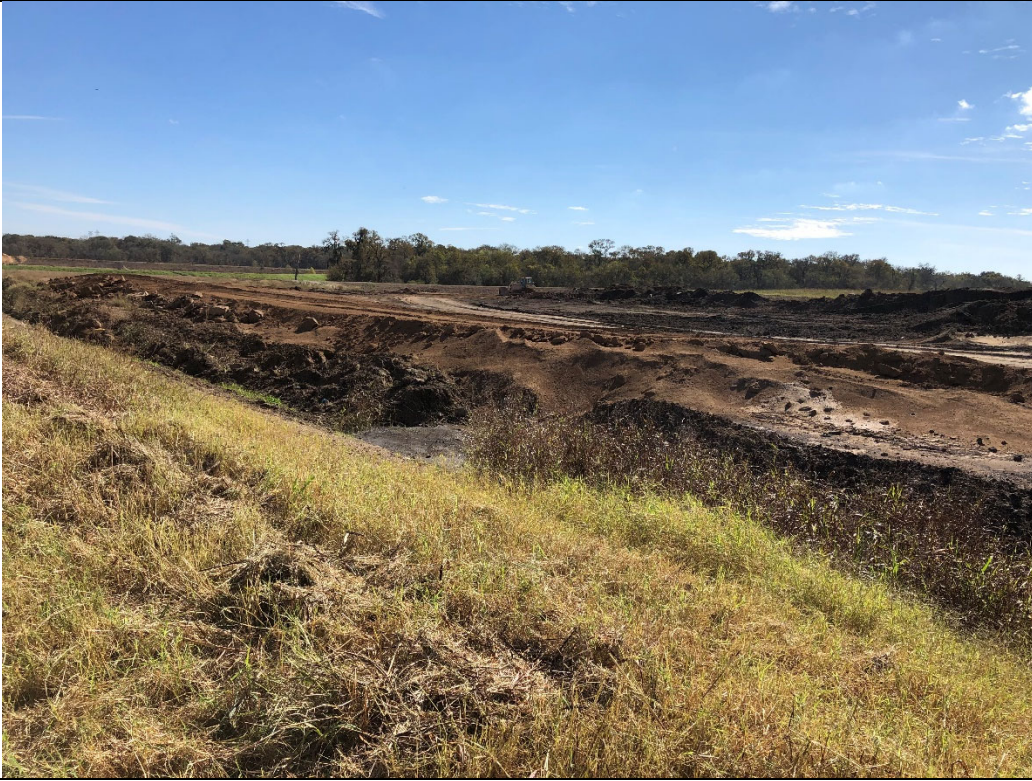
In general, the exterior slopes of the perimeter berms are well vegetated and demonstrate good alignment and slope grade. No significant adverse conditions were identified for the outside slopes of the perimeter berms. The crests of the perimeter berms were generally free of rutting and misalignment as shown on Photographs P-7 through P-9.

Photograph P-7: View looking northeast along the western berm of Cell 1C. Slopes were well stabilized. Although not visible, the crest road was stabilized with no significant rutting.

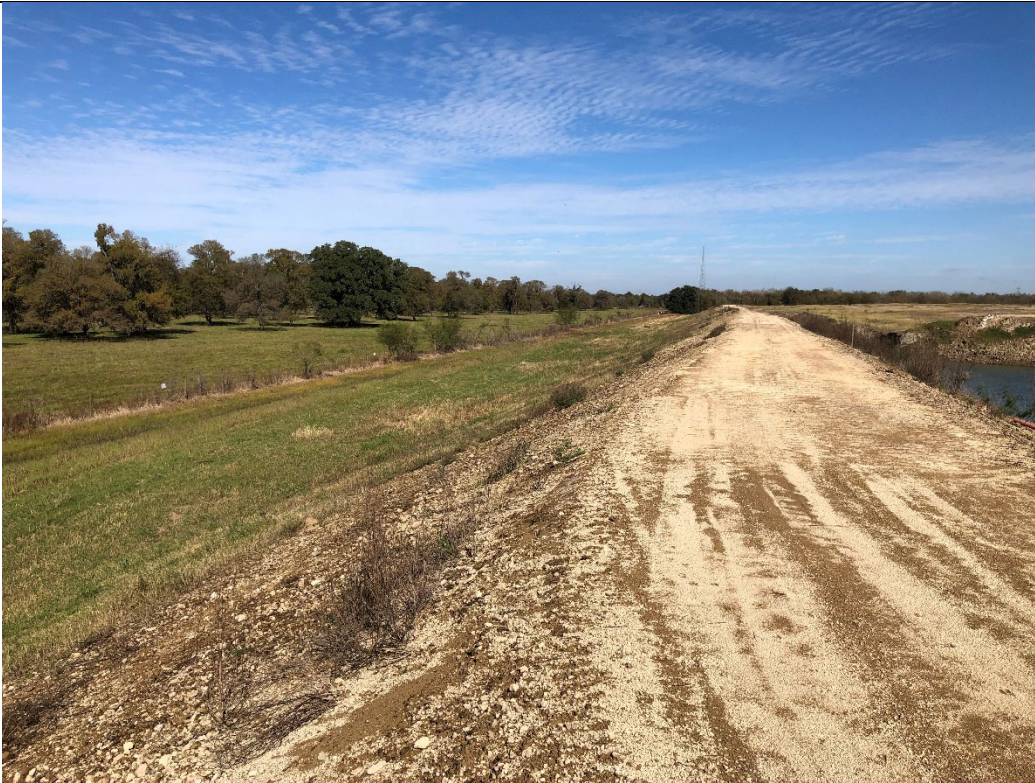
Photograph P-8: View looking north of the western berm of Cell 1C. The Cell 1C storm water pond is visible on the far right of this photograph.

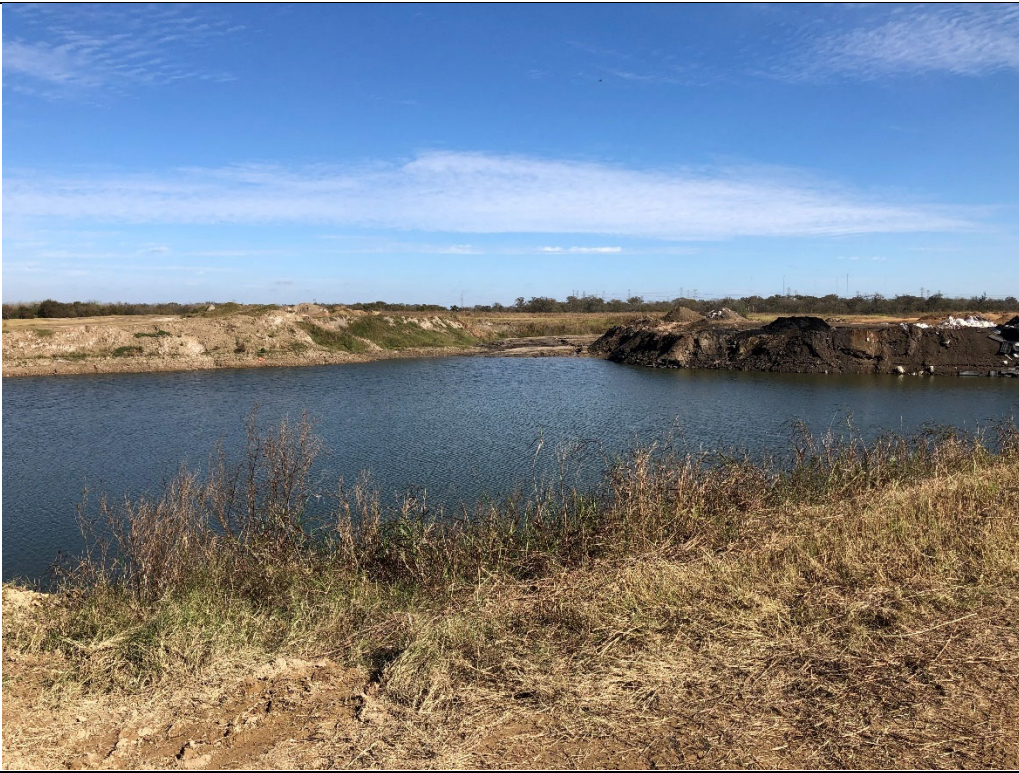
Photograph P-9: View looking northeast of the contact water pond in Cell 1C. Picture was taken from berm at southwest corner of Cell 1C.

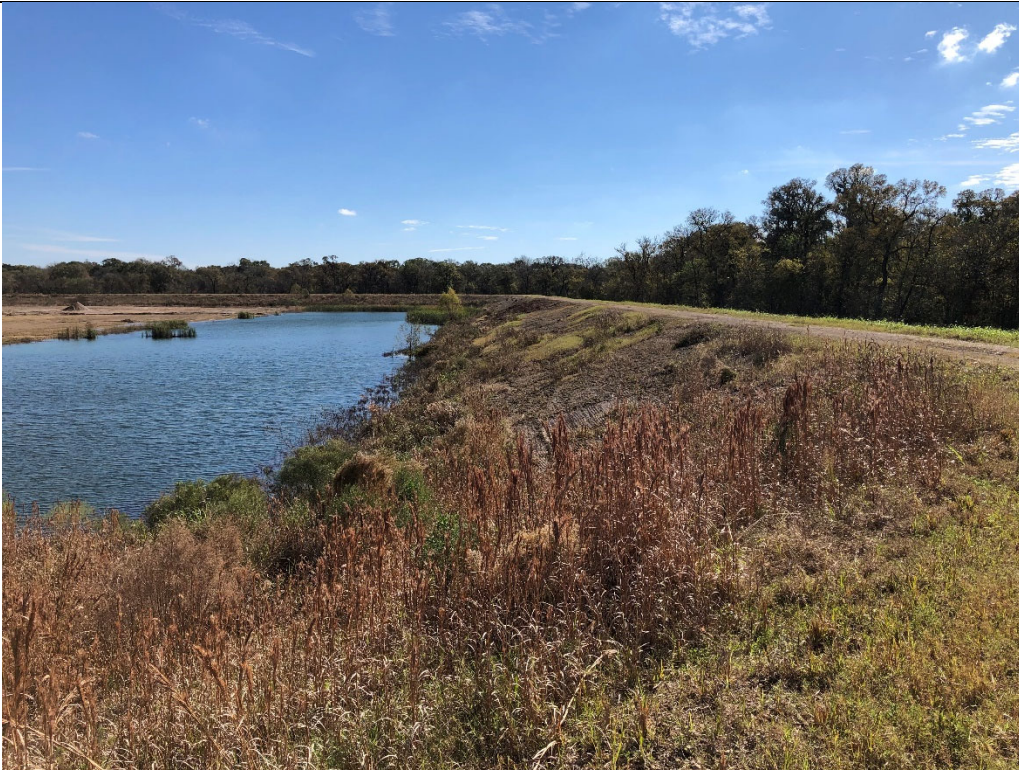
Minor sloughing of the interior slope of the southern berm has been a reoccurring issue in 2021. Sloughing was observed in the southwest corner of the landfill and near the center of the southern berm. A slough in the center of the interior slope of the southern berm was repaired in January 2021. A slough reoccurred in this area in May 2021, and was documented in weekly inspection reports until its final repair in October 2021. No sloughing was observed during the November 30, 2021 site visit.

Photograph P-10: View looking southeast of Cell 2B's southern berm from southwest corner of landfill. The Cell 2B stormwater pond is visible to the left.

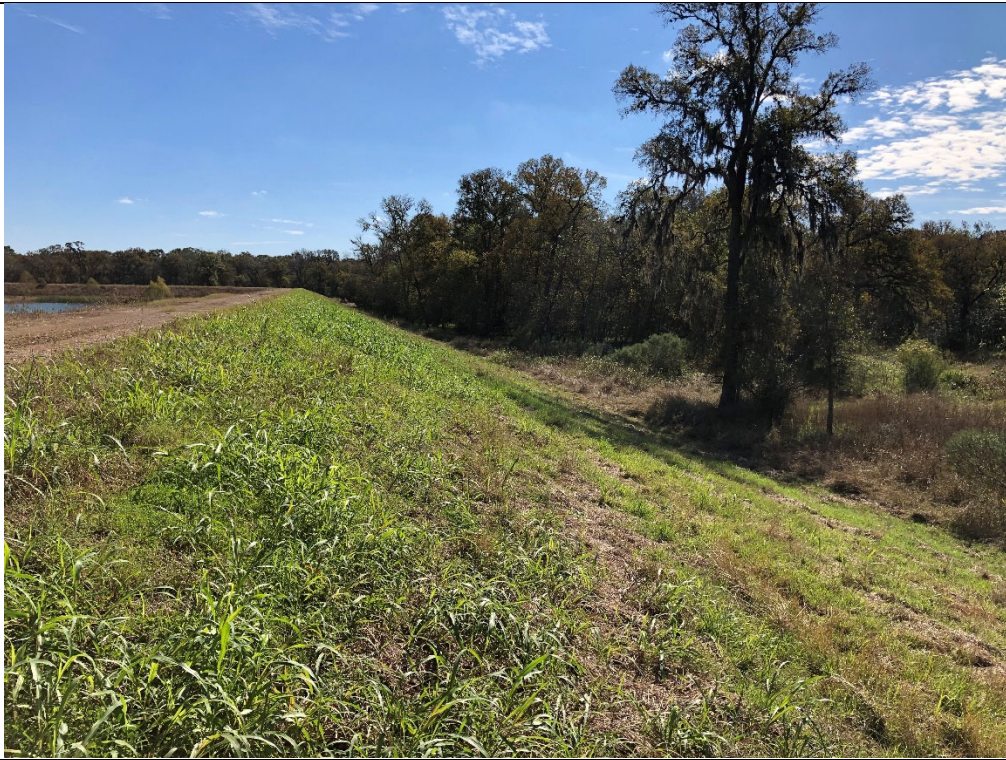
Photograph P-11: View looking southeast of the exterior slope of Cell 2B's southern berm. The exterior slope is well vegetated.

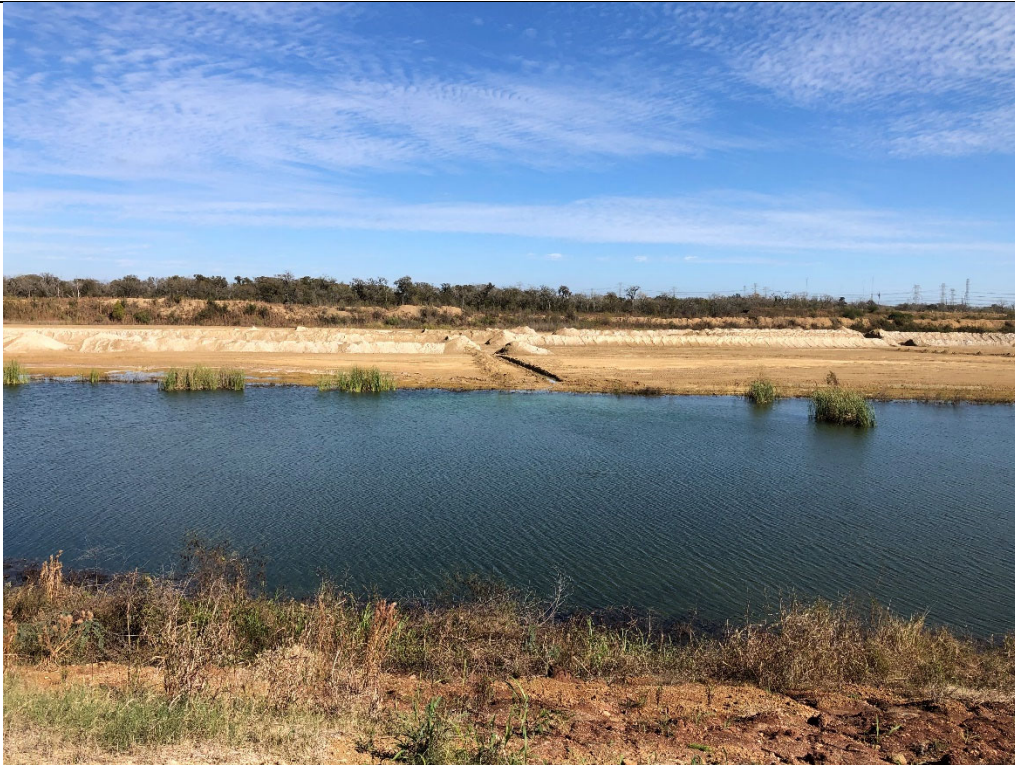
Photograph P-12: View looking northeast from southern berm across storm water pond at waste stored in Cell 2B. Stockpiled fly ash is visible in the center of the photograph, while CCR waste from the Flue Gas Desulfurization system is visible beyond the fly ash.
