# **2024 Annual Inspection of CCR Unit**

**W. A. Parish Electric Generating Station  
Thompsons, Texas**

**January 2025**

**NRG Texas Power LLC**

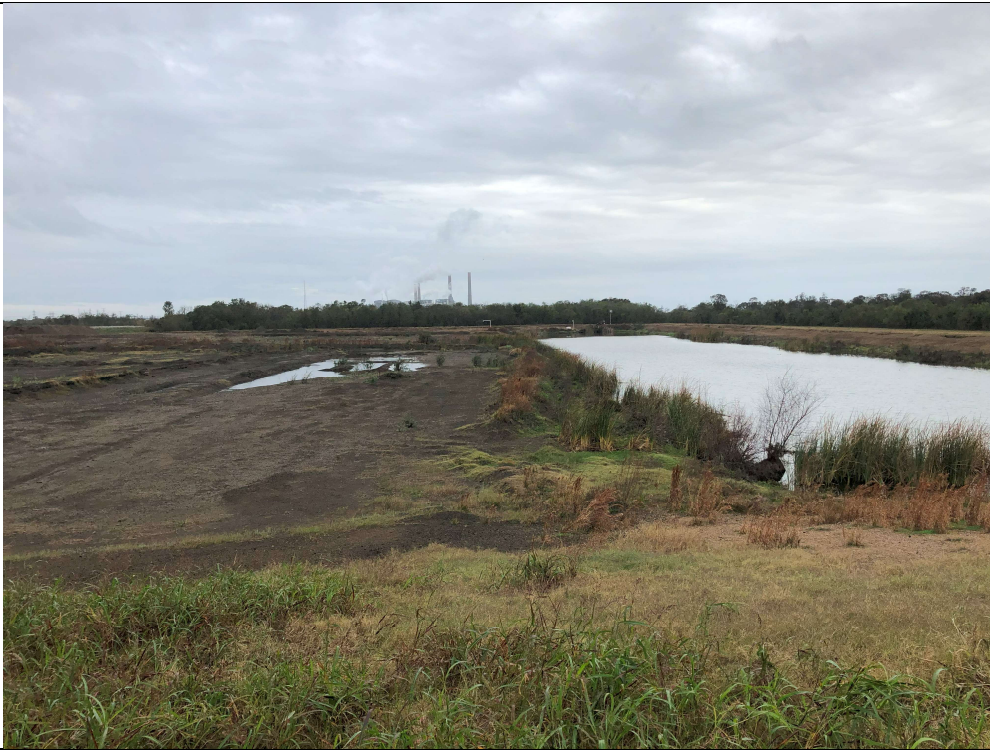
Cell 3 was observed to be in good condition without indications of risk of catastrophic or operational failure. The Cell 3 perimeter berms were observed to be in excellent condition.

Photograph P-1: View looking south at Cell 3 from top of its north berm. This view is directly of an area where bottom ash material has been excavated and sold as road base. The Cell 3 storm water pond is visible to the right. The interior slopes and crest roads of the berms are either vegetated (slopes) or have been stabilized with a cemented fly ash mixture.

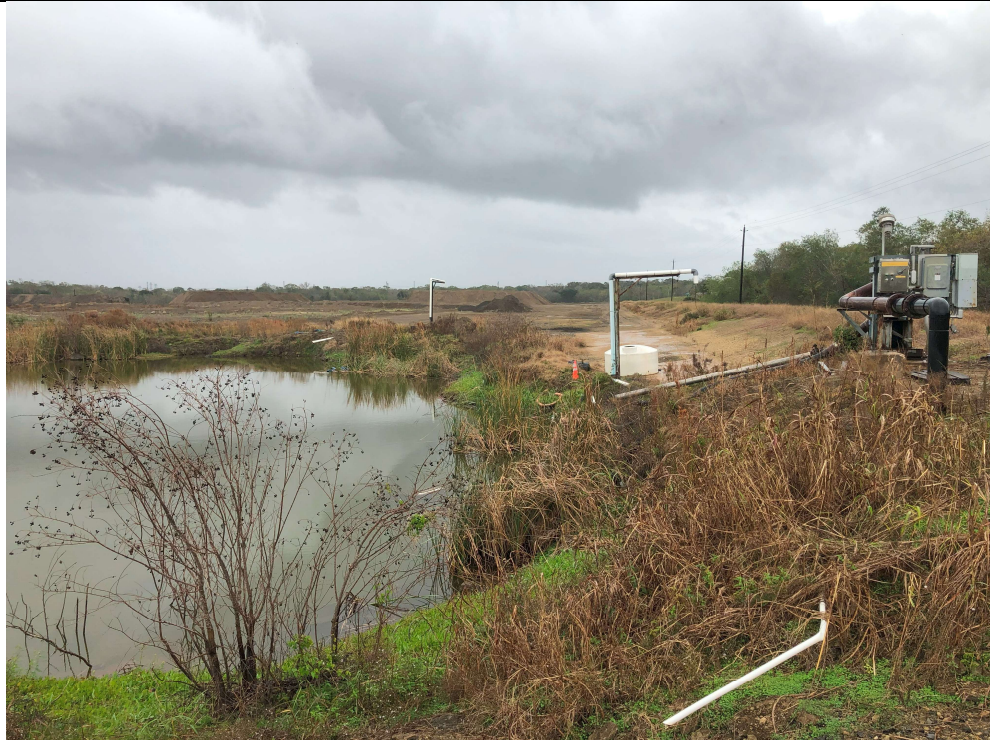
In general, the exterior slopes of the perimeter berms were well vegetated and demonstrated good alignment and slope grade. The crests of the berms around Cell 3 were free of rutting and misalignment.

Photograph P-2: View looking east from Cell 3's southwest interior corner. The crest road was well maintained, exterior slopes well vegetated without erosion issues, and interior slope either improved with stabilized CCR material or vegetated.

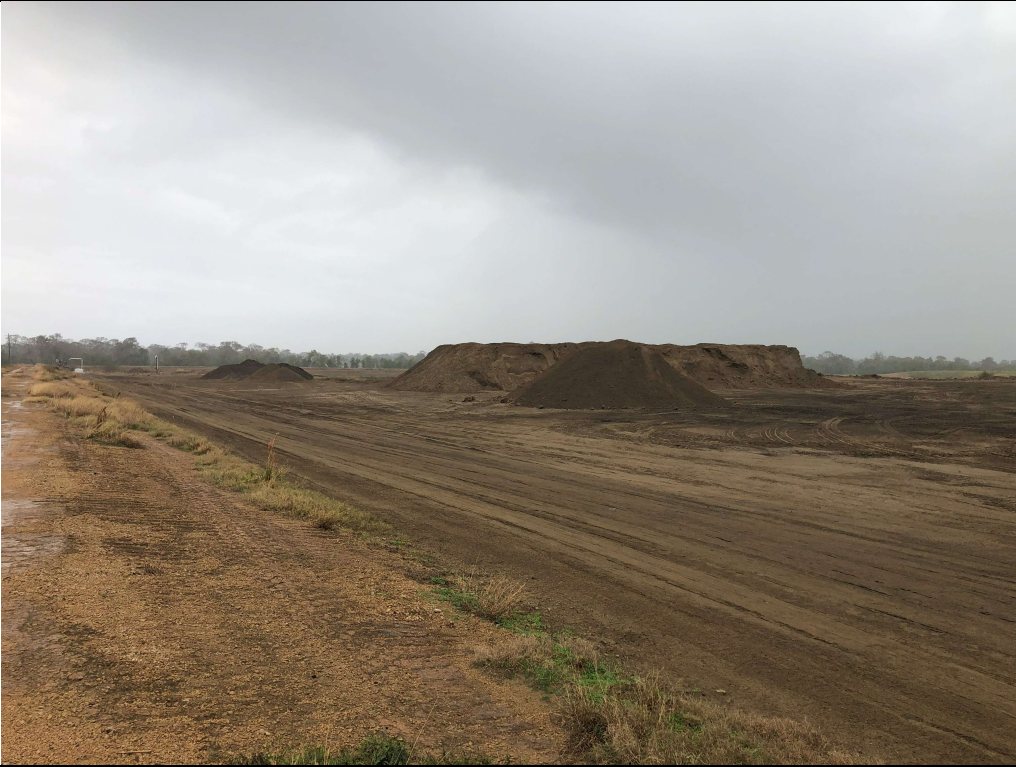
Photograph P-3: View looking northwest of the Cell 3 landfill and Cell 3 Coal Combustion Residual (CCR) waste piles. This material is being sold as road base.

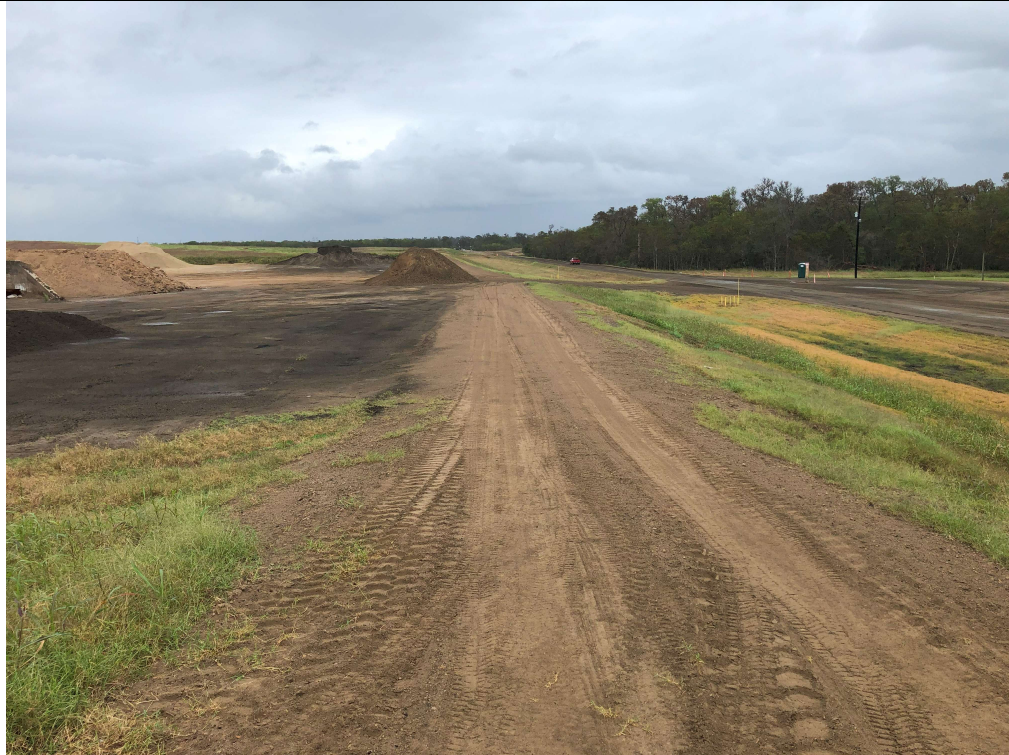
Photograph P-4: View looking north along the eastern edge of Cell 2A (the Pugmill Area). Stockpiled, salable CCR material is visible on the left side of this photograph.

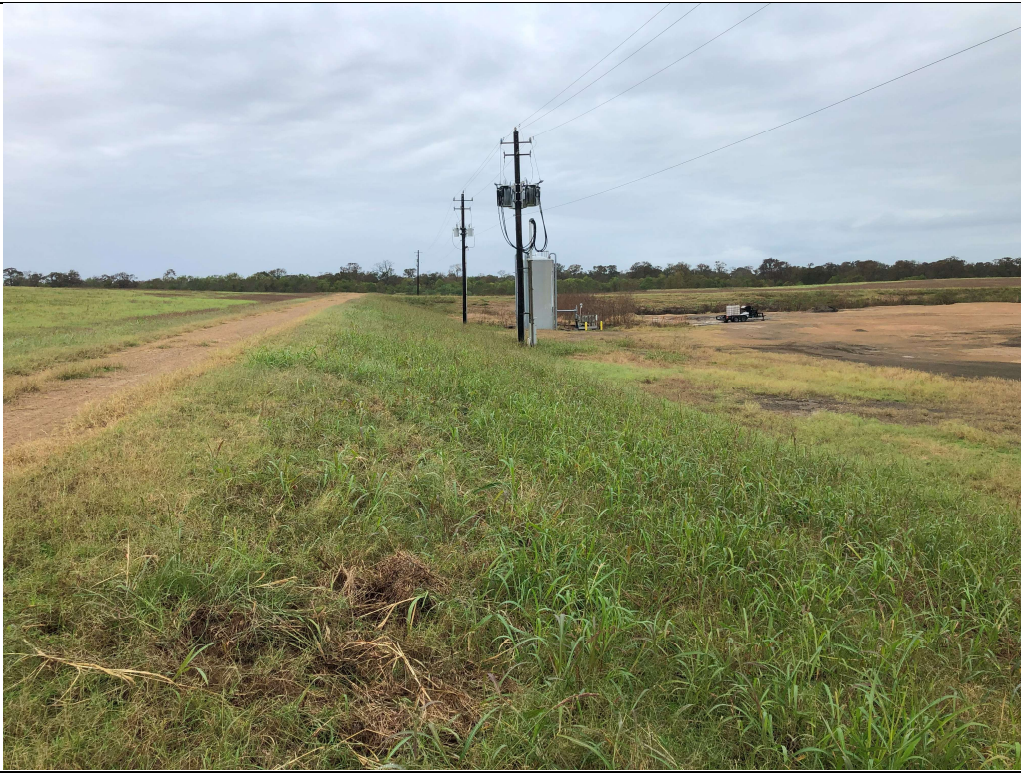
In general, the exterior slopes of the perimeter berms are well vegetated and demonstrate good alignment and slope grade. The surfaces of portions of the interior slopes were either well vegetated or stabilized. The berm crests were not significantly rutted or misaligned.

Photograph P-5: View looking west along the interior of the southern berm Cell 2A. This interior slope is well vegetated without erosion issues.

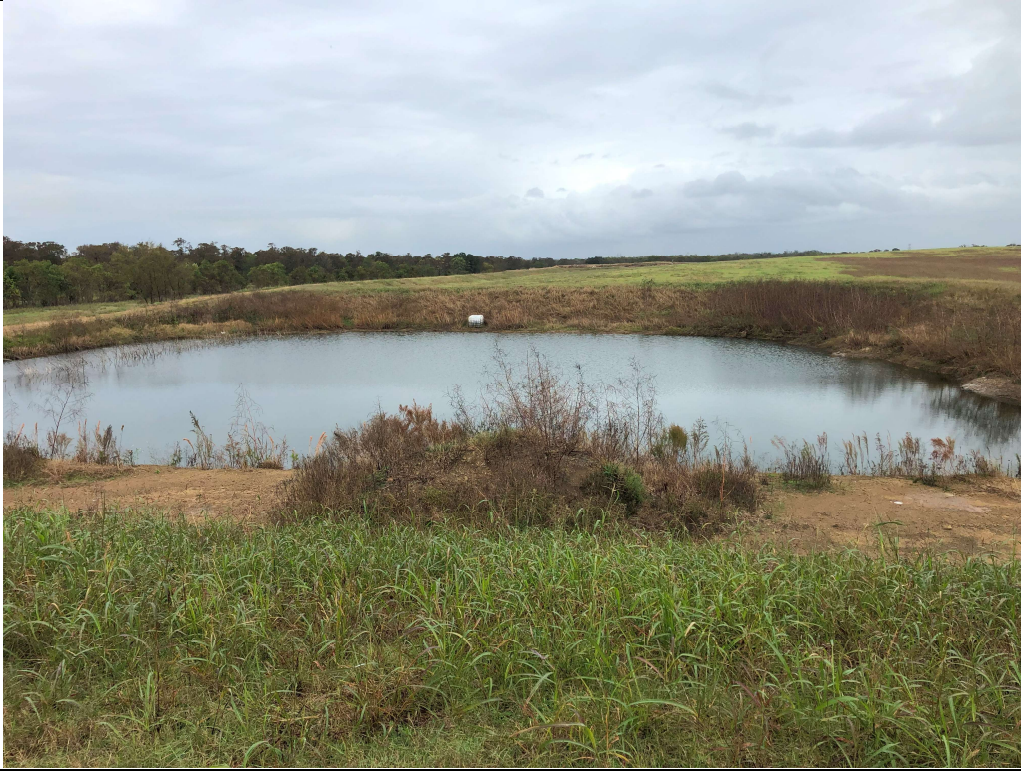
Photograph P-6: View looking north across the contact water pond in Cell 2A. Slopes were either stabilized or well vegetated.

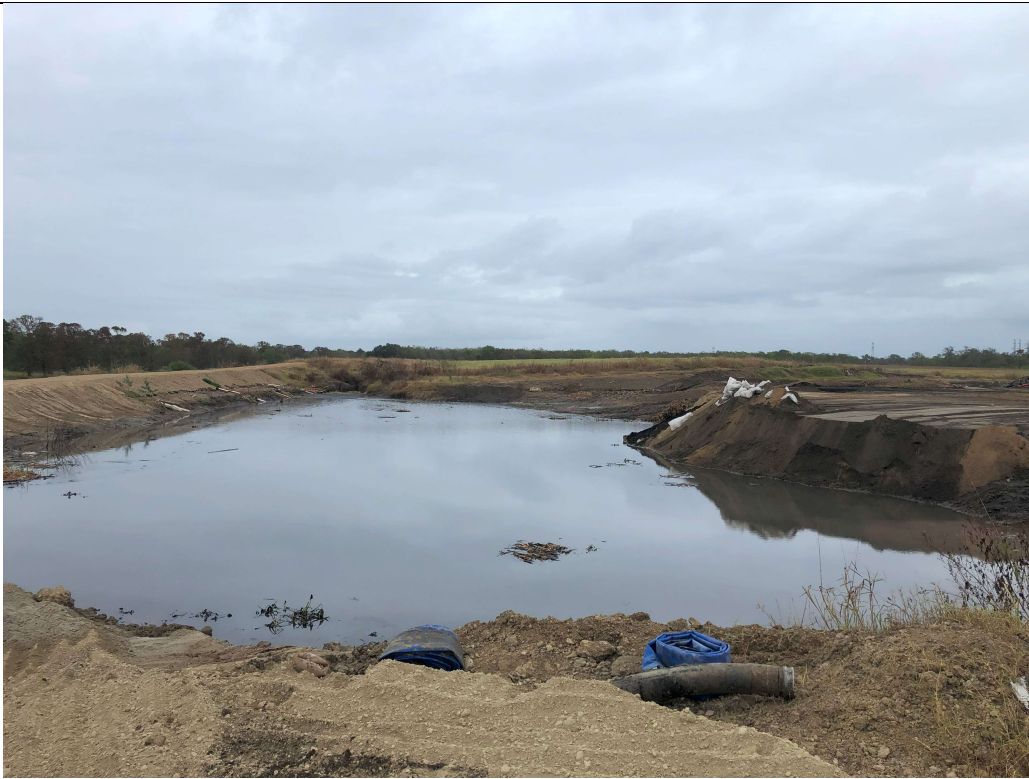
Photograph P-7: View looking northeast across the contact water pond in Cell 1C. This view is towards the area that was closed in 2022 (located just to the north of the pond and left background of this photograph).

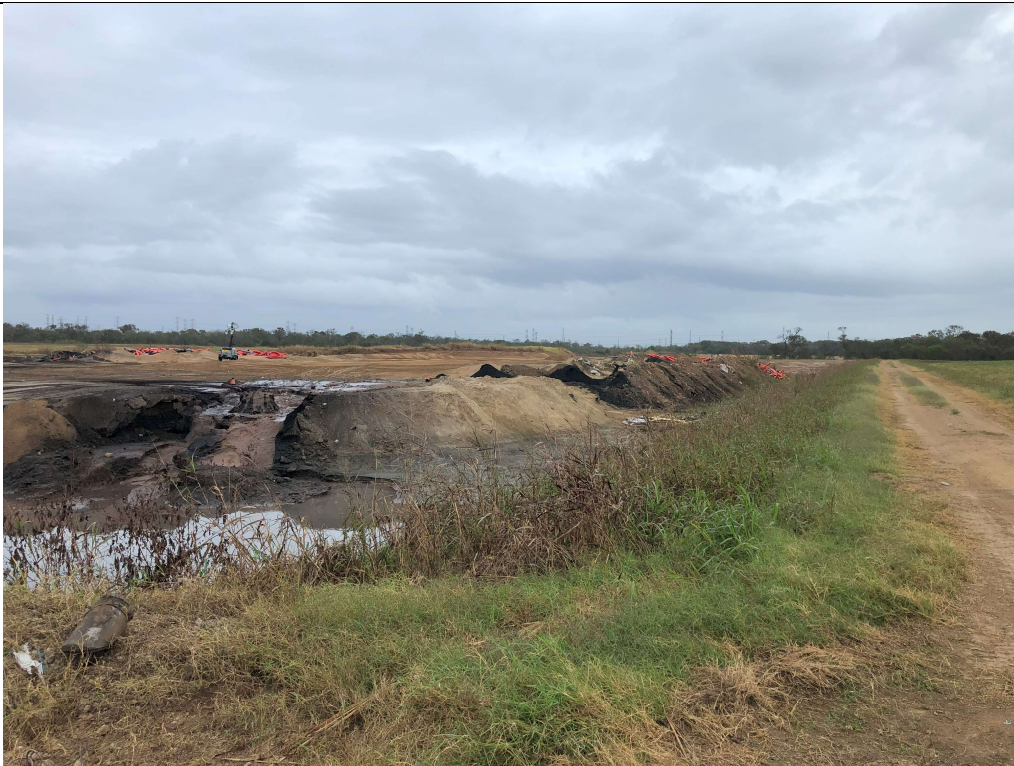
the perimeter berms. The crests of the perimeter berms were generally free of rutting and misalignment as shown on Photographs P-8 through P-10.

Photograph P-8: View looking northeast from the berm at the southwest corner of Cell 1C. The Cell 1C storm water pond is visible on the left side of this photograph, while the remaining active portion of this cell is visible in the background.

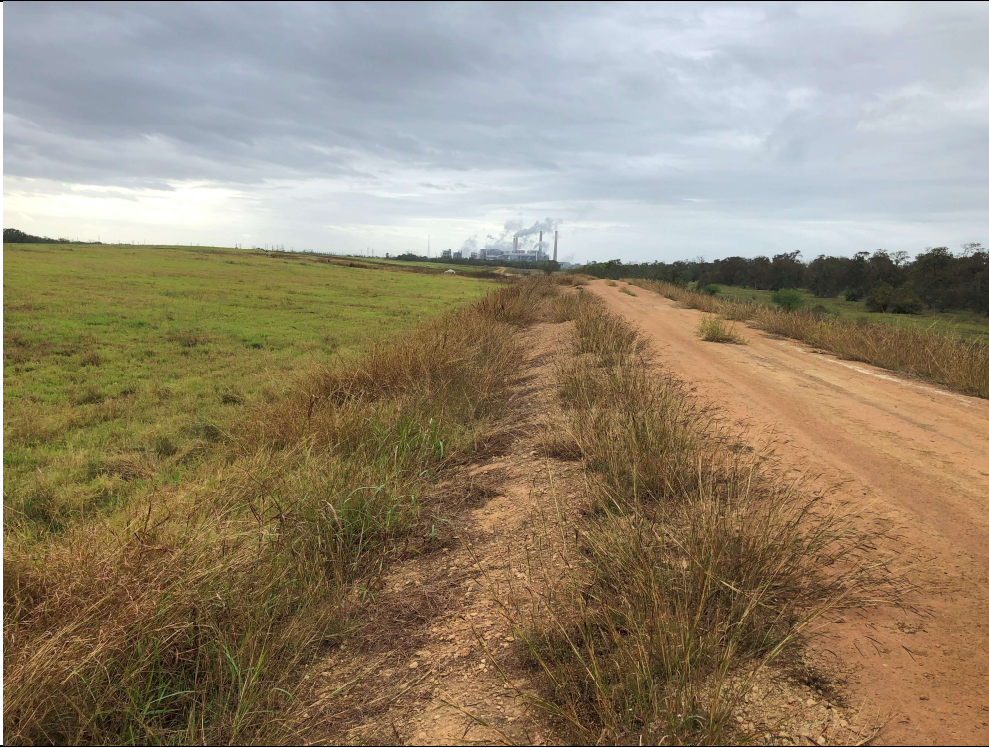
The interior slopes of Cell 1C exhibited good alignment, grades, and vegetation or erosion resistant stabilized material. No adverse conditions were identified for the inner slopes of the perimeter berms. An 11-acre portion of the landfill located along the western berm was closed in 2022. Photograph P-9 shows grass has been established on the topsoil portion of the cover system.

Photograph P-9: View looking south along the western berm of Cell 1C. The area closed in 2022 is visible to the left, and the berm crest road visible to the right. No significant rutting was observed.

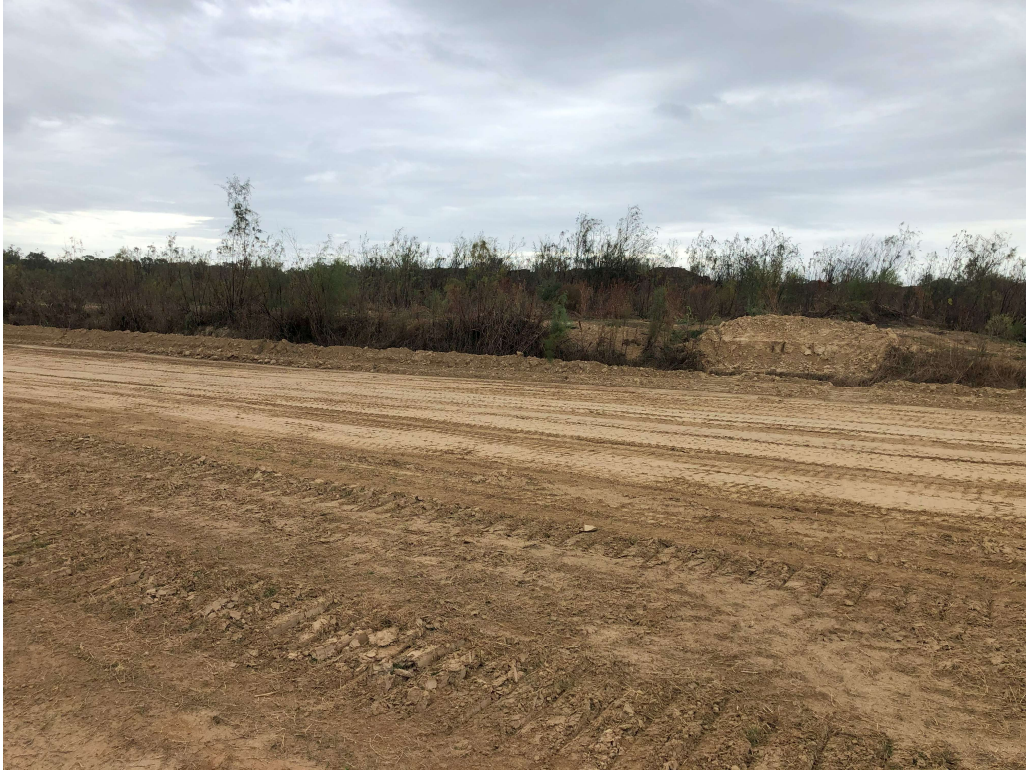
Photograph P-10: View looking southeast along the northern berm of Cell 2B. The tan material visible here is scrubber sludge.

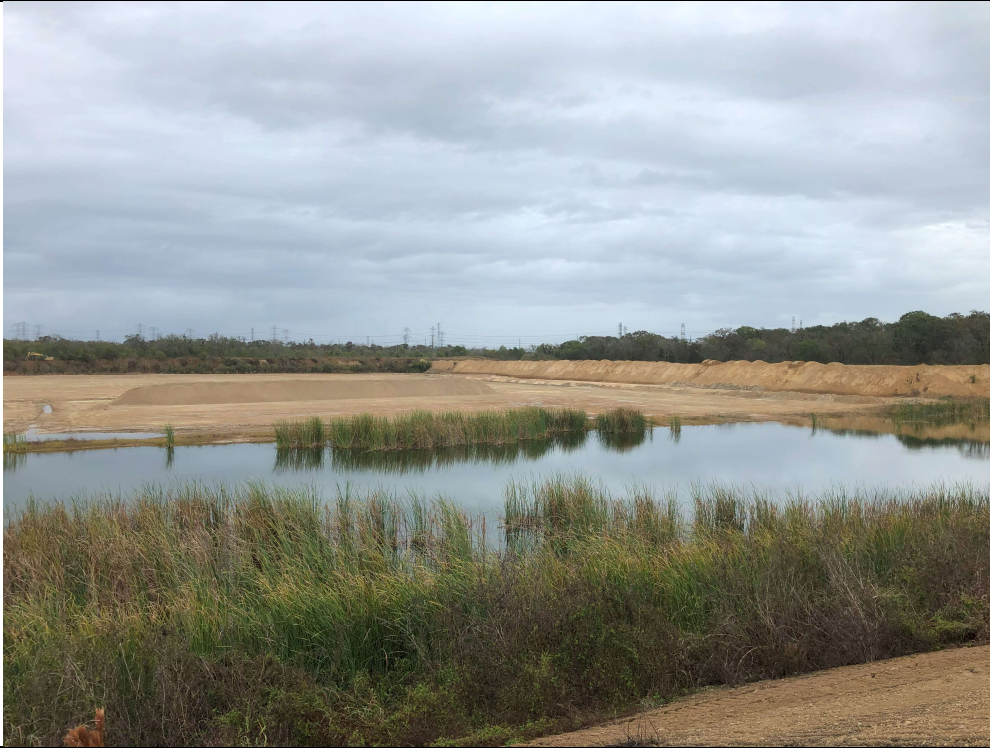
Photograph P-11: View looking north across contact water pond from Cell 2B's southern berm. The vegetation in the pond is controlled on an as needed basis. Stockpiled fly ash is visible to the north of the pond.

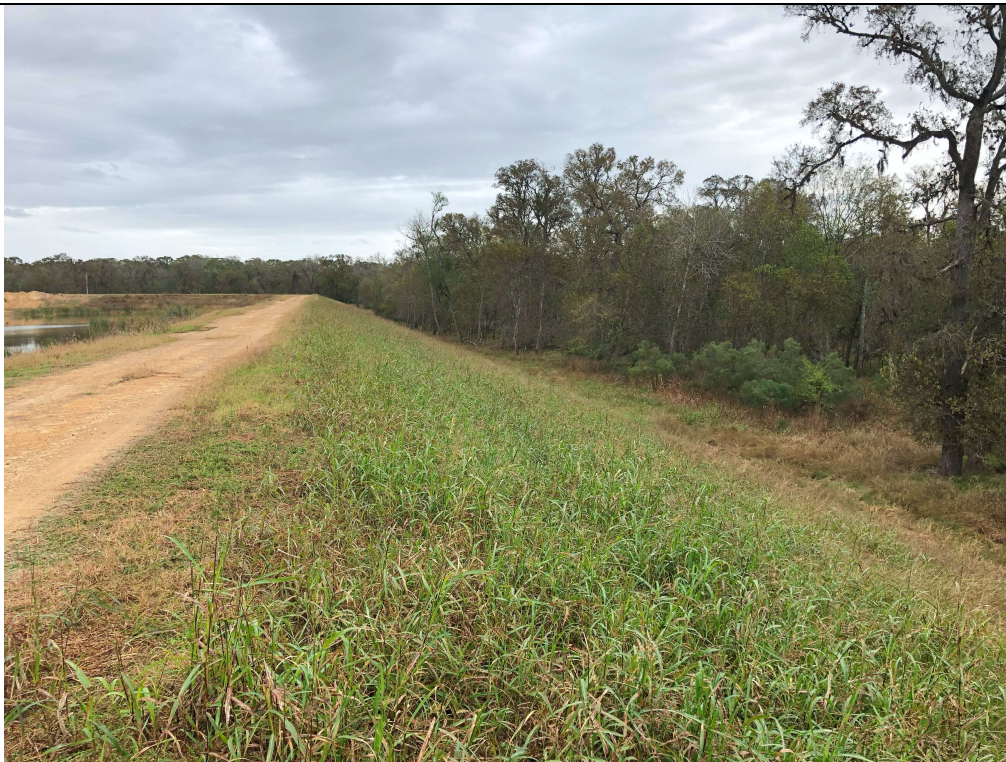
In general, the outside slopes of the perimeter berms exhibited good alignment, grades, and vegetation. There were no observed indications of instability of the outside slopes of the perimeter berms and the inner berms.

Photograph P-12: View looking southeast of the exterior slope of Cell 2B's southern berm. The exterior slope is well vegetated, stable, and not excessively steep. No erosional issues were observed.
