# **2025 Annual Inspection of CCR Unit**

**W. A. Parish Electric Generating Station  
Thompsons, Texas**

**January 2026**

**NRG Texas Power LLC**

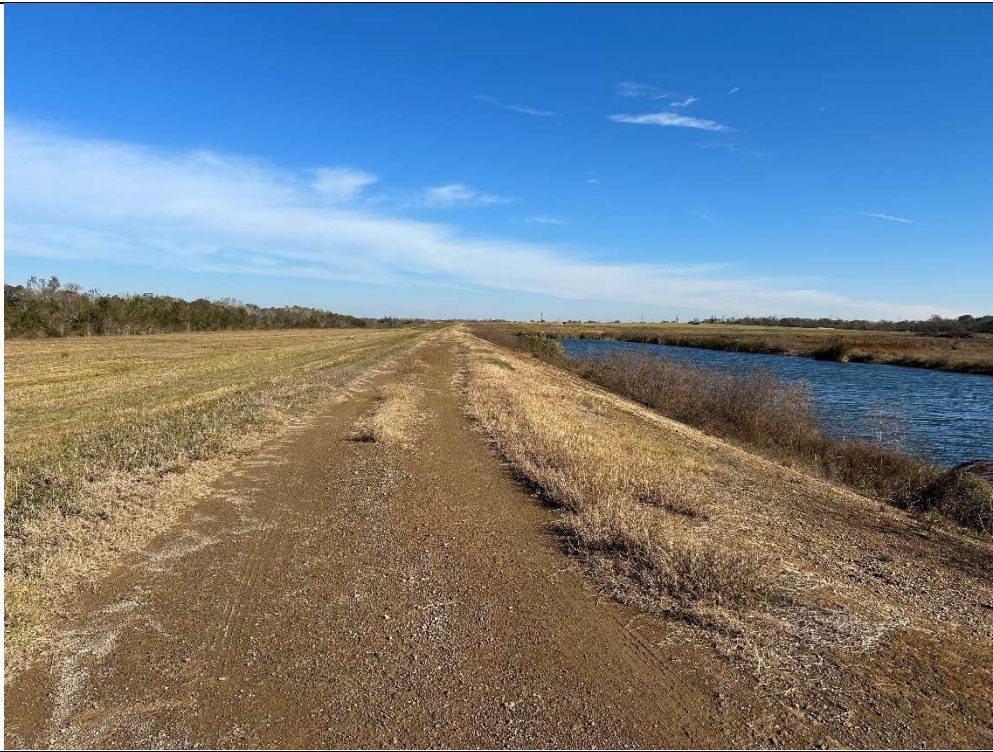
Photograph P-1: View looking north at Cell 3 from top of its west berm. The Cell 3 storm water pond is visible to the right. The interior slopes and crest roads of the berms are either vegetated (slopes) or have been stabilized with a cemented fly ash mixture.

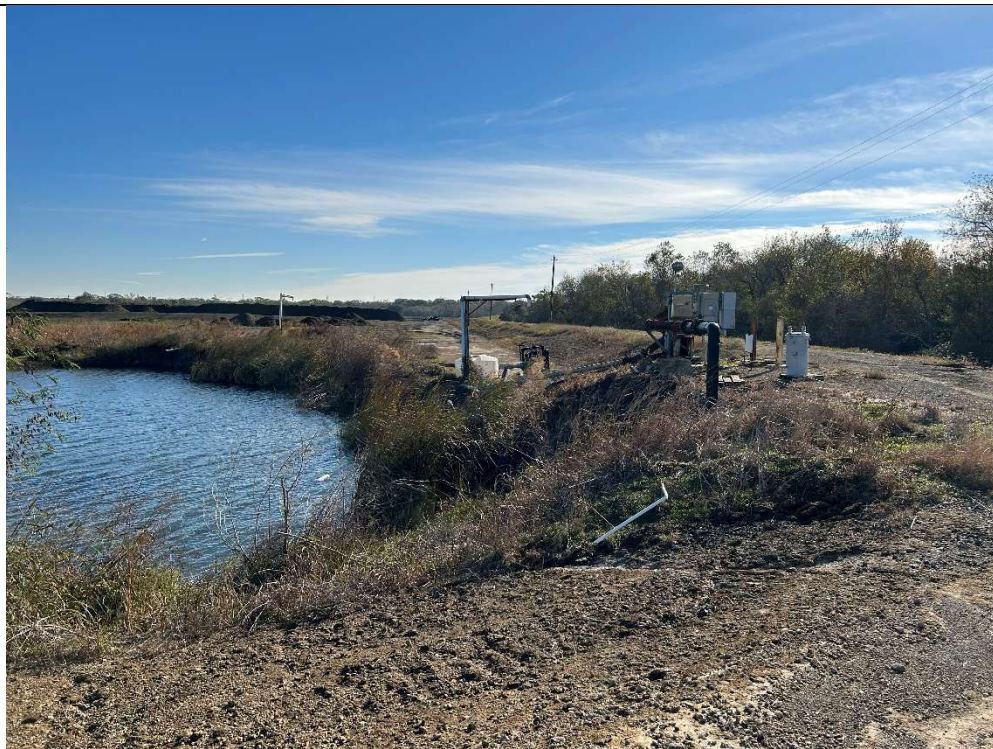
Photograph P-2: View looking east from Cell 3's southwest interior corner. The crest road was well maintained, exterior slopes well vegetated without erosion issues, and interior slope either improved with stabilized CCR material or vegetated.

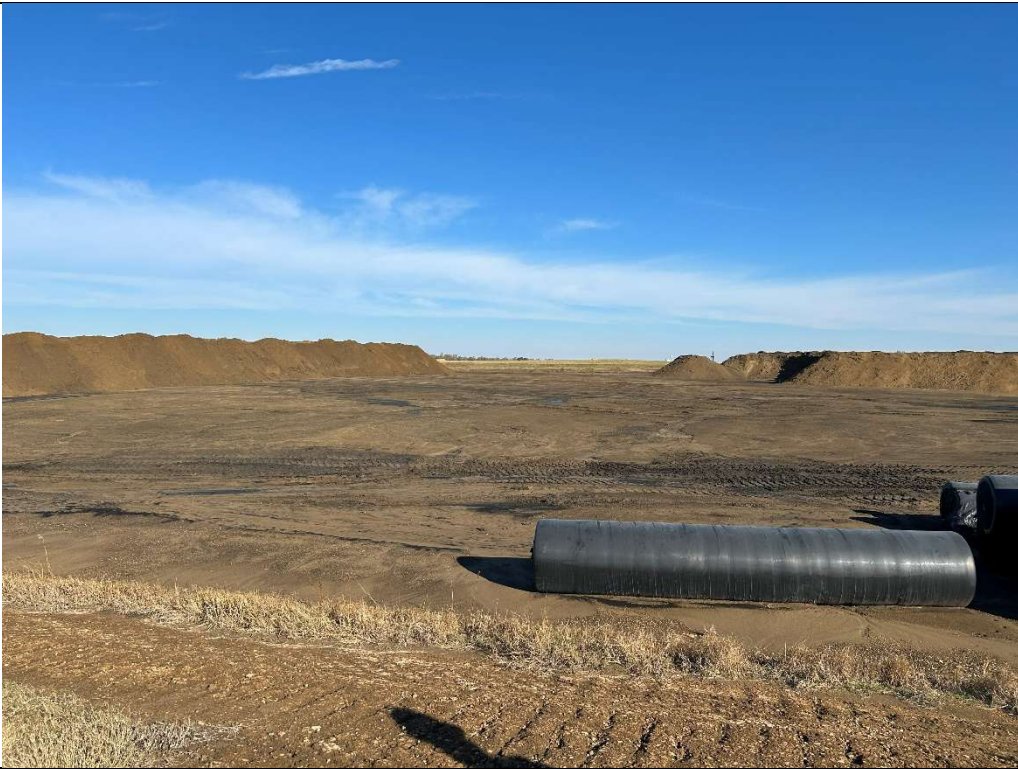
Photograph P-3: View looking northeast of the Cell 3 landfill and Cell 3 Coal Combustion Residual (CCR) waste piles. This material is being sold as road base.

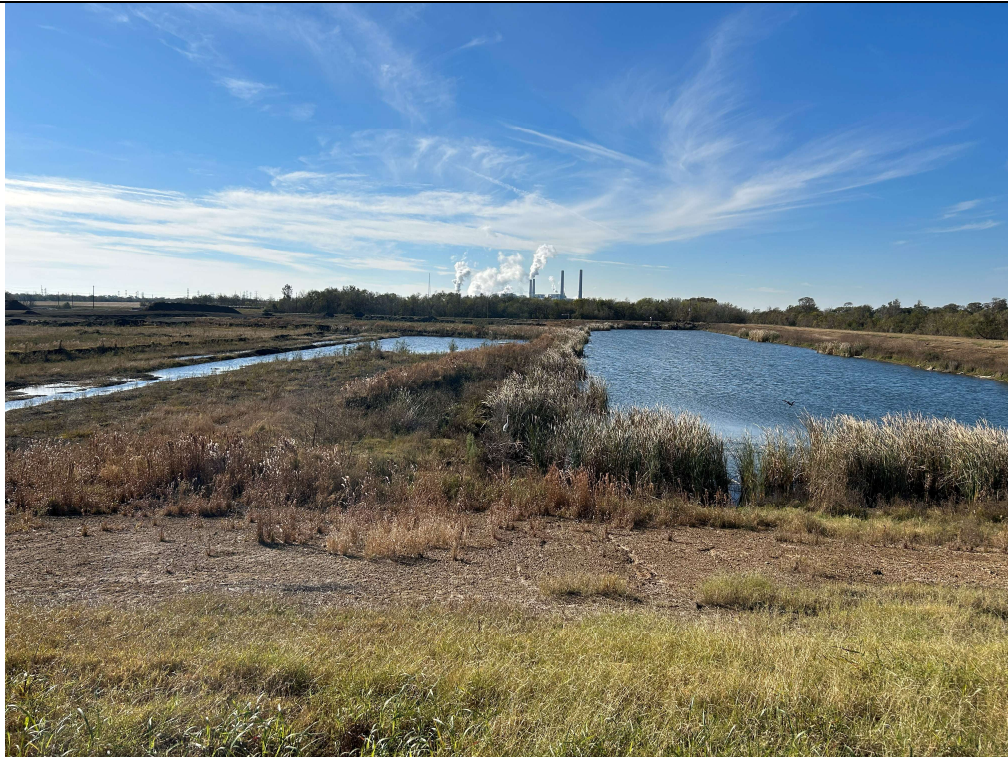
Photograph P-4: View looking south of Cell 3. The water body to the left (east) was created by the excavation and sale of bottom ash in 2025.

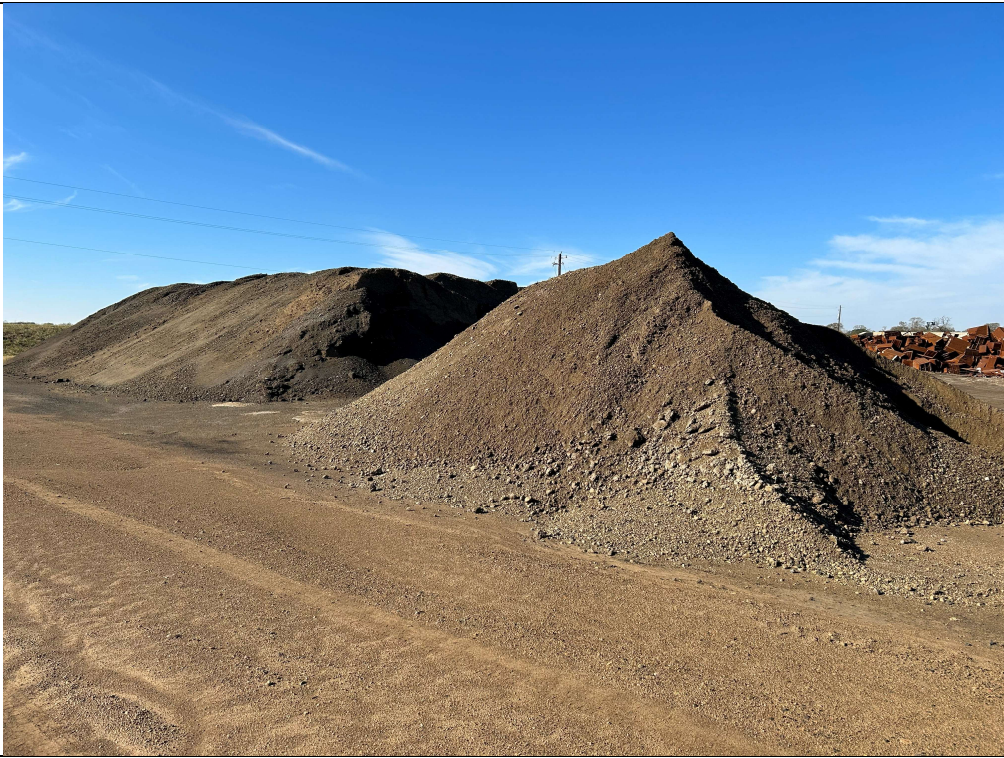
Photograph P-5: View looking southwest at material piles inside Cell 2A.

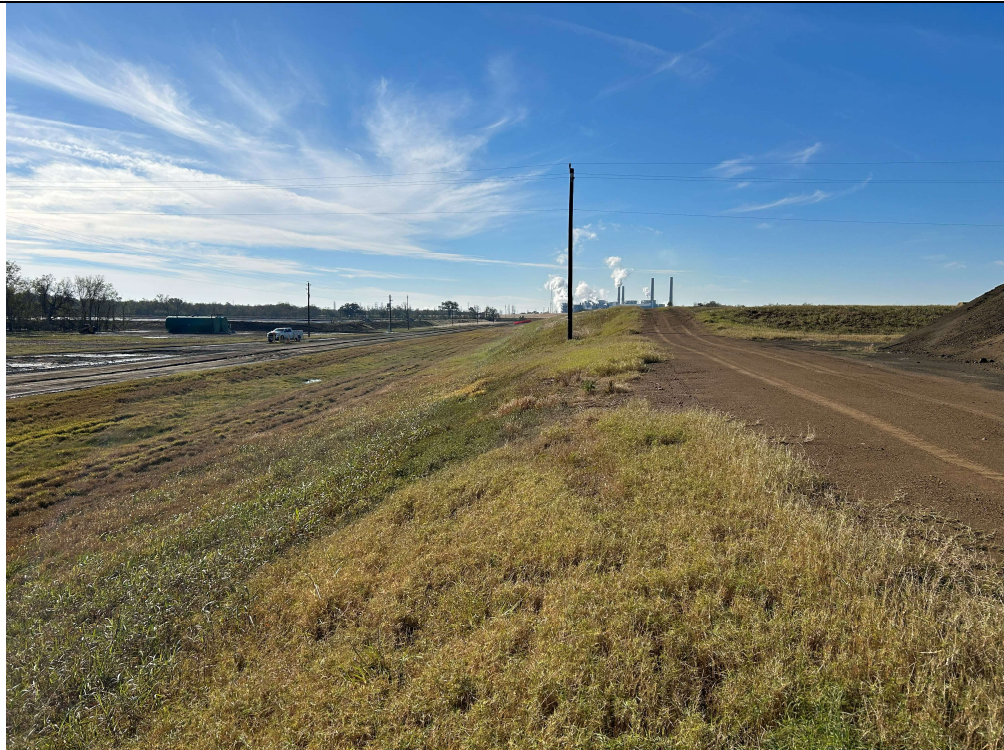
Photograph P-6: View looking south from the western berm of Cell 2A. Exterior berm slopes were well vegetated.

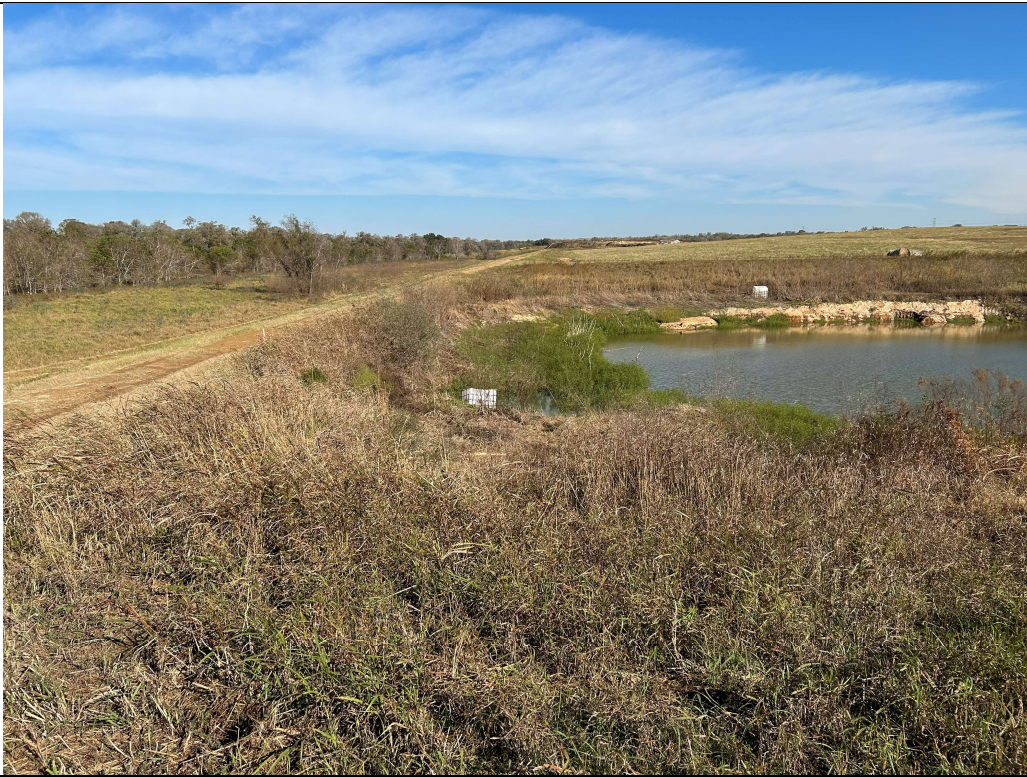
Photograph P-7: View looking north across the Cell 2A stormwater pond. Pond berms are either stabilized or well vegetated.

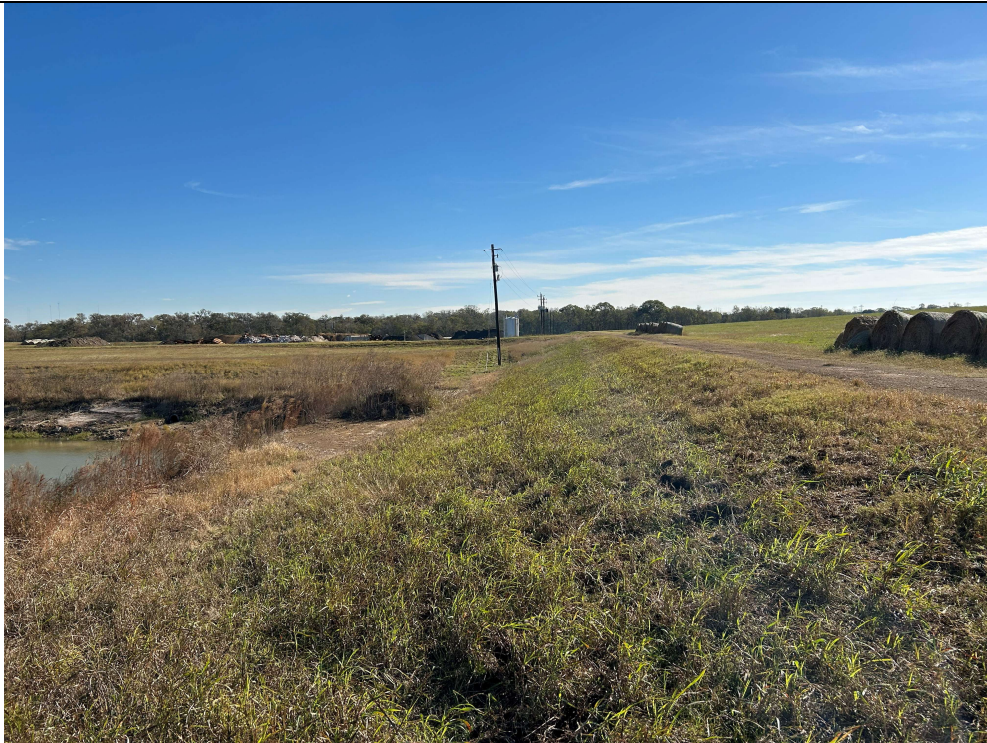
Photograph P-8: View looking east from the berm at the southwest corner of the Cell 2A stormwater pond. Pond berms are either stabilized or well vegetated.

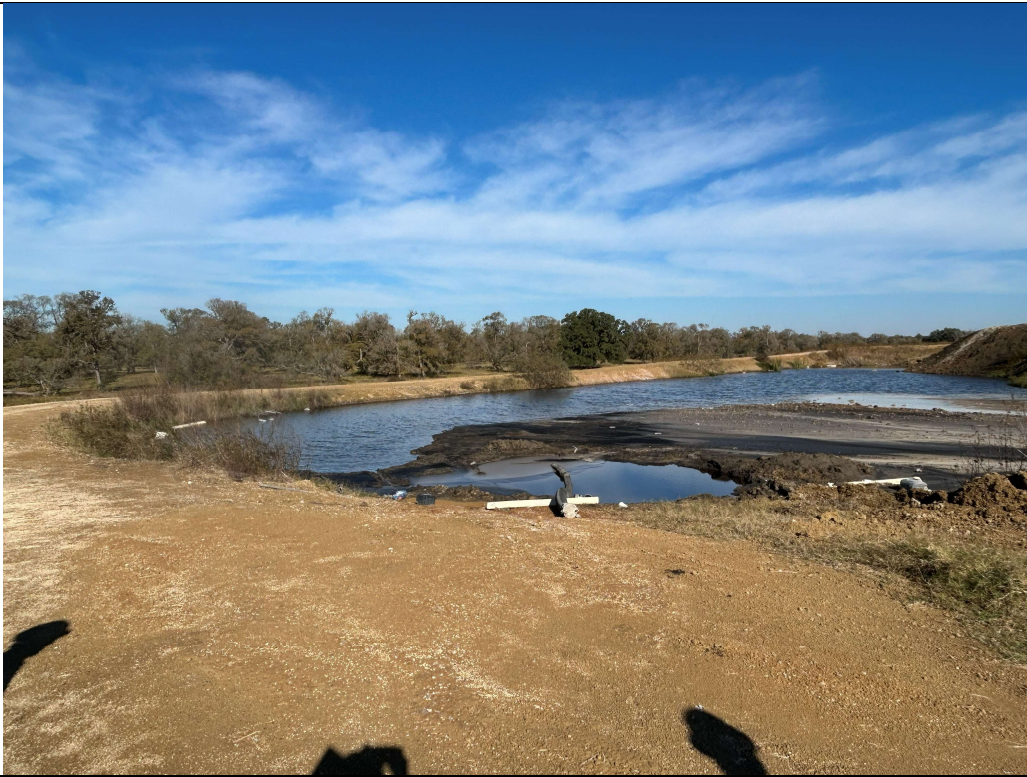
Photograph P-9: View looking northwest across contact water/stormwater pond in Cell 1C.

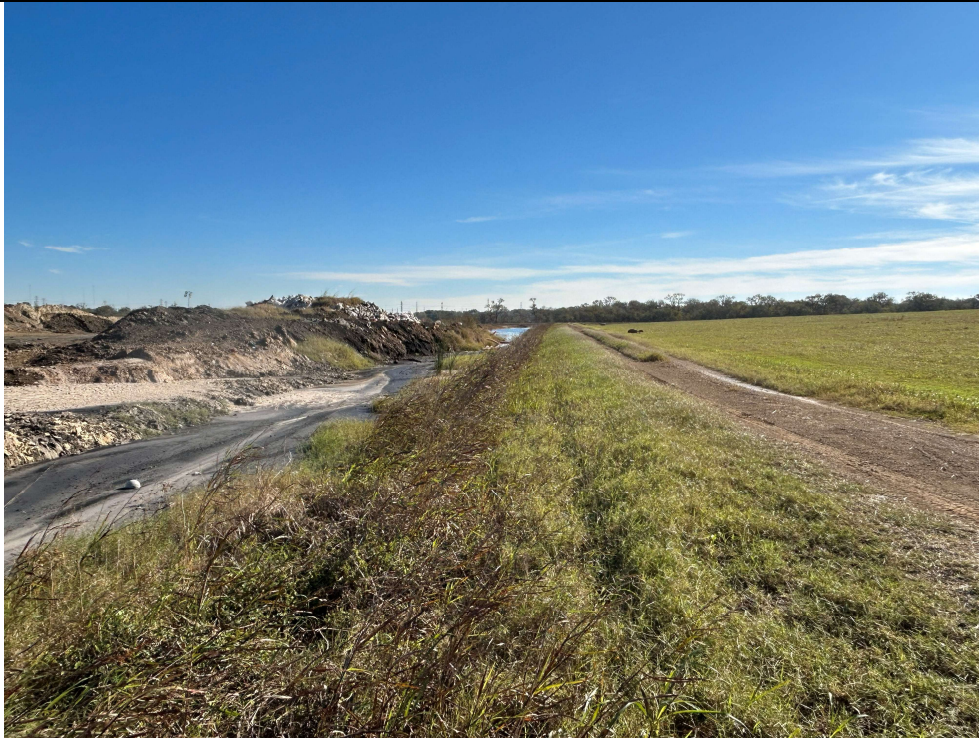
Photograph P-10: View looking east along the southern berm of Cell 1C. An open portion of Cell 1C is visible on the left side of the photograph.

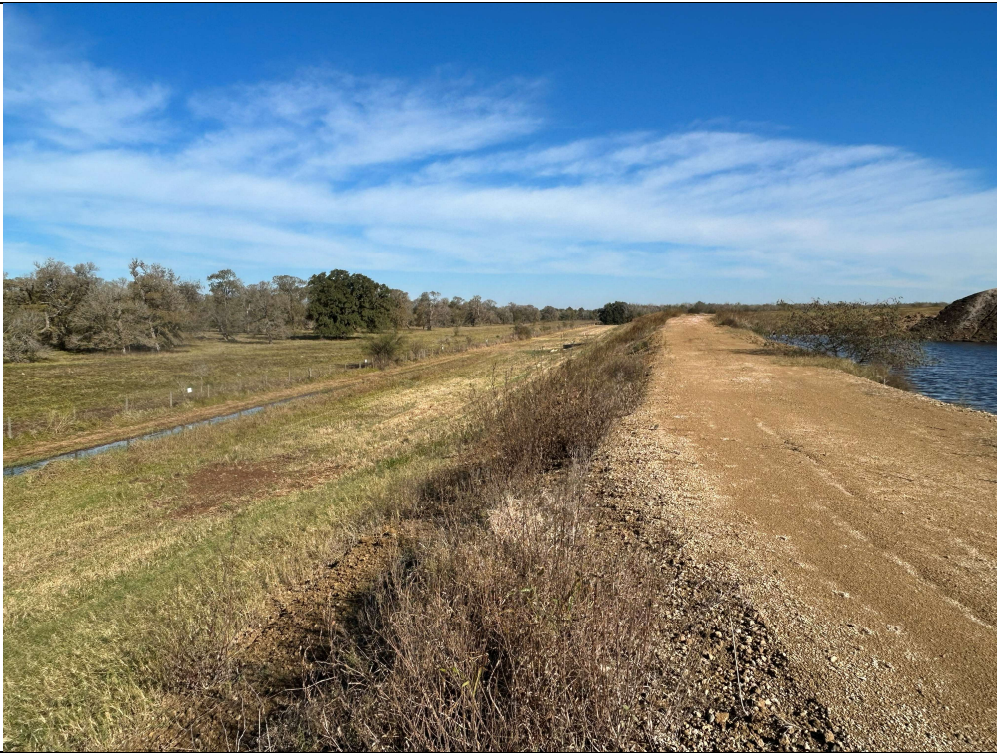
At the time of the inspection, the water level in the stormwater pond was higher than the elevation of the ground outside of the western berm. According to the review of weekly inspection reports (discussed in Section 6) this was an intermittent condition off and on during the 2025 calendar year. Reportedly, this is tied to the waste filling and gradual closure of Cell 1C. The general practice is to pump this water to the Cell 3 stormwater pond on an as needed basis.

Cell 1C was observed to be in fair condition without indications of risk of catastrophic or operational failure. However, care should be taken to reduce water levels in the Cell 1C stormwater pond and then maintain them at the same approximate elevation as the natural ground level outside of the cell. This operational practice will reduce the lateral pressure from the water on the landfill berms.

Photograph P-11: View looking north of the landfill berm. The berm road did not have rutting, but the water level in the Cell 1C stormwater pond was higher than normal.

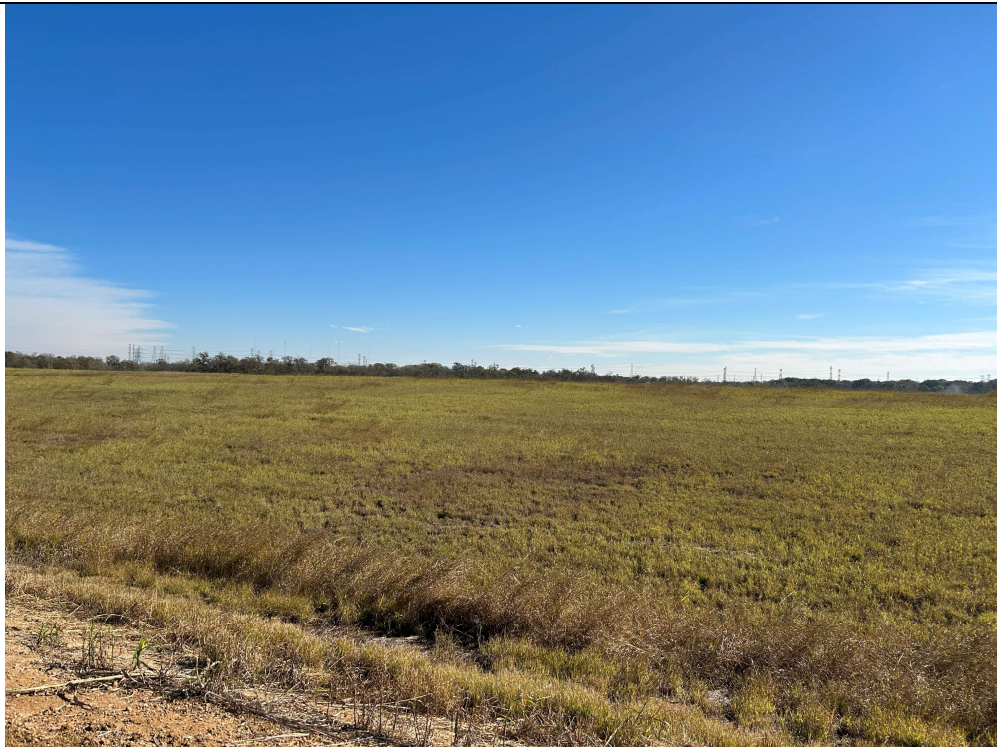
The interior slopes of Cell 1C exhibited good alignment, grades, and vegetation or erosion resistant stabilized material. No adverse conditions were identified for the inner slopes of the perimeter berms. However, minor sloughing of a small interior portion of the berm was reported in 2025. This issue had been repaired prior to the December 2, 2025 site visit. An 11-acre portion of the landfill located along the western berm was closed in 2022. Photograph P-12 shows grass has been established on the topsoil portion of the cover system.

Photograph P-12: View looking east of the portion of Cell 1C that was closed in 2022. The surface of the cover system is well vegetated. No erosional issues were observed.

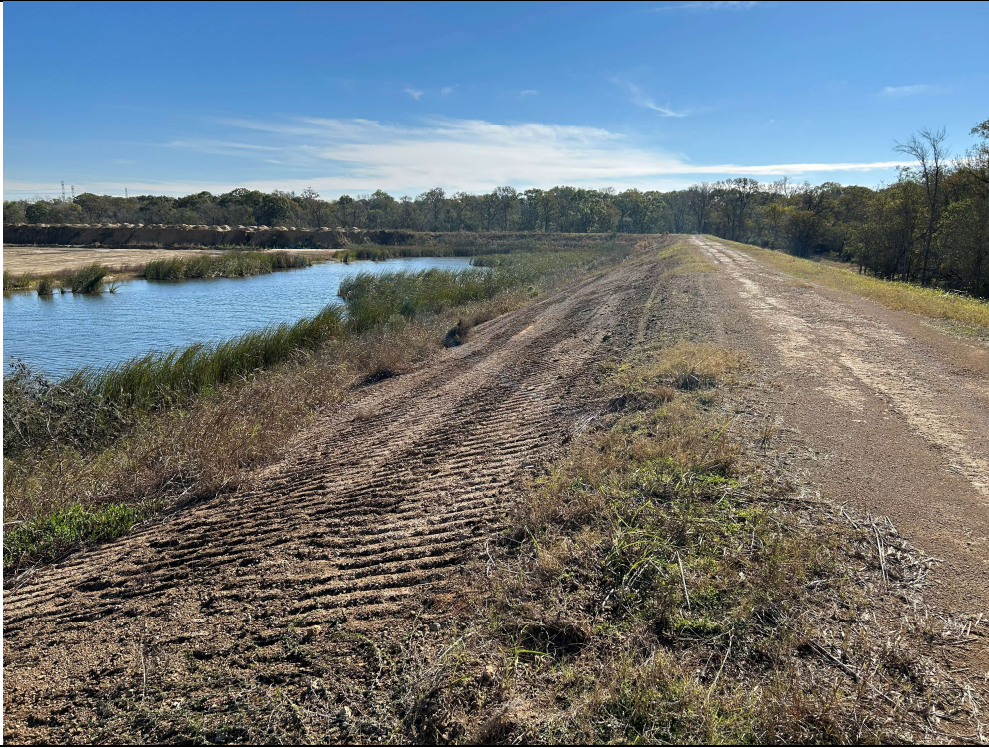
Photograph P-13: View looking northeast across stormwater pond from Cell 2B's southern berm. A repaired portion of the interior berm where a minor slough had occurred is visible in the center of the photograph. Stockpiled scrubber sludge waste is visible beyond the pond inside the landfill (left background).

To prevent minor sloughing repaired areas should be improved with compacted clay material. In addition, the stabilized CCR surface on interior slopes should be replaced, repaired, and/or maintained, particularly in areas where it was removed as part of a slough repair or other maintenance activity. If this is impracticable, it is suggested that the internal slopes, particularly repaired portions of internal slopes, be well vegetated with grass as soon as possible after the repair is complete.

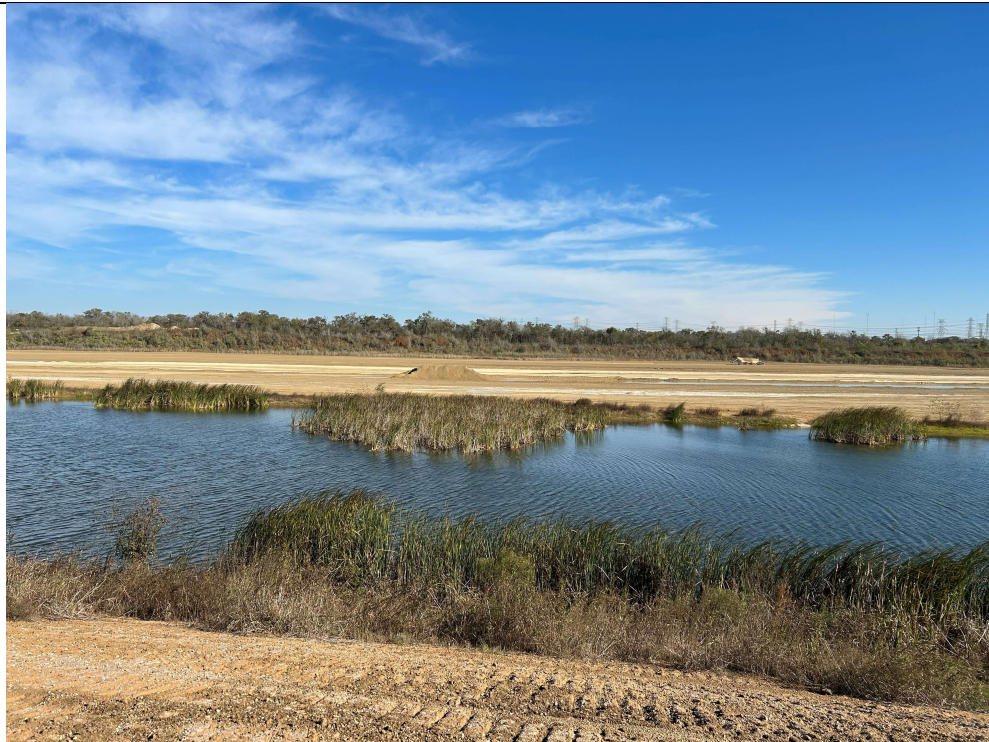
No sloughing was observed on the interior slope of the southern berm was observed during the December 2, 2025 site visit. Minor sloughing has been an ongoing maintenance issue in this area in the past. Photograph P-14 depicts the area where a minor slough was repaired in 2025. The interior slope is not excessively steep (it appears to be a 3:1 or 4:1 slope), and it does not appear that a minor slough could create a situation of catastrophic or operational failure.

Photograph P-14: View looking north across stormwater pond from Cell 2B's southern berm. The vegetation in the pond is controlled on an as needed basis. Stockpiled fly ash is visible to the north of the pond. Stockpiled scrubber sludge is visible beyond the fly ash (center background).

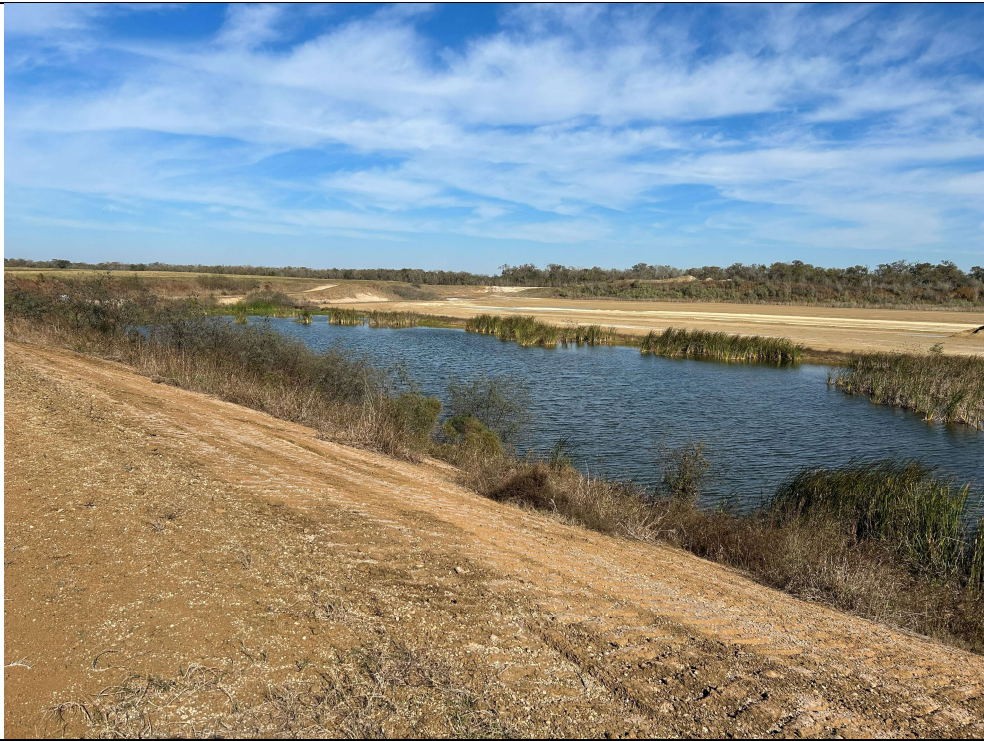
Photograph P-15: View looking northwest across stormwater pond from Cell 2B's southern berm. The vegetation in the pond is controlled on an as needed basis.

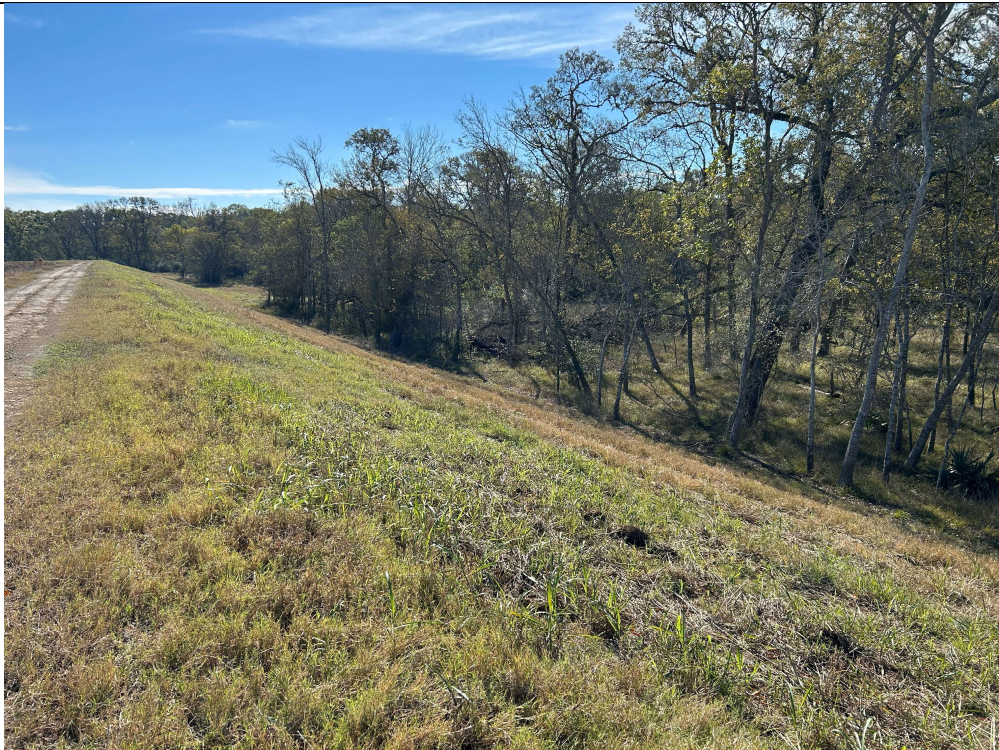
Photograph P-16: View looking southeast of the exterior slope of Cell 2B's southern berm. The exterior slope is well vegetated, stable, and not excessively steep. No erosional issues were observed.
