Waukegan Generating Station

2024 Structural Stability Assessment for East Ash Pond & West Ash Pond

October 13, 2024

Project No.: A12661.187

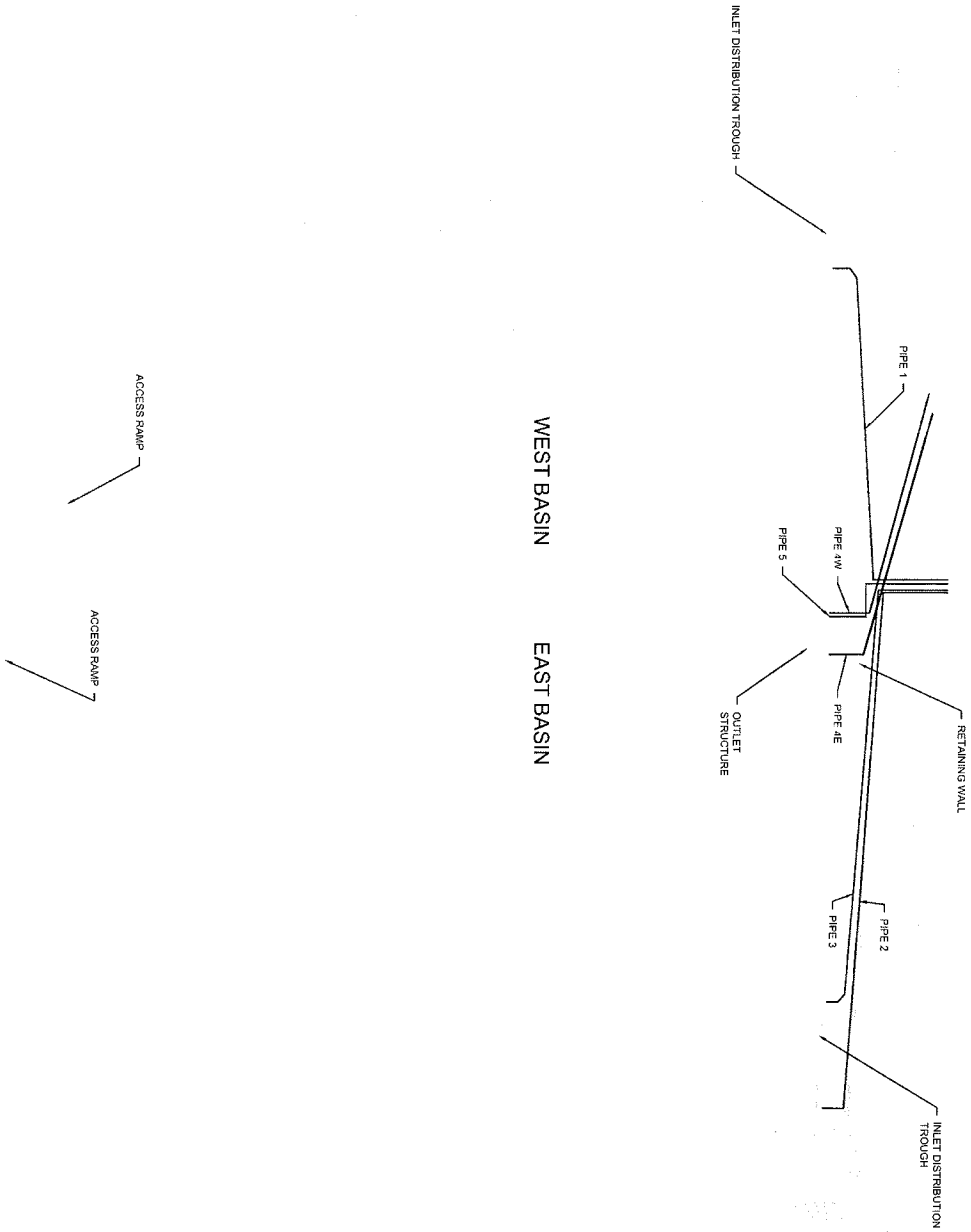
PIPE LOCATIONS WEST AND EAST ASH BASINS WAUKEGAN STATION WAUKEGAN, ILLINOIS	
	FIGURE 2
PROJECT NO: SW0251-08	OCTOBER 2016

The video inspections showed no significant deterioration, deformation, distortion, bedding deficiencies, sedimentation, or debris that would negatively affect the operation of Pipes 1, 2, 3, and 5. The video inspections identified isolated areas of deformation and deterioration of Pipes 4E and 4W, which are 24-inch diameter concrete pipes with invert locations at the bottom of the outlet structures for the East and West Ash Basins, respectively. These pipes are located under the north embankment and are utilized for dewatering the outlet structure. Repairs were made to Pipe 4E to mitigate the isolated areas of deformation and deterioration identified during the inspection. The valve for controlling flow into Pipe 4W has been closed by Site personnel, and Pipe 4W will not be used until a repair is completed. Pipe 4W is not required for normal operation of the West Ash Basin.

A structural stability deficiency associated Pipe 4W was identified in this initial structural stability assessment. Geosyntec suggests relining the interior of the deficient portions of the pipe as a corrective action. The pipe will remain out of service until the repair is complete. Documentation detailing the corrective measures taken to repair the pipe will be prepared after the repair is complete.

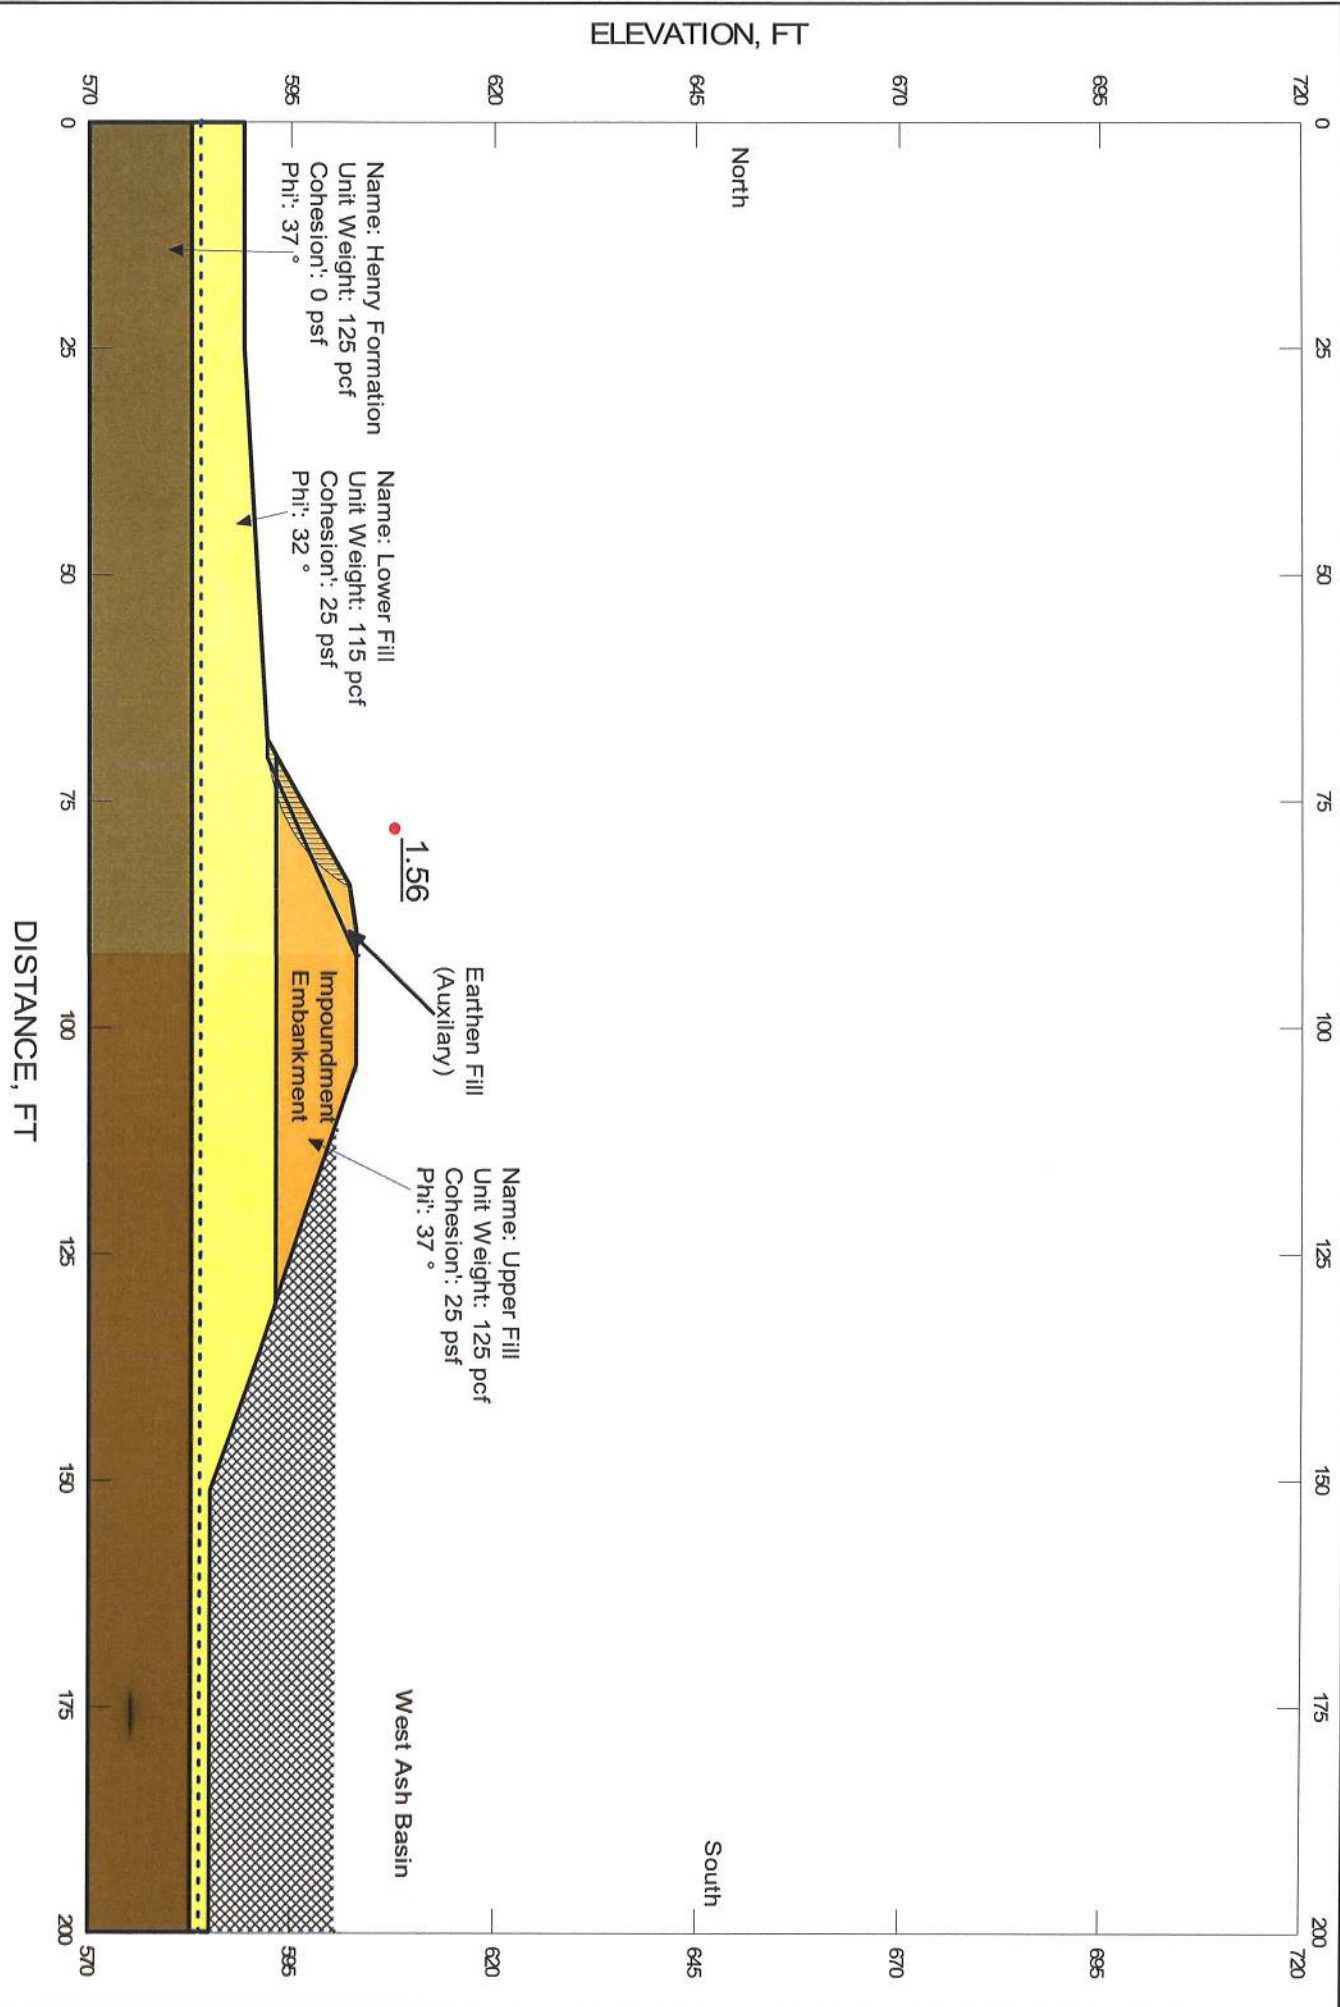
FIGURE 4

Analysis	Section 1 - §257.73(e)(1)(i): Long Term, Maximum Storage Pool Loading
Project	Waukegan East and West Ash Basins
File Name	Waukegan Section 1.gsz
Analysis By	Jay Griffin
Date	October 2016

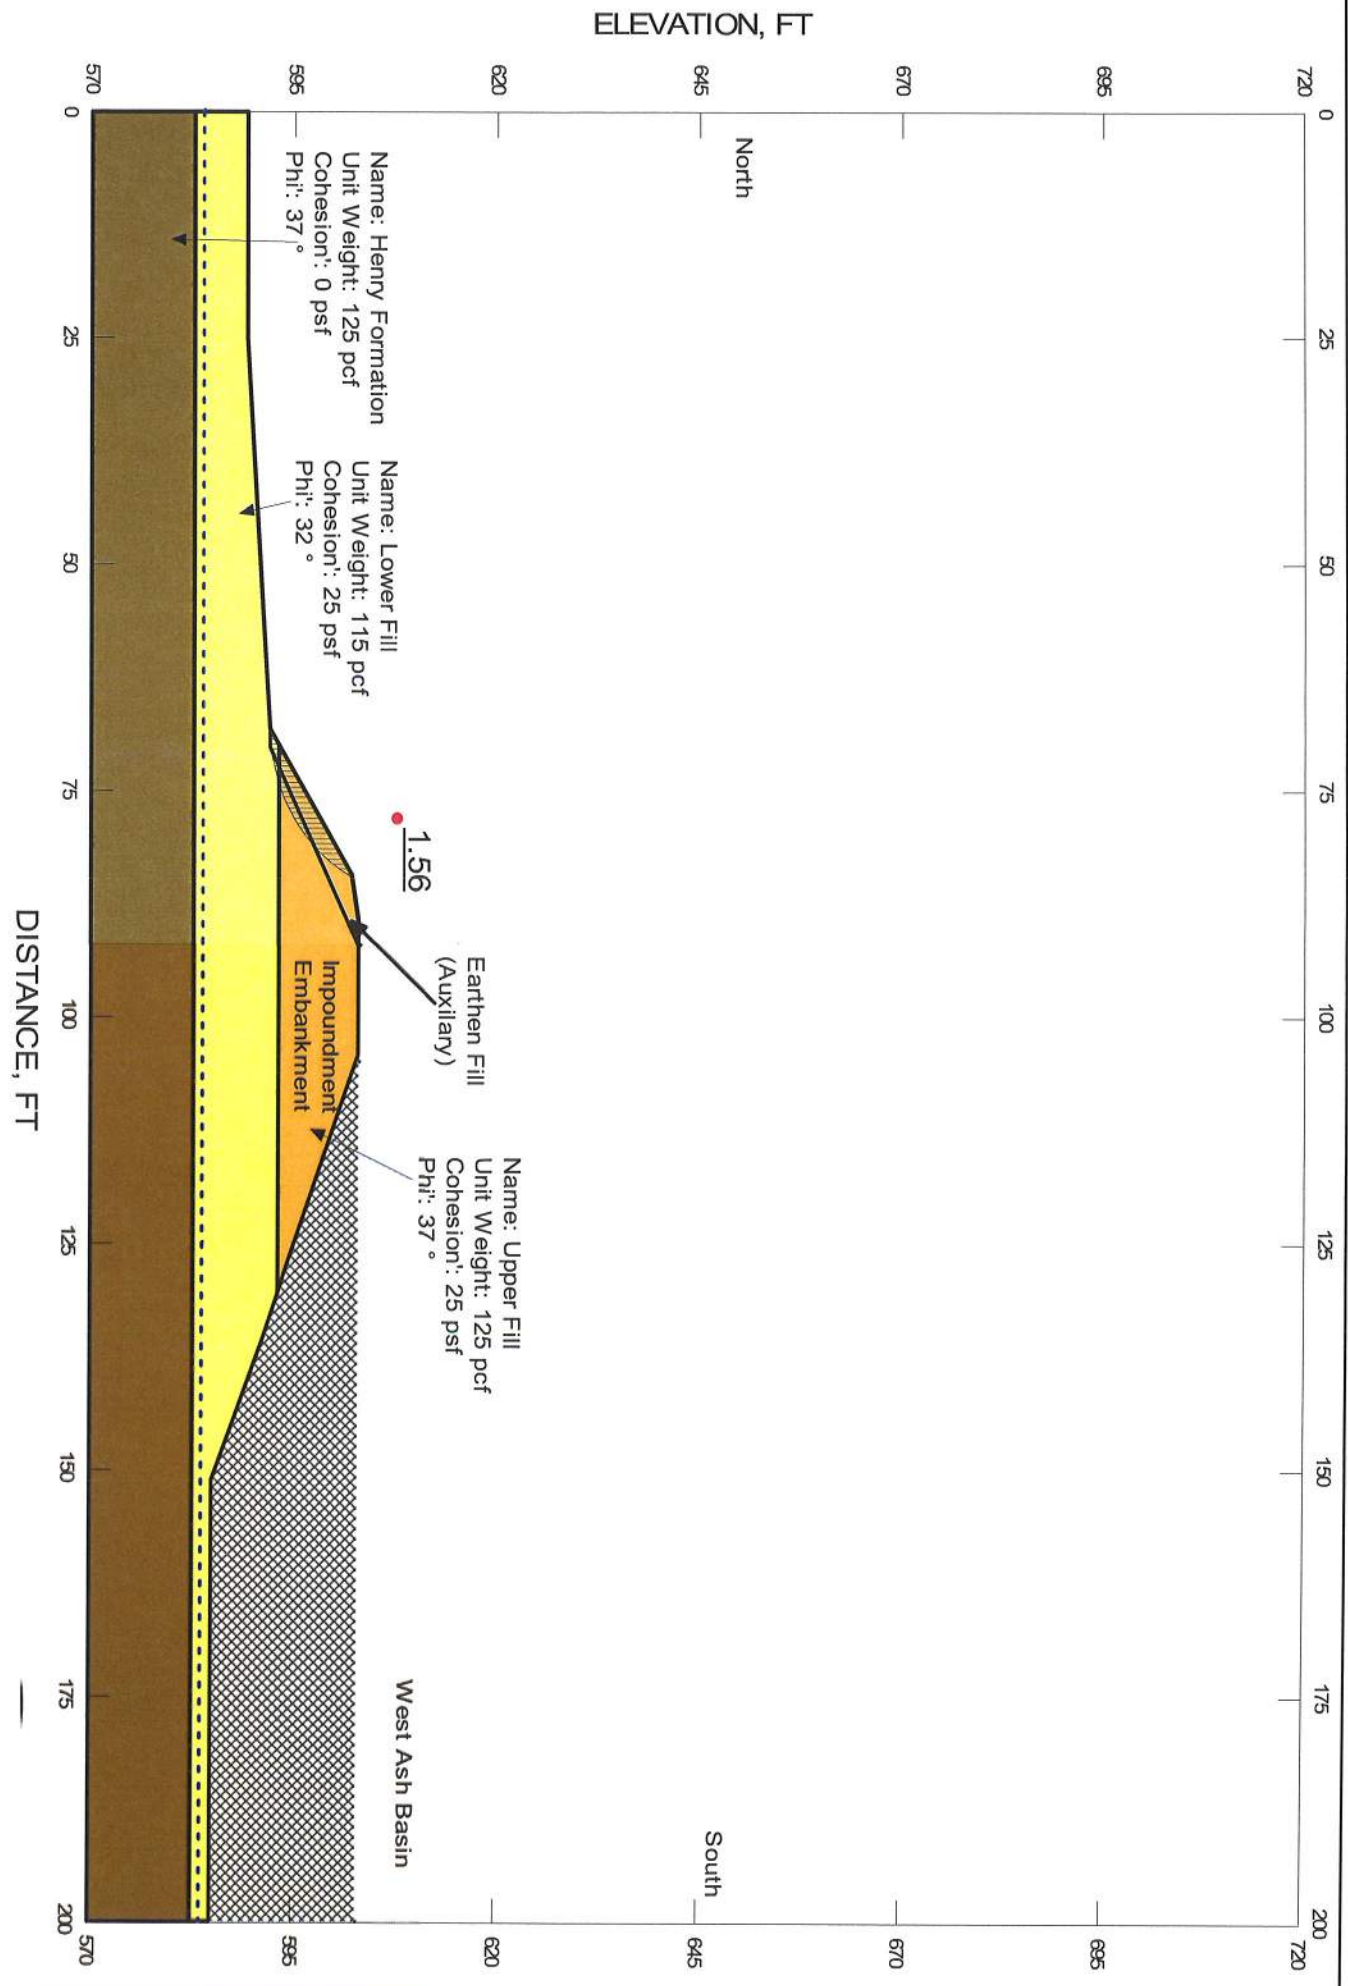
FIGURE 5

Analysis: Section 1 - §257.73(e)(1)(ii): Maximum Surcharge Pool Loading

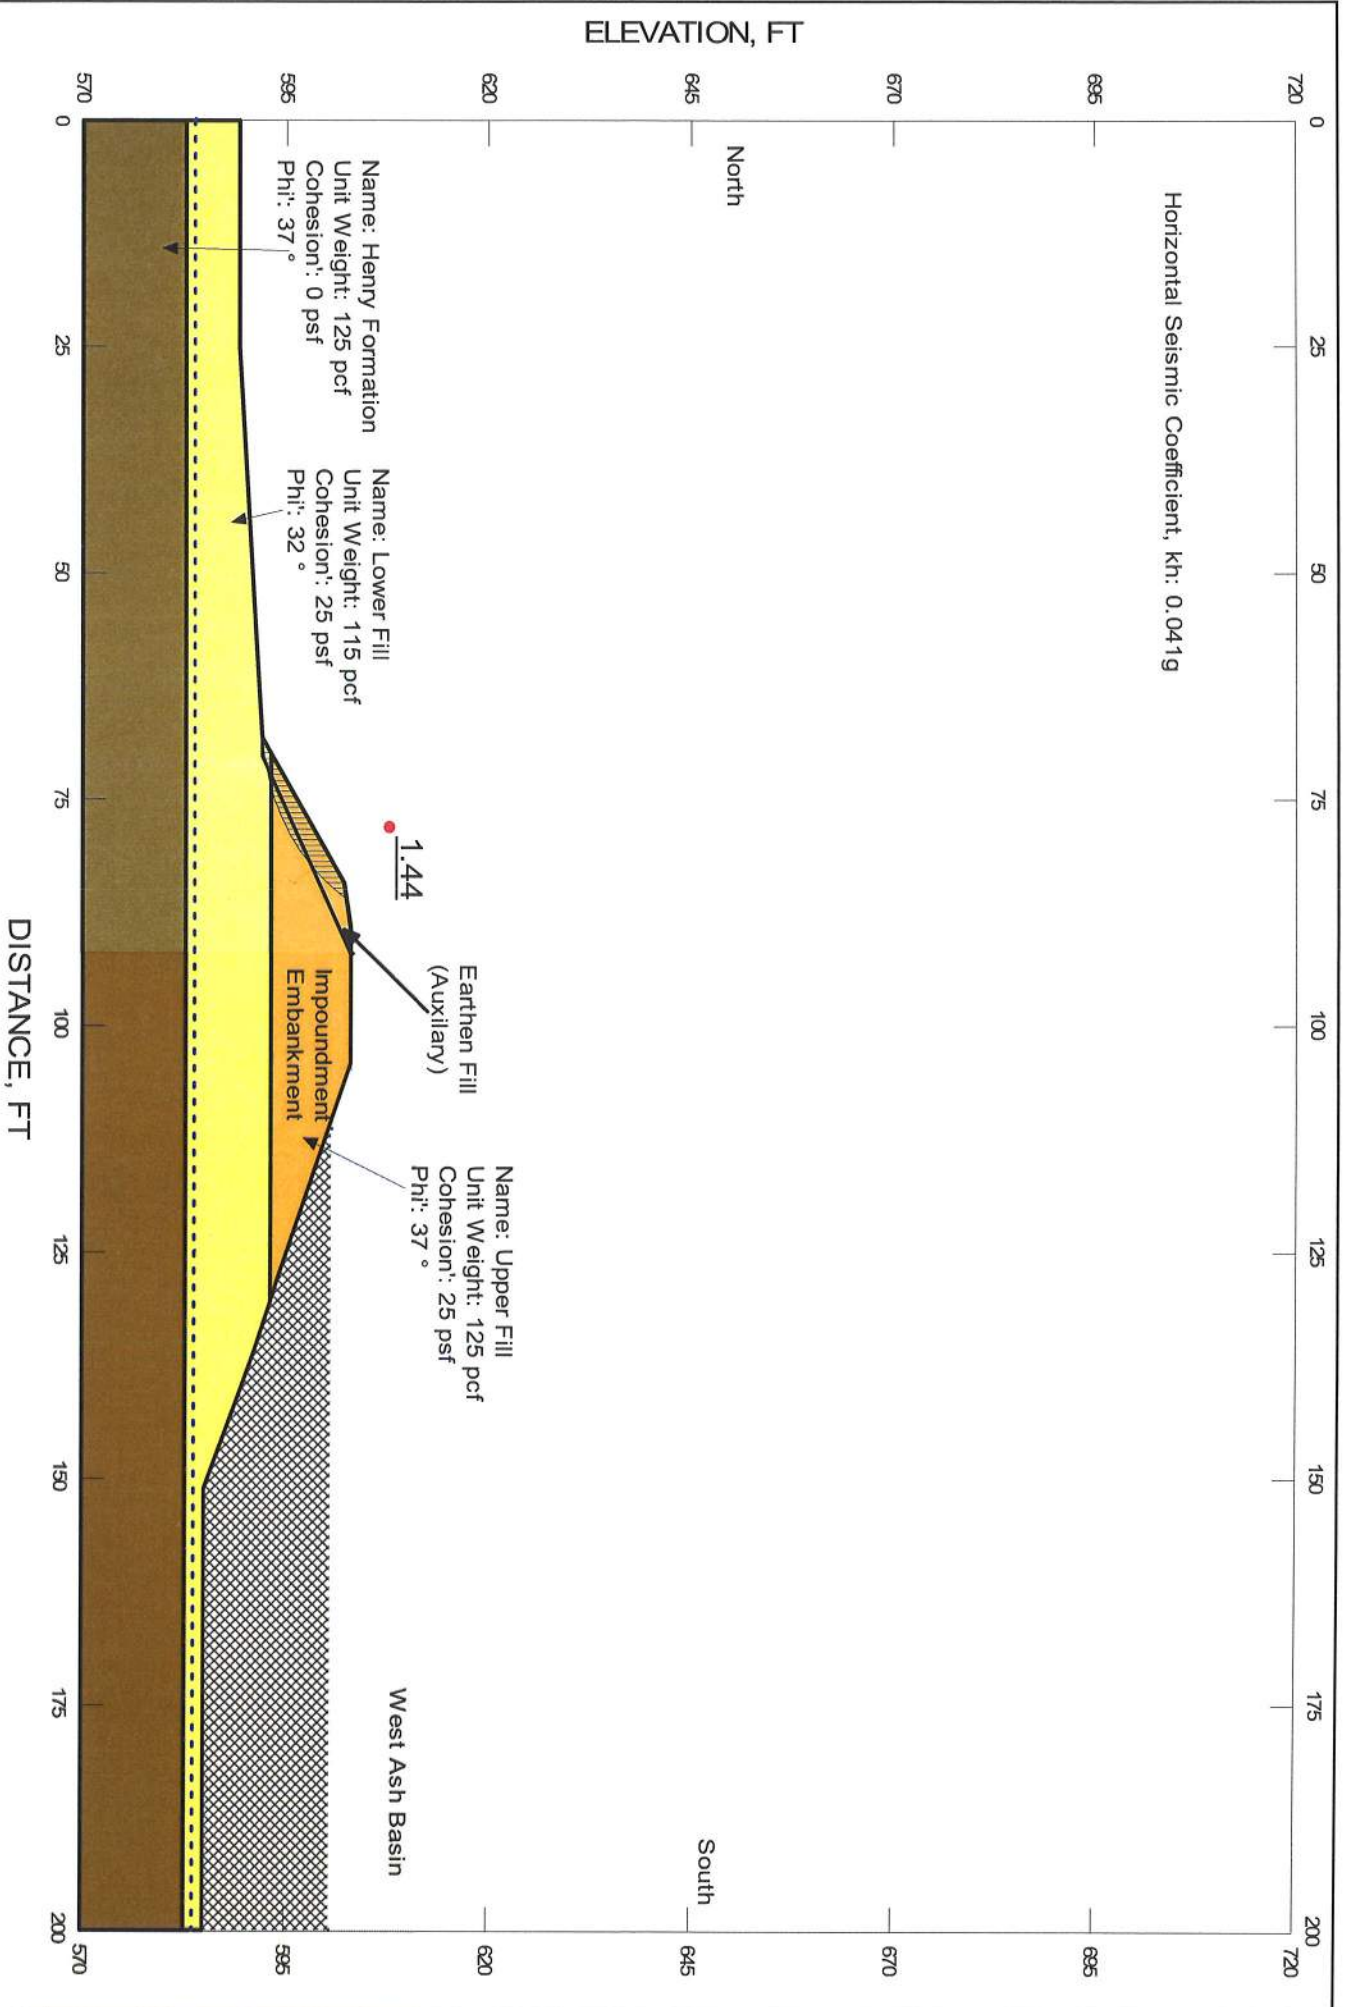
FIGURE 6

Analysis	Section 1 - §257.73(e)(1)(iii): Long Term, Maximum Storage Pool Loading with Seismic	Analysis By	Jay Griffin
Project	Waukegan East and West Ash Basins	Date	October 2016
File Name	Waukegan Section 1.gsz

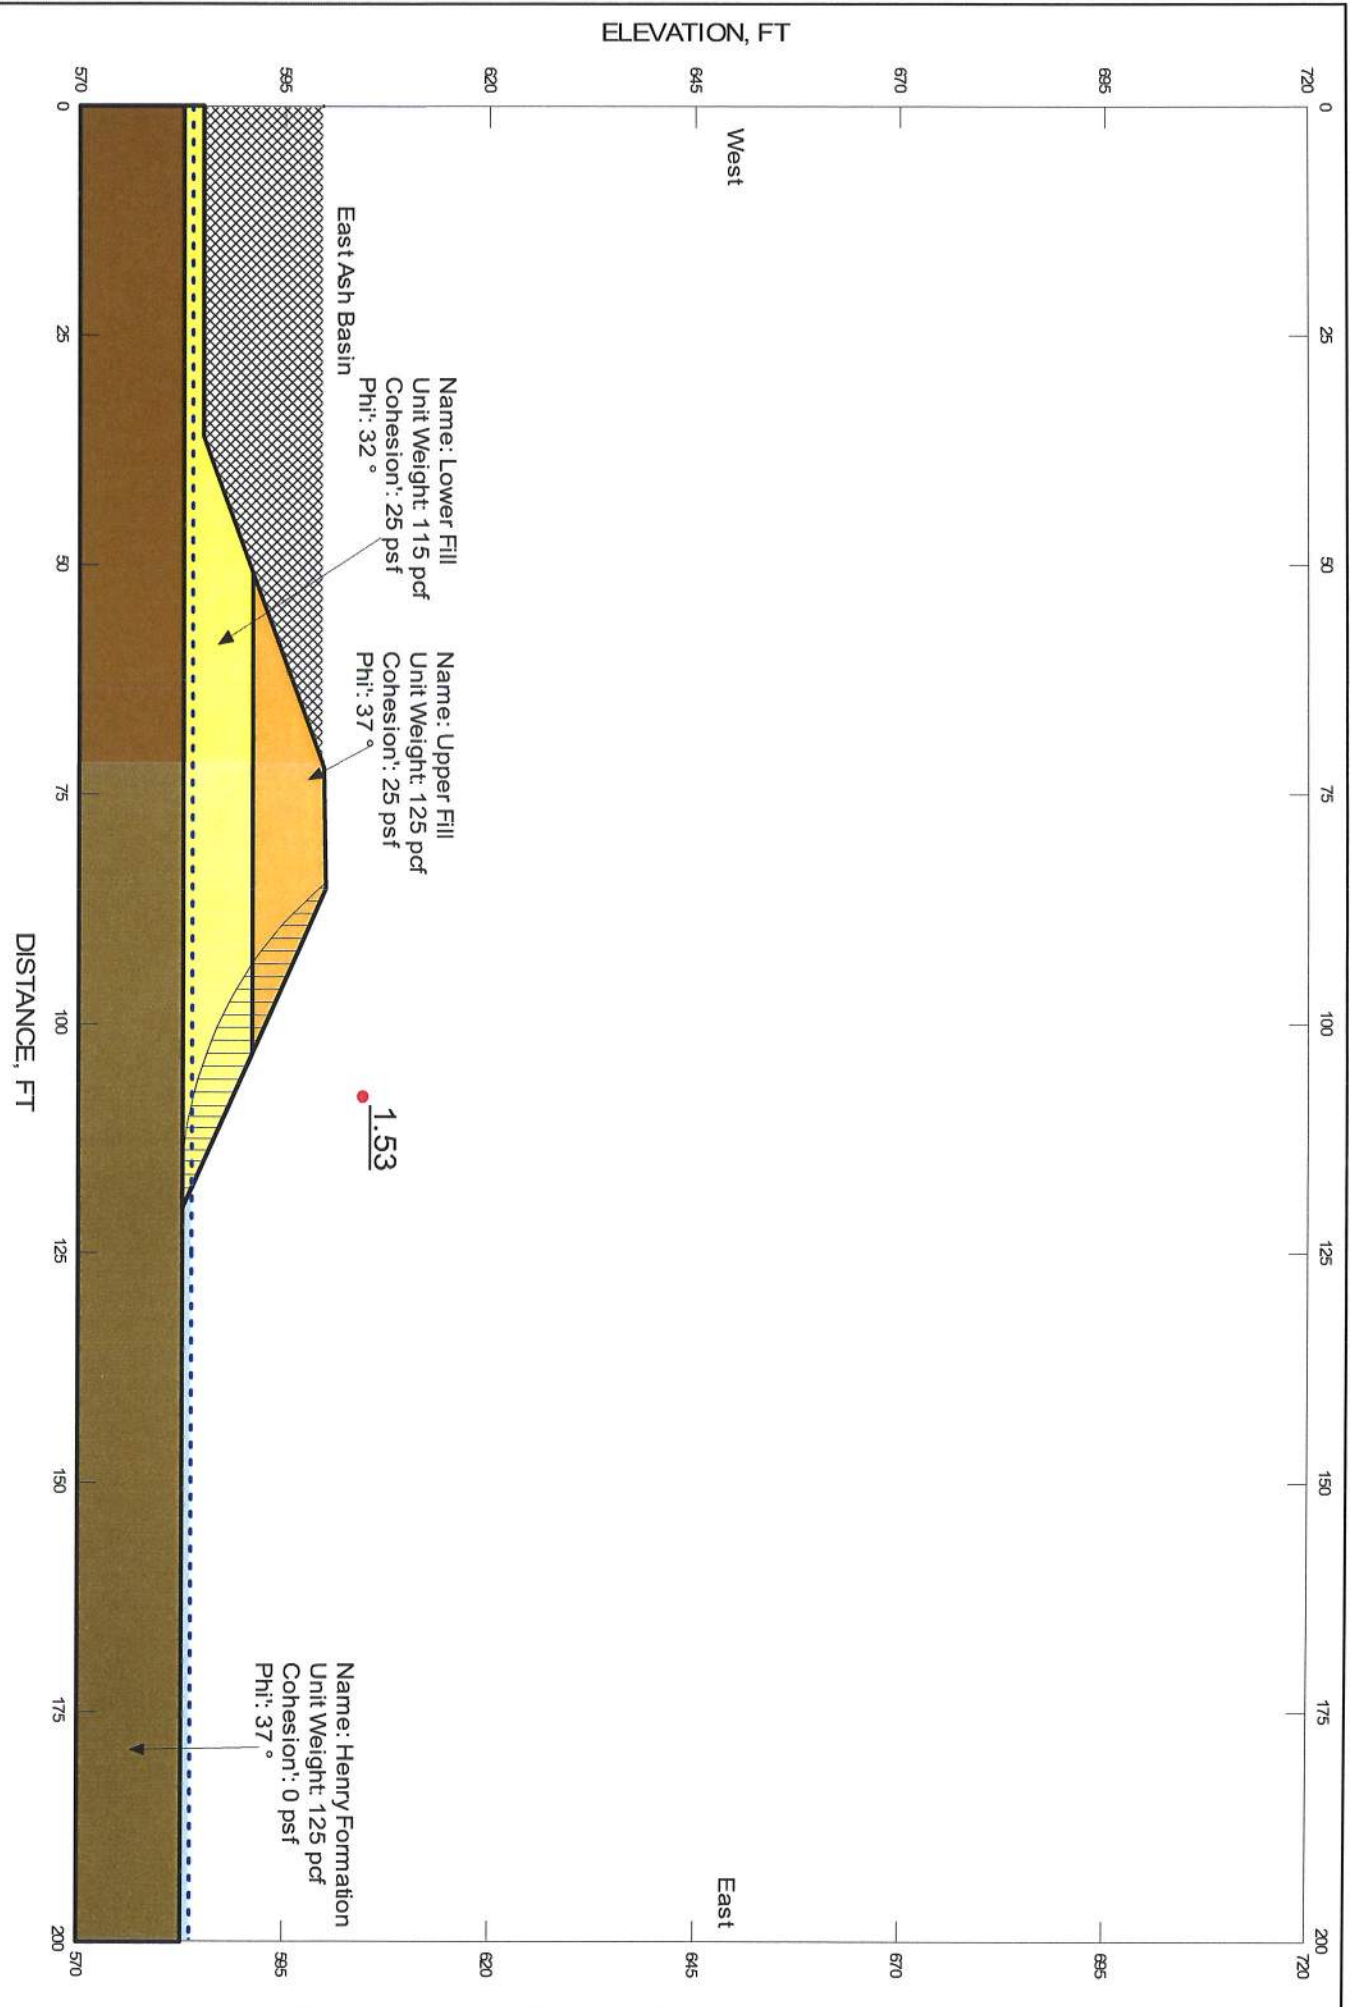
Section 2 - §257.73(e)(1)(ii): Maximum Surcharge Pool Loading	
Analysis	Project	Analysis By	Date
Waukegan East and West Ash Basins	Waukegan Section 2.gsz	Jay Griffin	October 2016
FIGURE 8
