Midwest Generation, LLC

Waukegan Generating Station

2025 Structural Stability Assessment for East Ash Pond & West Ash Pond

October 13, 2025

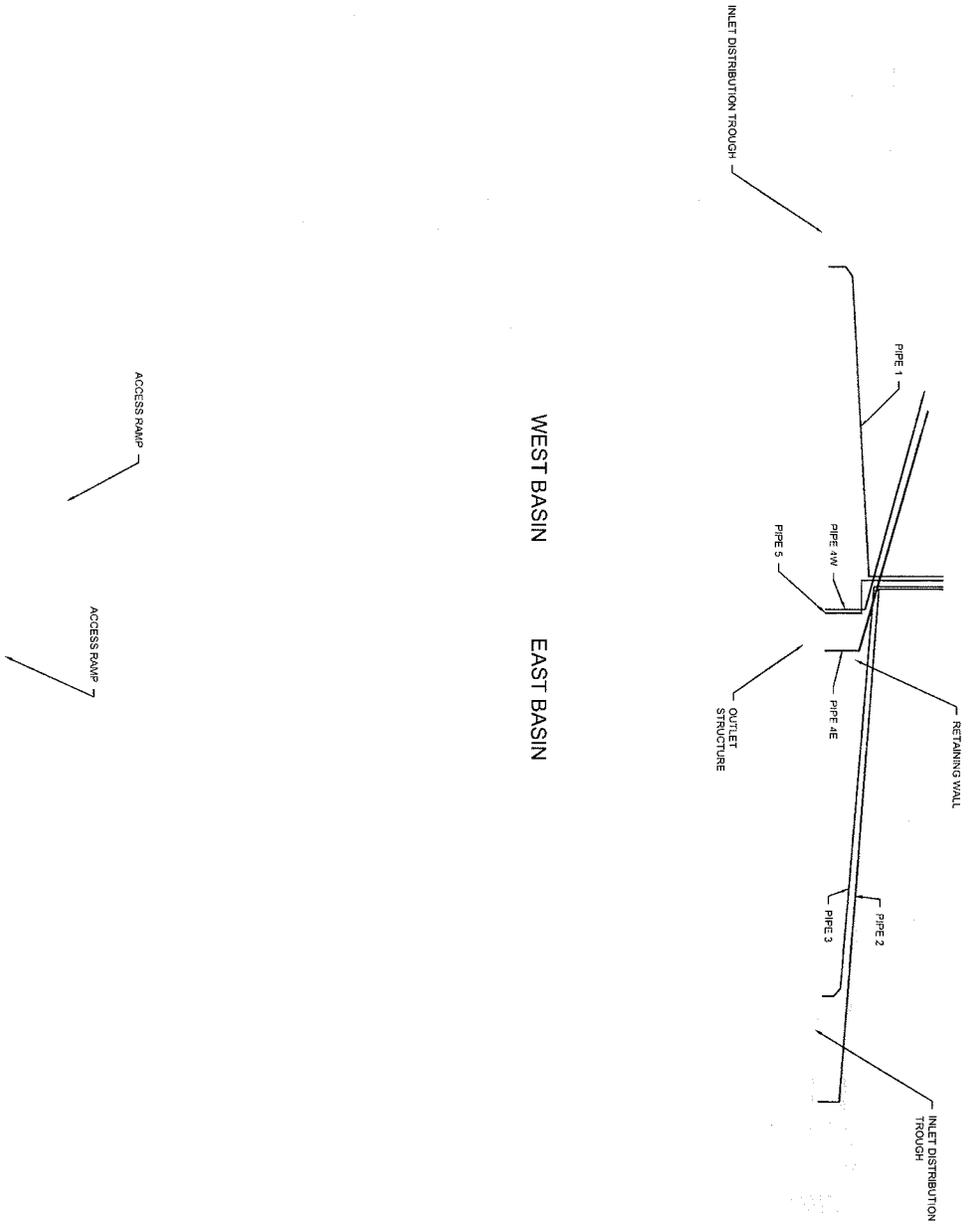
PIPE LOCATIONS WEST AND EAST ASH BASINS WAUKEGAN STATION WAUKEGAN, ILLINOIS		
		FIGURE 2
PROJECT NO: SW0251-08	OCTOBER 2016

Hydraulic structures passing through or beneath the embankments of the East and West Ash Basins consist of six pipes and conveyance structures associated with the inlet and outlet structures of the Basins. These structures and pipes were inspected between 1 June 2016 and 7 June 2016 by a company specializing in video camera pipe inspections. Inspections consisted

only of the length of the pipe or structure that passes through or beneath the Basins' embankments. The inspected structures and pipes related to the East and West Ash Basins are presented on Figure 2.

The video inspections showed no significant deterioration, deformation, distortion, bedding deficiencies, sedimentation, or debris that would negatively affect the operation of Pipes 1, 2, 3, and 5. The video inspections identified isolated areas of deformation and deterioration of Pipes 4E and 4W, which are 24-inch diameter concrete pipes with invert locations at the bottom of the outlet structures for the East and West Ash Basins, respectively. These pipes are located under the north embankment and are utilized for dewatering the outlet structure. Repairs were made to Pipe 4E to mitigate the isolated areas of deformation and deterioration identified during the inspection. The valve for controlling flow into Pipe 4W has been closed by Site personnel, and Pipe 4W will not be used until a repair is completed. Pipe 4W is not required for normal operation of the West Ash Basin.

A structural stability deficiency associated Pipe 4W was identified in this initial structural stability assessment. Geosyntec suggests relining the interior of the deficient portions of the pipe as a corrective action. The pipe will remain out of service until the repair is complete. Documentation detailing the corrective measures taken to repair the pipe will be prepared after the repair is complete.
