Midwest Generation, LLC

## Waukegan Generating Station

# 2025 Safety Factor Assessment for East Ash Pond & West Ash Pond

**October 13, 2025**

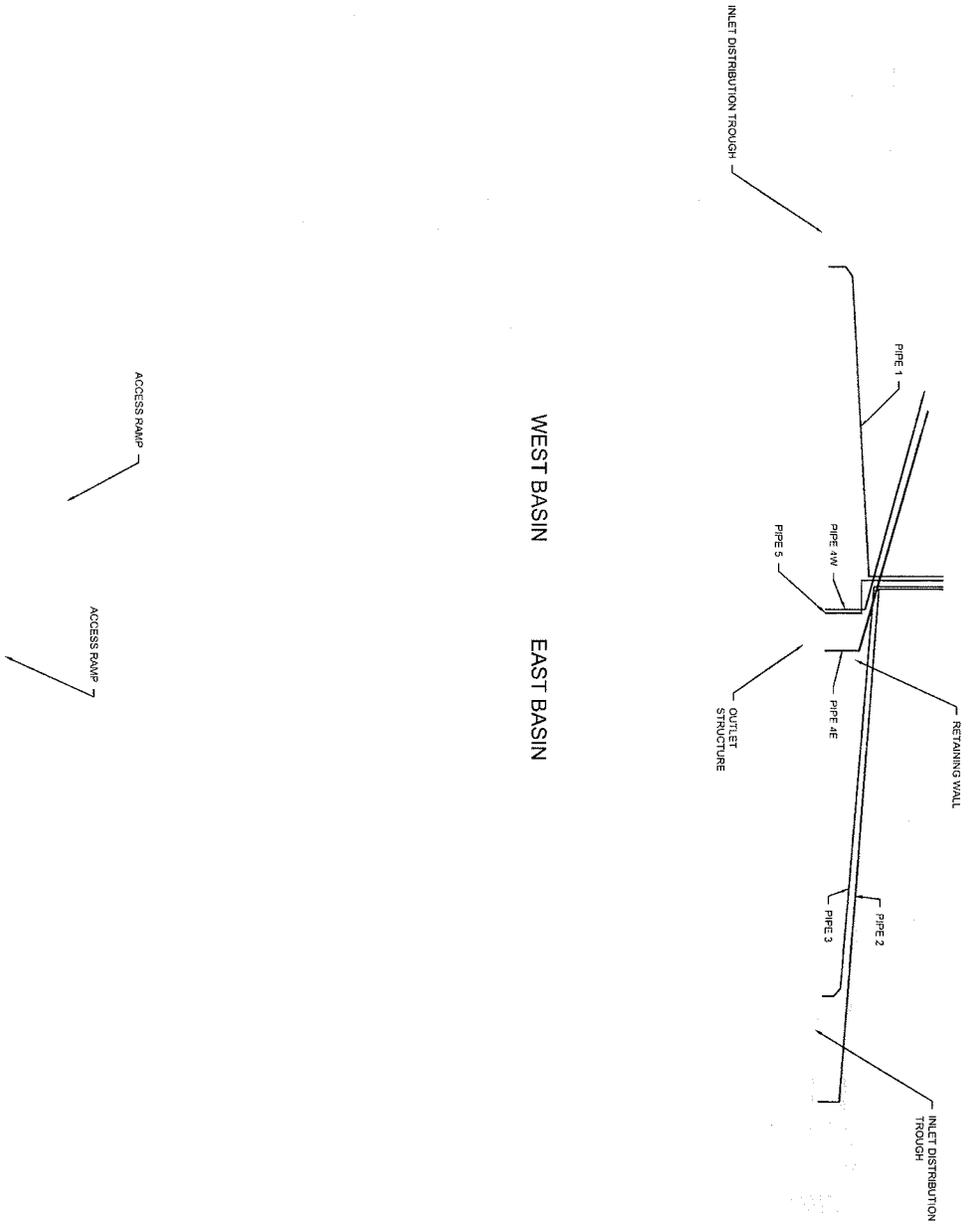
PIPE LOCATIONS WEST AND EAST ASH BASINS WAUKEGAN STATION WAUKEGAN, ILLINOIS	
	FIGURE <b>2</b>
PROJECT NO: SW0251-08	OCTOBER 2016

The video inspections showed no significant deterioration, deformation, distortion, bedding deficiencies, sedimentation, or debris that would negatively affect the operation of Pipes 1, 2, 3, and 5. The video inspections identified isolated areas of deformation and deterioration of Pipes 4E and 4W, which are 24-inch diameter concrete pipes with invert locations at the bottom of the outlet structures for the East and West Ash Basins, respectively. These pipes are located under the north embankment and are utilized for dewatering the outlet structure. Repairs were made to Pipe 4E to mitigate the isolated areas of deformation and deterioration identified during the inspection. The valve for controlling flow into Pipe 4W has been closed by Site personnel, and Pipe 4W will not be used until a repair is completed. Pipe 4W is not required for normal operation of the West Ash Basin.

A structural stability deficiency associated Pipe 4W was identified in this initial structural stability assessment. Geosyntec suggests relining the interior of the deficient portions of the pipe as a corrective action. The pipe will remain out of service until the repair is complete. Documentation detailing the corrective measures taken to repair the pipe will be prepared after the repair is complete.

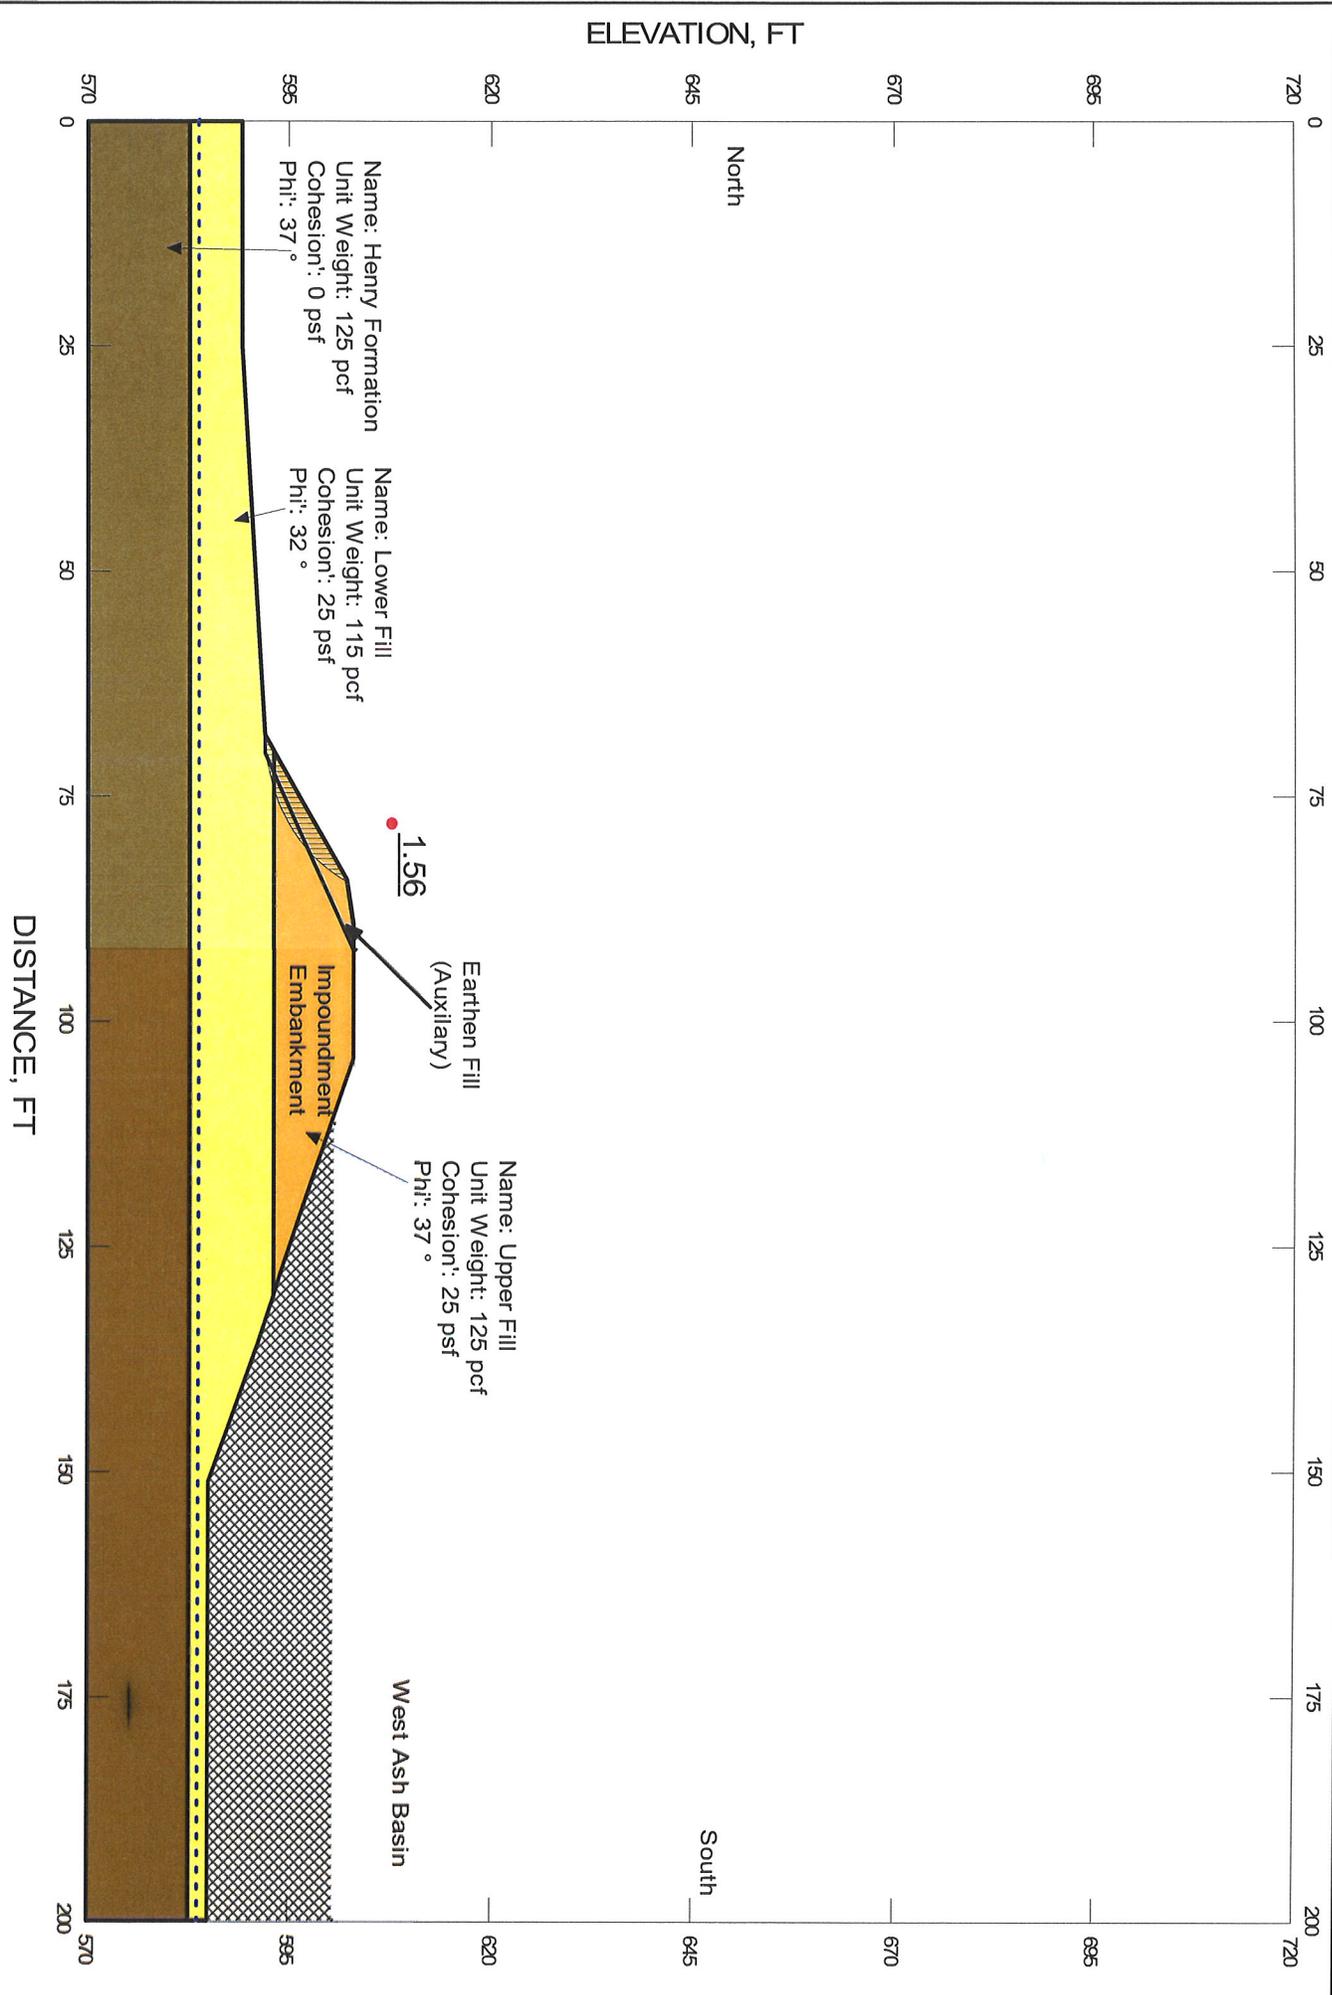
**FIGURE 4**

Analysis: Section 1 - §257.73(e)(1)(i): Long Term, Maximum Storage Pool Loading  
 Project: Waukegan East and West Ash Basins  
 File Name: Waukegan Section 1.gsz

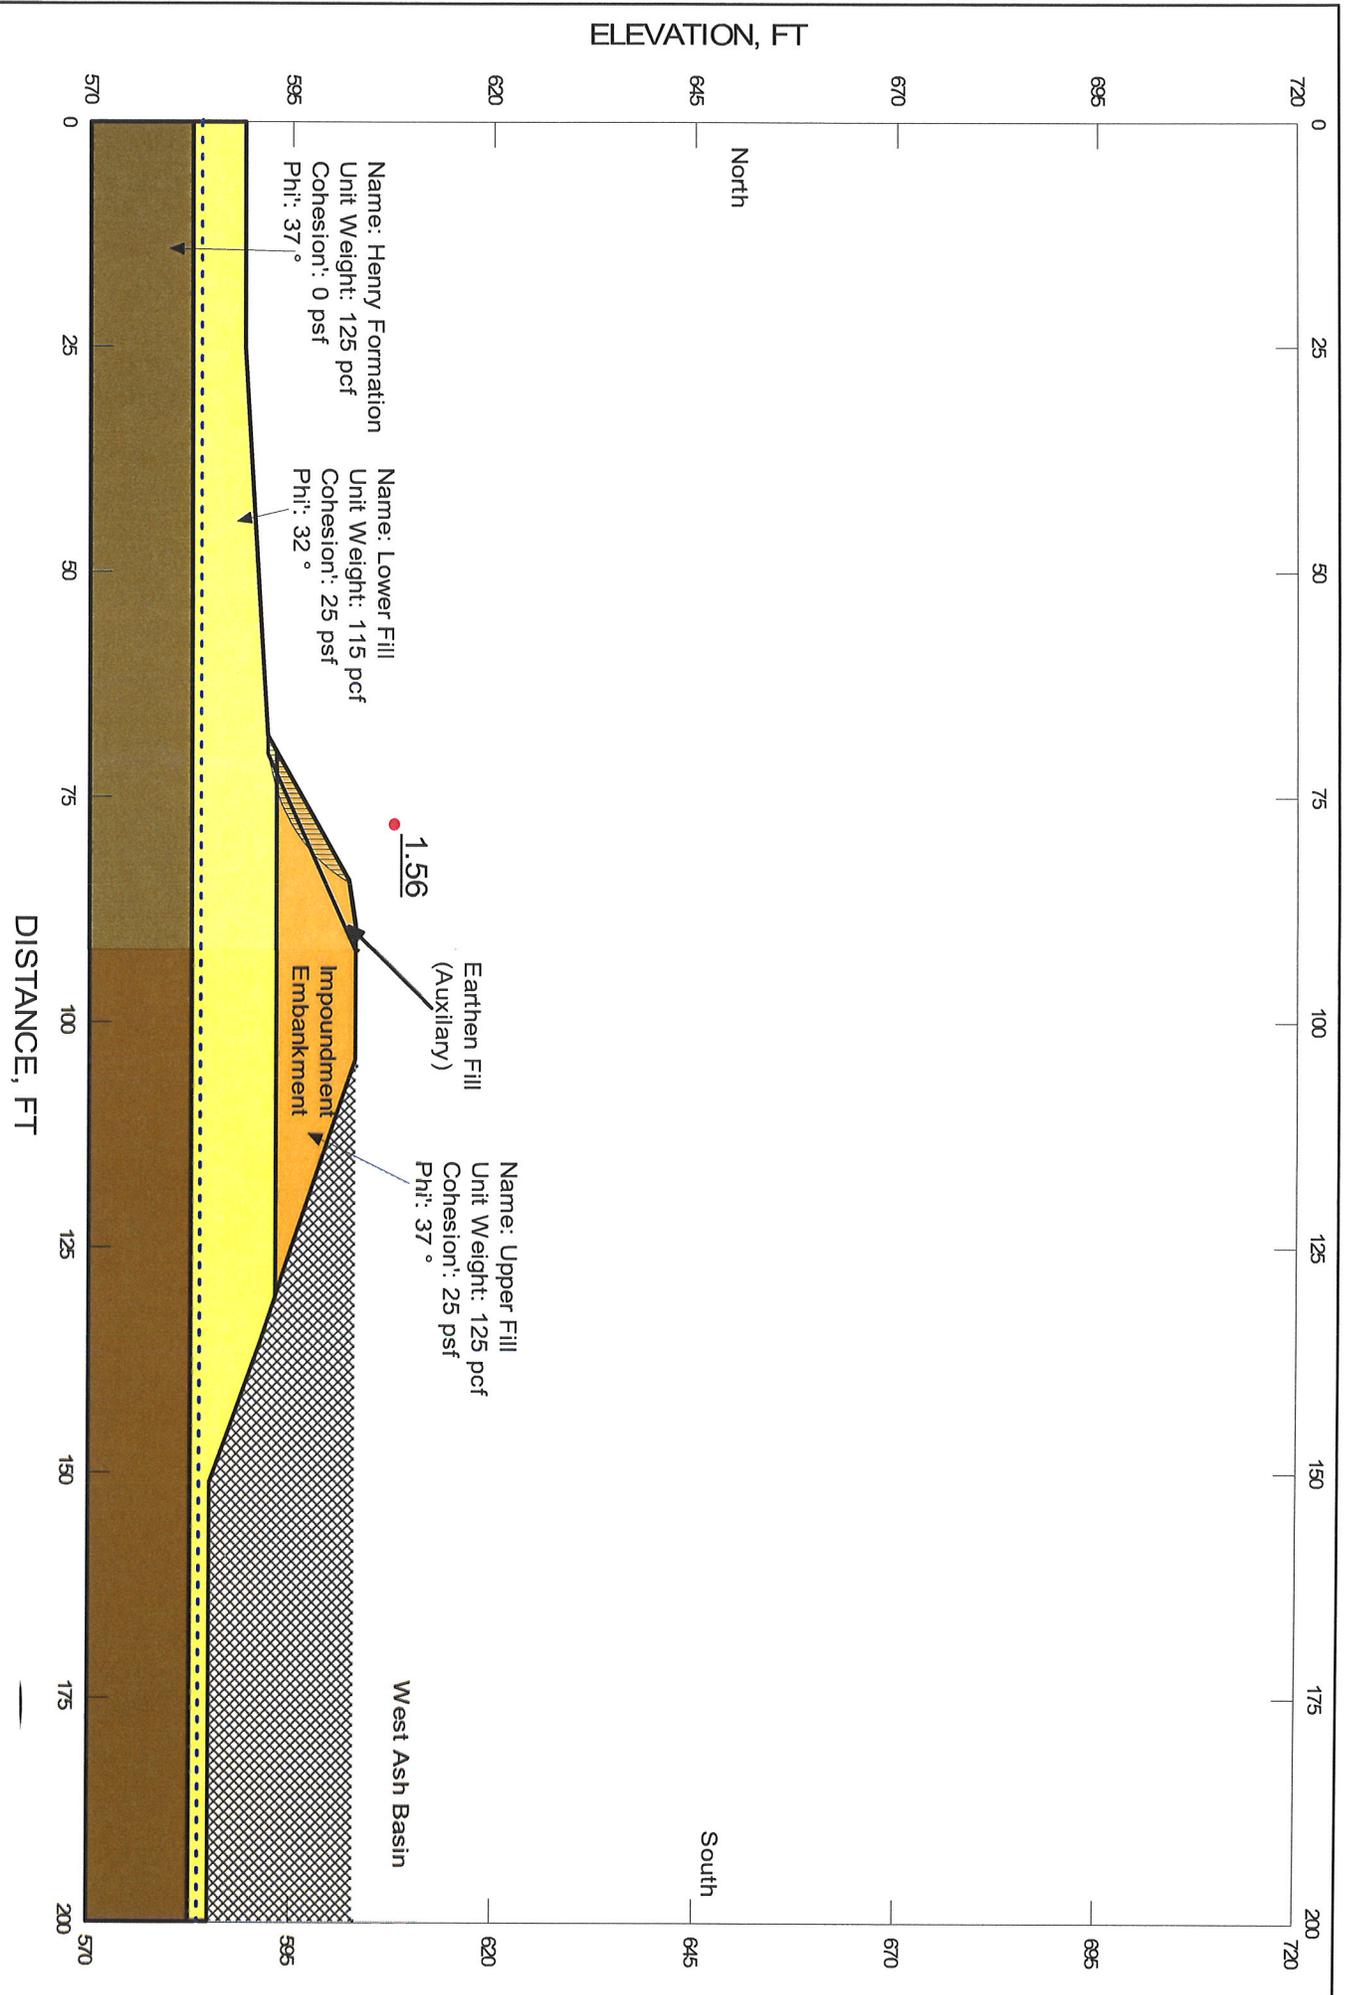
**FIGURE 5**

Analysis: Section 1 - §257.73(e)(1)(ii): Maximum Surcharge Pool Loading

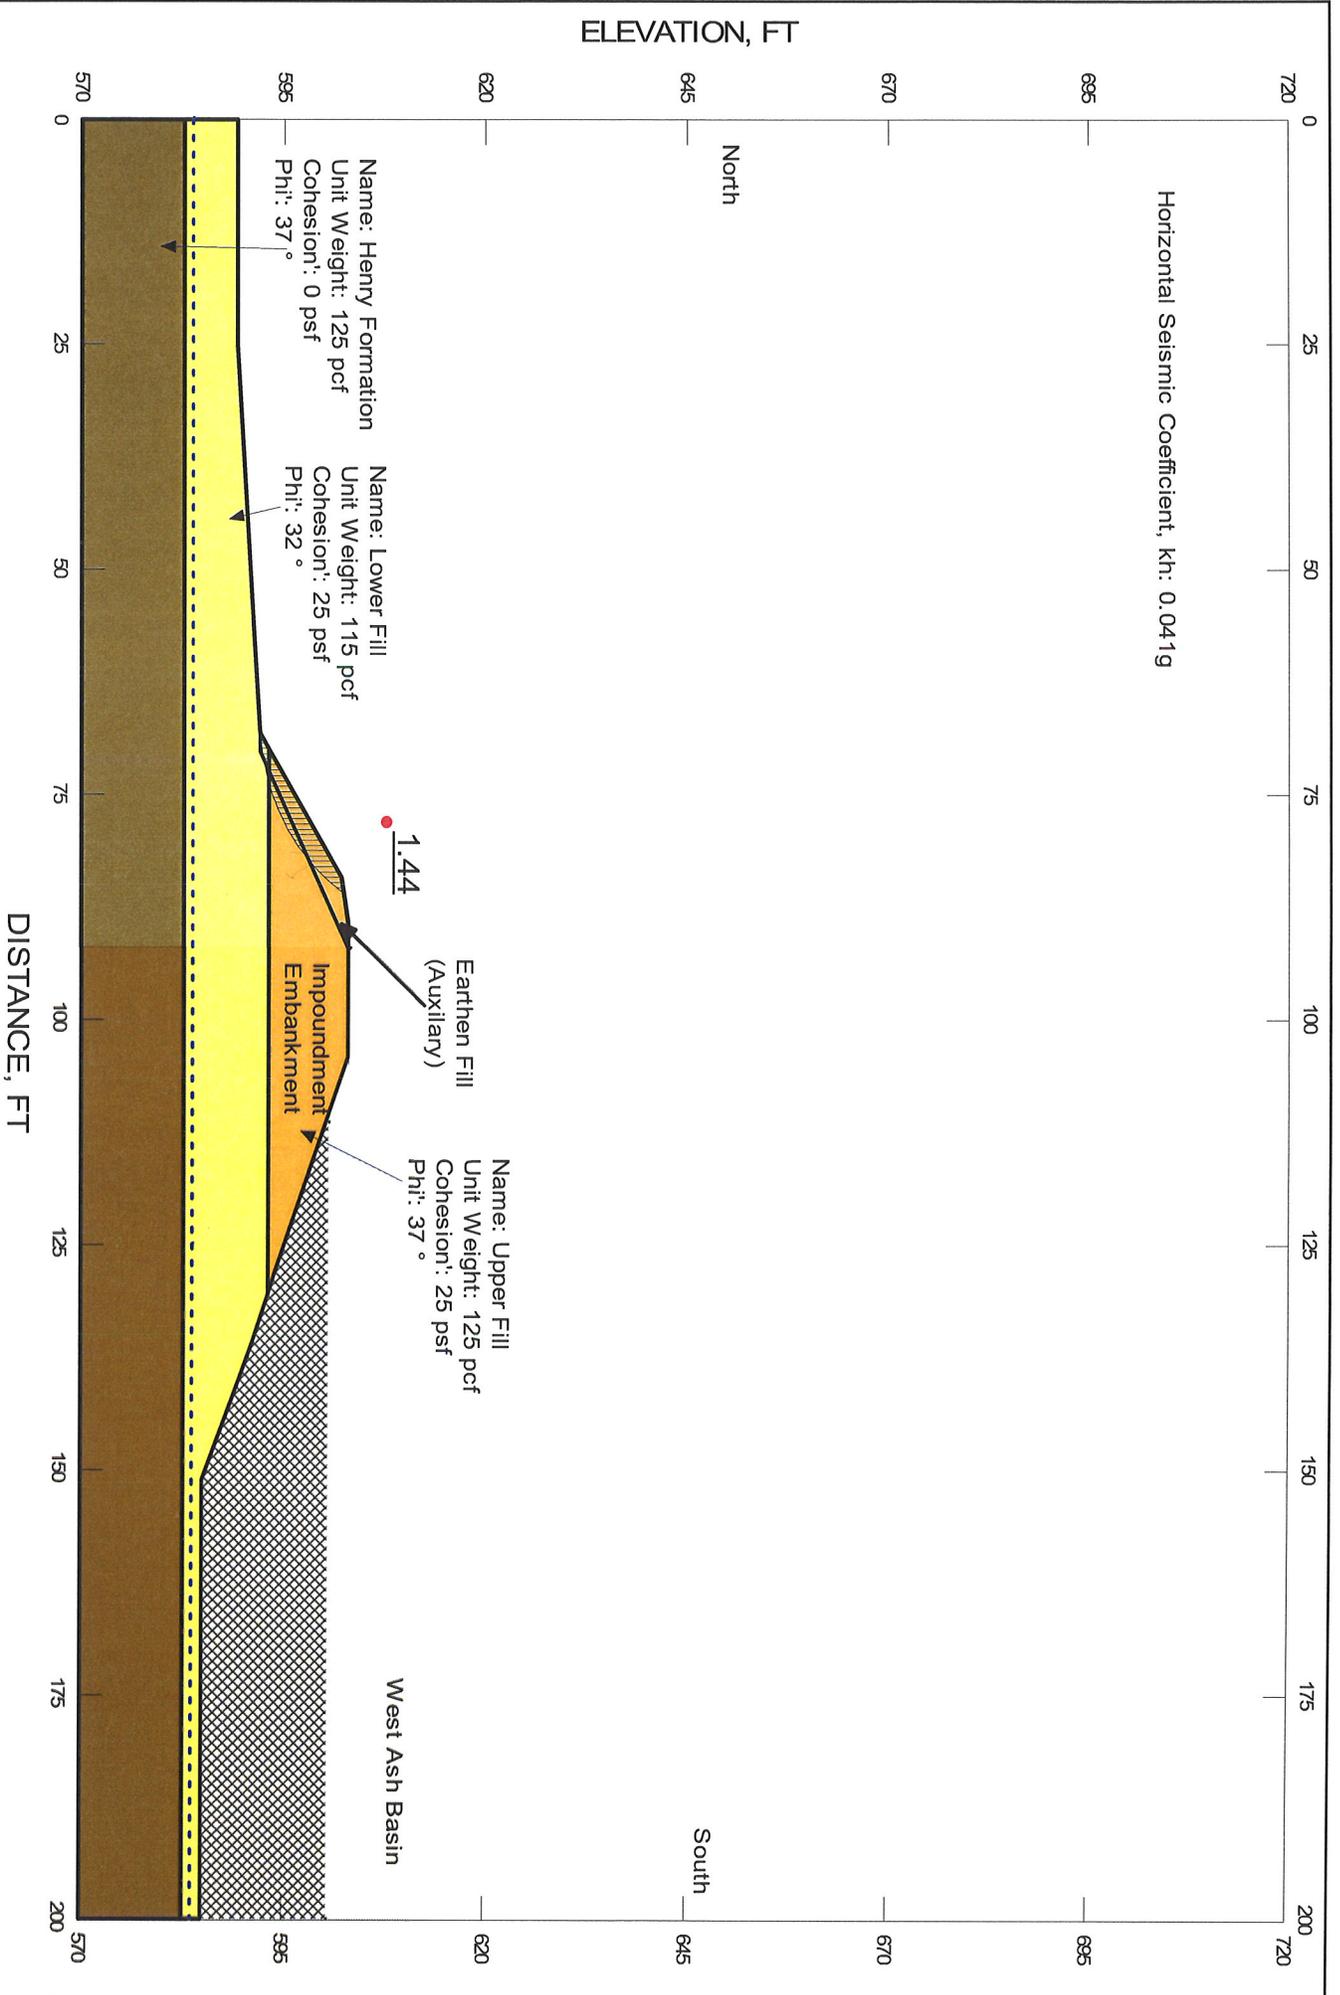
<b>Section 1 - §257.73(e)(1)(iii): Long Term, Maximum Storage Pool Loading with Seismic</b>		<b>FIGURE 6</b>
Project: Waukegan East and West Ash Basins		Analysis By: Jay Griffin		
File Name: Waukegan Section 1.gsz		Date: October 2016

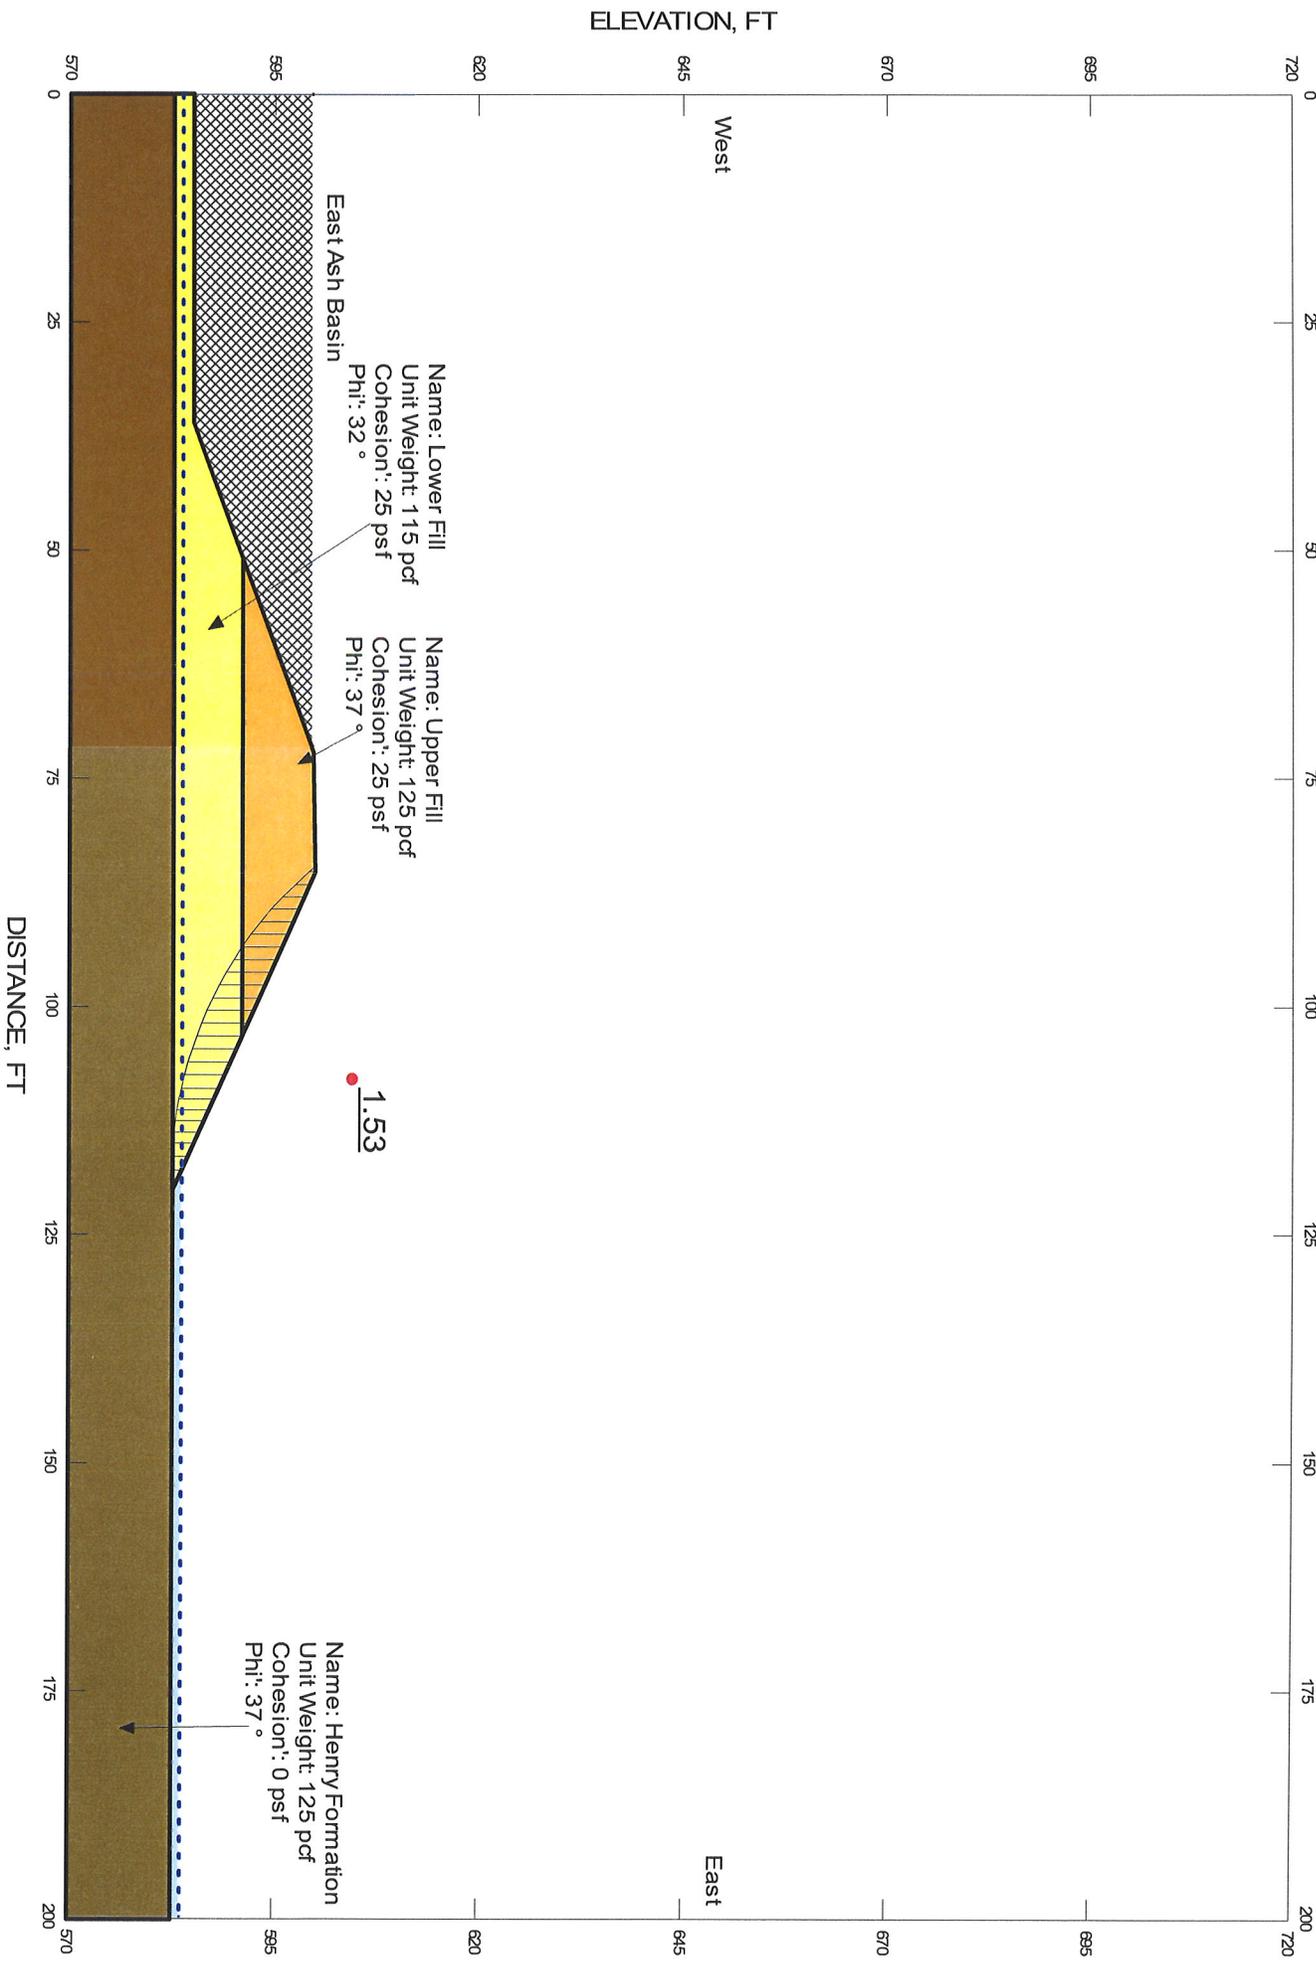
<b>Section 2 - §257.73(e)(1)(ii): Maximum Surcharge Pool Loading</b>	
Analysis	Project	Analysis By	Date
Waukegan East and West Ash Basins	Waukegan Section 2.gsz	Jay Griffin	October 2016
			<b>FIGURE 8</b>
