2019 Annual Inspection of CCR Landfill Cells

**W. A. Parish Electric Generating Station
Thompsons, Texas**

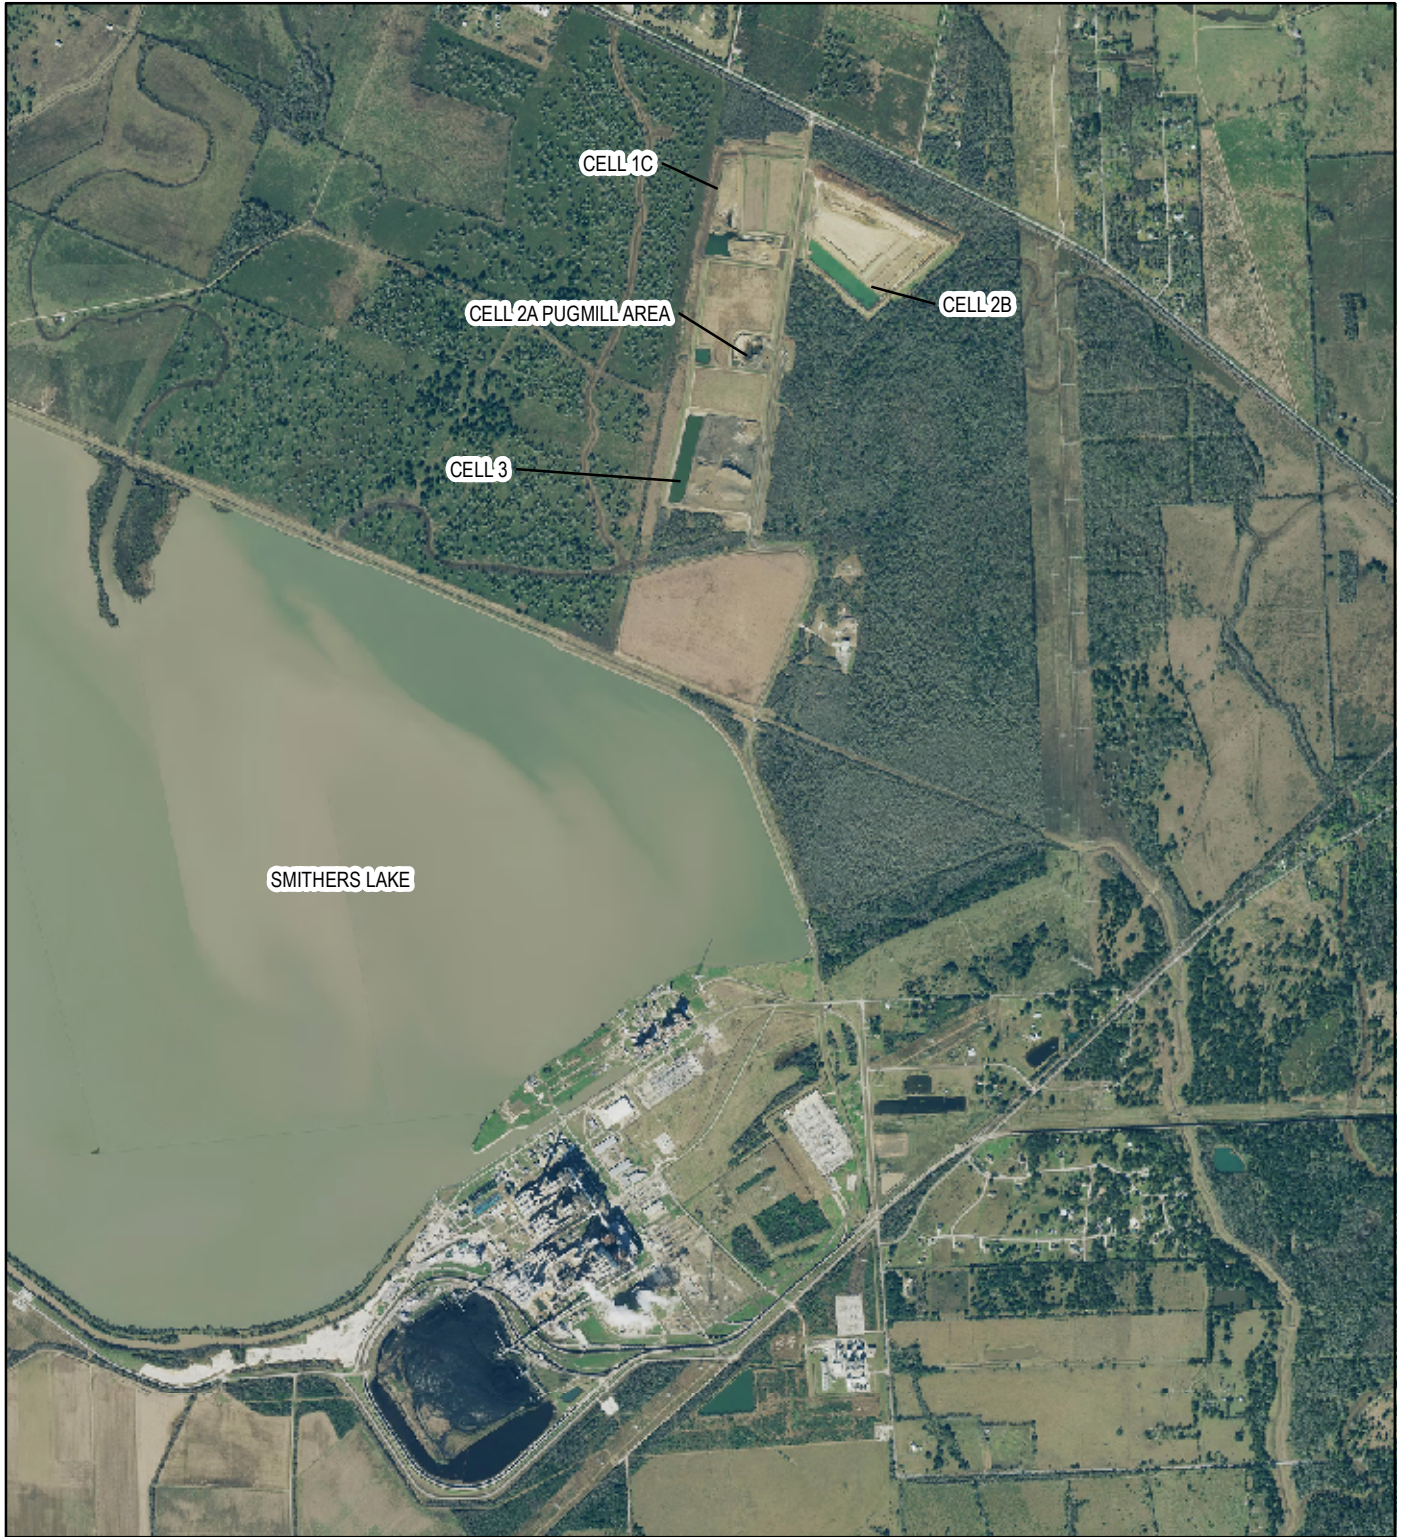
SOURCE: (12/10/2018) USDA FARM SERVICE, NAIP IMAGERY
