Re: CCR Landfill 2020 Annual Inspection
Dunkirk Generating Station
Van Buren Road
Pomfret, New York

GZA GeoEnvironmental of New York (GZA) presents this 2020 Annual Landfill Inspection report to Dunkirk Power LLC (Dunkirk) for the existing coal combustion residuals (CCR) landfill units at the Dunkirk Generating Station landfill located in Pomfret, New York (Site). This annual inspection is required by the United States Environmental Protection Agencies (USEPA) Hazardous and Solid Waste Management System; Disposal of Coal Combustion Residuals from Electric Utilities; Final Rule, as presented in the Federal Register Volume 80 No 74 dated April 17, 2015. In accordance with the CCR Rule (40 CFR 257.84), owners/operators of CCR landfill units are required to be inspected on a periodic basis by a qualified professional engineer to check the design, construction, operation and maintenance of the CCR unit is consistent with recognized and generally accepted good engineering standards.

Attachments: Figure 1 - 2019 Dunkirk Fill Progression Survey – Site Plan

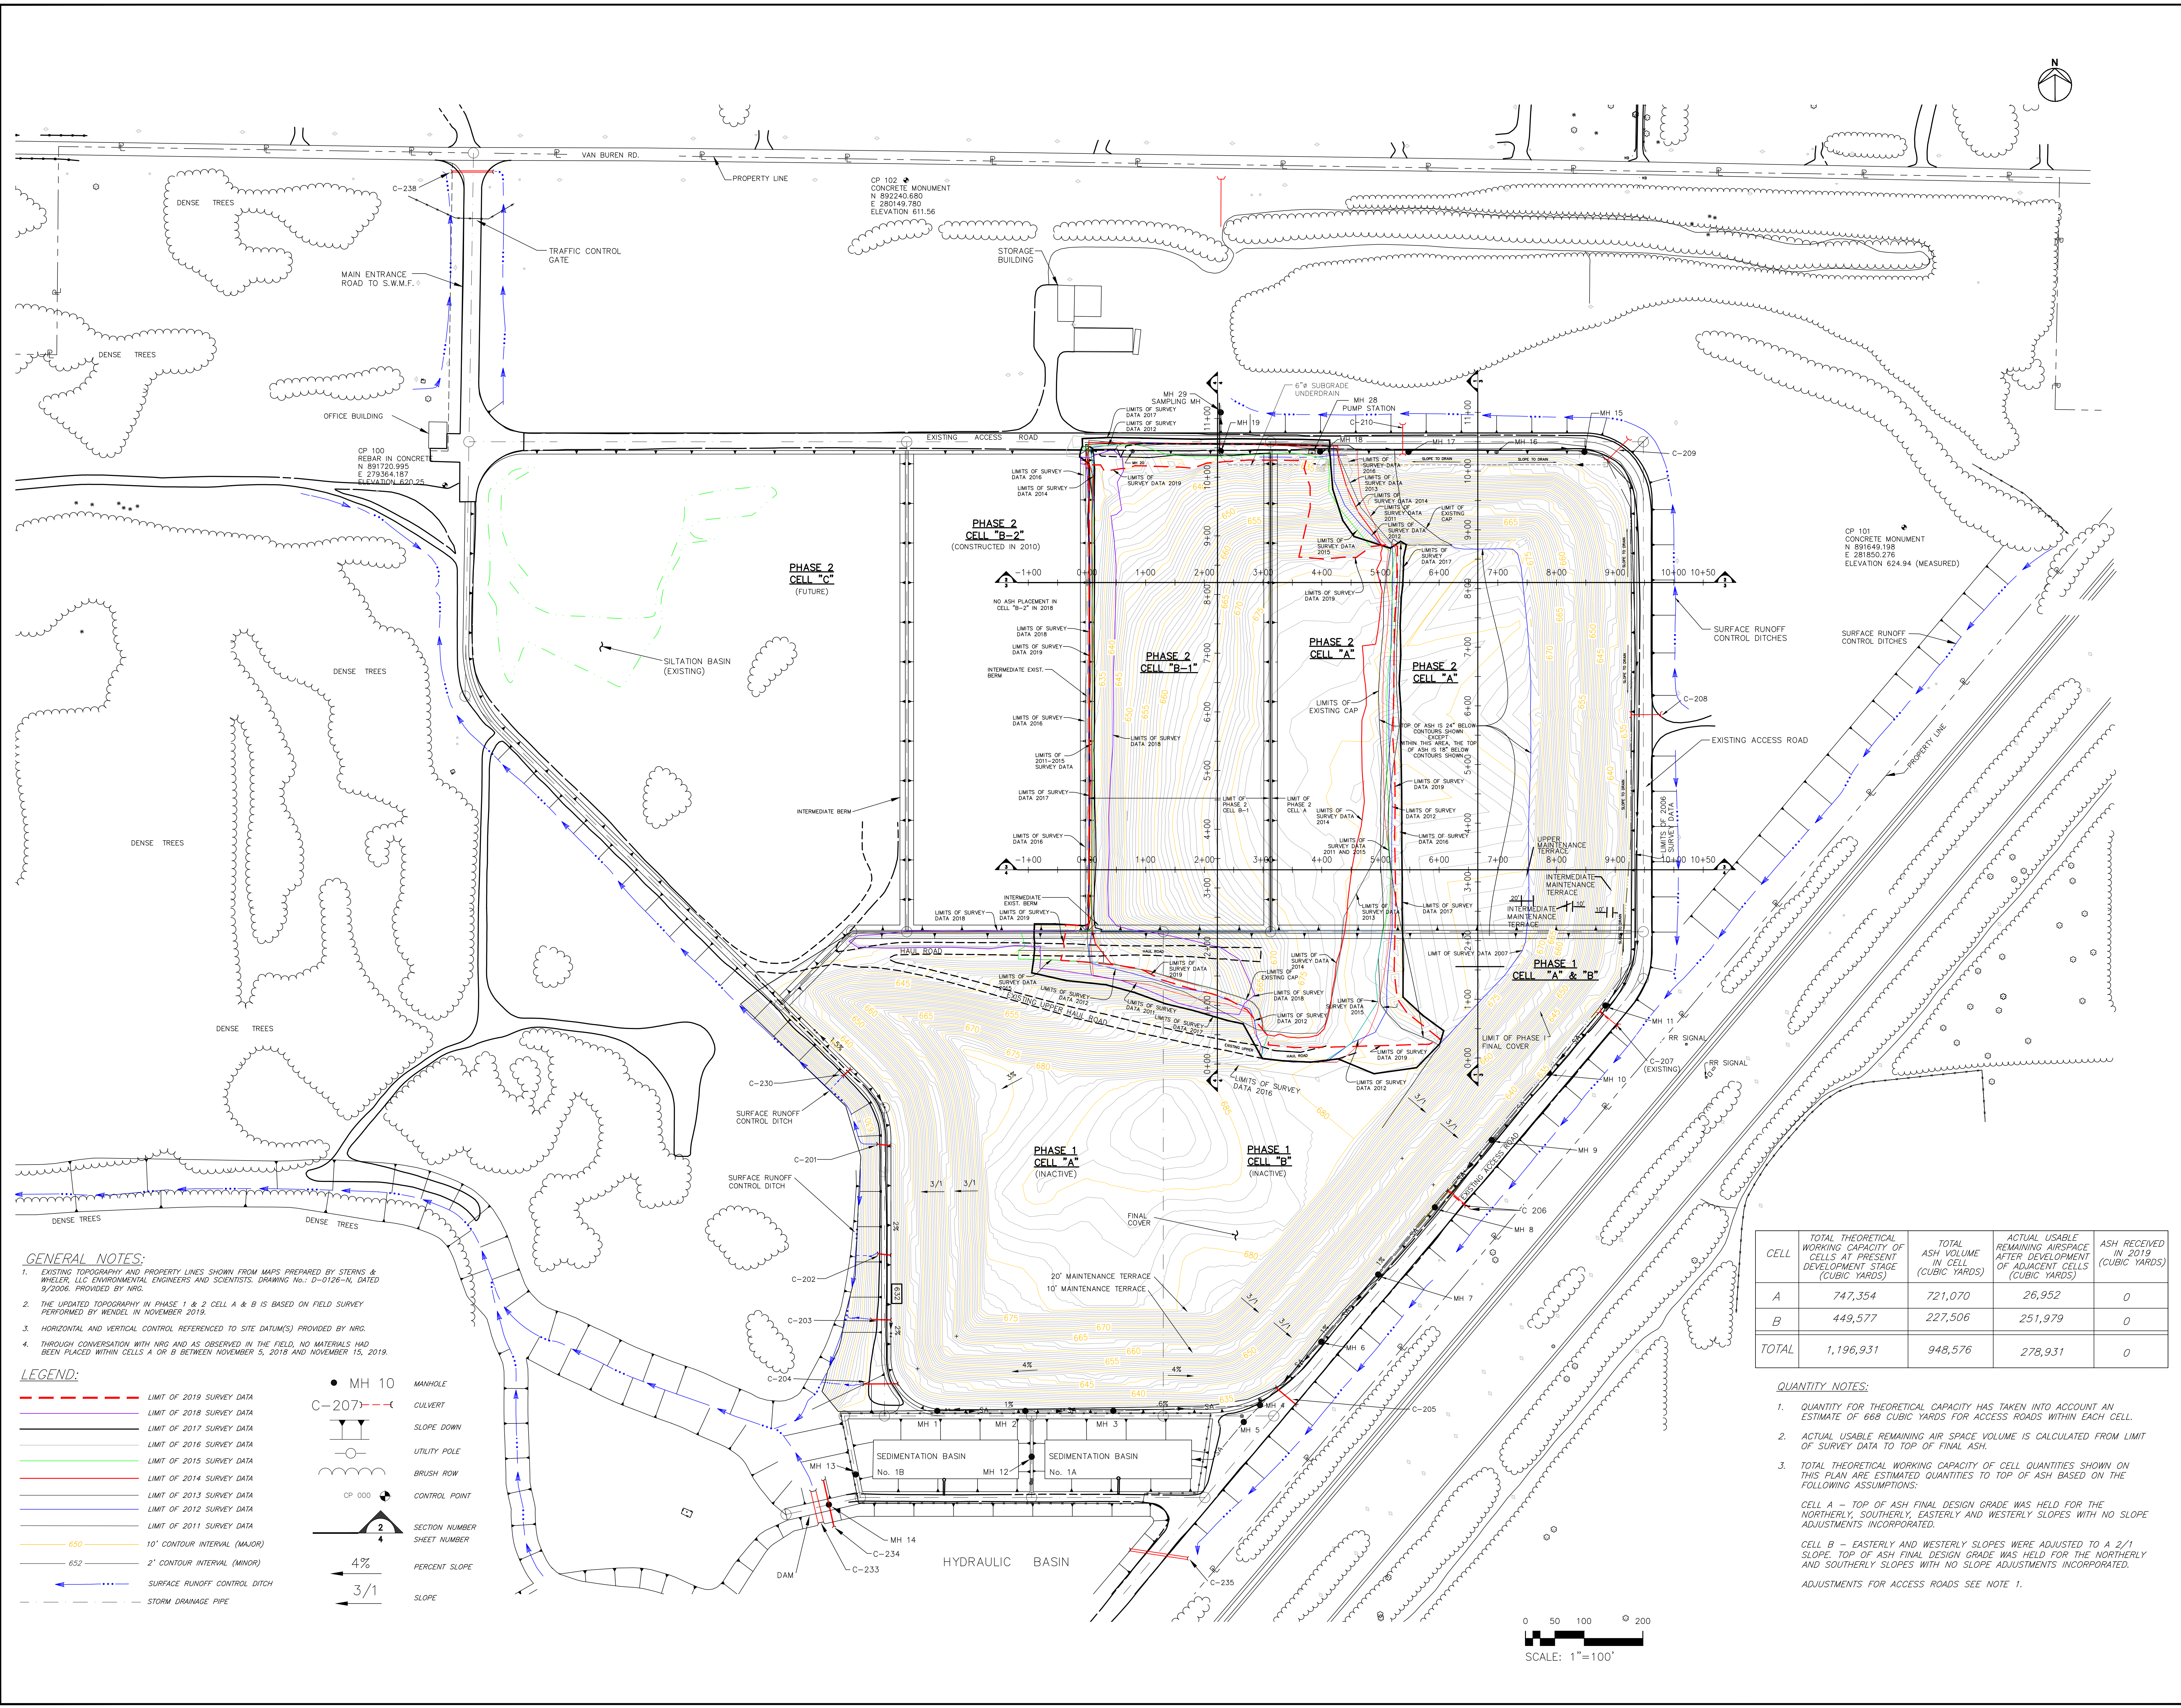
**DUNKIRK
2019 FILL PROGRESSION
SURVEY
SITE PLAN**

The Dunkirk Power landfill is currently permitted (ID#9-0658-00021/00008) with the New York State Department of Environmental Conservation (NYSDEC) to accept residual coal ash waste generated from the Dunkirk Power facility through May 22, 2021. We note that the power plant has been mothballed and associated equipment has been prepared for long term storage and is currently not in operation. A review of the 2019 (most recent) fill progression assessment for the Phase 2 Cells A and B-1 indicates the following information.

Phase 2 Landfill Cell	Ash/Material Received 2019 (cy)	Current Ash Volume (cy)	Volume Remaining (cy)
Cell A (western extent)	0	721,070	26,952
Cell B-1	0	227,506	251,979
Totals for A & B-1	0	948,576	278,931
