Re: CCR Landfill 2024 Annual Inspection Report
Huntley Generating Station
Tonawanda, New York

GZA GeoEnvironmental of New York (GZA) presents this 2024 Annual Landfill Inspection report to Huntley Power LLC (Huntley) for the existing coal combustion residuals (CCR) landfill units at the Huntley Generating Station landfill located in Tonawanda, New York (Site). This annual inspection is required by the United States Environmental Protection Agencies (USEPA) Hazardous and Solid Waste Management System; Disposal of Coal Combustion Residuals from Electric Utilities; Final Rule, as presented in the Federal Register Volume 80 No 74 dated April 17, 2015. In accordance with the CCR Rule (40 CFR 257.84), owners/operators of CCR landfill units are required to be inspected on a periodic basis by a qualified professional engineer to check the design, construction, operation and maintenance of the CCR unit is consistent with recognized and generally accepted good engineering standards.

Attachments: Figure 1 - 2023 Huntley Fill Progression Survey – General Plan

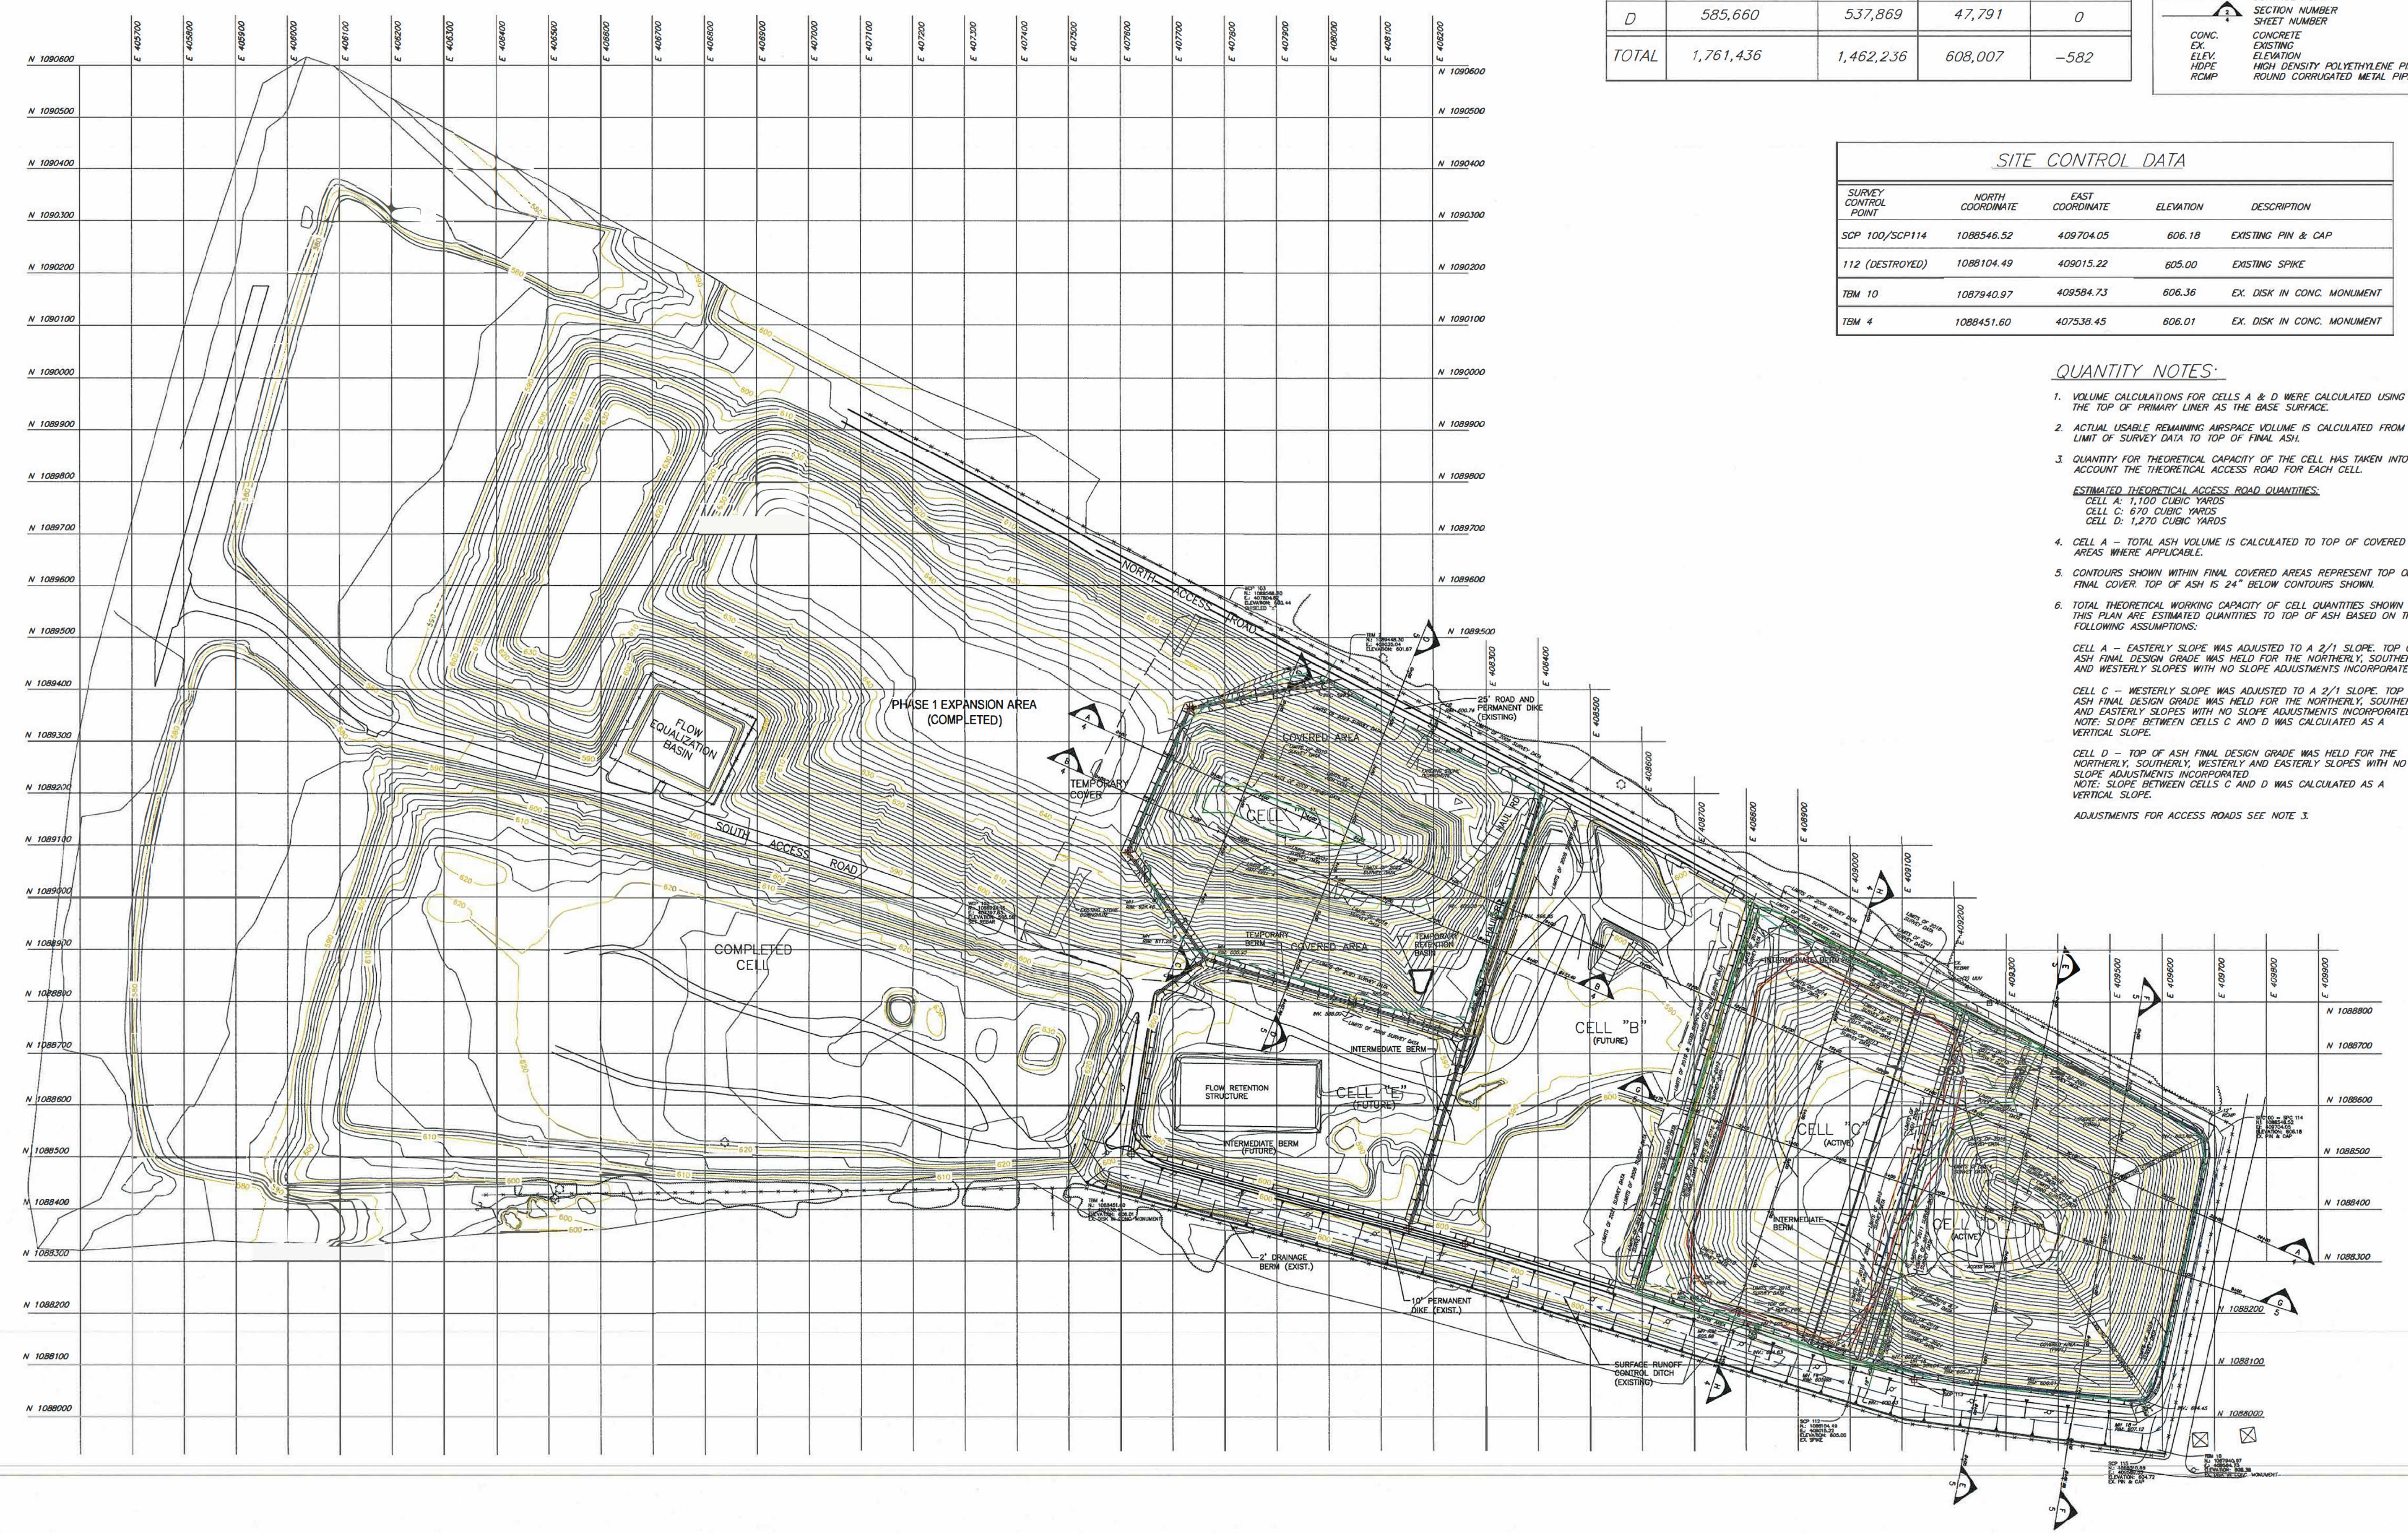
CELL	TOTAL THEORETICAL WORKING CAPACITY OF CELLS AT PRESENT DEVELOPMENT STAGE (CUBIC YARDS)	TOTAL ASH VOLUME IN CELL (CUBIC YARDS)	ACTUAL USABLE REMAINING AIRSPACE AFTER DEVELOPMENT OF ADJACENT CELLS (CUBIC YARDS)	ASH RECEIVED IN 2023 (CUBIC YARDS) (SEE NOTE #4)
A	573,849	509,264	196,276	0
C	601,927	415,103	363,940	-582
D	585,660	537,869	47,791	0
TOTAL	1,761,436	1,462,236	608,007	-582

- CONTOURS SHOWN WITHIN FINAL COVERED AREAS REPRESENT TOP OF FINAL COVER. TOP OF ASH IS 24" BELOW CONTOURS SHOWN.
 - TOTAL THEORETICAL WORKING CAPACITY OF CELL QUANTITIES SHOWN ON THIS PLAN ARE ESTIMATED QUANTITIES TO TOP OF ASH BASED ON THE FOLLOWING ASSUMPTIONS:
CELL A - EASTERLY SLOPE WAS ADJUSTED TO A 2/1 SLOPE. TOP OF ASH FINAL DESIGN GRADE WAS HELD FOR THE NORTHERLY, SOUTHERLY AND WESTERLY SLOPES WITH NO SLOPE ADJUSTMENTS INCORPORATED.
CELL C - WESTERLY SLOPE WAS ADJUSTED TO A 2/1 SLOPE. TOP OF ASH FINAL DESIGN GRADE WAS HELD FOR THE NORTHERLY, SOUTHERLY AND EASTERLY SLOPES WITH NO SLOPE ADJUSTMENTS INCORPORATED. NOTE: SLOPE BETWEEN CELLS C AND D WAS CALCULATED AS A VERTICAL SLOPE.
CELL D - TOP OF ASH FINAL DESIGN GRADE WAS HELD FOR THE NORTHERLY, SOUTHERLY, WESTERLY AND EASTERLY SLOPES WITH NO SLOPE ADJUSTMENTS INCORPORATED. NOTE: SLOPE BETWEEN CELLS C AND D WAS CALCULATED AS A VERTICAL SLOPE.
