Re: CCR Surface Impoundment Design Criteria  
Huntley Generating Station  
Tonawanda, New York

**NRG OCTOBER 2014 RESPONSE TO EPA REPORT  
NRG HUNTLEY PLANT  
TONAWANDA, NEW YORK**

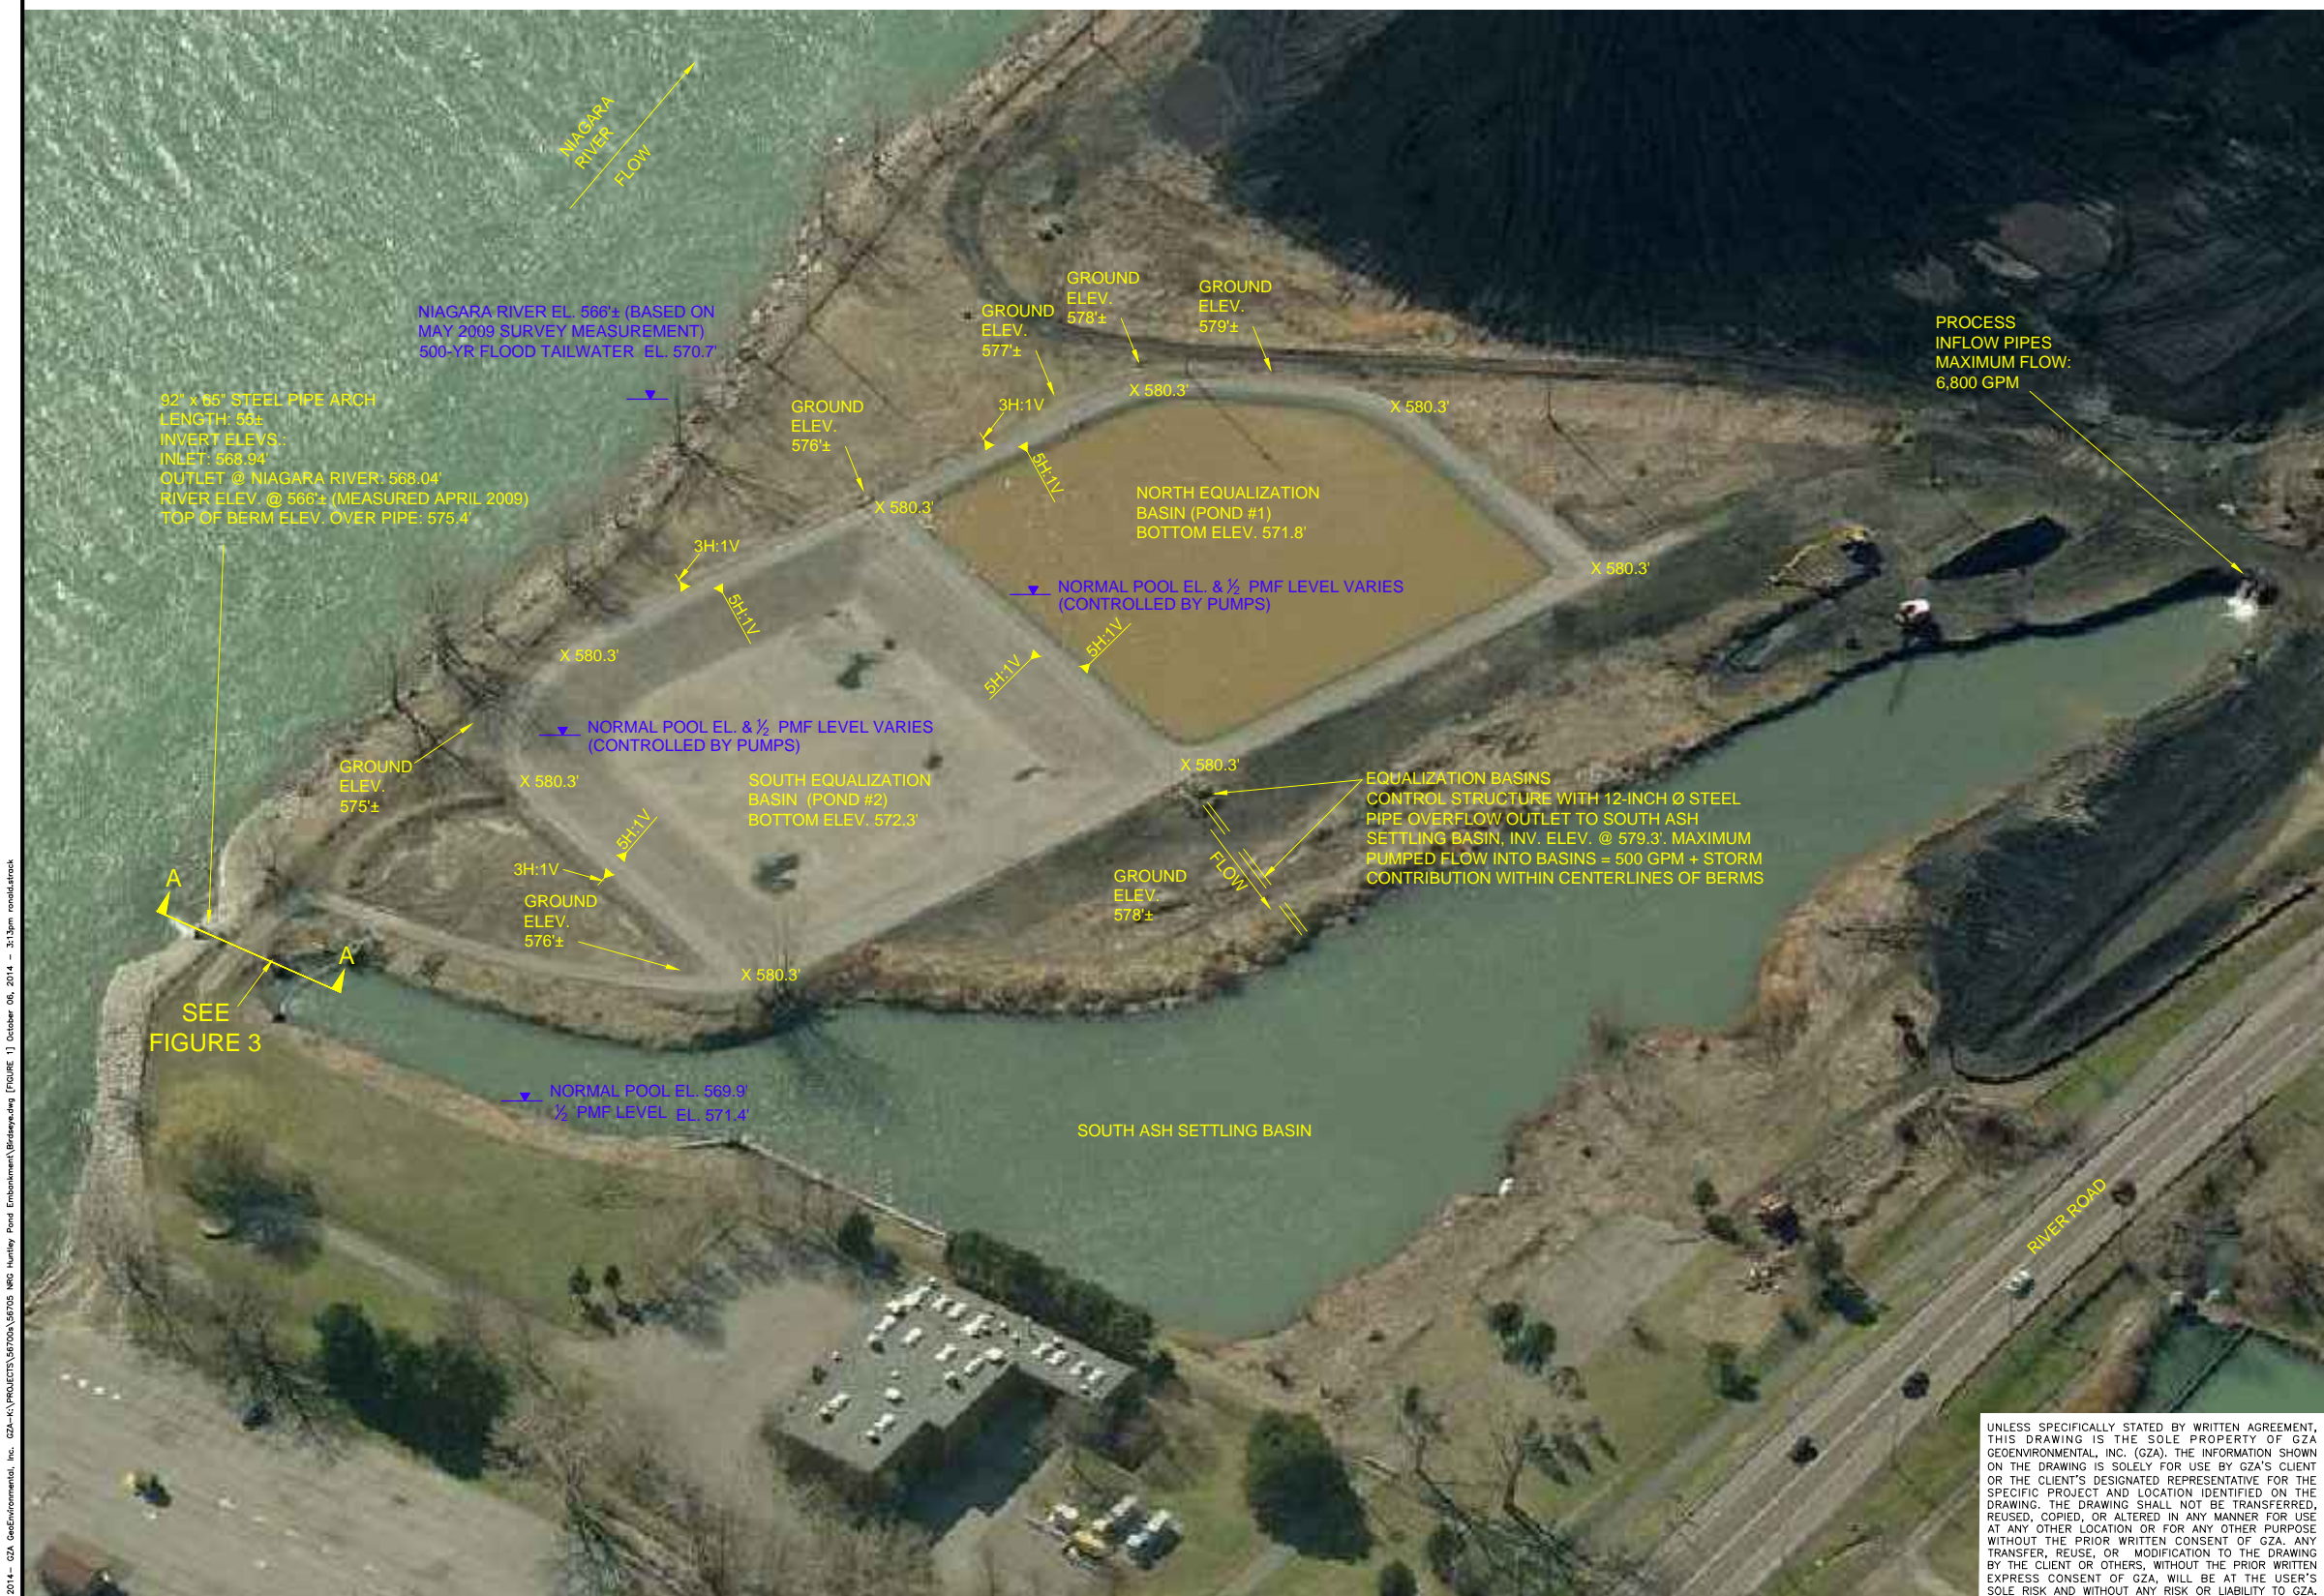
© 2014 - GZA GeoEnvironmental, Inc. GZA-\\G:\PROJECTS\2014\2014-10-06-3113pm\_monistat.mxd [FIGURE 1] October 06, 2014 - 3:13pm monistat.mxd

- The embankment located between the South Settling Pond and the Niagara River in the southern portion of the Site (See Figure 1); and
- Two embankments along the northern portion of the Site property associated with ponds identified as Pond 2 and Pond 3 (see Figure 2).

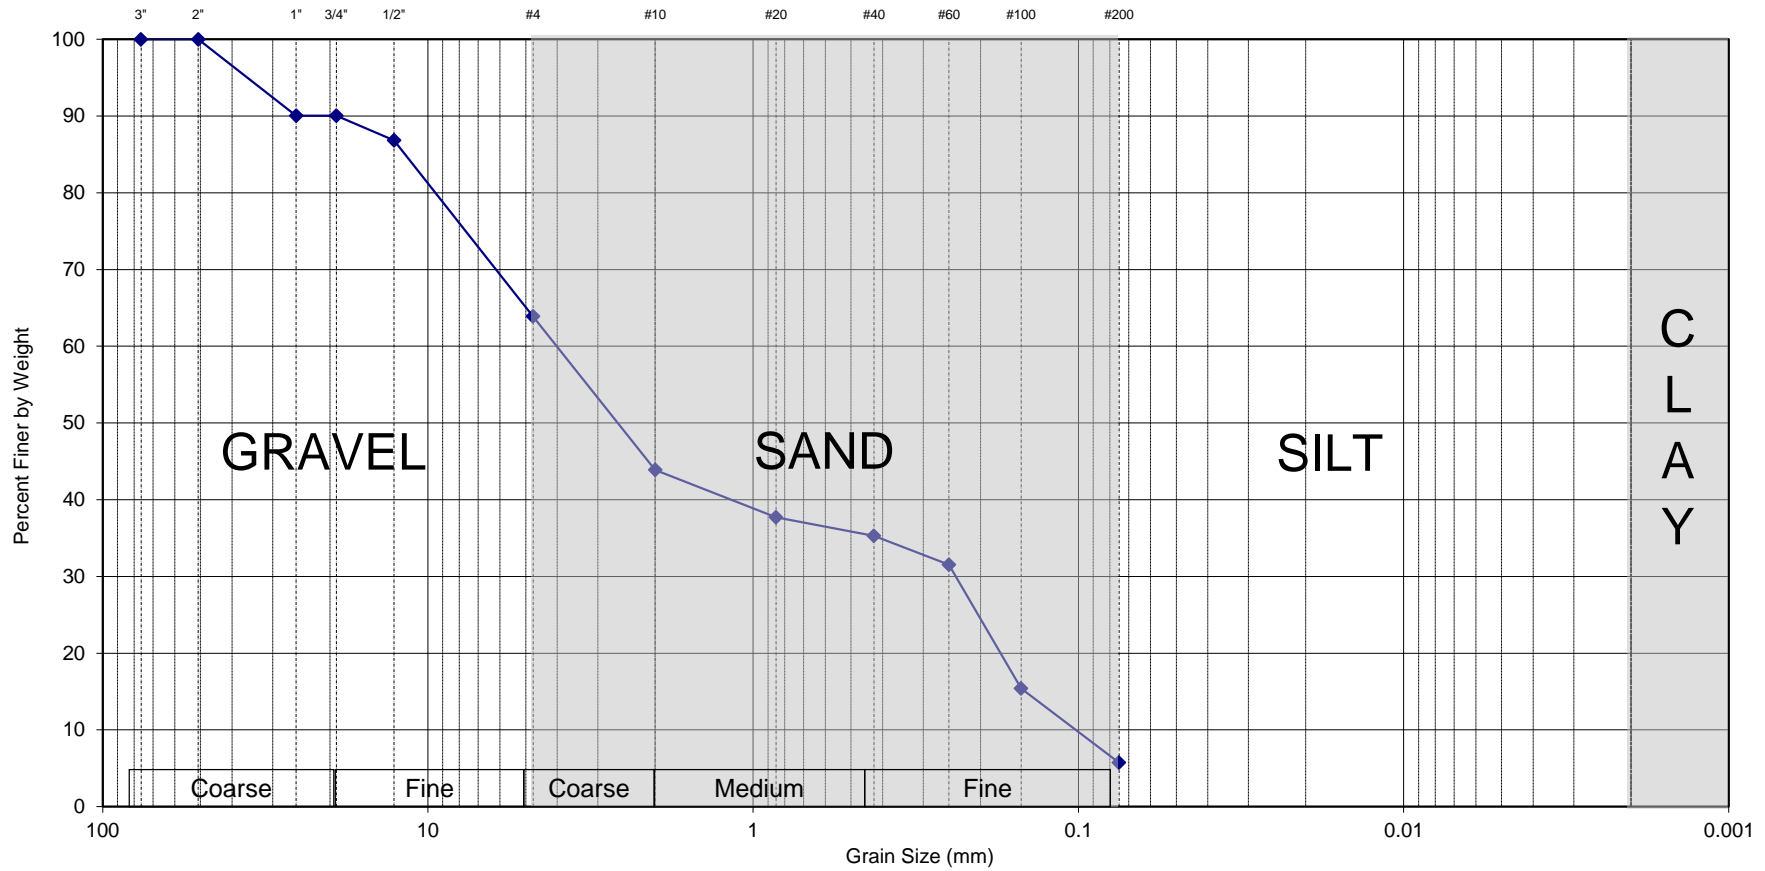
U.S. STANDARD SIEVE AND HYDROMETER

Gravel  
36.1%

Sand  
58.2%

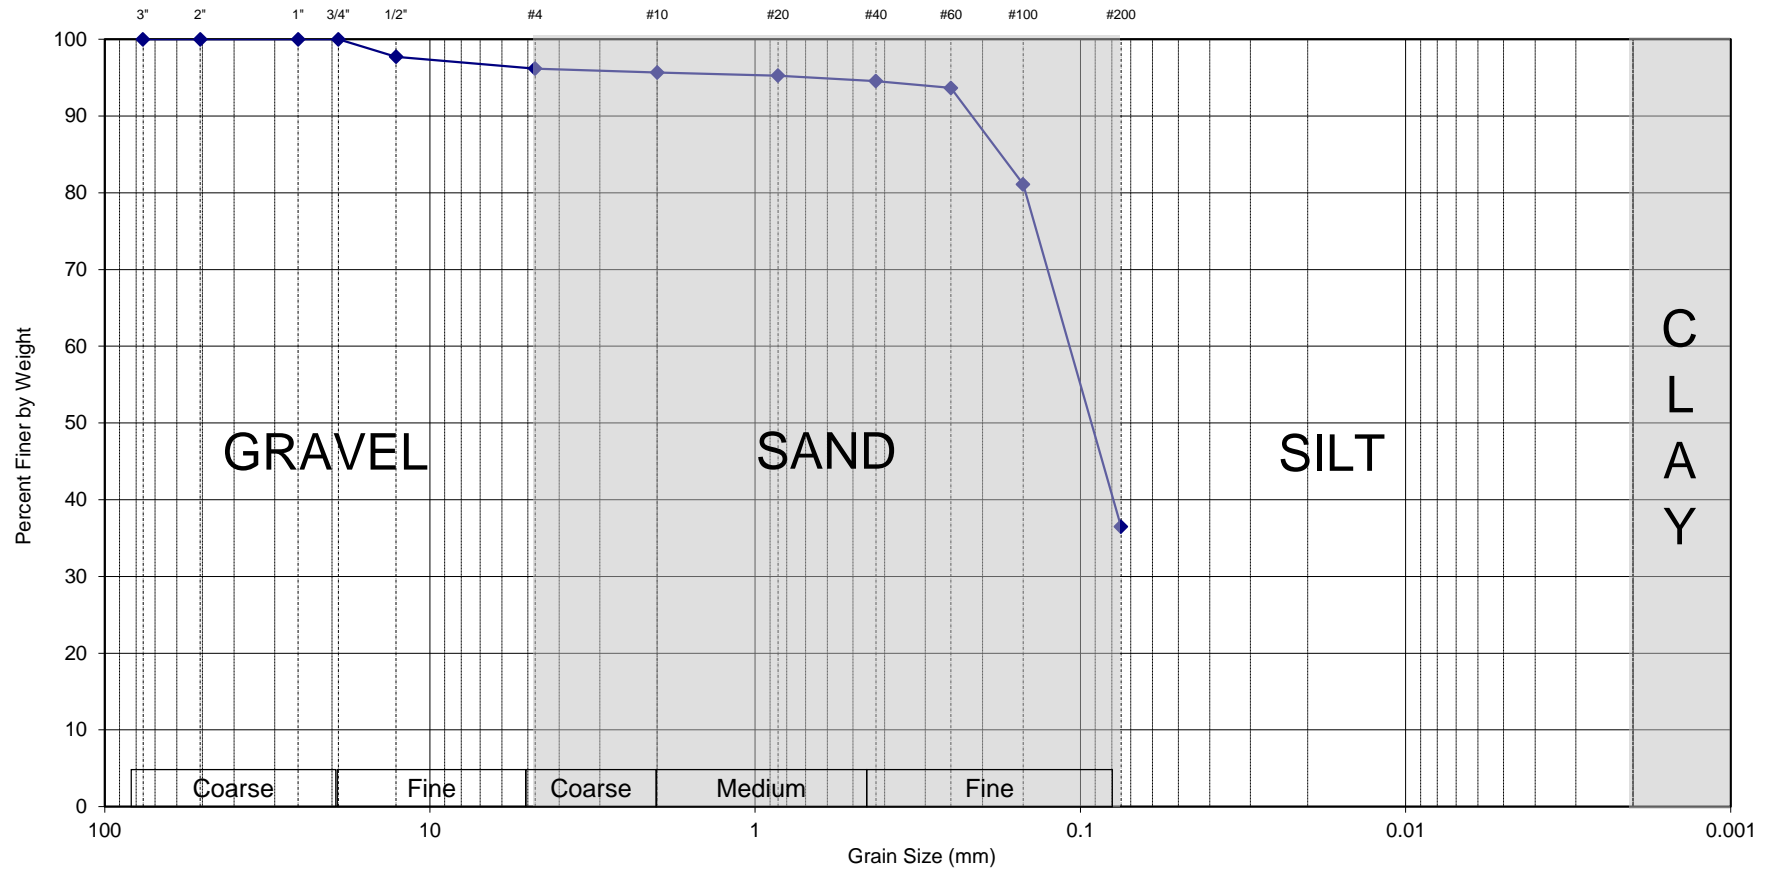
U.S. STANDARD SIEVE AND HYDROMETER

Gravel  
3.8%

Sand  
59.7%

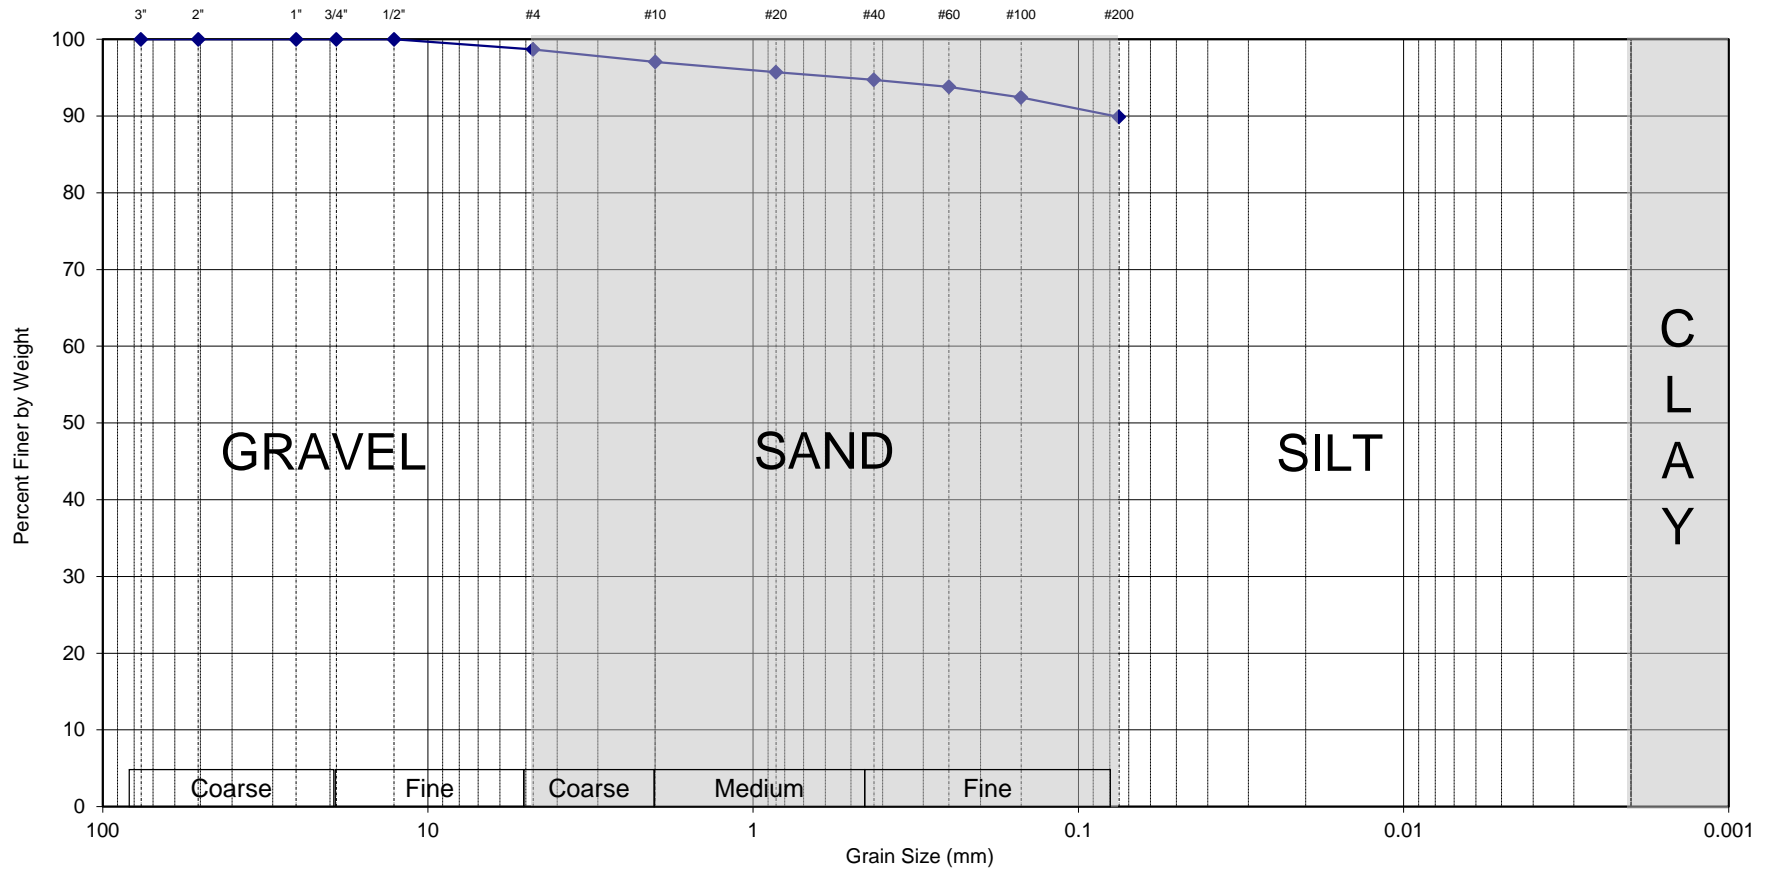
U.S. STANDARD SIEVE AND HYDROMETER

Gravel  
1.3%

Sand  
8.8%

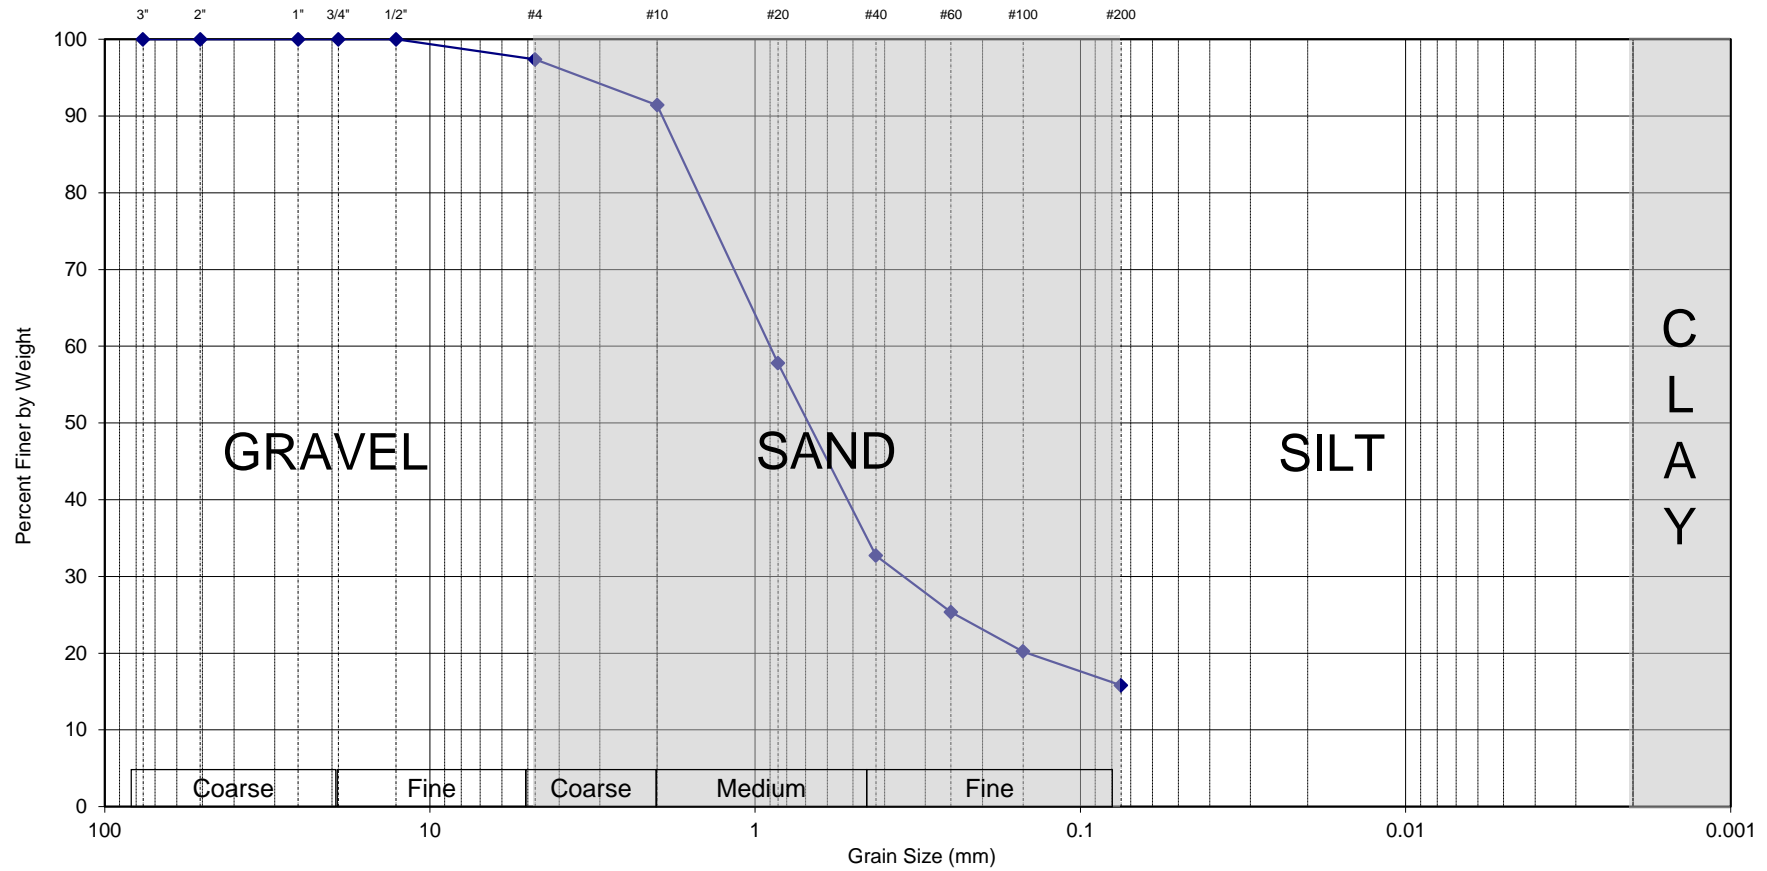
U.S. STANDARD SIEVE AND HYDROMETER

Gravel 2.6%      Sand 81.6%      Fines 15.8%

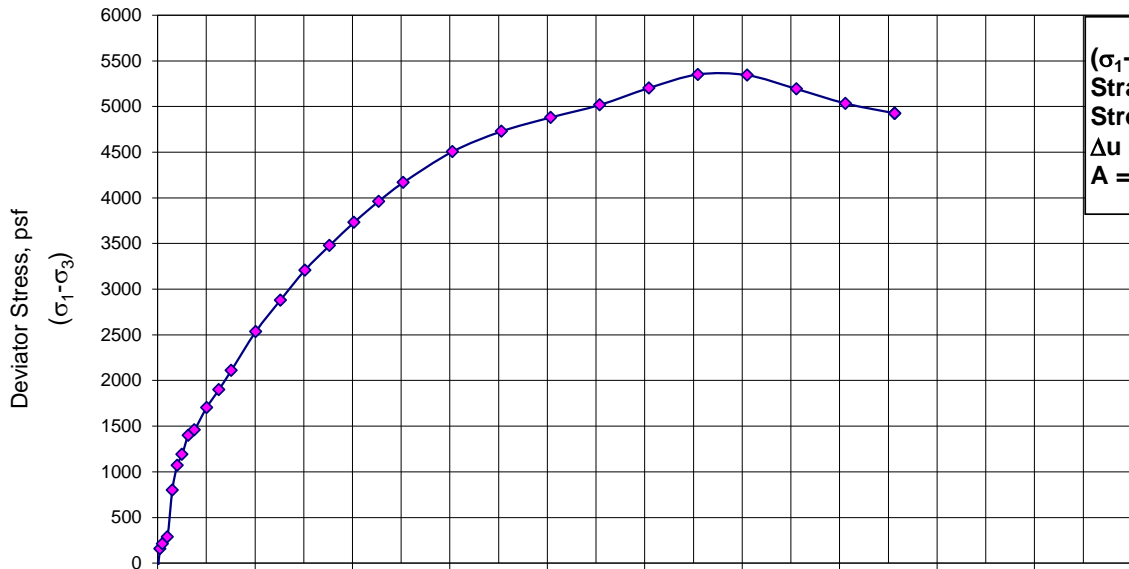
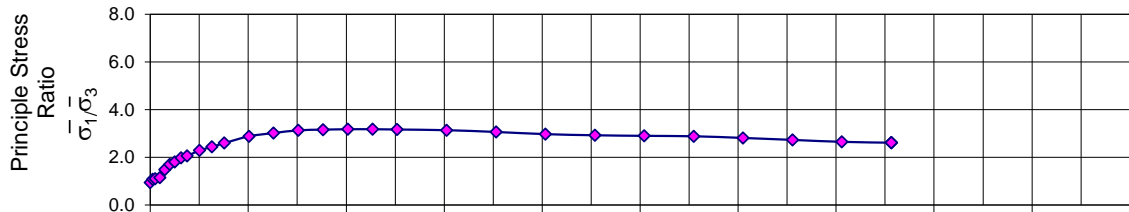
NRG Huntley Embankment Evaluation Tonawanda, NY TRIAXIAL COMPRESSION TESTS (CIU)	
BORING: B-8	FILE NO: 21.0056705.00
SAMPLE: ST-6	Date: 7/18/2014
DEPTH: 20.0-20.4'	Tech.: AS
TEST NO: T 3.1	Reviewer: MBP

( $\sigma_1 - \sigma_3$ ) (psf) = 3962  
 Strain % = 4.54  
 Stress Ratio = 3.18  
 $\Delta u = 183.4$   
 A = 0.05

It should be noted that only two Shelby tube samples (identified as ST-6 and ST-7 from B-8 and B-11, respectively) were identified as suitable for the CIU testing. The remaining tube samples generally had poor or insufficient recovery for this testing. A composite sample from tube samples ST-3 and ST-4 (from borings B-5 and B-6, respectfully) was prepared by the laboratory to determine shear angle by a direct shear test (ASTM D3080). The tube sample ST-2 (from boring B-4) was observed with driller's wax down the entire length of the sample and therefore the calculated average total unit weight value reported is not considered to be representative of the soil conditions and is not used in our stability analysis.

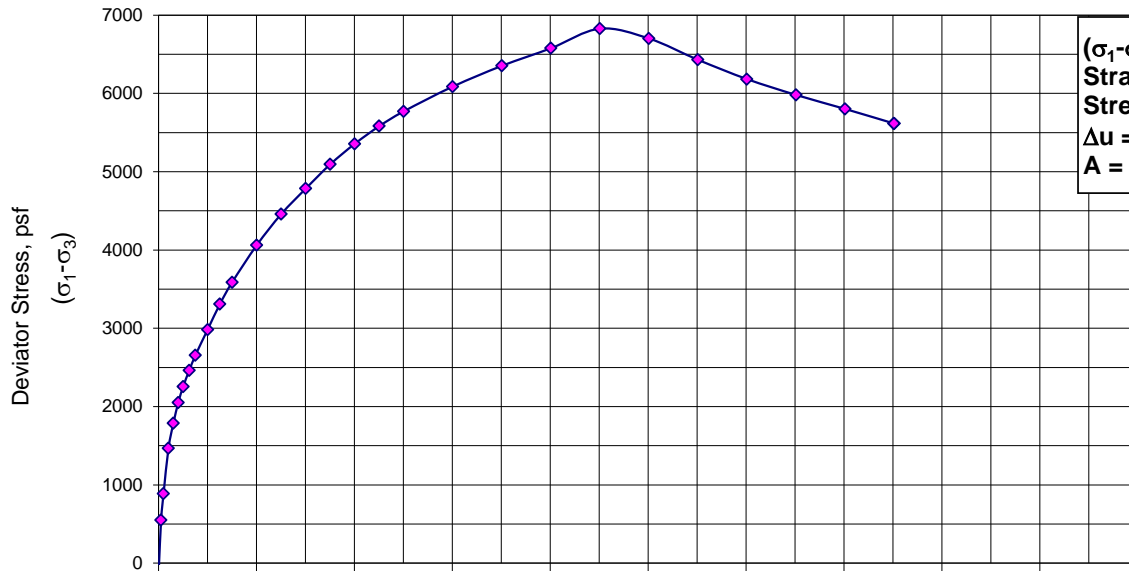
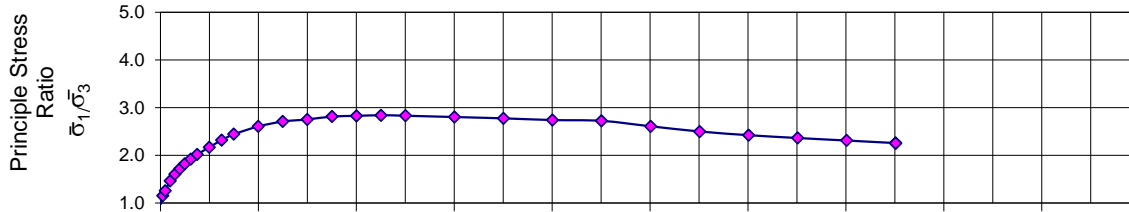
<b>NRG Huntley Embankment Evaluation</b> <b>Tonawanda, NY</b> <b>TRIAXIAL COMPRESSION TESTS (CIU)</b>	
BORING: B-8	FILE NO: 21.0056705.00
SAMPLE: ST-6	Date: 7/18/14
DEPTH: 20.4-20.8'	Tech.: AS
TEST NO: T 3.2	Reviewer: MBP

( $\sigma_1 - \sigma_3$ ) (psf) = 5582  
 Strain % = 4.51  
 Stress Ratio = 2.84  
 $\Delta u = 969.7$   
 A = 0.17

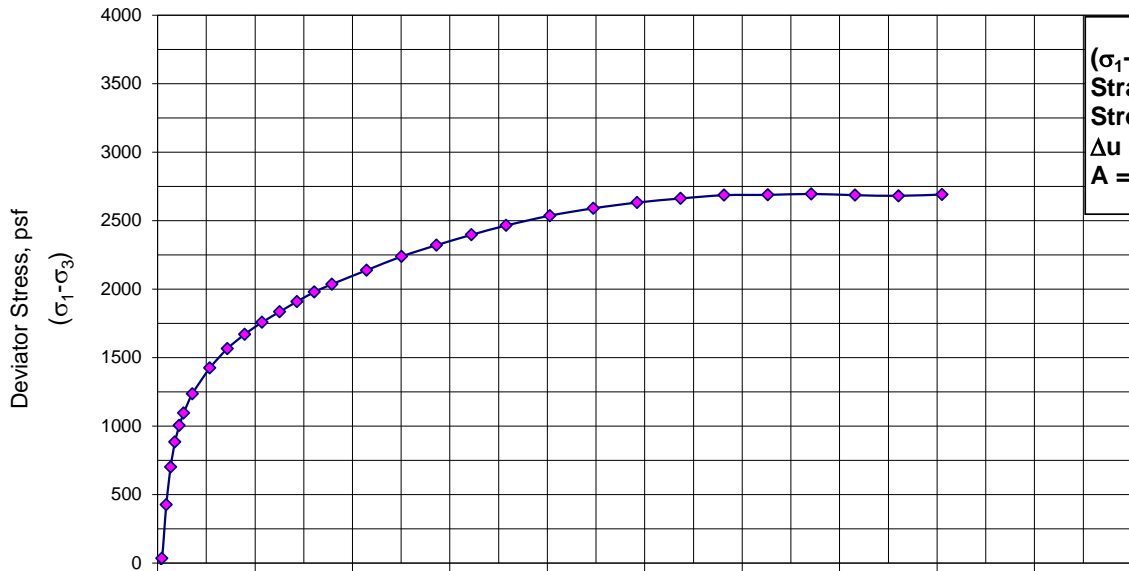
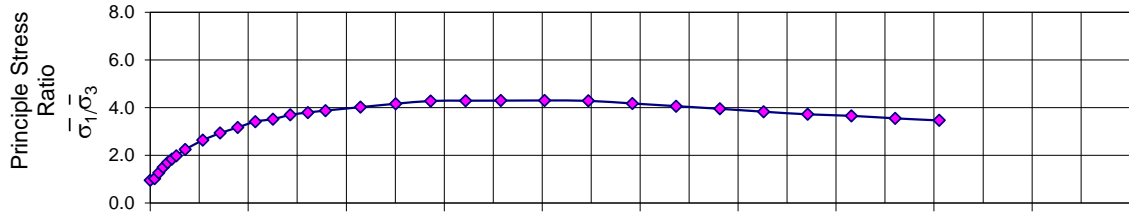
NRG Huntley Embankment Evaluation Tonawanda, NY TRIAXIAL COMPRESSION TESTS (CIU)	
BORING: B-11	FILE NO: 21.0056705.00
SAMPLE: ST-7	Date: 7/15/2014
DEPTH: 18.25-18.75	Tech.: AS
TEST NO: T 1.1	Reviewer: MBP

$(\sigma_1 - \sigma_3)$  (psf) = 2536  
 Strain % = 8.05  
 Stress Ratio = 4.30  
 $\Delta u = 1232.3$   
 $A = 0.47$

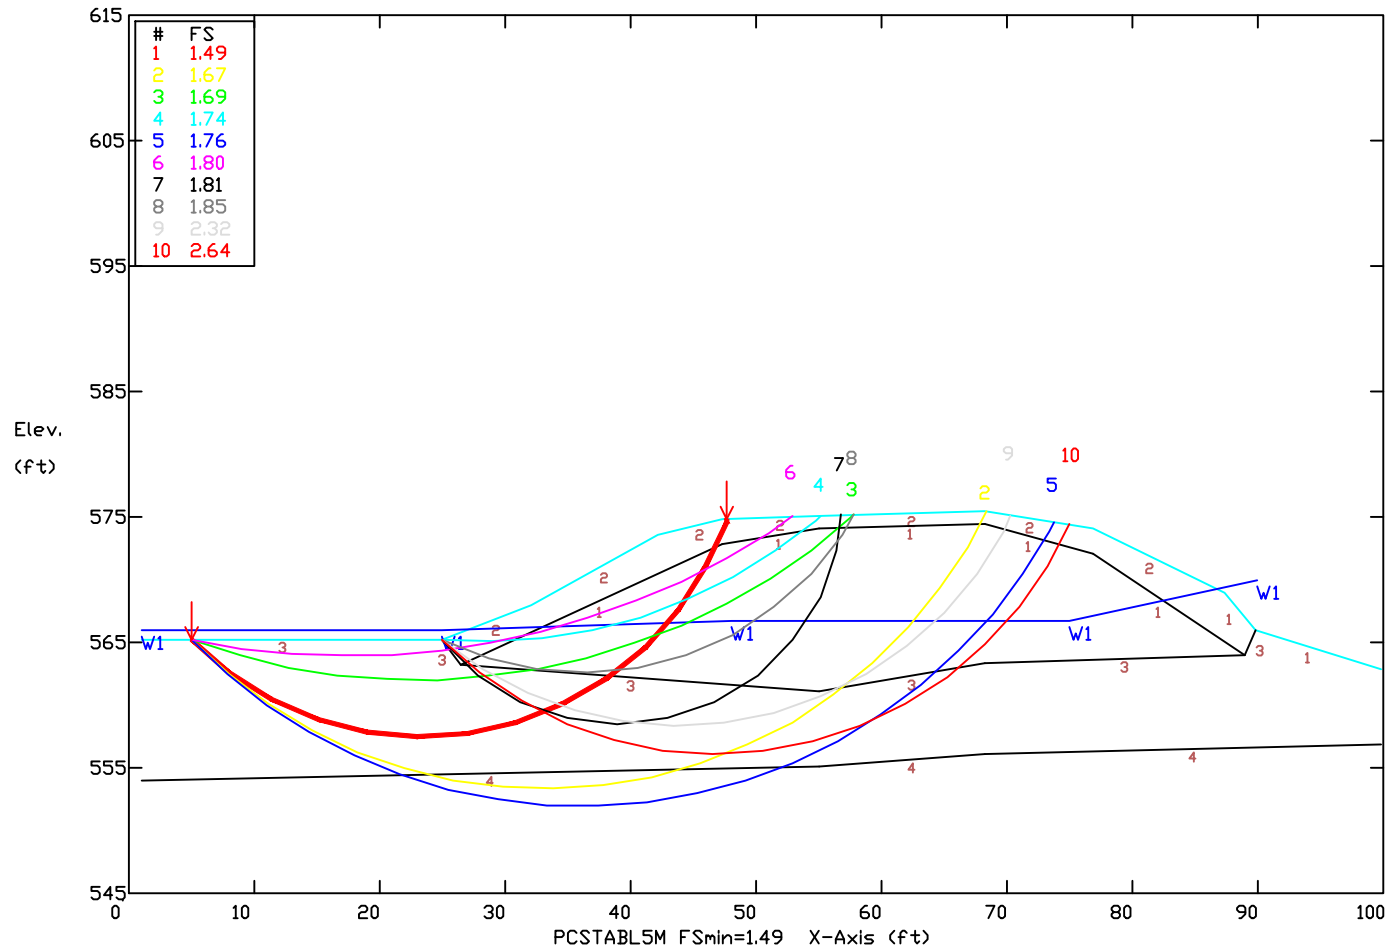
Ten Most Critical. C:\SPOND\DC.PL T By: GZA dtroy 10-03-14 2:59pm

Soil Type No.	Total Unit Wt. (pcf)	Saturated Unit Wt. (pcf)	Cohesion Intercept (psf)	Friction Angle (deg)	Pore Pressure Param.	Pressure Constant (psf)	Piez. Surface No.
1	128	130	0	30	0	0	1
2	140	140	0	40	0	0	0
3	120.5	124.5	0	25	0	0	1
4	126	130	0	19	0	0	1

As part of the previously completed Pond Embankment Evaluation report, a stability analysis was completed for the embankment in an effort to determine factors of safety for comparison to minimum EPA values for specific loading conditions (including normal pool, seismic conditions, rapid draw down and maximum pool (determined to be ½ PMF)) using the slope stability analysis program PCSTABL, Version 6 to provide an assessment of existing conditions at the Site. Additionally, soil parameters used in in the program were based on assumed soil index parameters that were based on soil test results and published values for similar soil types.

<b>Loading Condition</b>	<b>Calculated F.S.</b>	<b>EPA Minimum Required F.S.</b>
Circular Normal Pool (No Seismic)	1.5	1.5
Circular Normal Pool (W/ Seismic)	1.1	1.0
Block Normal Pool (No Seismic)	1.6	1.5
Block Normal Pool (W/ Seismic)	1.3	1.0
½ PMF	1.6	1.4
Rapid Draw Down	1.3	1.3

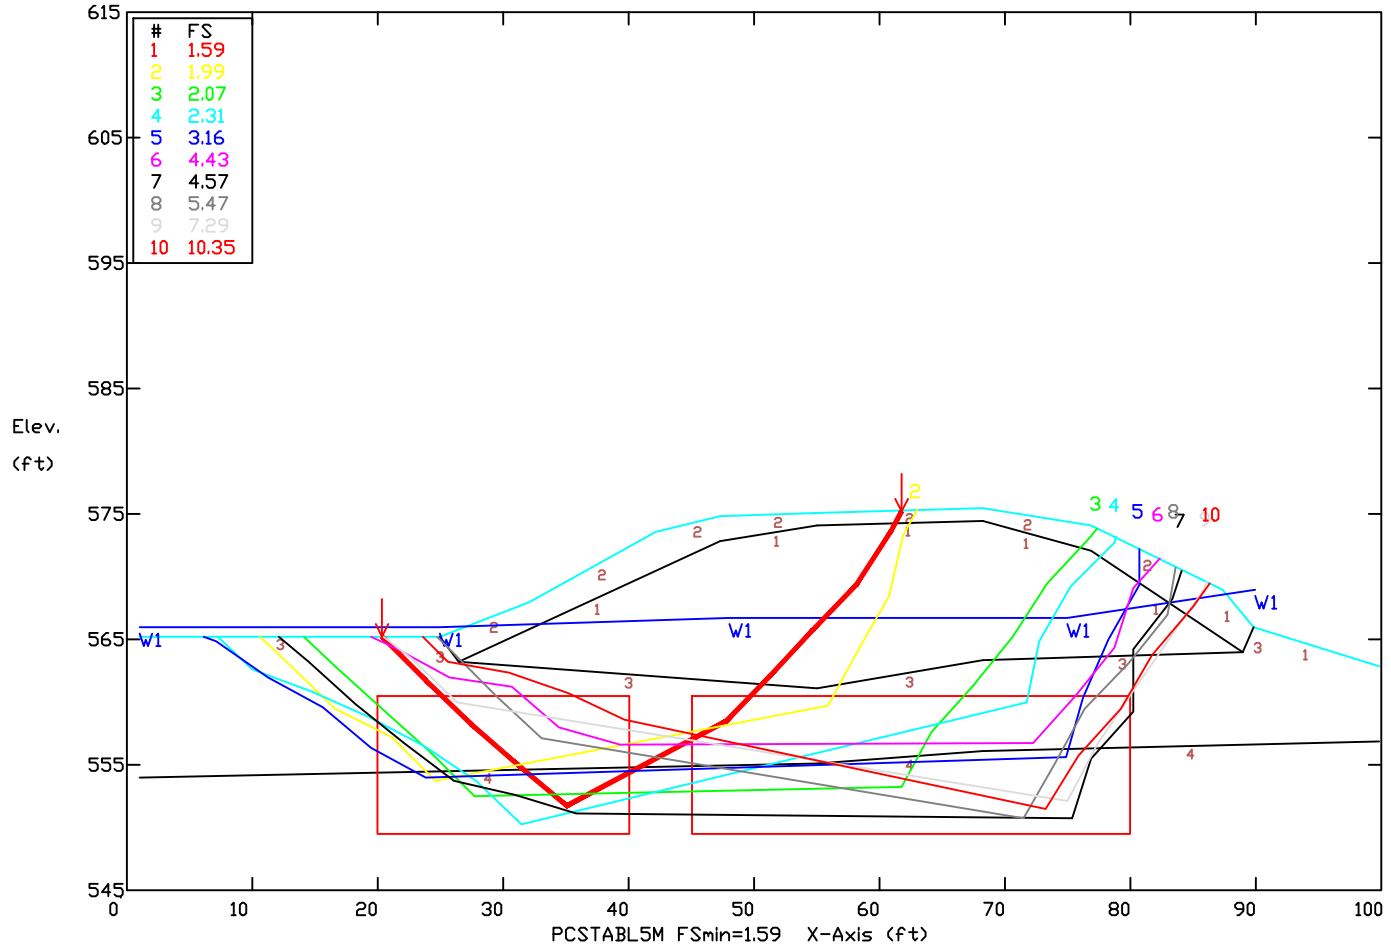
Ten Most Critical. C:\SPOND\B.PL T By: GZA dtroy 10-03-14 2:58pm

Soil Type No.	Total Unit Wt. (pcf)	Saturated Unit Wt. (pcf)	Cohesion Intercept (psf)	Friction Angle (deg)	Pore Pressure Param.	Pressure Constant (psf)	Piez. Surface No.
1	128	130	0	30	0	0	1
2	140	140	0	40	0	0	0
3	120.5	124.5	0	25	0	0	1
4	126	130	0	19	0	0	1

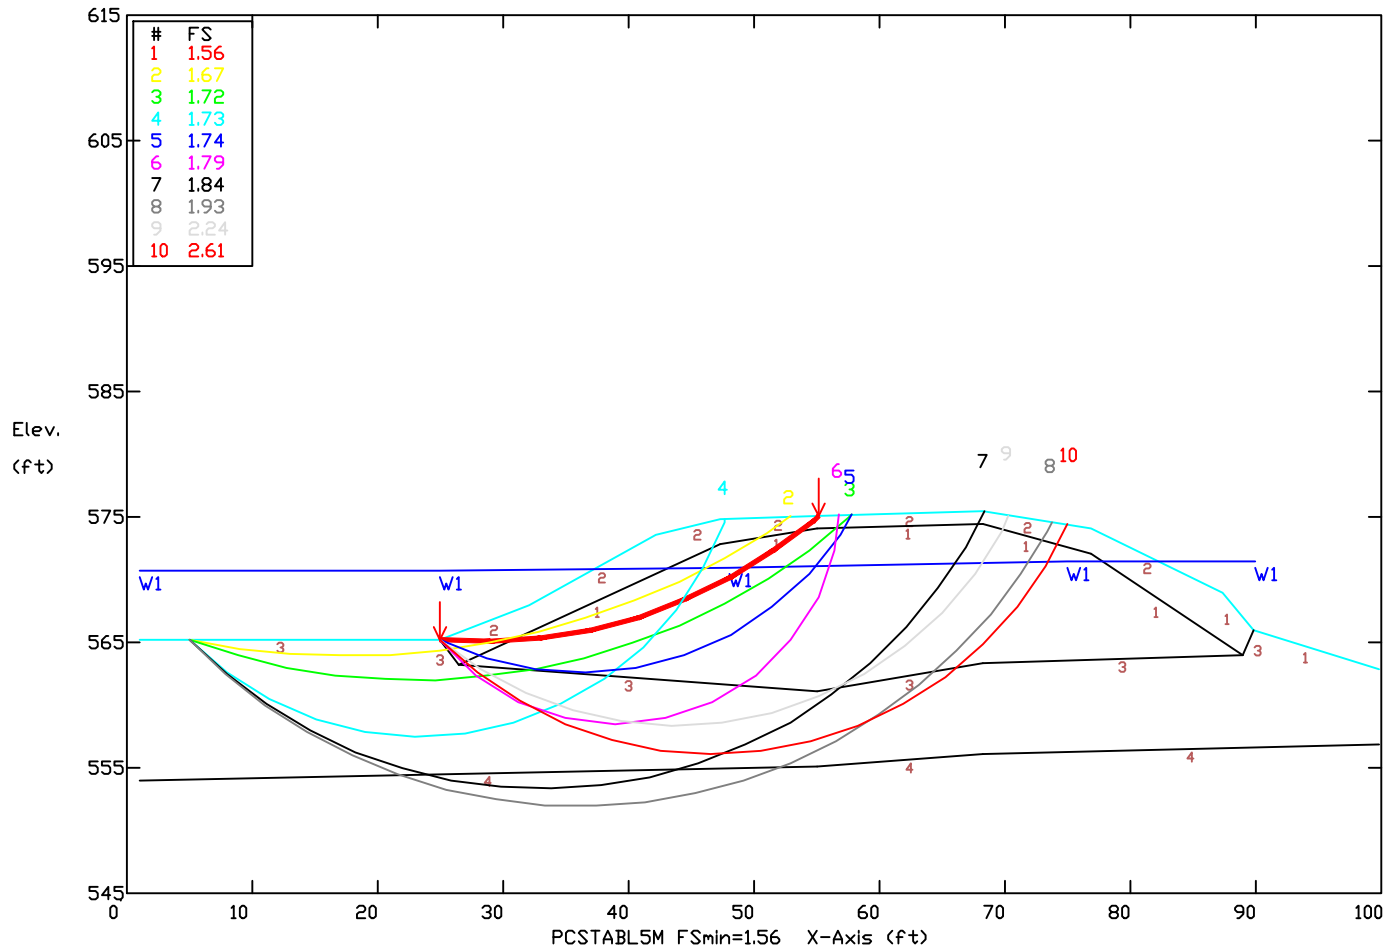
South Settling Pond 1/2 PMF NRG No Seismic  
 Ten Most Critical. C:SPCPMF.PLT By: GZA dtroy 10-03-14 2:57pm

Soil Type No.	Total Unit Wt. (pcf)	Saturated Unit Wt. (pcf)	Cohesion Intercept (psf)	Friction Angle (deg)	Pore Pressure Param.	Pressure Constant (psf)	Piez. Surface No.
1	128	130	0	30	0	0	1
2	140	140	0	40	0	0	1
3	120.5	124.5	0	25	0	0	1
4	126	130	0	19	0	0	1

A water level during normal conditions was assumed to range in elevation from about el. 566± (river elevation) to el. 570± (pond elevation) feet. The Pond elevation for ½ PMF was determined to be about el. 571.4± feet and the Niagara River elevation for the 500-year storm was determined to be el. 570.65 ft. The following factors of safety were calculated for specified loading conditions and compared to the EPA minimum required factors of safety.

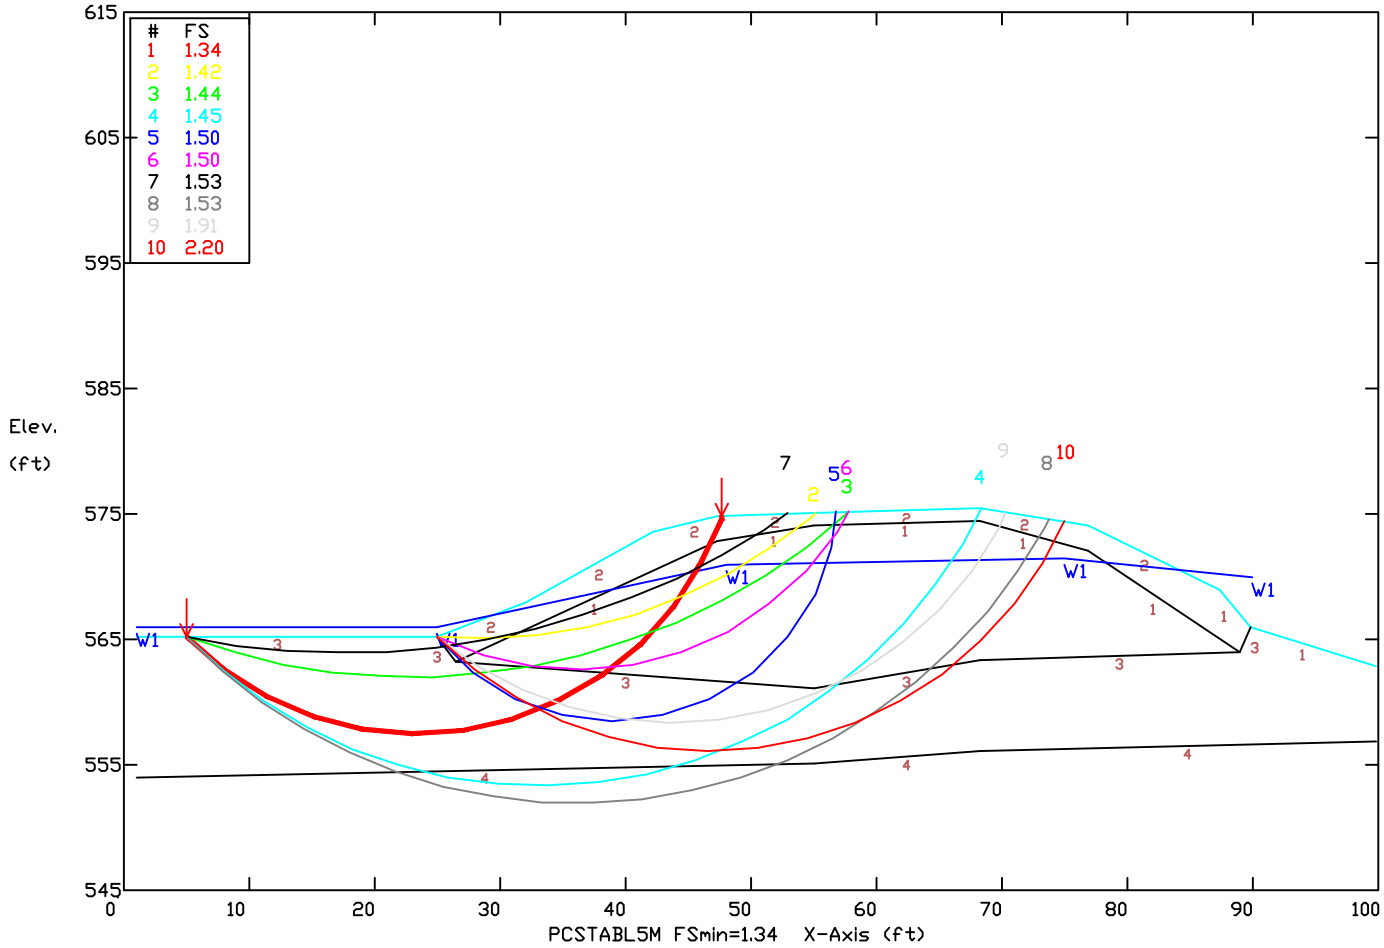
South Settling Pond RAPID DRAWDOWN NRG No Seismic  
 Ten Most Critical. C:SPCRDD.PLT By: GZA dtroy 10-03-14 2:58pm

Soil Type No.	Total Unit Wt. (pcf)	Saturated Unit Wt. (pcf)	Cohesion Intercept (psf)	Friction Angle (deg)	Pore Pressure Param.	Pressure Constant (psf)	Piez. Surface No.
1	128	130	0	30	0	0	1
2	140	140	0	40	0	0	1
3	120.5	124.5	0	25	0	0	1
4	126	130	0	19	0	0	1
