Landfill

(Unit 004)

Location Restrictions Demonstration

**Limestone Electric Generating Station
Jewett, Texas**

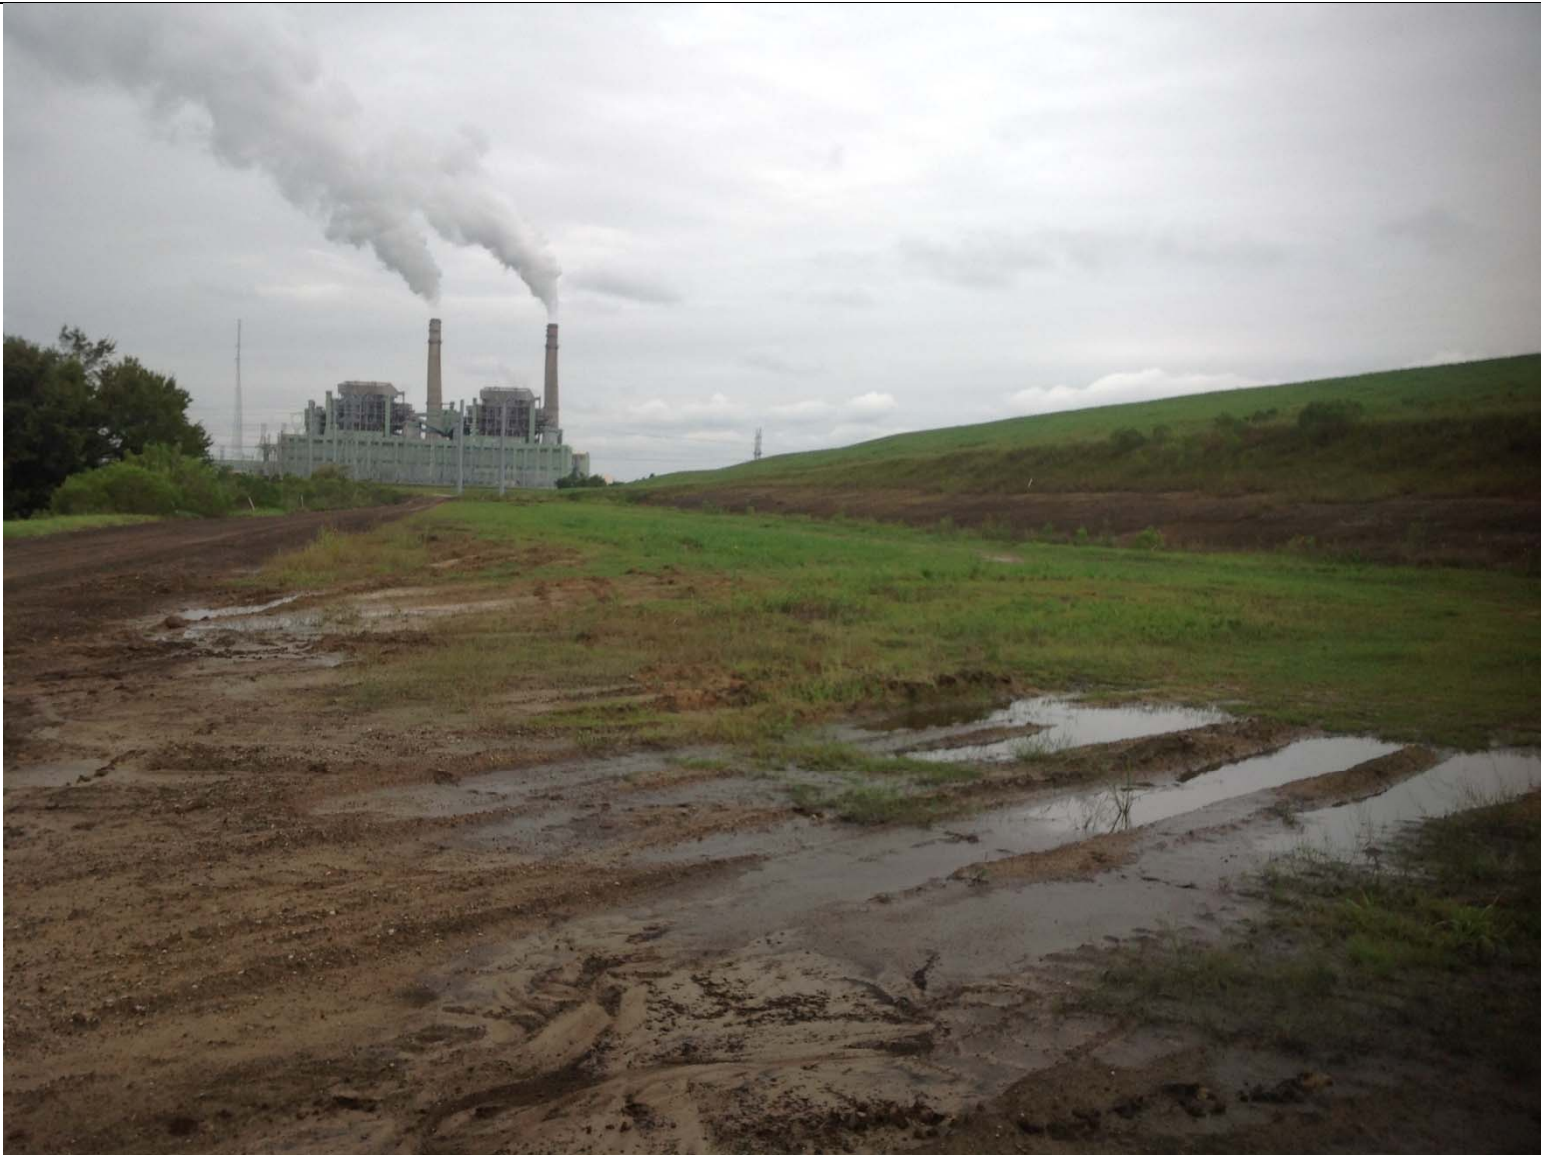
Location: S Side of Landfill CCR Unit 004 Facing W

Pollutant Discharge Elimination System (TPDES) Outfall 002. A large drainage swale runs along the toe of the south side berm, which collects most of the runoff from the active areas and then drains into Pond 002. This swale has eroded the vegetation from the bottom one-fourth of the berm near the transition between the completed landfill and the active area. In this eroded area, some seepage and erosion were observed. Because this area is in the transition between completed and active areas, the erosion and seepage observed do not represent an unstable feature.

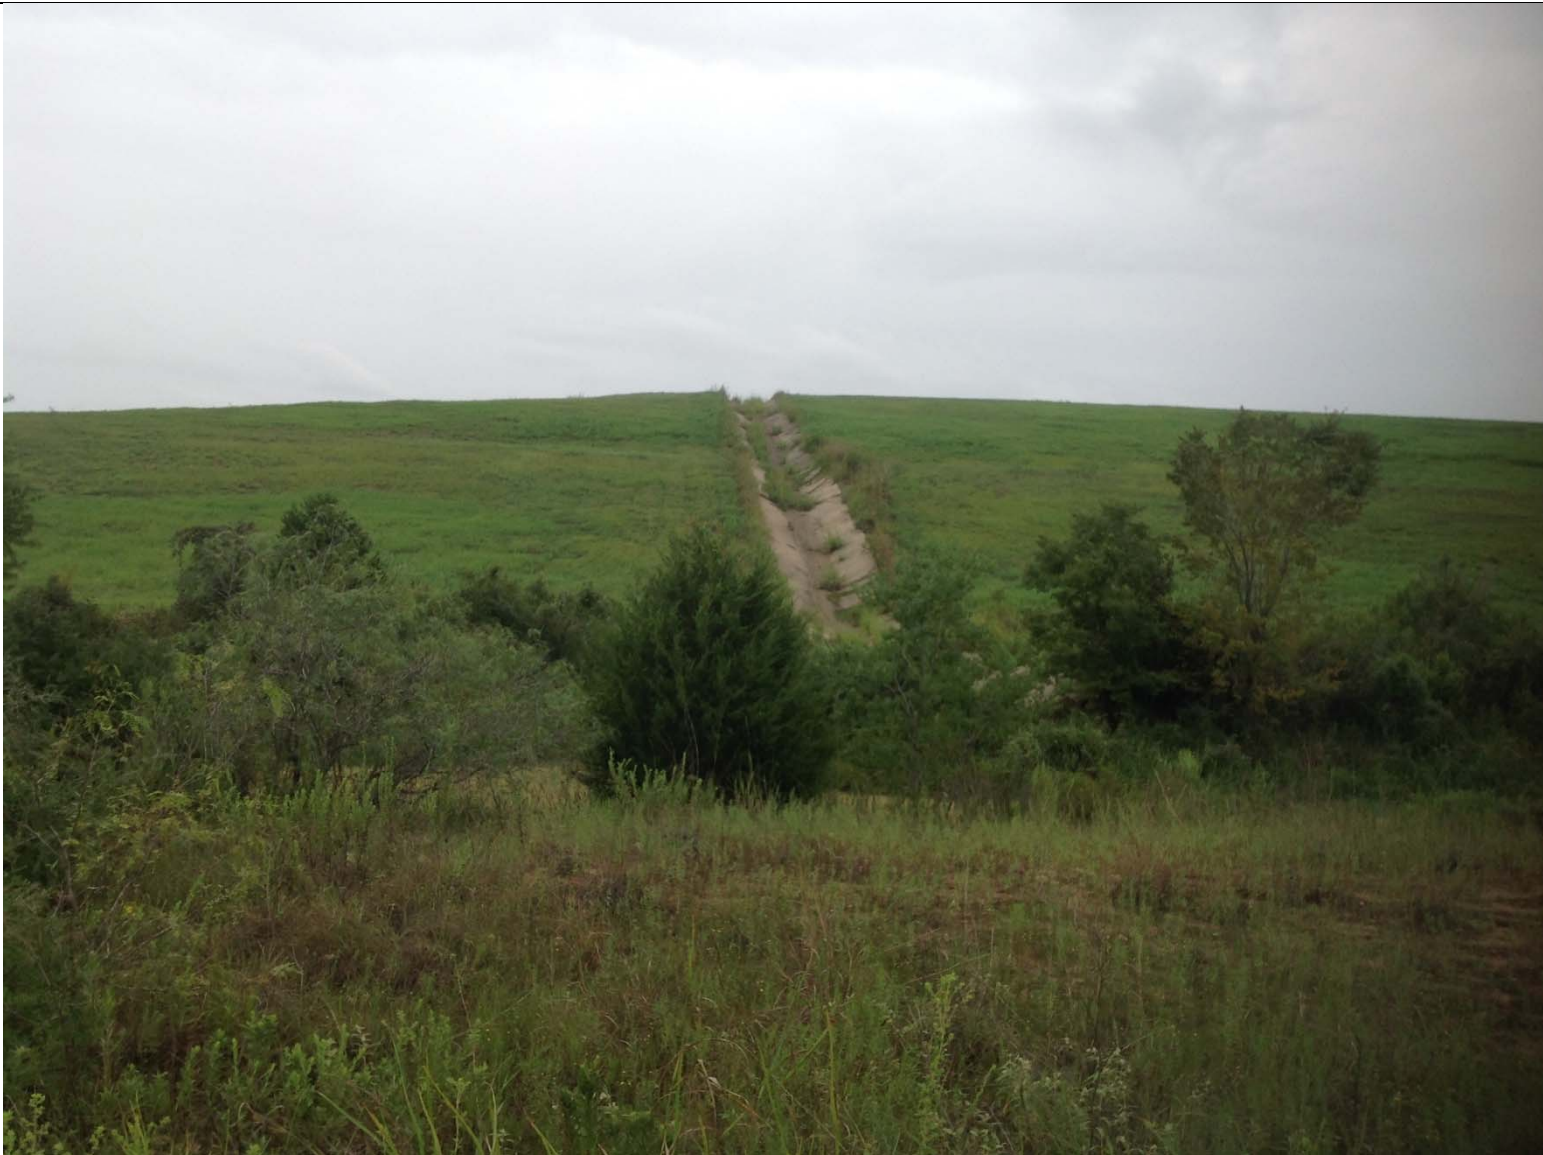
Location: N Side of Landfill CCR Unit 004 Facing S – drainage channel

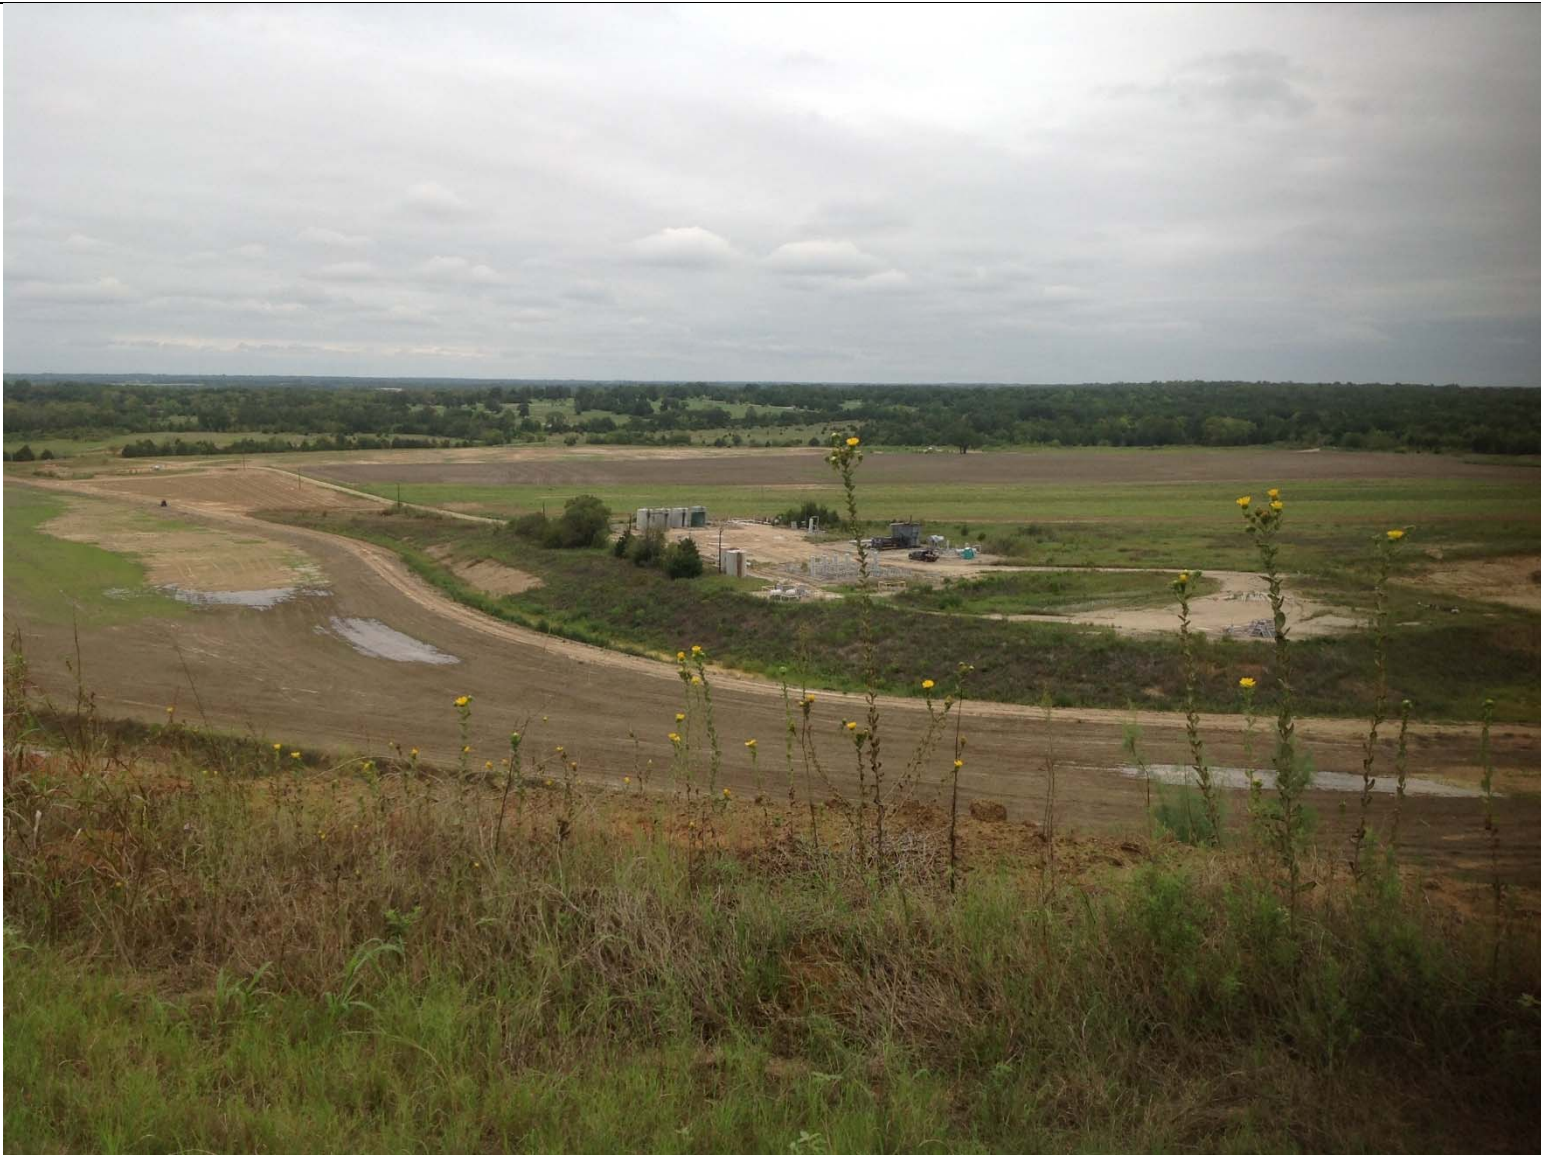
There is an active natural gas well along with associated compression equipment located in the center of the landfill, in the unused area 13. According to NRG representatives, the landfill will be built around the gas well pad. A narrow area between the gas pad and the completed landfill has been prepared to receive waste but has not yet been used. Aside from the well, no unstable areas were observed at the Landfill (Unit 004) area.

Location: E Side of Landfill CCR Unit 004 Facing NE – shows well pad
