Letter No. 12661-181-SL-IEPA-0004

Re: Analytical Test Results for Existing Bypass Basin Liner

Bypass Basin Liner Sample Locations

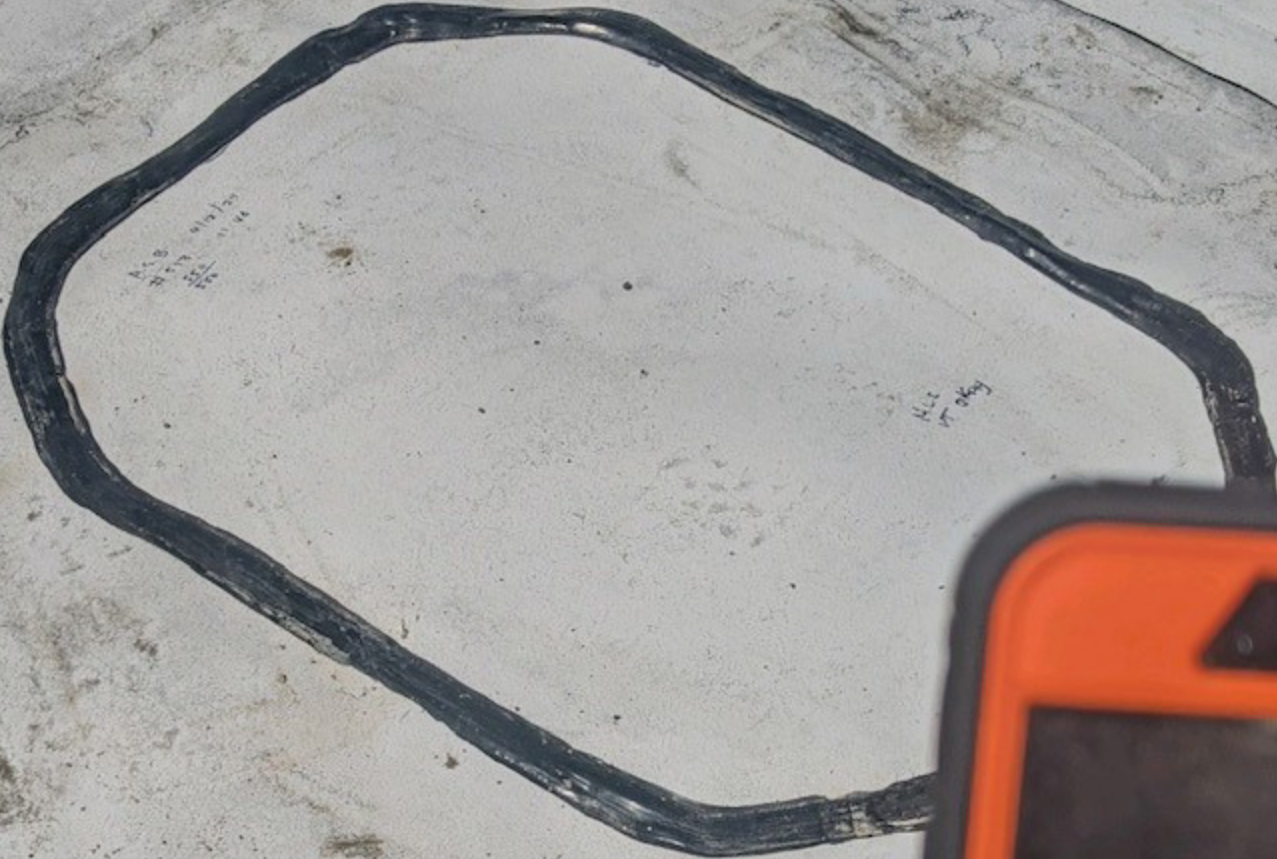
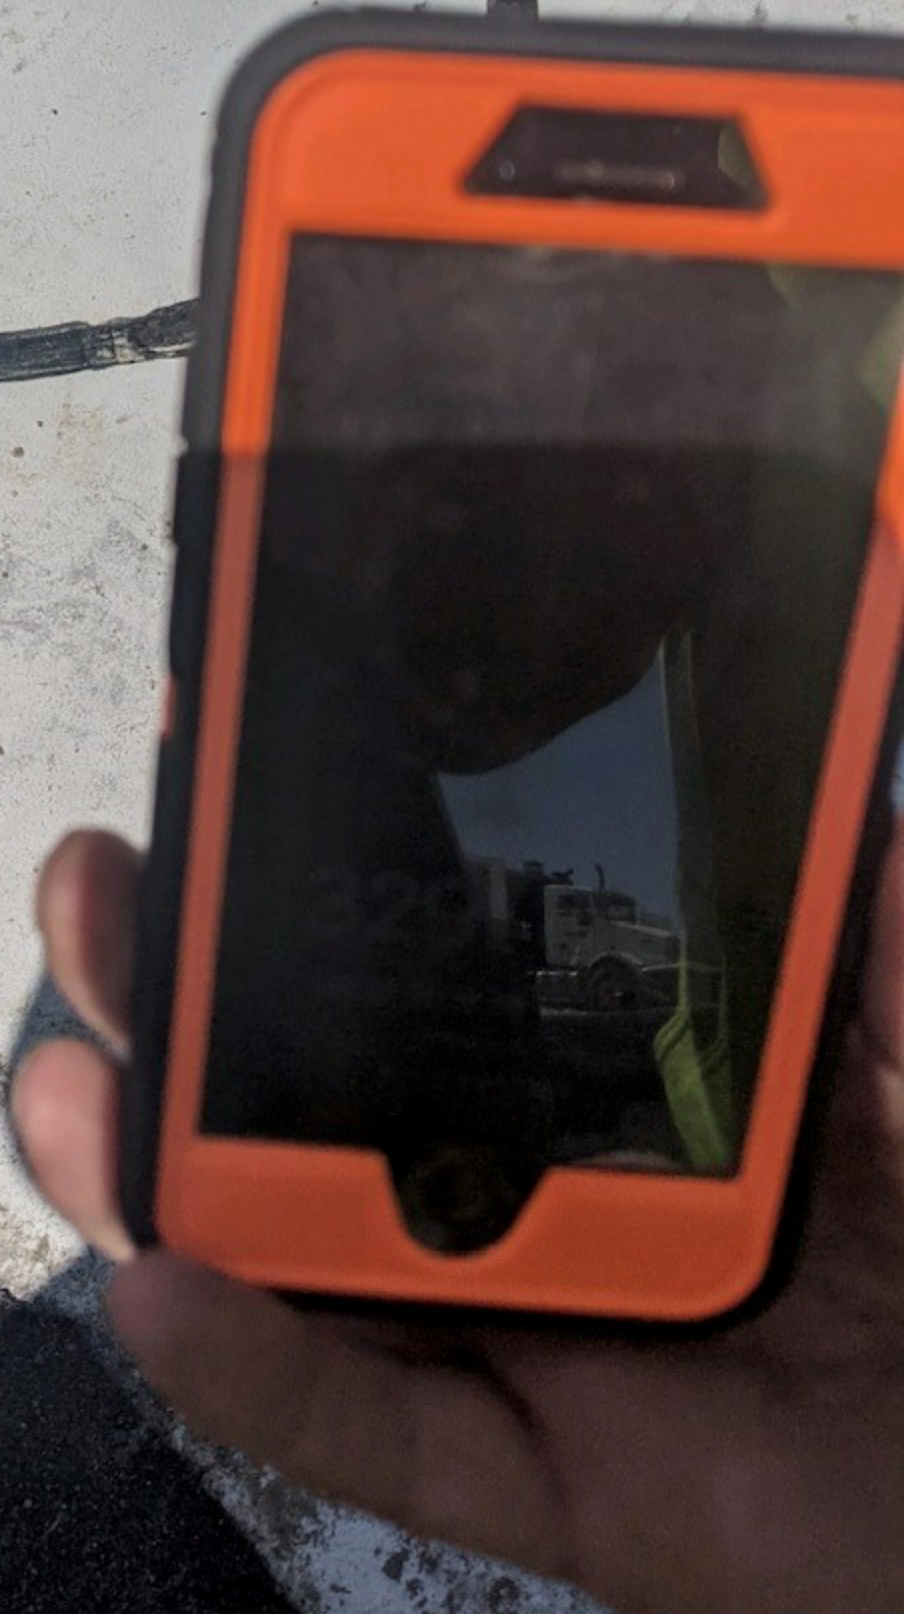
SAMPLE SP-1

On April 12, 2024, Station personnel collected three samples of the Bypass Basin's existing geomembrane liner that had been cleaned. As shown on the enclosed map, one sample was taken from the basin's west sideslope, and two samples were taken from the basin floor: one near the outlet structure and one near the inlet structure. Each sample was approximately 18-inches square, and each sample location was patched with 60-mil HDPE geomembrane fusion-welded to the existing geomembrane liner. The enclosed photographs show the three sample locations and the patches that were installed over these locations.
