Solid Waste Disposal Area Landfill

**(Landfill Cell 3, Landfill Cell 2A,
Landfill Cell 1C, Landfill Cell 2B)**

Location Restrictions Demonstration

**W.A. Parish Electric Generating Station
Thompsons, Texas**

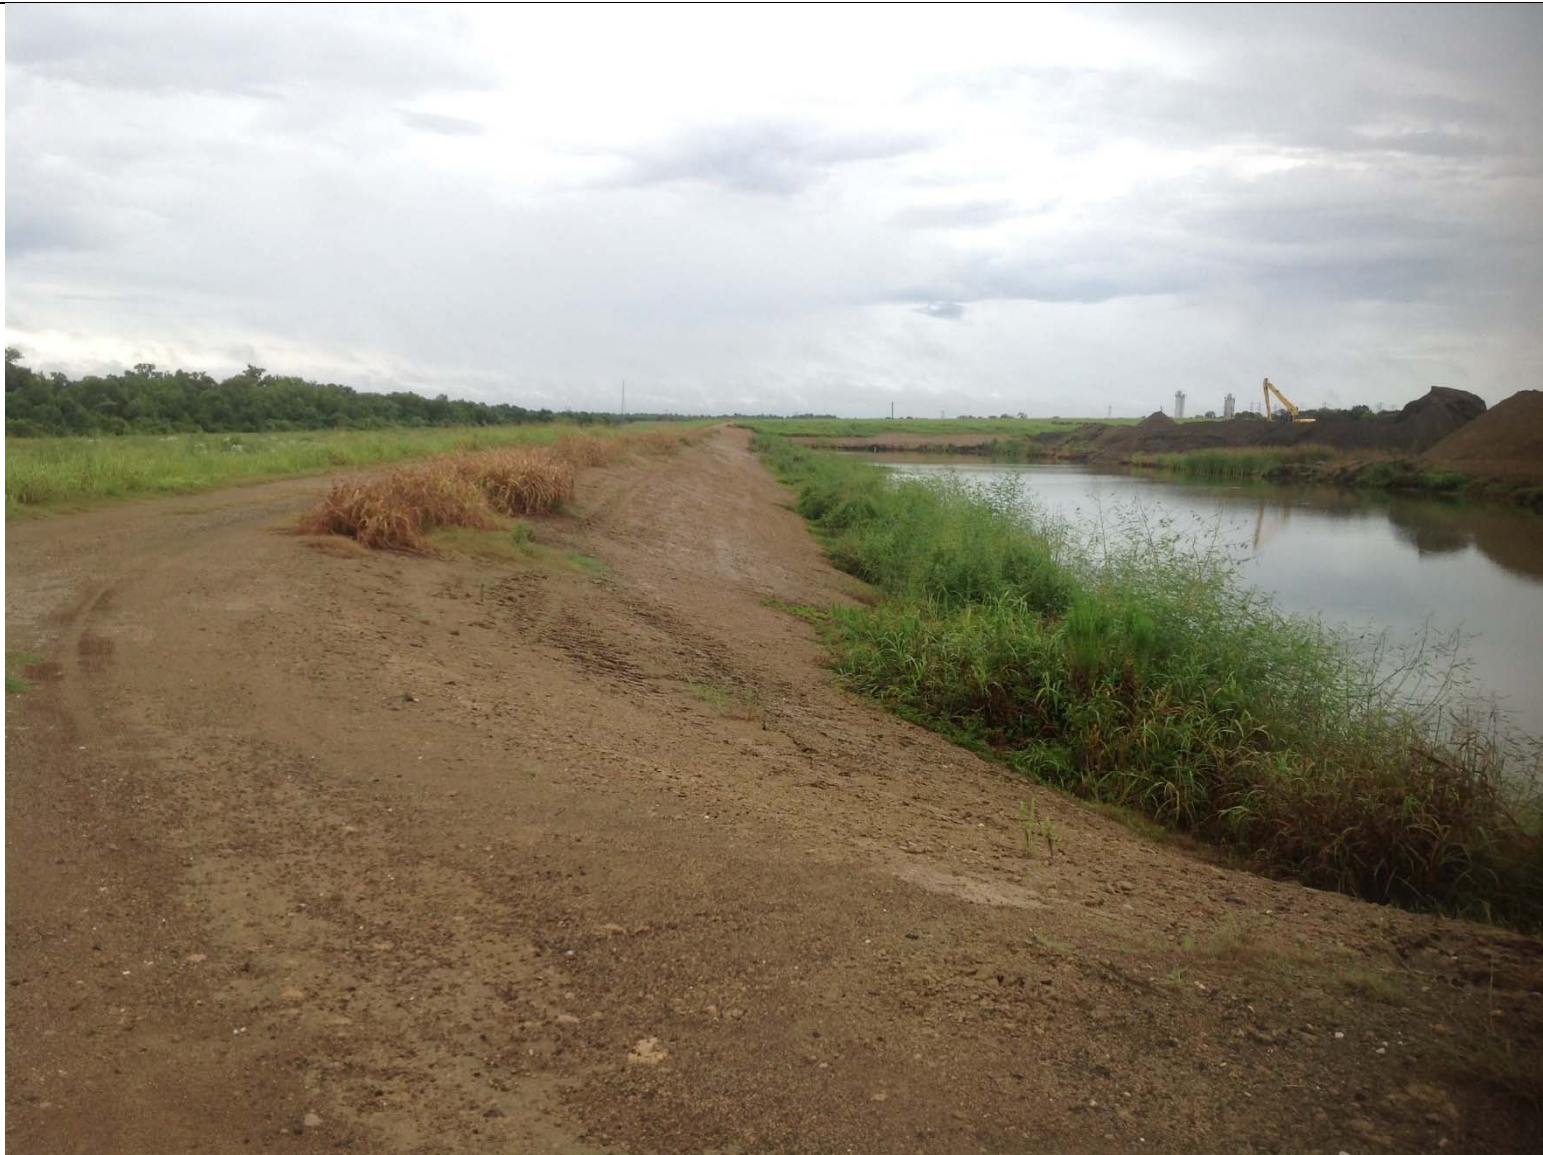
Location: SW Corner Side Cell 3 Landfill facing N

The berm around Cell 3 is flat and even, with even side slopes and no visual evidence of erosion, bulging, or settlement. The exterior of the berm is heavily vegetated and the toe of the

berm was not accessible during the inspection. The interior of the berm on the west side of the cell lacked vegetation and appeared to have been recently re-graded due to the presence of equipment tracks in the soil.

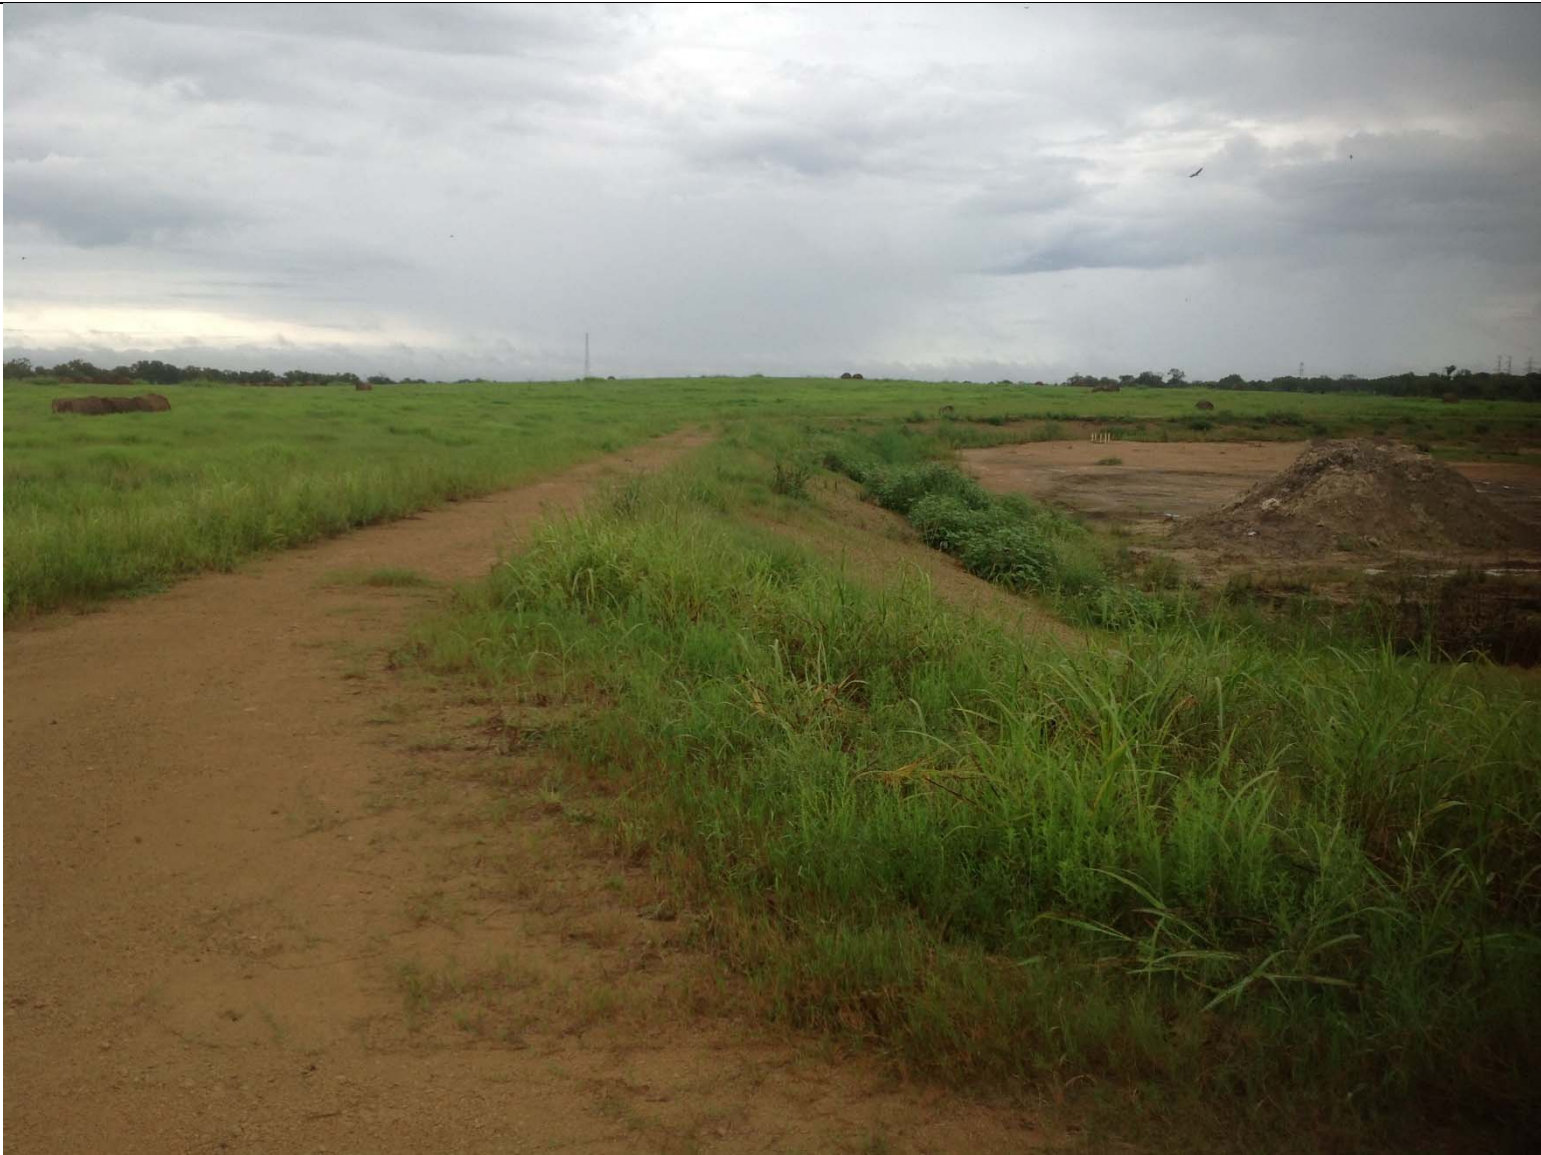
Location: SW Corner Cell 2a Pug Mill Area facing N

The cell is surrounded on three sides by a well-defined berm. The berms on the south, west, and north sides are flat, smooth and even. Both sides of the berm are moderately vegetated. No areas of bulging, erosion or settlement, and no seeps were observed during the inspection. A higher density of vegetation was present around the interior toe of the berm, preventing visual inspection.

The east side of the cell had a much lower perimeter (about five feet). An access road connects the cell to Cortez Road north of the midpoint of the east side of the cell. Based on visual inspection, it did not appear that there was a high point or peak where this access road crosses the perimeter of the cell, rather a consistent slope from the interior of the cell to Cortez Road. There was no active drainage occurring, even though it had rained less than eight hours before the inspection.

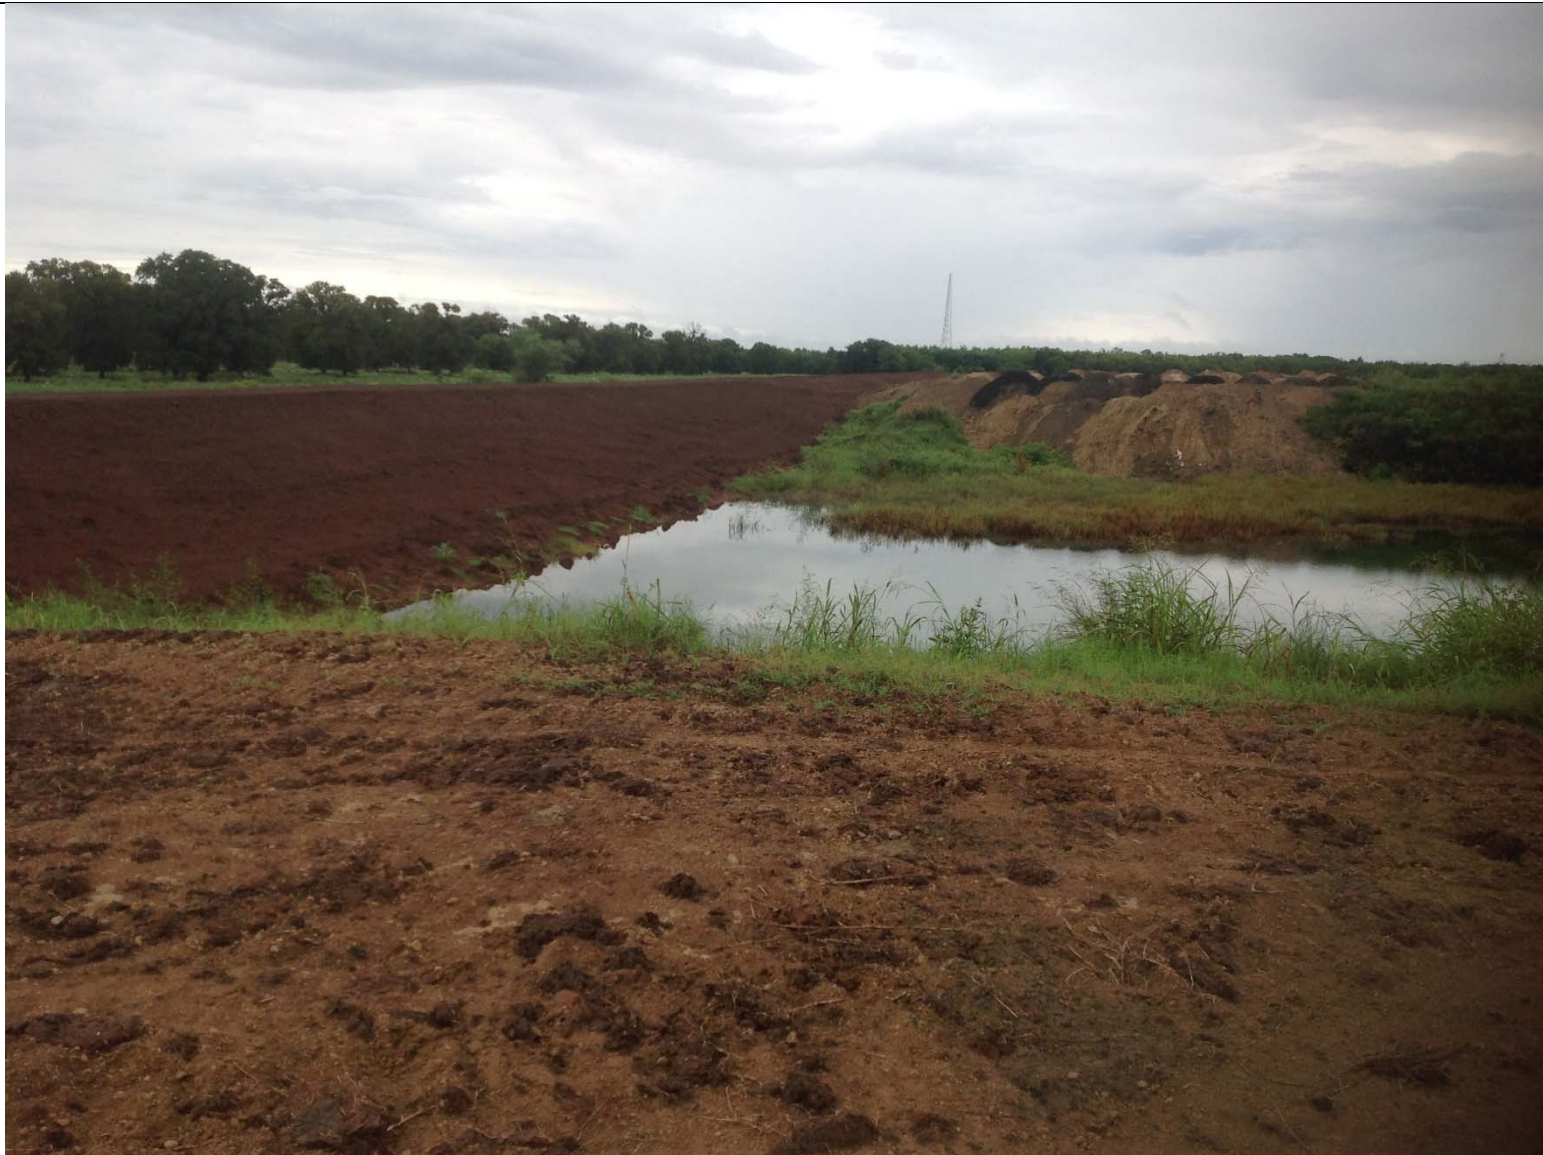
Location: SW Corner Side Cell 1c Landfill facing N

The berms are flat and even, with no bulging, settlement, or erosion. The west berm is not yet vegetated, but the berms along the south and east are heavily vegetated.

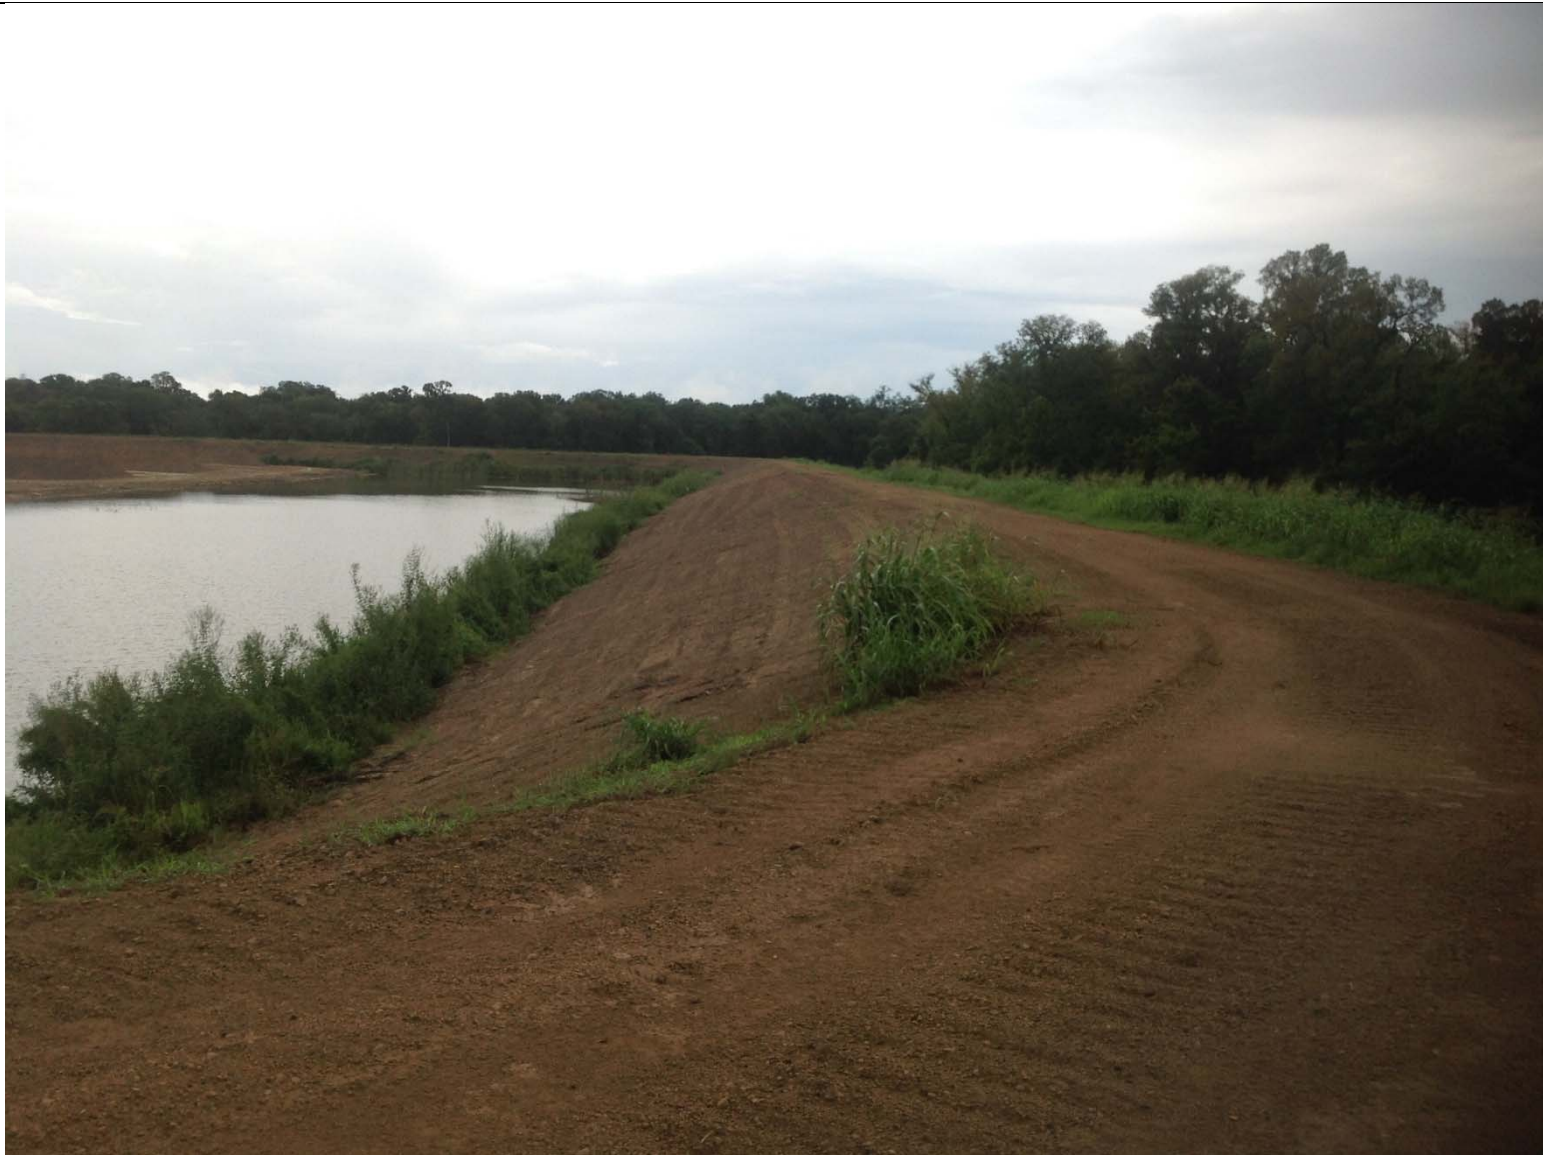
Location: SW Corner of Cell 2b Landfill Facing E

Cell 2B is located east of Cortez Road and east of Cell 1C. Cell 2B was constructed in 2012 and appears to have been recently re-graded along the south and east berms due to lack of vegetation and presence of equipment tracks.

The berms on all four sides of Cell 2B are flat, smooth and even with no areas of bulging, erosion, or settlement. The berms on the west, south and north are regular in shape. It appears that excavated material from the impoundment was placed in a pile that runs along the north berm. The exterior of the berms on all sides is heavily vegetated and not readily accessible for visual inspection.
