**STRUCTURAL STABILITY AND FACTOR OF SAFETY ASSESSMENT
EAST AND WEST ASH BASINS
WAUKEGAN STATION
OCTOBER 2016**

This report presents the initial periodic structural stability and initial safety factor assessment of the East and West Ash Basins (the Basins) at the Waukegan Station (Site) in Waukegan, Illinois (Figure 1). This report addresses the initial structural stability and safety factor assessment requirements of the Coal Combustion Residuals (CCR) regulations, Code of Federal Regulations Title 40, Part 257, Subpart D (referred to as the CCR Rule). These regulations were published in the Federal Register on 17 April 2015 and became effective on 19 October 2015. The Waukegan Station is owned and operated by Midwest Generation, LLC (Midwest Generation). Based on the results provided in this report, the East and West Ash Ponds meet the requirements of §257.73(d) and §257.73(e) of the CCR Rule.

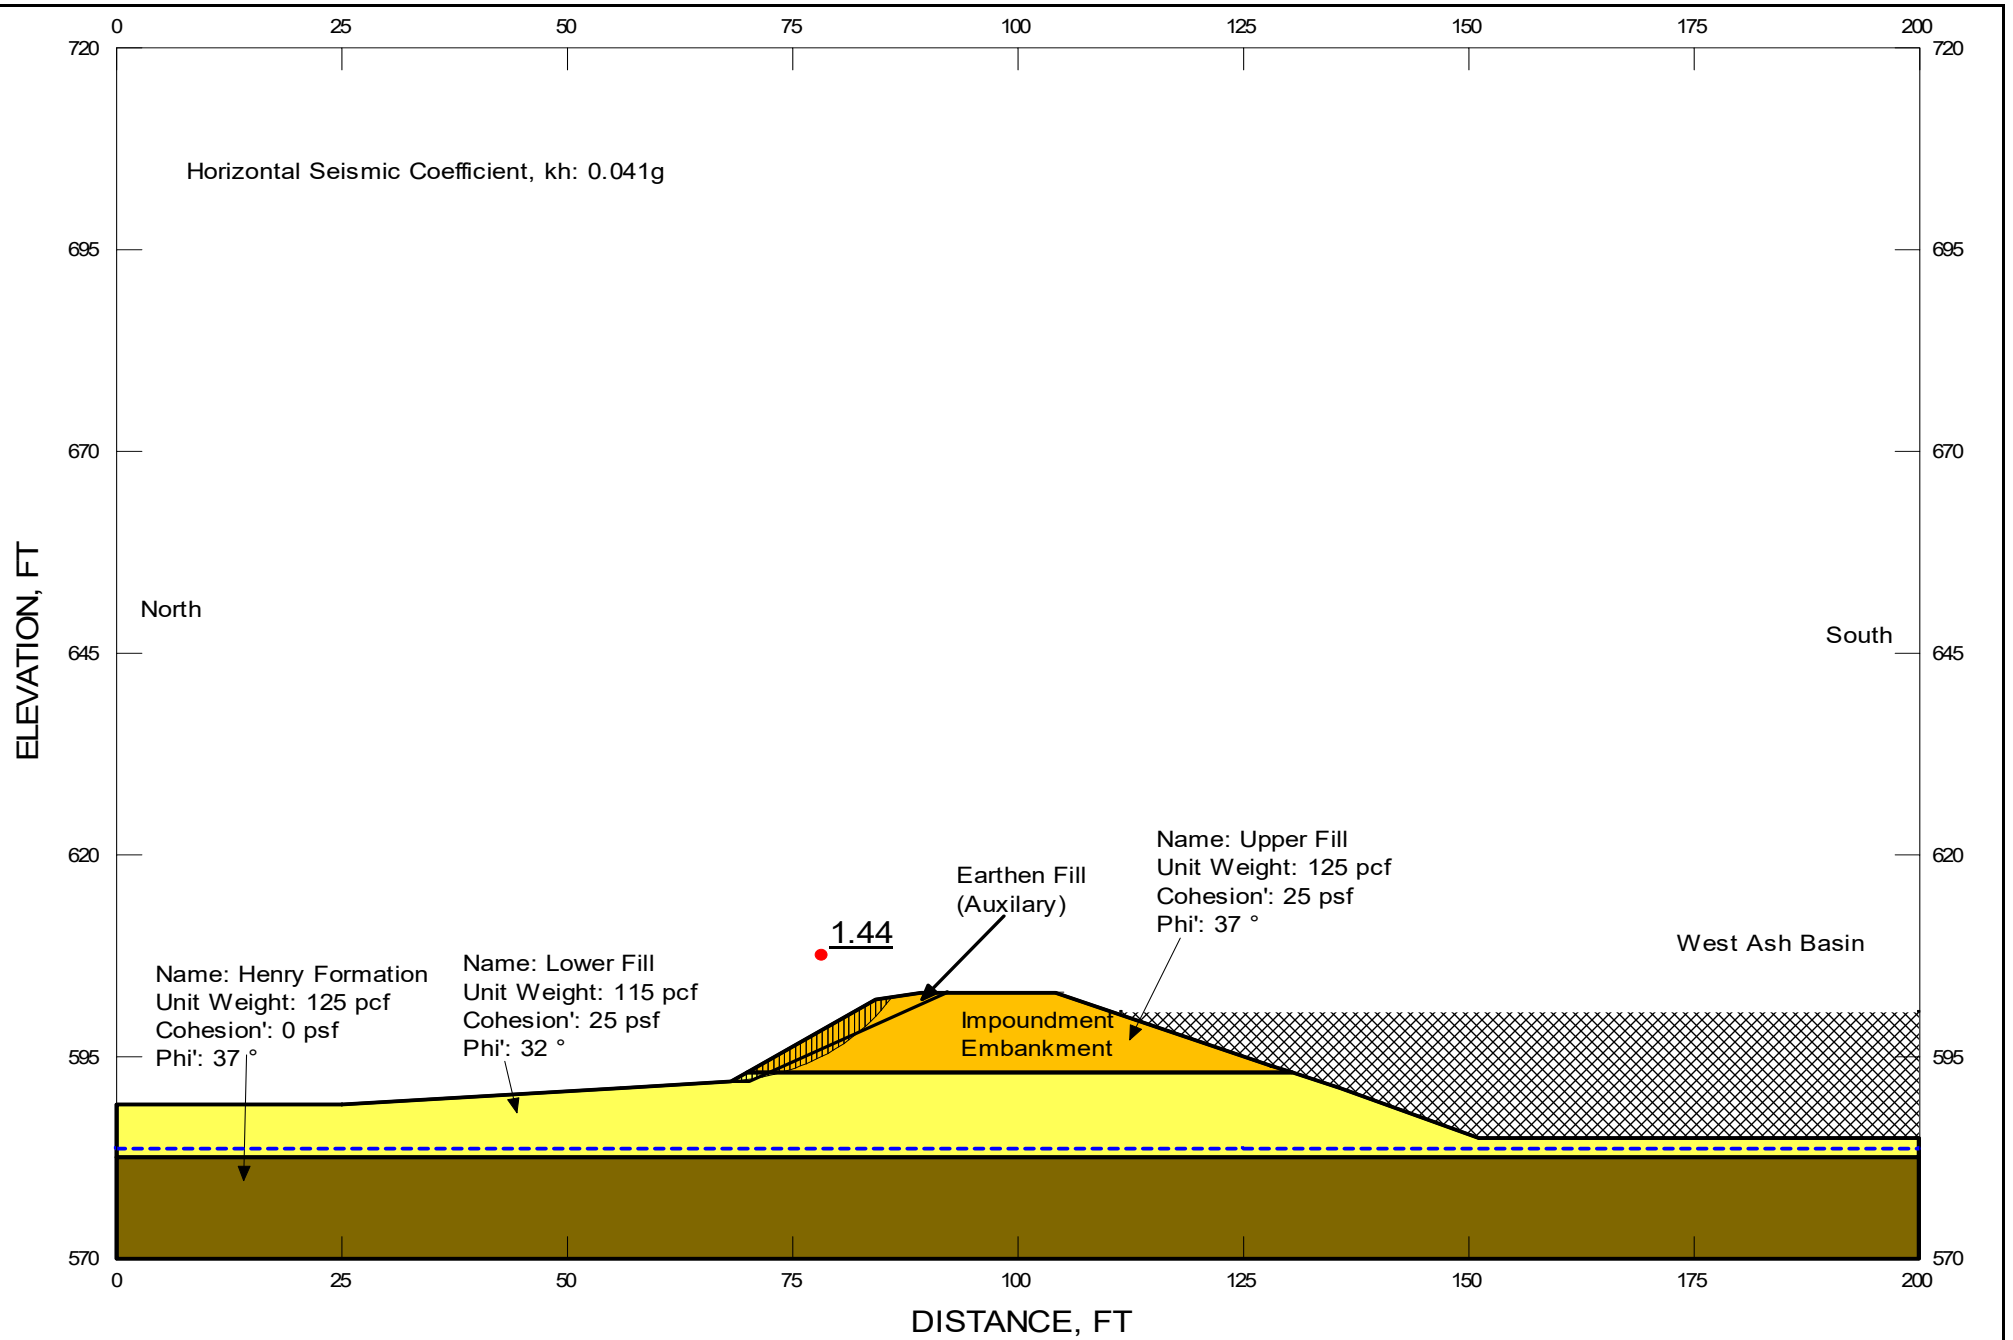
Figure 6 – Slope Stability Output, Section 1 - 257.73(e)(1)(iii)

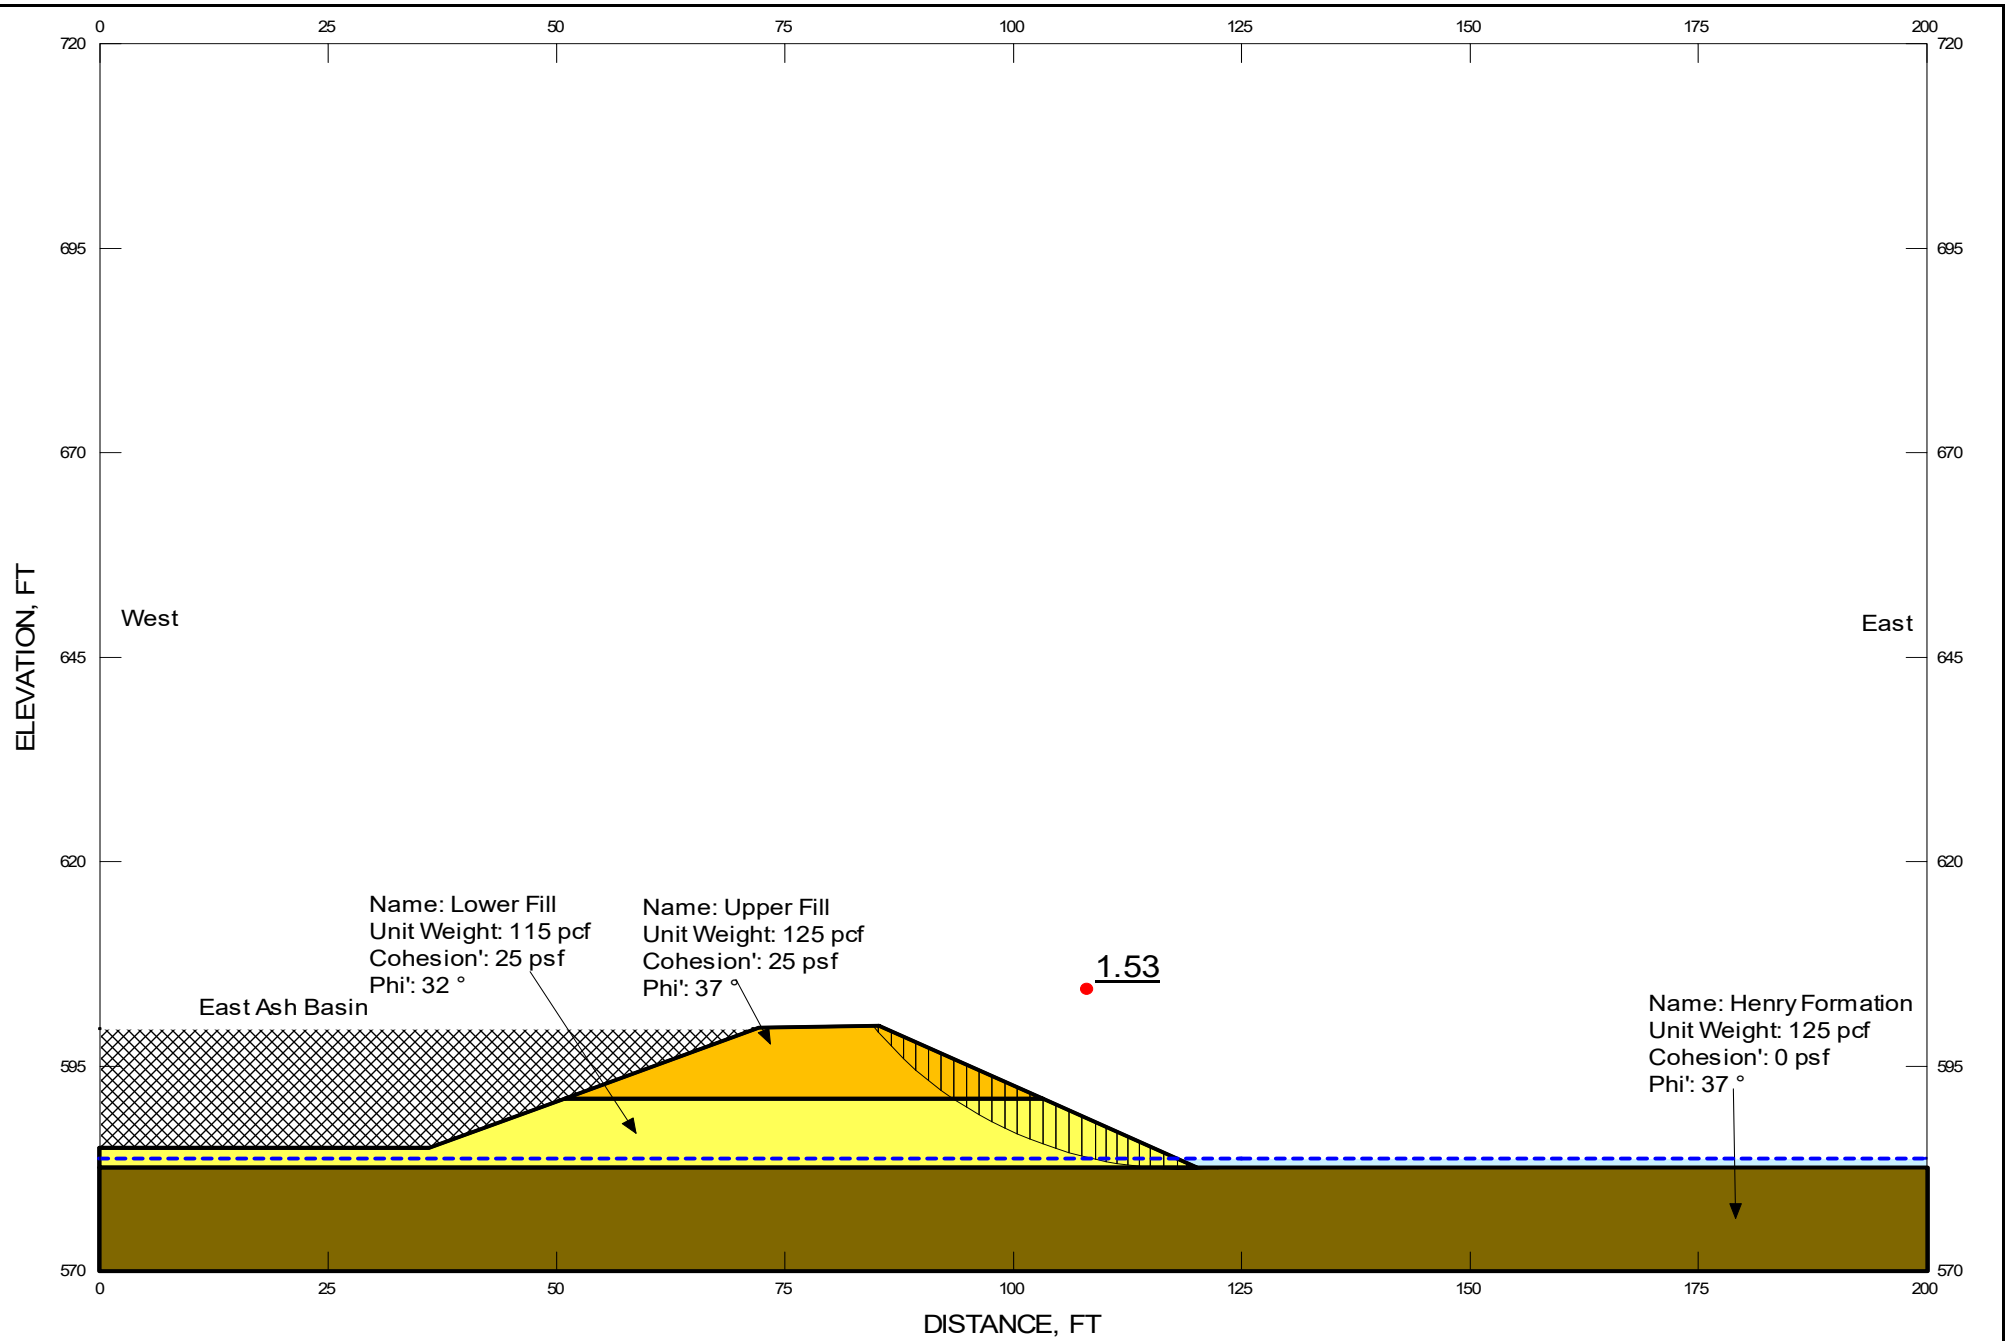
Figure 8 – Slope Stability Output, Section 2 - 257.73(e)(1)(ii)

| Analysis | Section 2 - §257.73(e)(1)(ii): Maximum Surcharge Pool Loading | |

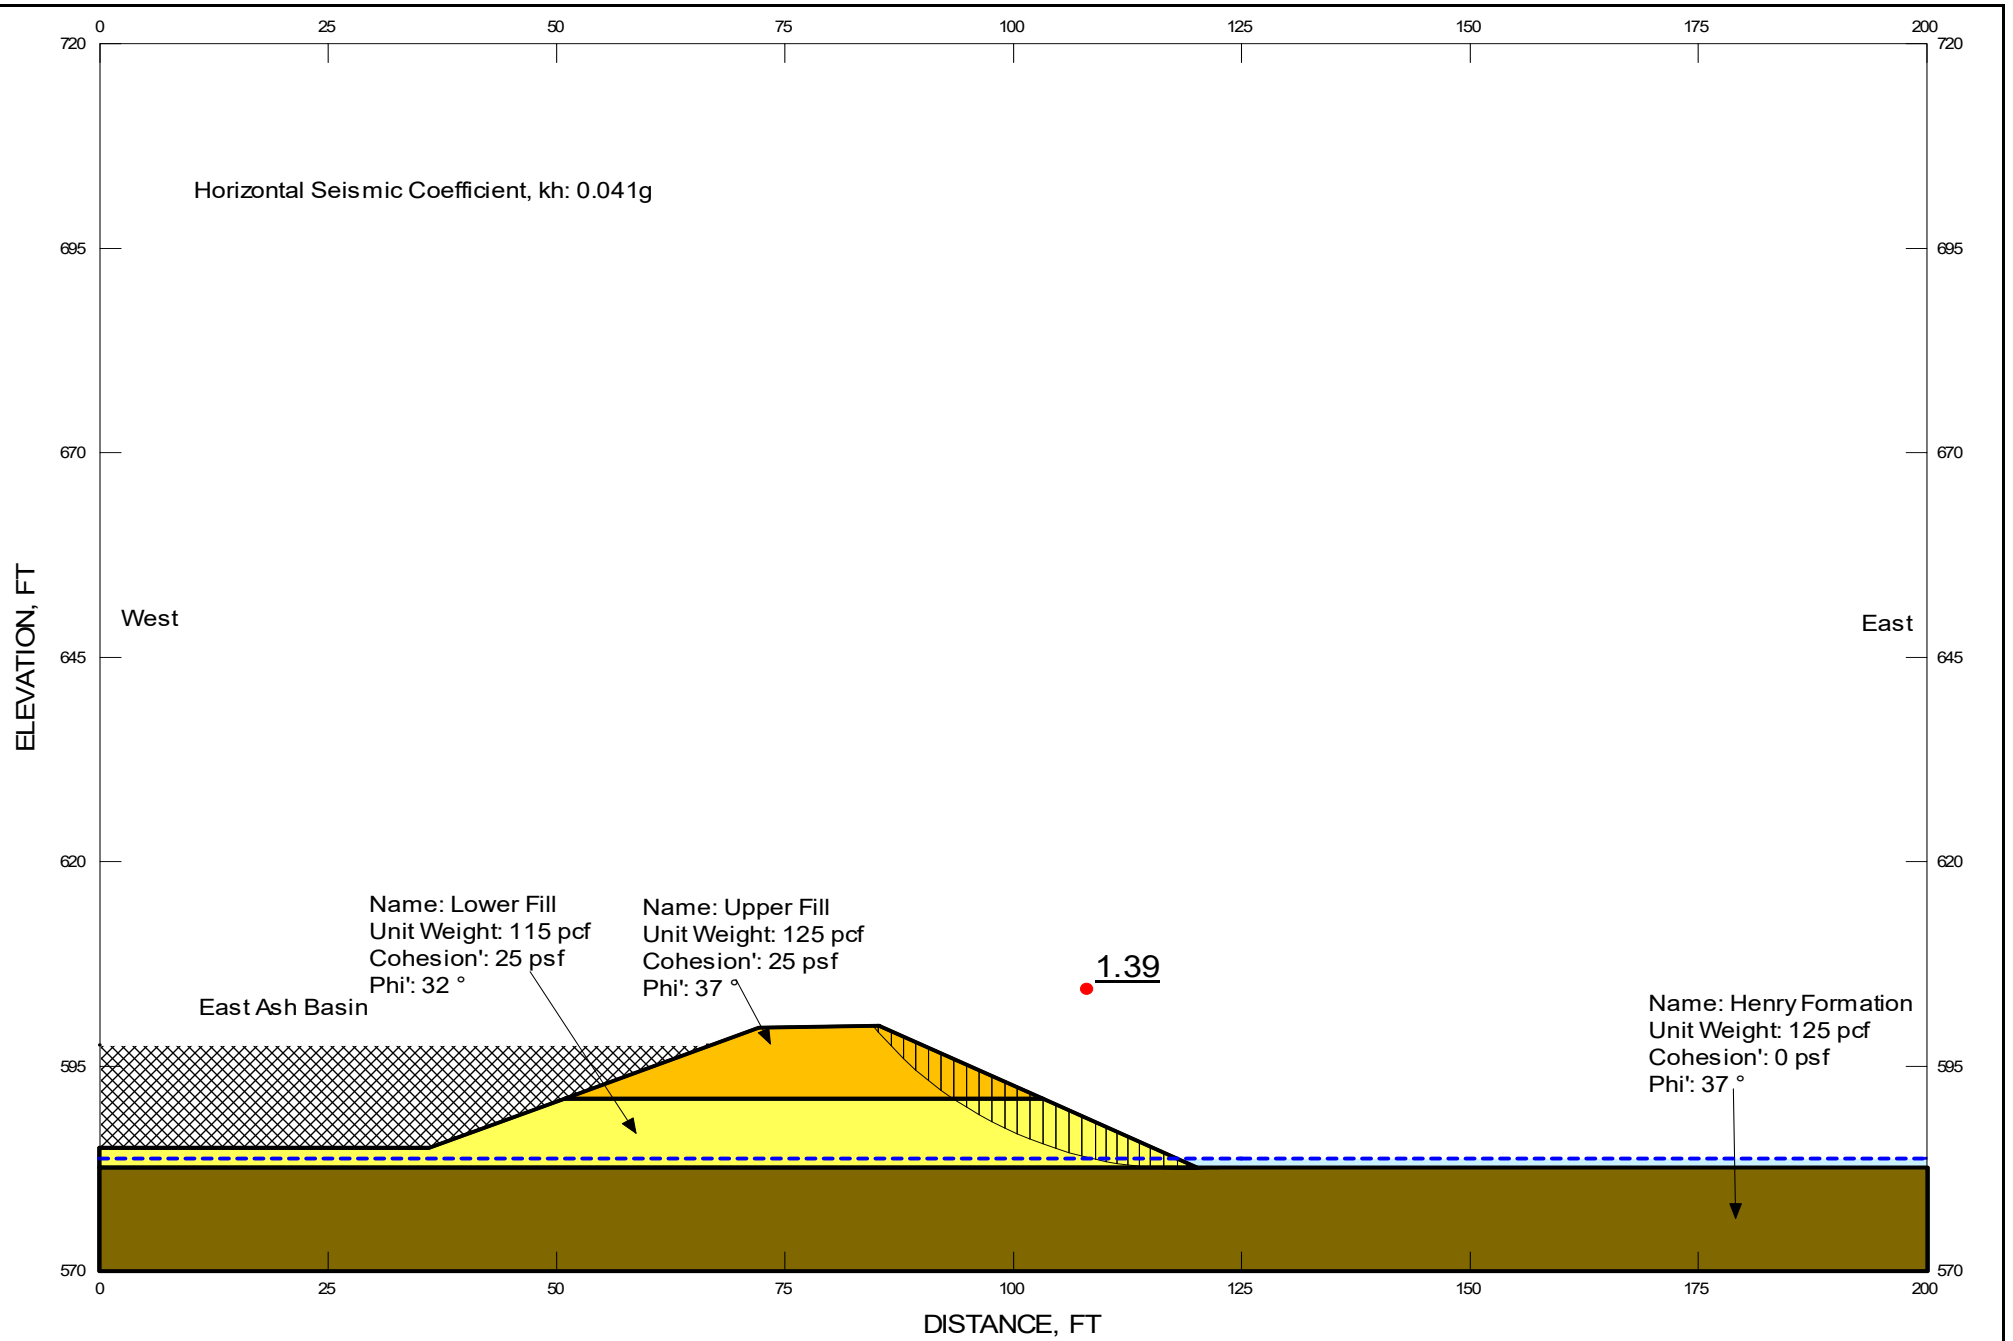
Figure 9 – Slope Stability Output, Section 2 - 257.73(e)(1)(iii)
