To: David Bacher, NRG
From: Richard Southorn, P.E., P.G.
Re: Indian River Landfill – Annual CCR Unit Inspection Report
Inspection Date: October 16, 2019
Memo Date: January 18, 2020

Project: Indian River 2019 Annual Inspection

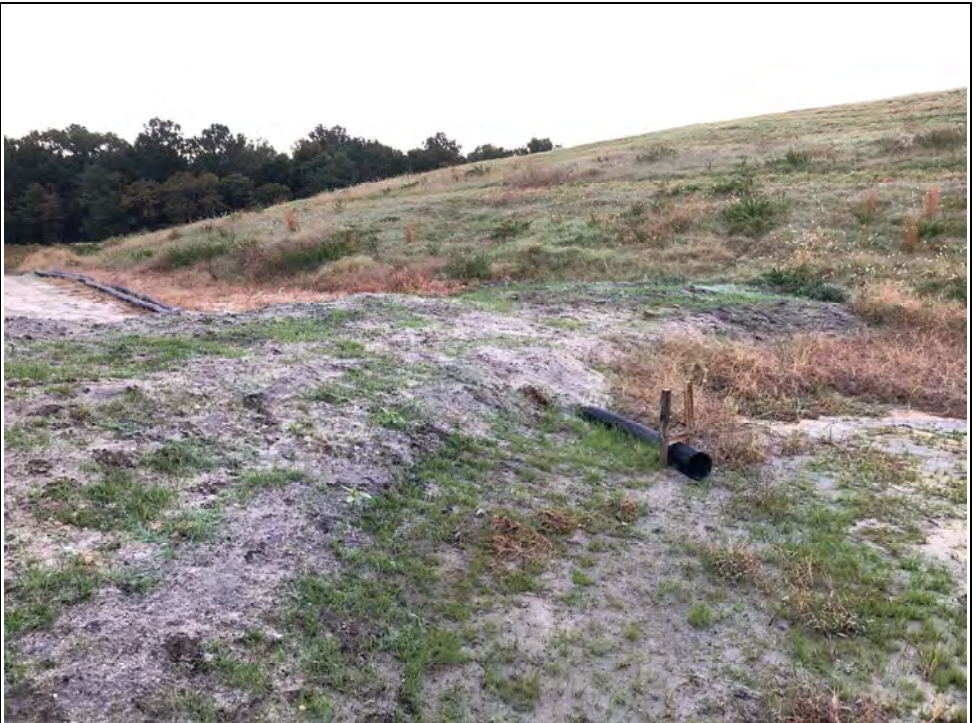
Image: 3243
 Date: 10/16/2019
 Time: 6:42:00 AM
 Direction: Northeast

Erosion control berm that has been established on active face. This berm slows contact water travelling over the active face during rain events, which in turn minimizes erosion. Pipes at the toe of the berm collect contact water and convey it to the leachate sump.

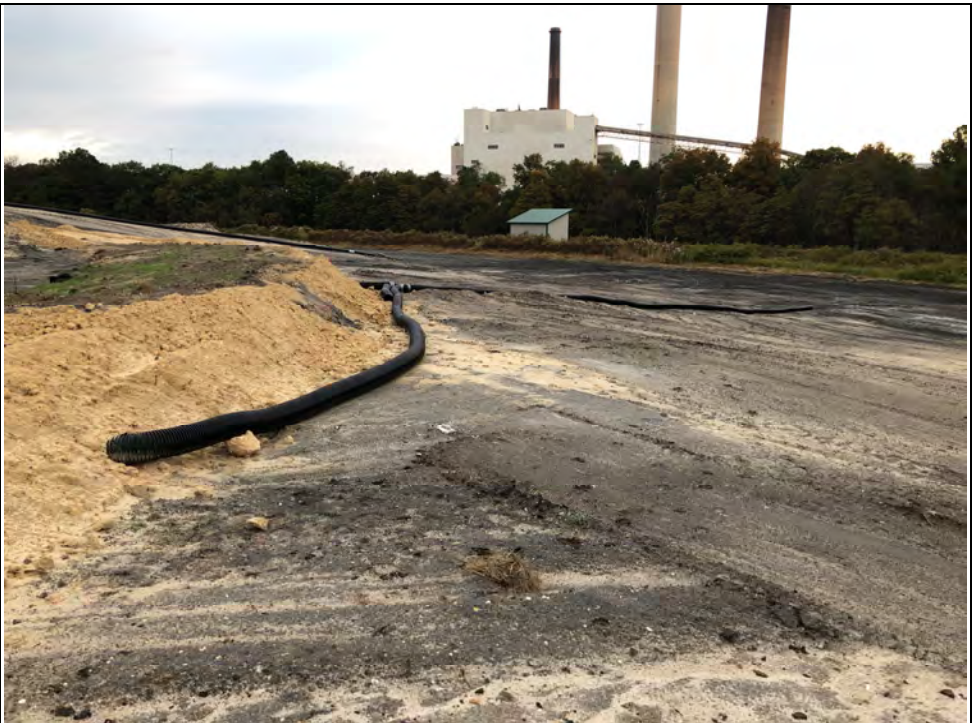
Image: 3245
 Date: 10/16/2019
 Time: 6:45:00 AM
 Direction: North

Erosion control berm that has been established on active face. This berm slows contact water travelling over the active face during rain events, which in turn minimizes erosion. Pipes at the toe of the berm collect contact water and convey it to the leachate sump.

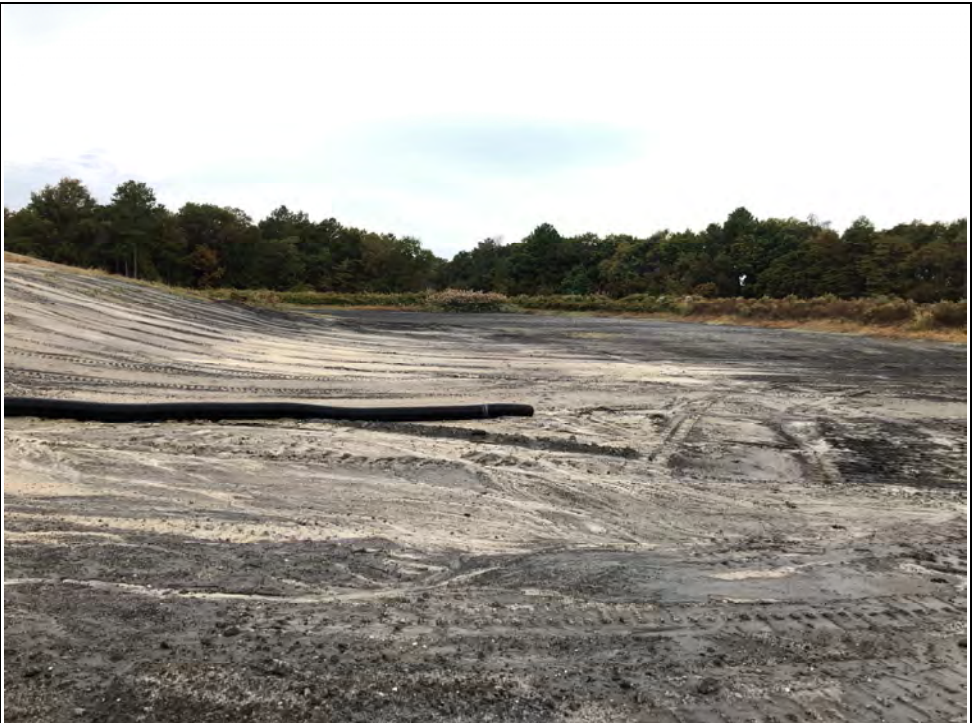
Image: 3247
Date: 10/16/2019
Time: 6:45:00 AM
Direction: Northwest

Sump area of active face. During the previous inspection, standing water was present in this location due to large rains. Significant efforts have been made to remove standing water, which was treated as leachate.

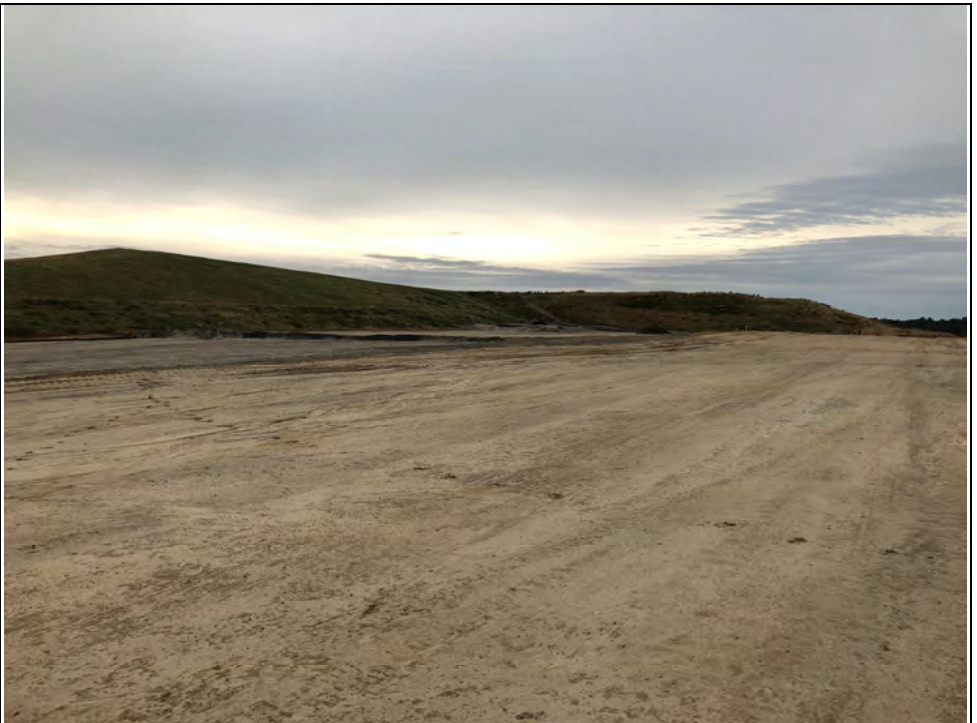
Image: 3249
Date: 10/16/2019
Time: 6:47:00 AM
Direction: Southeast

Lift of fly ash in active face. Well placed, graded, and maintained.

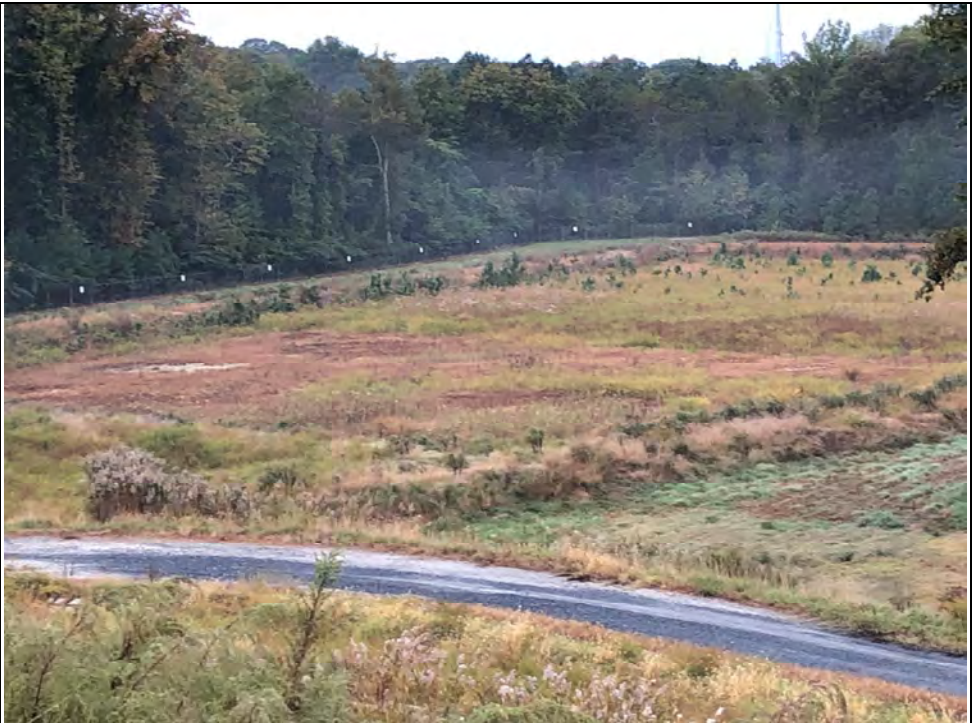
Image: 3263
Date: 10/16/2019
Time: 6:58:00 AM
Direction: Southwest

Overview of stormwater basin.

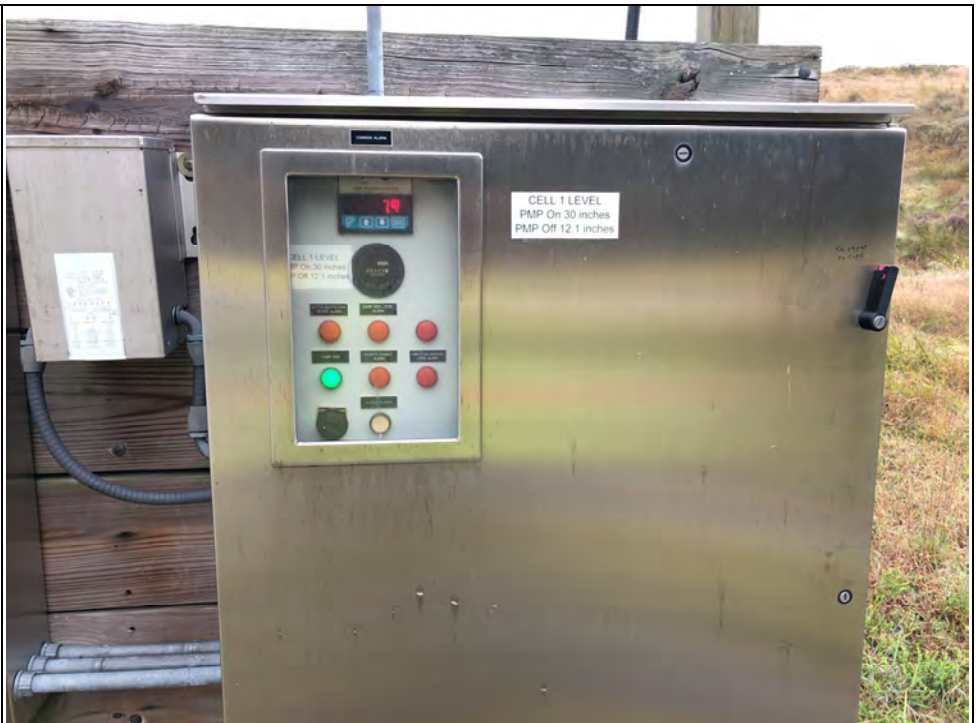
Image: 3271
 Date: 10/16/2019
 Time: 7:05:00 AM
 Direction: North

Phase 1, Cell 1 leachate instrument panel. Good working order.

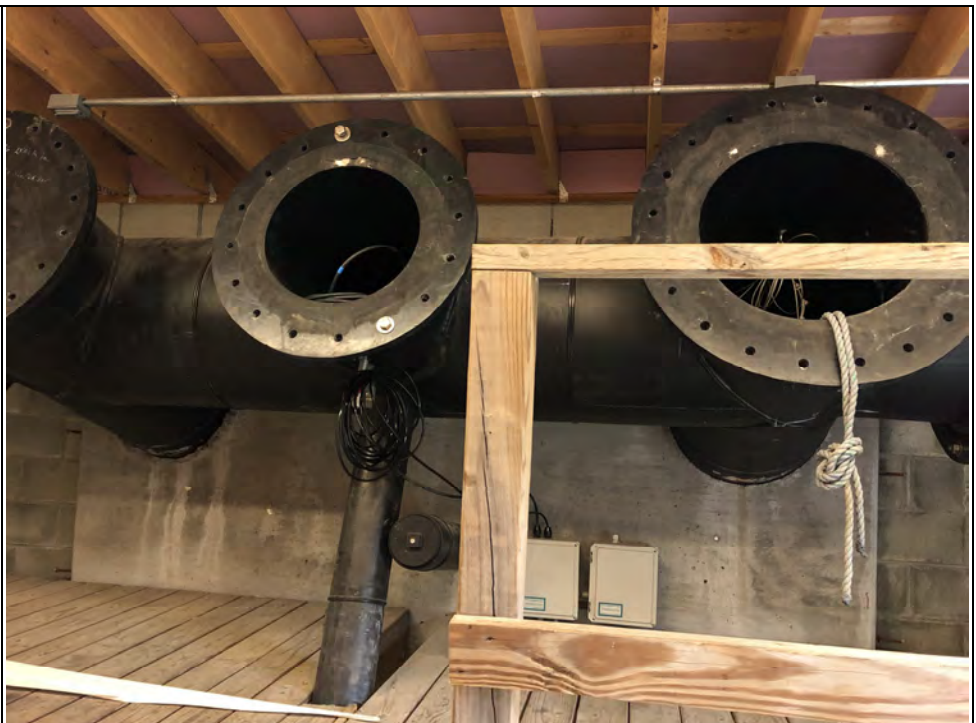
Image: 3273
 Date: 10/16/2019
 Time: 7:05:00 AM
 Direction: Northwest

Inside Phase 1, Cell 1 Leachate Pump House. Cleanout riser and pump risers with T connection to forcemain shown. Building is well maintained.

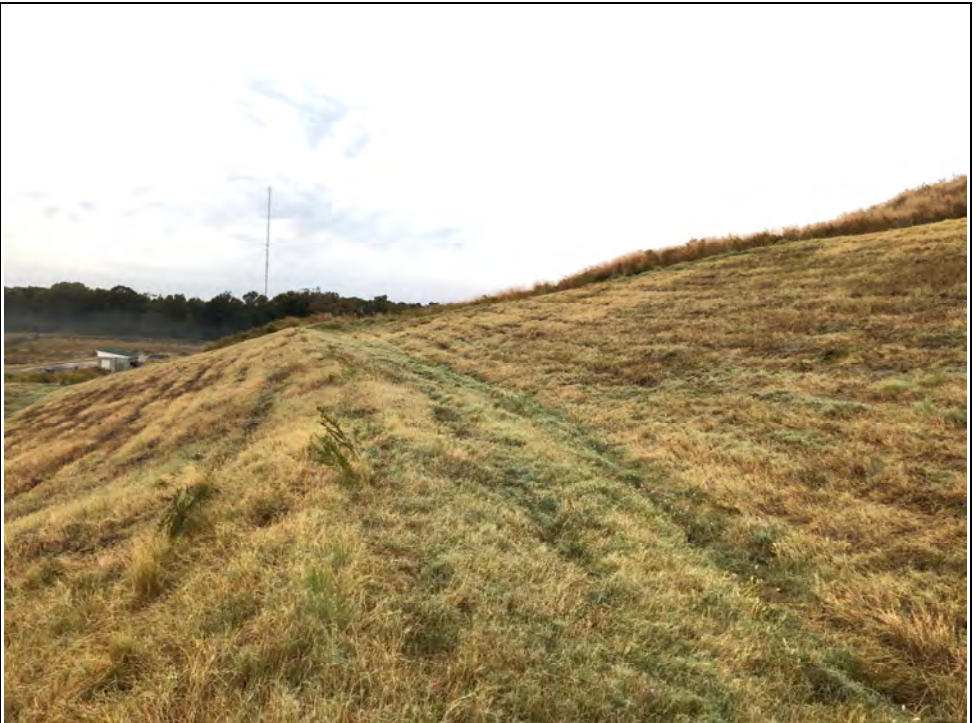
Image: 3279
Date: 10/16/2019
Time: 7:09:00 AM
Direction: West

Terrace berm. Clear of obstructions and functioning as intended. Vegetative cover is dense and healthy.

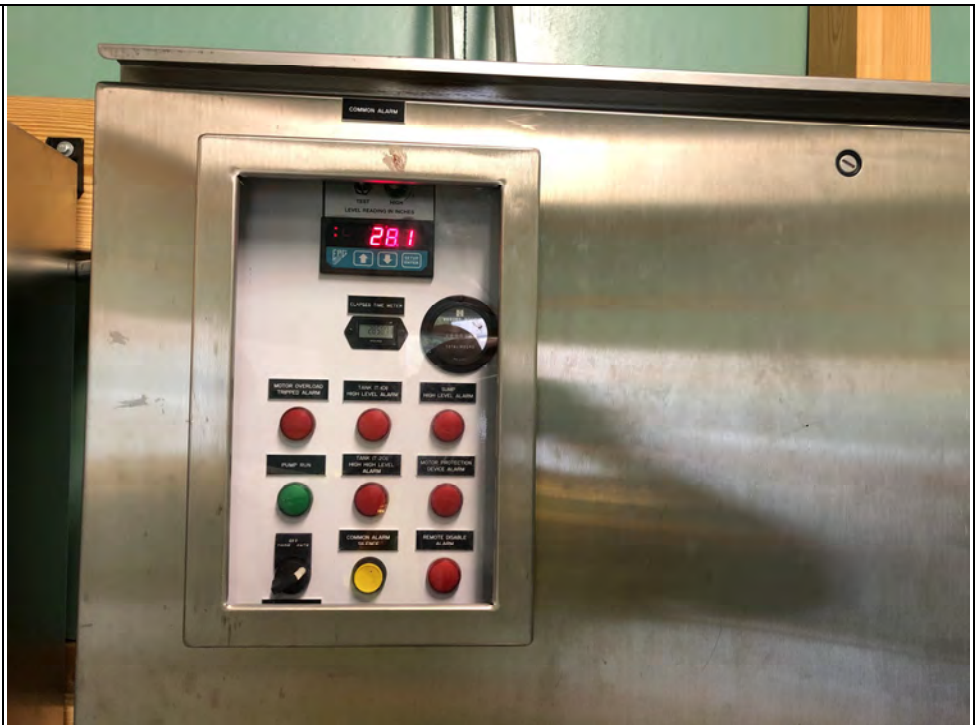
Image: 3283
 Date: 10/16/2019
 Time: 7:13:00 AM
 Direction: Southeast

Leachate liquid level indicator and controls in the Phase 2, Cell 2 leachate pump house.

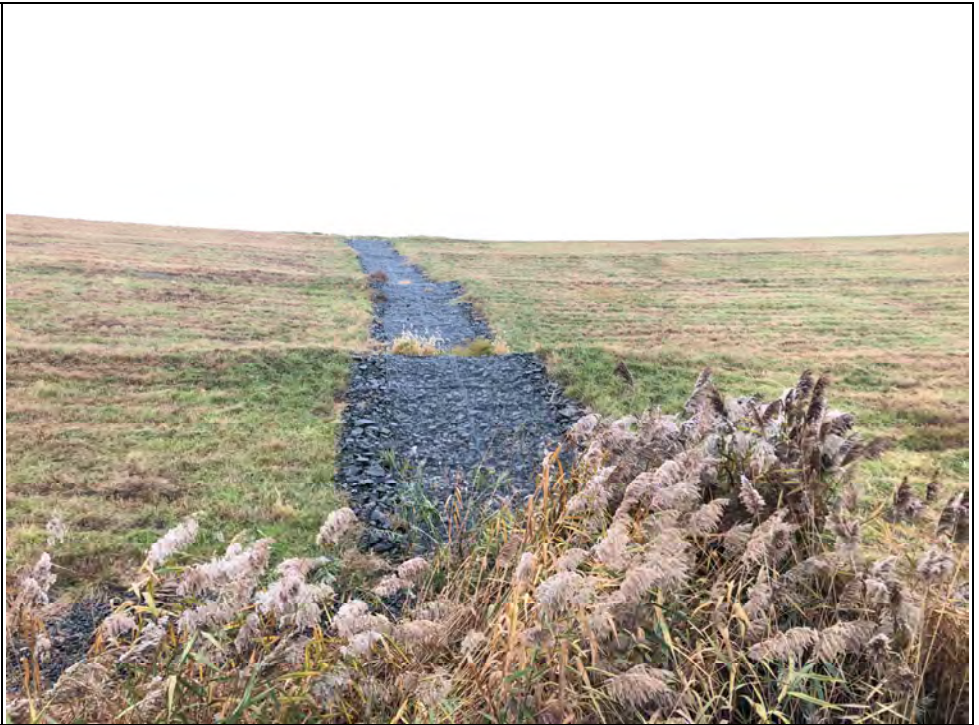
Image: 3287
Date: 10/16/2019
Time: 7:19:00 AM
Direction: South

Downchute near southwest forebay of Northeast Detention Basin.

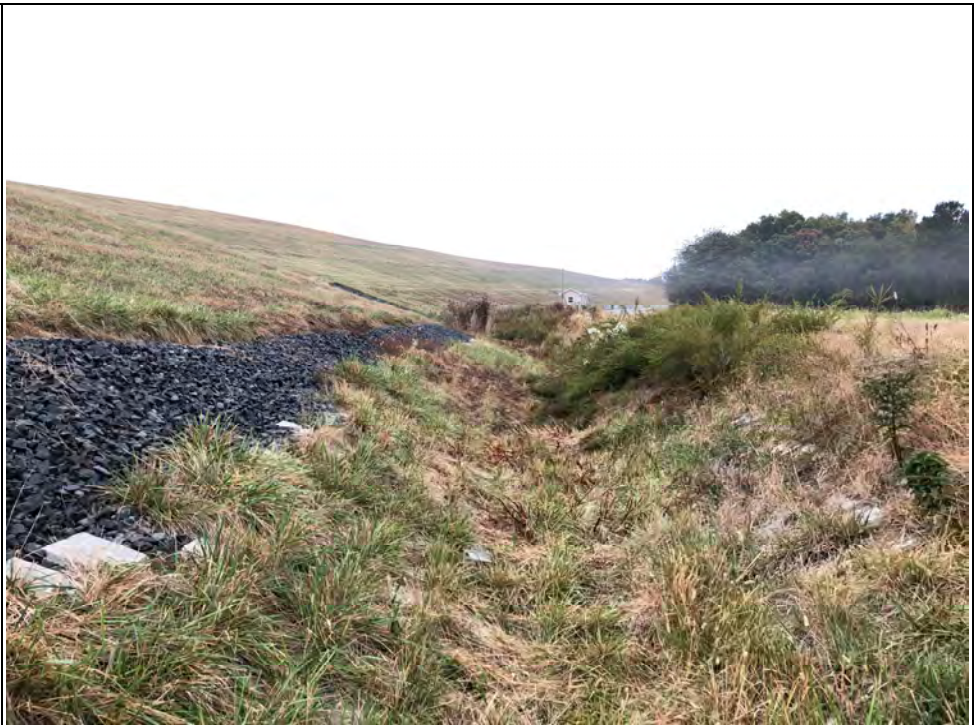
Image: 3289
Date: 10/16/2019
Time: 7:20:00 AM
Direction: West

Final cover on sideslopes with stormwater ditch in foreground.

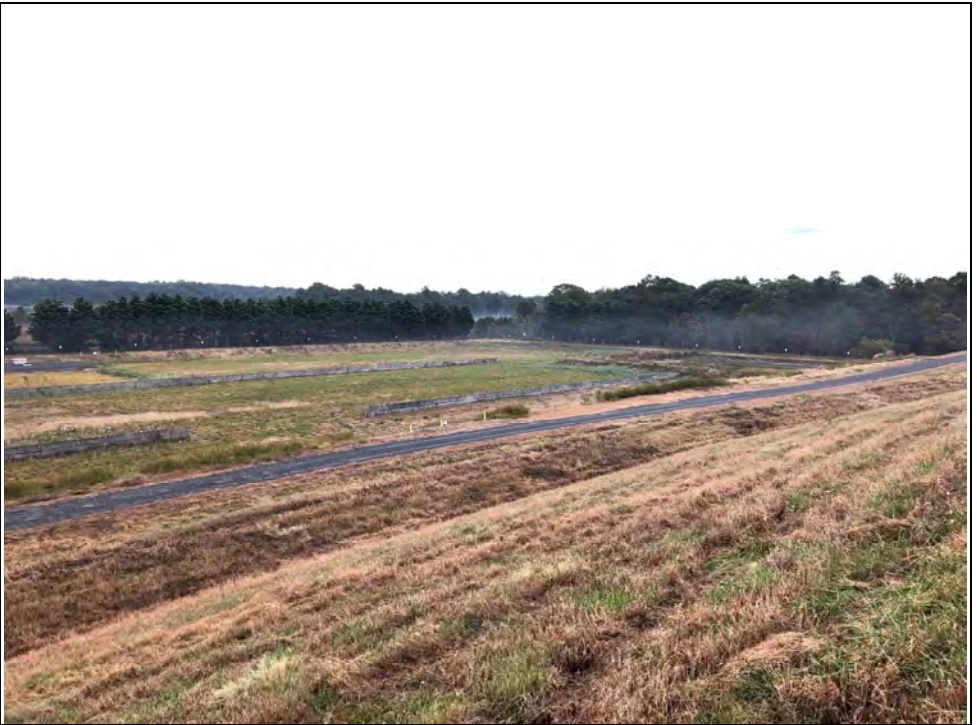
Image: 3295
Date: 10/16/2019
Time: 7:21:00 AM
Direction: Northeast

Phase 1 final cover.
Vegetative cover is dense
and healthy.

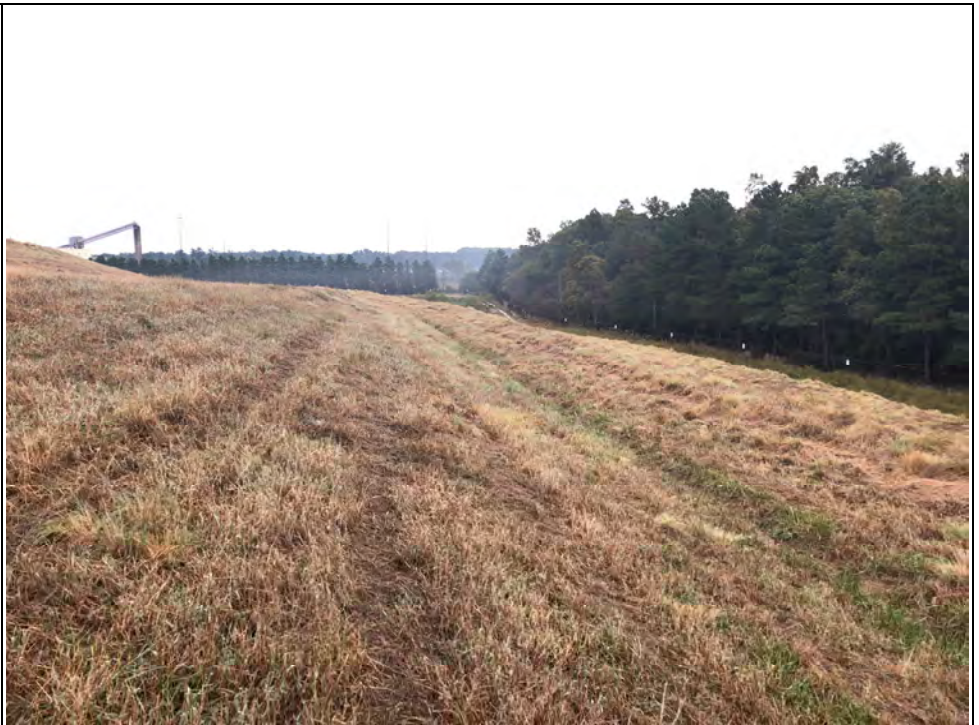
Image: 3301
Date: 10/16/2019
Time: 7:26:00 AM
Direction: North

Phase 1 final cover. Vegetative cover is dense and healthy.

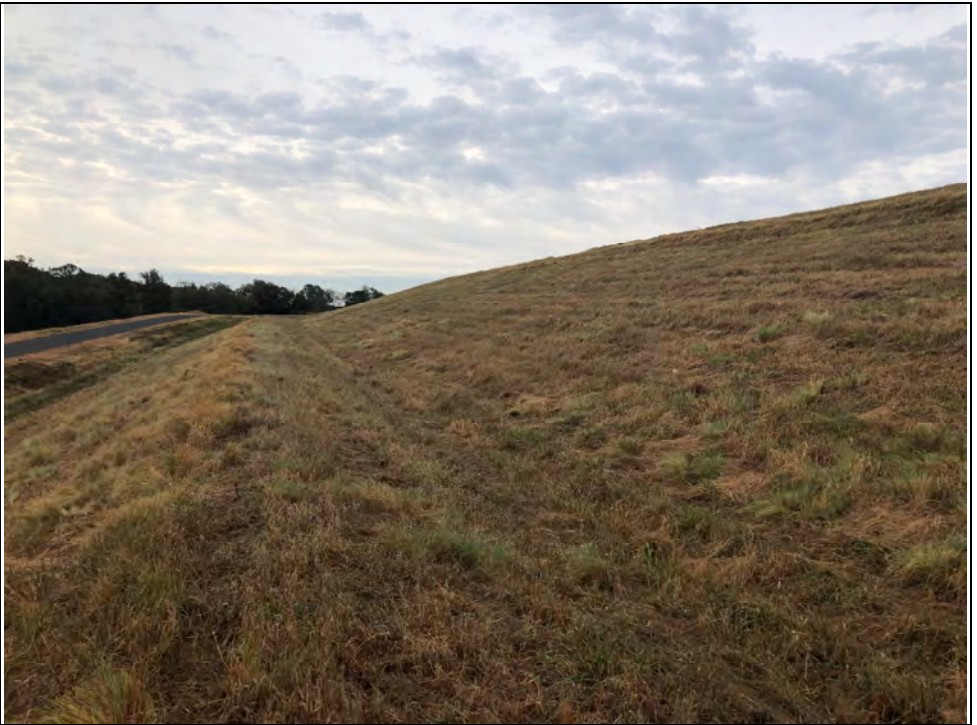
Image: 3303
Date: 10/16/2019
Time: 7:26:00 AM
Direction: South

Phase 1 terrace berm.
Clear of obstructions and
functioning as intended.
Vegetative cover is dense
and healthy.

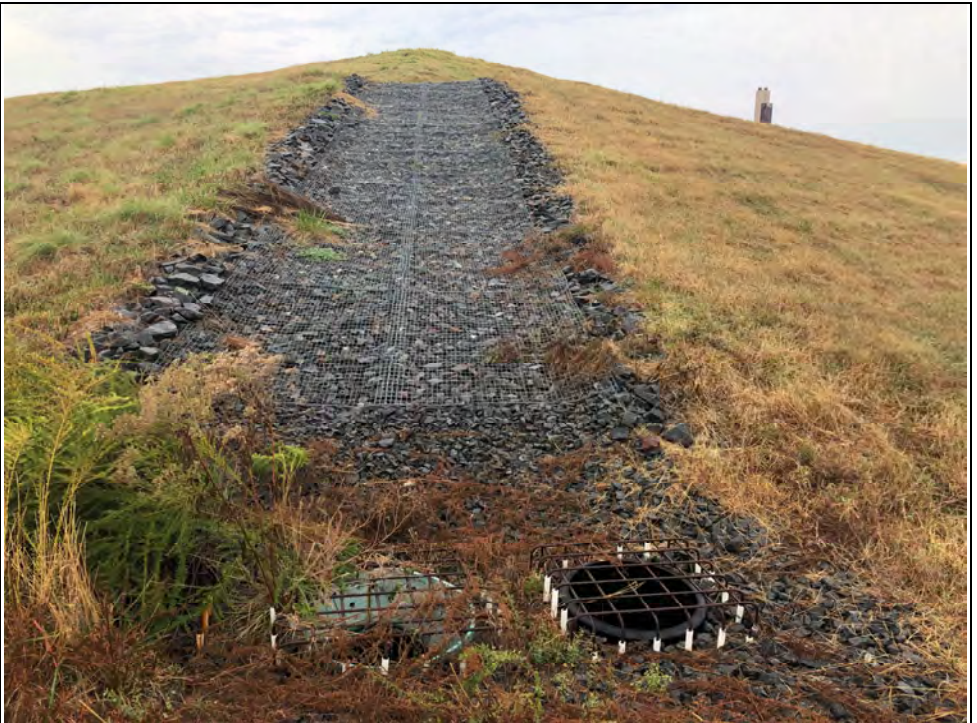
Image: 3307
Date: 10/16/2019
Time: 7:28:00 AM
Direction: Northwest

Phase 1 corner downchute. Rock is in-place and not migrating. No evidence of washouts.

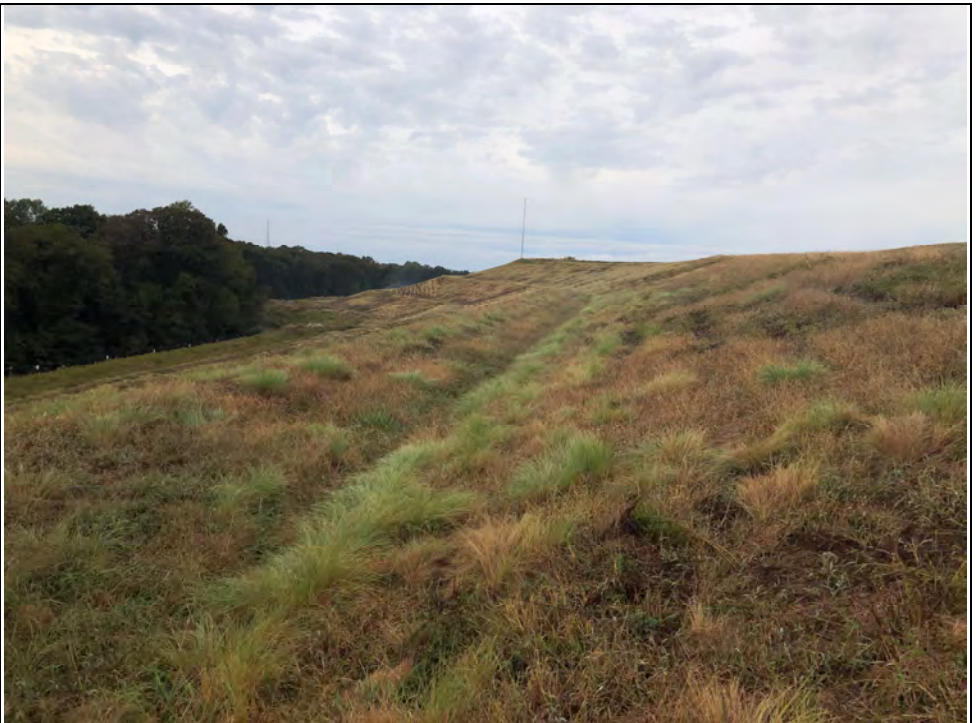
Image: 3309
Date: 10/16/2019
Time: 7:29:00 AM
Direction: Southwest

Phase 1 final cover and stormwater terraces. Well maintained and functioning as intended.

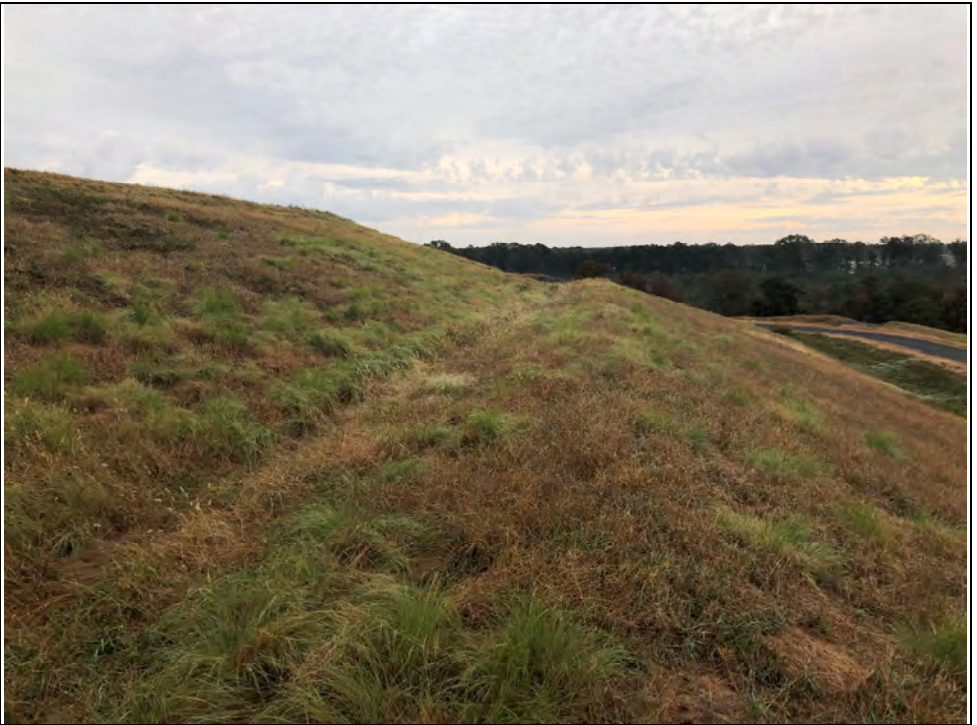
Image: 3311
Date: 10/16/2019
Time: 7:30:00 AM
Direction: Northeast

Phase 1 final cover and stormwater terraces. Well maintained and functioning as intended.

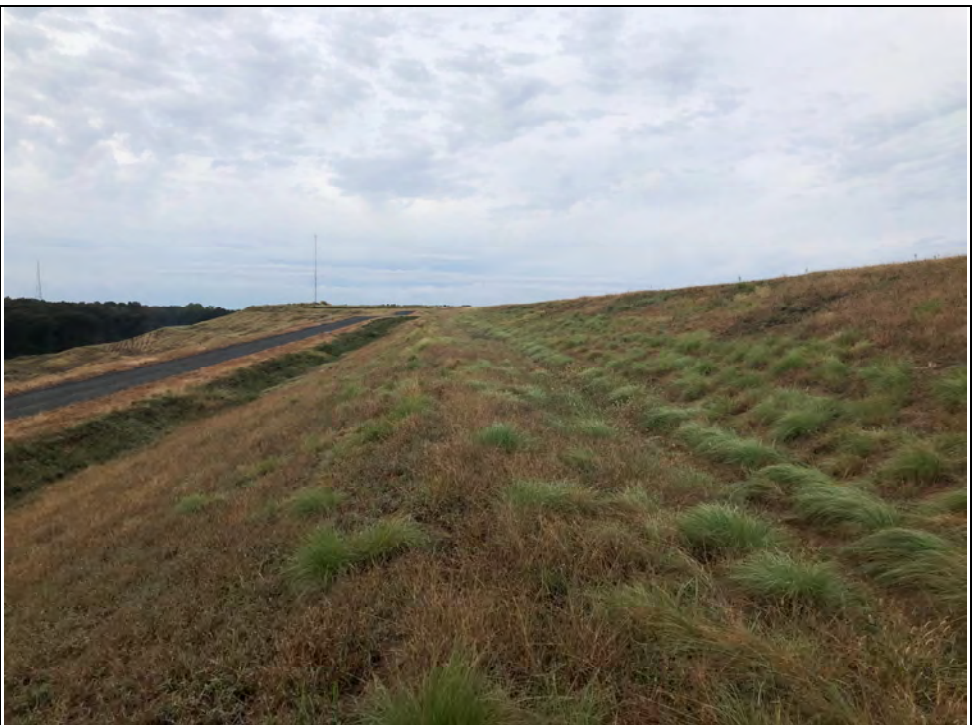
Image: 3313
Date: 10/16/2019
Time: 7:30:00 AM
Direction: West

Phase 1 final cover and stormwater terraces. Well maintained and functioning as intended.

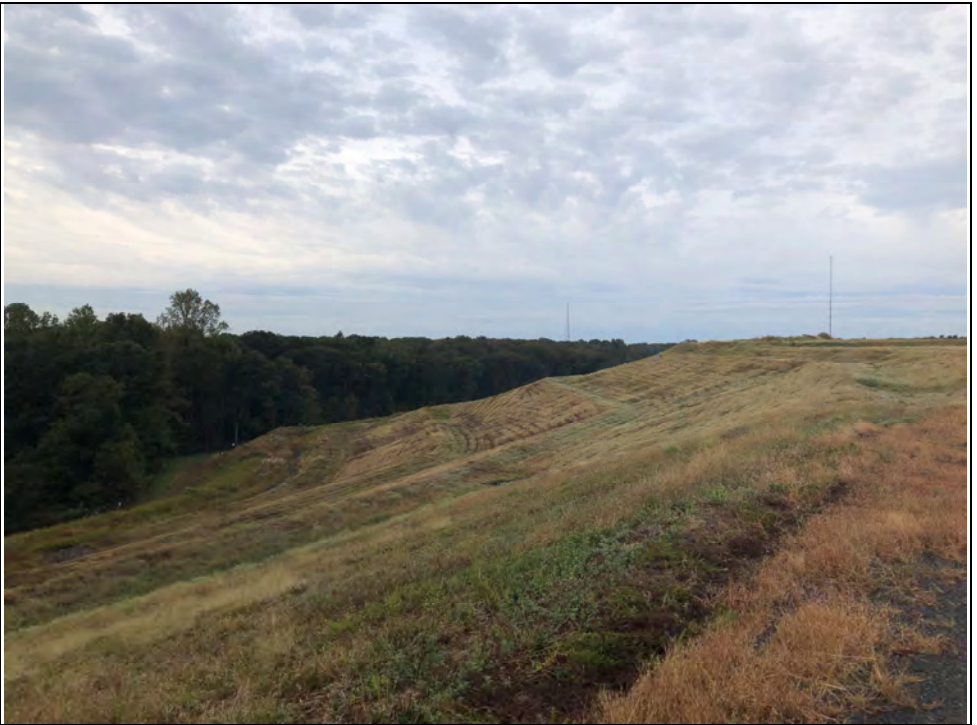
Image: 3315
Date: 10/16/2019
Time: 7:31:00 AM
Direction: Southwest

Phase 1 final cover and stormwater terraces. Well maintained and functioning as intended.

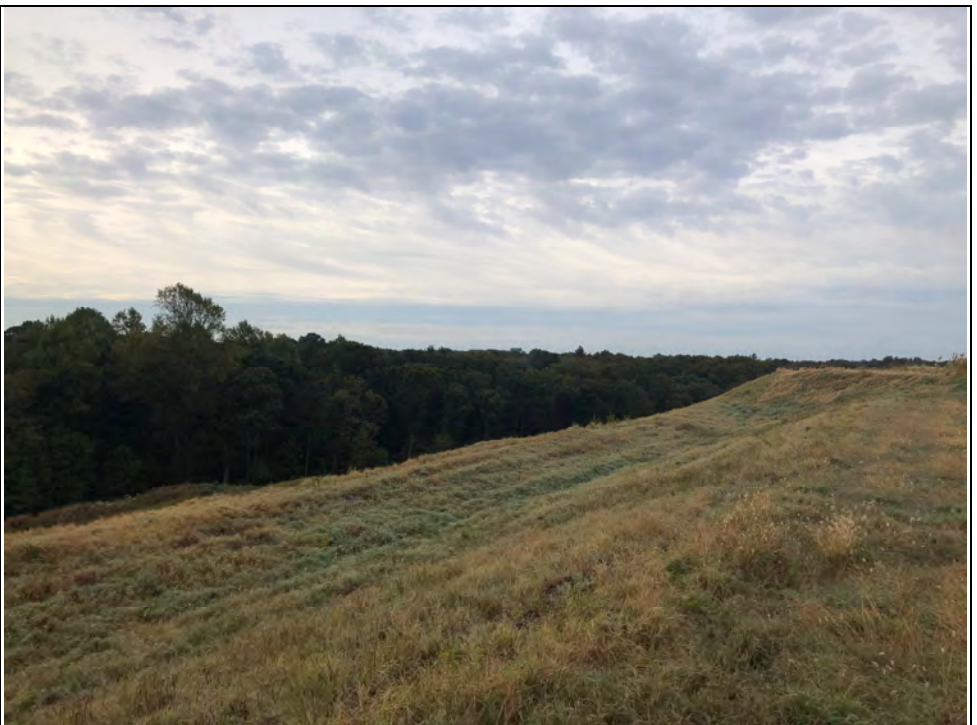
Image: 3317
Date: 10/16/2019
Time: 7:31:00 AM
Direction: Southwest

Final cover on plateau. Vegetation is well established. No signs of animal burrows or erosion.

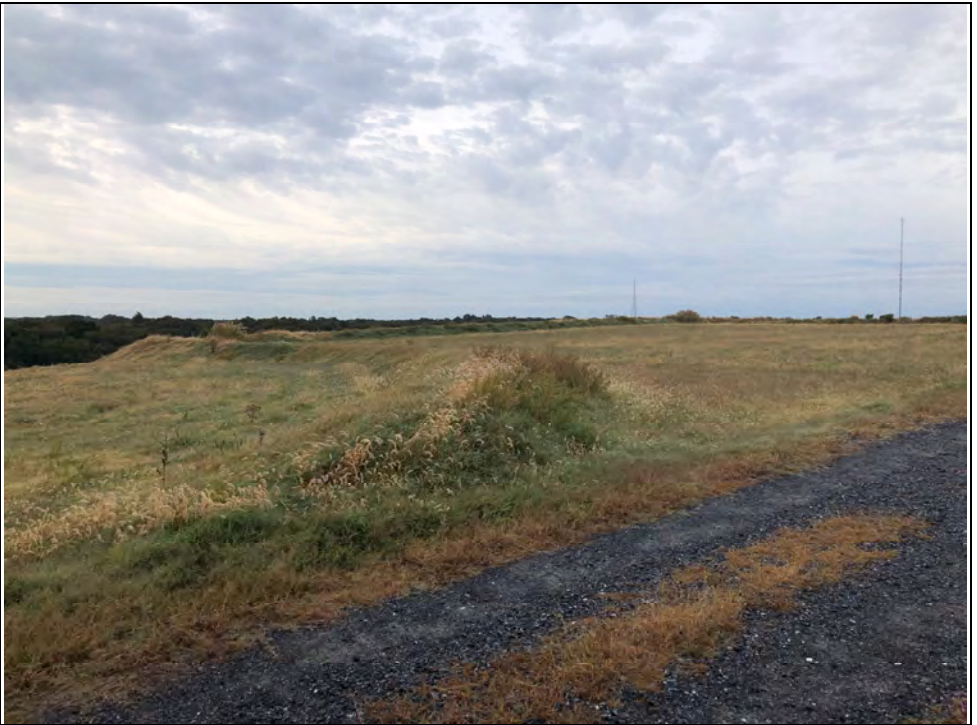
Image: 3319
Date: 10/16/2019
Time: 7:32:00 AM
Direction: Southwest

Final cover on plateau.
Vegetation is well established. No signs of animal burrows or erosion.

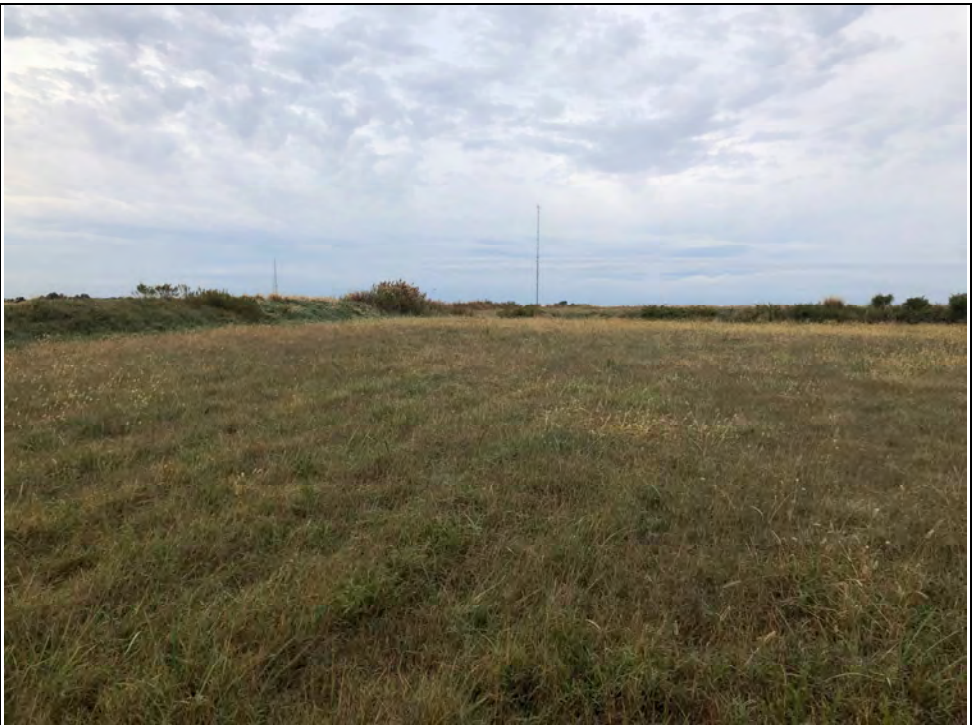
Image: 3321
Date: 10/16/2019
Time: 7:33:00 AM
Direction: West

Final cover on plateau.
Vegetation is well established. No signs of animal burrows or erosion.

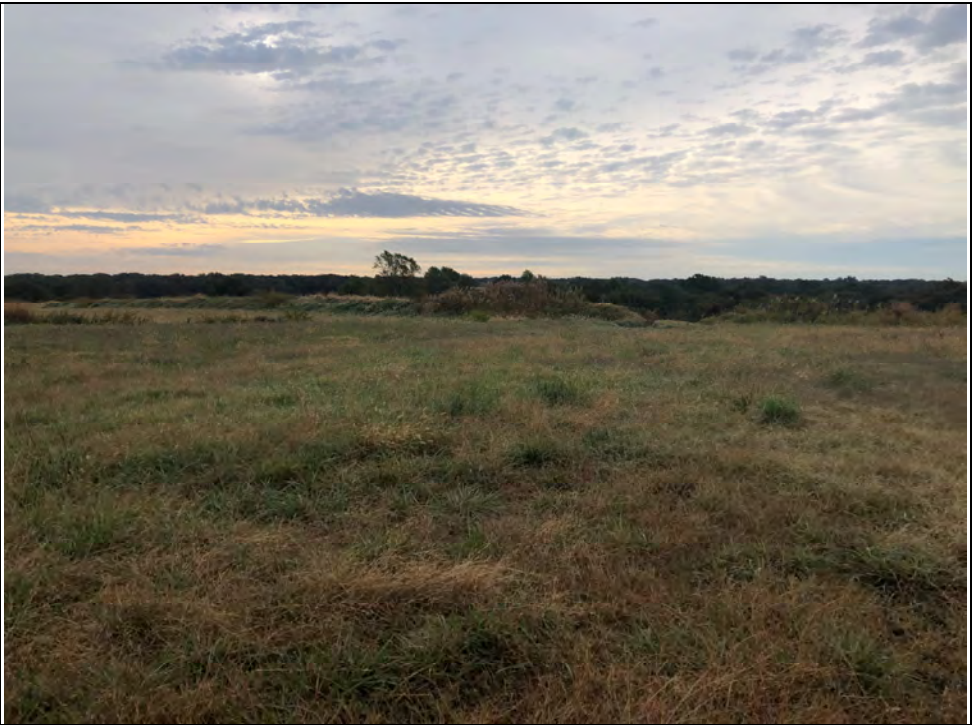
Image: 3323
Date: 10/16/2019
Time: 7:33:00 AM
Direction: Southeast

Final cover on plateau.
Vegetation is well established. No signs of animal burrows or erosion.

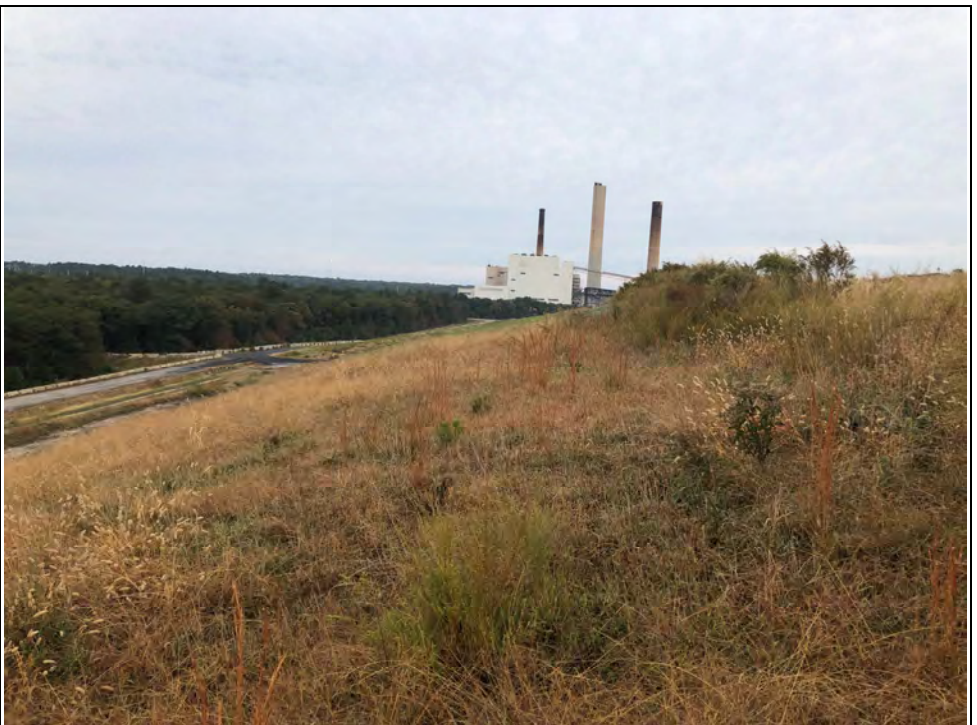
Image: 3325
Date: 10/16/2019
Time: 7:35:00 AM
Direction: North

Final cover on plateau.
Vegetation is well established. No signs of animal burrows or erosion.

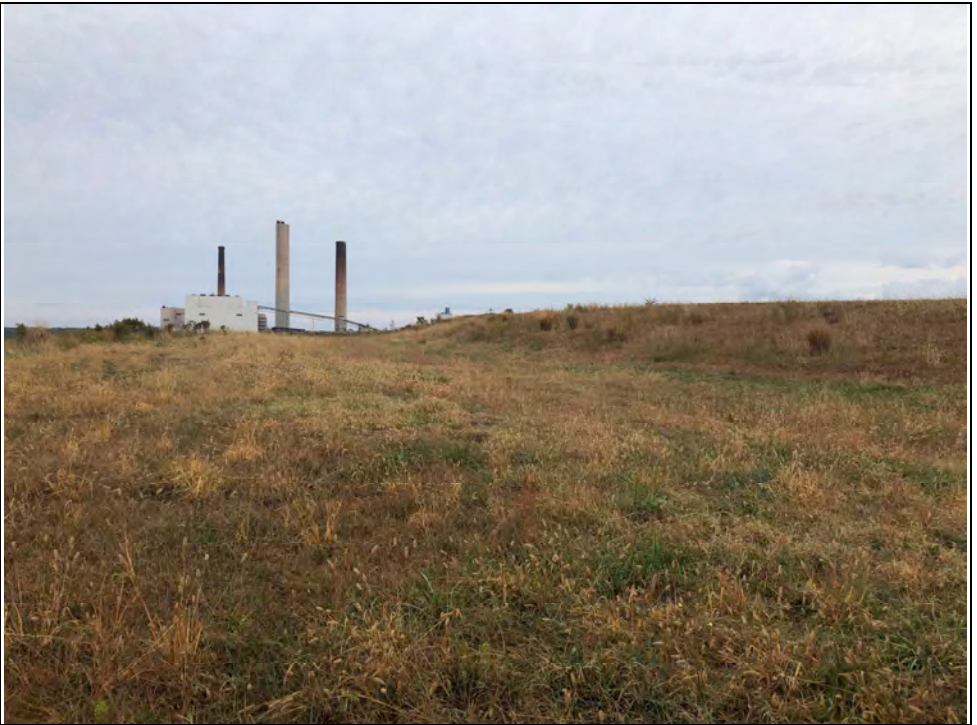
Image: 3327
Date: 10/16/2019
Time: 7:36:00 AM
Direction: North

Final cover on plateau.
Vegetation is well established. No signs of animal burrows or erosion.

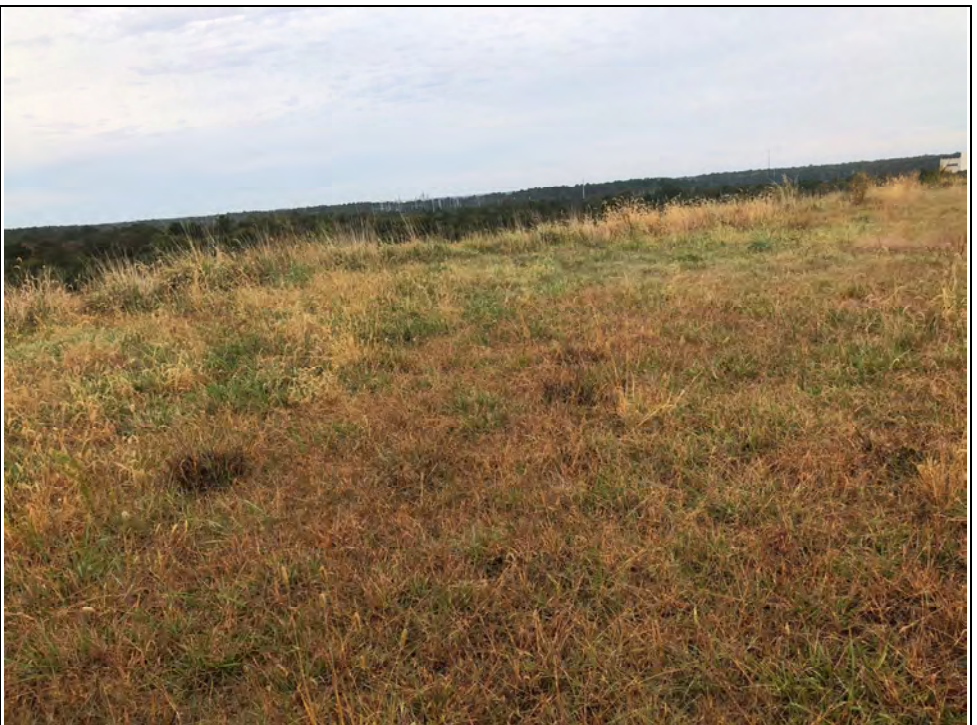
Image: 3329
Date: 10/16/2019
Time: 7:36:00 AM
Direction: Northwest

Final cover on plateau.
Vegetation is well established. No signs of animal burrows or erosion.

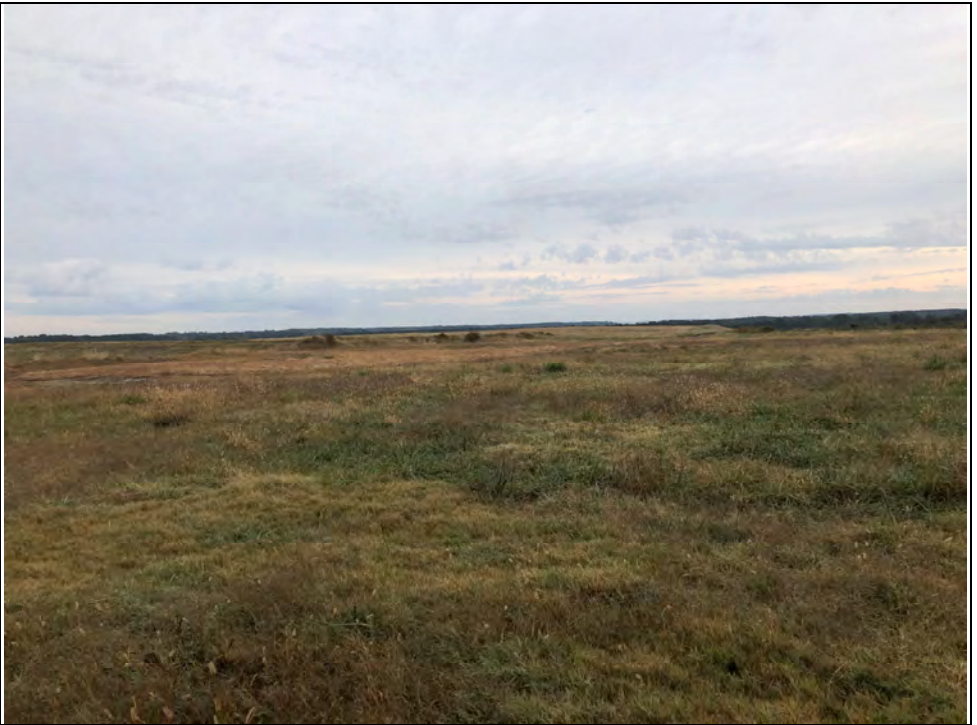
Image: 3331
Date: 10/16/2019
Time: 7:37:00 AM
Direction: Northeast

Final cover on plateau.
Vegetation is well established. No signs of animal burrows or erosion.

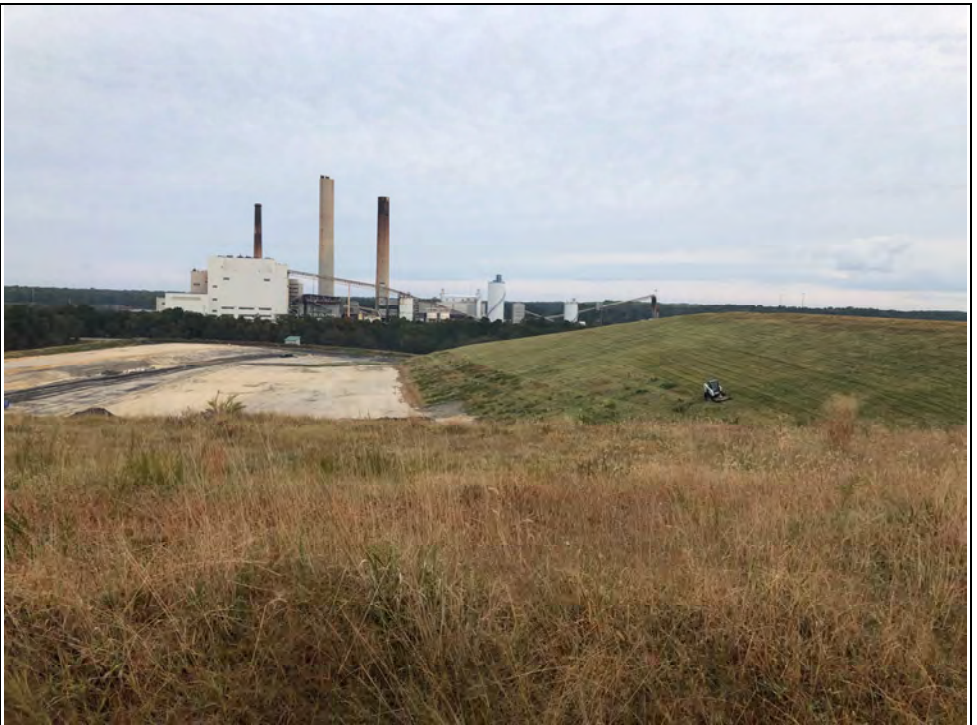
Image: 3333
Date: 10/16/2019
Time: 7:37:00 AM
Direction: North

Phase 2, Cell 2 active area from Phase 2 Cell 1 plateau.

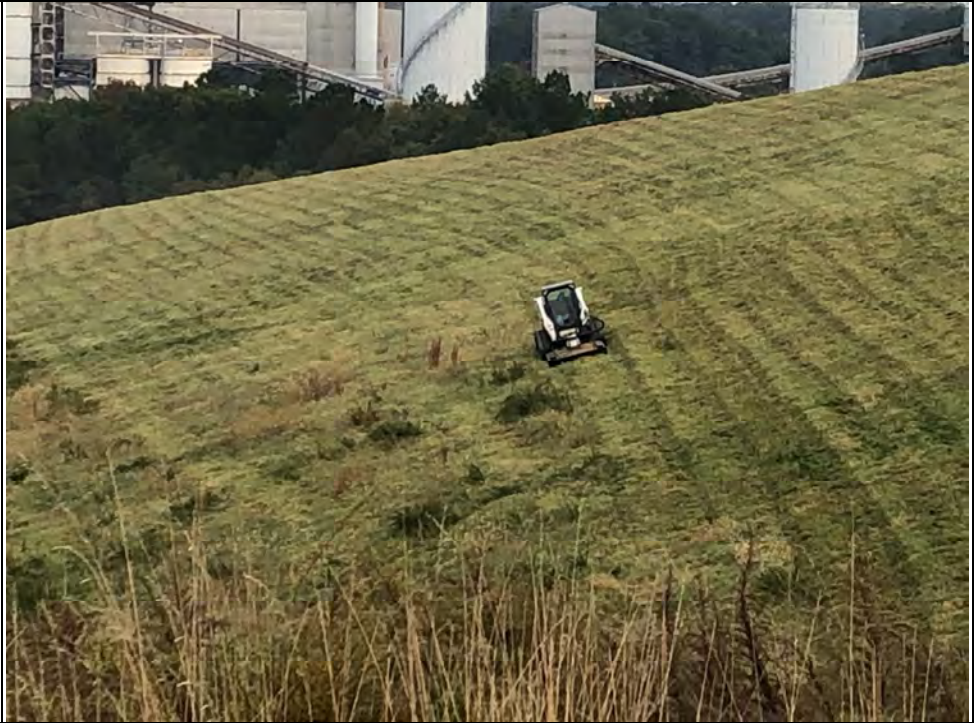
Image: 3335
Date: 10/16/2019
Time: 7:38:00 AM
Direction: North

Mowing being completed on the Phase I intermediate cover slopes. Slopes are well vegetated with no sign of erosion or sloughing.

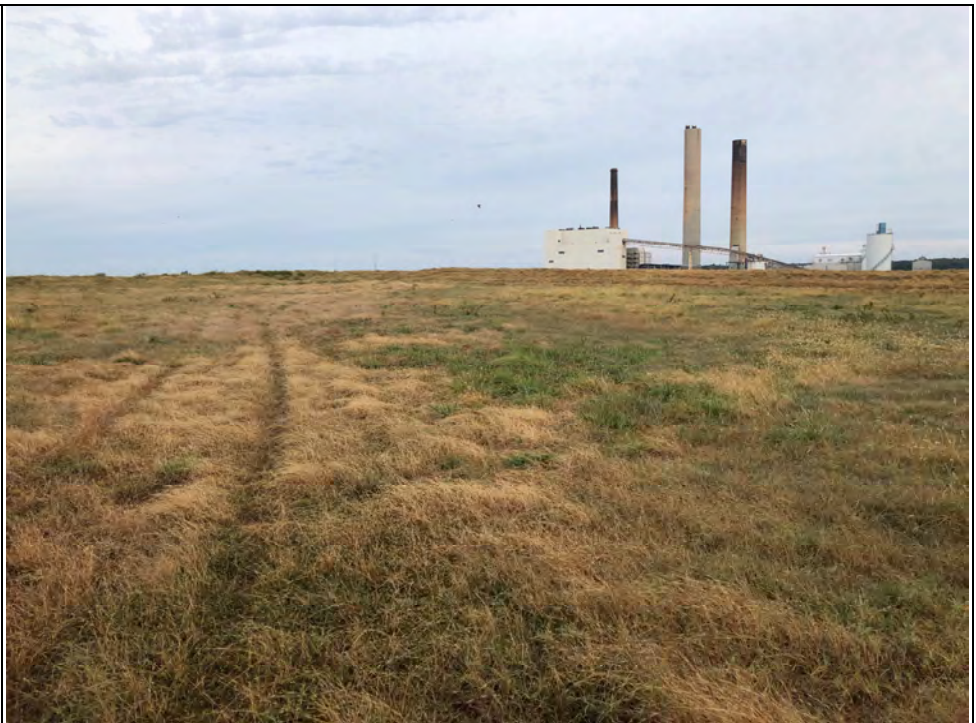
Image: 3339
Date: 10/16/2019
Time: 7:39:00 AM
Direction: Northwest

Final cover on plateau.
Vegetation is well established. No signs of animal burrows or erosion.
