To: David Bacher, NRG
From: Richard Southorn, P.E., P.G.
Re: Indian River Landfill – Annual CCR Unit Inspection Report
Inspection Date: October 16, 2019
Memo Date: January 18, 2020

Project: Indian River 2019 Annual Inspection

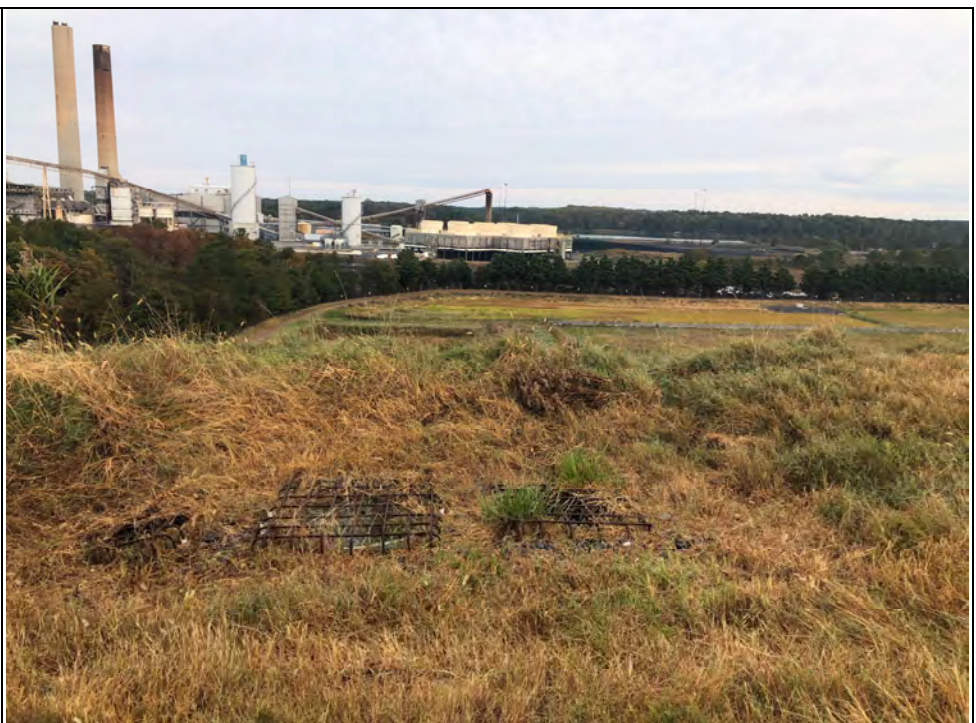
Image: 3341
Date: 10/16/2019
Time: 7:40:00 AM
Direction: North

Final cover on plateau.
Vegetation is well established. No signs of animal burrows or erosion.

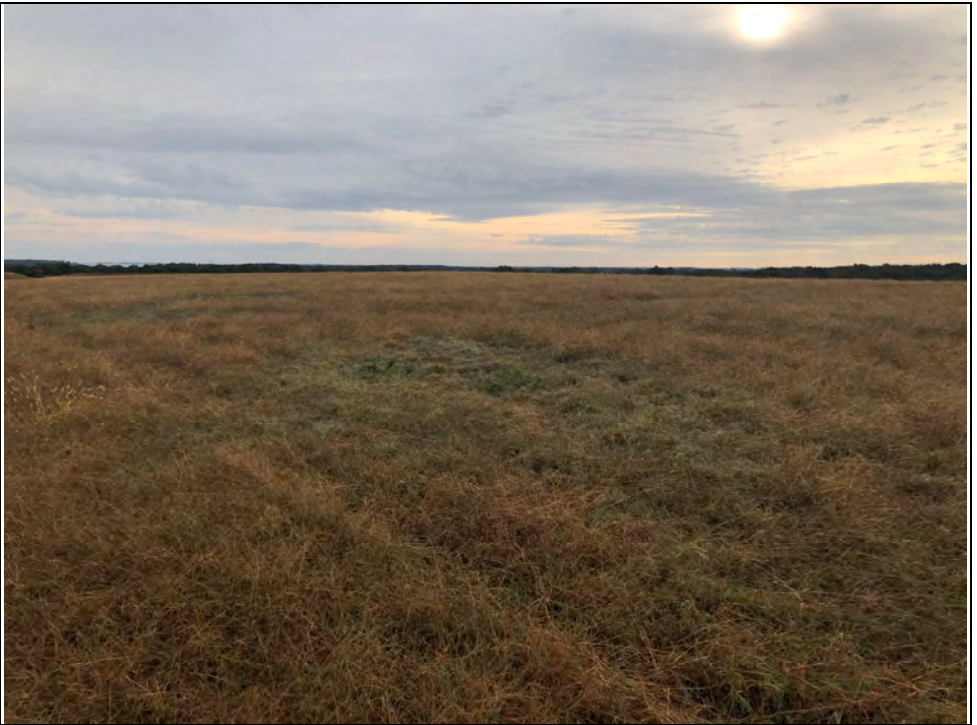
Image: 3343
Date: 10/16/2019
Time: 7:41:00 AM
Direction: East

Final cover on plateau.
Vegetation is well established. No signs of animal burrows or erosion.

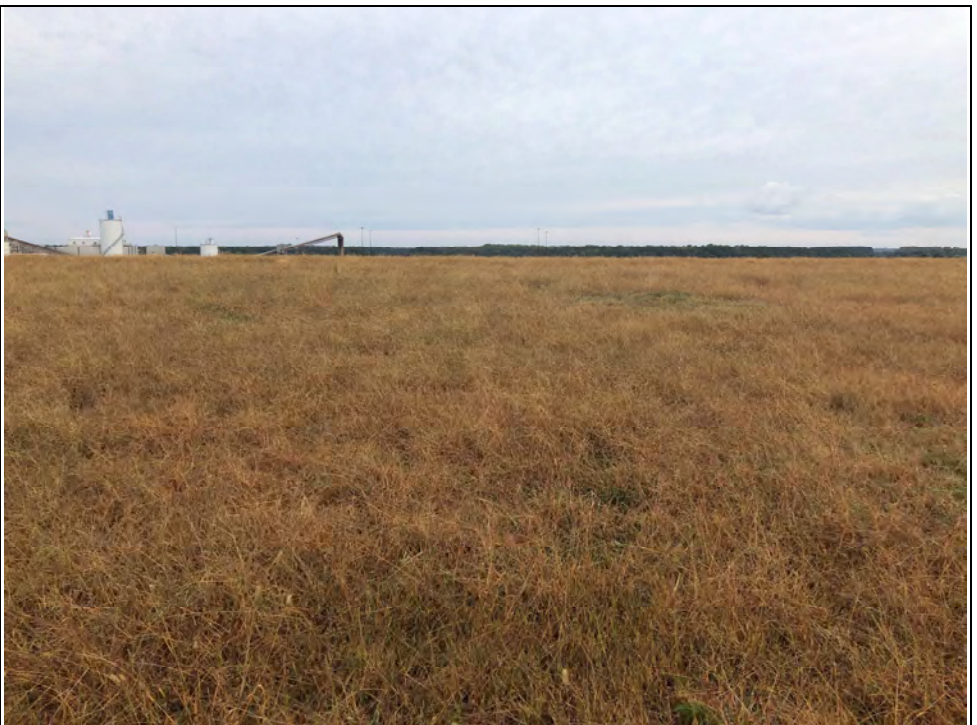
Image: 3345
Date: 10/16/2019
Time: 7:41:00 AM
Direction: North

Final cover on plateau.
Vegetation is well established. No signs of animal burrows or erosion.

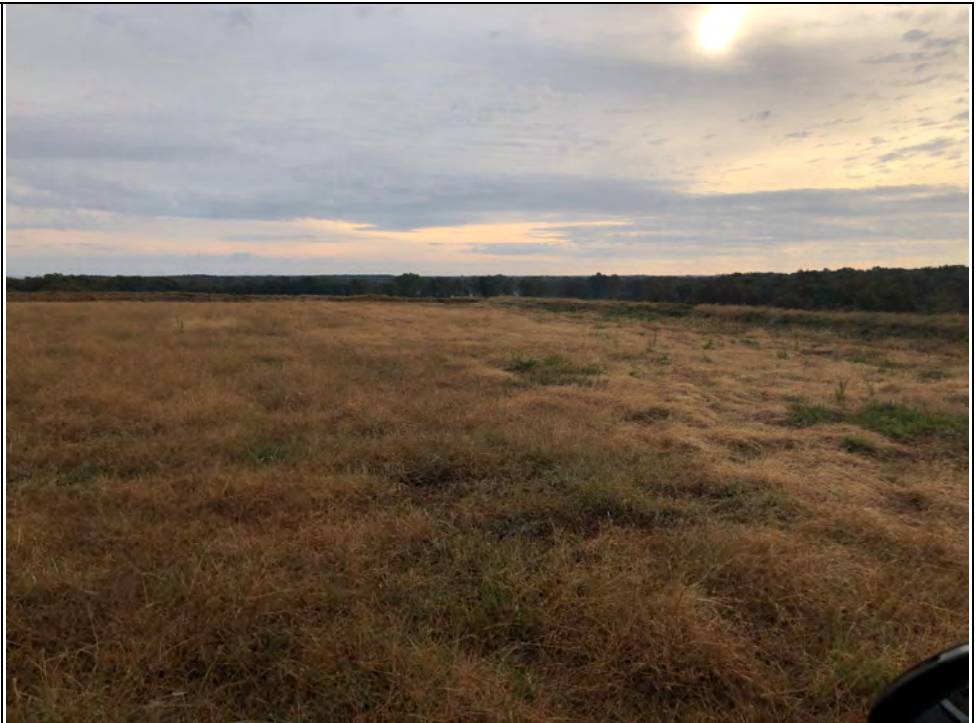
Image: 3347
Date: 10/16/2019
Time: 7:41:00 AM
Direction: East

Final cover on plateau.
Vegetation is well established. No signs of animal burrows or erosion.

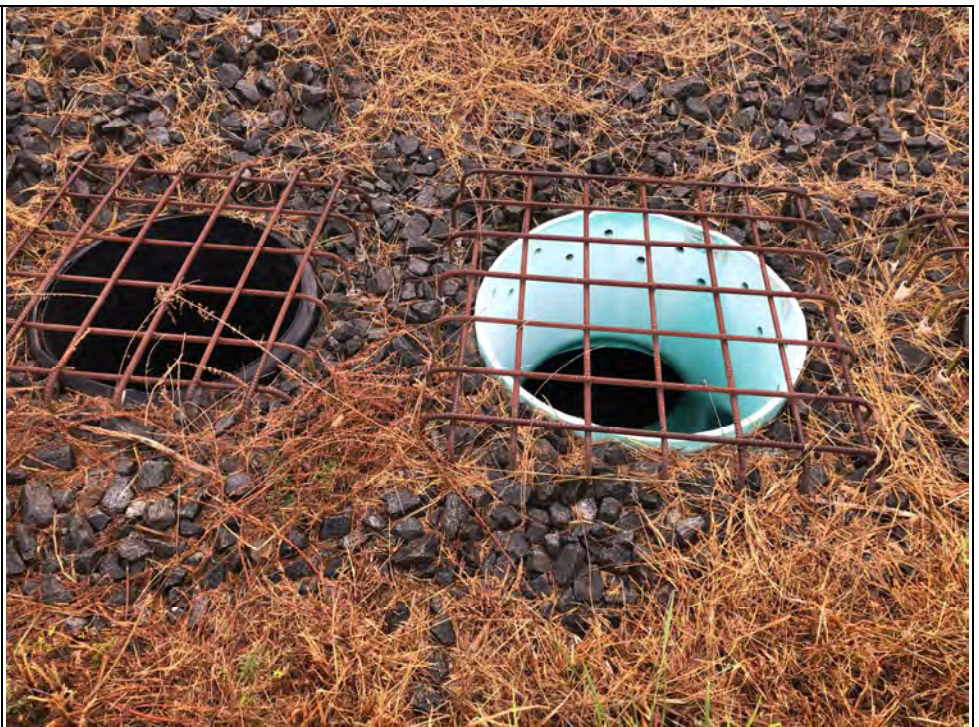
Image: 3349
Date: 10/16/2019
Time: 7:42:00 AM
Direction: Southeast

Inlet pipes on inside plateau berm to letdown channel.

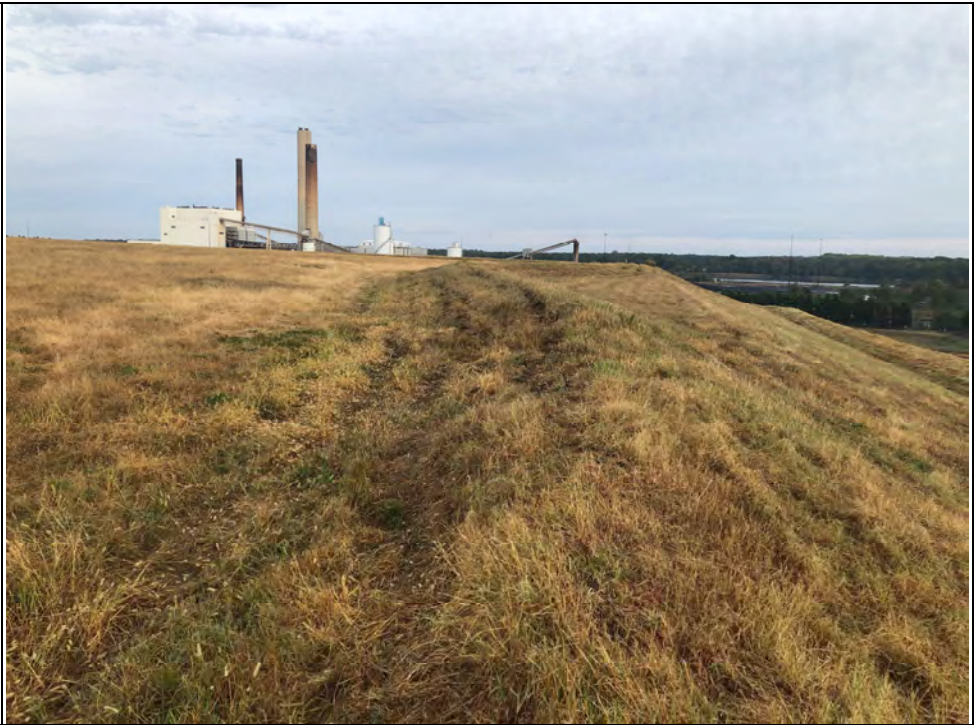
Image: 3351
Date: 10/16/2019
Time: 7:42:00 AM
Direction: North

Final cover on plateau.
Vegetation is well established. No signs of animal burrows or erosion.

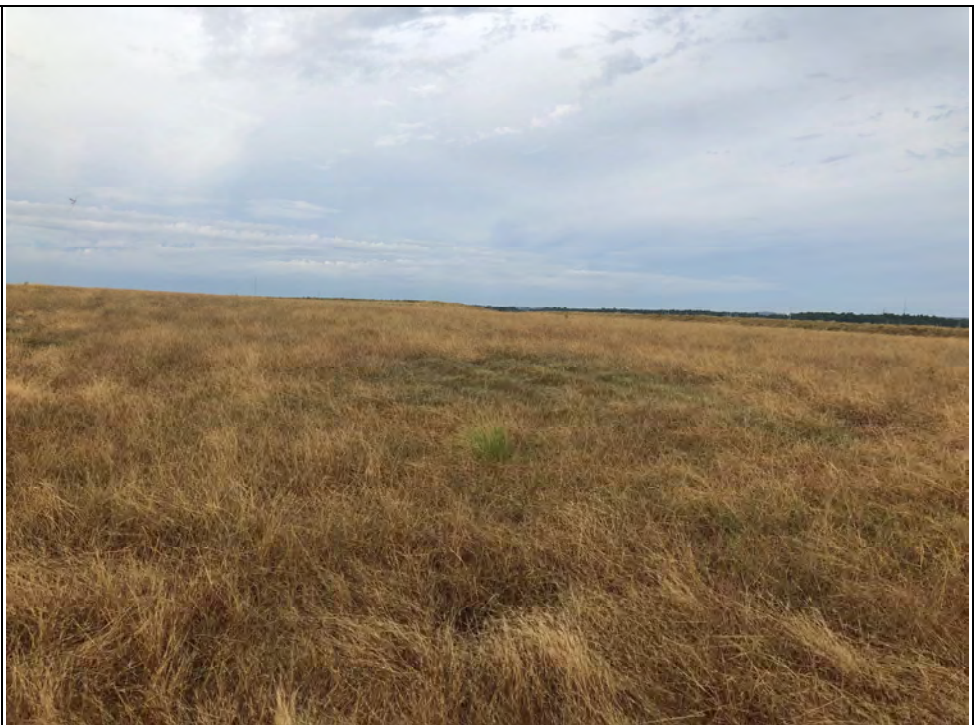
Image: 3353
Date: 10/16/2019
Time: 7:43:00 AM
Direction: Northwest

Final cover on plateau.
Vegetation is well established. No signs of animal burrows or erosion.

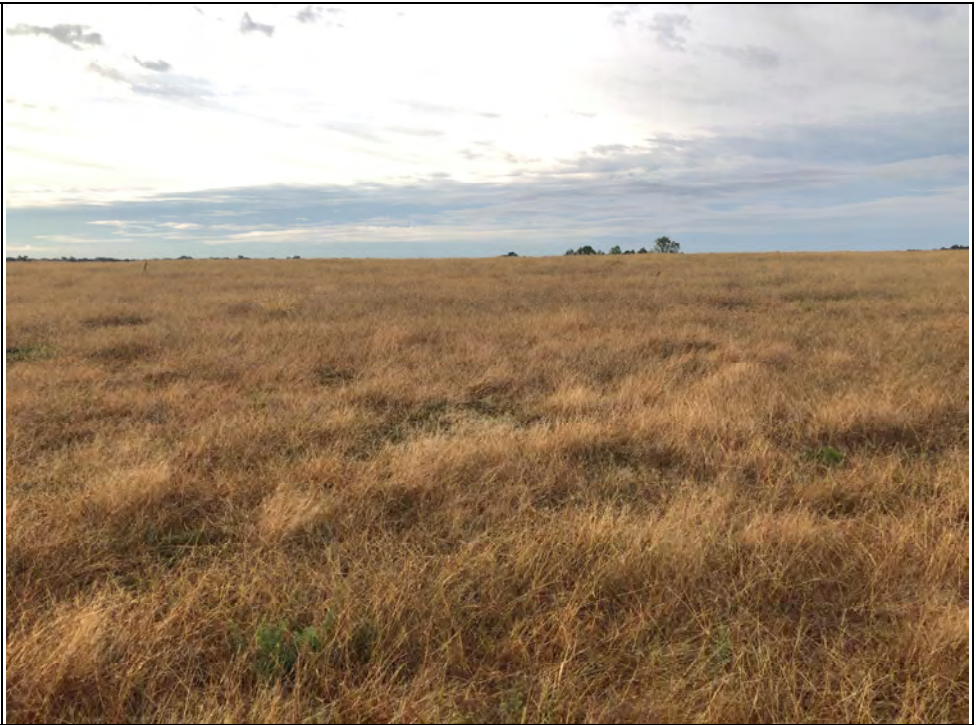
Image: 3355
Date: 10/16/2019
Time: 7:44:00 AM
Direction: South

Final cover on plateau.
Vegetation is well established. No signs of animal burrows or erosion.

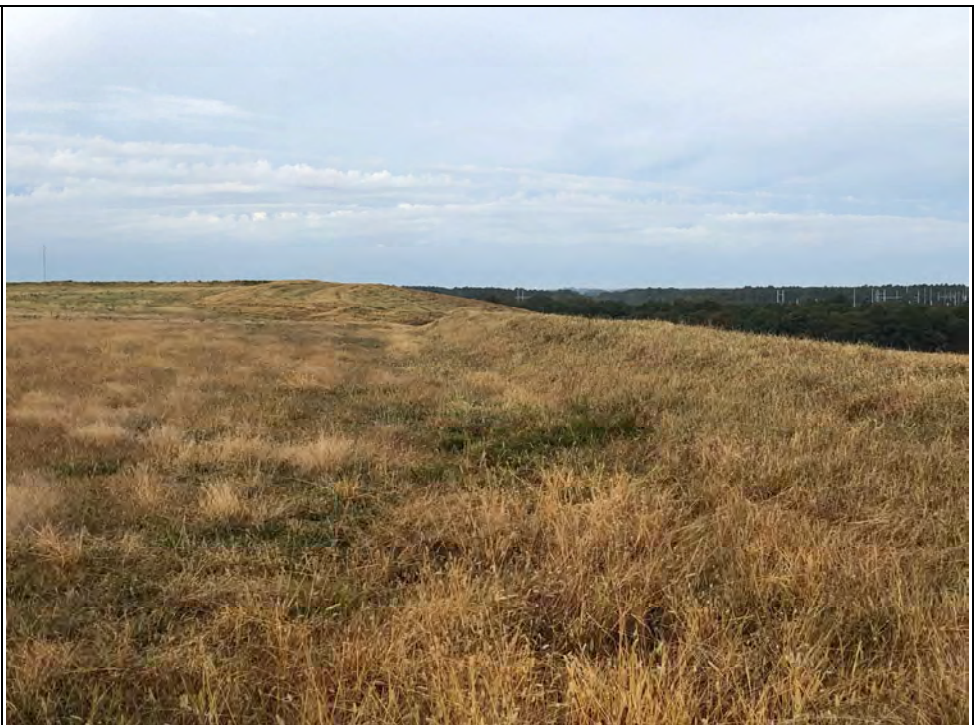
Image: 3357
Date: 10/16/2019
Time: 7:44:00 AM
Direction: Northwest

Final cover on plateau.
Vegetation is well established. No signs of animal burrows or erosion.

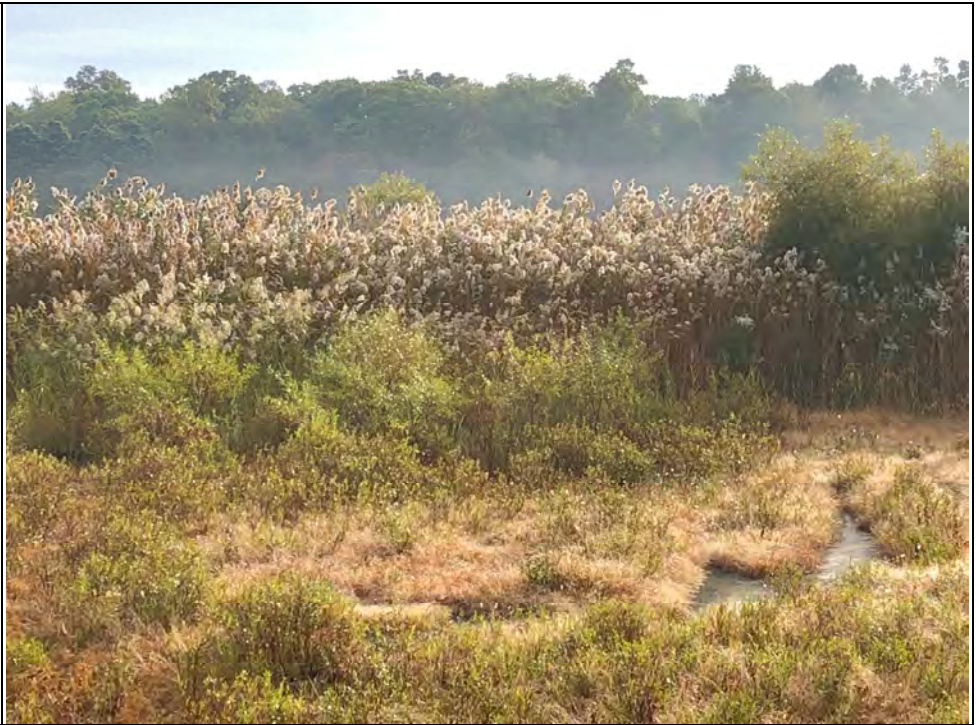
Image: 3359
Date: 10/16/2019
Time: 7:48:00 AM
Direction: East

Southwest forebay of Northeast Detention Basin (Non-Contact Water). Functioning as intended.

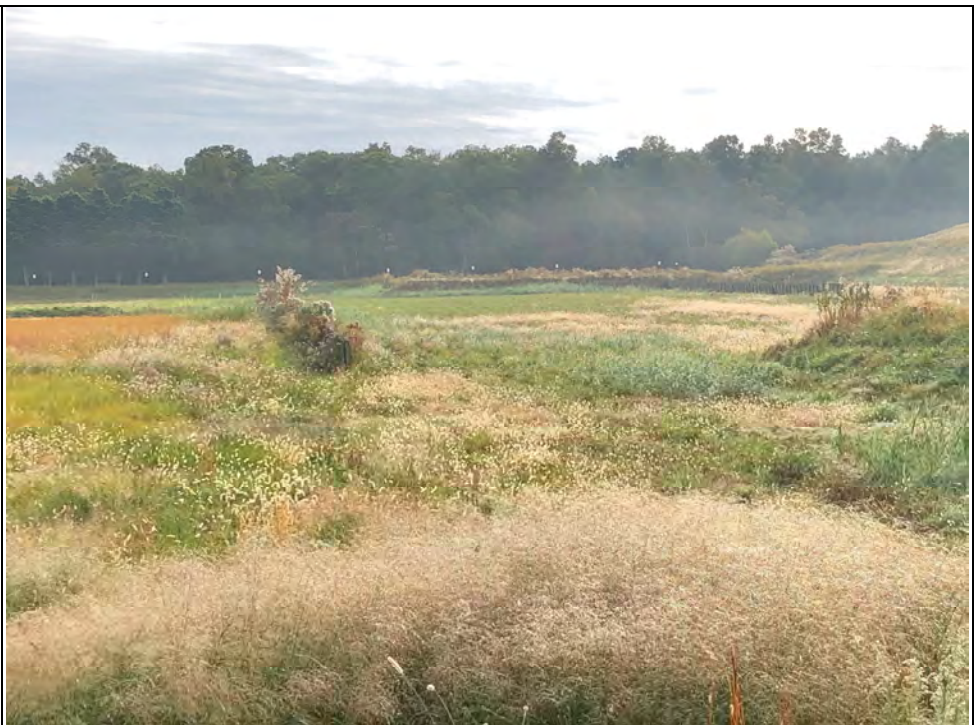
Image: 3361
Date: 10/16/2019
Time: 7:49:00 AM
Direction: East

Northeast Detention Basin (Non-Contact Water).

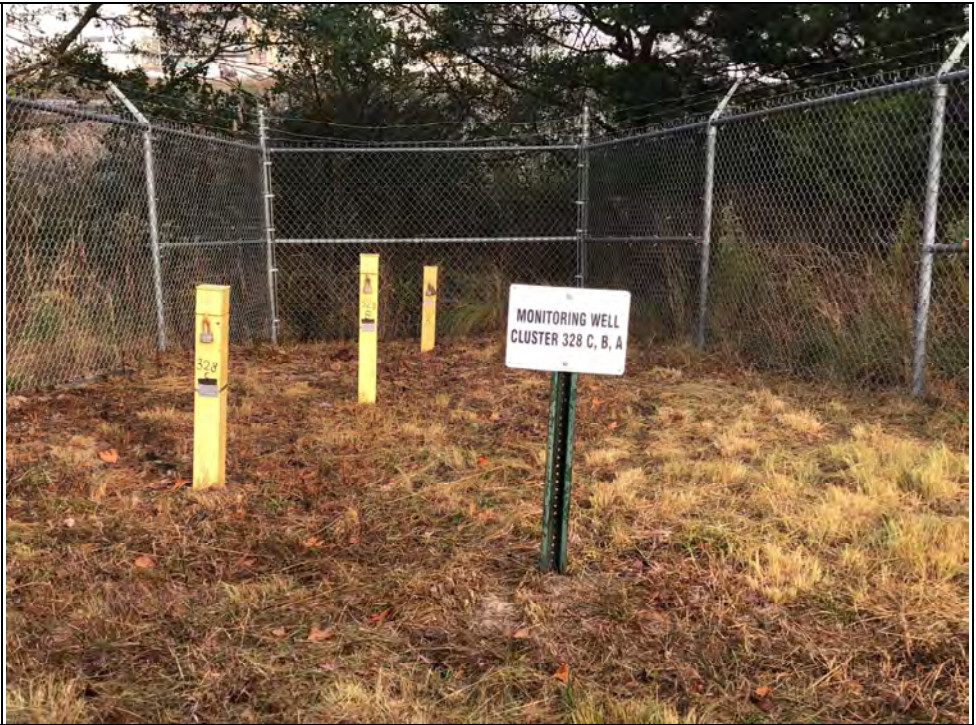
Image: 3363
Date: 10/16/2019
Time: 7:49:00 AM
Direction: North

Description:
Monitoring well cluster.

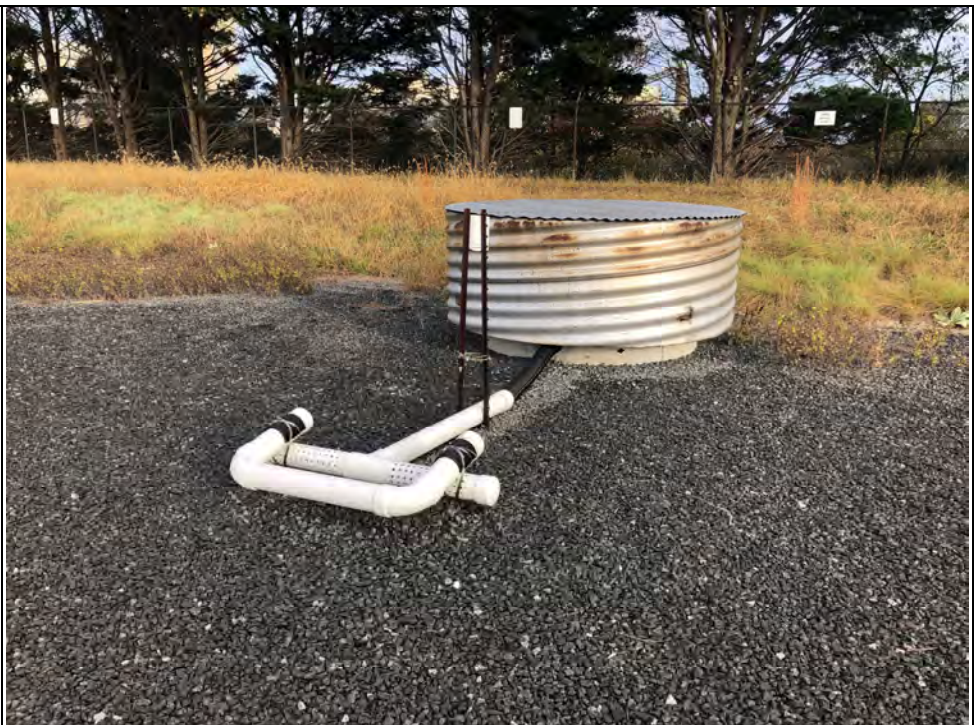
Image: 3365
Date: 10/16/2019
Time: 7:51:00 AM
Direction: Northwest

Description:
Northeast Detention Basin outlet skimmer.

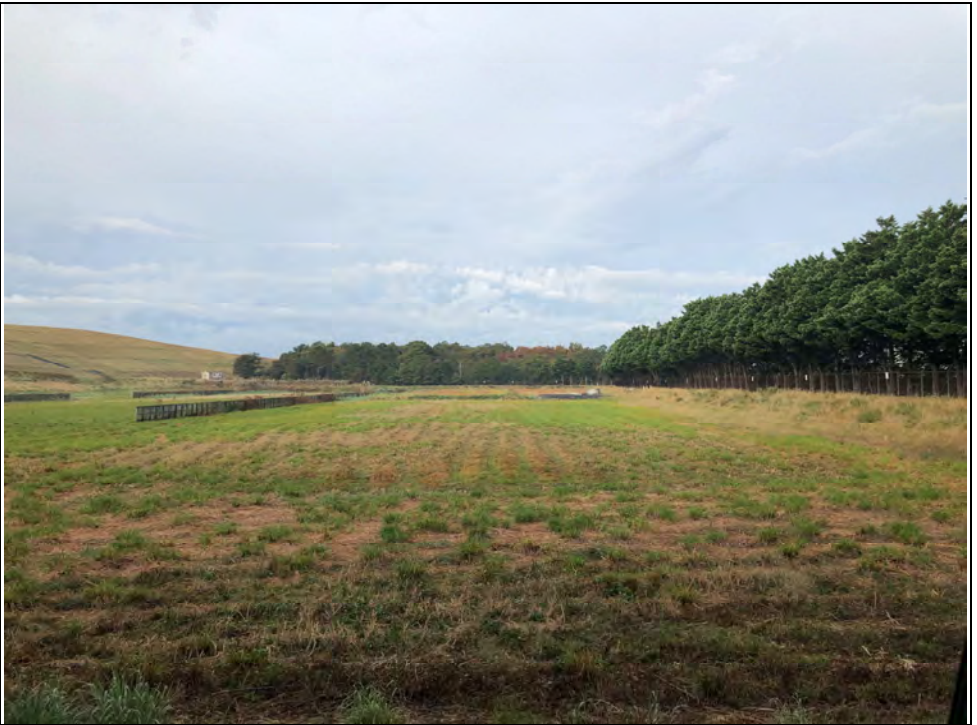
Image: 3367
Date: 10/16/2019
Time: 7:53:00 AM
Direction: West

Northeast Detention Basin
(Non-Contact Water).

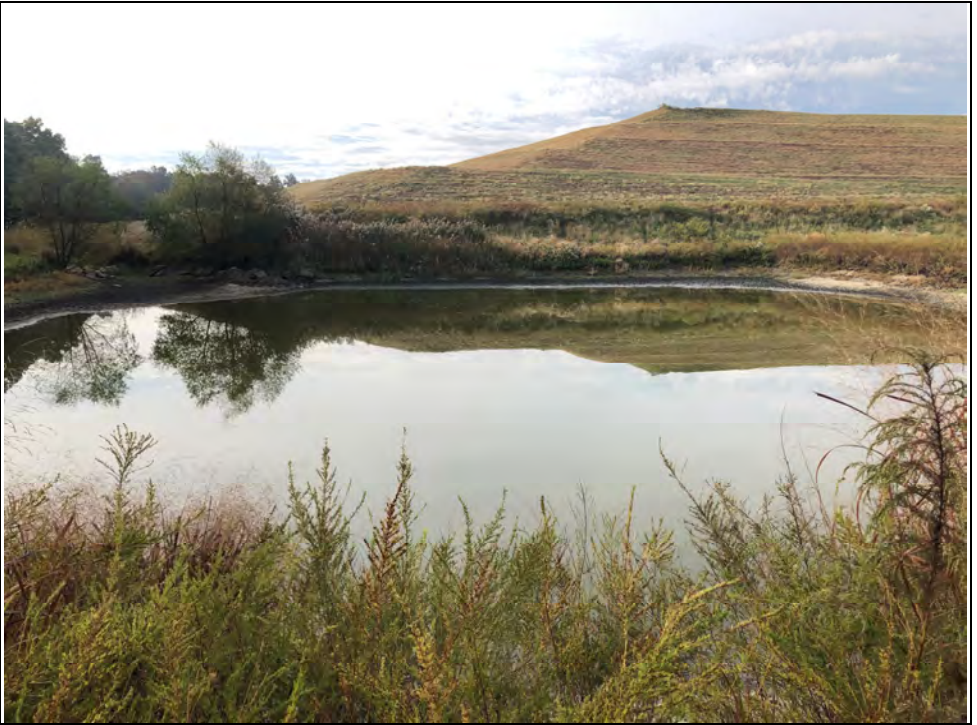
Image: 3369
Date: 10/16/2019
Time: 7:53:00 AM
Direction: South

Southeast forebay of
Northeast Detention Basin
(Non-Contact Water).
Functioning as intended.

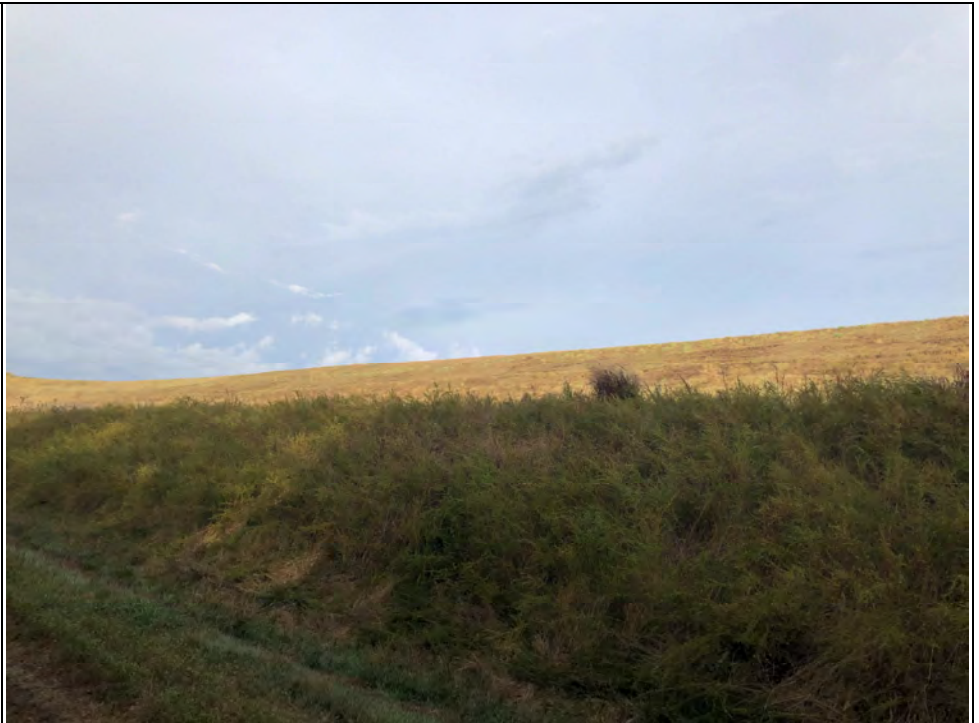
Toe of slope. No sign of erosion or slope stability issues.
