## Inspection Report

**To:** David Bacher, NRG  
**From:** Richard Southorn, P.E., P.G.  
**Re:** Indian River Landfill – Annual CCR Unit Inspection Report  
**Inspection Date:** October 29, 2020  
**Memo Date:** January 18, 2021

**Project: Indian River Landfill 2020 Annual Inspection**

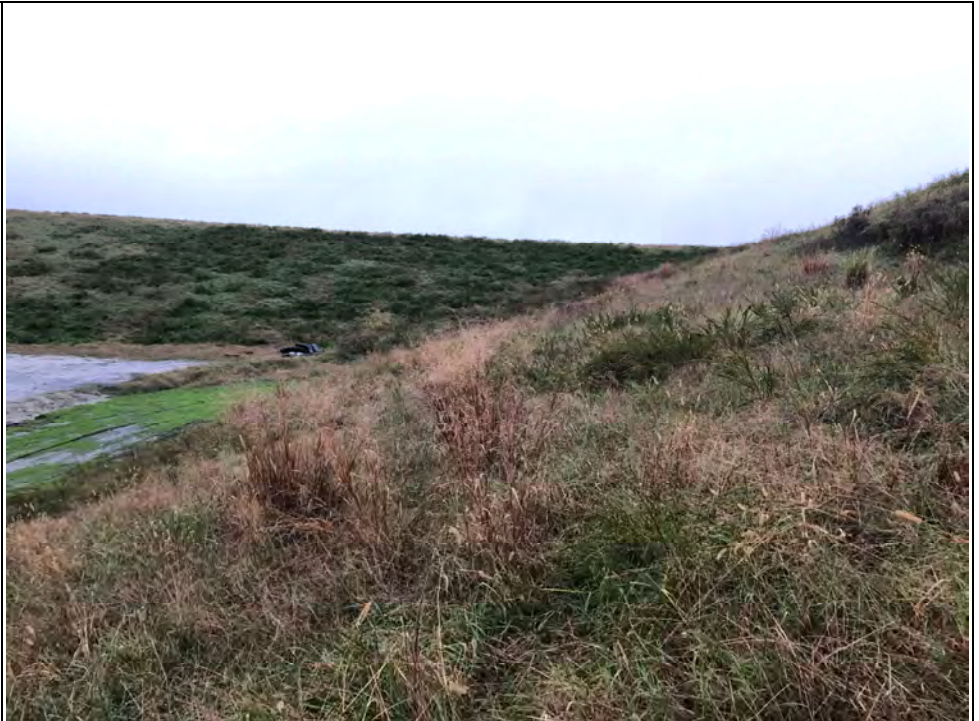
Image: 7384  
 Date: 10/29/2020  
 Time: 6:36 AM  
 Direction: East

Phase 2 Cell 1/Cell 2 boundary. Slopes are well vegetated with no sign of erosion, sloughing, or animal borrows.

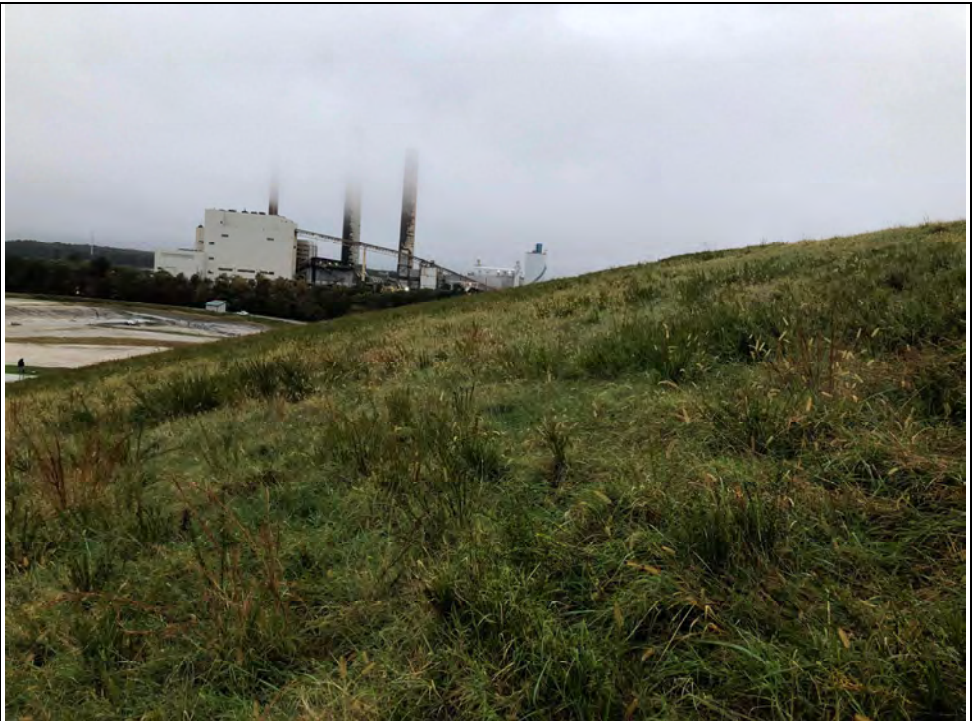
Image: 7402  
Date: 10/29/2020  
Time: 6:41 AM  
Direction: North

Phase I intermediate cover slopes are well vegetated with no sign of erosion or sloughing. Vegetation shown was mowed shortly before inspection.

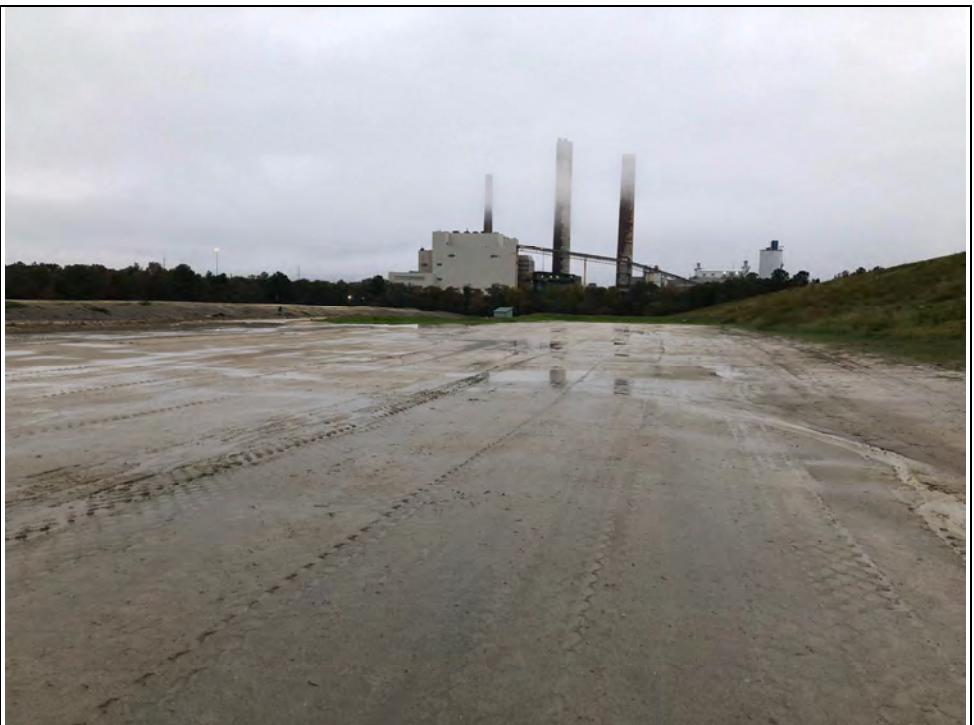
Image: 7404  
Date: 10/29/2020  
Time: 6:42 AM  
Direction: North-Northwest

Active face is well maintained. Material is graded and compacted. No ponding water.

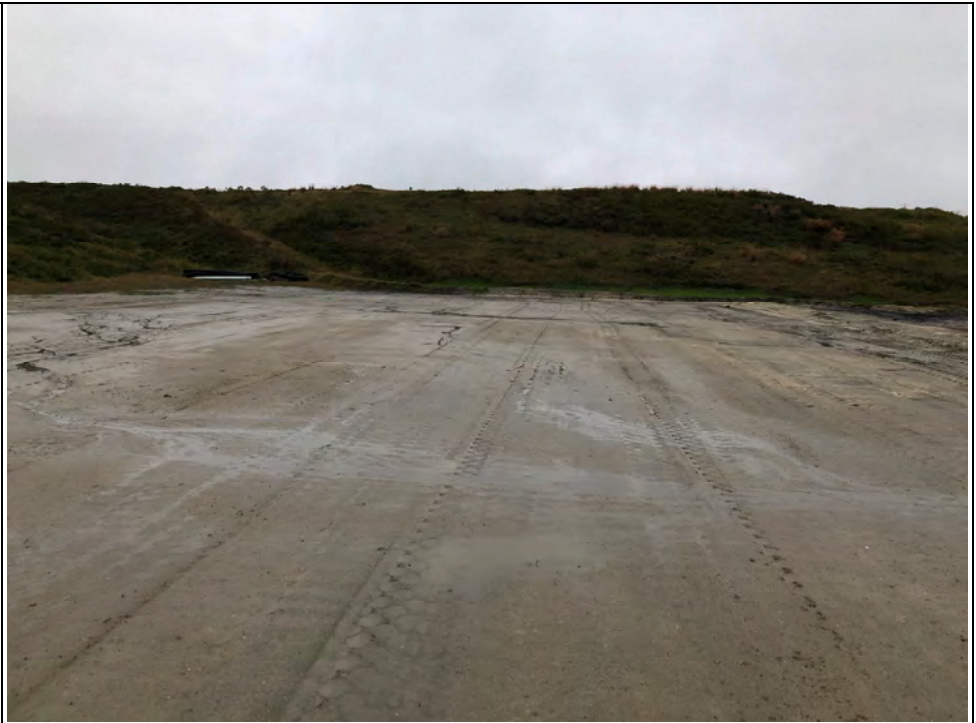
Image: 7406  
 Date: 10/29/2020  
 Time: 6:43 AM  
 Direction: South

Active face is well maintained. Material is graded and compacted. No ponding water.

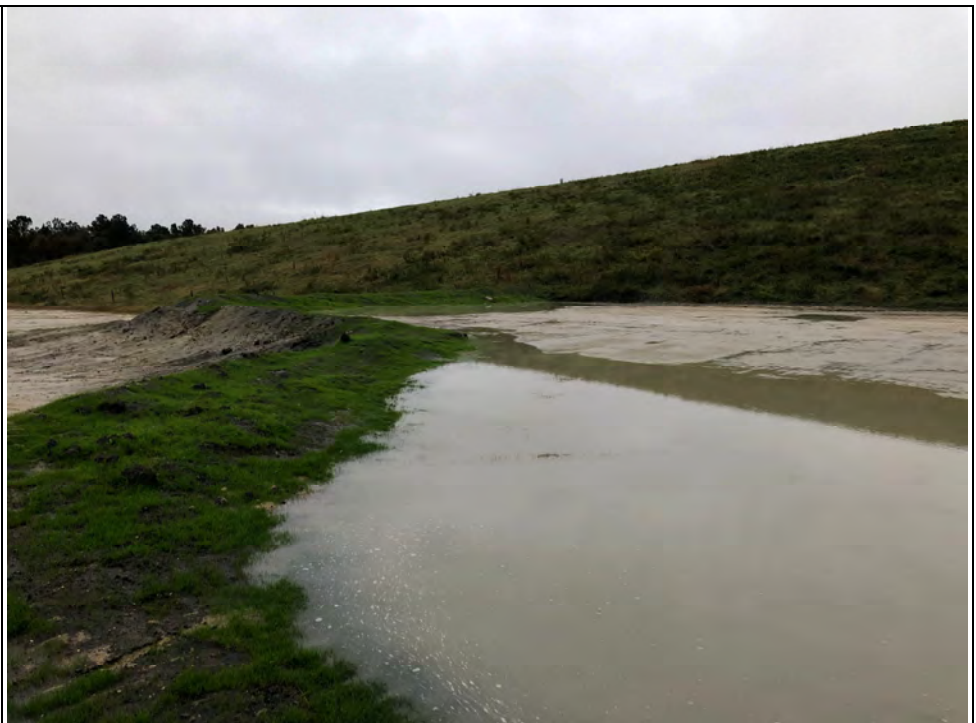
Image: 7408  
 Date: 10/29/2020  
 Time: 6:44 AM  
 Direction: Northeast

Erosion control berm that has been established on active face. This berm slows contact water travelling over the active face during rain events, which in turn minimizes erosion. Pipes at the toe of the berm collect contact water and convey it to the leachate sump.

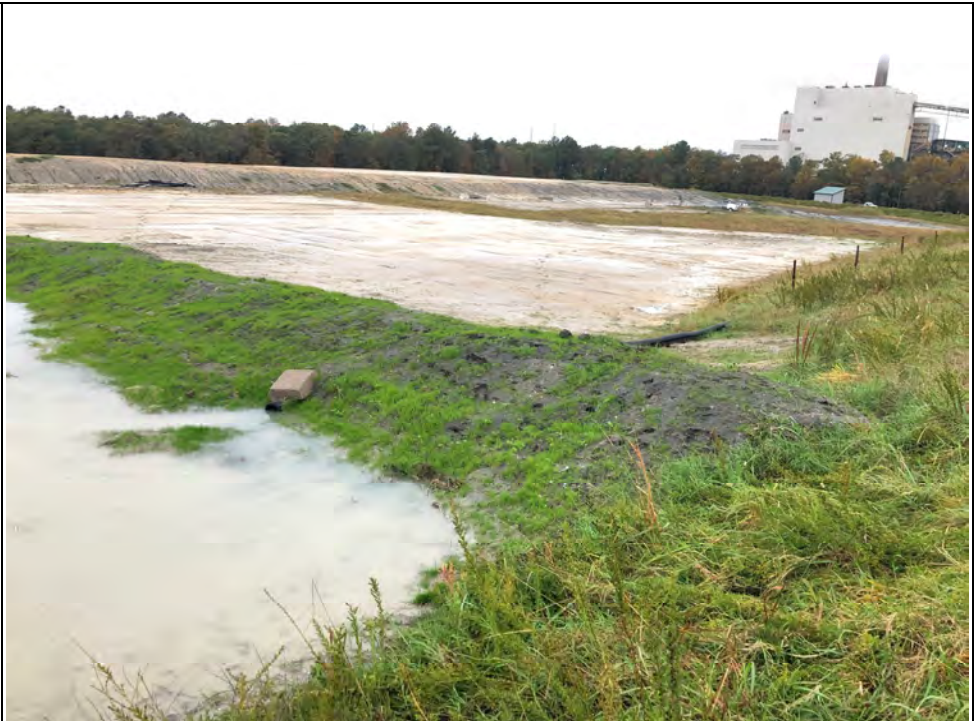
Image: 7414  
 Date: 10/29/2020  
 Time: 6:46 AM  
 Direction: Northwest

Description: Erosion control berm that has been established on active face. This berm slows contact water travelling over the active face during rain events, which in turn minimizes erosion. Pipes at the toe of the berm collect contact water and convey it to the leachate sump. The pipe inlet is below a concrete block; the pipe can be seen in the photograph.

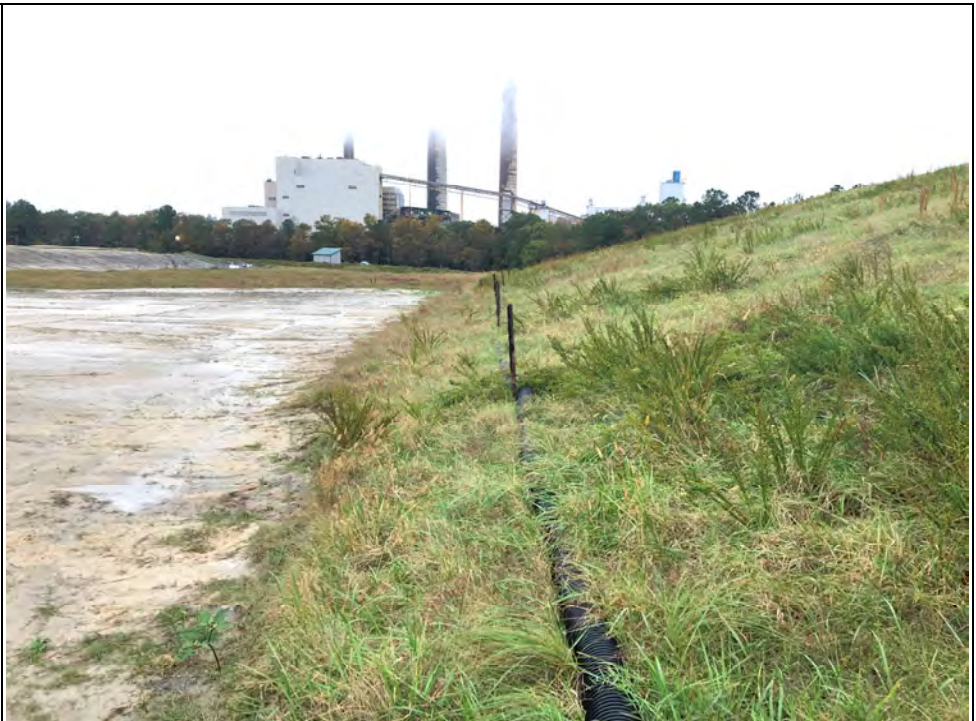
Image: 7416  
 Date: 10/29/2020  
 Time: 6:47 AM  
 Direction: North

Phase I intermediate cover slopes are well vegetated with no sign of erosion or sloughing. Active face is on left. Contact water run-off pipe described in photograph 7414 is shown running along toe of slope.

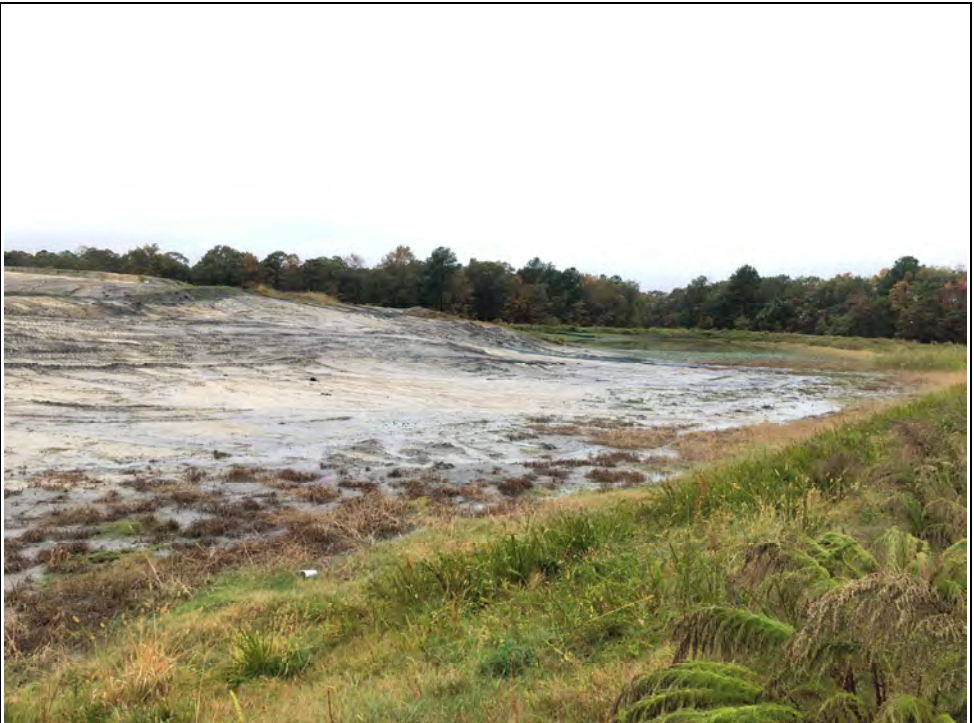
Image: 7432  
Date: 10/29/2020  
Time: 6:55 AM  
Direction: West-Northwest

Sump area of active face. During the previous inspection, standing water was present in this location due to large rains. Significant efforts have been made to remove standing water, which was treated as leachate.

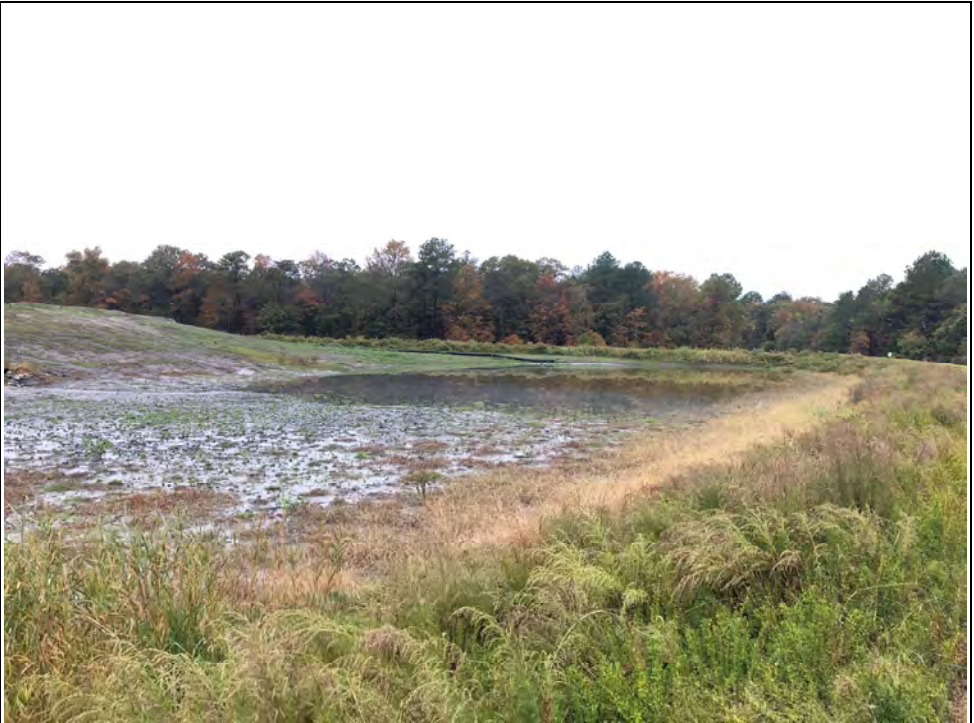
Image: 7434  
Date: 10/29/2020  
Time: 6:57 AM  
Direction: West

Sump area of active face. Standing water is present in this location due to large rains. Significant efforts have been made to remove standing water, which was treated as leachate.

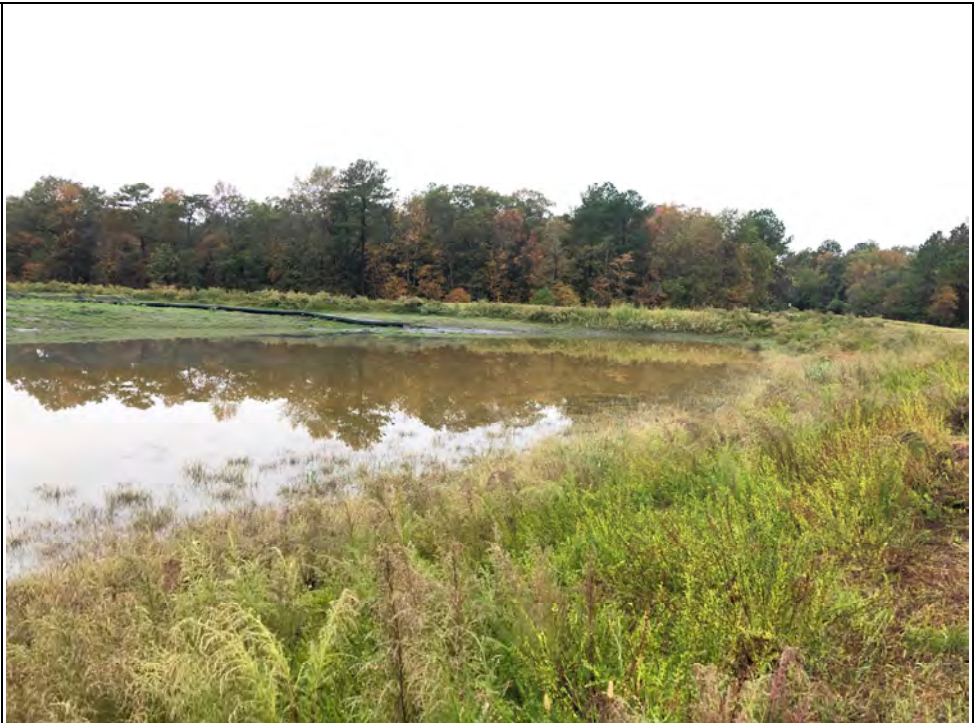
Image: 7436  
Date: 10/29/2020  
Time: 6:58 AM  
Direction: West

Sump area of active face. Standing water is present in this location due to large rains. Significant efforts have been made to remove standing water, which was treated as leachate.

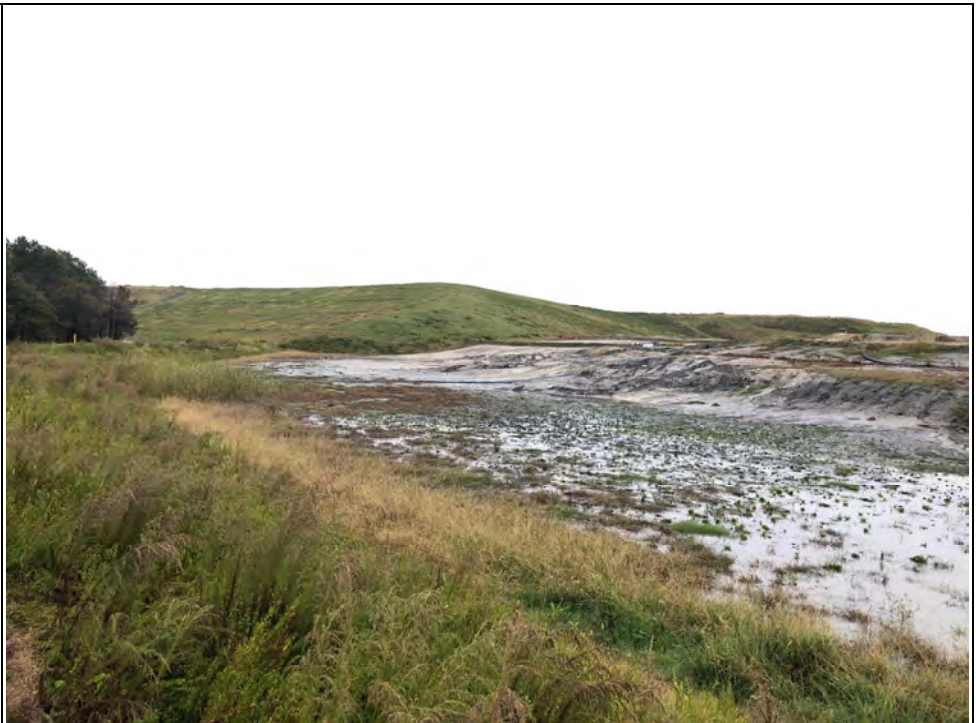
Image: 7438  
Date: 10/29/2020  
Time: 6:58 AM  
Direction: South-Southeast

Sump area of active face. Standing water is present in this location due to large rains. Significant efforts have been made to remove standing water, which was treated as leachate.

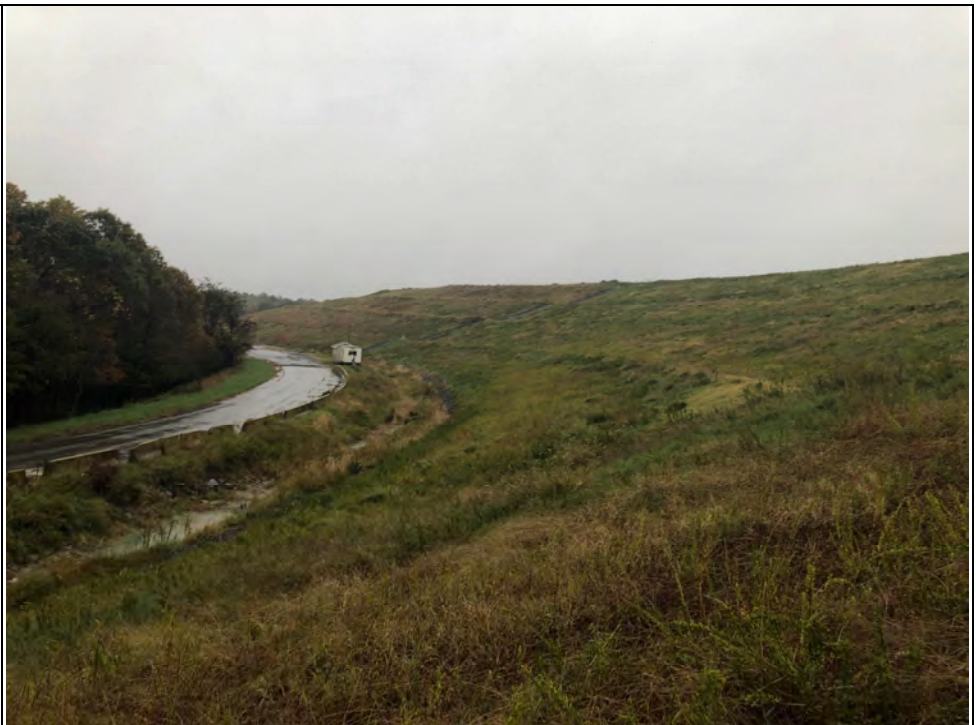
Image: 7482  
Date: 10/29/2020  
Time: 7:31 AM  
Direction: East-Southeast

Landfilll sideslopes and terraces are well maintained. No evidence of slope stability issues.

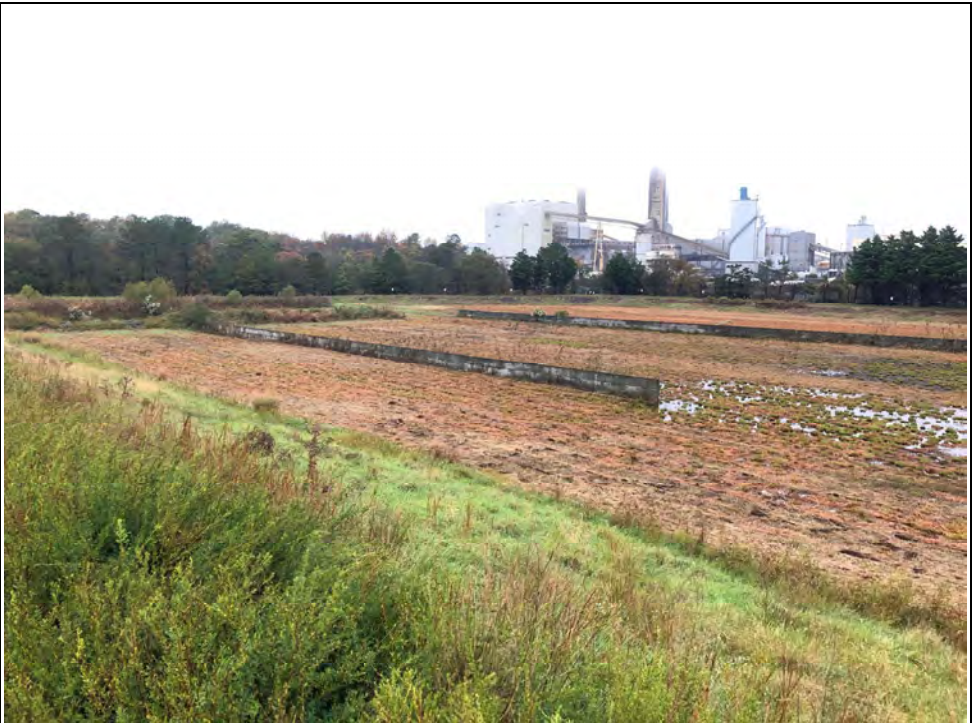
Image: 7492  
Date: 10/29/2020  
Time: 7:59 AM  
Direction: Northwest

Overview of detention basin. No appreciable water retention, despite significant rains occurring at time of inspection.

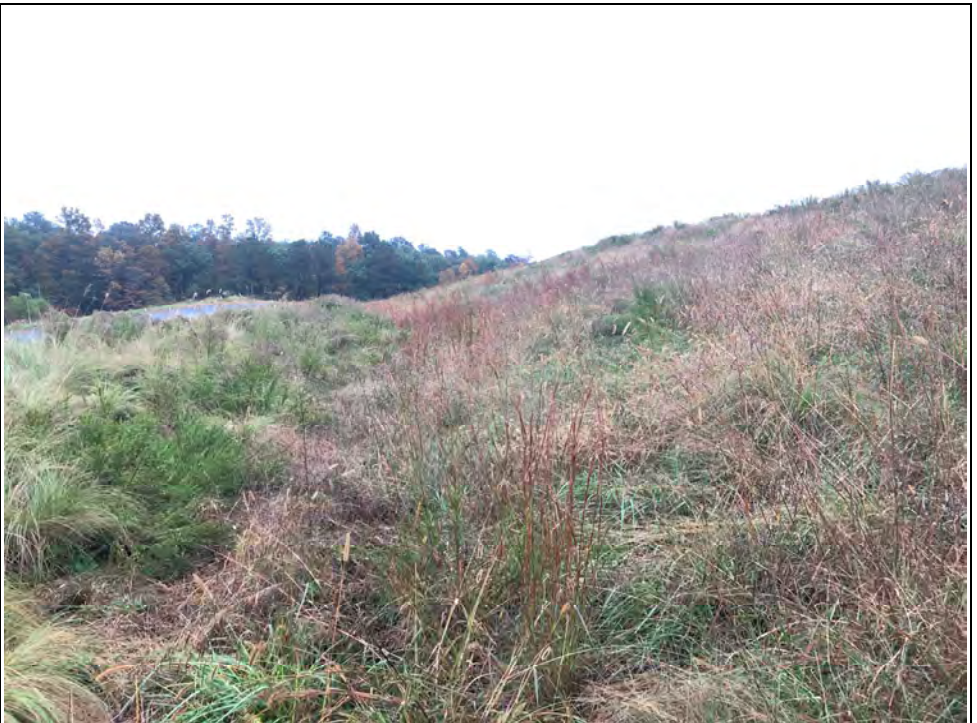
Image: 7494  
Date: 10/29/2020  
Time: 8:00 AM  
Direction:

Phase 1 terrace berm. Clear of obstructions and functioning as intended. Vegetative cover is dense and healthy.

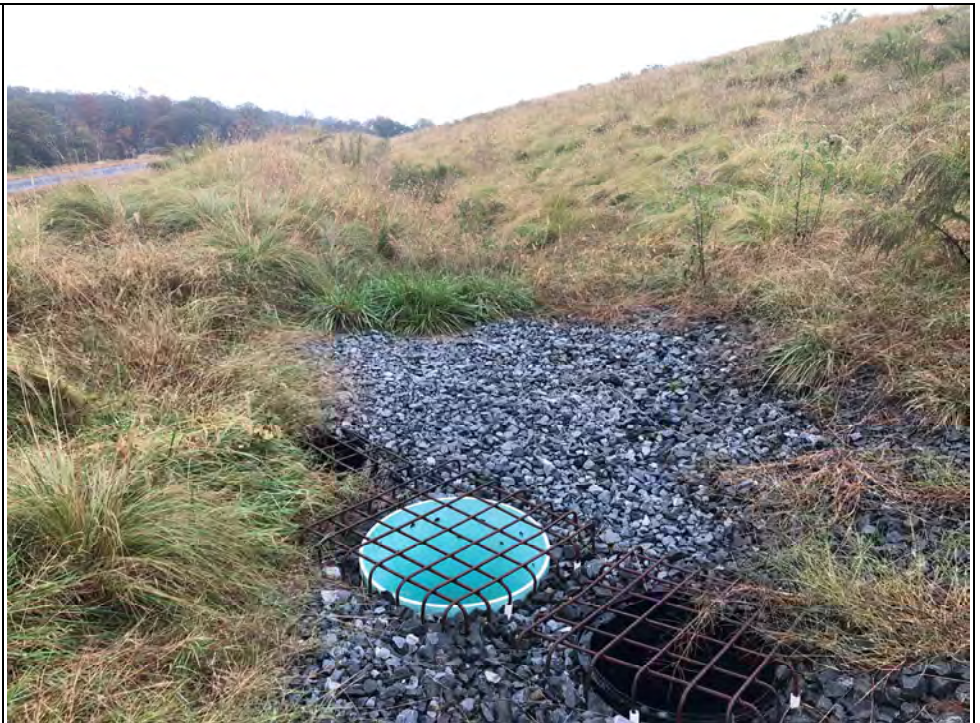
7504

Phase 1 corner downchute road crossing equalizing pipes. Free of obstructions.

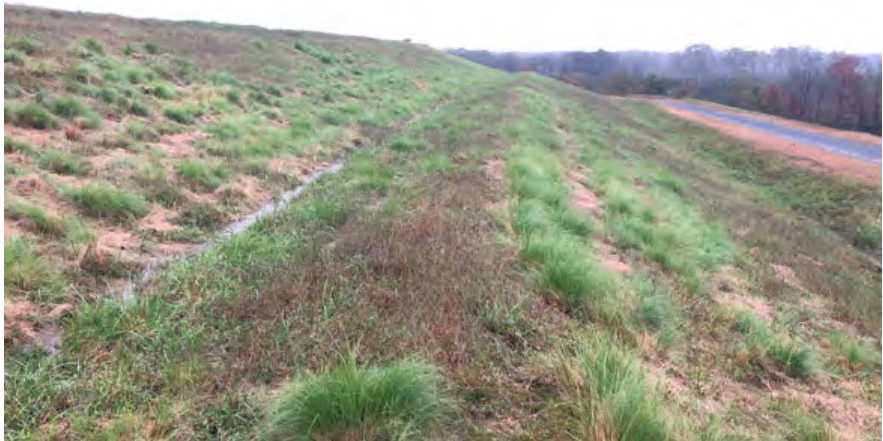
Image: 7520  
Date: 10/29/2020  
Time: 8:12 AM  
Direction: East Northeast

Phase 1 final cover and stormwater terraces. Well maintained and functioning as intended.

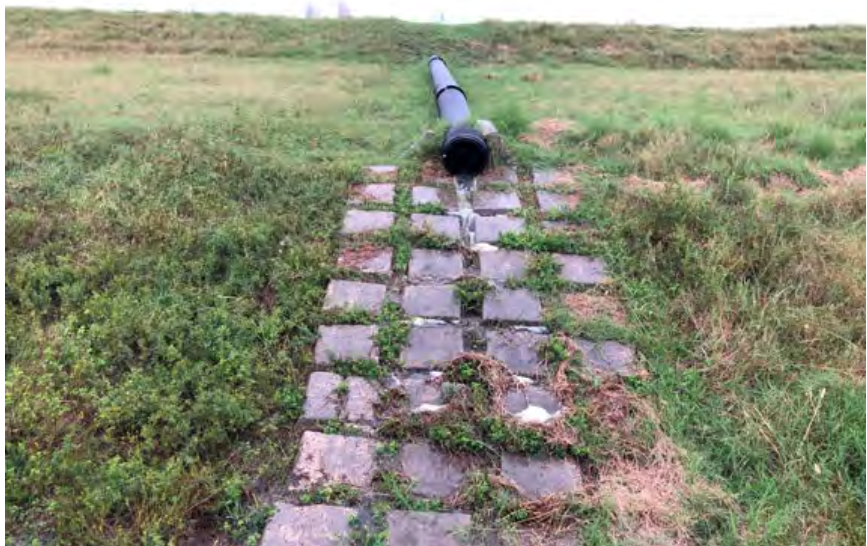
Image: 7523  
Date: 10/29/2020  
Time: 8:13 AM  
Direction: North Northwest

Letdown pipe location from plateau terrace into access road ditch. Free draining. No evidence of erosion.

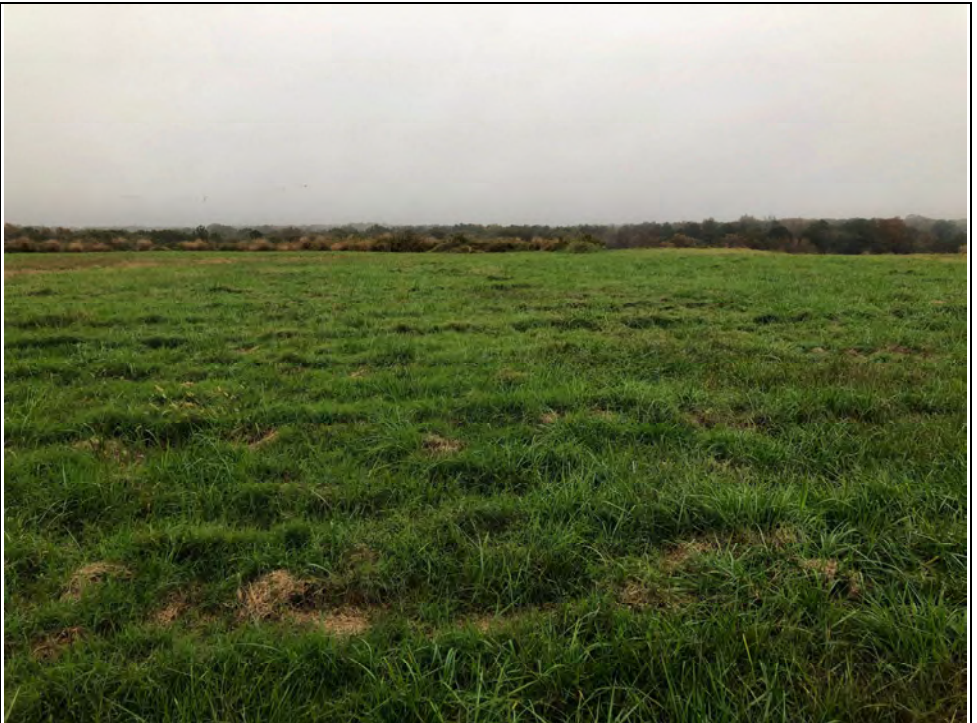
Image: 7528  
Date: 10/29/2020  
Time: 8:16 AM  
Direction: West Northwest

Final cover on plateau.  
Vegetation is well established. No signs of animal burrows or erosion.

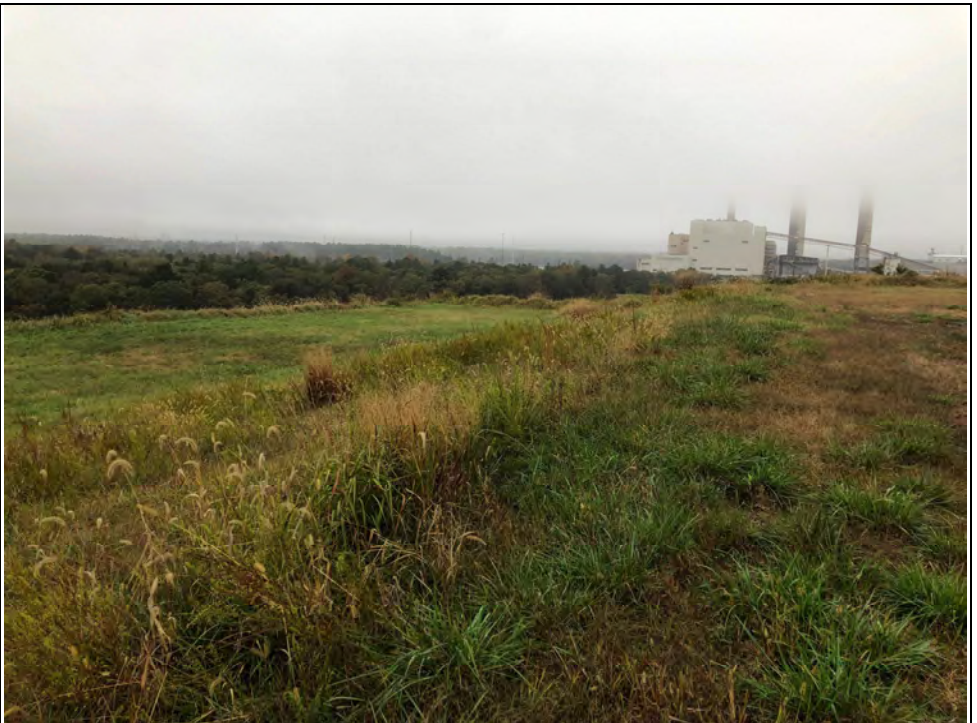
Image: 7530  
Date: 10/29/2020  
Time: 7:34 AM  
Direction:

Final cover on plateau.  
Vegetation is well established. No signs of animal burrows or erosion.

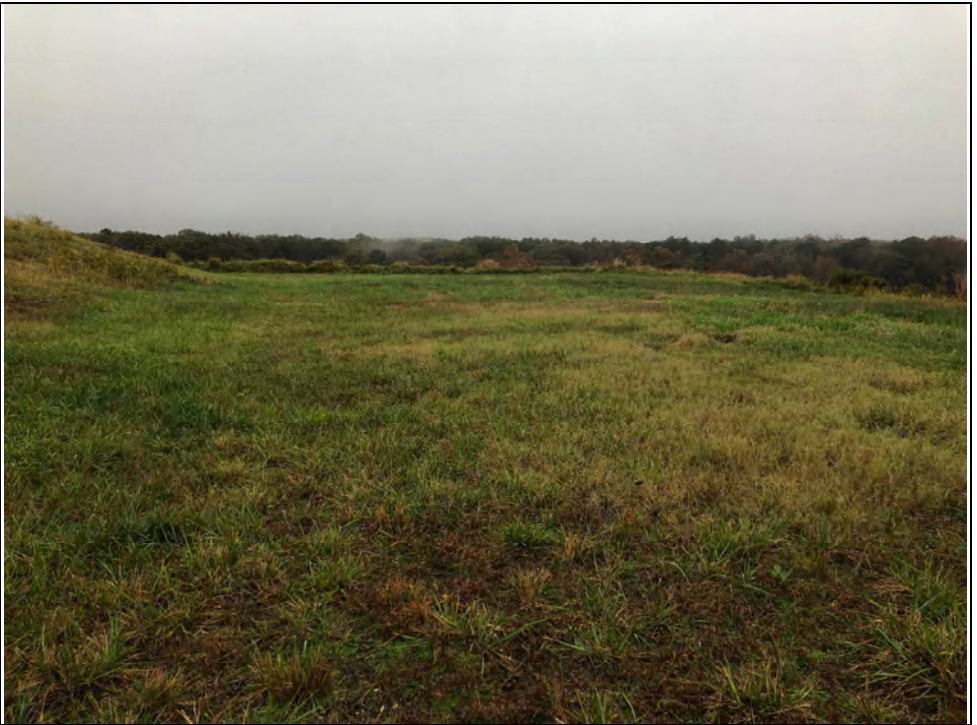
Image: 7532  
Date: 10/29/2020  
Time: 7:35 AM  
Direction: South

Final cover on plateau.  
Vegetation is well established. No signs of animal burrows or erosion.

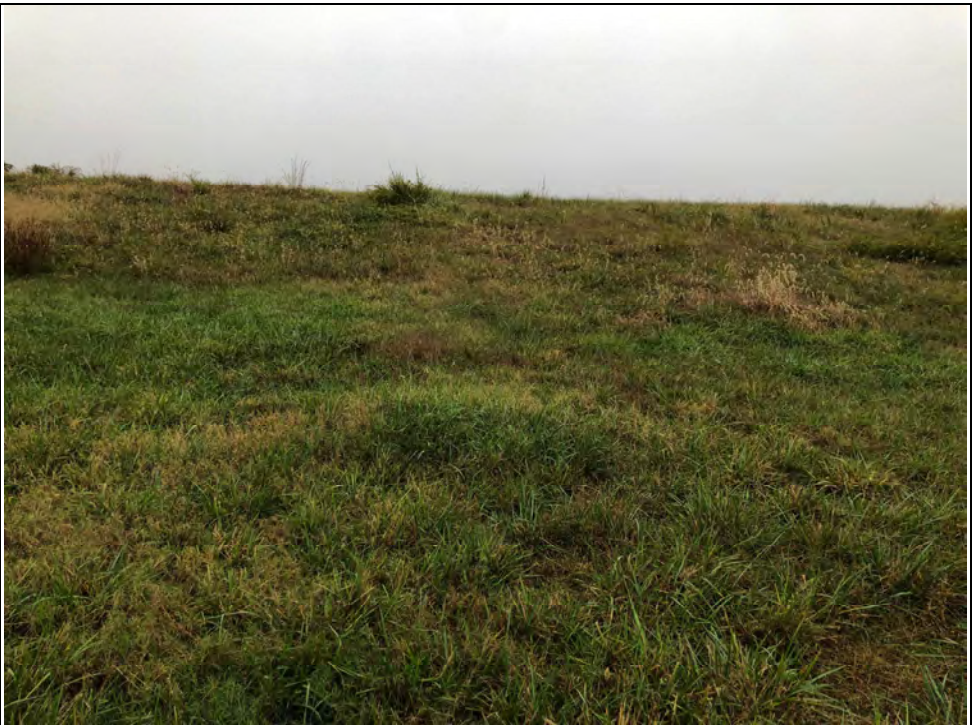
Image: 7534  
Date: 10/29/2020  
Time: 7:38 AM  
Direction: West

Final cover on sideslopes.  
Vegetation is well established. No signs of animal burrows or erosion.

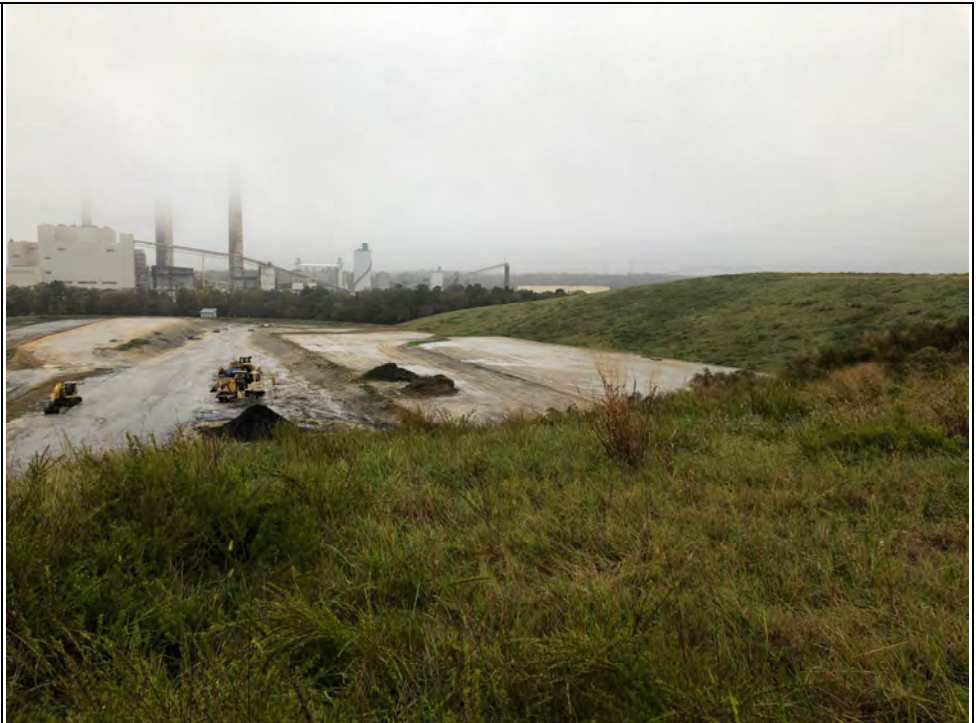
Image: 7536  
Date: 10/29/2020  
Time: 7:40 AM  
Direction: North Northwest

Phase 2, Cell 2 active area from Phase 2 Cell 1 plateau.

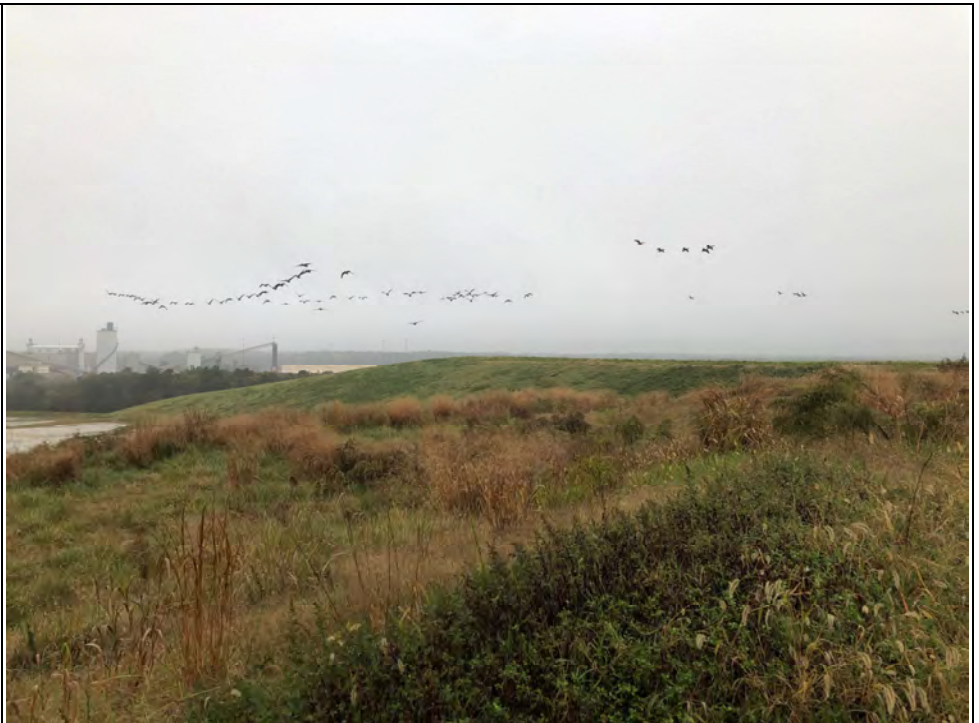
Image: 7538  
Date: 10/29/2020  
Time: 7:41 AM  
Direction: East Northeast

Sideslopes near active face are well maintained.

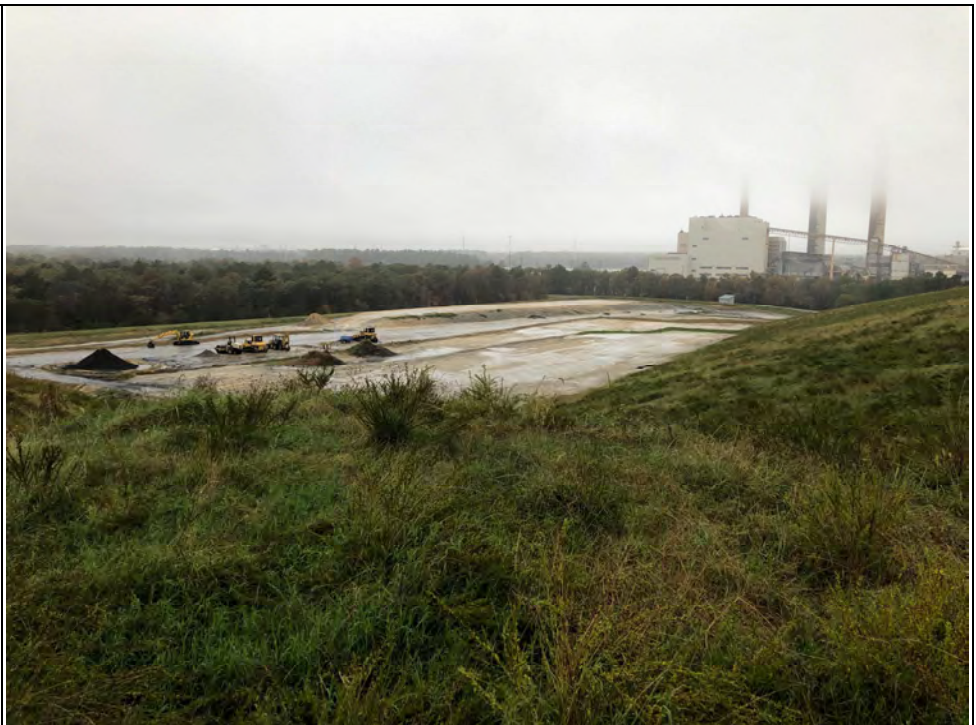
Image: 7540  
Date: 10/29/2020  
Time: 7:41 AM  
Direction: Northwest

Phase 2, Cell 2 active area from Phase 2 Cell 1 plateau.

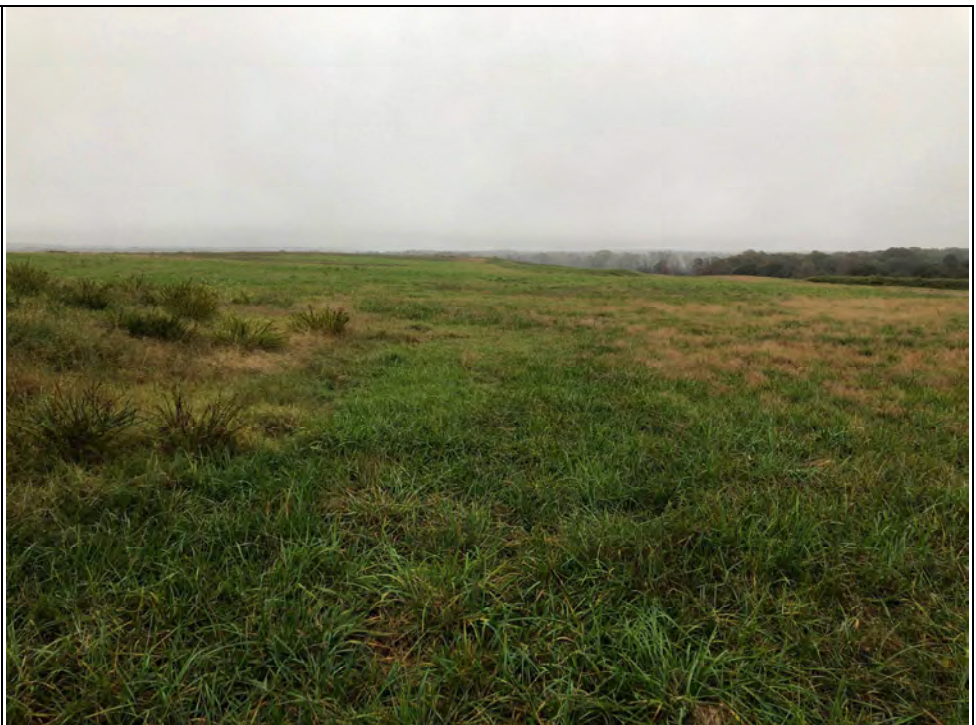
Image: 7542  
Date: 10/29/2020  
Time: 7:43 AM  
Direction:

Final cover on plateau. Vegetation is well established. No signs of animal burrows or erosion.

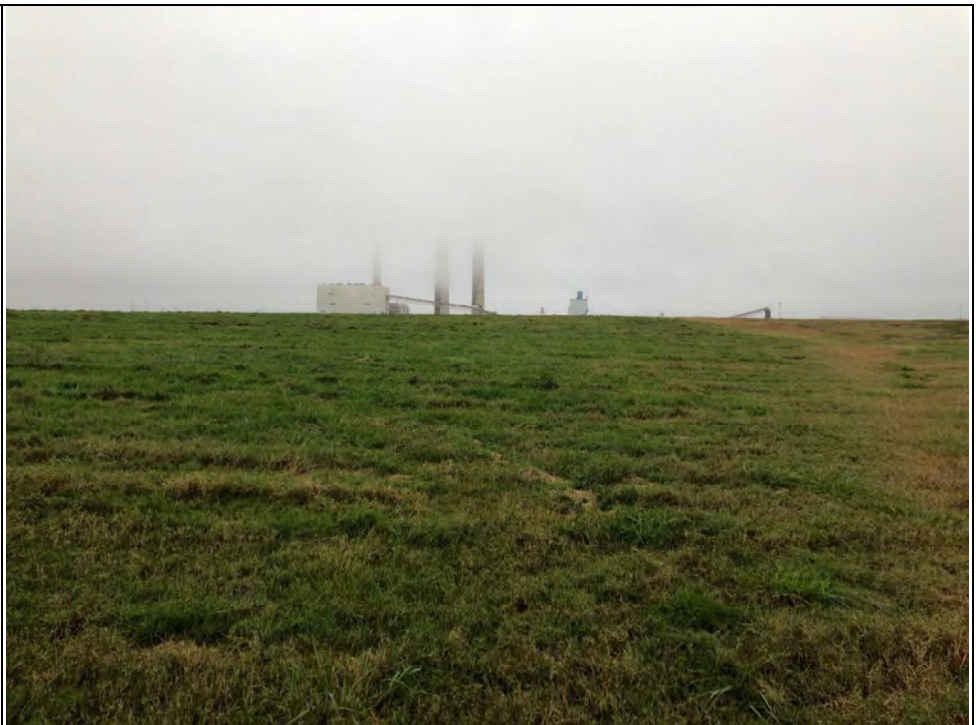
Image: 7544  
Date: 10/29/2020  
Time: 7:43 AM  
Direction:

Final cover on plateau.  
Vegetation is well  
established. No signs of  
animal burrows or erosion.

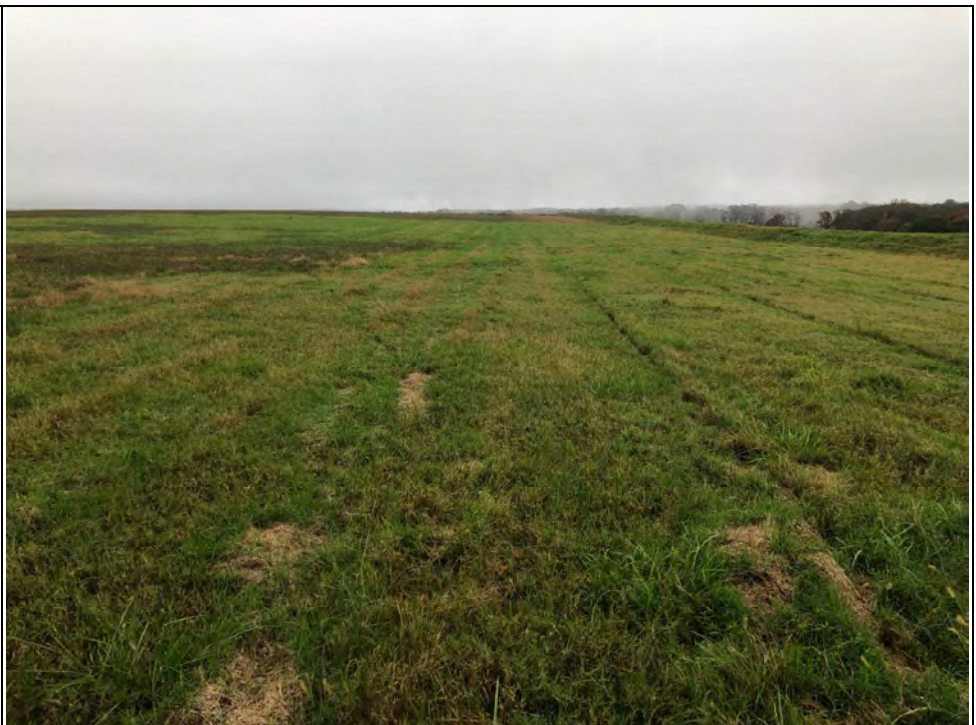
Image: 7546  
Date: 10/29/2020  
Time: 7:43 AM  
Direction: East Northeast

Final cover on plateau.  
Vegetation is well  
established. No signs of  
animal burrows or erosion.

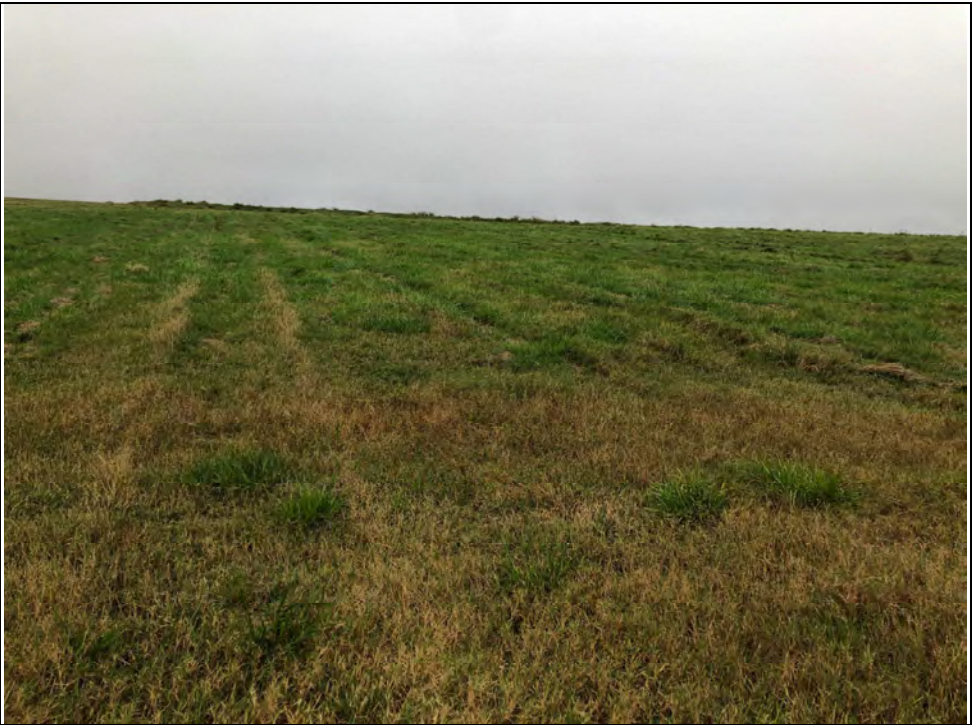
Image: 7548  
Date: 10/29/2020  
Time: 7:43 AM  
Direction: West

Final cover on plateau.  
Vegetation is well established. No signs of animal burrows or erosion.

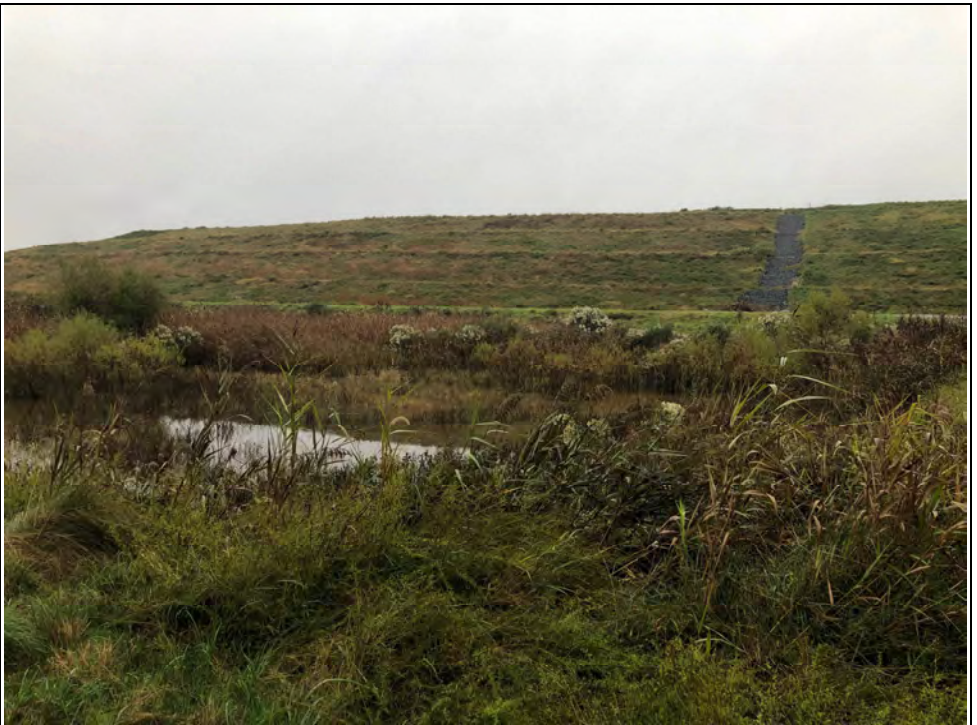
Image: 7550  
Date: 10/29/2020  
Time: 7:45 AM  
Direction: Southeast

Southwest forebay of  
Northeast Detention Basin  
(Non-Contact Water).  
Functioning as intended.

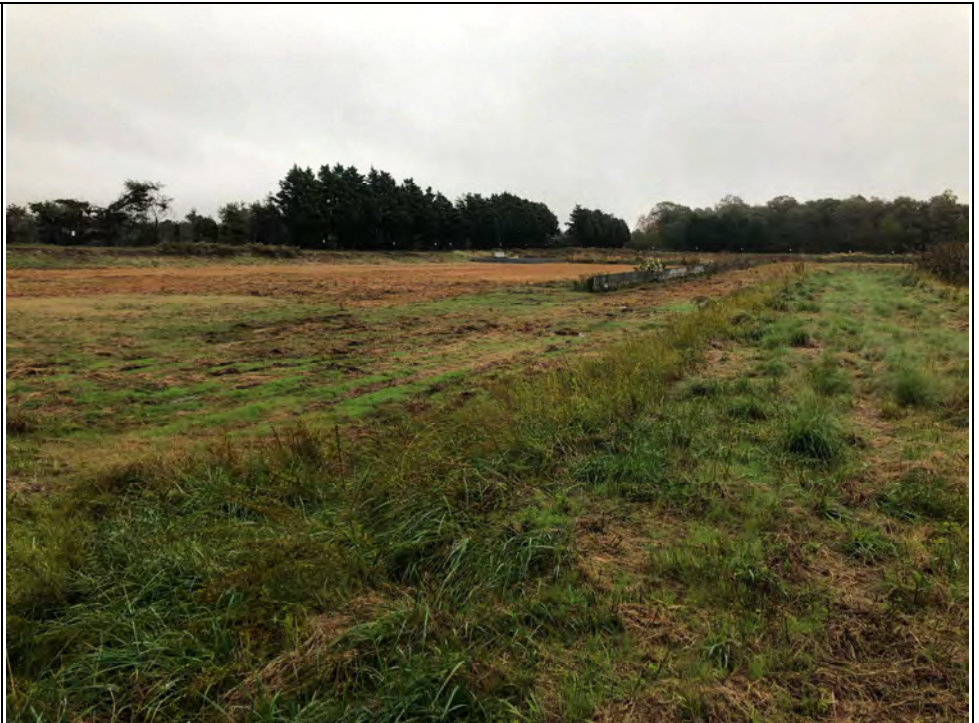
Image: 7552  
Date: 10/29/2020  
Time: 7:45 AM  
Direction: East Northeast

Northeast Detention Basin  
(Non-Contact Water).

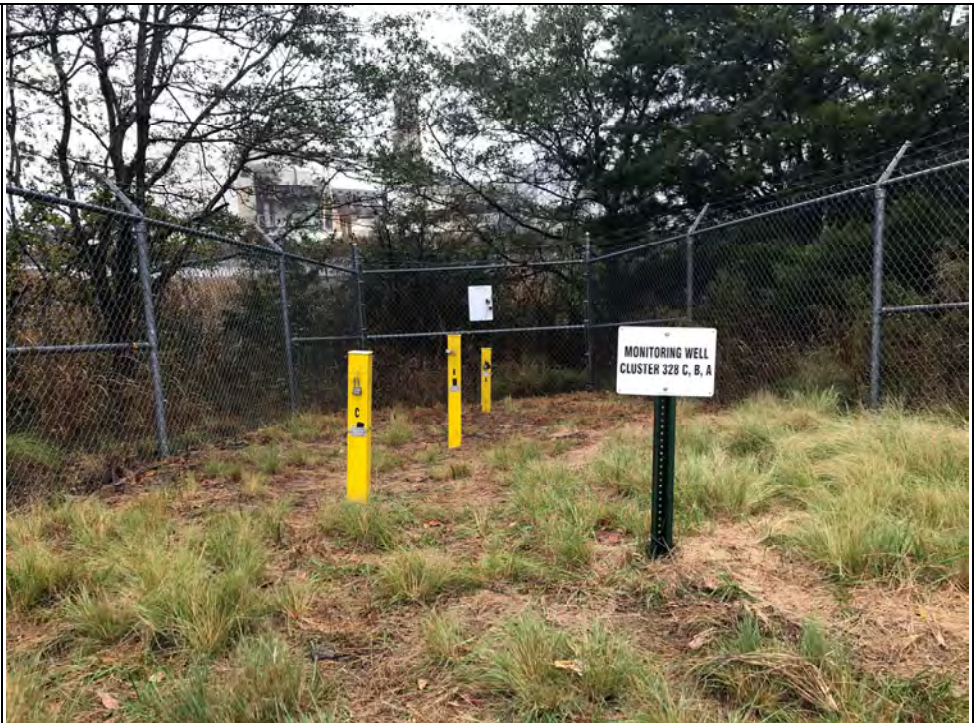
Image: 7554  
Date: 10/29/2020  
Time: 7:46 AM  
Direction: North Northwest

Monitoring well cluster.
