## Inspection Report

**To:** David Bacher, NRG  
**From:** Richard Southorn, P.E., P.G.  
**Re:** Indian River Landfill – Annual CCR Unit Inspection Report  
**Inspection Date:** October 29, 2020  
**Memo Date:** January 18, 2021

**Project: Indian River Landfill 2020 Annual Inspection**

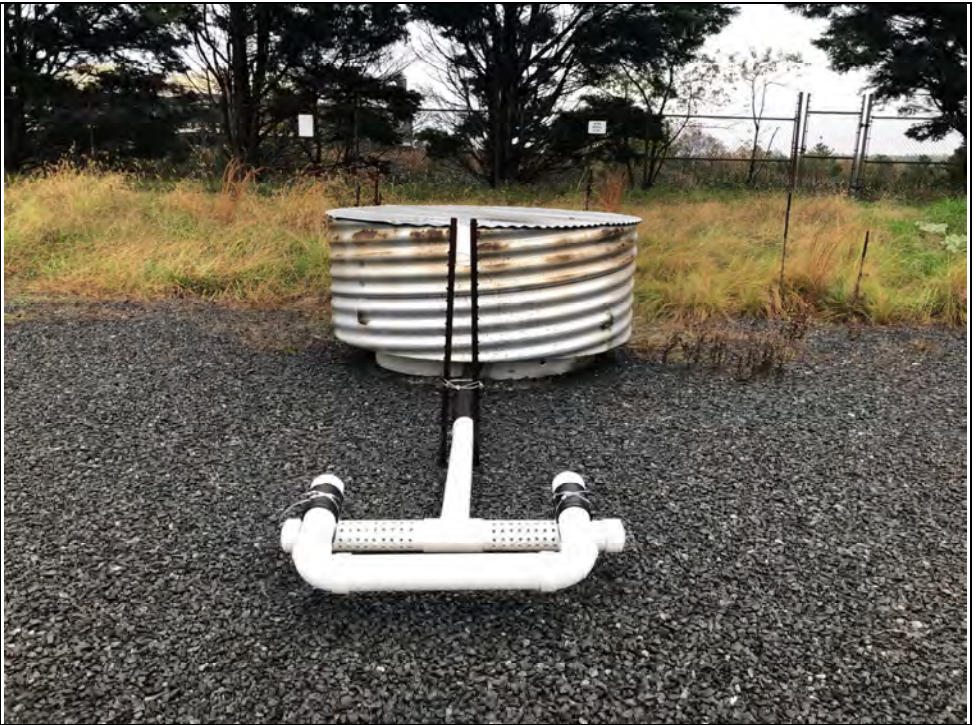
Image: 7556  
Date: 10/29/2020  
Time: 7:47 AM  
Direction: West

Description:  
Northeast Detention Basin outlet skimmer.

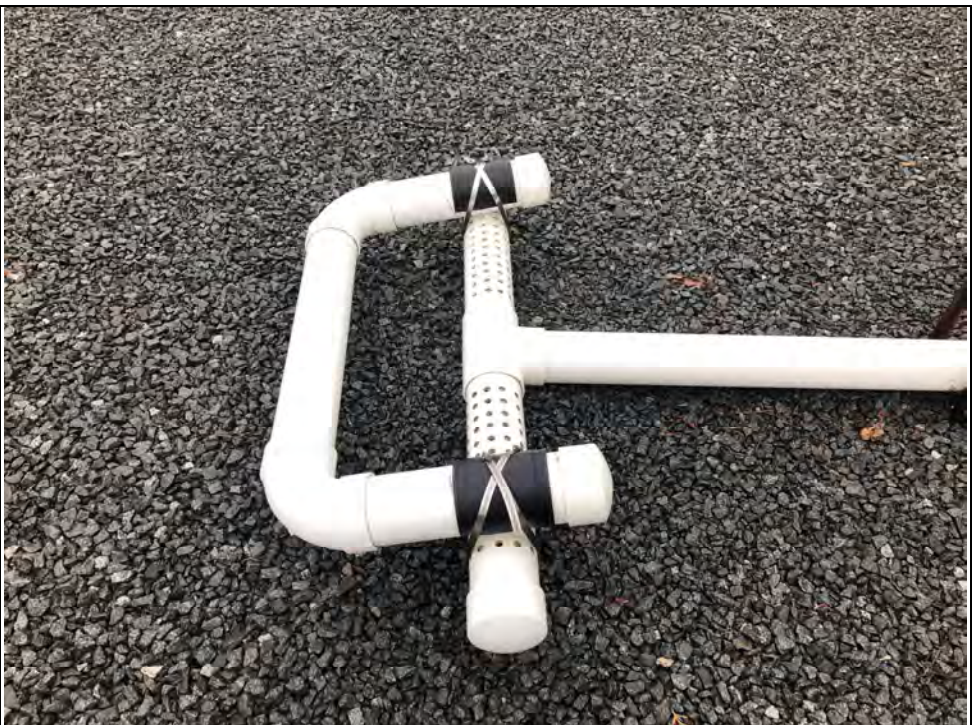
Image: 7558  
Date: 10/29/2020  
Time: 7:47 AM  
Direction: West

Description:  
Northeast Detention Basin outlet skimmer.

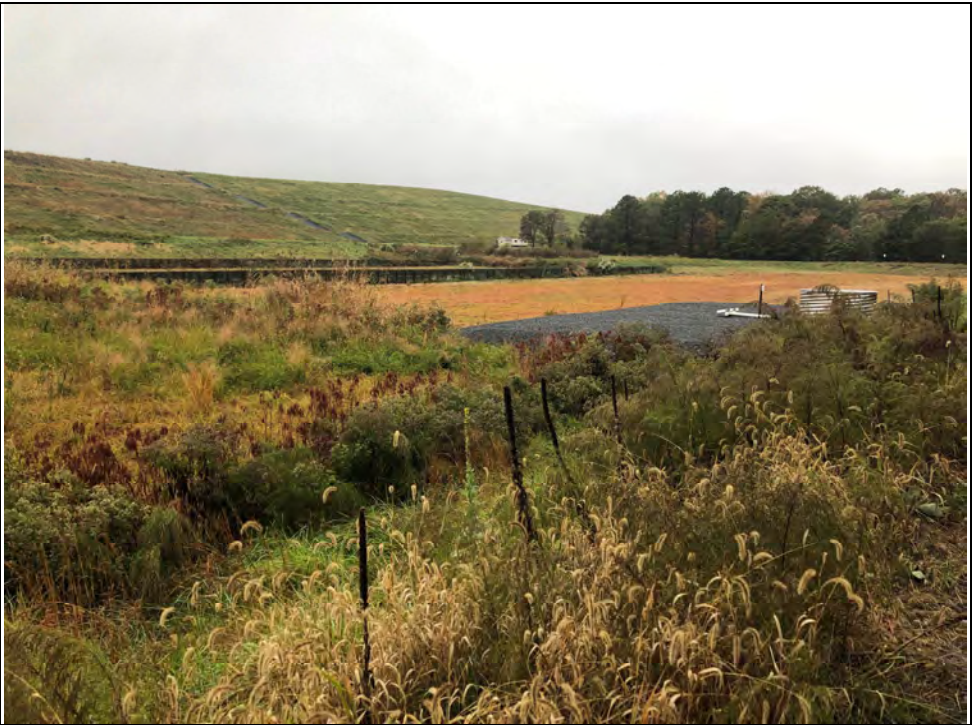
Image: 7560  
Date: 10/29/2020  
Time: 7:48 AM  
Direction: Southwest

Northeast Detention Basin (Non-Contact Water). Little accumulated water, despite significant rains at time of inspection.

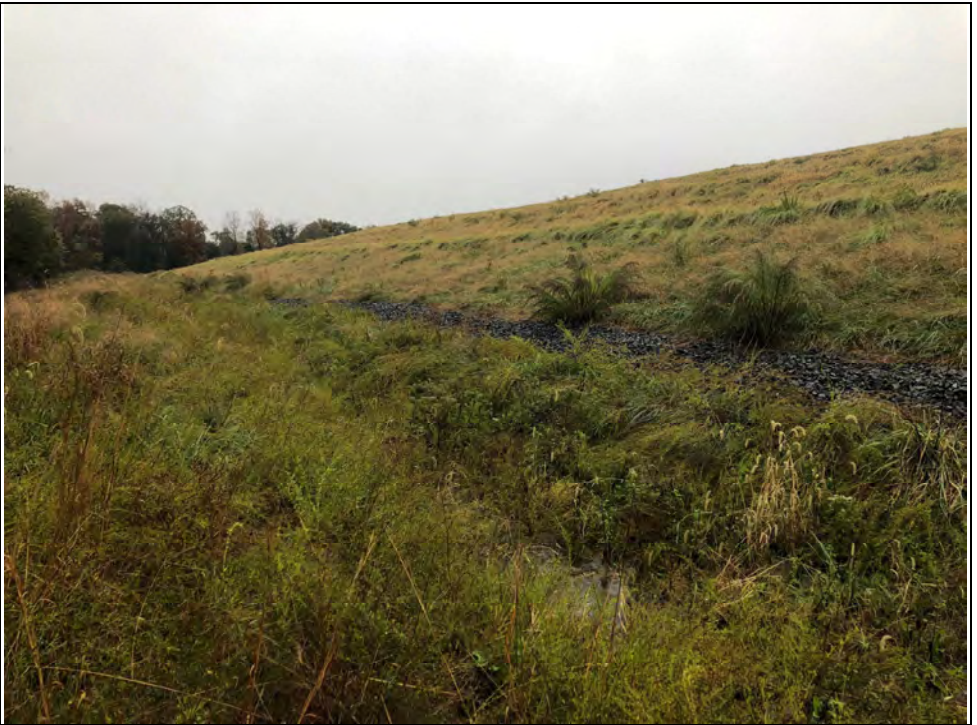
Image: 7564  
Date: 10/29/2020  
Time: 7:49 AM  
Direction: Southwest

Toe of slope. No sign of erosion or slope stability issues.

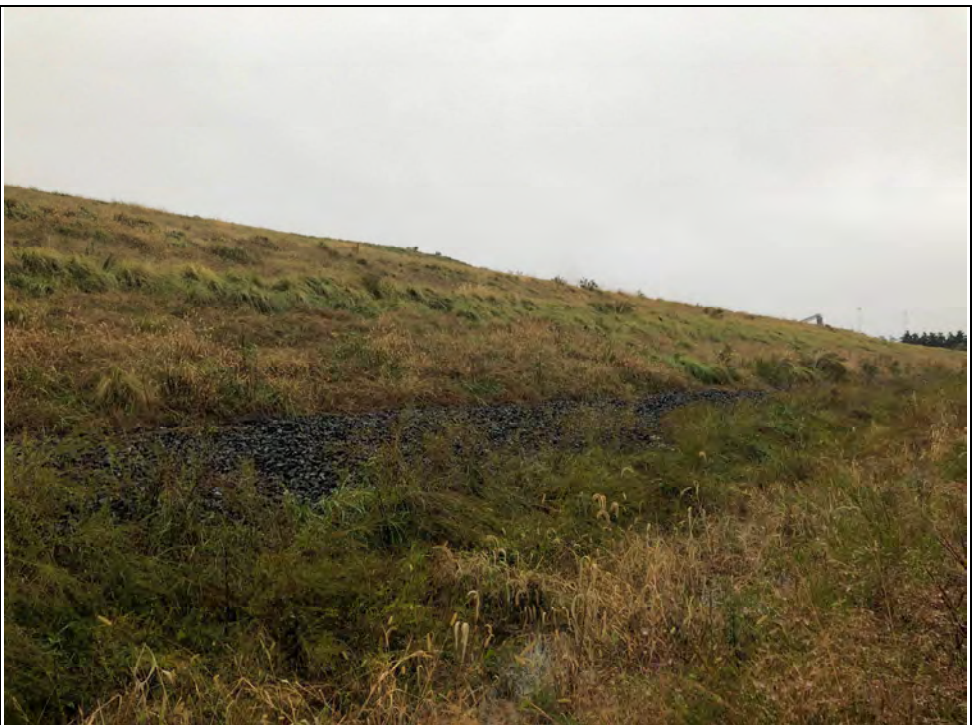
Image: 7566  
Date: 10/29/2020  
Time: 7:51 AM  
Direction: Northwest

Toe of slope. No sign of erosion or slope stability issues.

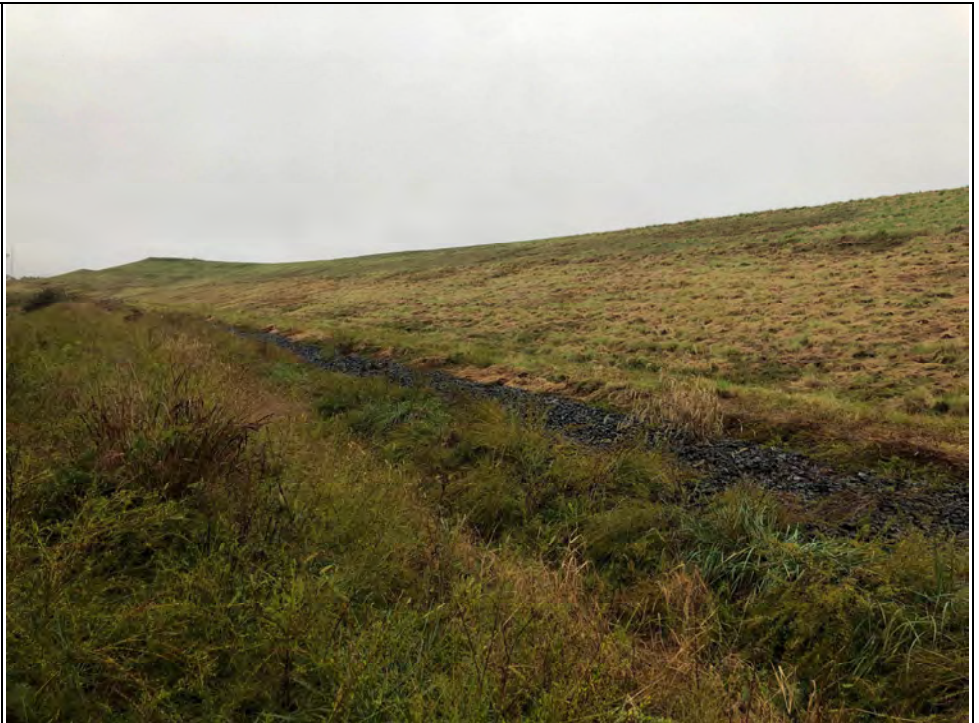
Image: 7568  
Date: 10/29/2020  
Time: 7:52 AM  
Direction: West Southwest

Toe of slope. No sign of erosion or slope stability issues.

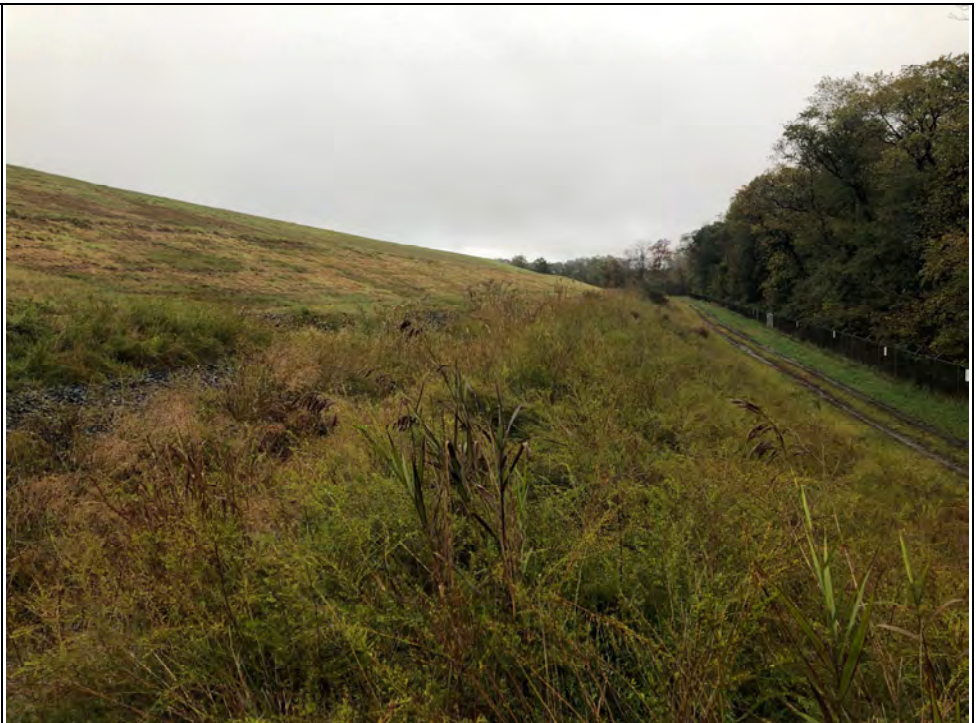
Toe of slope. No sign of erosion or slope stability issues.
