2022 ANNUAL CCR UNIT INSPECTION
INDIAN RIVER LANDFILL
NRG INDIAN RIVER STATION
DAGSBORO, DELAWARE

SCS ENGINEERS

25221158.00 | January 18, 2023

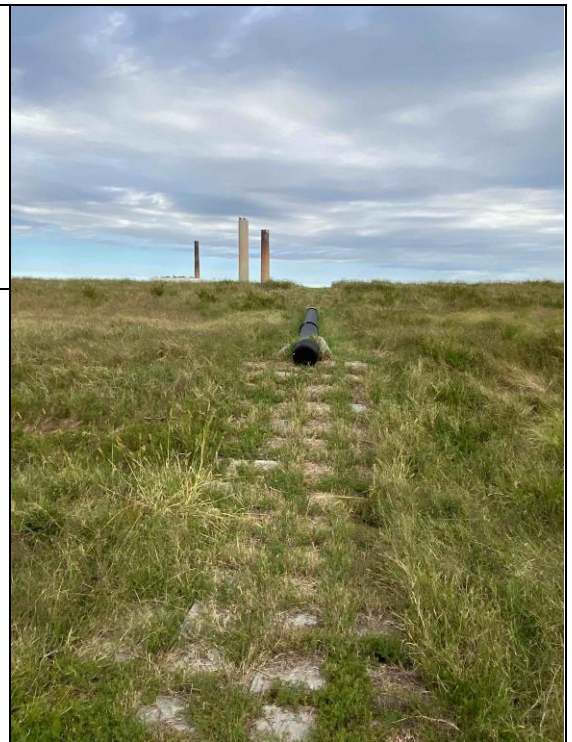
Image Number: 1229
Date: October 18, 2022
Time: 8:53 AM
Direction: North-Northwest

Description: Letdown pipe location from plateau terrace into access road ditch on Phase I final cover area. Free draining with no obstructions. No evidence of erosion or scour.

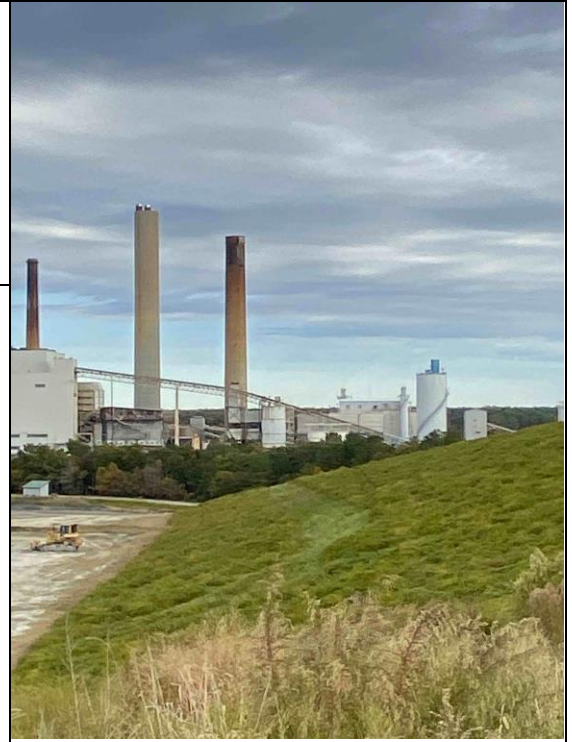
Image Number: 1241
Date: October 18, 2022
Time: 8:56 AM
Direction: North-Northwest

Description: Vegetated side slope into active area. Vegetation coverage is dense and healthy.

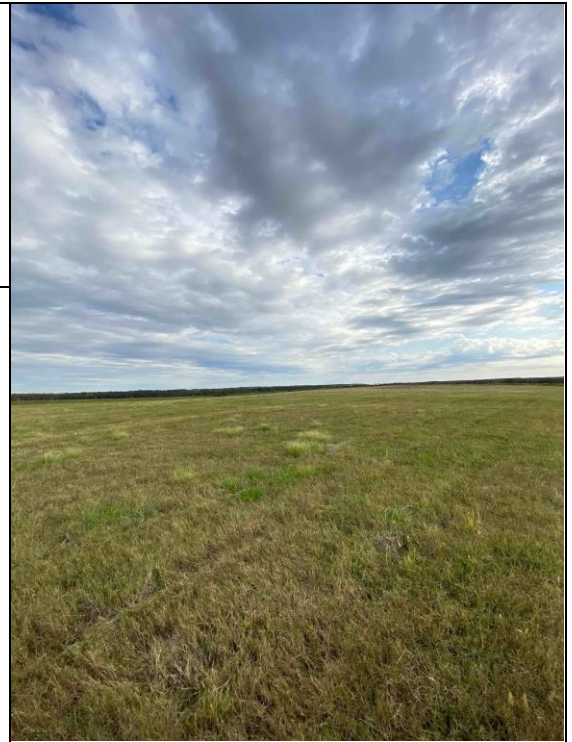
Image Number: 1245
Date: October 18, 2022
Time: 8:58 AM
Direction: North-Northeast

Description: Phase I final cover plateau area. Vegetation coverage is dense and healthy.

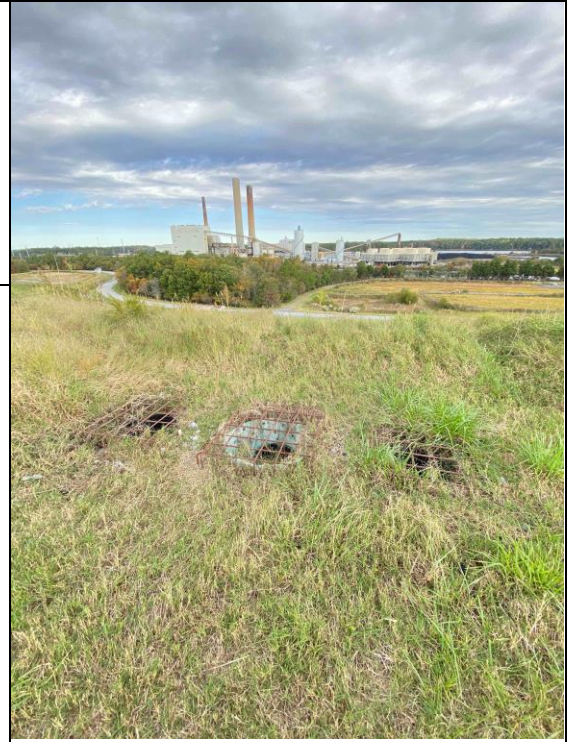
Image Number: 1249
Date: October 18, 2022
Time: 8:59 AM
Direction: North-Northwest

Description: Phase I downchute pipe inlets with grated covers. Free of obstructions and functioning.

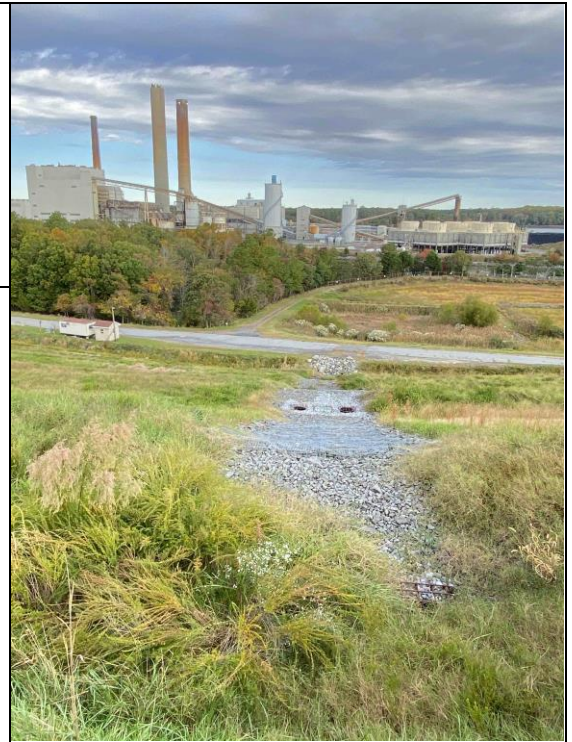
Image Number: 1251
Date: October 18, 2022
Time: 9:00 AM
Direction: North

Description: Phase I downchute downchute riprap. Free of obstructions and functioning. No signs of wash out or erosion.

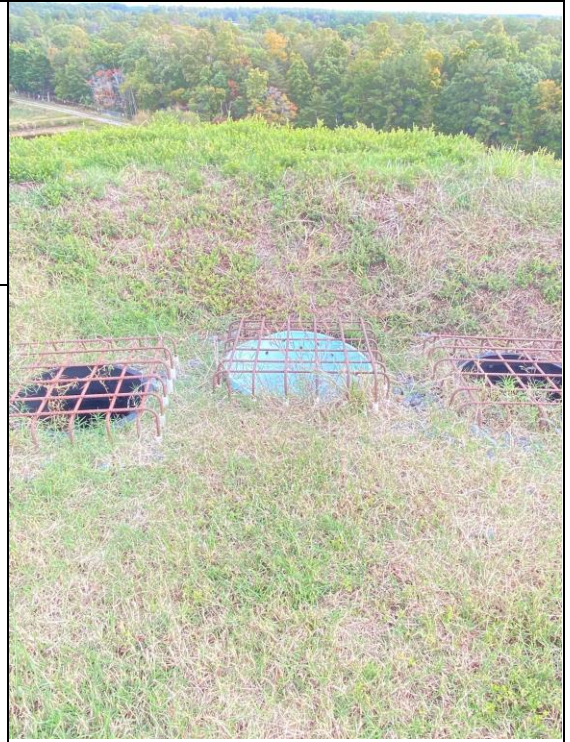
Image Number: 1255
Date: October 18, 2022
Time: 9:01 AM
Direction: Northeast

Description: Phase I downchute pipe inlets with grated covers. Free of obstructions and functioning.

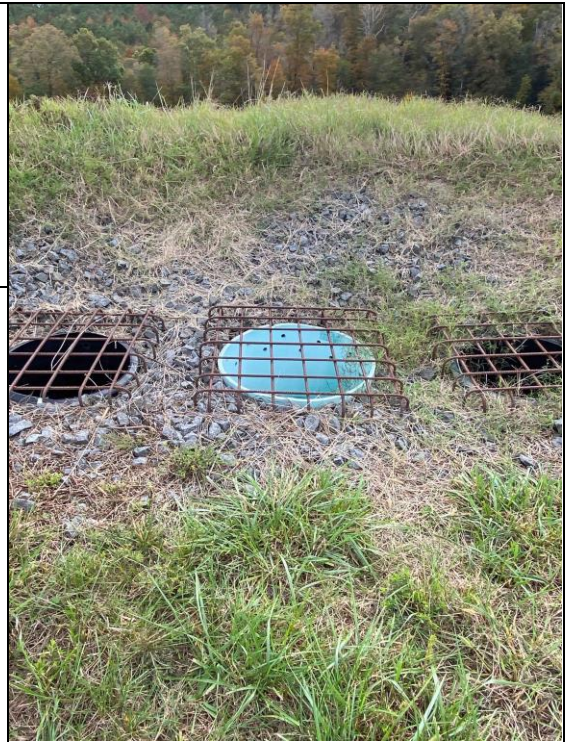
Image Number: 1261
Date: October 18, 2022
Time: 9:03 AM
Direction: East-Southeast

Description: Phase I downchute pipe inlets with grated covers. Free of obstructions and functioning.

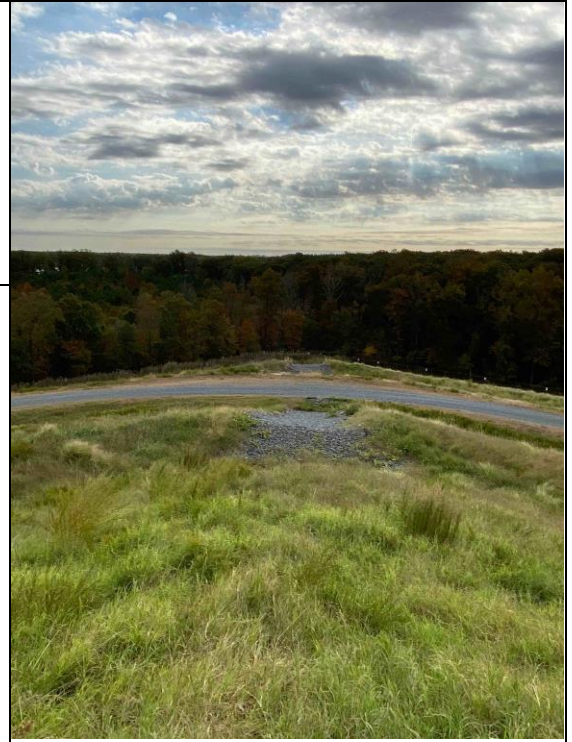
Image Number: 1263
Date: October 18, 2022
Time: 9:03 AM
Direction: East-Southeast

Description: Phase I downchute riprap. Free of obstructions and functioning. No signs of wash out or erosion.

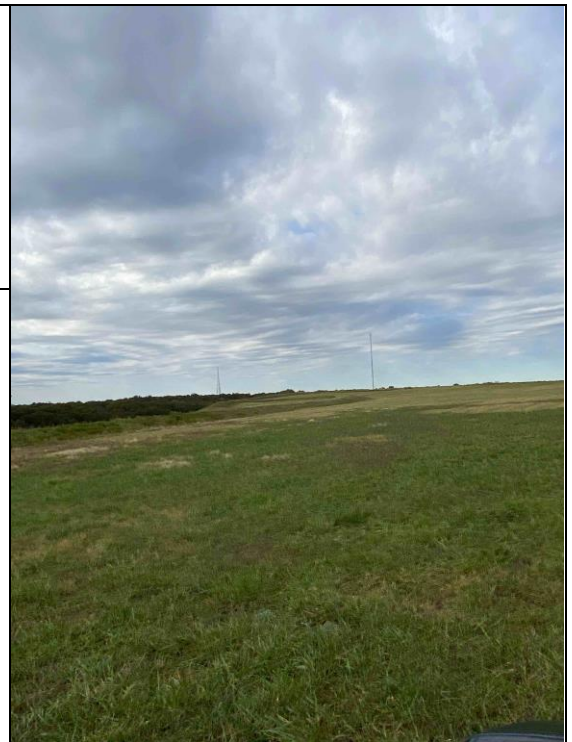
Image Number: 1265
Date: October 18, 2022
Time: 9:05 AM
Direction: West-Southwest

Description: Phase I final cover plateau area. Vegetation coverage is dense and healthy.
