2023 ANNUAL CCR UNIT INSPECTION
INDIAN RIVER LANDFILL
NRG INDIAN RIVER STATION
DAGSBORO, DELAWARE

SCS ENGINEERS

25221158.00 | January 18, 2024

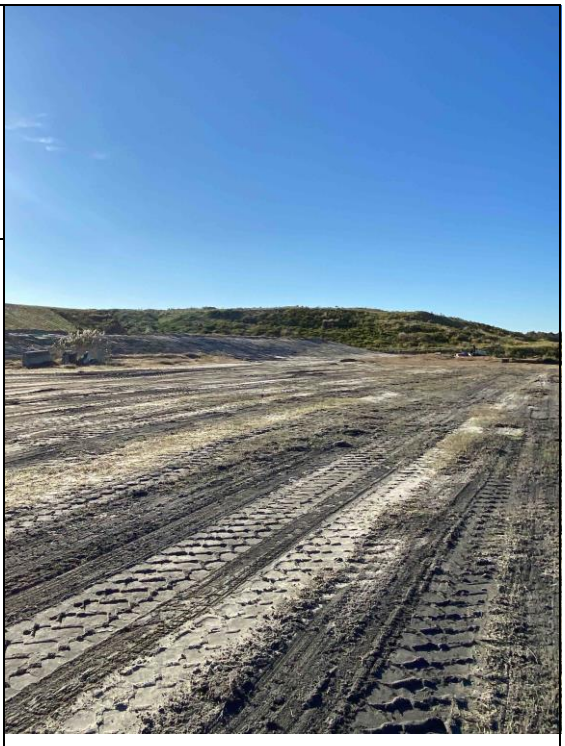
<p>Image Number: 3338 Date: 10/17/2023 Time: 8:05 AM Direction: South-Southeast</p>

<p>Description: Phase II Cell 2 intermediate cover. Material is graded and well maintained.</p>

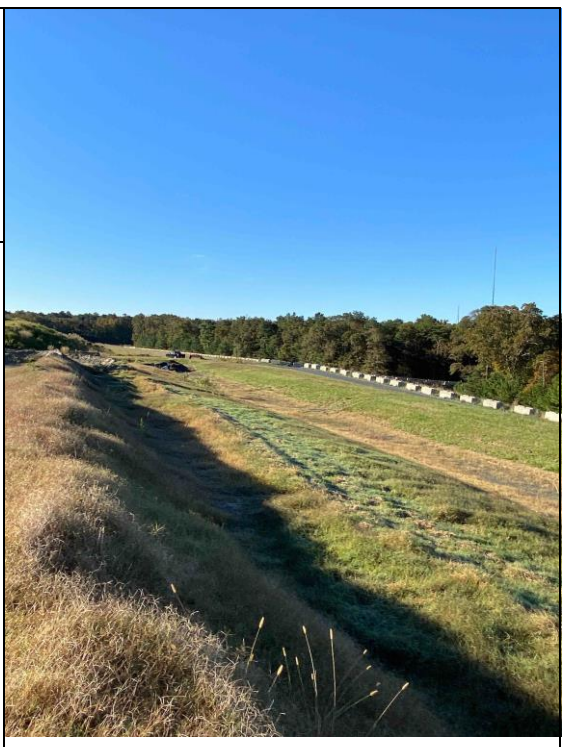
<p>Image Number: 3340 Date: 10/17/2023 Time: 8:06 AM Direction: South-Southwest</p>

<p>Description: Vegetated intermediate cover on terrace near exterior of Phase II, Cell II. Well maintained. No observed ponding or significant erosion.</p>

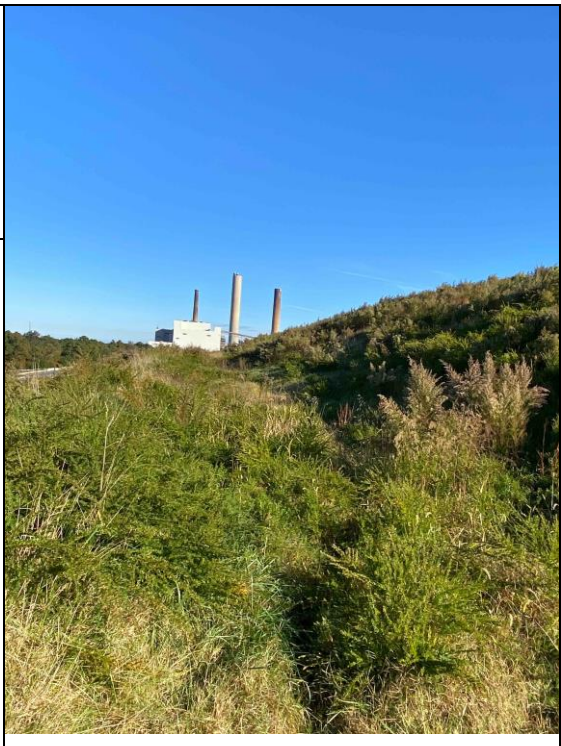
<p>Image Number: 3344 Date: 10/17/2023 Time: 8:20 AM Direction: North-Northeast</p>

<p>Description: Well vegetated sideslope terrace. Well maintained. No erosion, sloughing, or animal borrows were observed.</p>

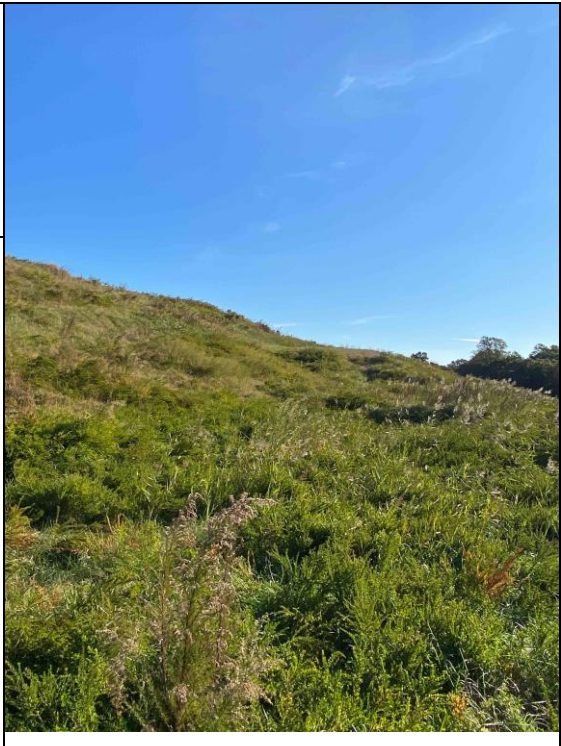
<p>Image Number: 3346 Date: 10/17/2023 Time: 8:20 AM Direction: East-Northeast</p>

<p>Description: Vegetation on side slopes is well established. Vegetation on side slopes of landfill is well established. No signs of erosion, sloughing, or animal borrows.</p>

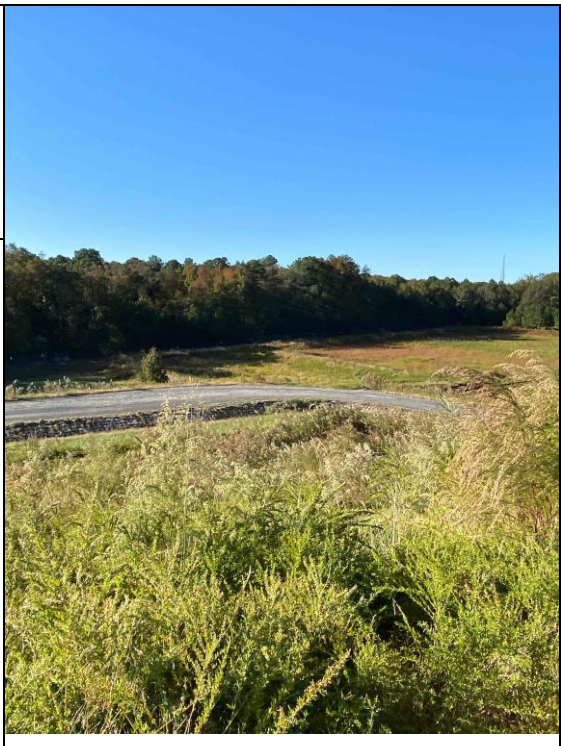
<p>Image Number: 3348 Date: 10/17/2023 Time: 8:20 AM Direction: South-Southwest</p>

<p>Description: Standing on landfill final cover with overview of south settling basin in background. Vegetation on side slopes of landfill is well established. No signs of erosion, sloughing, or animal borrows.</p>

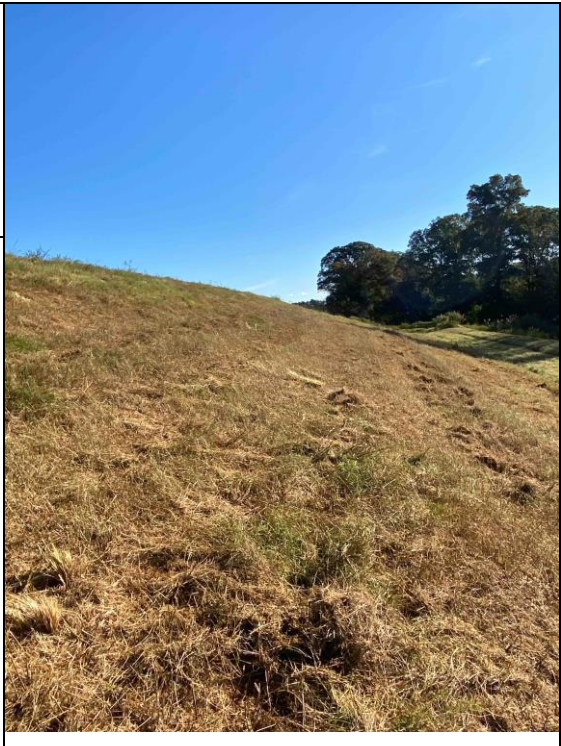
<p>Image Number: 3356 Date: 10/17/2023 Time: 8:26 AM Direction: East-Northeast</p>

<p>Description: Vegetation on side slopes is well established. No signs of erosion, sloughing, or animal borrows.</p>

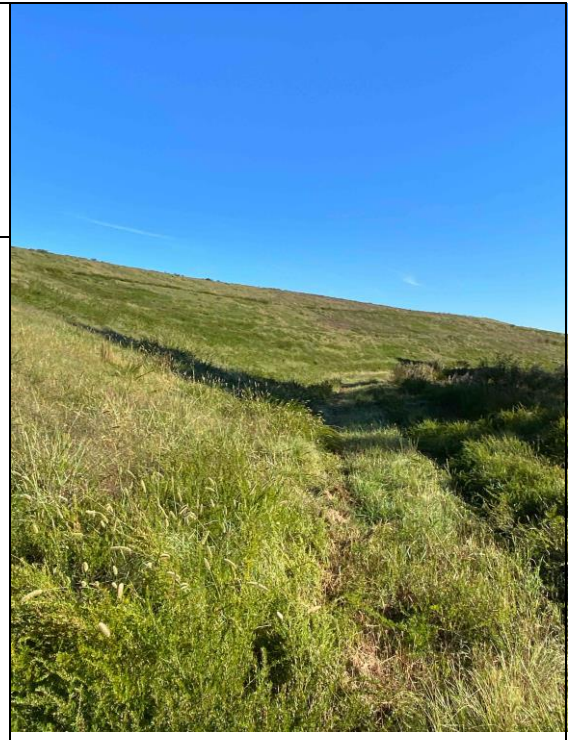
Image Number: 3360
Date: 10/17/2023
Time: 8:40 AM
Direction: Northeast

Description:
Terrace berm segment on the Phase I landfill side slope. Clear of obstructions and functioning as intended. Vegetative cover is dense and healthy.

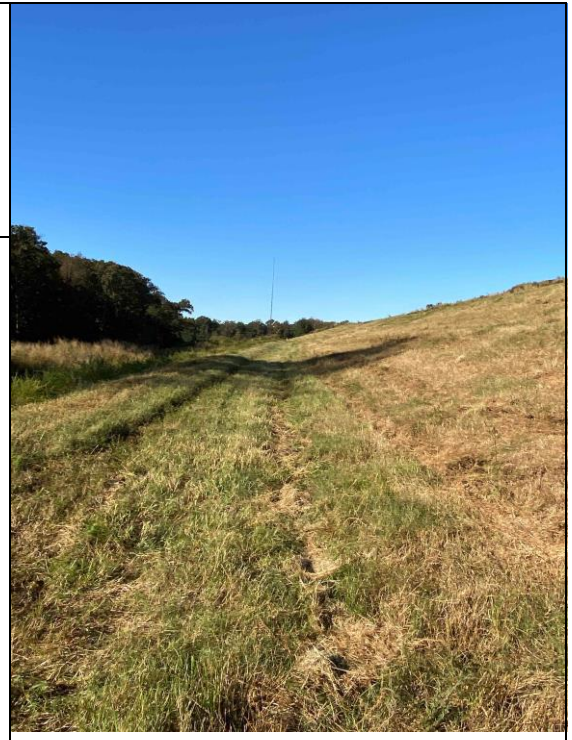
Image Number: 3362
Date: 10/17/2023
Time: 8:40 AM
Direction: West-Southwest

Description:
Final cover on side slopes of Phase II, Cell 1. Vegetation is healthy with full coverage. No signs of erosion or stability issues were observed.

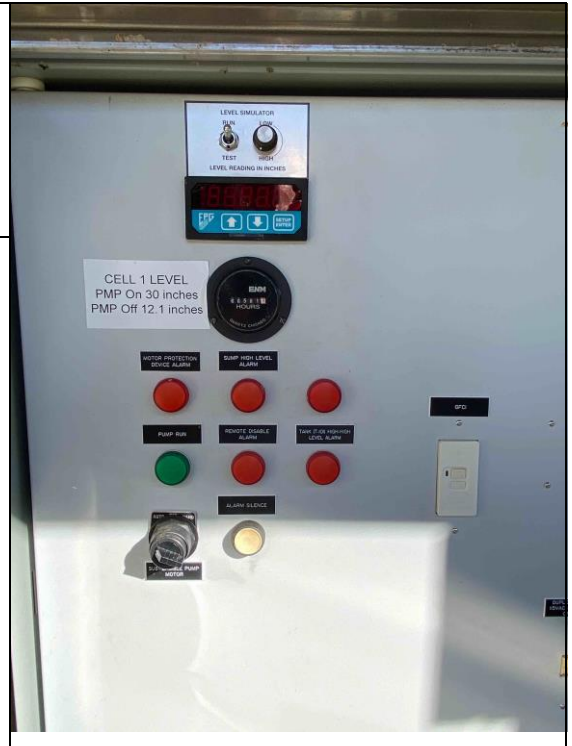
Image Number: 3366
 Date: 10/17/2023
 Time: 8:56 AM
 Direction: North

Description:
 Phase I, Cell 1 leachate liquid level indicator and controls in working condition.

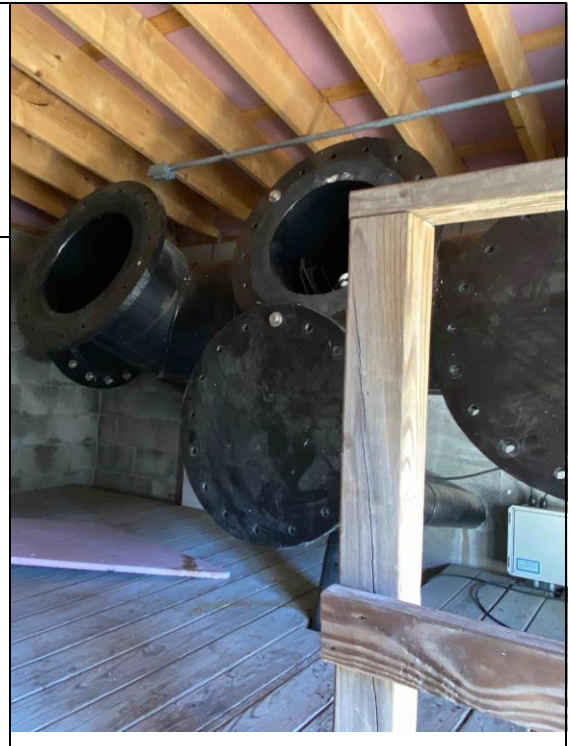
Image Number: 3368
 Date: 10/17/2023
 Time: 8:56 AM
 Direction: Northwest

Description:
 Inside the Phase I, Cell 1 leachate pump house. Cleanout riser and pump risers with T-connections to forcemain are shown in this photograph. Building is well maintained.

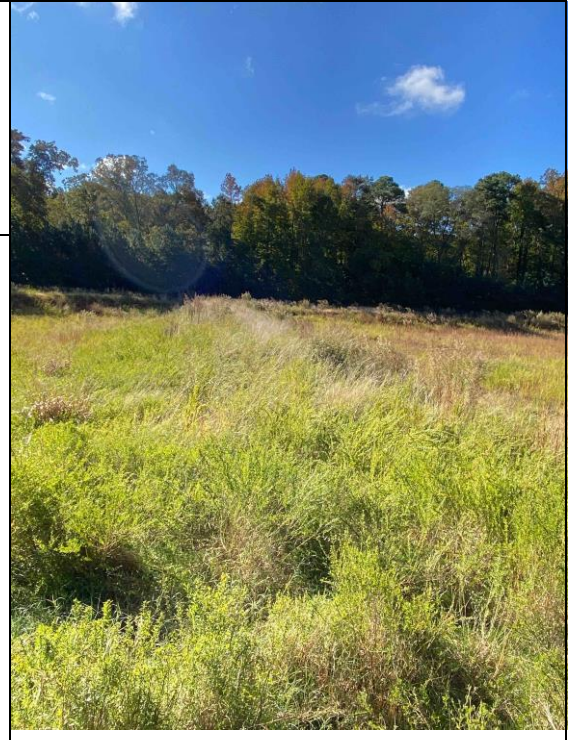
Image Number: 3374
Date: 10/17/2023
Time: 9:01 AM
Direction: South

Description:
Forebay berm within the Southeast Detention Basin in good condition. Vegetation coverage is dense and healthy.

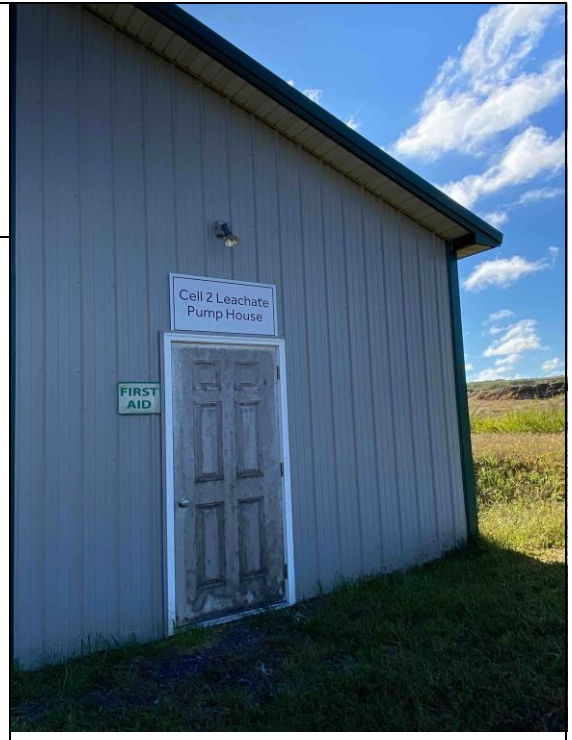
Image Number: 3378
Date: 10/17/2023
Time: 9:05 AM
Direction: South-Southeast

Description:
Phase II, Cell 2 leachate pump house. Building exterior is in good condition. Building is appropriately marked (signage).

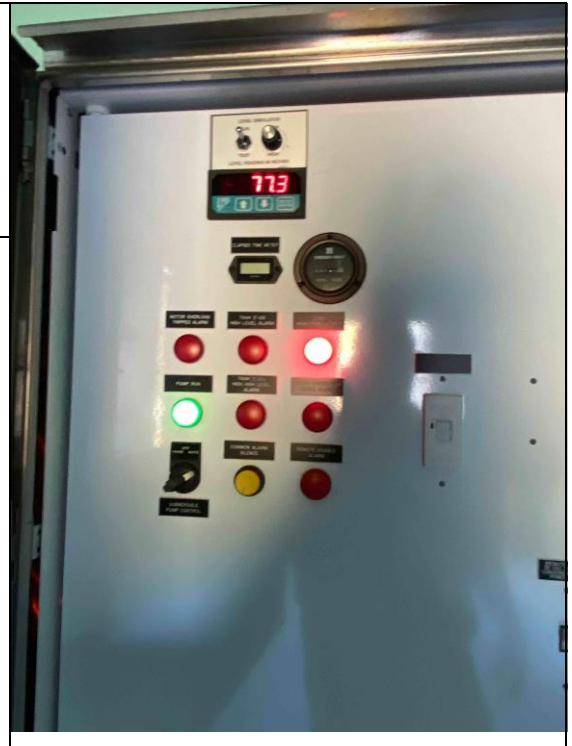
Image Number: 3380
Date: 10/17/2023
Time: 9:05 AM
Direction: East

Description:
Phase II, Cell 2 leachate liquid level indicator and controls in working condition.

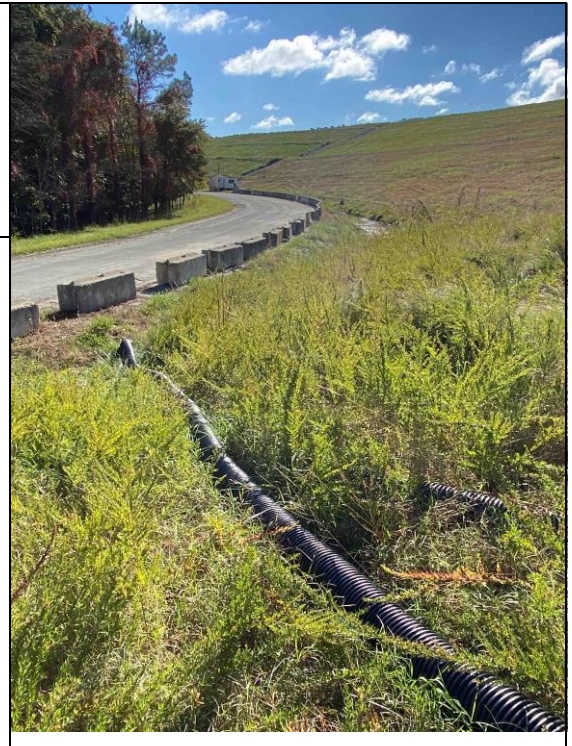
Image Number: 3382
Date: 10/17/2023
Time: 9:07 AM
Direction: East-Southeast

Description:
Pipes from intermediate cover areas of Phase II Cell 2 convey non-contact water into north perimeter ditch.

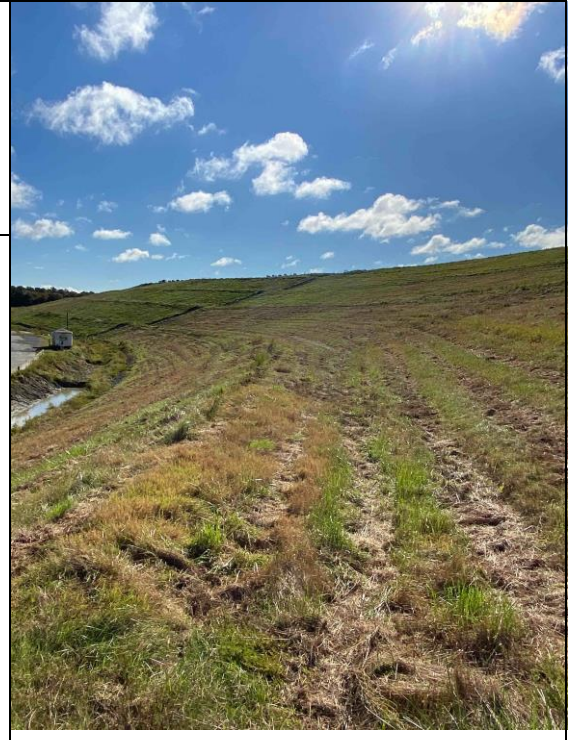
Image Number: 3384
Date: 10/17/2023
Time: 9:08 AM
Direction: East-Southeast

Description:
Landfill side slopes and terrace are well maintained. No evidence of slope stability issues or erosion.

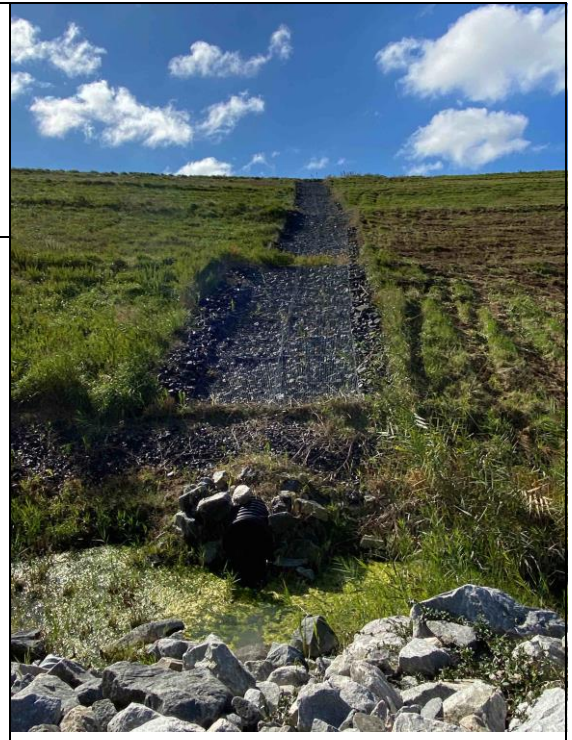
Image Number: 3386
Date: 10/17/2023
Time: 9:10 AM
Direction: South

Description:
Downchute near southwest forebay of the Northeast Detention Basin. Pipe and downchute are functioning appropriately, as intended.

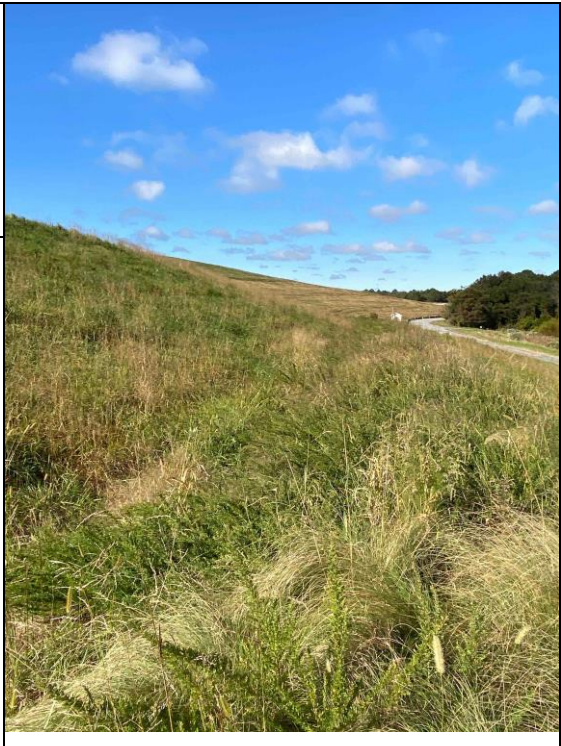
<p>Image Number: 3388 Date: 10/17/2023 Time: 9:12 AM Direction: West</p>

<p>Description: Phase I final cover and terrace berm. Vegetation coverage is dense and healthy.</p>

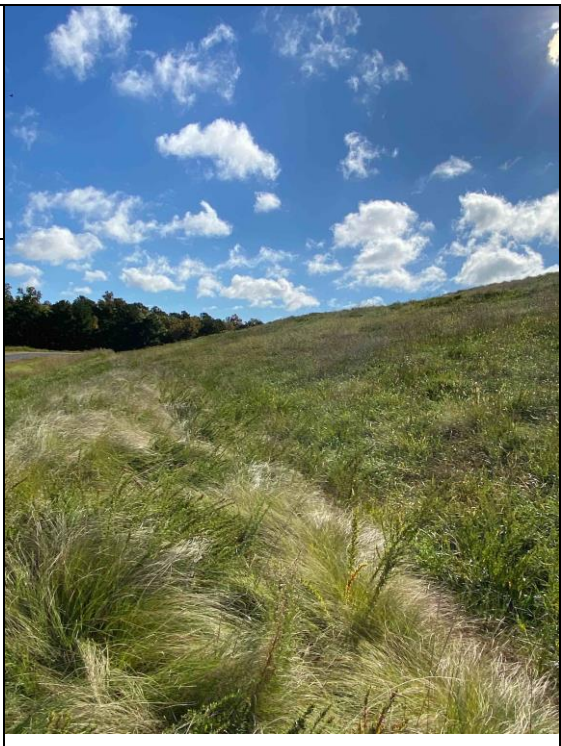
<p>Image Number: 3390 Date: 10/17/2023 Time: 9:12 AM Direction: East-Southeast</p>

<p>Description: Phase I final cover. Vegetation coverage is dense and healthy. No animal burrows, erosion, or sloughing were observed.</p>

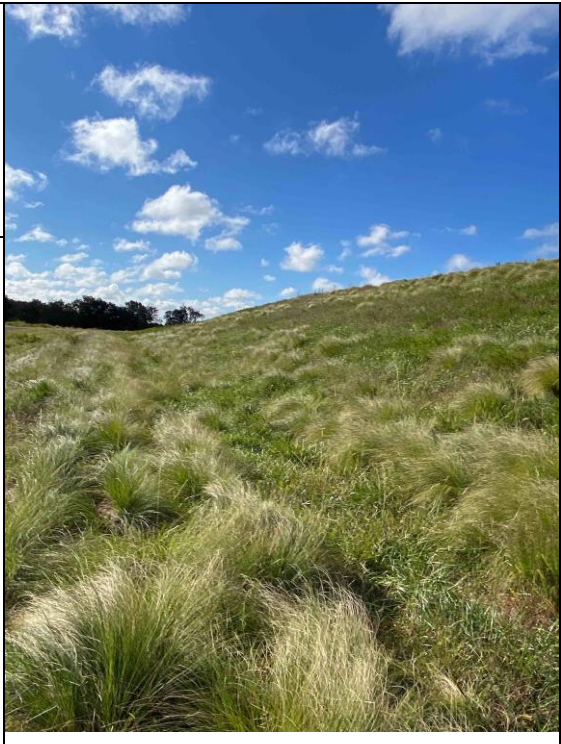
<p>Image Number: 3392 Date: 10/17/2023 Time: 9:14 AM Direction: South</p>

<p>Description: Phase I final cover. Vegetation coverage is dense and healthy. No animal burrows, erosion, or sloughing were observed.</p>

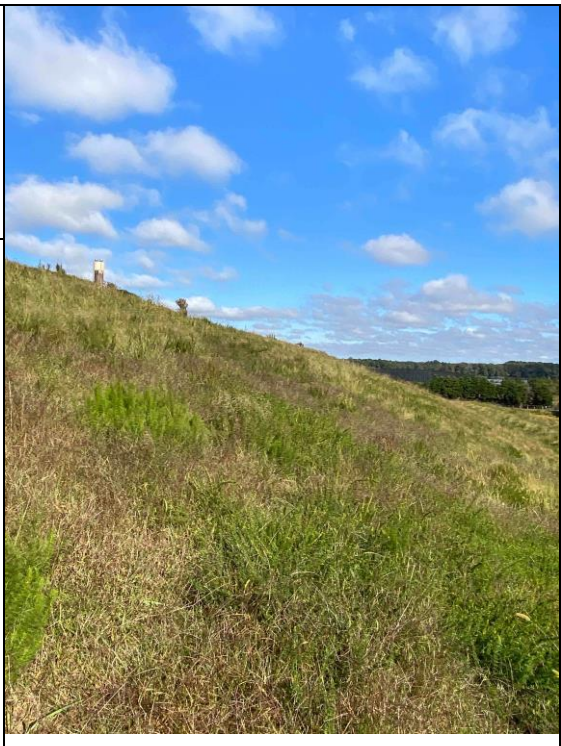
<p>Image Number: 3394 Date: 10/17/2023 Time: 9:15 AM Direction: North-Northwest</p>

<p>Description: Phase I final cover. Vegetation coverage is dense and healthy. No animal burrows, erosion, or sloughing were observed.</p>

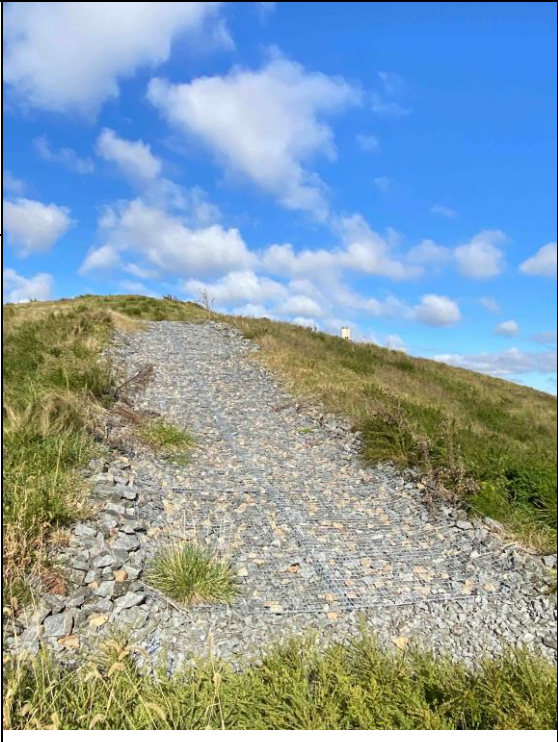
Image Number: 3396
Date: 10/17/2023
Time: 9:17 AM
Direction: North-Northwest

Description:
Downchute is well maintained and functions as intended.

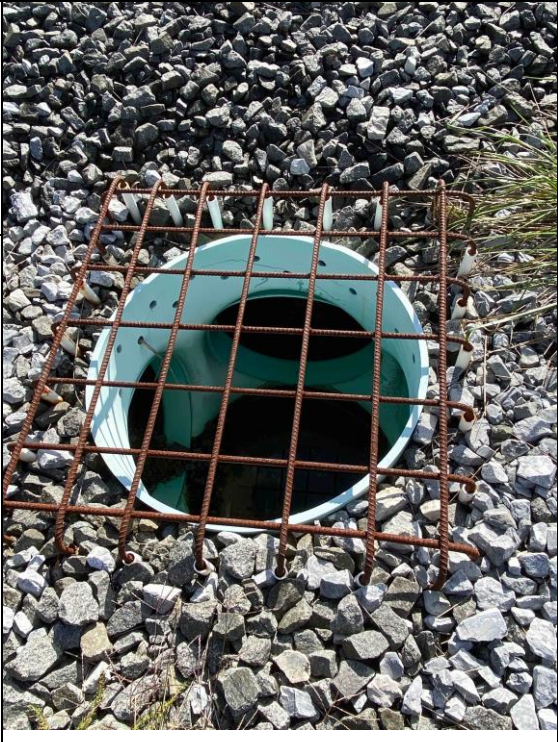
Image Number: 3398
Date: 10/17/2023
Time: 9:17 AM
Direction: East-Southeast

Description:
Downslope pipe inlets are well maintained and free of obstructions.

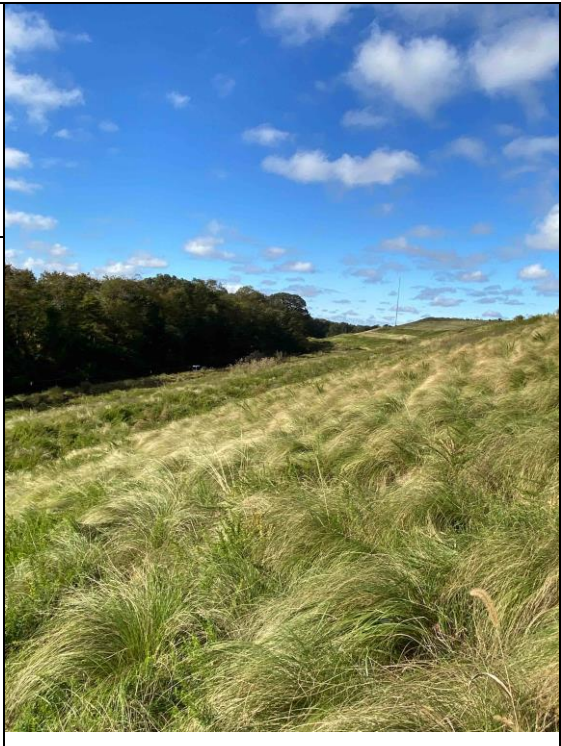
<p>Image Number: 3400 Date: 10/17/2023 Time: 9:18 AM Direction: West-Southwest</p>

<p>Description: Phase I final cover. Vegetation coverage is dense and healthy. No animal burrows, erosion, or sloughing were observed.</p>

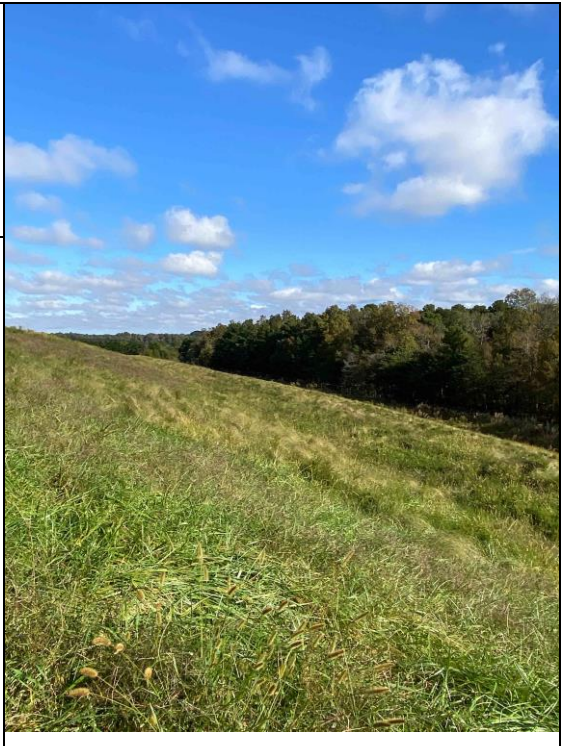
<p>Image Number: 3402 Date: 10/17/2023 Time: 9:18 AM Direction: North-Northeast</p>

<p>Description: Phase I side slopes and terrace berm are well maintained. No evidence of slope stability issues or erosion.</p>

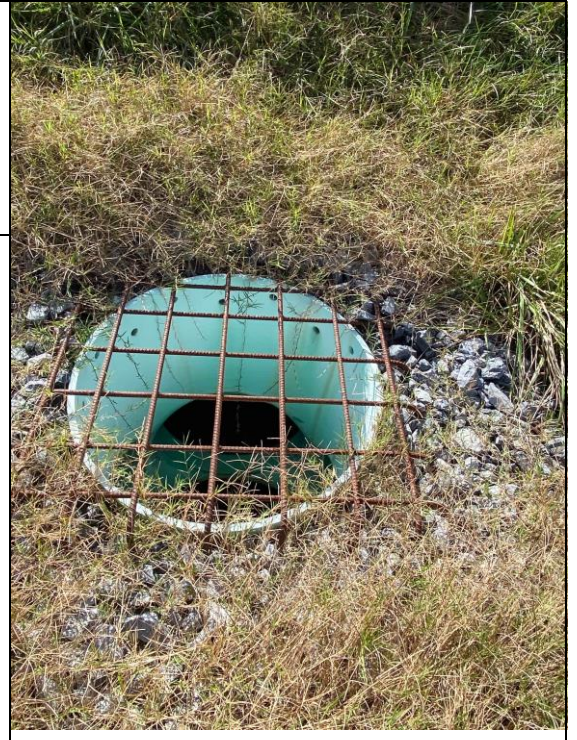
Image Number: 3404
Date: 10/17/2023
Time: 9:24 AM
Direction: South-Southeast

Description:
Inlet to non-contact water pipe is well maintained and clear from obstructions.

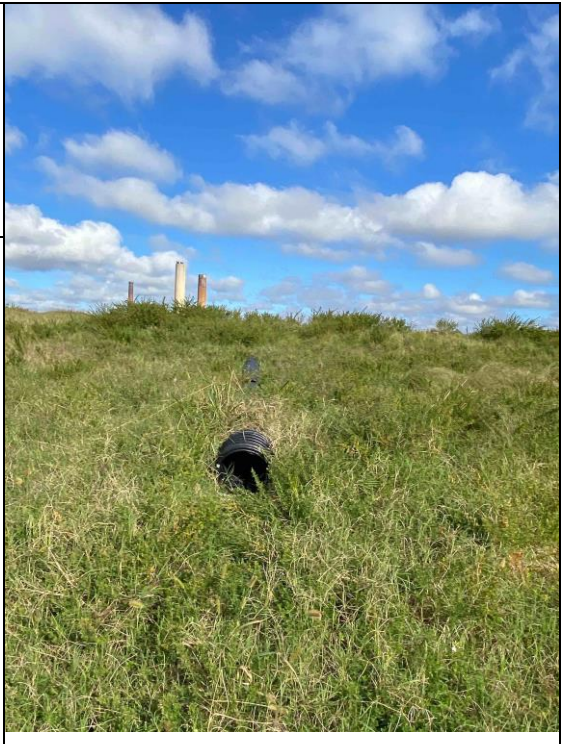
<p>Image Number: 3408 Date: 10/17/2023 Time: 9:24 AM Direction: North</p>

<p>Description: Letdown pipe location from plateau terrace into access road ditch on Phase I final cover area. Free draining with no obstructions. No evidence of erosion or scour.</p>

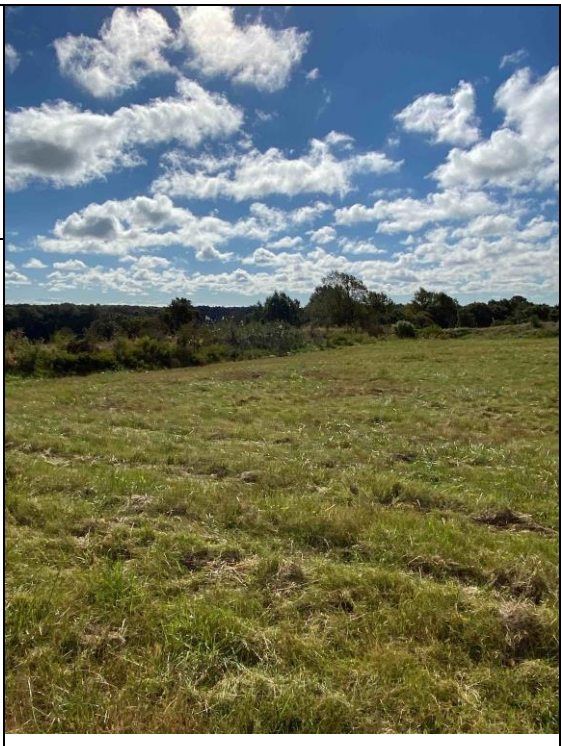
<p>Image Number: 3410 Date: 10/17/2023 Time: 9:25 AM Direction: South-Southeast</p>

<p>Description: Phase II final cover plateau area. Vegetation coverage is dense and healthy. No animal burrows, erosion, or sloughing were observed.</p>

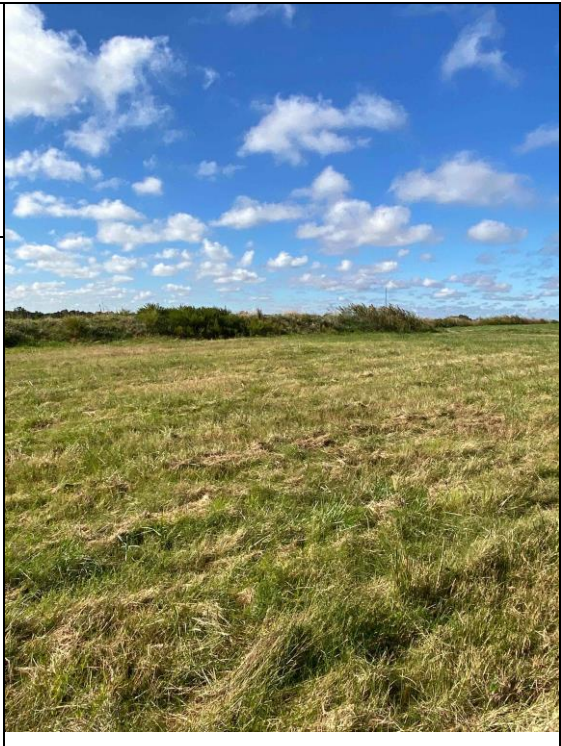
<p>Image Number: 3412 Date: 10/17/2023 Time: 9:26 AM Direction: Southwest</p>

<p>Description: Phase II final cover plateau area. Vegetation coverage is dense and healthy. No animal burrows, erosion, or sloughing were observed.</p>

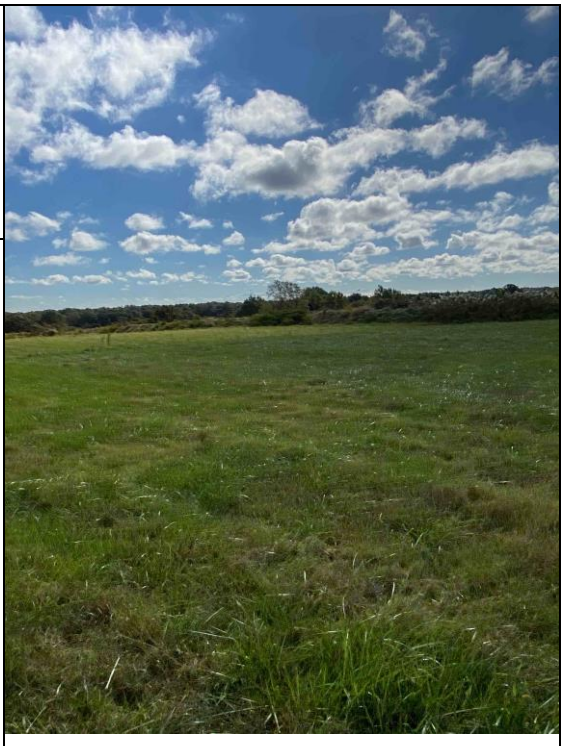
<p>Image Number: 3414 Date: 10/17/2023 Time: 9:27 AM Direction: East-Southeast</p>

<p>Description: Phase II final cover plateau area. Vegetation coverage is dense and healthy. No animal burrows, erosion, or sloughing were observed.</p>

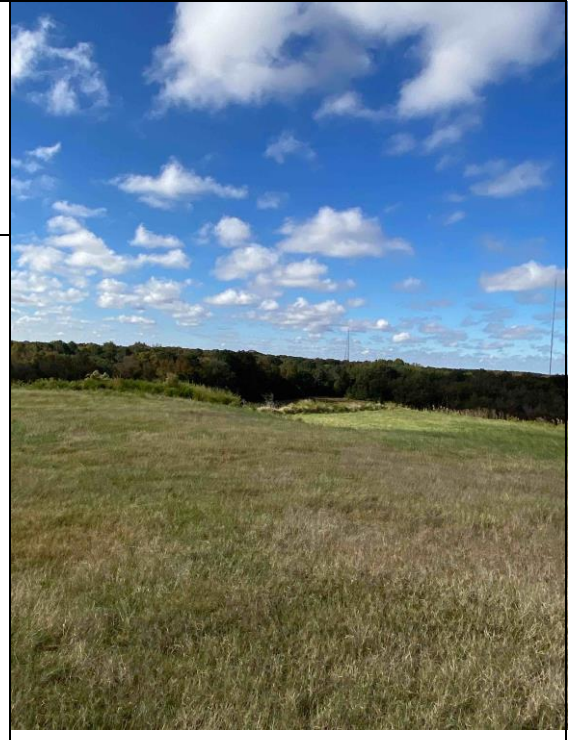
Image Number: 3416
Date: 10/17/2023
Time: 9:27 AM
Direction: Southwest

Description:
Phase II final cover plateau area. Vegetation coverage is dense and healthy. No animal burrows, erosion, or sloughing were observed.

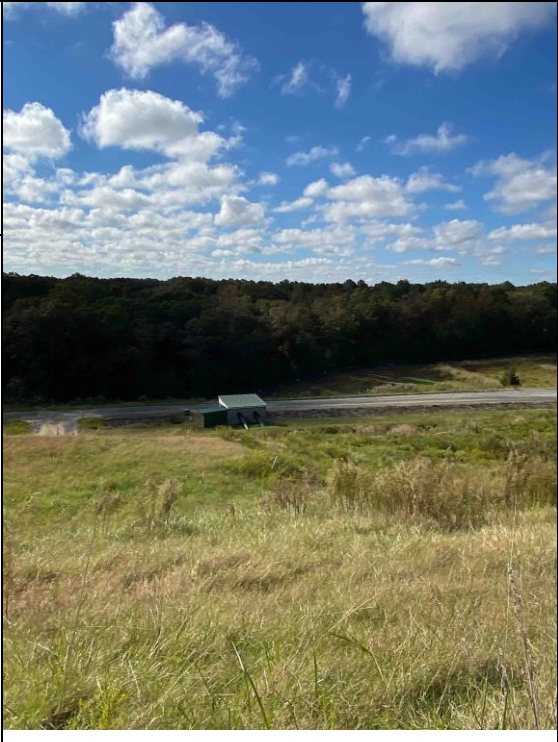
Image Number: 3420
 Date: 10/17/2023
 Time: 9:28 AM
 Direction: South

Description:
 Final cover on plateau, with Phase II Cell 1 pump house in the background. Vegetation is dense and healthy. No animal burrows, erosion, or sloughing were observed.

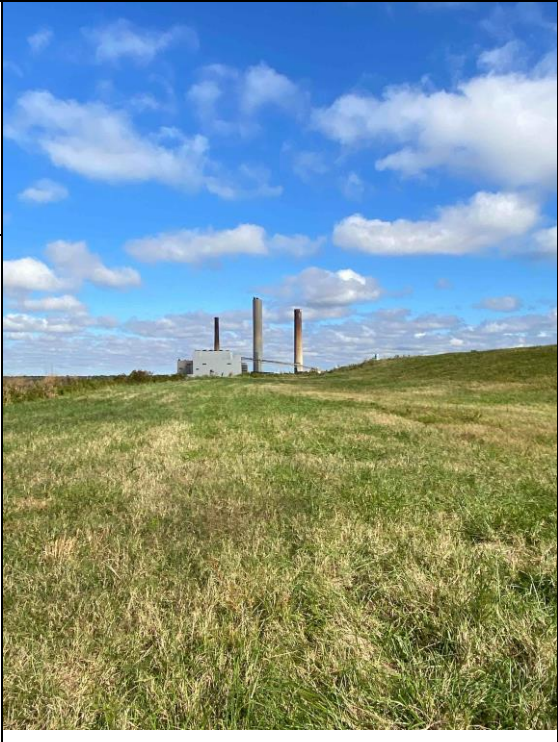
Image Number: 3422
 Date: 10/17/2023
 Time: 9:28 AM
 Direction: North

Description:
 Phase II final cover plateau. Vegetation is well established with no signs of erosion, sloughing, or animal burrows.

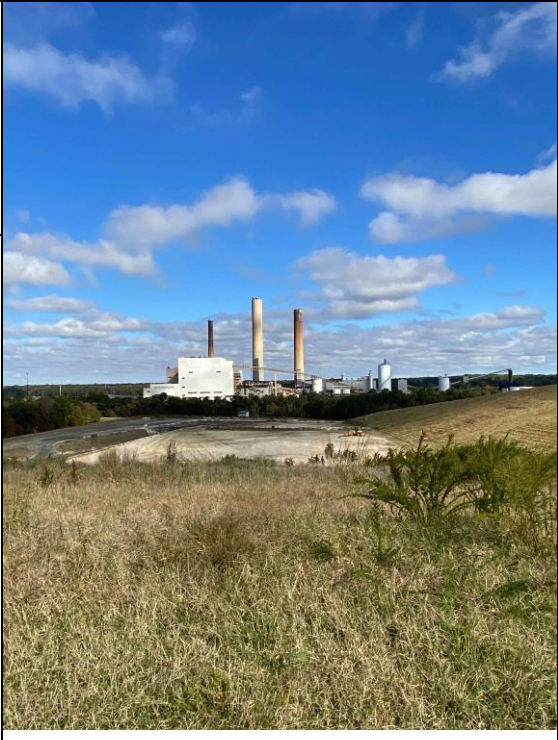
Image Number: 3424
Date: 10/17/2023
Time: 9:30 AM
Direction: Northwest

Description:
Overlooking Phase II, Cell 2 active area from Phase II, Cell 1 plateau.
Phase II final cover plateau. Vegetation is well established with no signs of erosion, sloughing, or animal burrows.

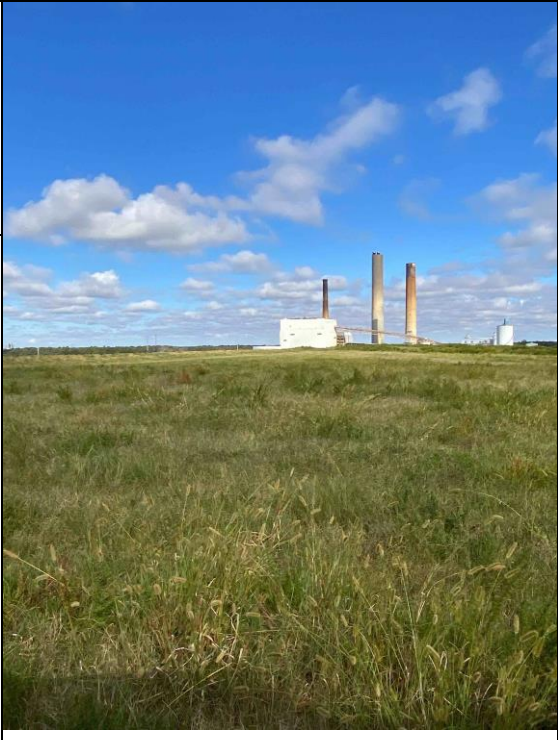
Image Number: 3428
Date: 10/17/2023
Time: 9:31 AM
Direction: West-Northwest

Description:
Phase II final cover plateau area. Vegetation coverage is dense and healthy. No signs of erosion, sloughing, or animal burrows.

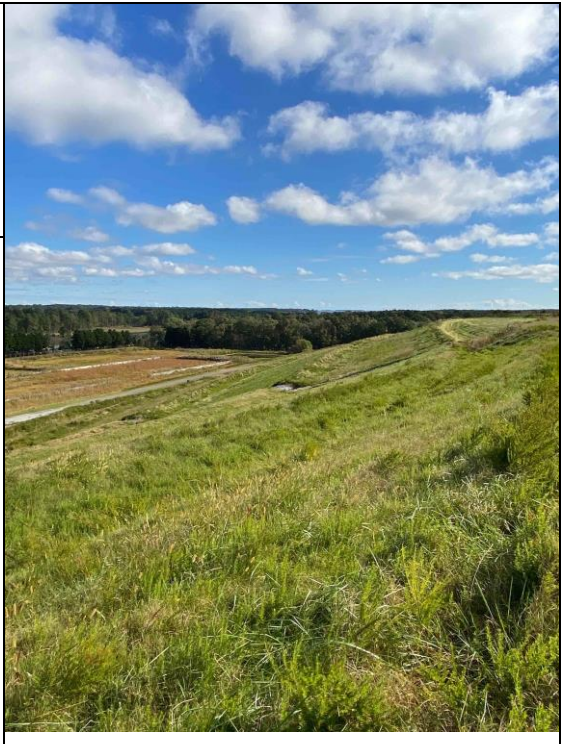
<p>Image Number: 3430 Date: 10/17/2023 Time: 9:32 AM Direction: East-Northeast</p>

<p>Description: Overview of Phase II sideslope final cover in foreground, Phase I sideslope final cover in background, and Northwest Basin.</p>

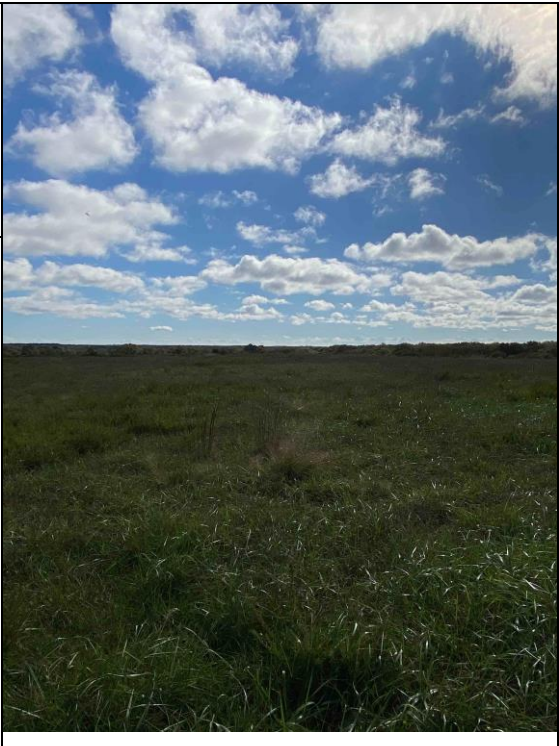
Image Number: 3434 Date: 10/17/2023 Time: 9:35 AM Direction: Southeast

Description: Phase II final cover plateau area. Vegetation coverage is dense and healthy. No signs of erosion, sloughing, or animal burrows.

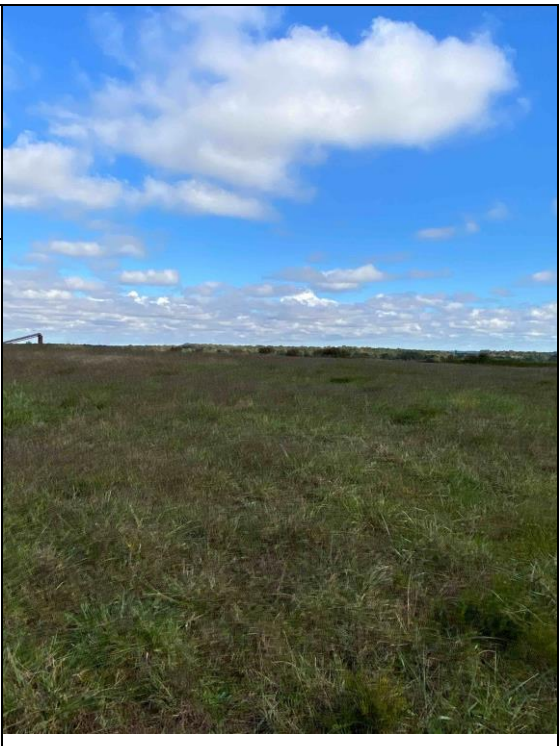
Image Number: 3436 Date: 10/17/2023 Time: 9:36 AM Direction: East-Northeast

Description: Phase II final cover plateau. Vegetation is well established with no signs of erosion, sloughing, or animal burrows.

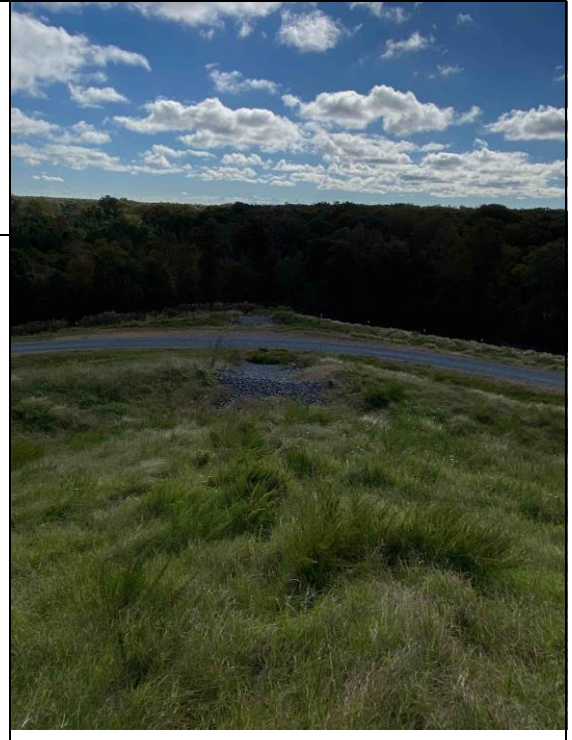
Image Number: 3438
Date: 10/17/2023
Time: 9:36 AM
Direction: Southeast

Description:
Phase I downchute riprap. Free of obstructions and functioning. No signs of wash out or erosion.

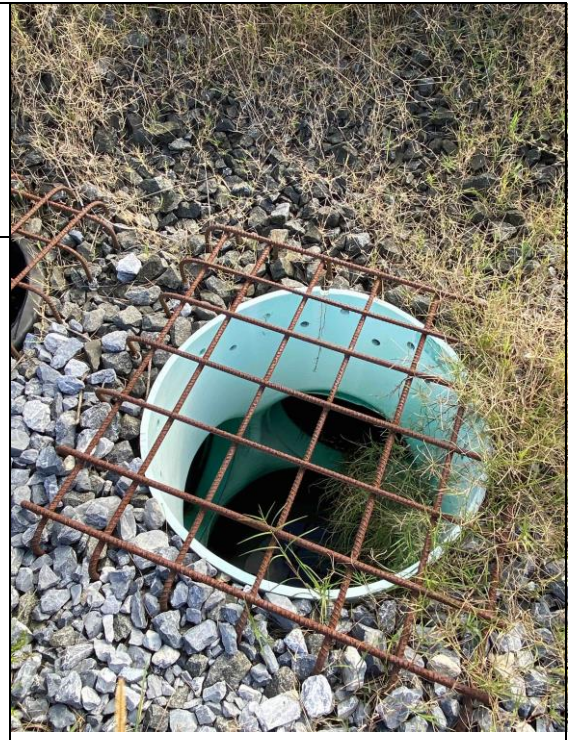
Image Number: 3440
Date: 10/17/2023
Time: 9:37 AM
Direction: East

Description:
Phase I downchute pipe inlets with grated covers. Free of obstructions and functioning.

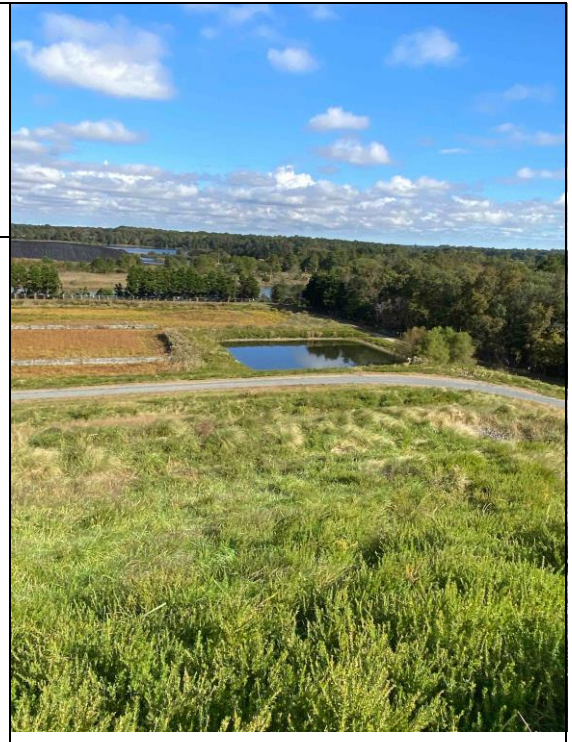
Image Number: 3444
Date: 10/17/2023
Time: 9:39 AM
Direction: North-Northeast

Description:
Overview of Northwest Basin settling pond from landfill plateau. Final cover is well maintained.
