2024 ANNUAL CCR UNIT INSPECTION
INDIAN RIVER LANDFILL
NRG INDIAN RIVER STATION
DAGSBORO, DELAWARE

SCS ENGINEERS

25221158.00 | January 18, 2025

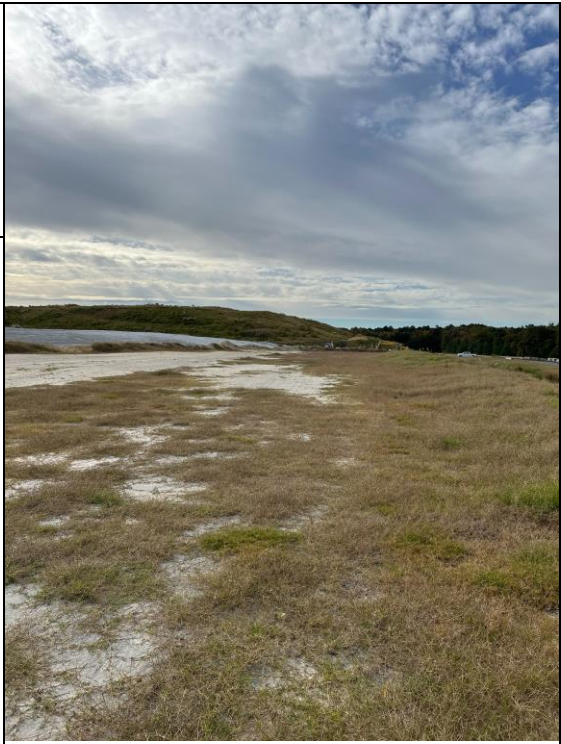
<p>Image Number: 17 Date: 10/15/2024 Time: 8:53 AM Direction: South</p>

<p>Description: Vegetation establishing on Phase II Cell 2 intermediate cover. Material is graded and well maintained.</p>

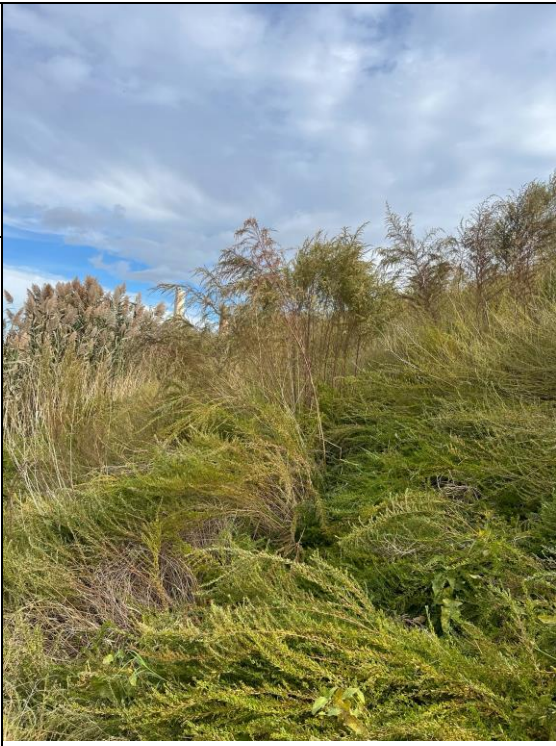
Image Number: 19
Date: 10/15/2024
Time: 8:59 AM
Direction: North-Northeast

Description:
Vegetation on side slopes of landfill is well established. No signs of erosion, sloughing, or animal borrows.

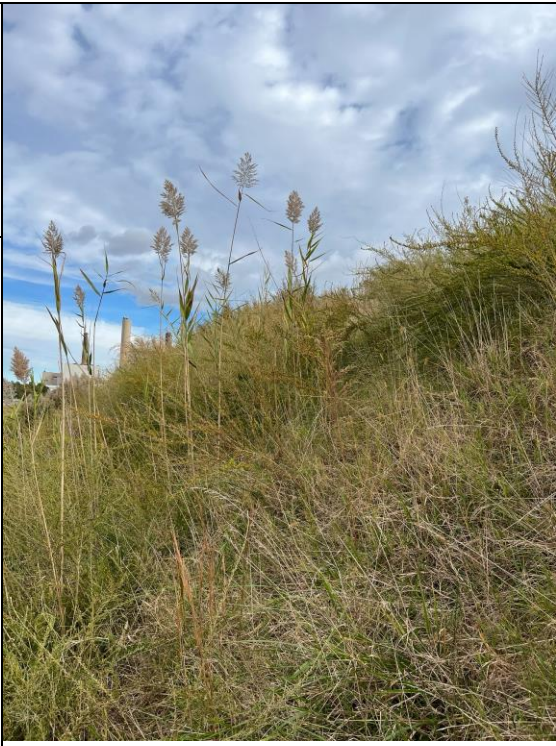
Image Number: 20
Date: 10/15/2024
Time: 9:01 AM
Direction: North-Northeast

Description:
Vegetation on side slopes of landfill is well established. No signs of erosion, sloughing, or animal borrows.

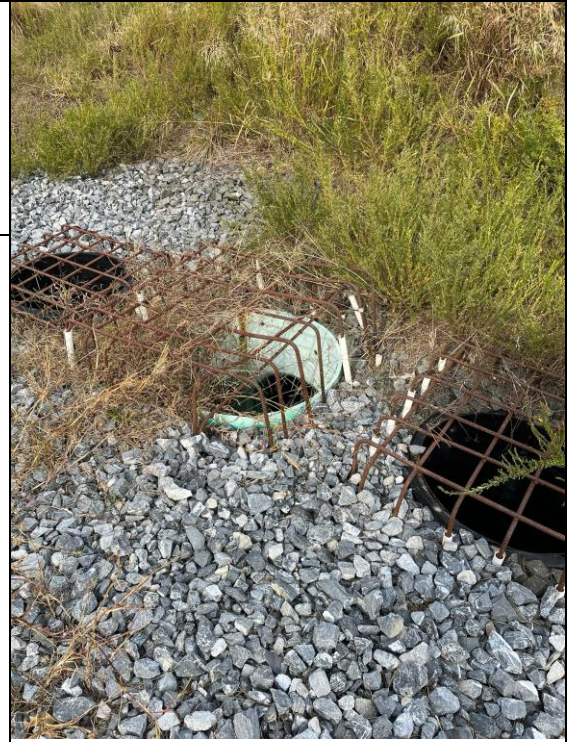
Image Number: 33
Date: 10/15/2024
Time: 9:16 AM
Direction: West-Northwest

Description:
Downslope pipe inlets are well maintained and free of obstructions.

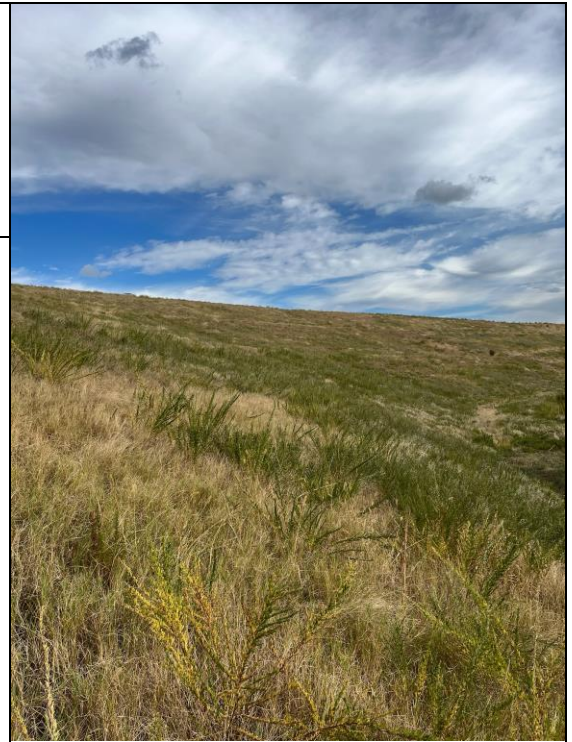
Image Number: 34
Date: 10/15/2024
Time: 9:17 AM
Direction: North-Northeast

Description:
Vegetation on side slopes is well established. Vegetation on side slopes of landfill is well established. No signs of erosion, sloughing, or animal borrows.

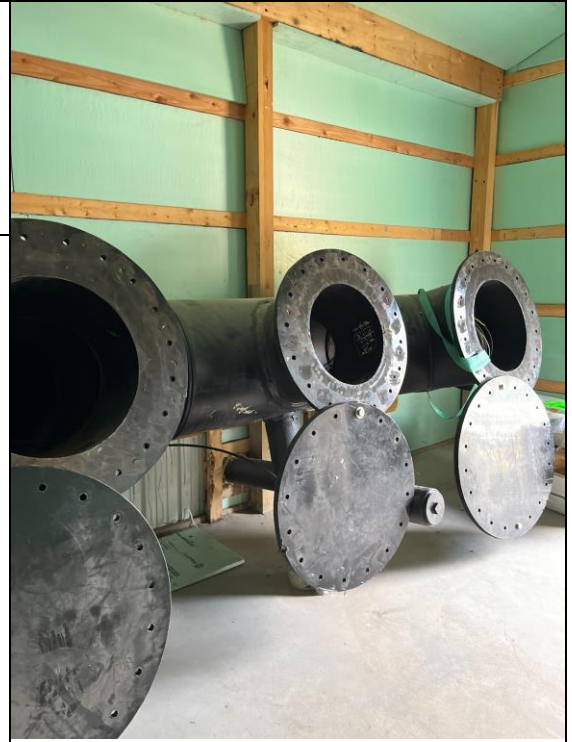
Image Number: 37
Date: 10/15/2024
Time: 9:22 AM
Direction: West-Southwest

Description:
Inside the Phase I, Cell 2 leachate pump house. Cleanout riser and pump risers with T-connections to forcemain are shown in this photograph. Building is well maintained.

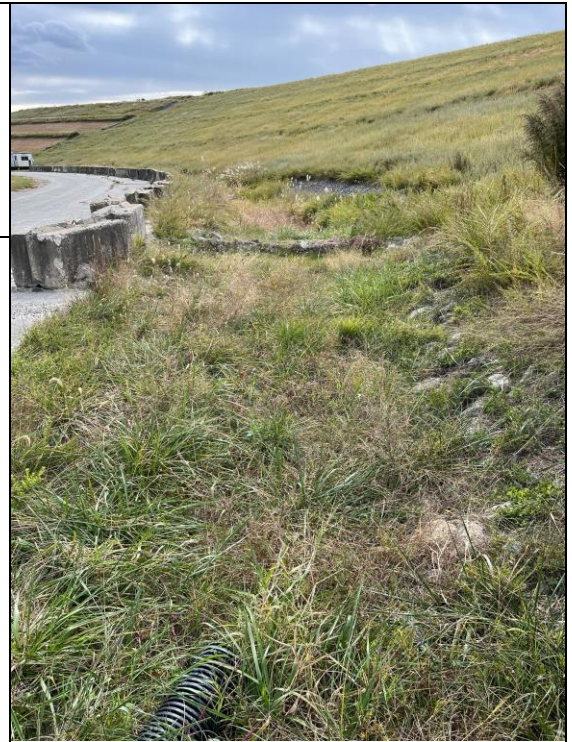
Image Number: 38
Date: 10/15/2024
Time: 9:23 AM
Direction: Southeast

Description:
Pipes from intermediate cover areas of Phase II Cell 2 convey non-contact water into north perimeter ditch.

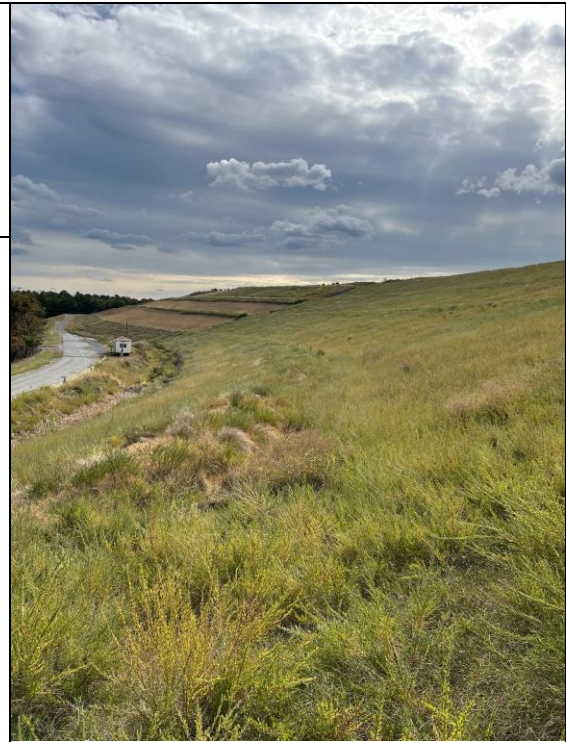
Image Number: 39
Date: 10/15/2024
Time: 9:25 AM
Direction: East-Southeast

Description:
Landfill side slopes and terrace are well maintained. No evidence of slope stability issues or erosion.

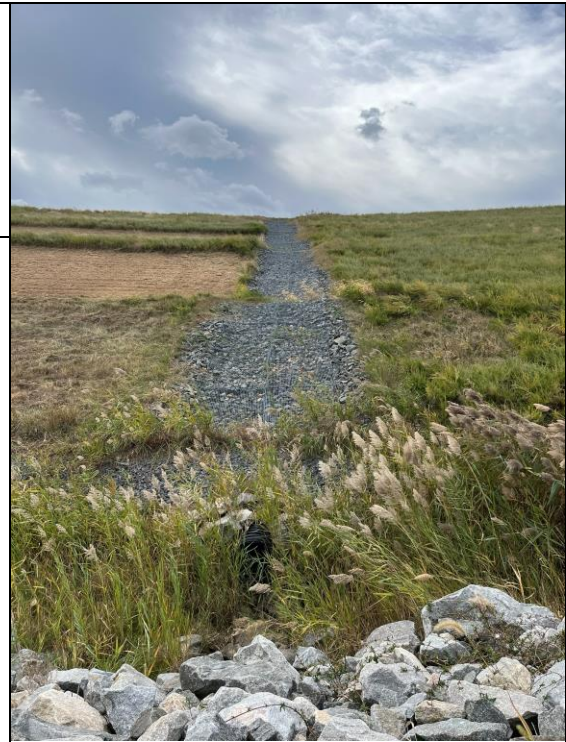
Image Number: 40
Date: 10/15/2024
Time: 9:28 AM
Direction: South

Description:
Downchute near southwest forebay of the Northeast Detention Basin. Pipe and downchute are functioning appropriately, as intended.

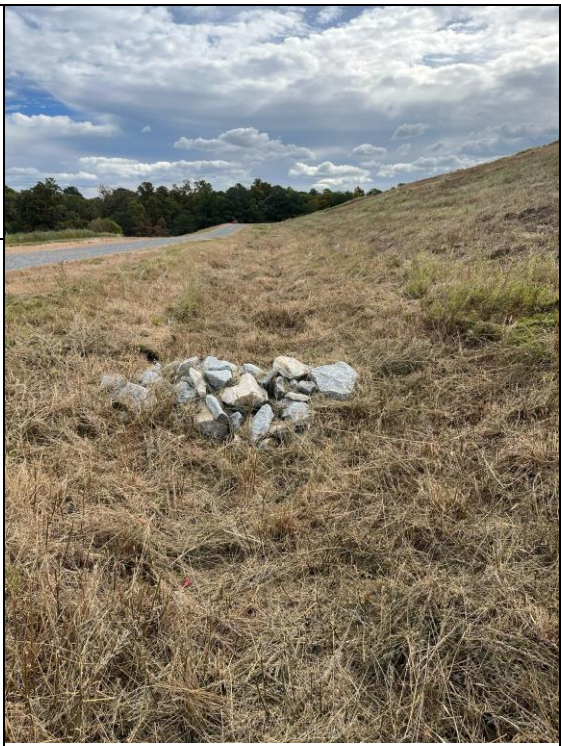
<p>Image Number: 41 Date: 10/15/2024 Time: 9:29 AM Direction: East</p>

A photograph showing a pile of grey rocks in the center of a grassy, sloping terrace berm. The grass is dry and yellowish-brown. In the background, there is a line of trees and a cloudy sky.
<p>Description: Rock check in Phase 1 final cover terrace berm is well maintained.</p>

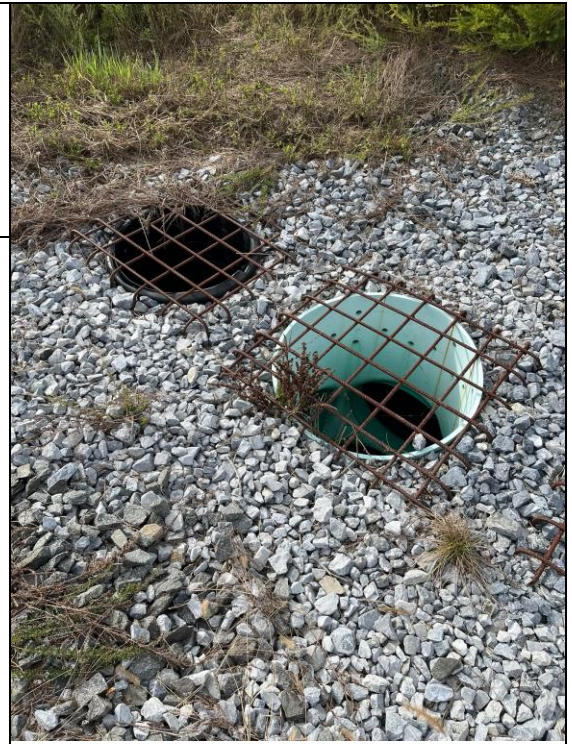
Image Number: 44
Date: 10/15/2024
Time: 9:32 AM
Direction: South

Description:
Downslope pipe inlets are well maintained and free of obstructions.

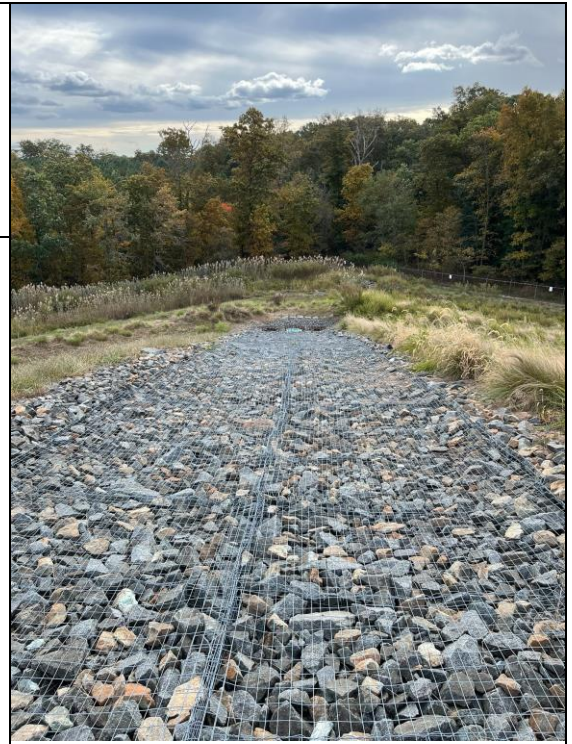
Image Number: 47
Date: 10/15/2024
Time: 9:35 AM
Direction: East-Southeast

Description:
Phase I downchute riprap. Free of obstructions and functioning. No signs of wash out or erosion.

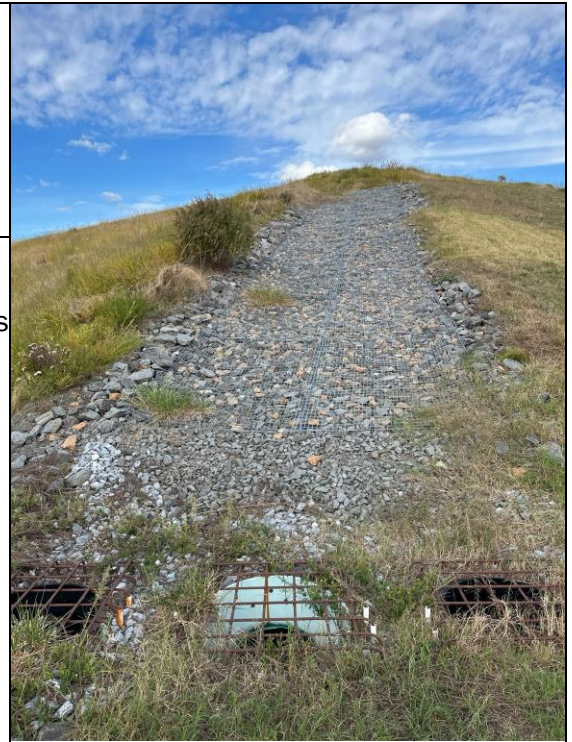
Image Number: 48
Date: 10/15/2024
Time: 9:35 AM
Direction: West-Northwest

Description:
Phase I downchute riprap. Free of obstructions and functioning. No signs of wash out or erosion.

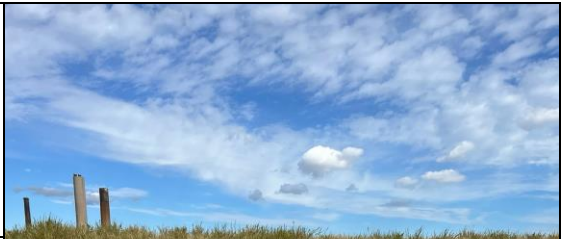
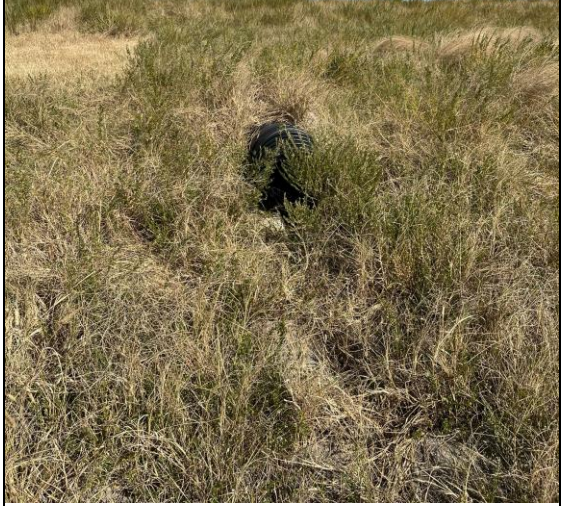
<p>Image Number: 51 Date: 10/15/2024 Time: 9:40 AM Direction: North</p>

<p>Description: Letdown pipe location from plateau terrace into access road ditch on Phase I final cover area. Free draining with no obstructions. No evidence of erosion or scour.</p>

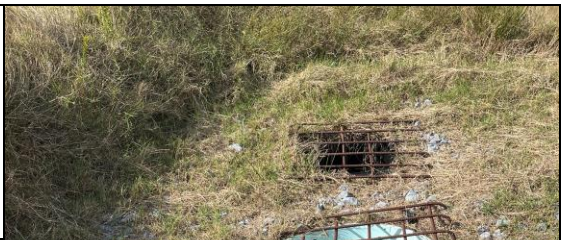
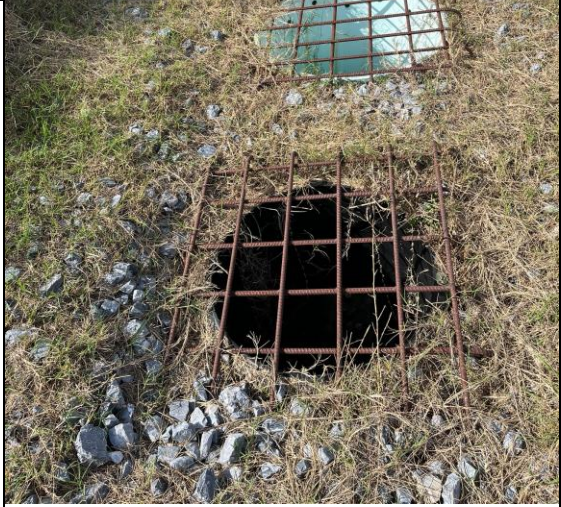
<p>Image Number: 52 Date: 10/15/2024 Time: 9:41 AM Direction: West-Southwest</p>

<p>Description: Phase I downchute pipe inlets with grated covers. Free of obstructions and functioning.</p>

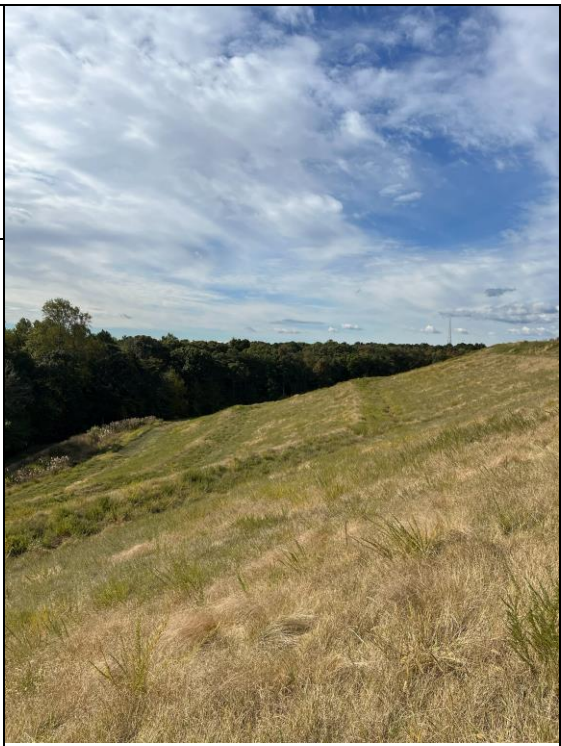
<p>Image Number: 53 Date: 10/15/2024 Time: 9:41 AM Direction: Southwest</p>

<p>Description: Phase I final cover. Vegetation coverage is dense and healthy. No animal burrows, erosion, or sloughing were observed.</p>

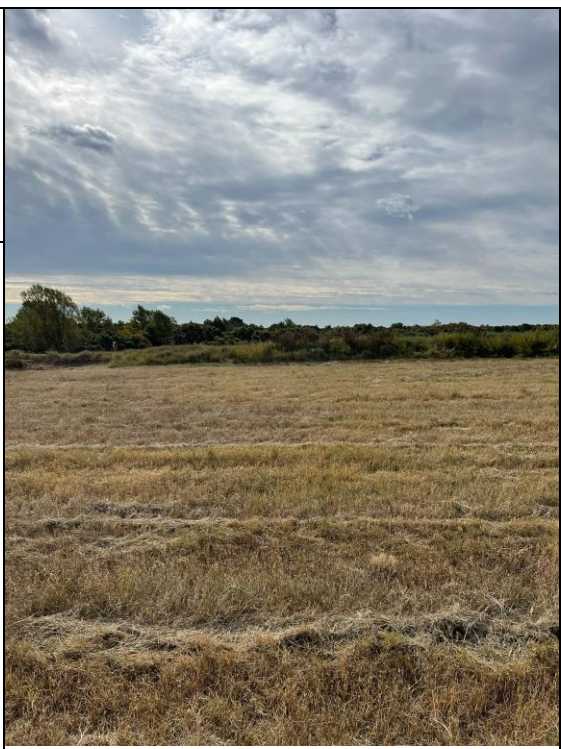
<p>Image Number: 54 Date: 10/15/2024 Time: 9:42 AM Direction: South</p>

<p>Description: Final cover plateau area. Vegetation coverage is dense and healthy. No animal burrows, erosion, or sloughing were observed.</p>

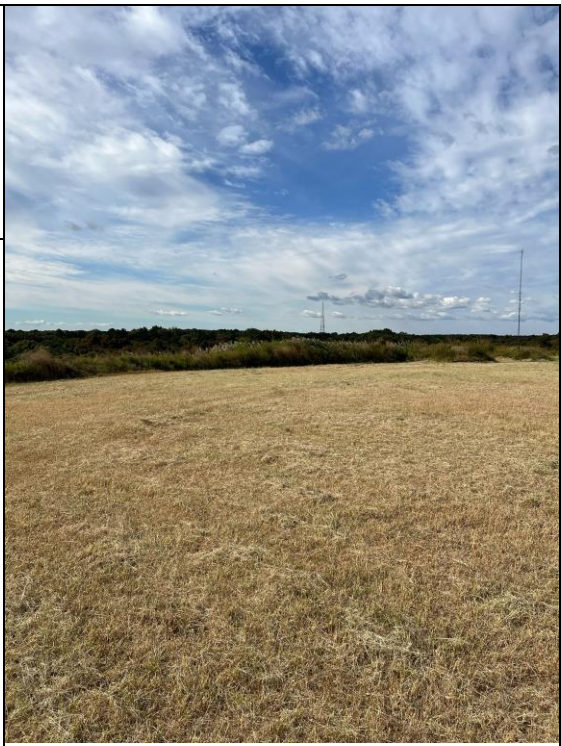
<p>Image Number: 55 Date: 10/15/2024 Time: 9:42 AM Direction: South-Southwest</p>

<p>Description: Final cover plateau area. Vegetation coverage is dense and healthy. No animal burrows, erosion, or sloughing were observed.</p>

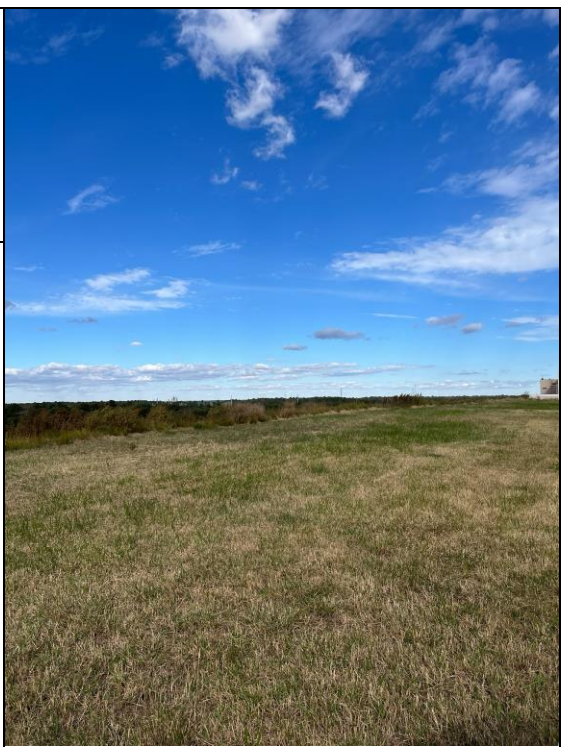
<p>Image Number: 56 Date: 10/15/2024 Time: 9:43 AM Direction: Northwest</p>

<p>Description: Final cover plateau area. Vegetation coverage is dense and healthy. No animal burrows, erosion, or sloughing were observed.</p>

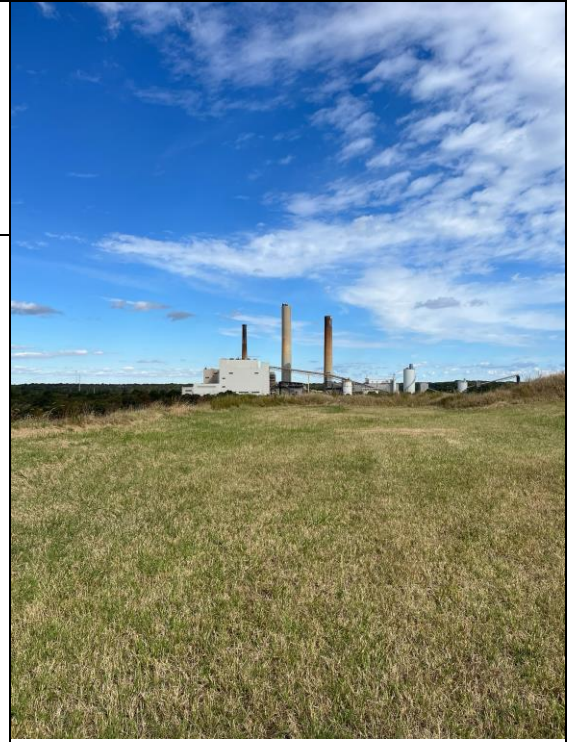
Image Number: 57
Date: 10/15/2024
Time: 9:45 AM
Direction: North

Description:
Final cover plateau area. Vegetation coverage is dense and healthy. No animal burrows, erosion, or sloughing were observed.

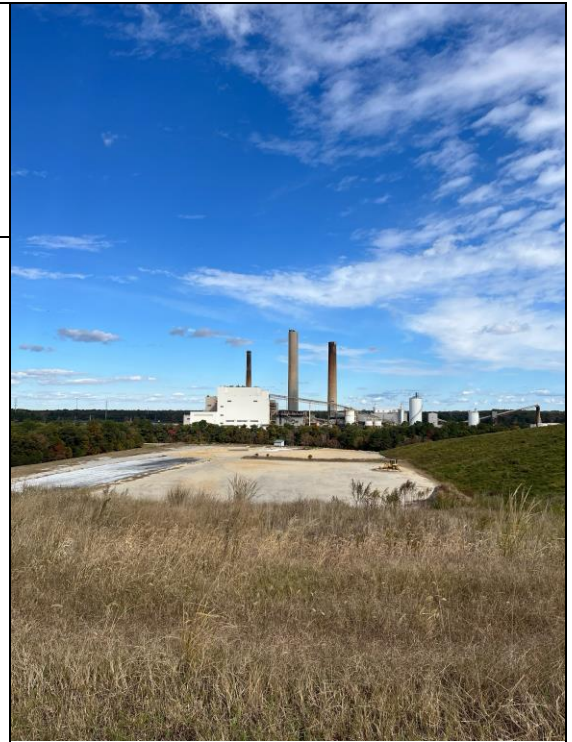
Image Number: 58
Date: 10/15/2024
Time: 9:46 AM
Direction: North

Description:
Overlooking Phase II, Cell 2 active area from Phase II, Cell 1 plateau.
Vegetation on plateau is well established with no signs of erosion, sloughing, or animal burrows.

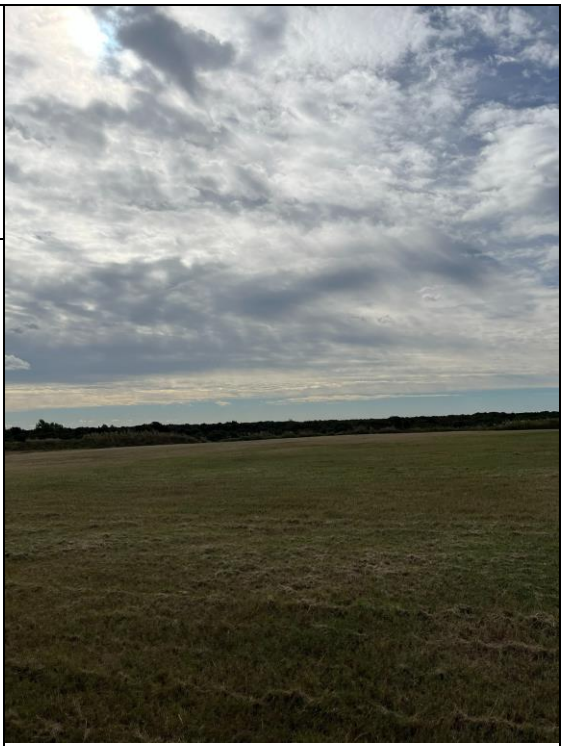
<p>Image Number: 59 Date: 10/15/2024 Time: 9:46 AM Direction: South-Southeast</p>

<p>Description: Final cover plateau area. Vegetation coverage is dense and healthy. No animal burrows, erosion, or sloughing were observed.</p>

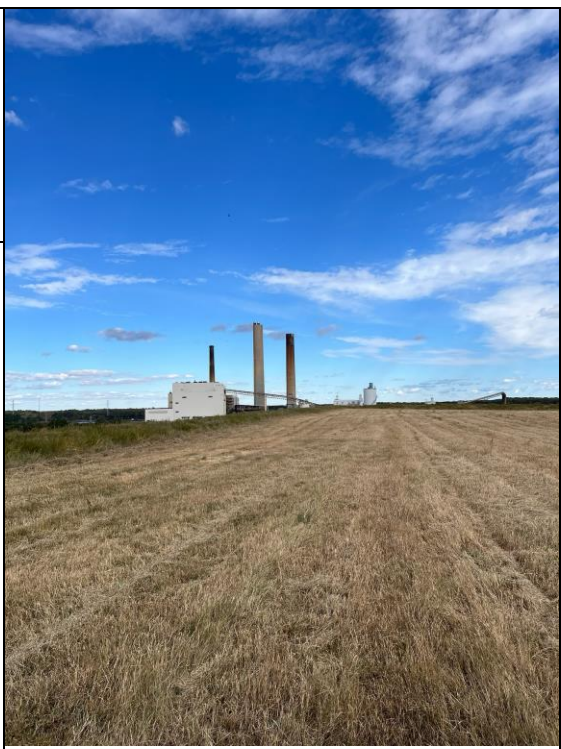
<p>Image Number: 60 Date: 10/15/2024 Time: 9:46 AM Direction: North</p>

<p>Description: Final cover plateau area. Vegetation coverage is dense and healthy. No animal burrows, erosion, or sloughing were observed.</p>

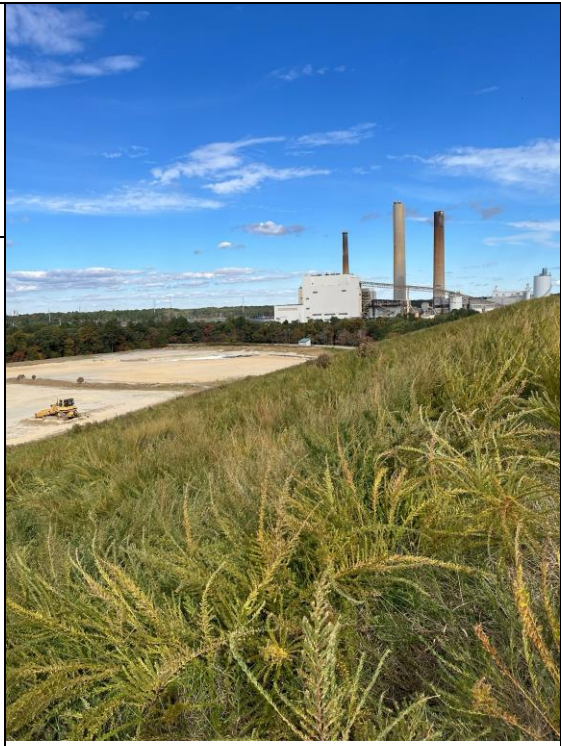
Image Number: 61
Date: 10/15/2024
Time: 9:47 AM
Direction: North-Northwest

Description:
Phase 1 sideslope (right) has well established vegetation.
Phase 2 Cell 2 intermediate cover are

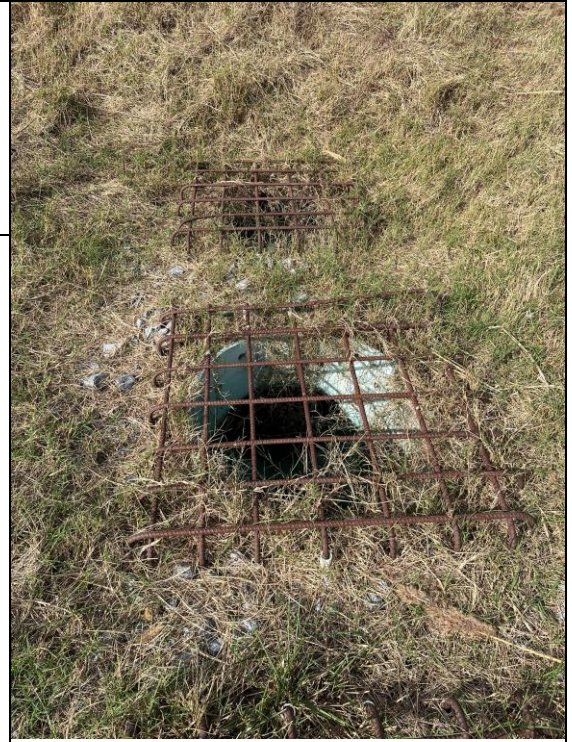
Image Number: 63
Date: 10/15/2024
Time: 9:49 AM
Direction: West

Description:
Downslope pipe inlets are well maintained and free of obstructions.

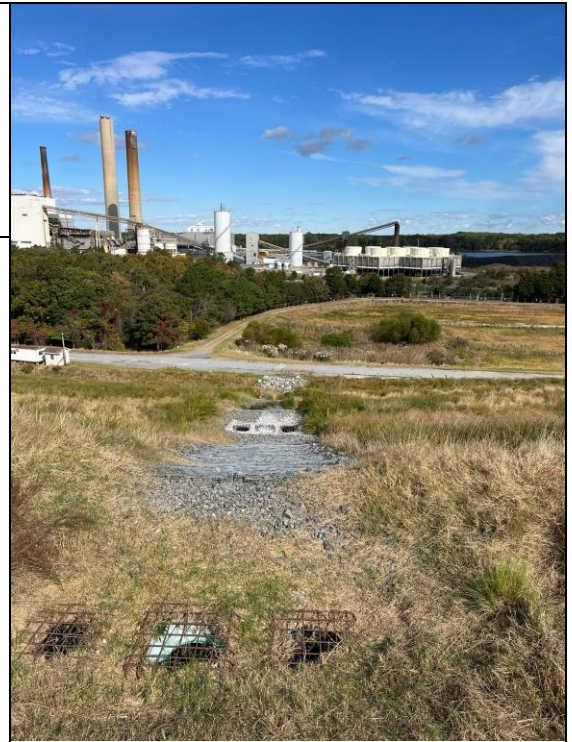
Image Number: 64
Date: 10/15/2024
Time: 9:49 AM
Direction: North

Description:
Phase I downchute riprap. Free of obstructions and functioning. No signs of wash out or erosion. Northwest Detention Basin shown in midground.

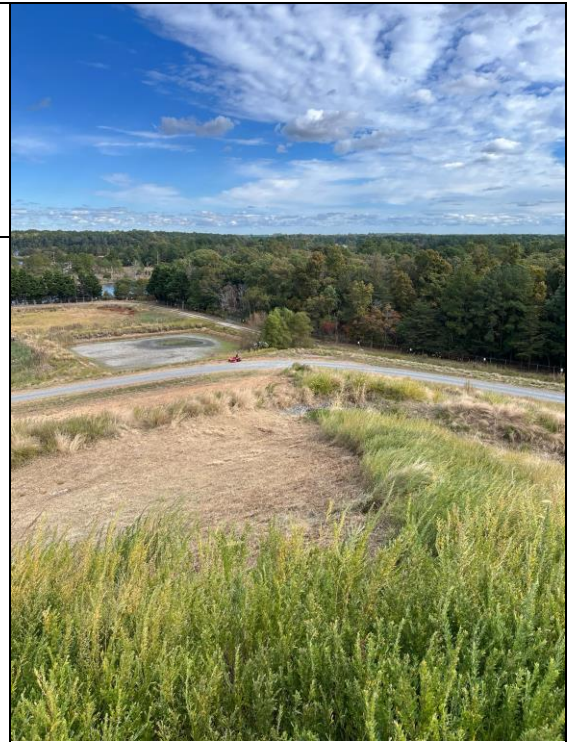
Image Number: 67
Date: 10/15/2024
Time: 9:59 AM
Direction: North-Northeast

Description:
Overview of Northwest Basin settling pond forebay from landfill plateau. Final cover is well maintained.

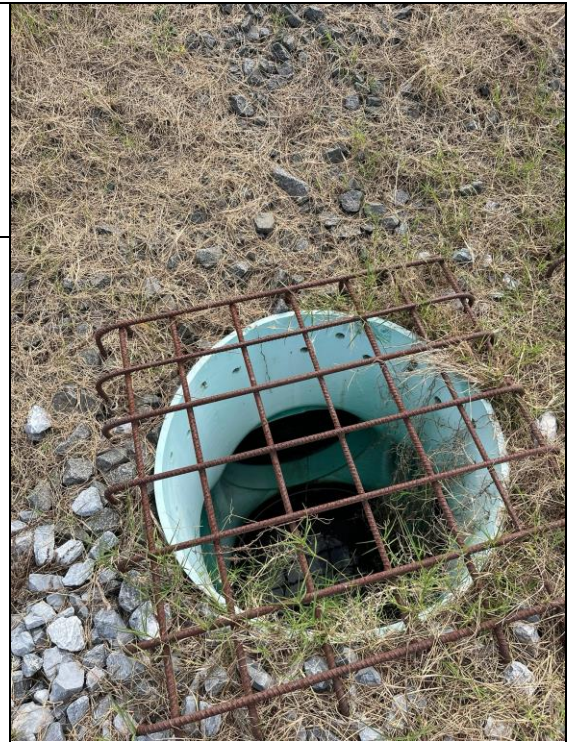
Image Number: 68
Date: 10/15/2024
Time: 10:01 AM
Direction: Southeast

Description:
Phase I downchute pipe inlets with grated covers are well maintained and free of obstructions.

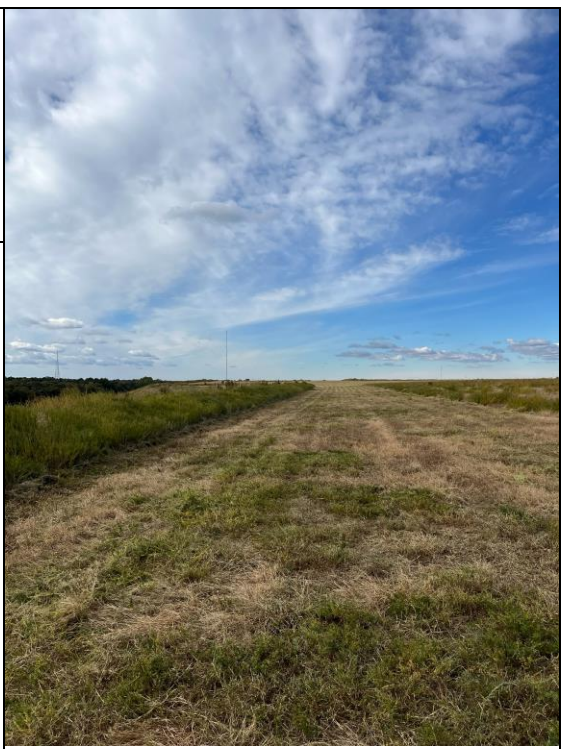
<p>Image Number: 70 Date: 10/15/2024 Time: 10:02 AM Direction: West-Southwest</p>

<p>Description: Final cover plateau area. Vegetation coverage is dense and healthy. No animal burrows, erosion, or sloughing were observed.</p>

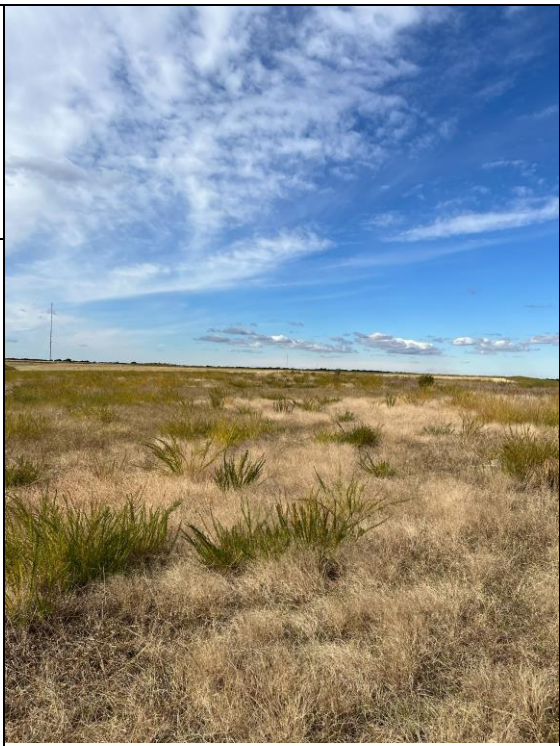
<p>Image Number: 71 Date: 10/15/2024 Time: 10:02 AM Direction: West</p>

<p>Description: Final cover plateau area. Vegetation coverage is dense and healthy. No animal burrows, erosion, or sloughing were observed.</p>

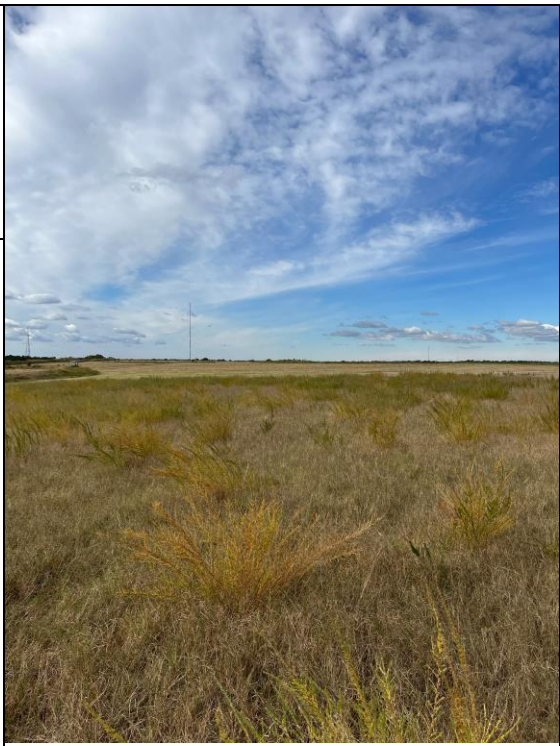
<p>Image Number: 72 Date: 10/15/2024 Time: 10:02 AM Direction: West-Southwest</p>

<p>Description: Final cover plateau area. Vegetation coverage is dense and healthy. No animal burrows, erosion, or sloughing were observed.</p>

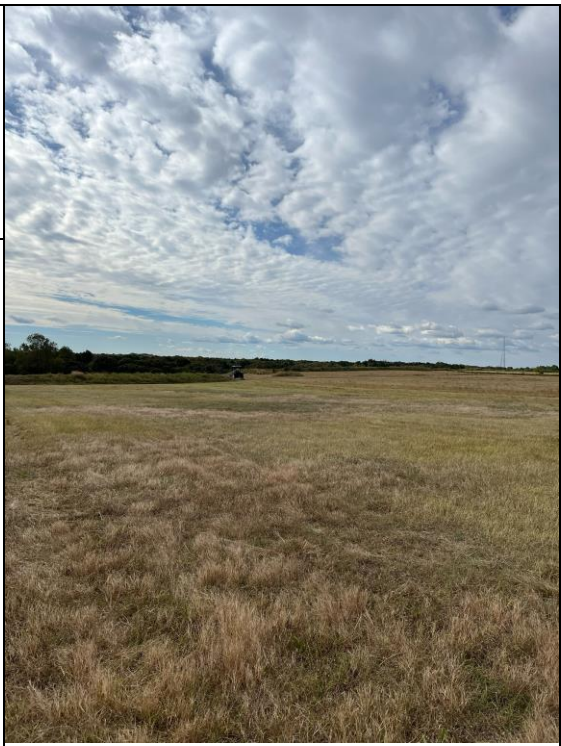
<p>Image Number: 73 Date: 10/15/2024 Time: 10:03 AM Direction: South</p>

<p>Description: Final cover plateau area. Vegetation coverage is dense and healthy. No animal burrows, erosion, or sloughing were observed.</p>

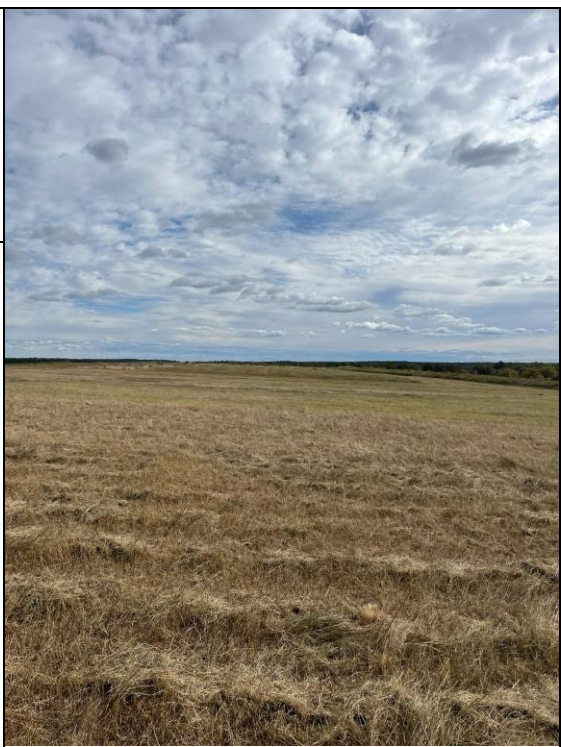
<p>Image Number: 74 Date: 10/15/2024 Time: 10:03 AM Direction: East-Northeast</p>

<p>Description: Final cover plateau area. Vegetation coverage is dense and healthy. No animal burrows, erosion, or sloughing were observed.</p>
