2025 ANNUAL CCR UNIT INSPECTION
INDIAN RIVER LANDFILL
NRG INDIAN RIVER STATION
DAGSBORO, DELAWARE

SCS ENGINEERS

25221158.00 | January 18, 2026

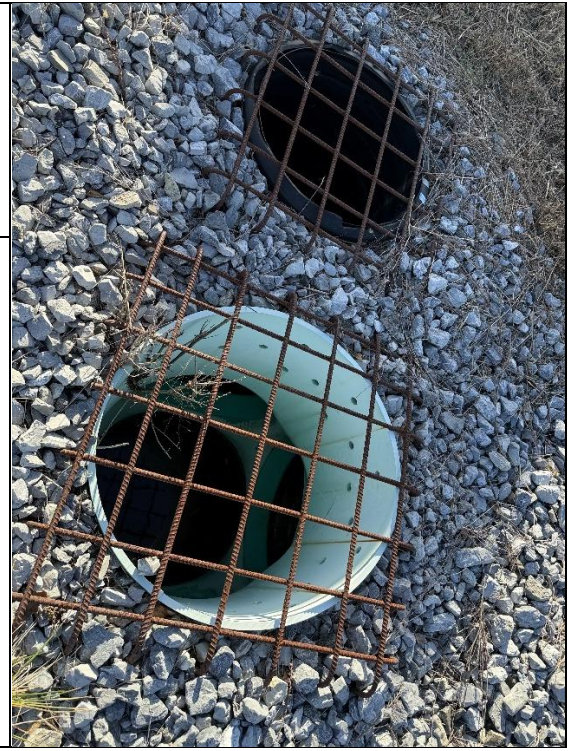
Image Number: 37
Date: 11/13/2025
Time: 8:39 AM
Direction: South-Southwest

Description:
Downslope pipe inlets are well maintained and free of obstructions.

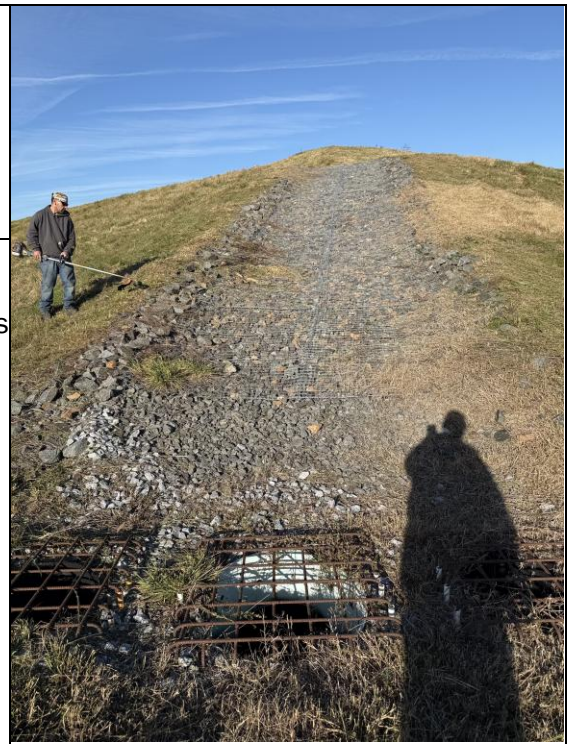
Image Number: 38
Date: 11/13/2025
Time: 8:39 AM
Direction: Northwest

Description:
Phase I downchute riprap. Free of obstructions and functioning. No signs of wash out or erosion.

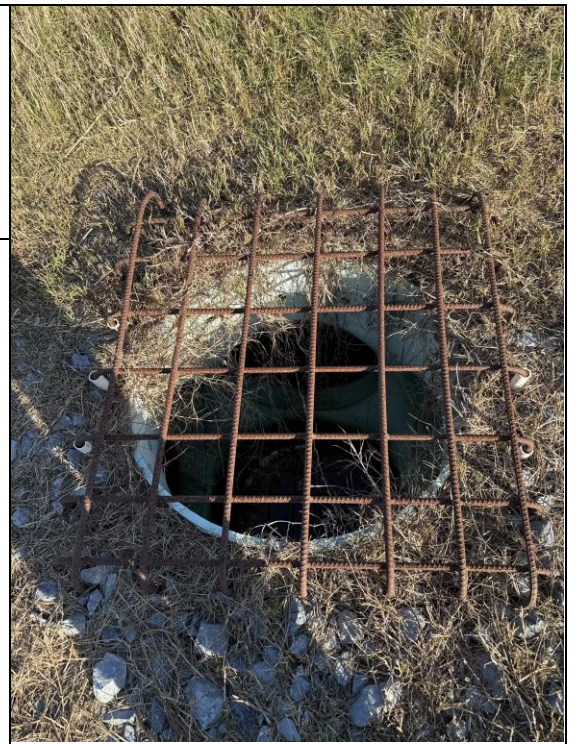
Image Number: 48
Date: 11/13/2025
Time: 8:48 AM
Direction: North

Description:
Downslope pipe inlets are well maintained and free of obstructions.
