2018 Annual Inspection of CCR Units

Limestone Electric Generating Station
Jewett, Texas

January 2019

NRG Texas Power LLC

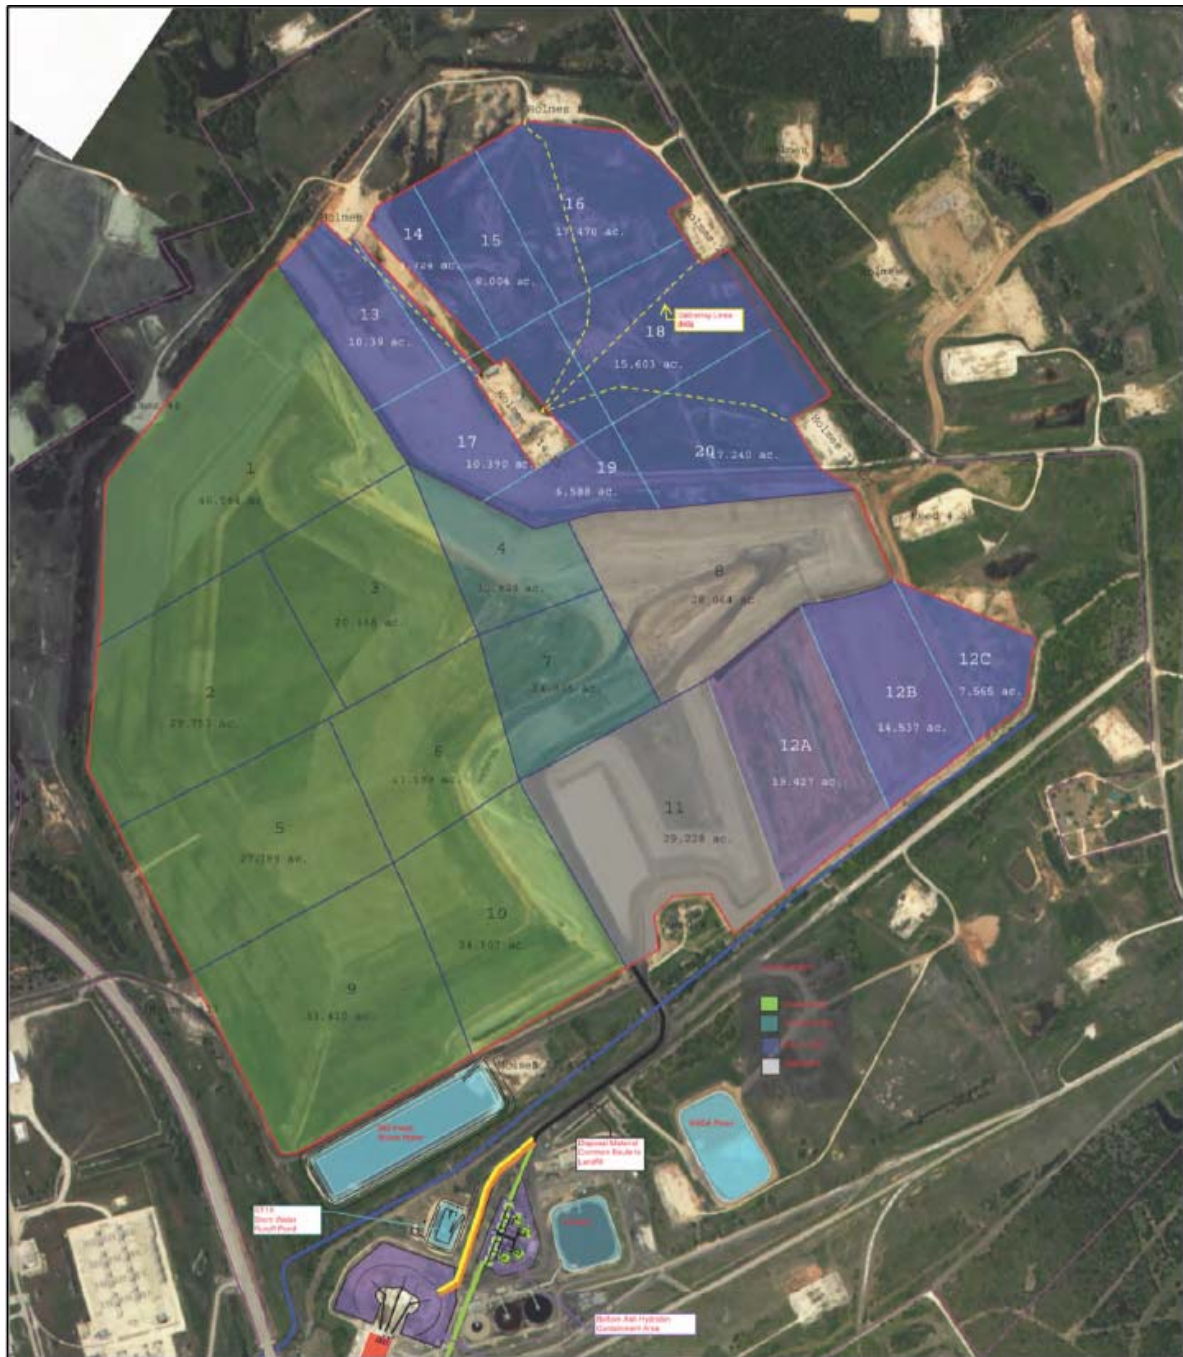
Figure 2
Aerial View of Unit 004 Landfill
Limestone Station

The landfill is located east of FM 39. The landfill areas are designed as Class II Industrial Waste Landfill under the criteria of the Texas Commission on Environmental Quality (TCEQ). The landfill is managed using tracking areas indicated on Figure 2. These areas have no physical boundaries in the landfill and are hydraulically connected. The areas are considered to be in one of three stages. The stages for the tracking areas are capped, uncapped, and areas under construction.

The location and general arrangement of the landfill is depicted on Figure 2. The individual areas discussed in this report are also depicted on Figure 2.

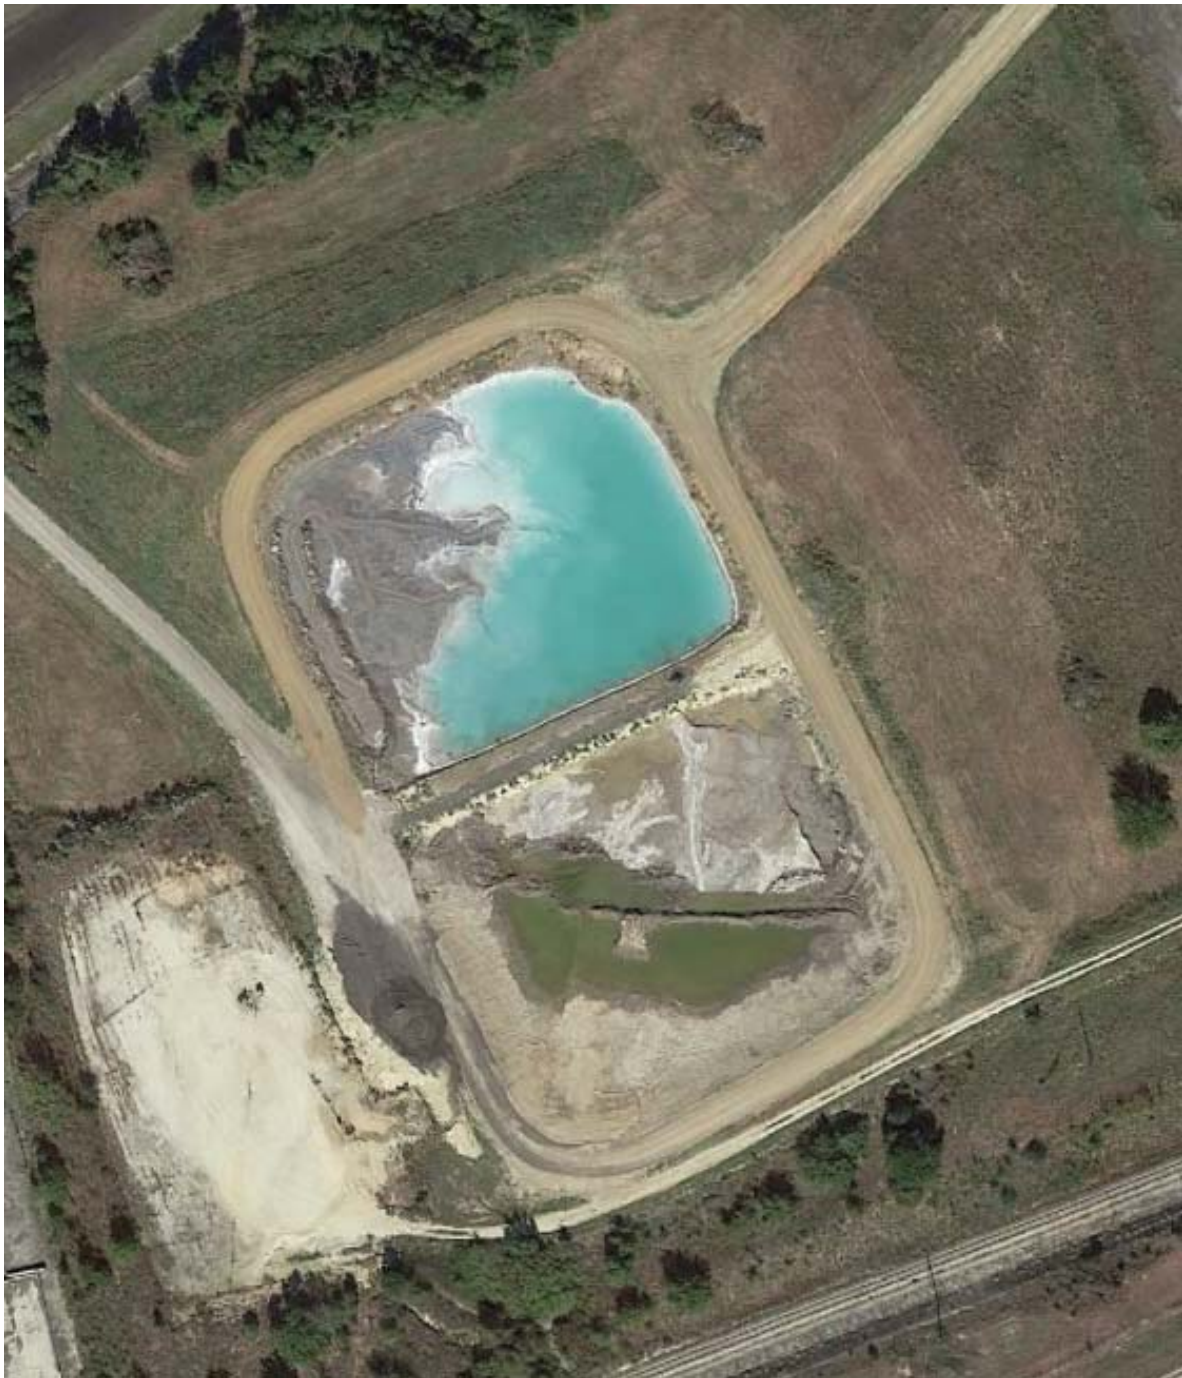
Figure 3

The location and general arrangement of the Secondary E Pond are depicted on Figure 3.
