2020 Annual Inspection of CCR Unit

**Limestone Electric Generating Station
Jewett, Texas**

January 2021

NRG Texas Power LLC

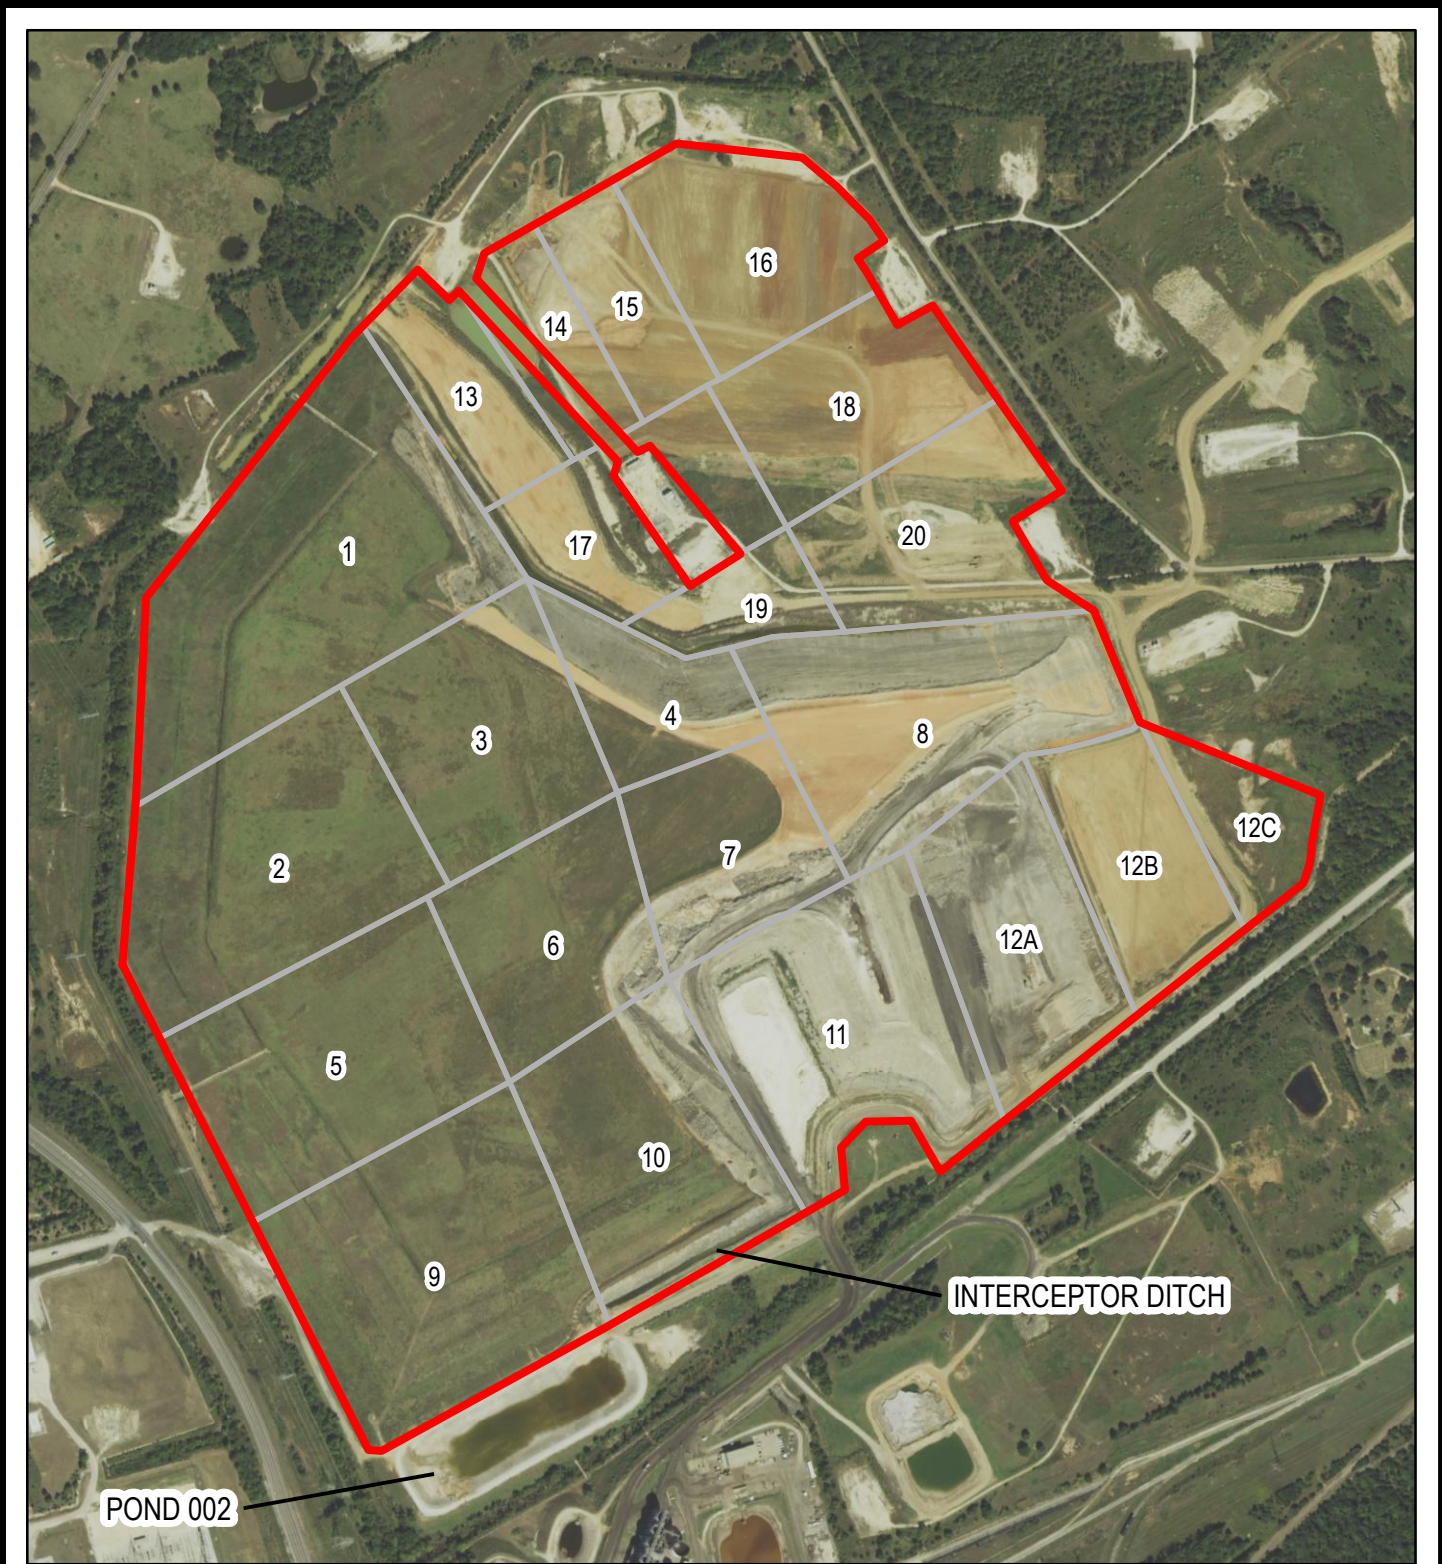
FIGURE 2

The landfill is located east of FM 39. The landfill is designated as a Class II Industrial Waste Landfill under the criteria of the Texas Commission on Environmental Quality (TCEQ). The landfill is managed based on the areas indicated on Figure 2. These areas have no physical boundaries in the landfill and are hydraulically connected. As of the date of the annual inspection, the areas are in one of three stages: Capped, uncapped, and future expansion areas.

Although landfill Areas 1, 2, 3, 5, 6, 9, and 10 are considered to be capped, exposed slopes of CCR are present in Areas 1, 3, 6, and 10, where uncapped and future expansion areas will abut the existing CCR material (Figure 2). The plateaued portion of the capped areas is well vegetated and generally well graded to prevent the localized ponding of stormwater and to direct the flow of stormwater as depicted in Photographs P-1, P-2, and P-3. Photograph P-1 also shows the grassed berms used to separate stormwater between the capped and uncapped areas.
