**NRG TEXAS POWER, LLC
LIMESTONE STATION, UNITS 1 & 2**

ANNUAL INSPECTION OF CCR IMPOUNDMENTS AND LANDFILL

SL Report No.: SL-013201
Revision 0
Date: January 15, 2016
Project No.: 12661-042

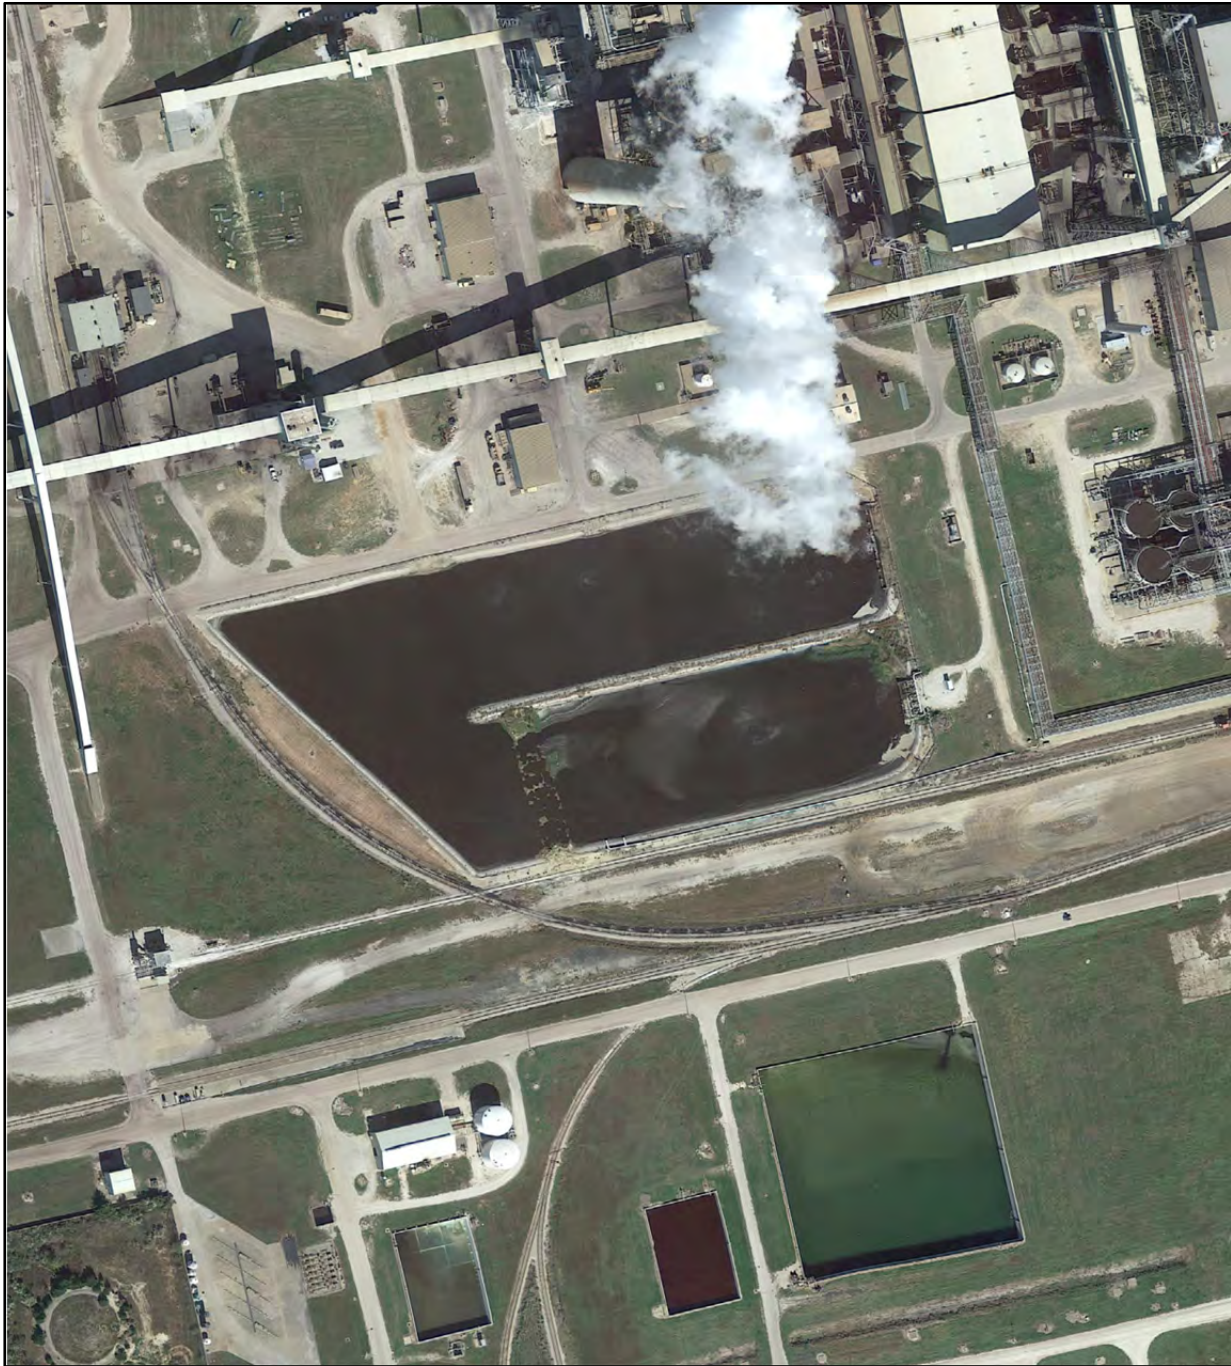
The location and general arrangement of Pond K are depicted on Figure 1 and also Photograph P-1, which were both obtained from Google Earth Pro®. This Google Earth Pro image appears to accurately represent the conditions observed at Pond K by S&L on November 11, 2015.

Photograph P-1 – From Google Earth Pro Downloaded December 31, 2015
Pond K: Aerial view of incised Pond K.

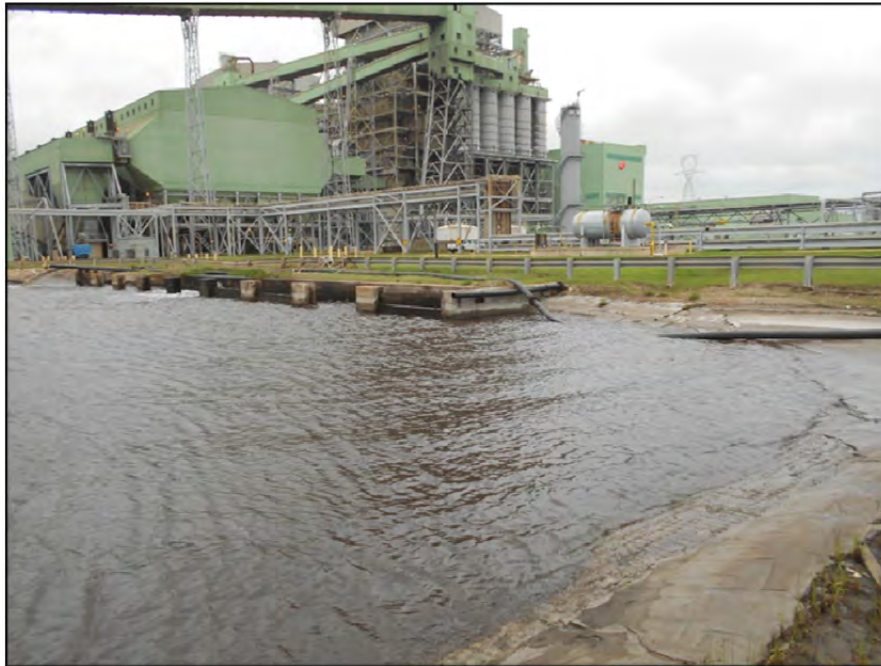
Although the Federal CCR Rule requirement for annual inspection does not apply to Pond K as discussed in Section 6.1, Photographs P-1 through P-4 (found in Appendix A) are presented to validate the fully incised condition.

Photograph P-2 – Taken November 11, 2015 by David E. Nielson
Pond K: Looking north-northeast at the eastern bank, which is incised.
This verifies that the Federal CCR Rule regarding inspections is not applicable to Pond K.

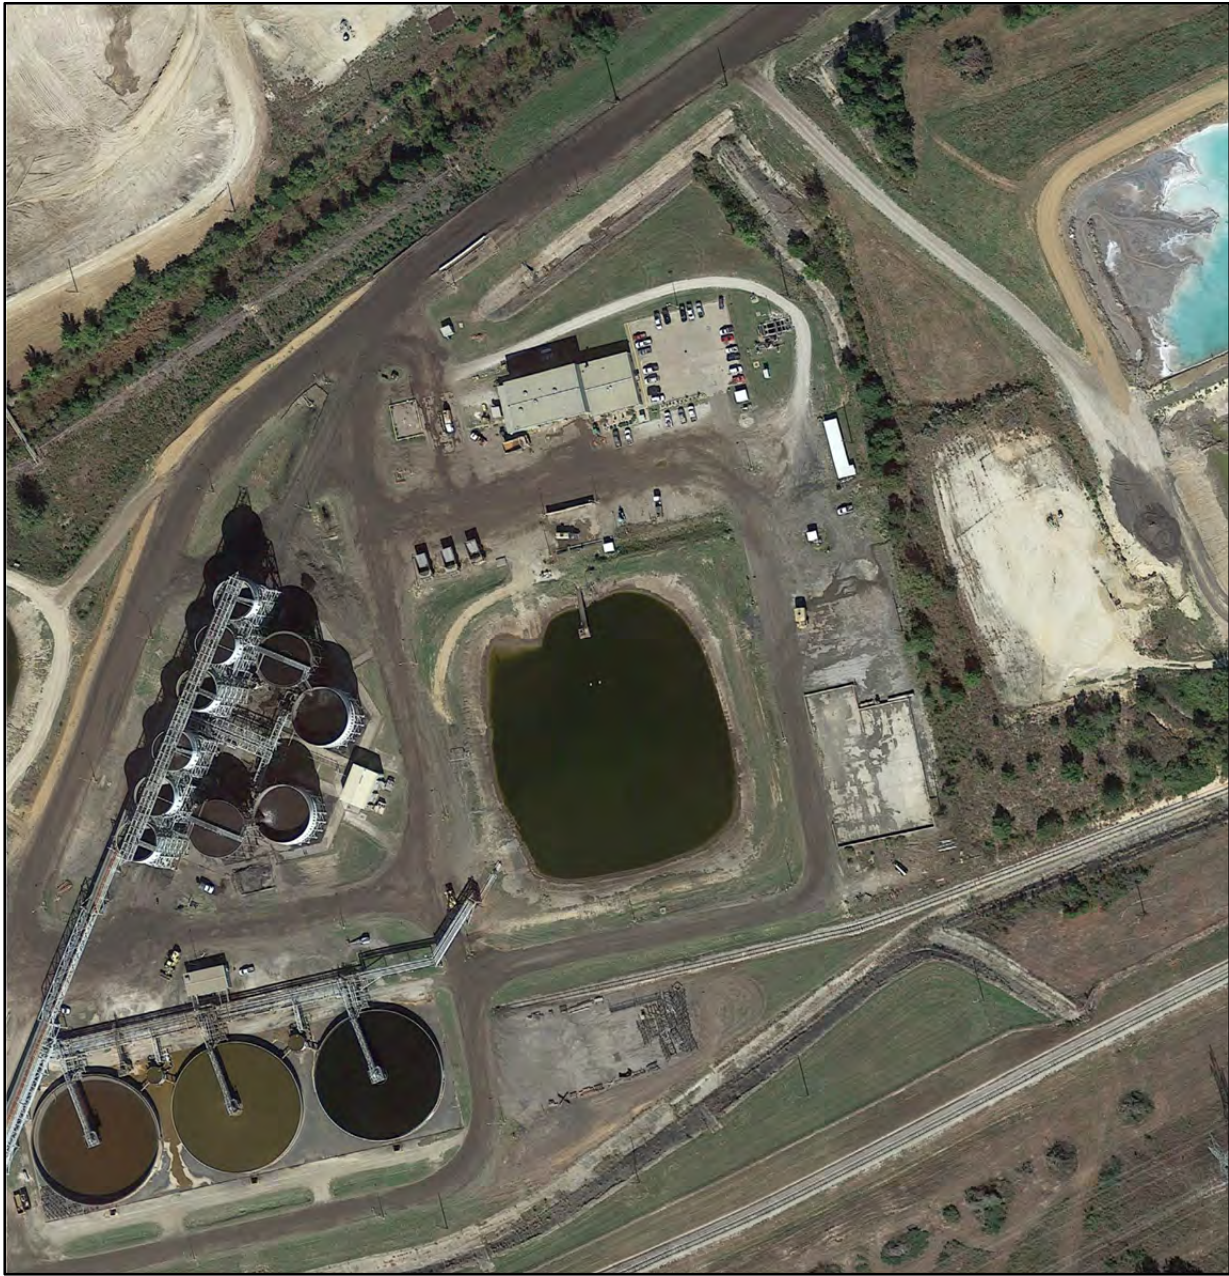
The location and general arrangement of Pond E are depicted on Figure 1 and also on Photograph P-5, which were both obtained from Google Earth Pro®. This Google Earth Pro image appears to accurately represent the conditions observed at Pond E by S&L on November 11, 2015.

Photograph P-5 – From Google Earth Pro Downloaded January 1, 2016
Pond E: Aerial view of partially incised Pond E.

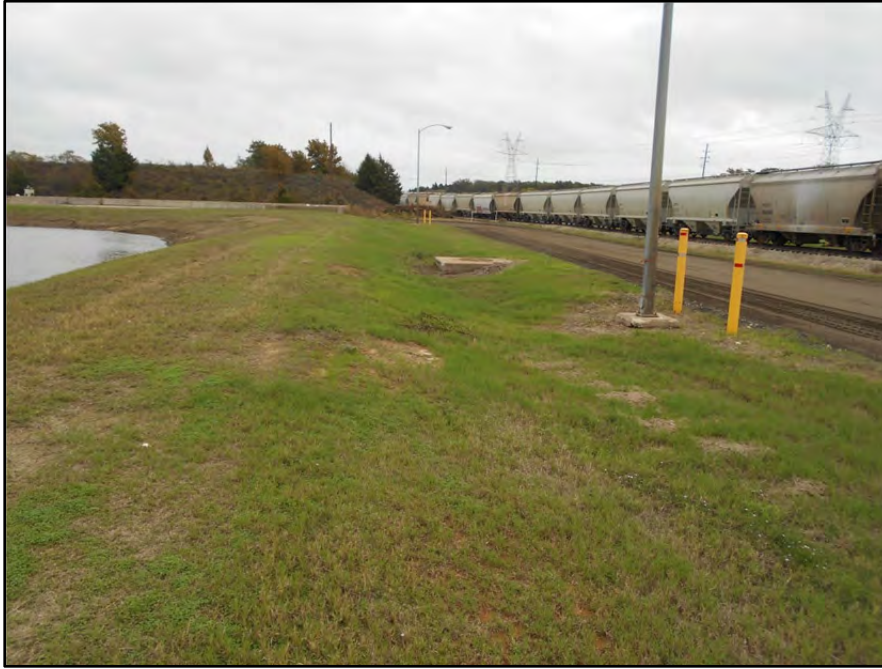
The south and west sides of Pond E are incised as shown on Photographs P-6 and P-8. The risk of catastrophic failure in these areas is minimal since the surface of the water and CCR materials is lower than the surrounding ground surface. A fabriform concrete splash pad was present in the southern portion

Photograph P-8 – Taken November 11, 2015 by David E. Nielson
Pond E: Looking east at southern bank, which is incised.

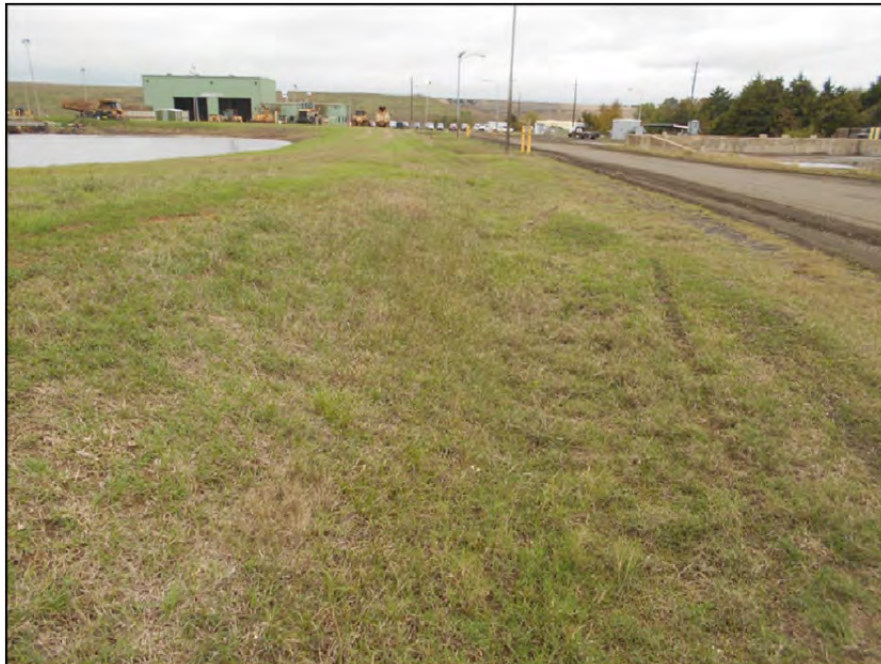
The east dike is shown in Photographs P-9 and P-10. This dike is in good condition with good grass vegetation. Photograph P-10 shows some minor slope irregularity, which is manifest by the slightly meandering shoreline. Careful evaluation of this area indicates this is most likely the result of pond cleaning activity and not slope instability. No slope instability was observed.

Photograph P-9 – Taken November 11, 2015 by David E. Nielson
Pond E: Looking north at the outside slope of the eastern dike.

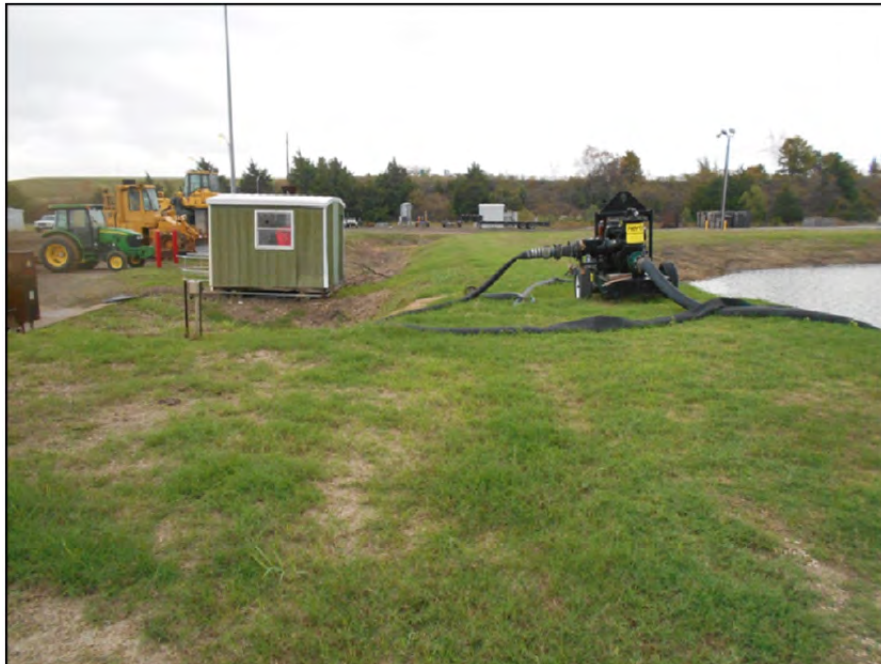
The crest of the north dike is relatively wide and the outside slope (downstream slope) is relatively gentle as shown on Photograph P-11. The inside slope (upstream slope) of the north dike is generally well sloped, with some localized exceptions of steep areas. These steep areas are shown in Photographs P-12 and P-13. This appears to be the result of incomplete cleaning of the CCR material, not a misalignment from the initial construction nor a deformation of the dike slope. Photograph P-13 also shows the stump of a former tree that had been cut. A small erosional feature was noted in the inside slope of the north dike near the valve and pump hose installation as shown of Photograph P-14.

Photograph P-11 – Taken November 11, 2015 by David E. Nielson
Pond E: Looking east at the outside slope of the north dike.

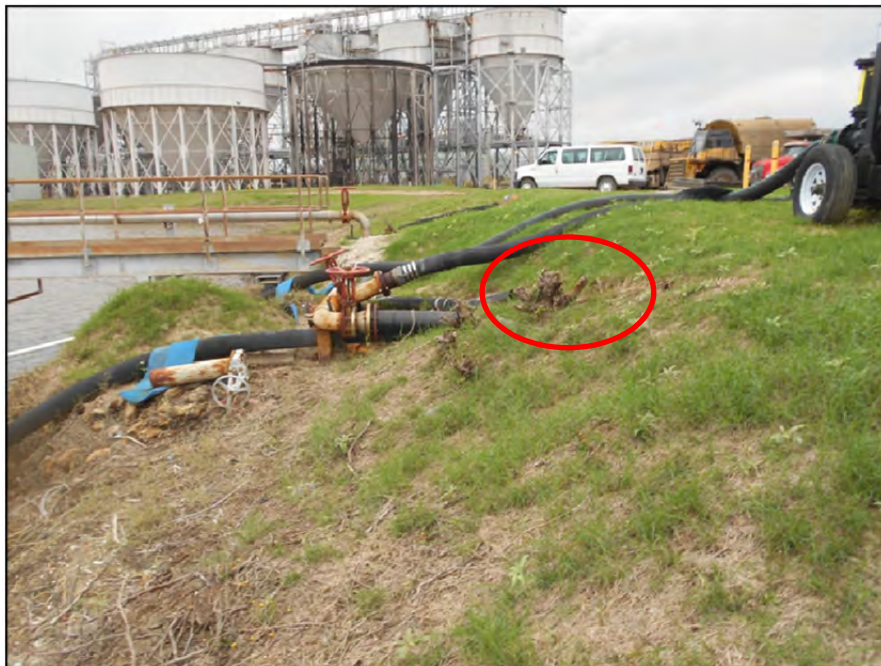
Photograph P-13 – Taken November 11, 2015 by David E. Nielson
Pond E: Looking west at the inside slope of the north dike at the discharge piping equipment.
Note evidence of recent tree removal and sparse grass.

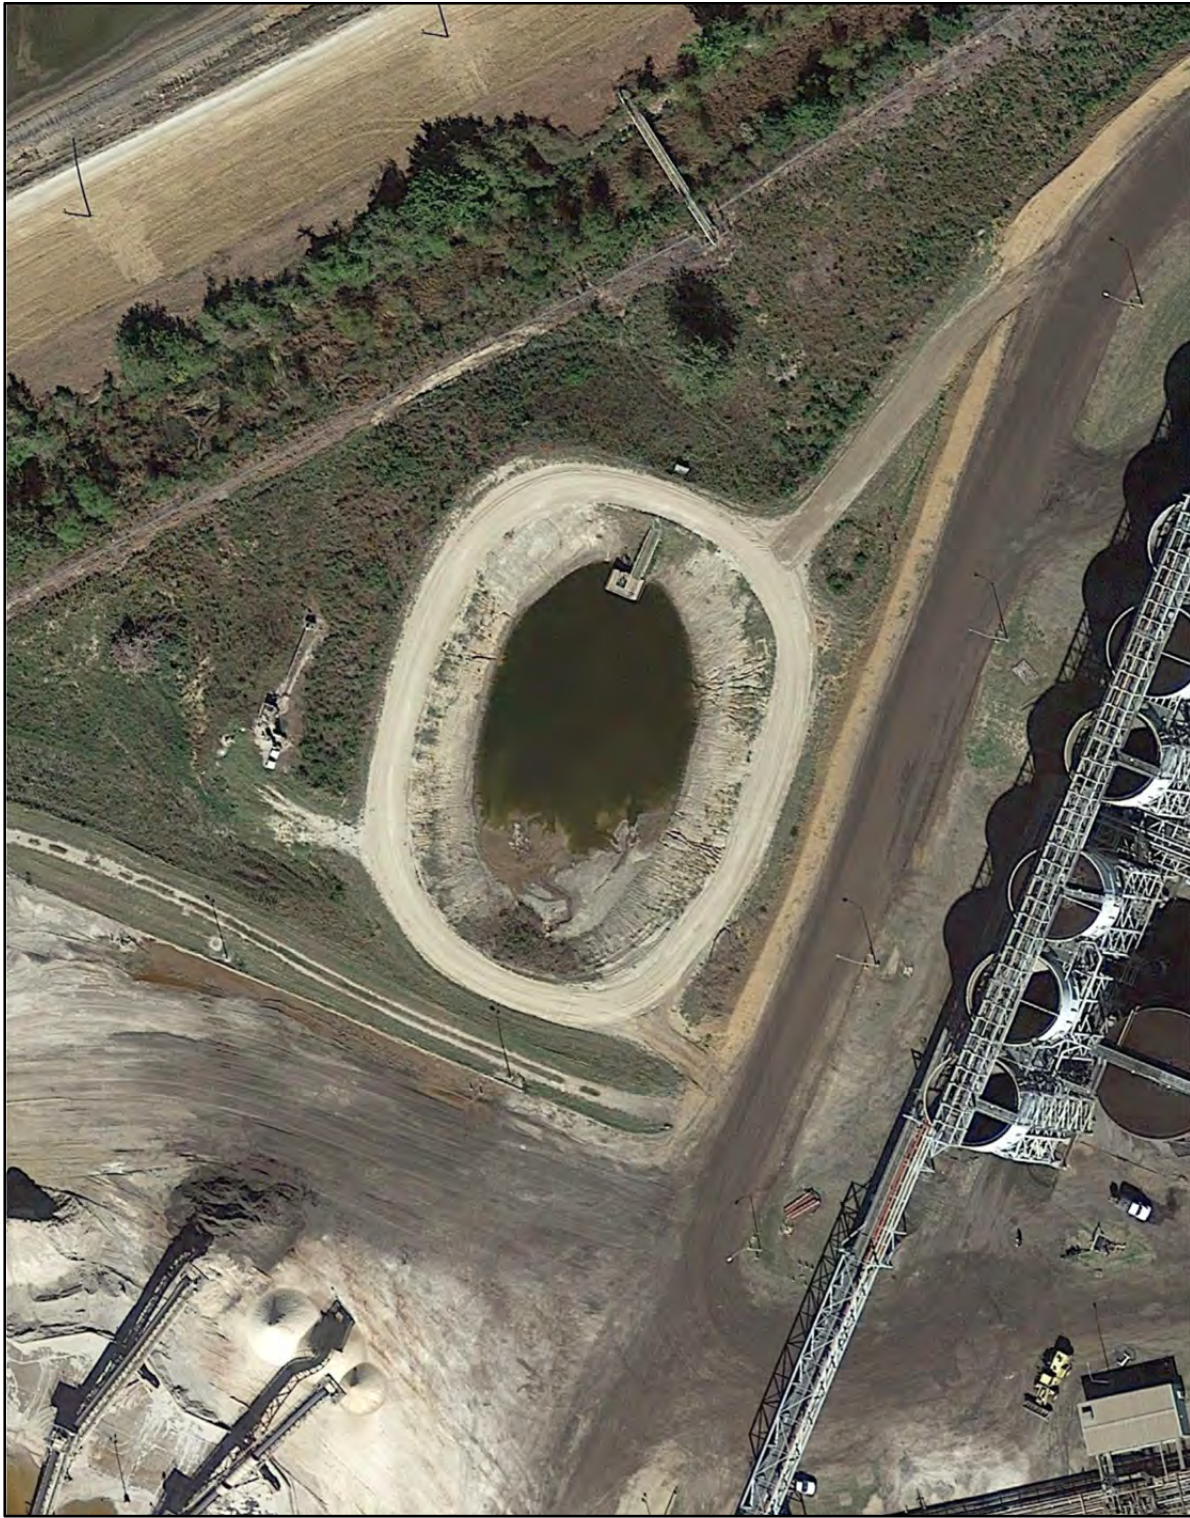
The location and general arrangement of Pond ST-18 are depicted on Figure 1 and also Photograph P-16, which were both obtained from Google Earth Pro®. This Google Earth Pro image appears to accurately represent the conditions observed at Pond ST-18 by S&L on November 11, 2015, with the exception that brush and other vegetation on the outside slopes of the north and west dikes had been cut.

Photograph P-16 – From Google Earth Pro Downloaded January 1, 2016
Pond ST-18: Aerial view of partially incised Pond ST-18.

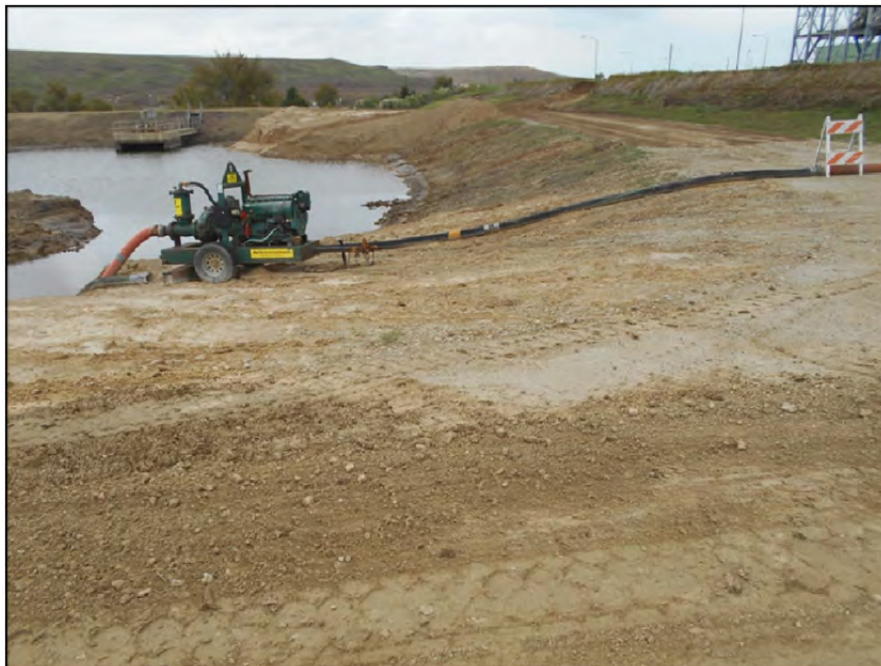
The south and east sides of Pond ST-18 are incised as shown on Photographs P-17 and P-18. The risk of catastrophic failure in these areas is minimal since the surface of the water and CCR materials is lower than the surrounding ground surface. Moreover, since the slopes up to other areas are well vegetated and reasonably graded, the risk of upslope areas exhibiting instability and deforming into Pond ST-18 visually appears to be quite low.

Photograph P-18 – Taken November 11, 2015 by David E. Nielson
Pond ST-18: Looking north at inside slope of eastern edge of incised portion of pond.

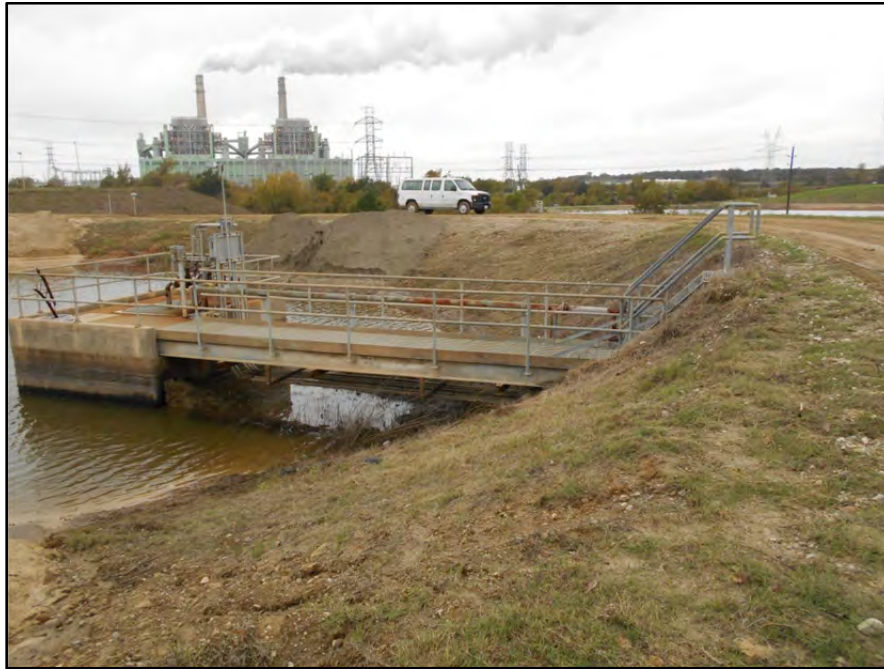
The inside slope of the north dike looked to be constructed and maintained in a reasonable manner as shown in Photograph P-19. The outside slope of the north dike exhibited a section near the outlet structure manhole that was steeper than the industry standard as shown in Photographs P-20 and P-21. Although this area does not exhibit evidence of instability, placement of additional fill is recommended to match the slopes of the other dikes.

Photograph P-19 – Taken November 11, 2015 by David E. Nielson
Pond ST-18: Looking west at inside slope of north dike of pond and outlet structure.

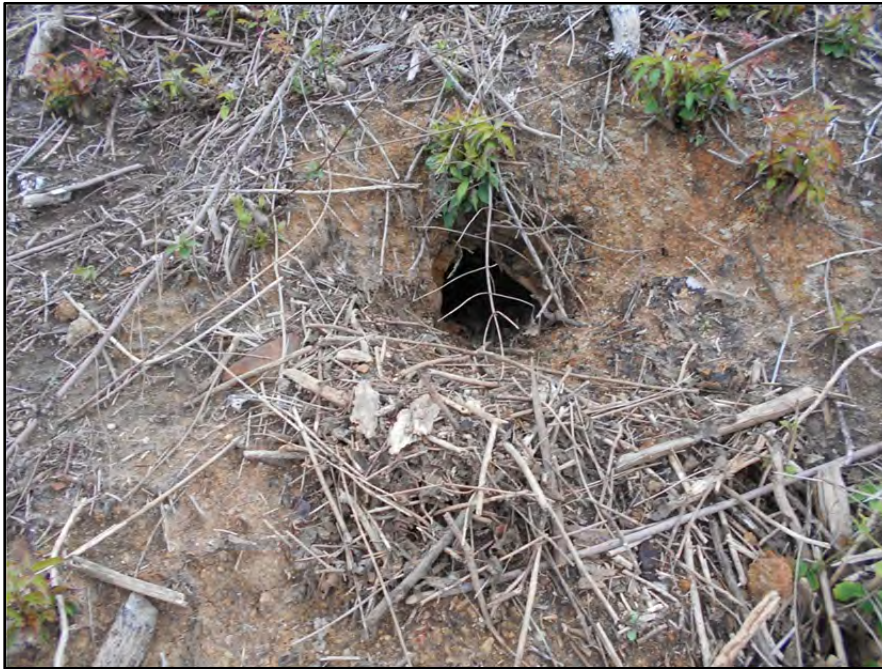
Photograph P-25 – Taken November 11, 2015 by David E. Nielson

Pond ST-18: Looking at outside slope of the western dike.

Evidence of recent vegetation cutting and an inactive rodent burrow was observed. The burrow was probed and was less than 18 inches deep. Grass should be reestablished. The rodent population should be controlled and rodent holes filled.

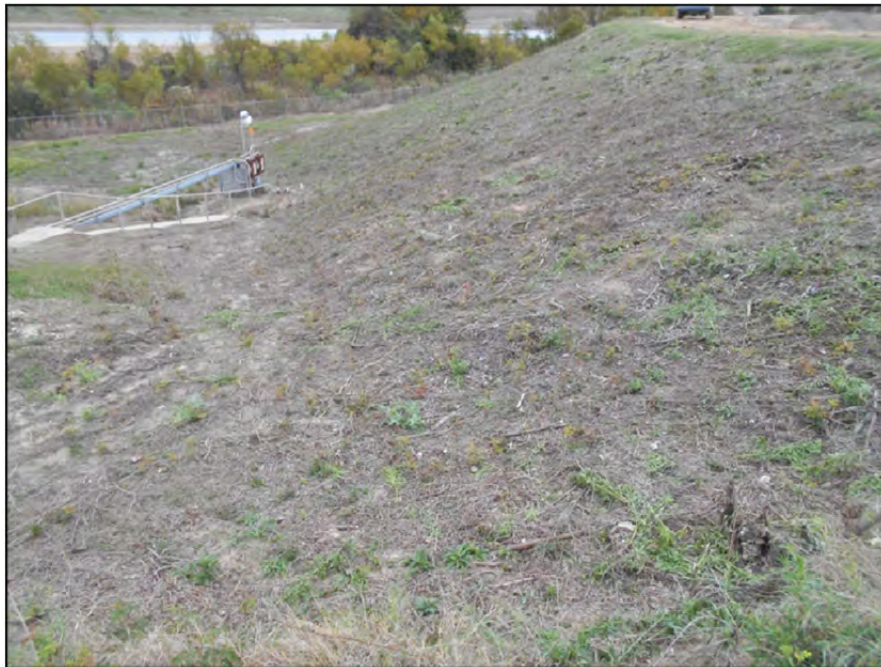
Photograph P-26 – Taken November 11, 2015 by David E. Nielson

Pond ST-18: Looking north at outside slope of western dike.

Grass vegetation should be reestablished.

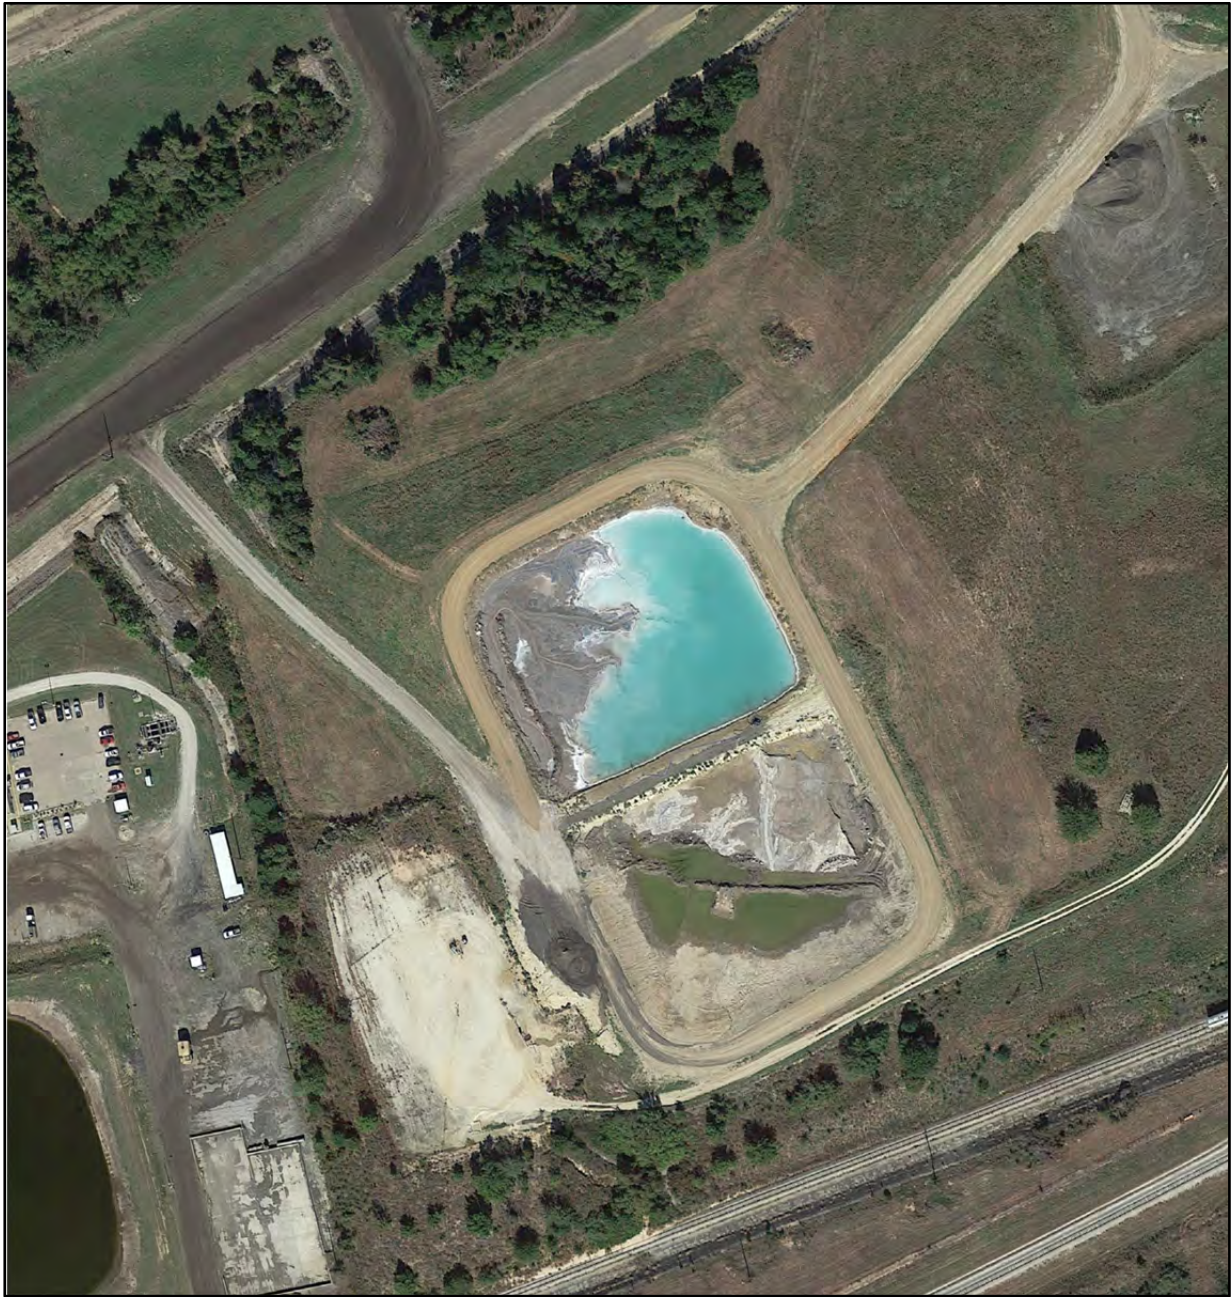
The location and general arrangement of the Secondary E Pond are depicted on Figure 1 and also Photograph P-27, which were both obtained from Google Earth Pro®. This Google Earth Pro image appears to accurately represent the condition of the dikes observed at the Secondary E Pond by S&L on November 11, 2015.

Photograph P-27 – From Google Earth Pro Downloaded January 1, 2016
Secondary E Pond: Aerial view.

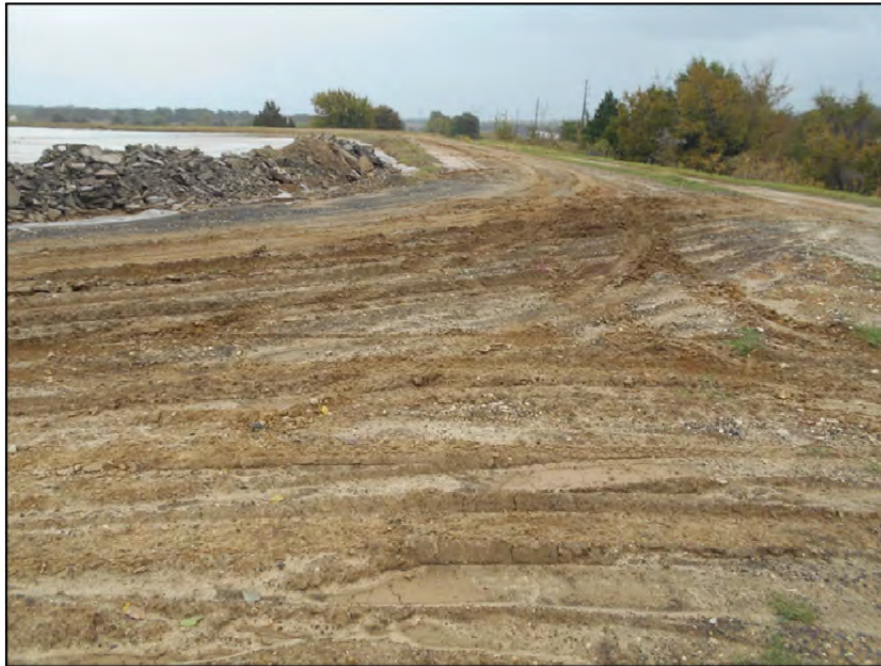
Photograph P-28 – Taken November 11, 2015 by David E. Nielson
Secondary E Pond: Looking east at inside slope of the southern dike.
Note rigid consistency of excavated stabilized sludge. The Secondary E Pond has significant accumulations of stabilized sludge that promotes stability of the dike system.
Also note traffic rutting of top of dike in truck access area.

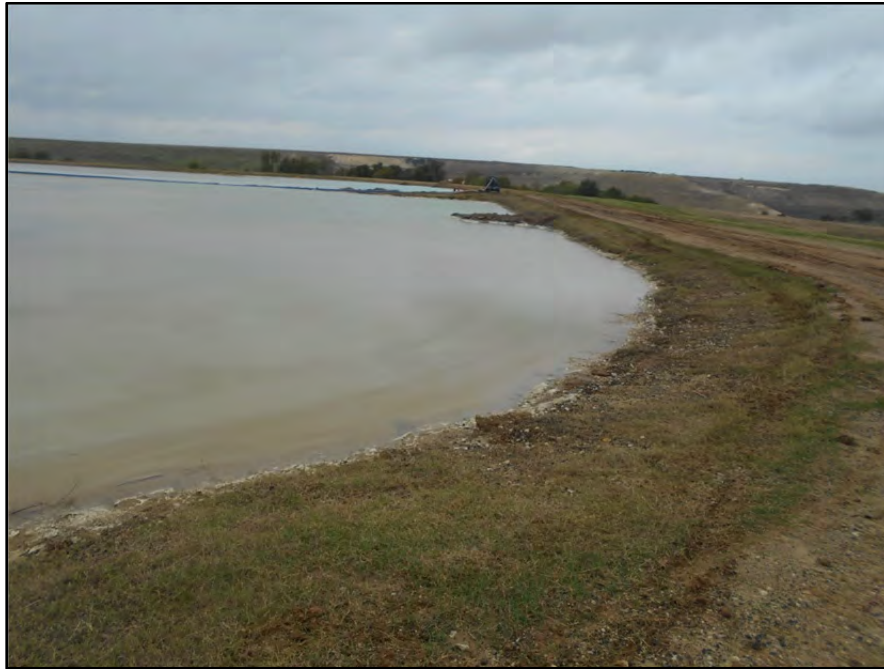
Photograph P-32 – Taken November 11, 2015 by David E. Nielson
Secondary E Pond: Looking north along the inside slope of the eastern dike.

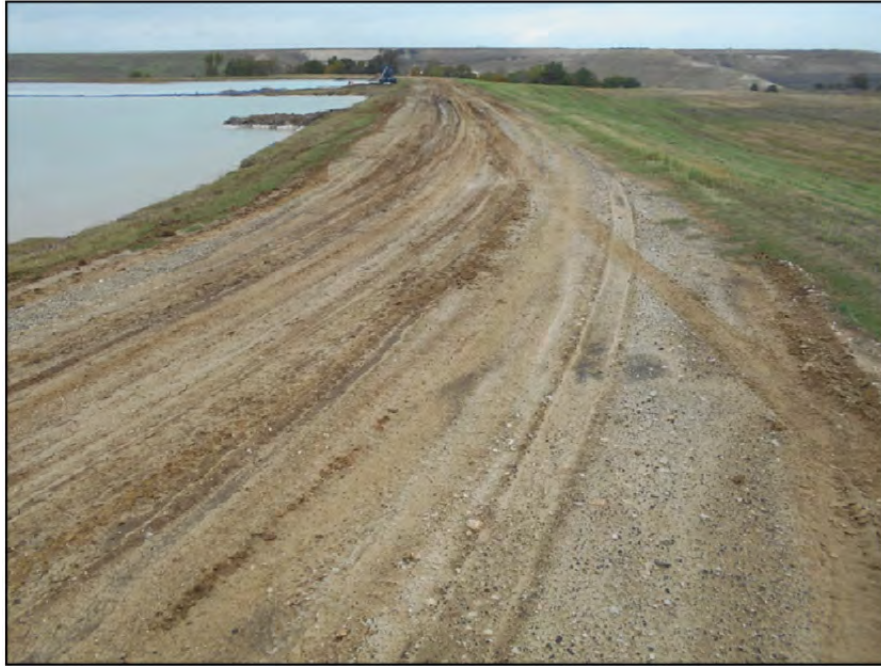
Photograph P-34 – Taken November 11, 2015 by David E. Nielson
Secondary E Pond: Looking north along the eastern dike crest.

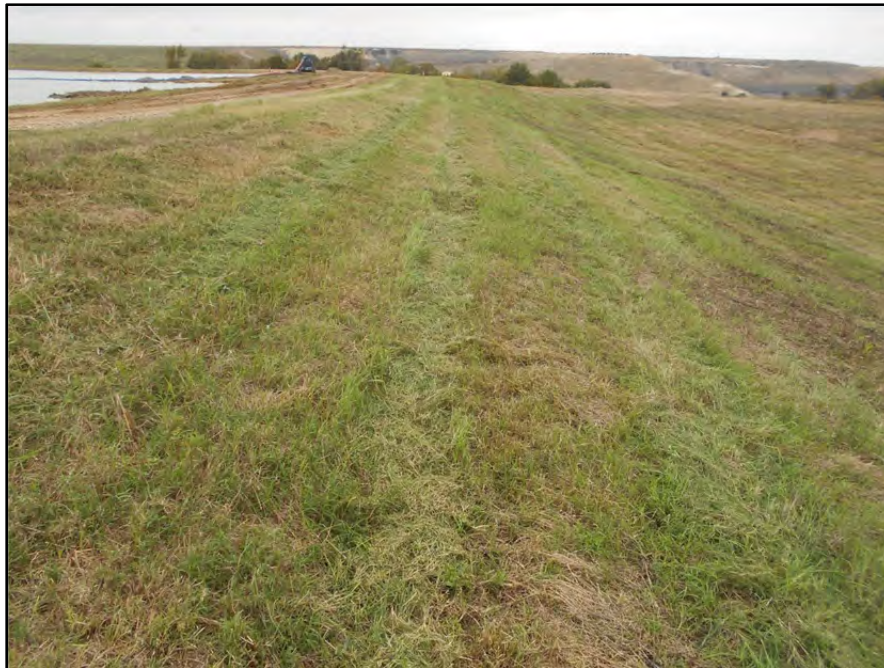
The outside slopes of the Secondary E Pond dikes are generally appropriately sloped and well vegetated with grass as shown in Photographs P-35, P-38, P-39 and P-42. Several localized small areas of disturbed grass were observed (Photograph P-38). However, it is estimated that in the spring growing season these areas will fill in with grass from the surrounding turf.

Photograph P-35 – Taken November 11, 2015 by David E. Nielson
Secondary E Pond: Looking north at outside slope of eastern dike.
Note good grass vegetation.

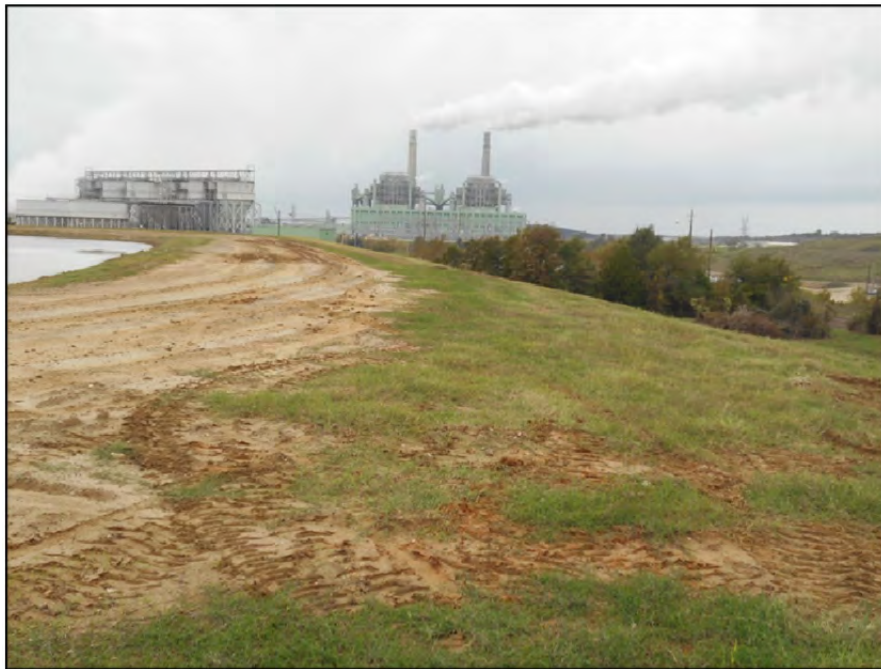
Photograph P-37 – Taken November 11, 2015 by David E. Nielson
Secondary E Pond: Looking west along the northern dike crest.

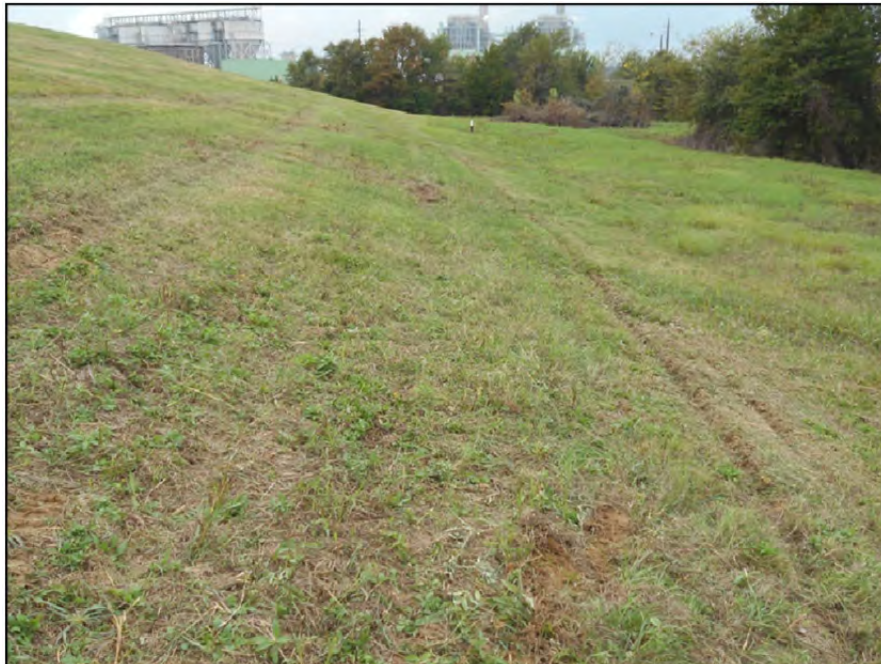
Photograph P-39 – Taken November 11, 2015 by David E. Nielson
Secondary E Pond: Looking west along the outside slope and toe of slope of the northern dike.
Note good grass vegetation in most areas. Note good slope and alignment.

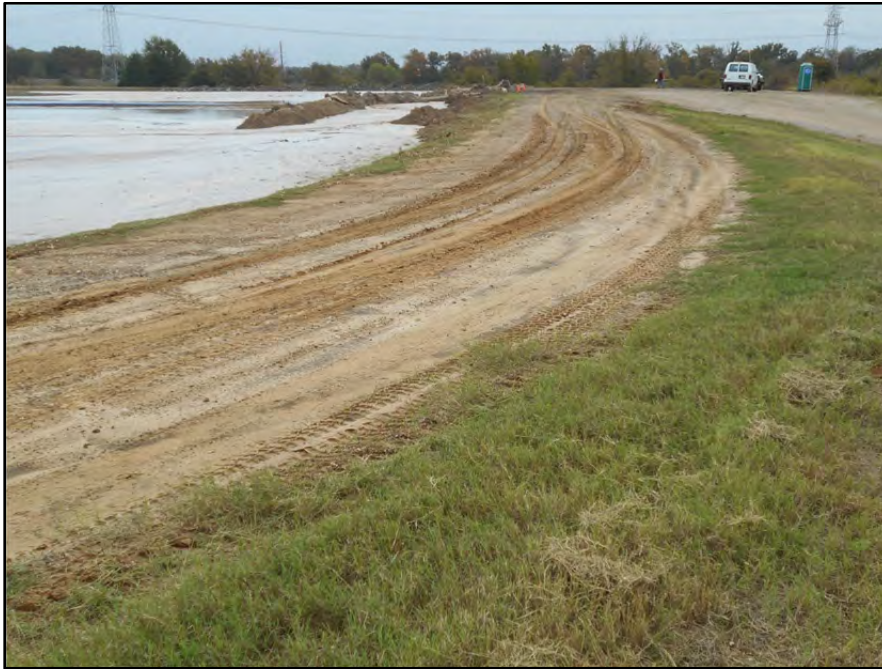
Photograph P-40 – Taken November 11, 2015 by David E. Nielson
Secondary E Pond: Looking south at inside slope of the western dike.

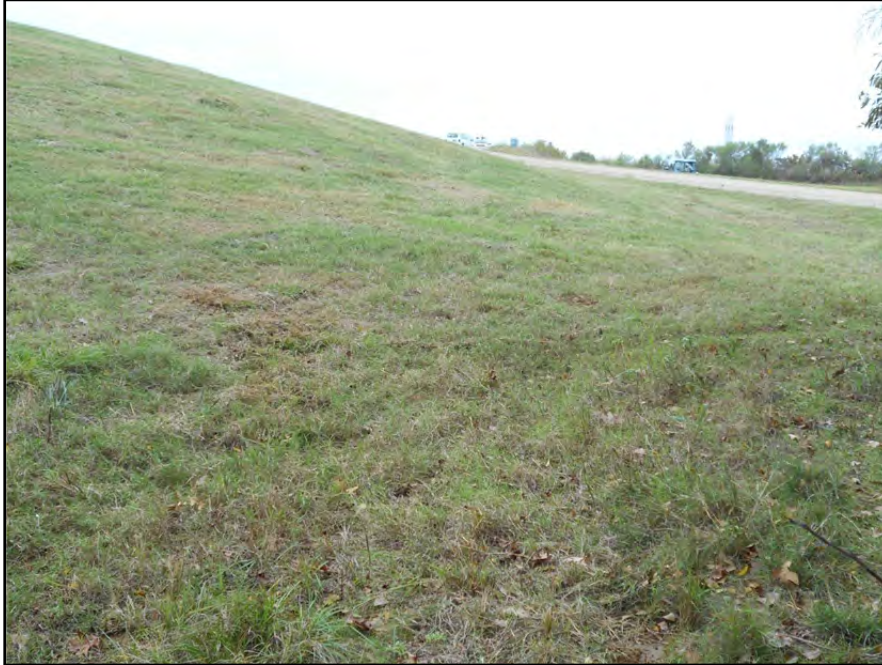
Photograph P-42 – Taken November 11, 2015 by David E. Nielson
Secondary E Pond: Looking south along the outside slope of the western dike and the dike toe.
Note good grass vegetation in most areas. Note good slope and alignment.

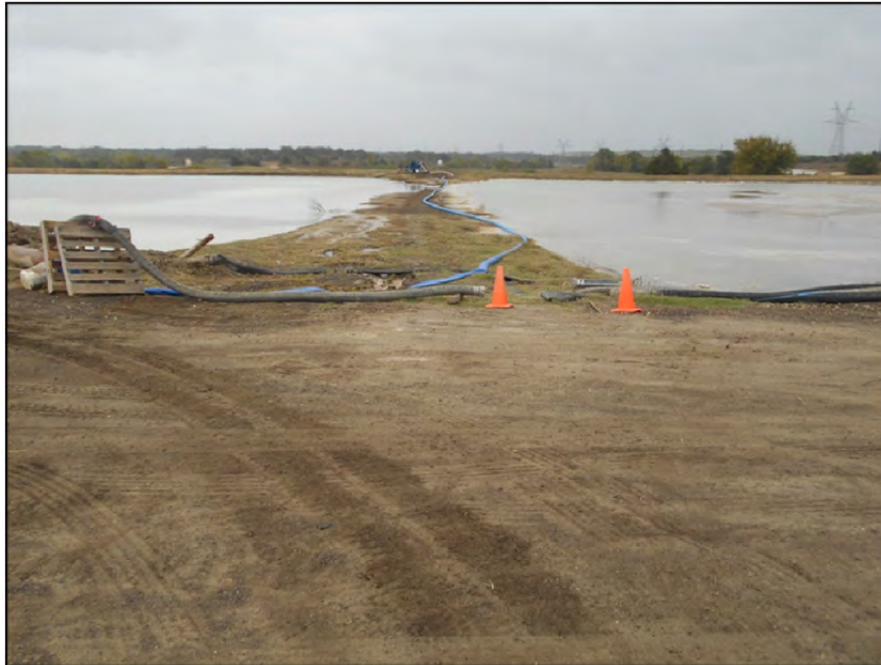
Photograph P-43 – Taken November 11, 2015 by David E. Nielson
Secondary E Pond: Looking east at central dividing dike.

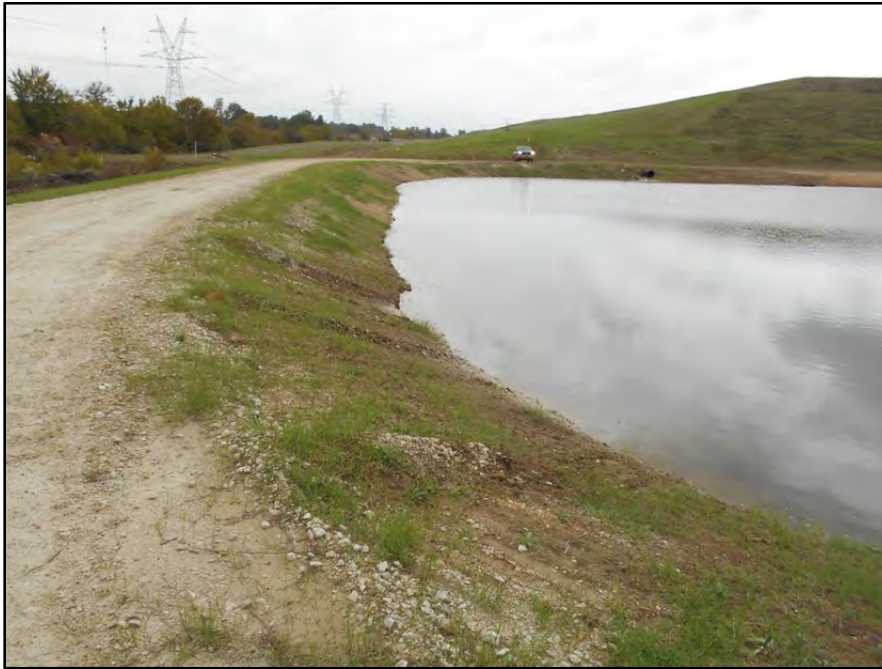
The inside slope of the Pond 002 dikes was observed to be appropriately graded as shown in Photographs P-45 and P-48.

Photograph P-45 – Taken November 11, 2015 by David E. Nielson
Pond 002: Looking north along the inside slope of the western dike.

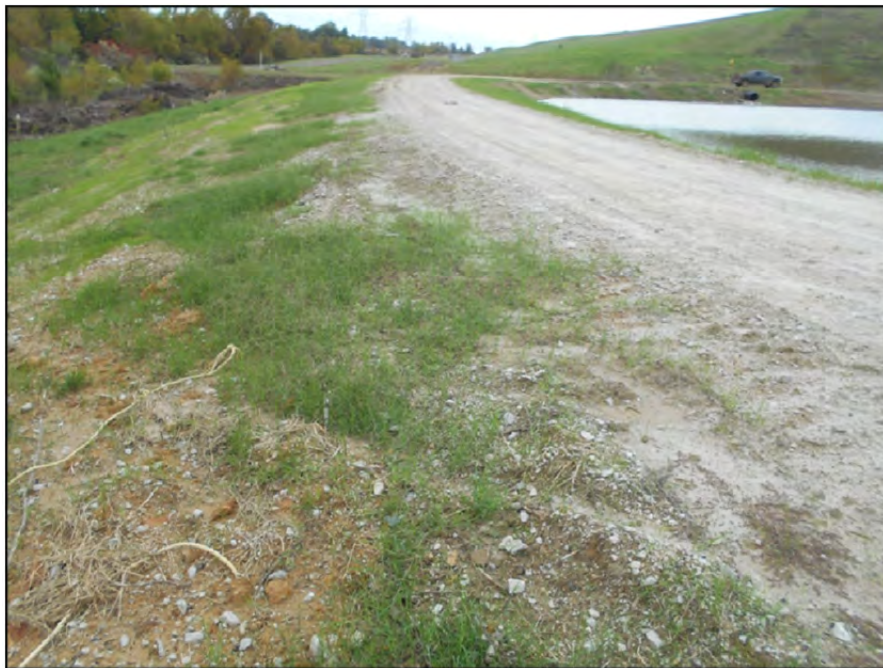
Photograph P-46 – Taken November 11, 2015 by David E. Nielson
Pond 002: Looking north along the crest and outside slope of the western dike.

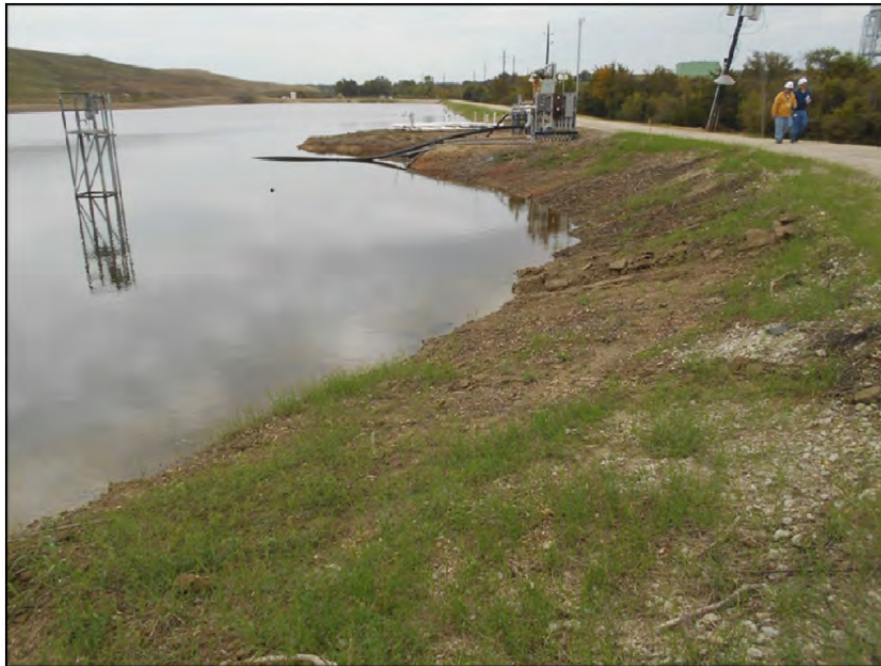
Photograph P-48 – Taken November 11, 2015 by David E. Nielson
Pond 002: Looking east along the inside slope of the southern dike.

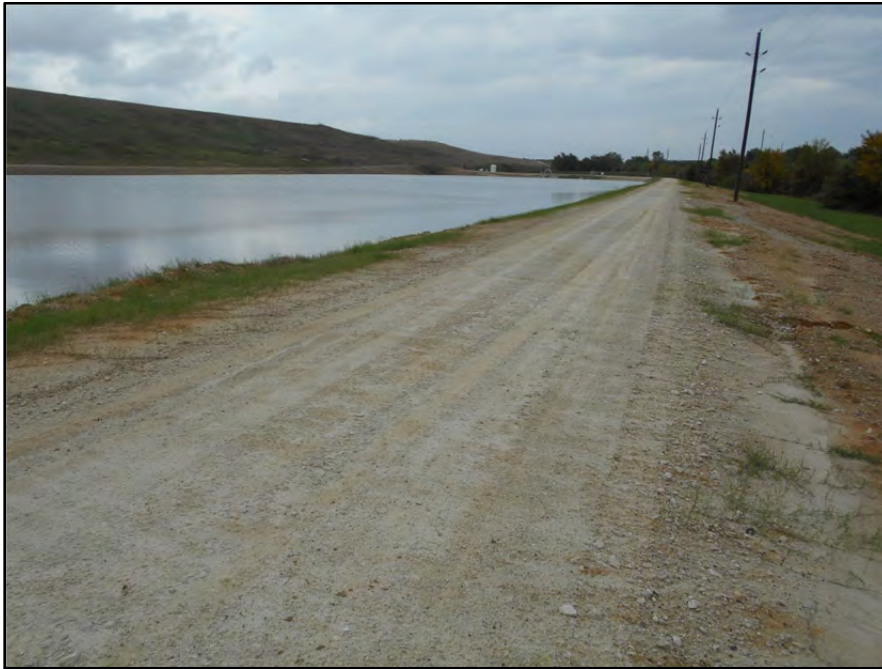
Photograph P-49 – Taken November 11, 2015 by David E. Nielson
Pond 002: Looking east along the crest of the southern dike.
