**NRG TEXAS POWER, LLC
LIMESTONE STATION, UNITS 1 & 2**

ANNUAL INSPECTION OF CCR IMPOUNDMENTS AND LANDFILL

SL Report No.: SL-013201
Revision 0
Date: January 15, 2016
Project No.: 12661-042

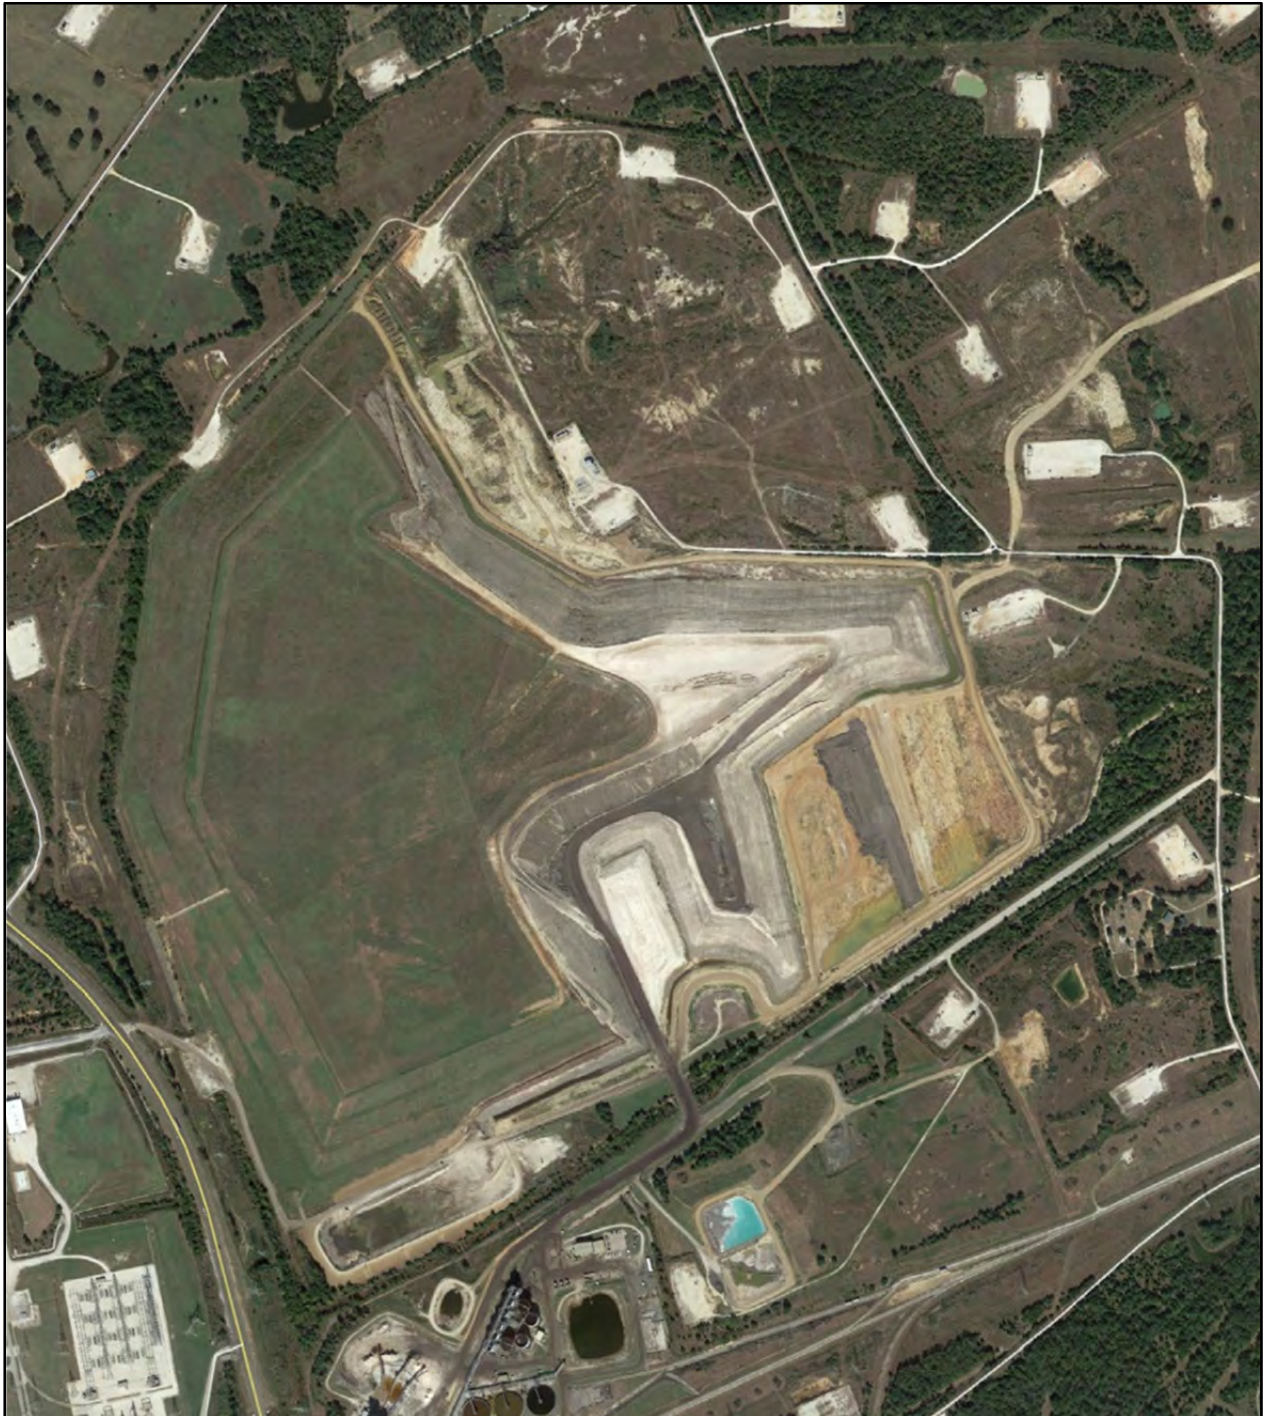
The location and general arrangement of the landfill is depicted on Figure 1 and also Photographs P-52 and P-53, which were obtained from Google Earth Pro®. The individual areas discussed in this report are depicted on Photograph P-53. The Google Earth Pro image (Photograph P-52) appears to accurately represent the condition of the landfill as observed by S&L on November 11, 2015, except for the construction work for new areas to prepare for and place the new compacted clay liner as discussed in Section 8.6.3 of this report.

Photograph P-52 – From Google Earth Pro Downloaded January 1, 2016
Landfill: Aerial view.

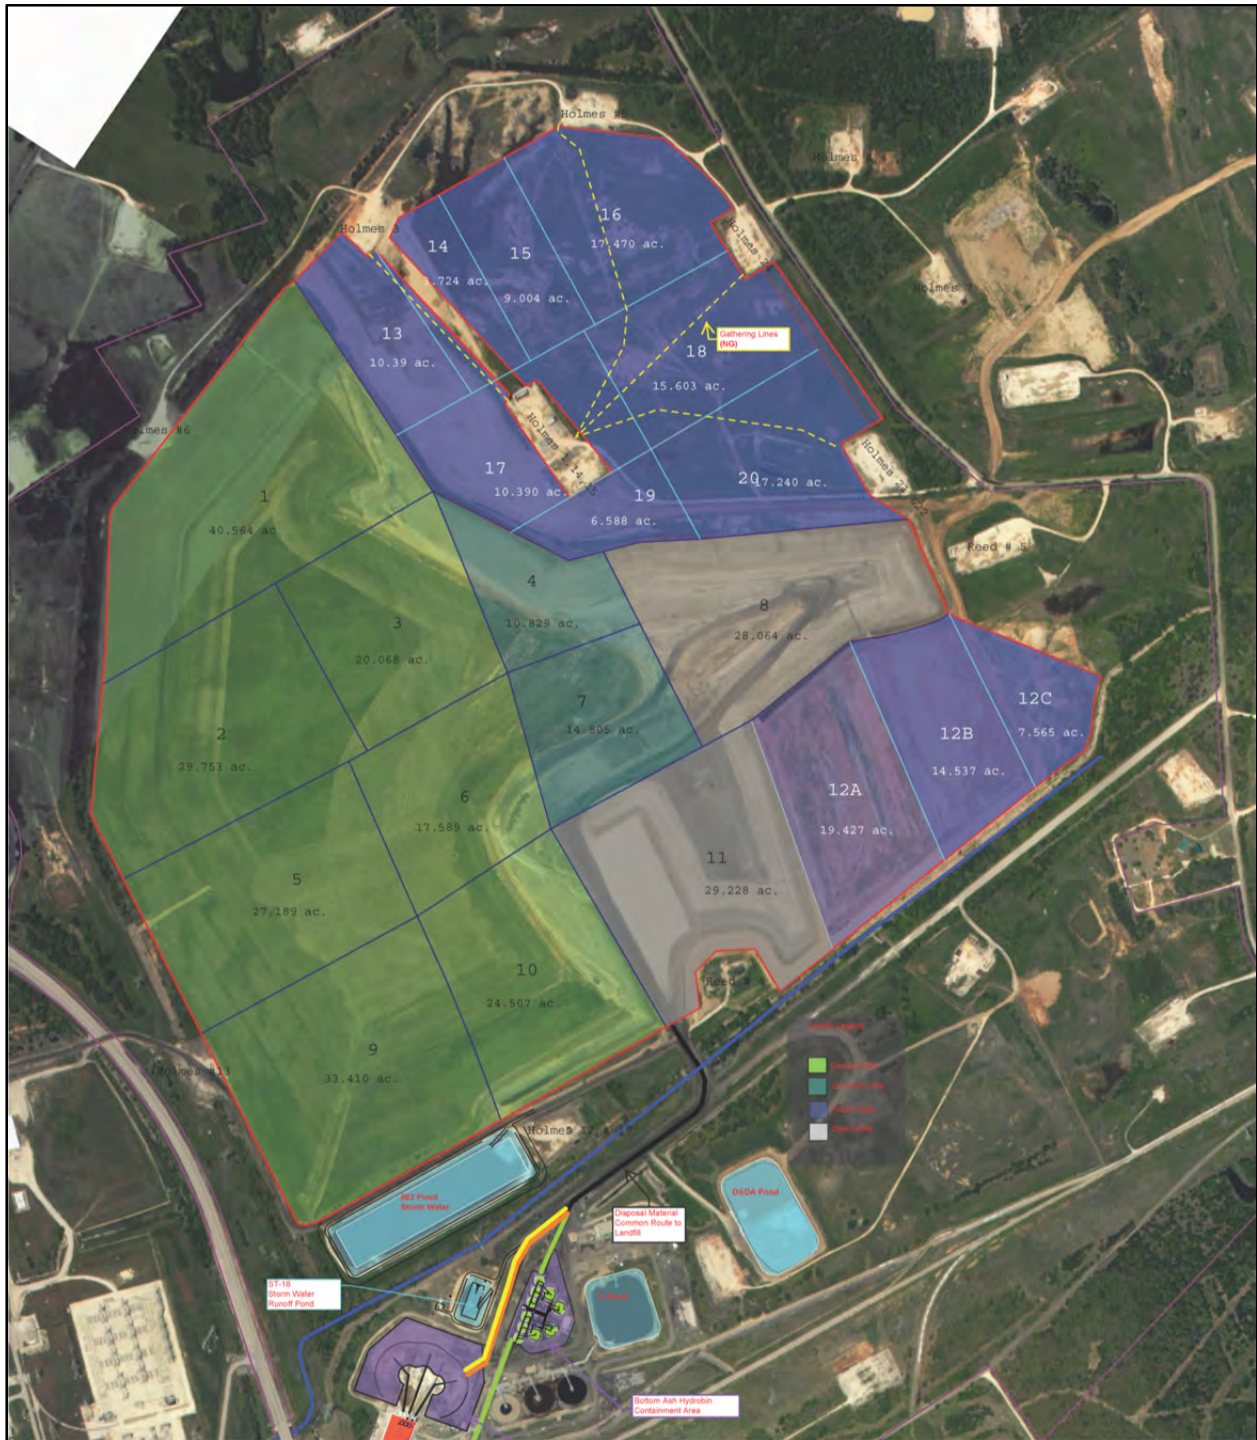
Photograph P-53 – From Google Earth
 Landfill: Aerial view with individual landfill areas noted.

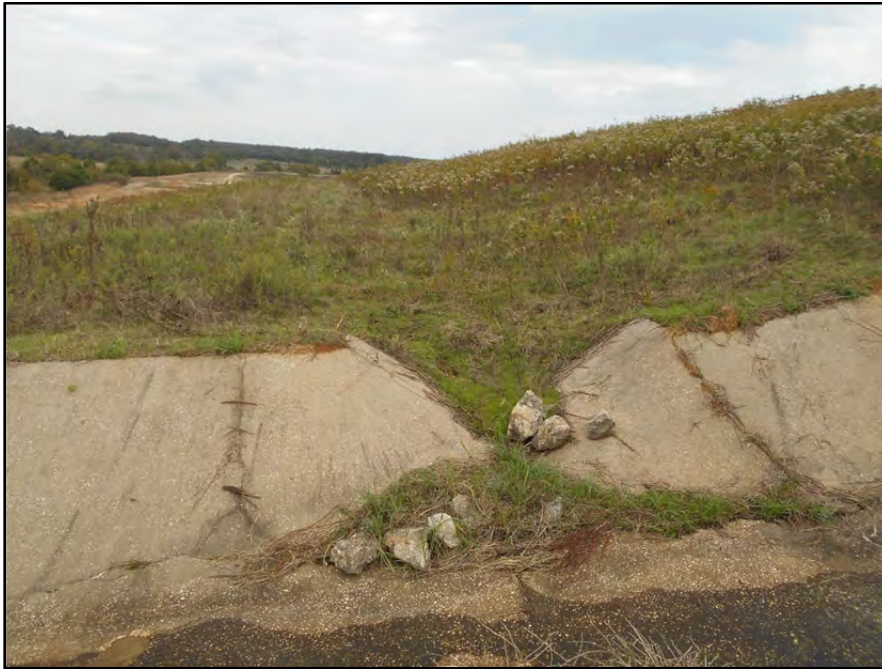
Photograph P-54 – Taken November 11, 2015 by David E. Nielson
Landfill Area 1: Looking northeast at mid-slope bench and stormwater inlet into rundown channel. Note good vegetation on landfill cover (cap).

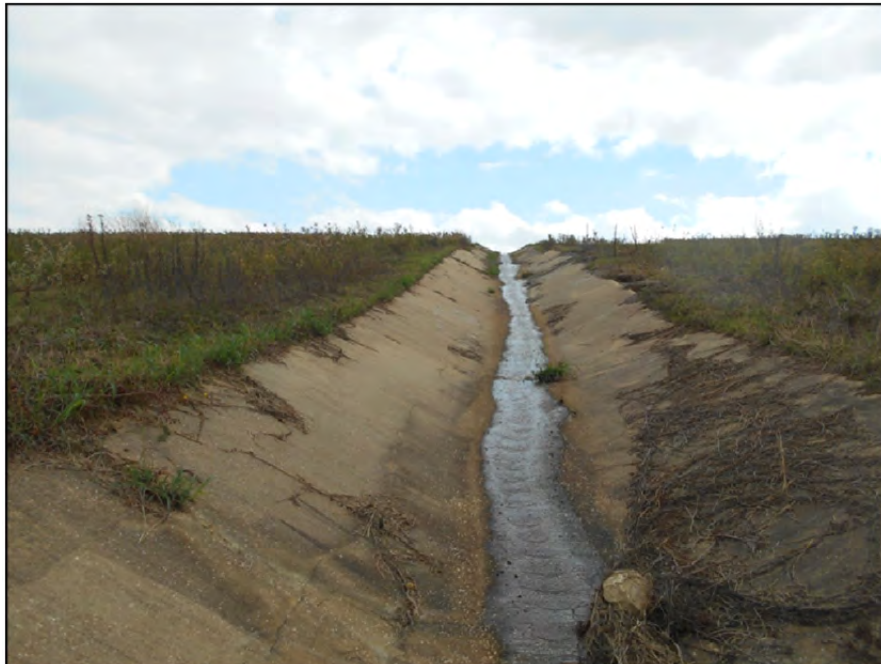
Photograph P-55 – Taken November 11, 2015 by David E. Nielson
Landfill Area 1: Looking southeast and up at flow line of stormwater rundown channel.

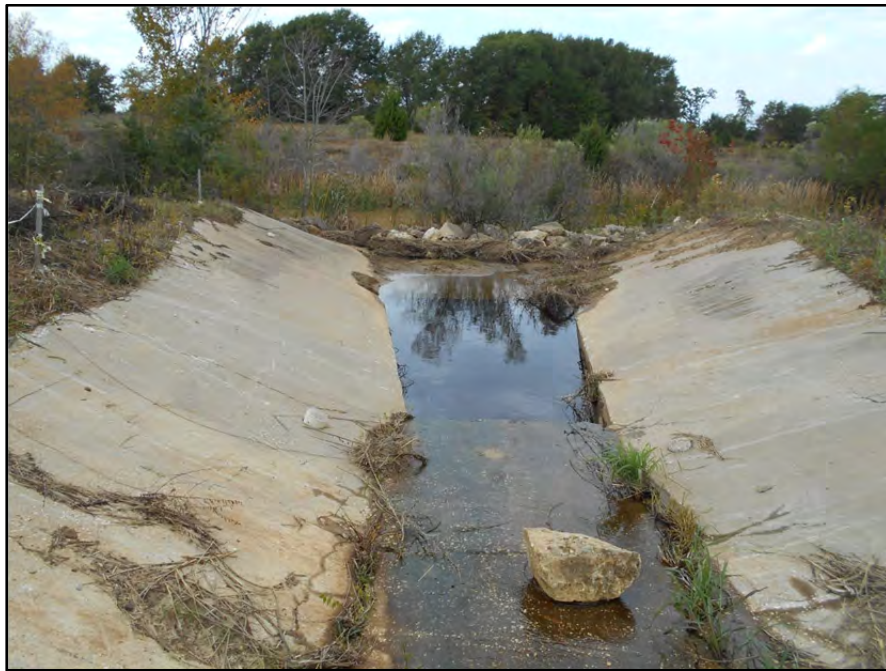
Photograph P-56 – Taken November 11, 2015 by David E. Nielson
Landfill Area 1: Looking northwest at stormwater rundown channel discharge into perimeter ditch. Note energy dissipation pit and riprap at mouth of discharge. Also note vegetation in perimeter ditch, which indicates sufficient velocity control of stormwater.

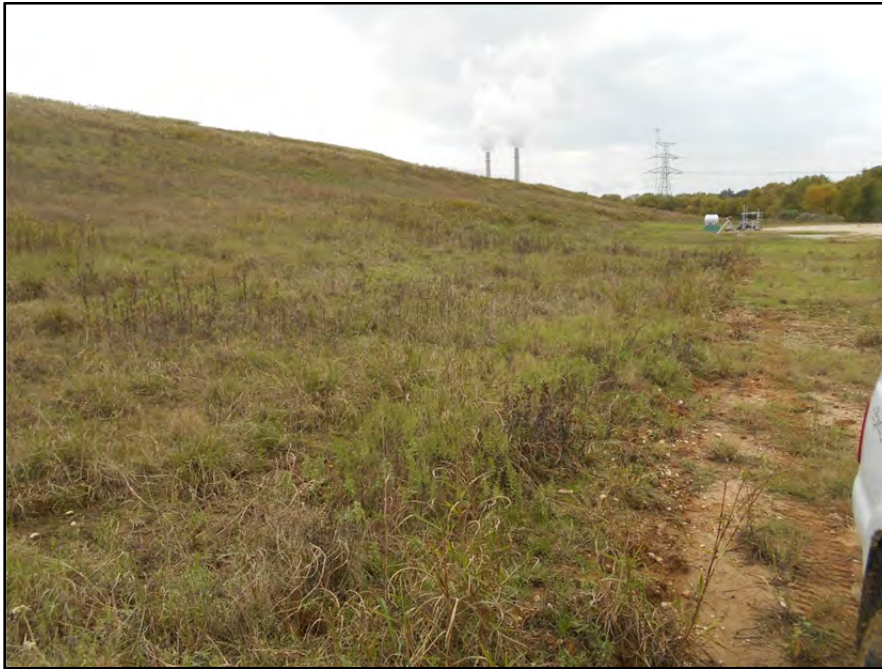
Photograph P-58 – Taken November 11, 2015 by David E. Nielson
Landfill Area 1: Looking southwest along the toe of the capped landfill slope.
Note good vegetation cover and lack of erosion of slope.

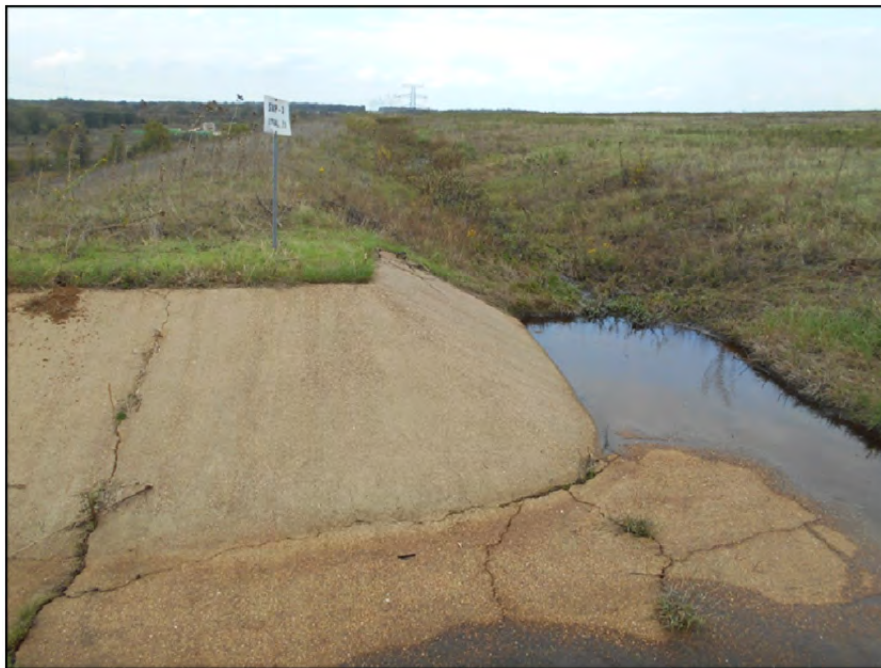
Photograph P-59 – Taken November 11, 2015 by David E. Nielson
Landfill Area 5: Looking northwest at stormwater collection ditch at crest of landfill slope
where it discharges into concrete lined rundown channel.
Note cracks in channel concrete and good vegetation cover.
Ponded water is from recent precipitation and not of concern.

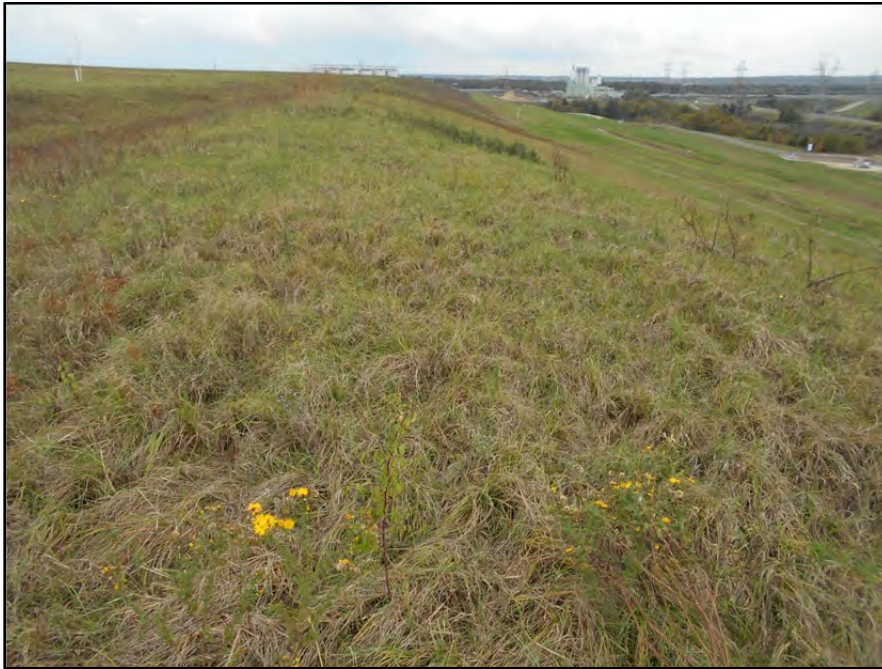
Photograph P-60 – Taken November 11, 2015 by David E. Nielson
Landfill Area 5: Looking southeast along the stormwater collection ditch at the crest of landfill slope, near where it discharges into concrete lined rundown channel. Note slope uniformity and good vegetation cover and good downslope profile.

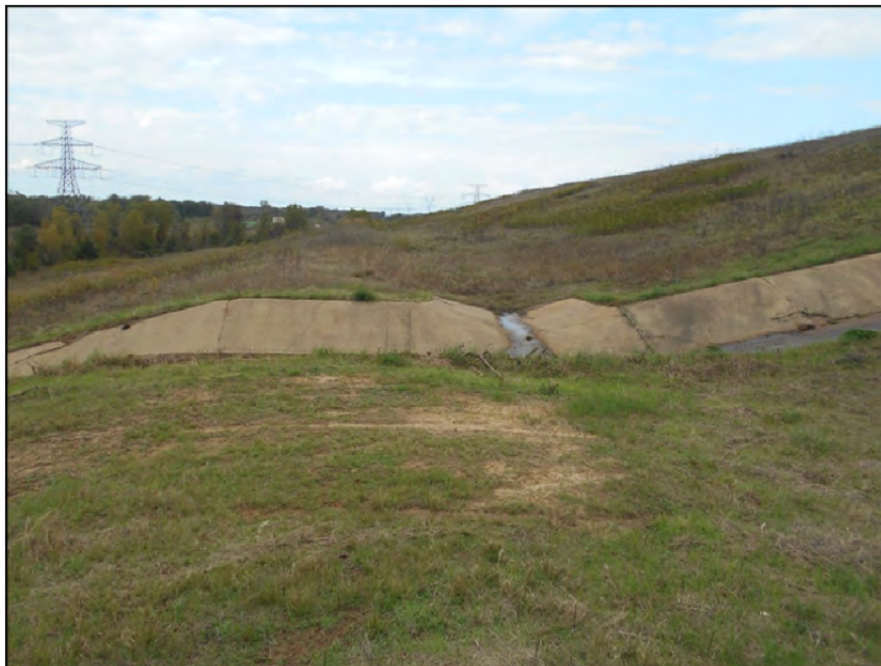
Photograph P-61 – Taken November 11, 2015 by David E. Nielson
Landfill Area 5: Looking northwest along the mid-slope bench. Note good slope uniformity and good vegetation cover.

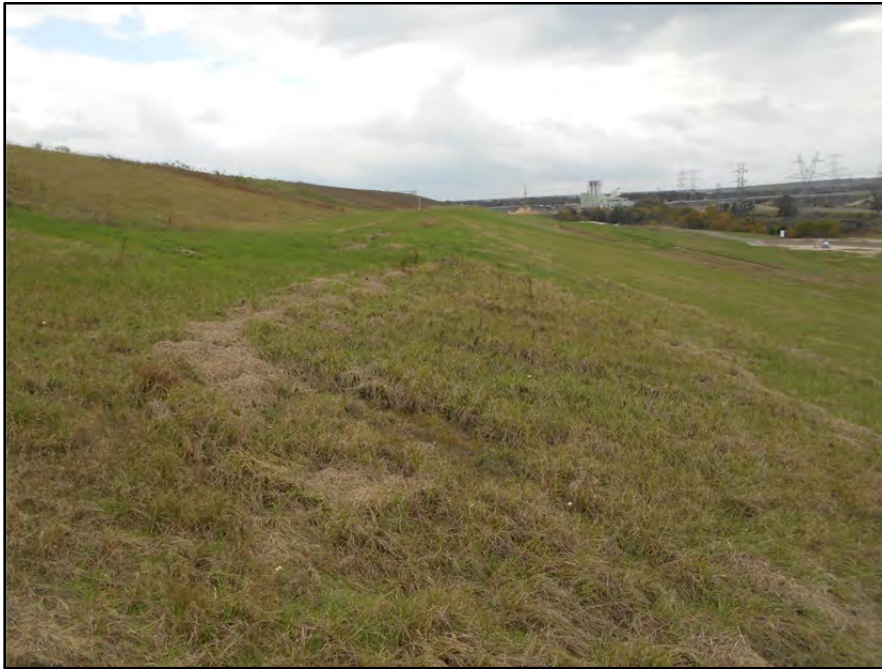
Photograph P-62 – Taken November 11, 2015 by David E. Nielson
Landfill Area 5: Looking southeast along the mid-slope bench.
Note good slope uniformity and good vegetation cover.

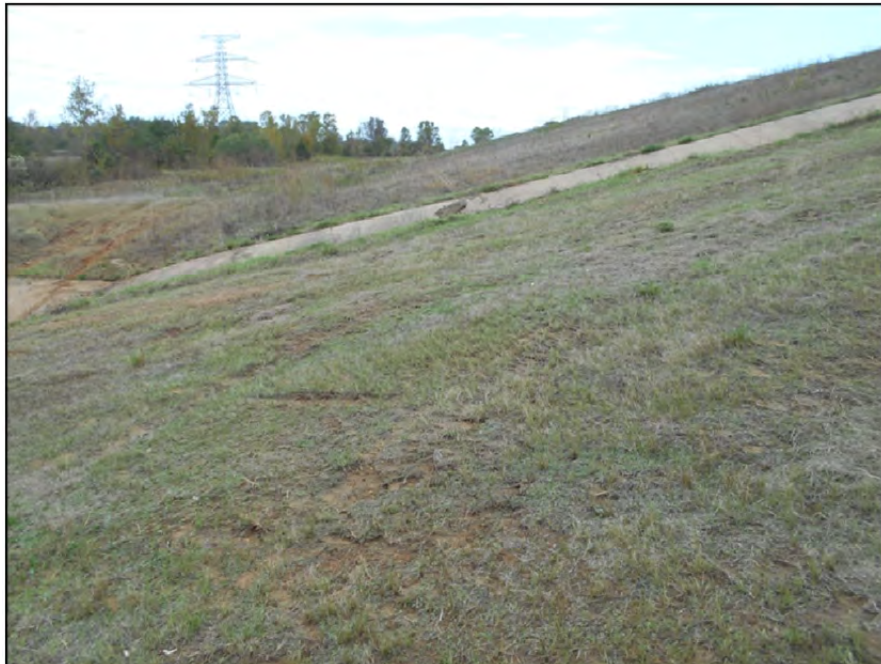
Photograph P-63 – Taken November 11, 2015 by David E. Nielson
Landfill Area 5: Looking northwest at toe of side slope of capped landfill
with concrete rundown channel.
Note good vegetation cover, landfill slopes and absence of erosion.

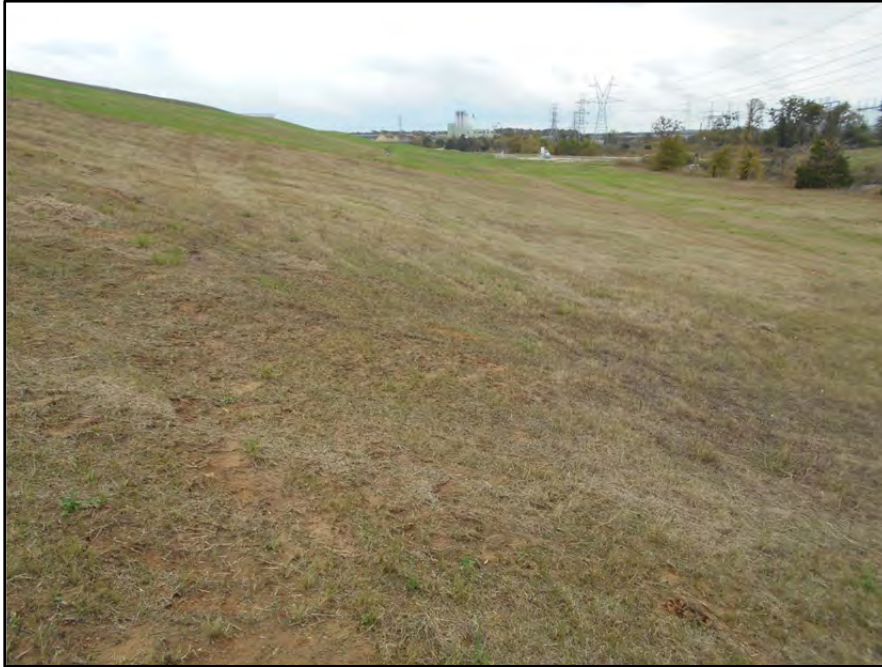
Photograph P-64 – Taken November 11, 2015 by David E. Nielson
Landfill Area 5: Looking southeast along the toe of side slope of capped landfill.
Note slope uniformity and absence of erosion.

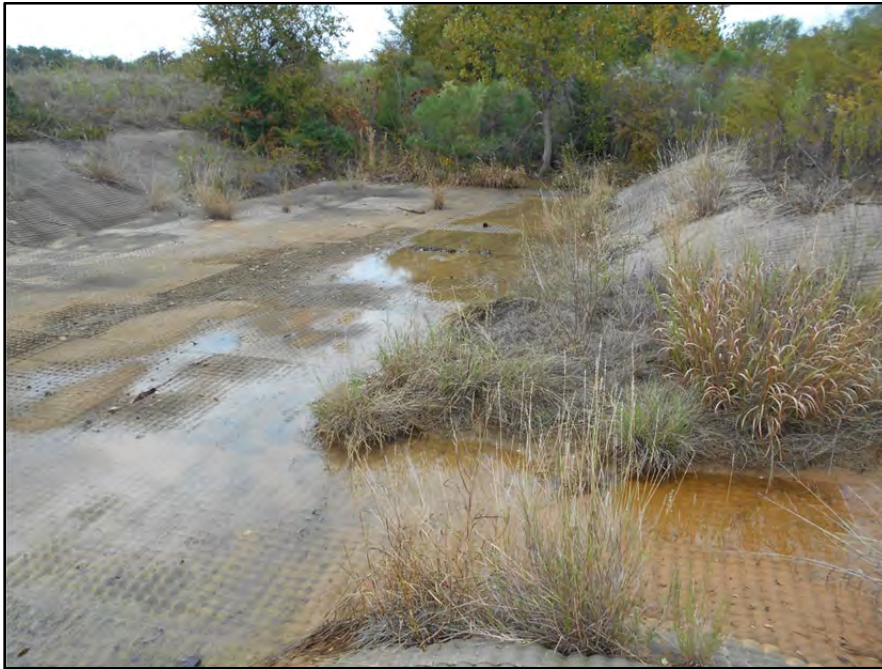
Photograph P-66 – Taken November 11, 2015 by David E. Nielson
Landfill Area 5: Looking northwest at perimeter ditch upstream from discharge of concrete lined stormwater runoff channel. Note significant vegetation in upstream ditch, which should be removed before additional stormwater flows from upstream landfill areas are diverted into this ditch.

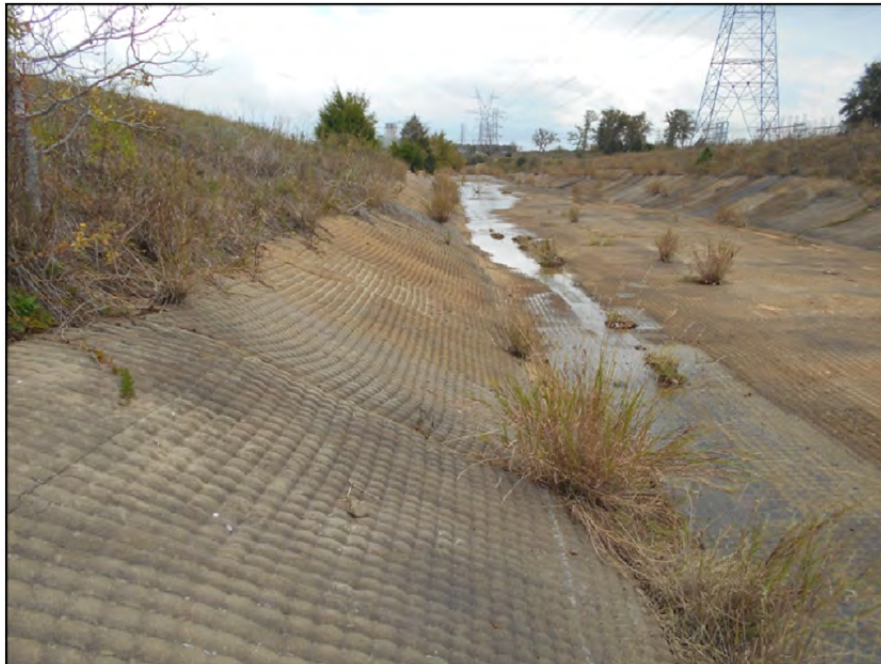
Photograph P-67 – Taken November 11, 2015 by David E. Nielson
Landfill Area 5: Looking southeast along the perimeter ditch downstream from the discharge of concrete lined stormwater runoff channel. Note good condition of fabric form concrete lining.

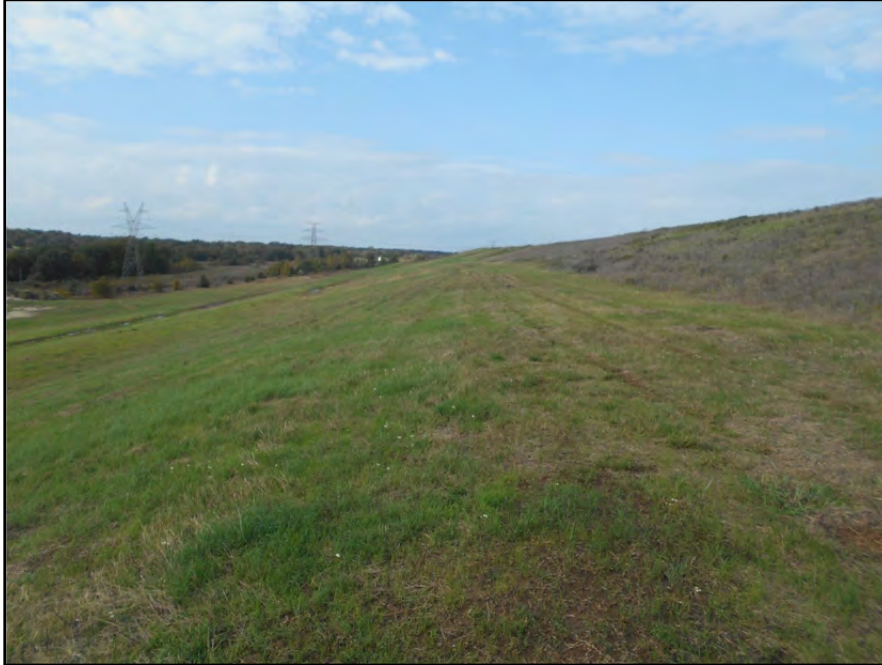
Photograph P-68 – Taken November 11, 2015 by David E. Nielson
Landfill Area 9: Looking northwest along the mid-slope bench in the capped landfill slope.
Note good vegetation cover and lack of erosion of slope.

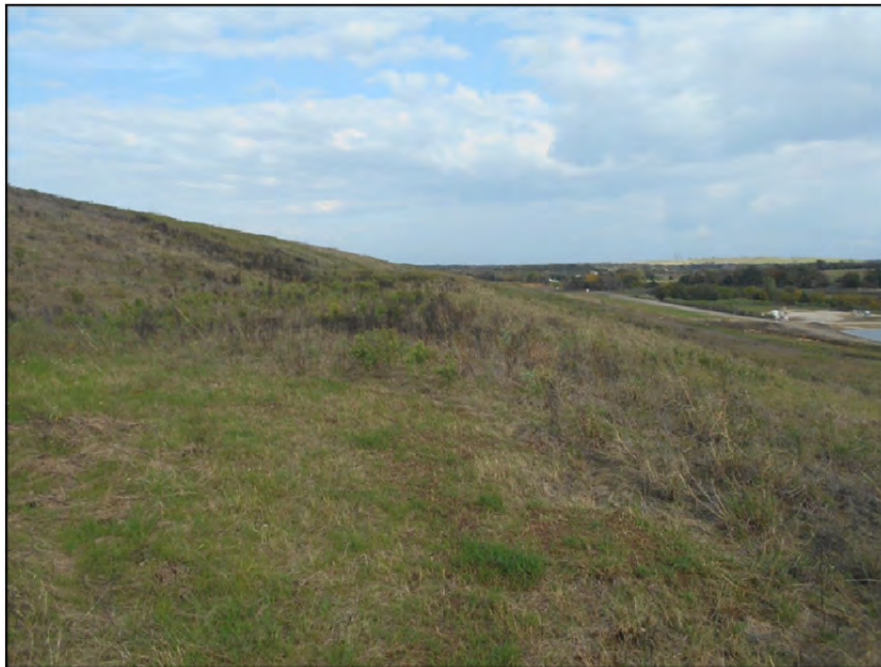
Photograph P-69 – Taken November 11, 2015 by David E. Nielson
Landfill Area 9: Looking southeast along the mid-slope bench in the capped landfill slope.
Note good vegetation cover and lack of erosion of slope.

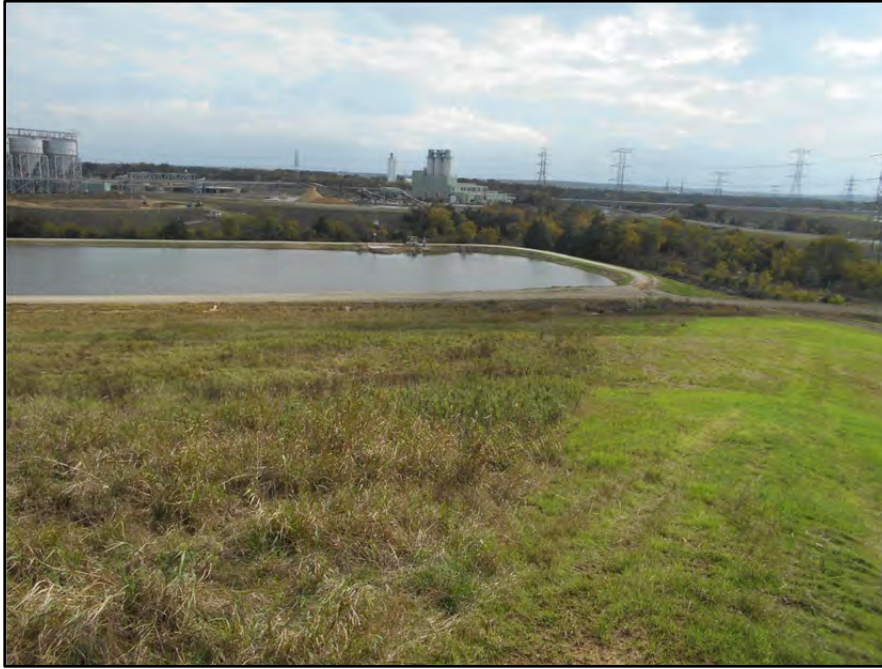
Photograph P-72 – Taken November 11, 2015 by David E. Nielson
Landfill Area 9: Looking southeast and down slope to where landfill drains into Pond 002.
Note good vegetation and lack of erosion.

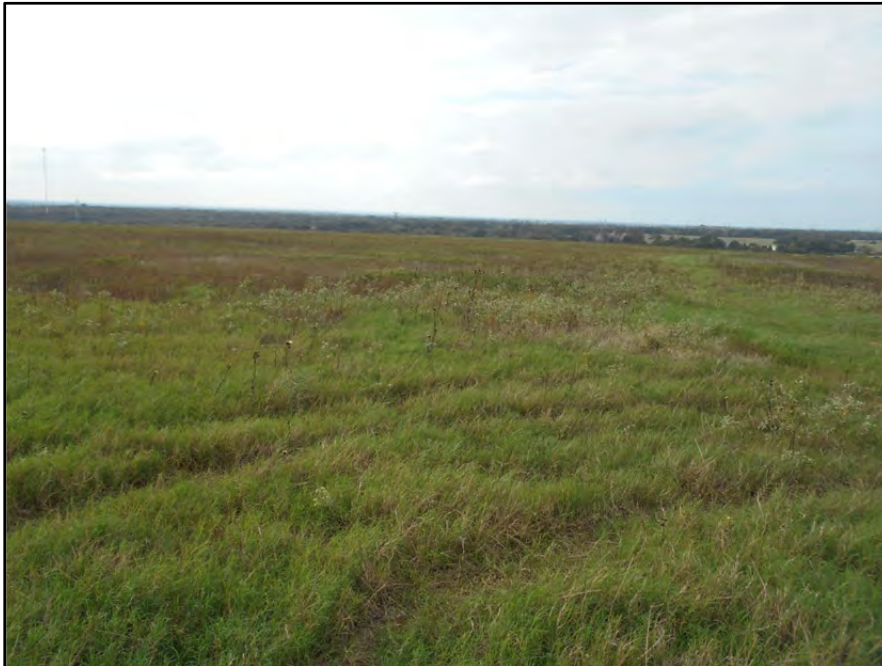
Photograph P-73 – Taken November 11, 2015 by David E. Nielson
Landfill Area 3: Looking northwest at top of capped landfill area.
Note good vegetation and the absence of ponded water.

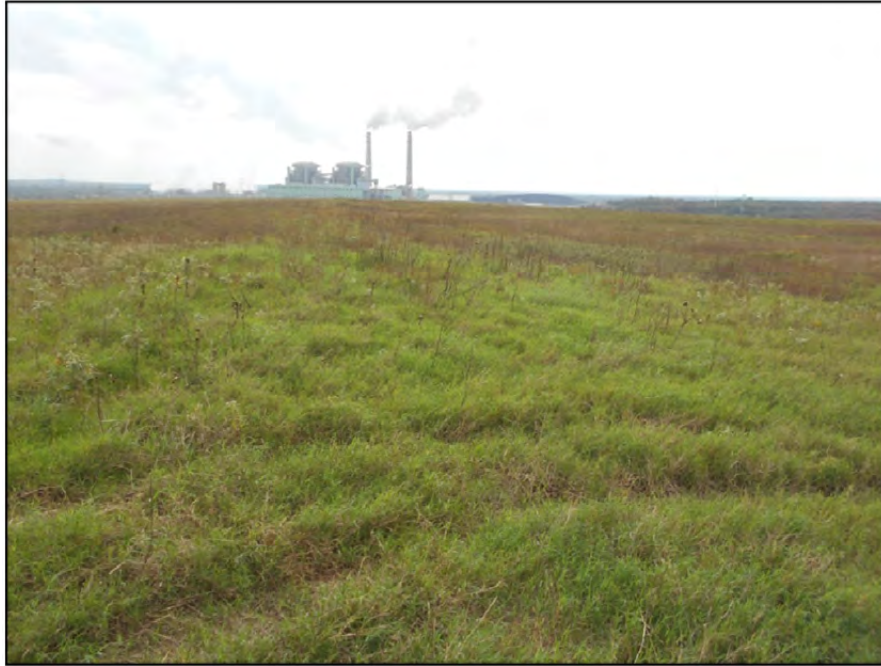
Photograph P-74 – Taken November 11, 2015 by David E. Nielson
Landfill Area 3: Looking southwest at top of capped landfill area.
Note good vegetation and the absence of ponded water.

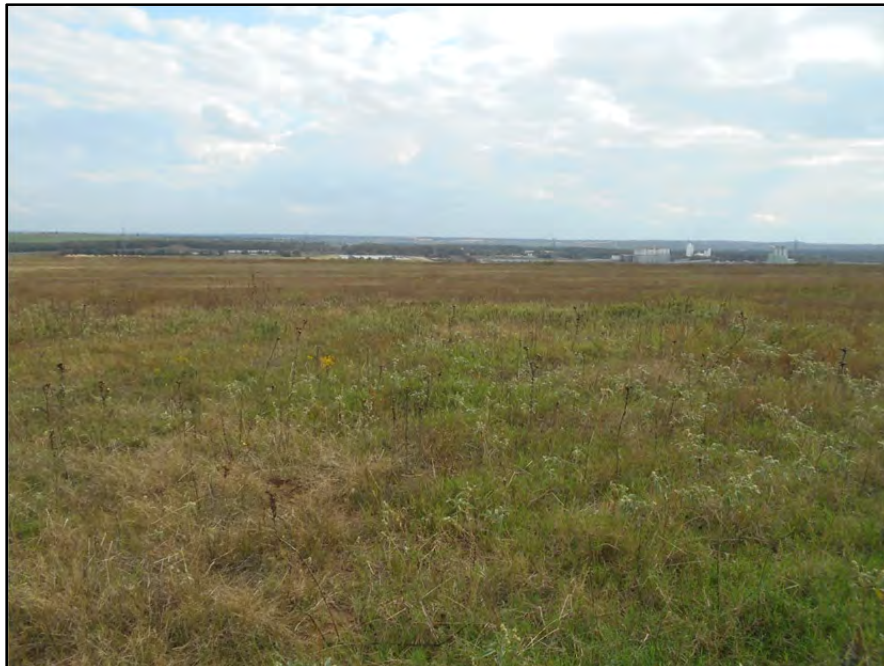
Photograph P-75 – Taken November 11, 2015 by David E. Nielson
Landfill Area 3: Looking southeast at top of capped landfill area.
Note good vegetation and the absence of ponded water.

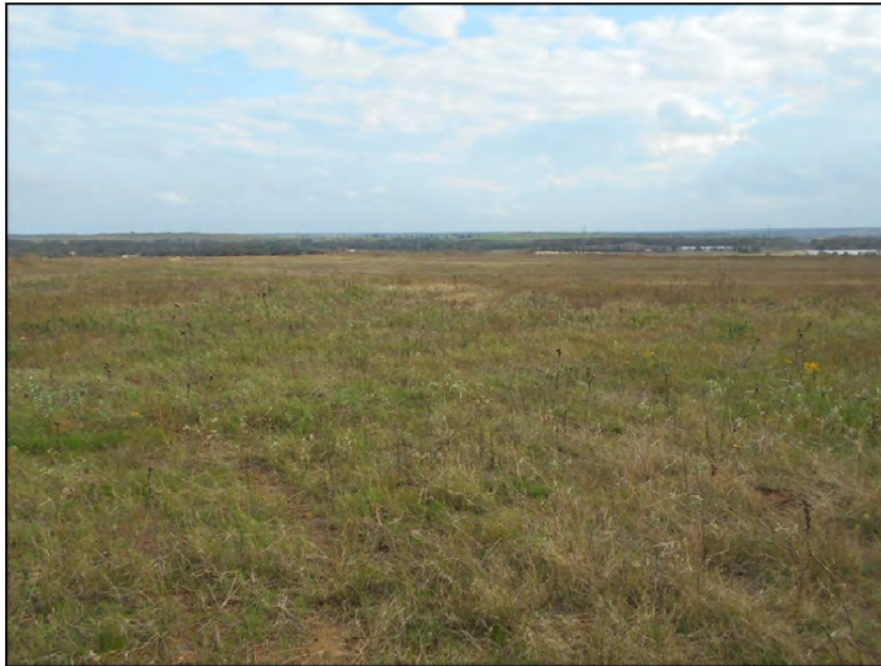
Photograph P-76 – Taken November 11, 2015 by David E. Nielson
Landfill Area 3: Looking northeast at top of capped landfill area.
Note good vegetation and the absence of ponded water.

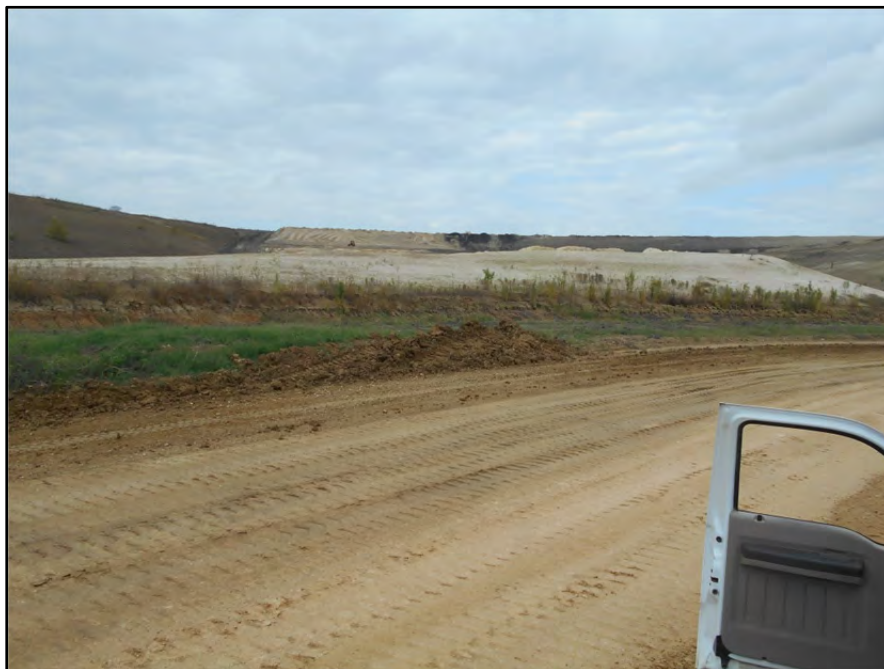
Photograph P-77 – Taken November 11, 2015 by David E. Nielson
Landfill Area 11 (uncapped area): Looking north at uncapped fill area and marketable gypsum
stored inside landfill Area 11.
Note perimeter ditch is between roadway and white gypsum pile in landfill area.

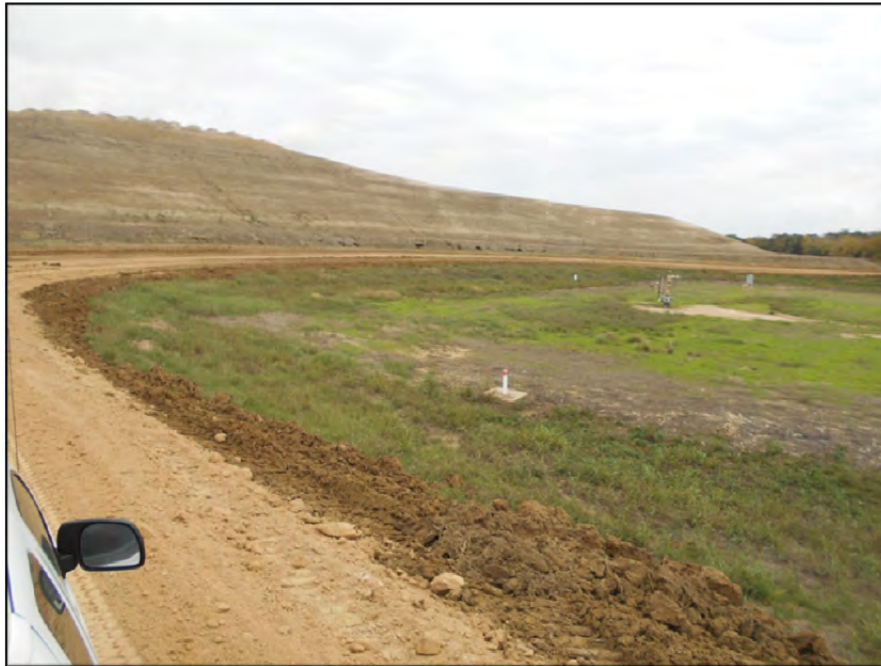
Photograph P-78 – Taken November 11, 2015 by David E. Nielson
Landfill Area 11(uncapped area): Looking northeast at an uncapped CCR material slope
that will be capped when Area 11 is capped.
Note eroded material is intercepted in perimeter ditch that drains to Pond 002.

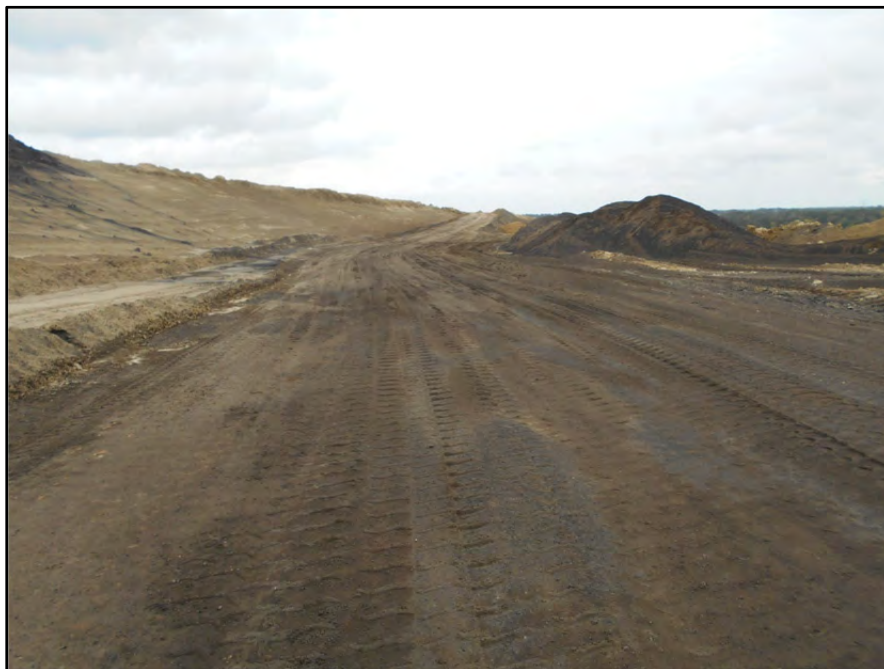
The haul road used to transport CCR materials to the top of the landfill is shown in Photograph P-79. This photograph demonstrates that the CCR materials can be placed in a relatively stable condition since ruts were not observed.

Photograph P-79 – Taken November 11, 2015 by David E. Nielson
Landfill Area 11 (uncapped area): Looking north at active haul road to top of uncapped area.
Note absence or rutting of CCR material under heavy haul truck traffic,
which implies stability of material.

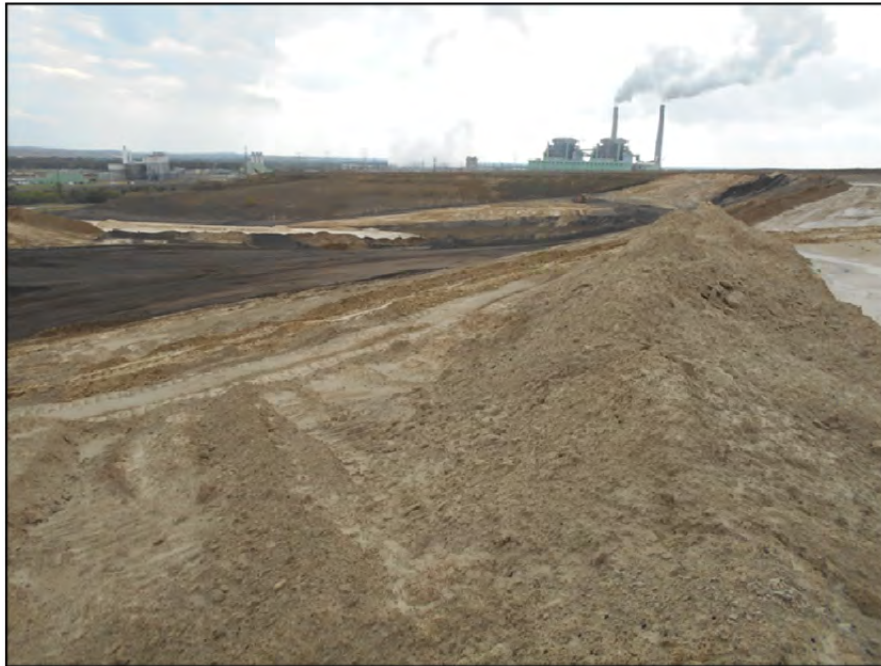
Photograph P-80 – Taken November 11, 2015 by David E. Nielson
Landfill Area 11(uncapped area): Looking southwest at active disposal area.

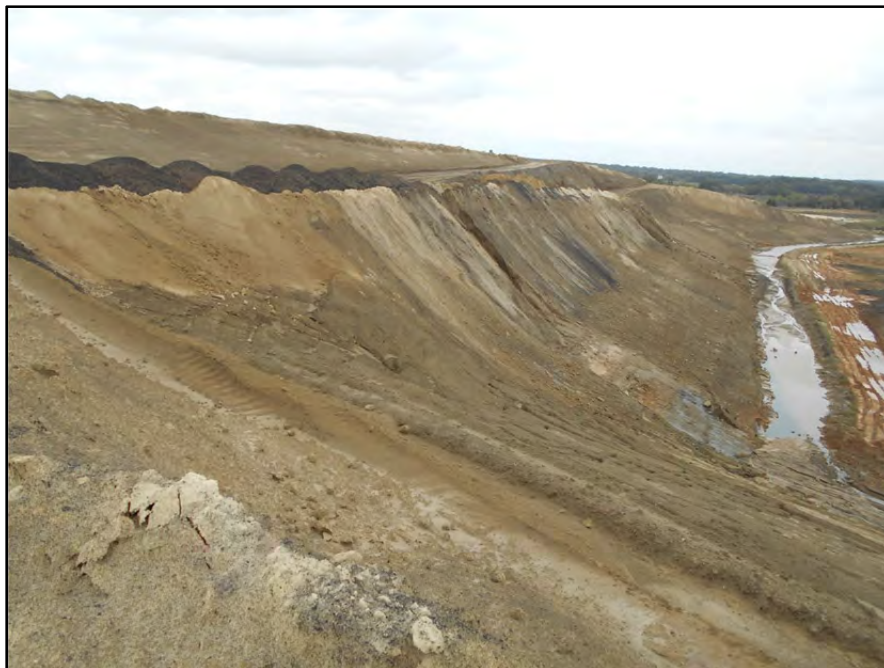
Photograph P-81 – Taken November 11, 2015 by David E. Nielson
Landfill Area 8 (uncapped area): Looking northeast at temporary face of uncapped area where it will abut landfill Area 12. Note perimeter interceptor ditch to collect contact water and eroded CCR. This ditch drains to Pond 002.
Also note erosion of CCR material and steep slopes.

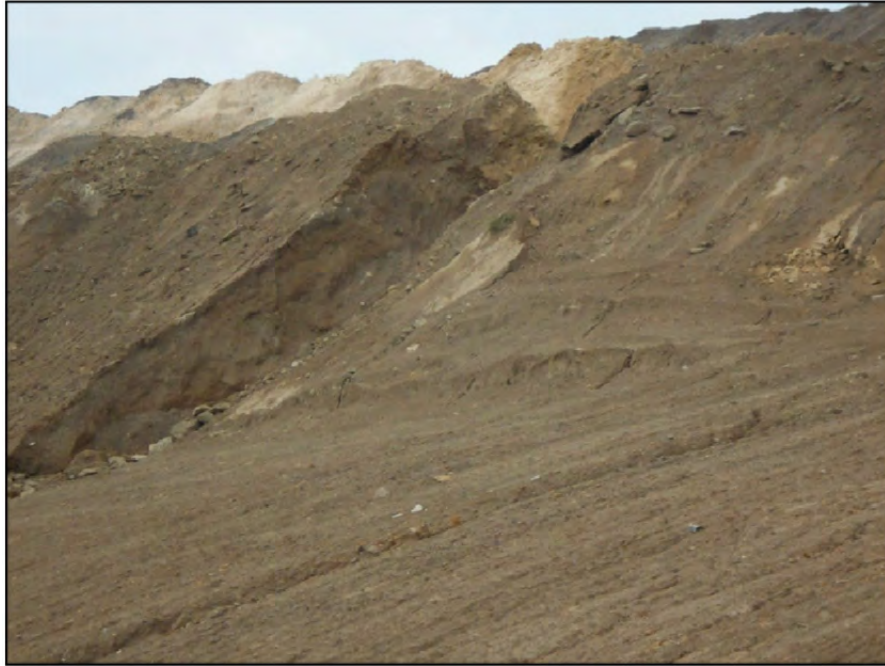
Photograph P-82 – Taken November 11, 2015 by David E. Nielson
Landfill Area 8 (uncapped area): An alternate view of slope shown in Photograph P-81.
Looking northwest at temporary face of uncapped area where it will abut landfill Area 12.
Note erosion of CCR material and steep slopes.

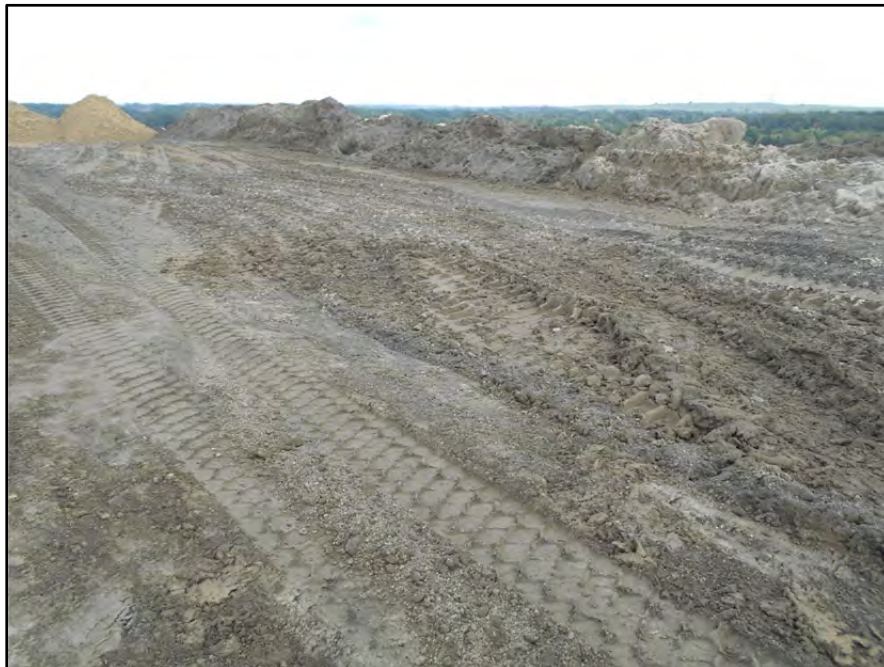
Photograph P-83 – Taken November 11, 2015 by David E. Nielson
Landfill Area 8 (uncapped area): Looking east at crest of temporary slope shown in
Photographs P-81 and P-82. Note uncapped placement of CCR material to prevent further
erosion of temporary slope face.

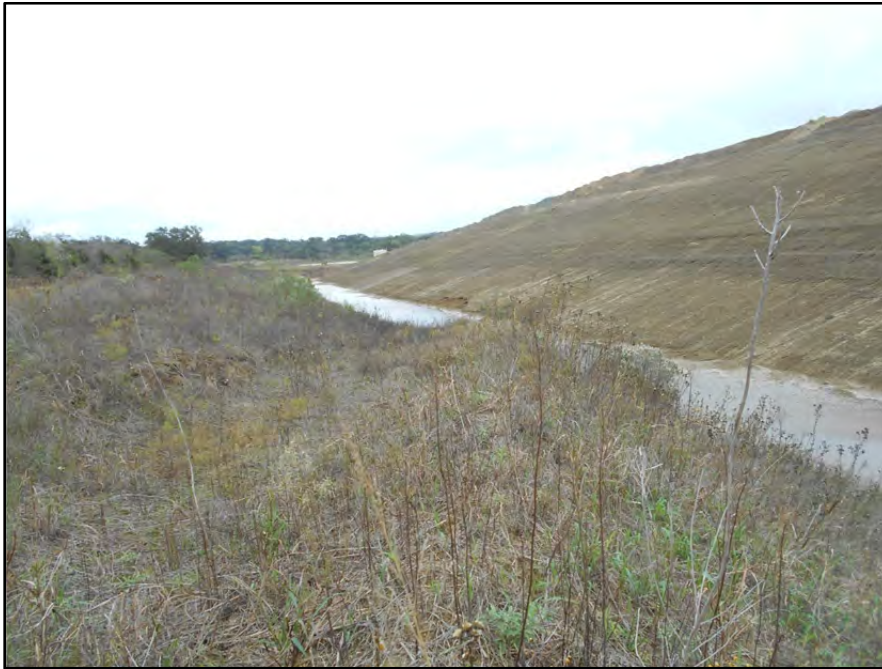
Photograph P-84 – Taken November 11, 2015 by David E. Nielson
Landfill Area 8 (uncapped area): Looking south along the temporary slope of Area 8 that will about landfill Area 20. Also looking along the perimeter interceptor ditch that collects contact water and eroded CCR material. Note minor erosion of CCR material is evident.

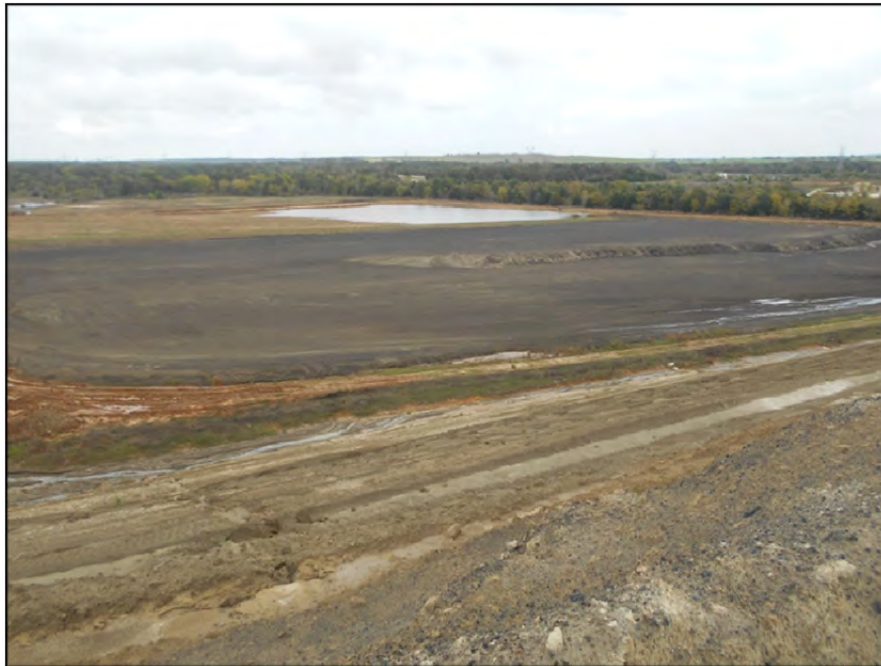
Photograph P-85 – Taken November 11, 2015 by David E. Nielson
Landfill Area 12 (area under construction): Looking southeast from top of uncapped landfill at landfill Area 12. Note clay liner (reddish tan in background), protective layer over liner (gray material) and construction of new perimeter interceptor ditch in distant background, with interceptor ditch in foreground.

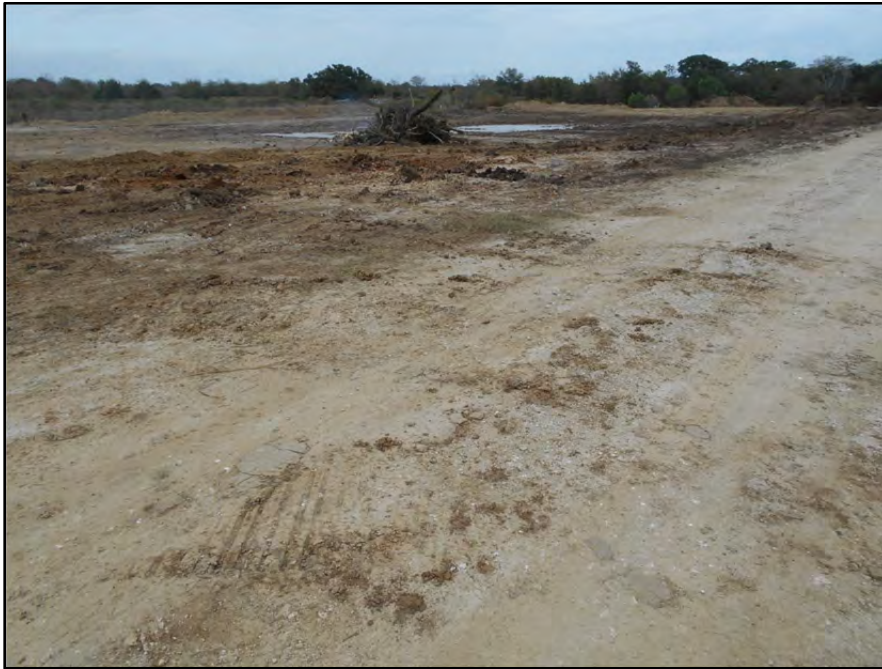
Photograph P-86 – Taken November 11, 2015 by David E. Nielson
Landfill Area 20 (area under construction): Looking northeast at area that has been partially cleared and grubbed in preparation for placement of clay liner for landfill Area 20.
