**NRG TEXAS POWER, LLC
LIMESTONE STATION, UNITS 1 & 2**

ANNUAL INSPECTION OF CCR IMPOUNDMENTS AND LANDFILL

SL Report No.: SL-013201
Revision 0
Date: January 15, 2016
Project No.: 12661-042

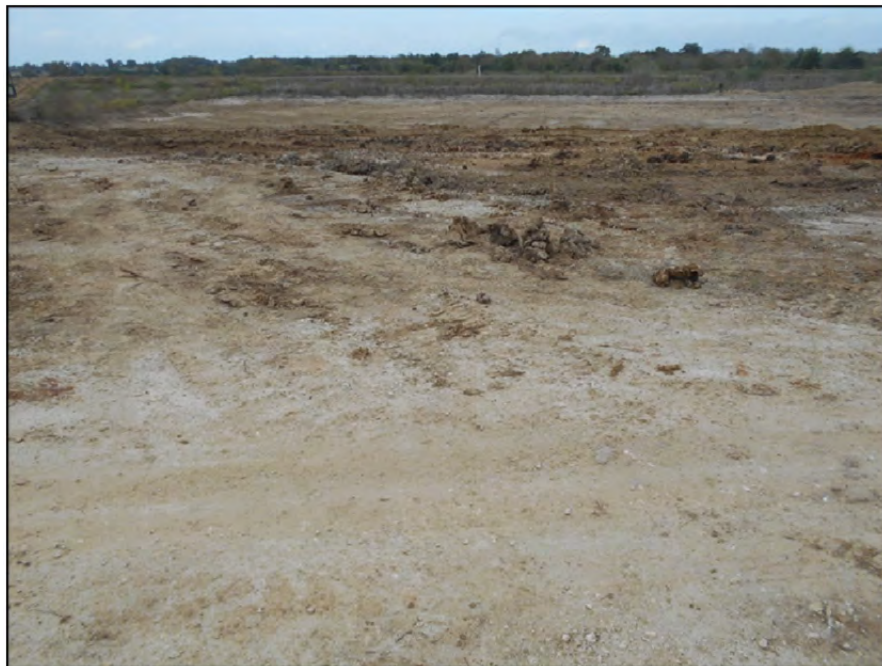
Photograph P-87 – Taken November 11, 2015 by David E. Nielson
Landfill Area 20 (area under construction): Looking northwest at area that has been partially cleared and grubbed in preparation for placement of clay liner for Area 20.

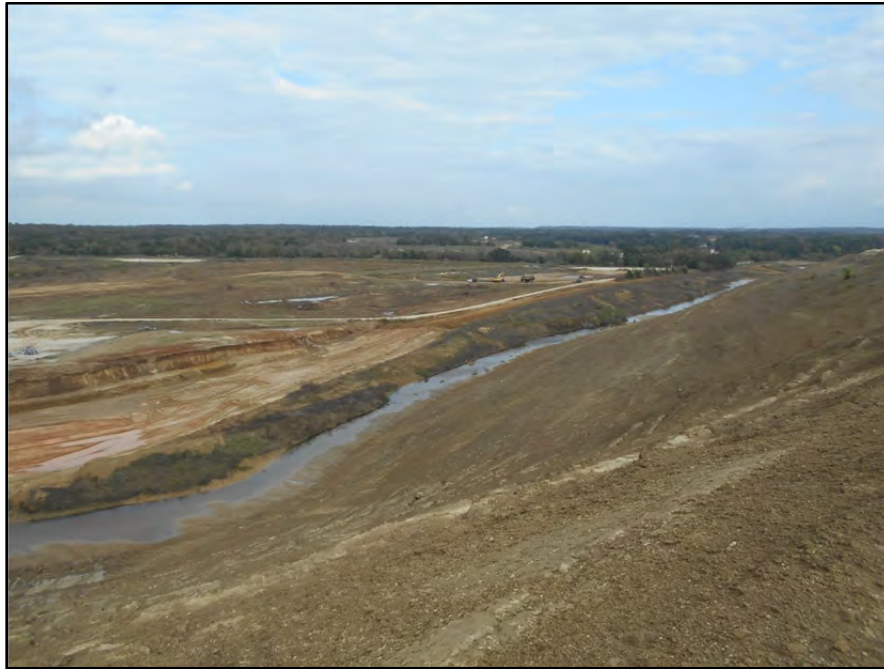
Photograph P-88 – Taken November 11, 2015 by David E. Nielson
Landfill Area 20 in background and landfill Area 19 in foreground: Looking northeast from top of landfill Area 7. Note Area 20 ongoing construction tasks to clear and grub in preparation for placement of clay liner, while Area 19 has been cleared and grubbed except along perimeter interceptor ditch, which will be relocated. Some reddish brown clay liner has been placed in Area 19.

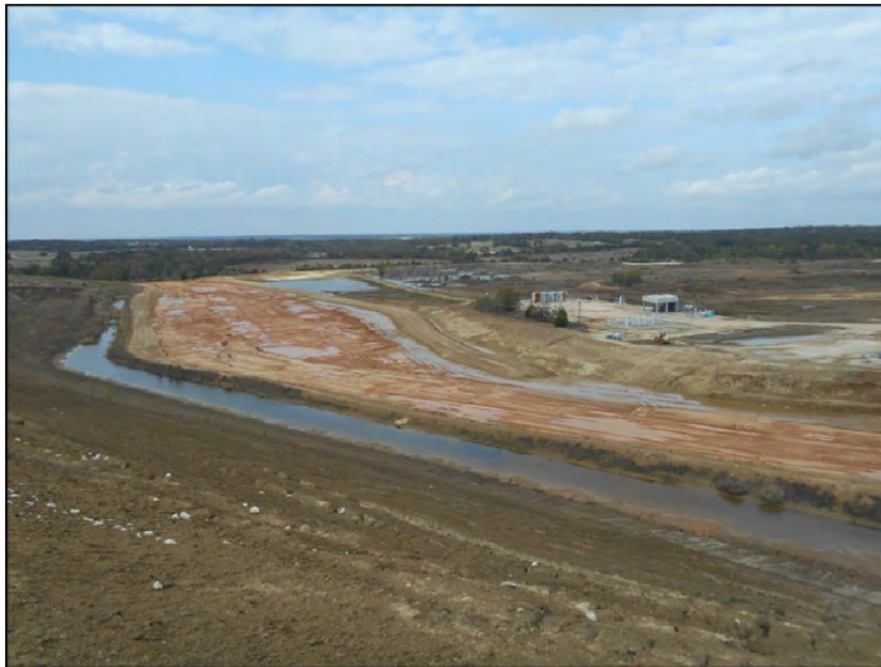
Photograph P-89 – Taken November 11, 2015 by David E. Nielson
Landfill Area 13 (area under construction): Looking north at area that has been cleared and grubbed, with partial placement of clay liner (reddish brown material).
