2025 Annual Inspection of CCR Unit

**Limestone Electric Generating Station
Jewett, Texas**

January 2026

NRG Texas Power LLC

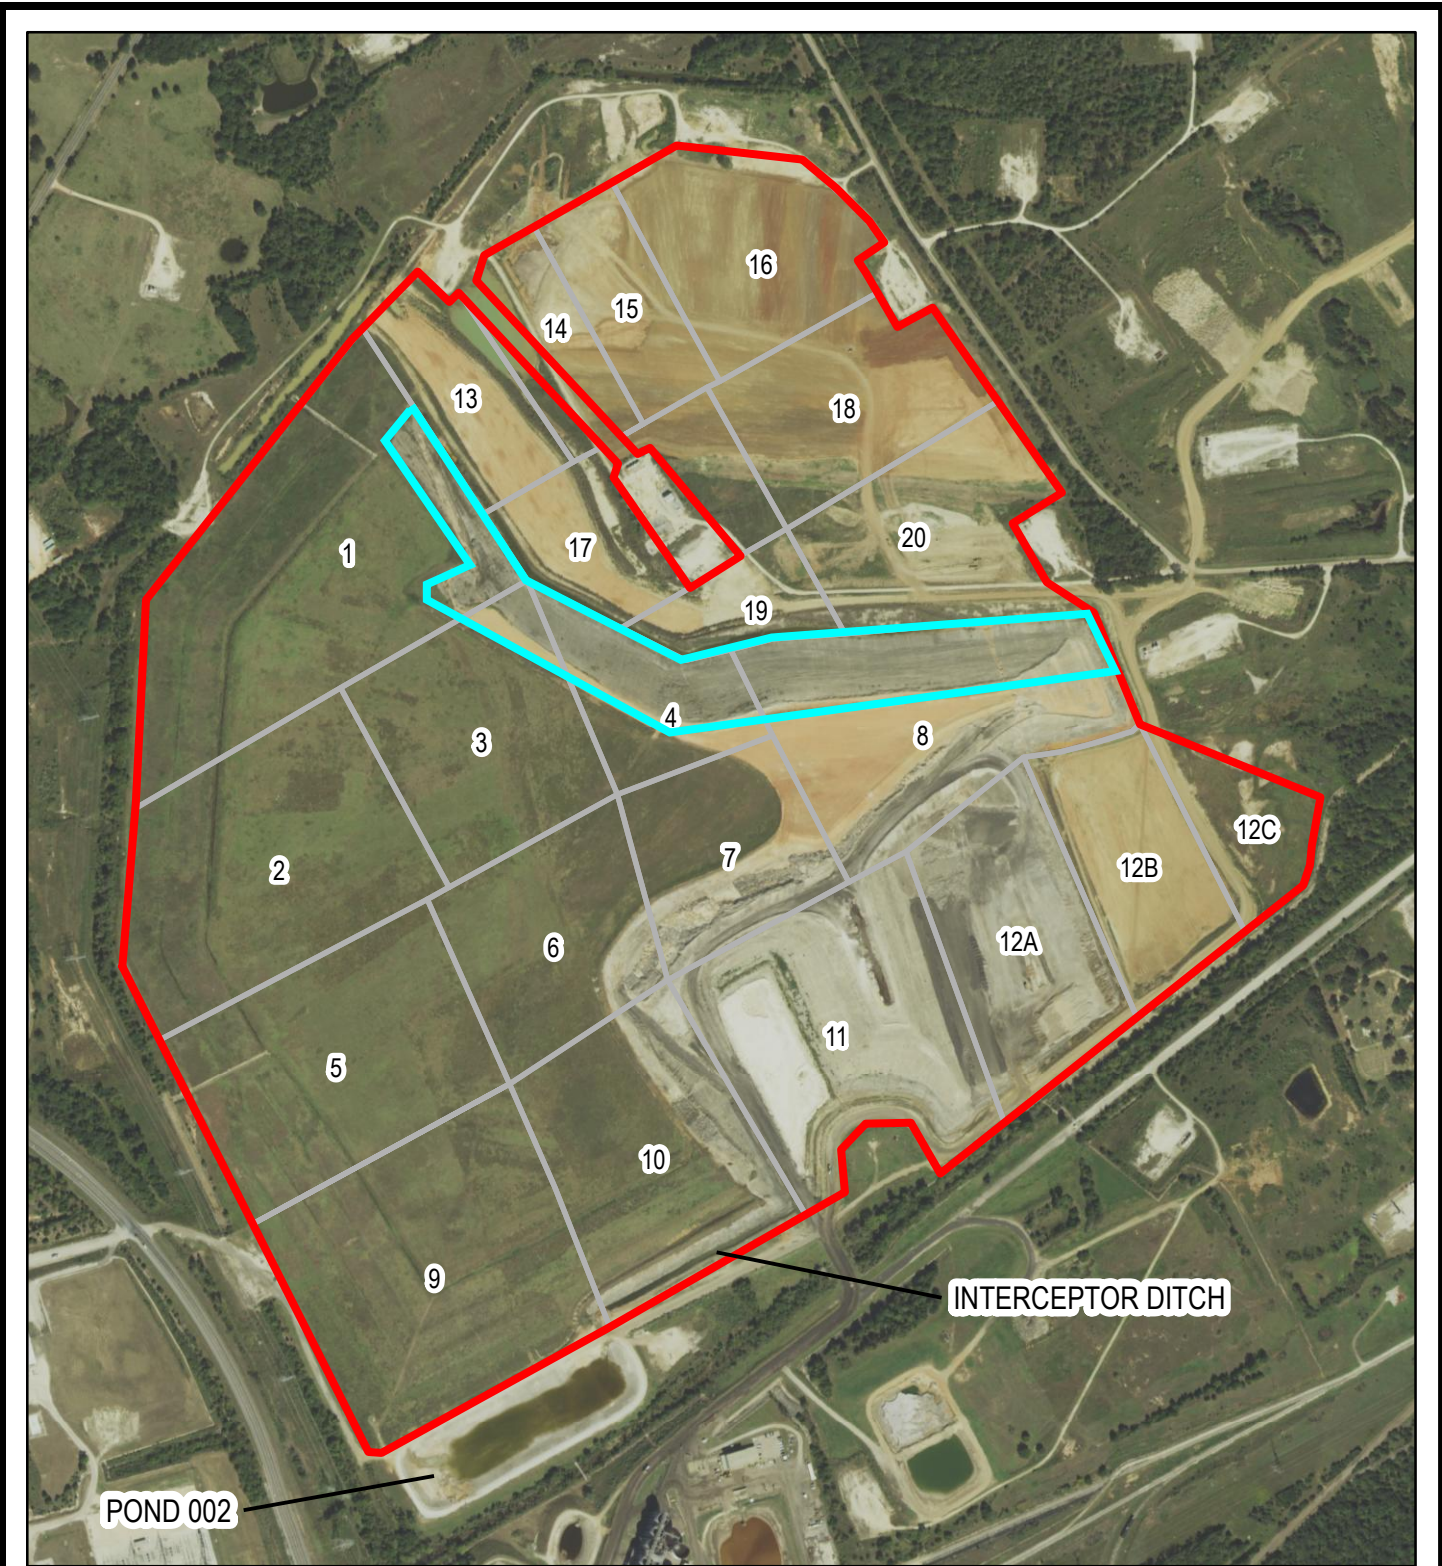
FIGURE 2

The landfill is located east of FM 39. The landfill is designated as a Class II Industrial Waste Landfill under the criteria of the Texas Commission on Environmental Quality (TCEQ). The landfill is managed based on the areas indicated on Figure 2. These areas have no physical boundaries in the landfill. As of

On December 3, 2025, Mr. Richard Varnell, PE (TX), Mr. Jared Stoffel, PG (TX), and Mr. Jason Scott of NRG, visually inspected the Unit 004 Landfill at the Limestone Electric Generating Station. This visual inspection was performed to evaluate if the design, construction, operation, and maintenance of the landfill is consistent with recognized and generally accepted good engineering practice. The individual operational areas at the landfill are depicted on Figure 2. The individual areas discussed in this report are also depicted on Figure 2.
