## Powerton Generating Station

# 2024 Structural Stability Assessment for Ash Surge Basin, Bypass Basin, & Former Ash Basin

October 13, 2024

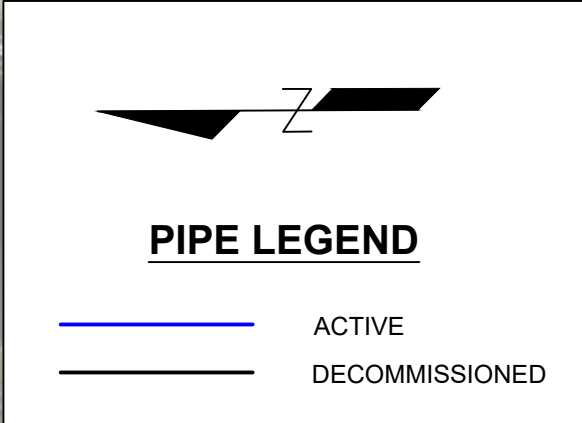
**FIGURE 1**

Figure 1: Embedded Pipes at Ash Surge & Bypass Basins, Powerton Generating Station

As shown on Figure 1, there are four active pipes and one decommissioned pipe that underlie or pass through the Ash Surge Basin's dikes. Pipe 4 is the Ash Surge Basin's outlet pipe to the Ash Surge Basin Sump. Pipe 5 is the common header into which the three pumps in the Ash Surge Basin Sump pump water to the wastewater building identified on Figure 1. Refer to Section 3.2.5 for a discussion of Pipes 2, 3, and 6.

When it was first built, the Bypass Basin had an emergency overflow riser pipe located at the northeast corner of the basin. However, this riser pipe and the downstream 30-in.-diameter corrugated metal pipe into the Ash Surge Basin (identified as Pipe 2 in Figure 1) were decommissioned and plugged with flowable fill during retrofit construction activities. As documented in the basins' 2024 inflow design flood control system plan (Ref. 26), the basin is capable of containing the design flood event (1,000-year, 24-hour storm) without a spillway.

As shown on Figure 1, there are two active pipes and two decommissioned pipes that underlie or pass through the Bypass Basin's dikes. Pipe 3 is a 36-in.-diameter reinforced concrete pipe (RCP) that conveys effluent from the Bypass Basin's discharge structure in its southeastern corner to the Ash Surge Basin Sump. Meanwhile, Pipe 6 is a new 36-in.-diameter corrugated HPDE (CHPDE) pipe that was installed during the retrofit of the Bypass Basin to divert non-CCR wastestreams away from the retrofitted Bypass Basin. As previously stated in Section 3.2.4, Pipe 2, which was a 30-in.-diameter corrugated metal pipe within the northern embankment of the Bypass Basin, was decommissioned and plugged with flowable fill during retrofit construction activities. Finally, Pipe 1, which was a 15-in.-diameter RCP located in the basin's outlet structure, was also filled with flowable fill during retrofit construction activities. After the pipe was plugged, structural fill was placed over the decommissioned pipe to support installation of the basin's new composite liner system.
