**STRUCTURAL STABILITY ASSESSMENT
FORMER ASH BASIN
POWERTON STATION
APRIL 2018**

Former Ash Basin, Powerton Station
Structural Stability Assessment
April 2018

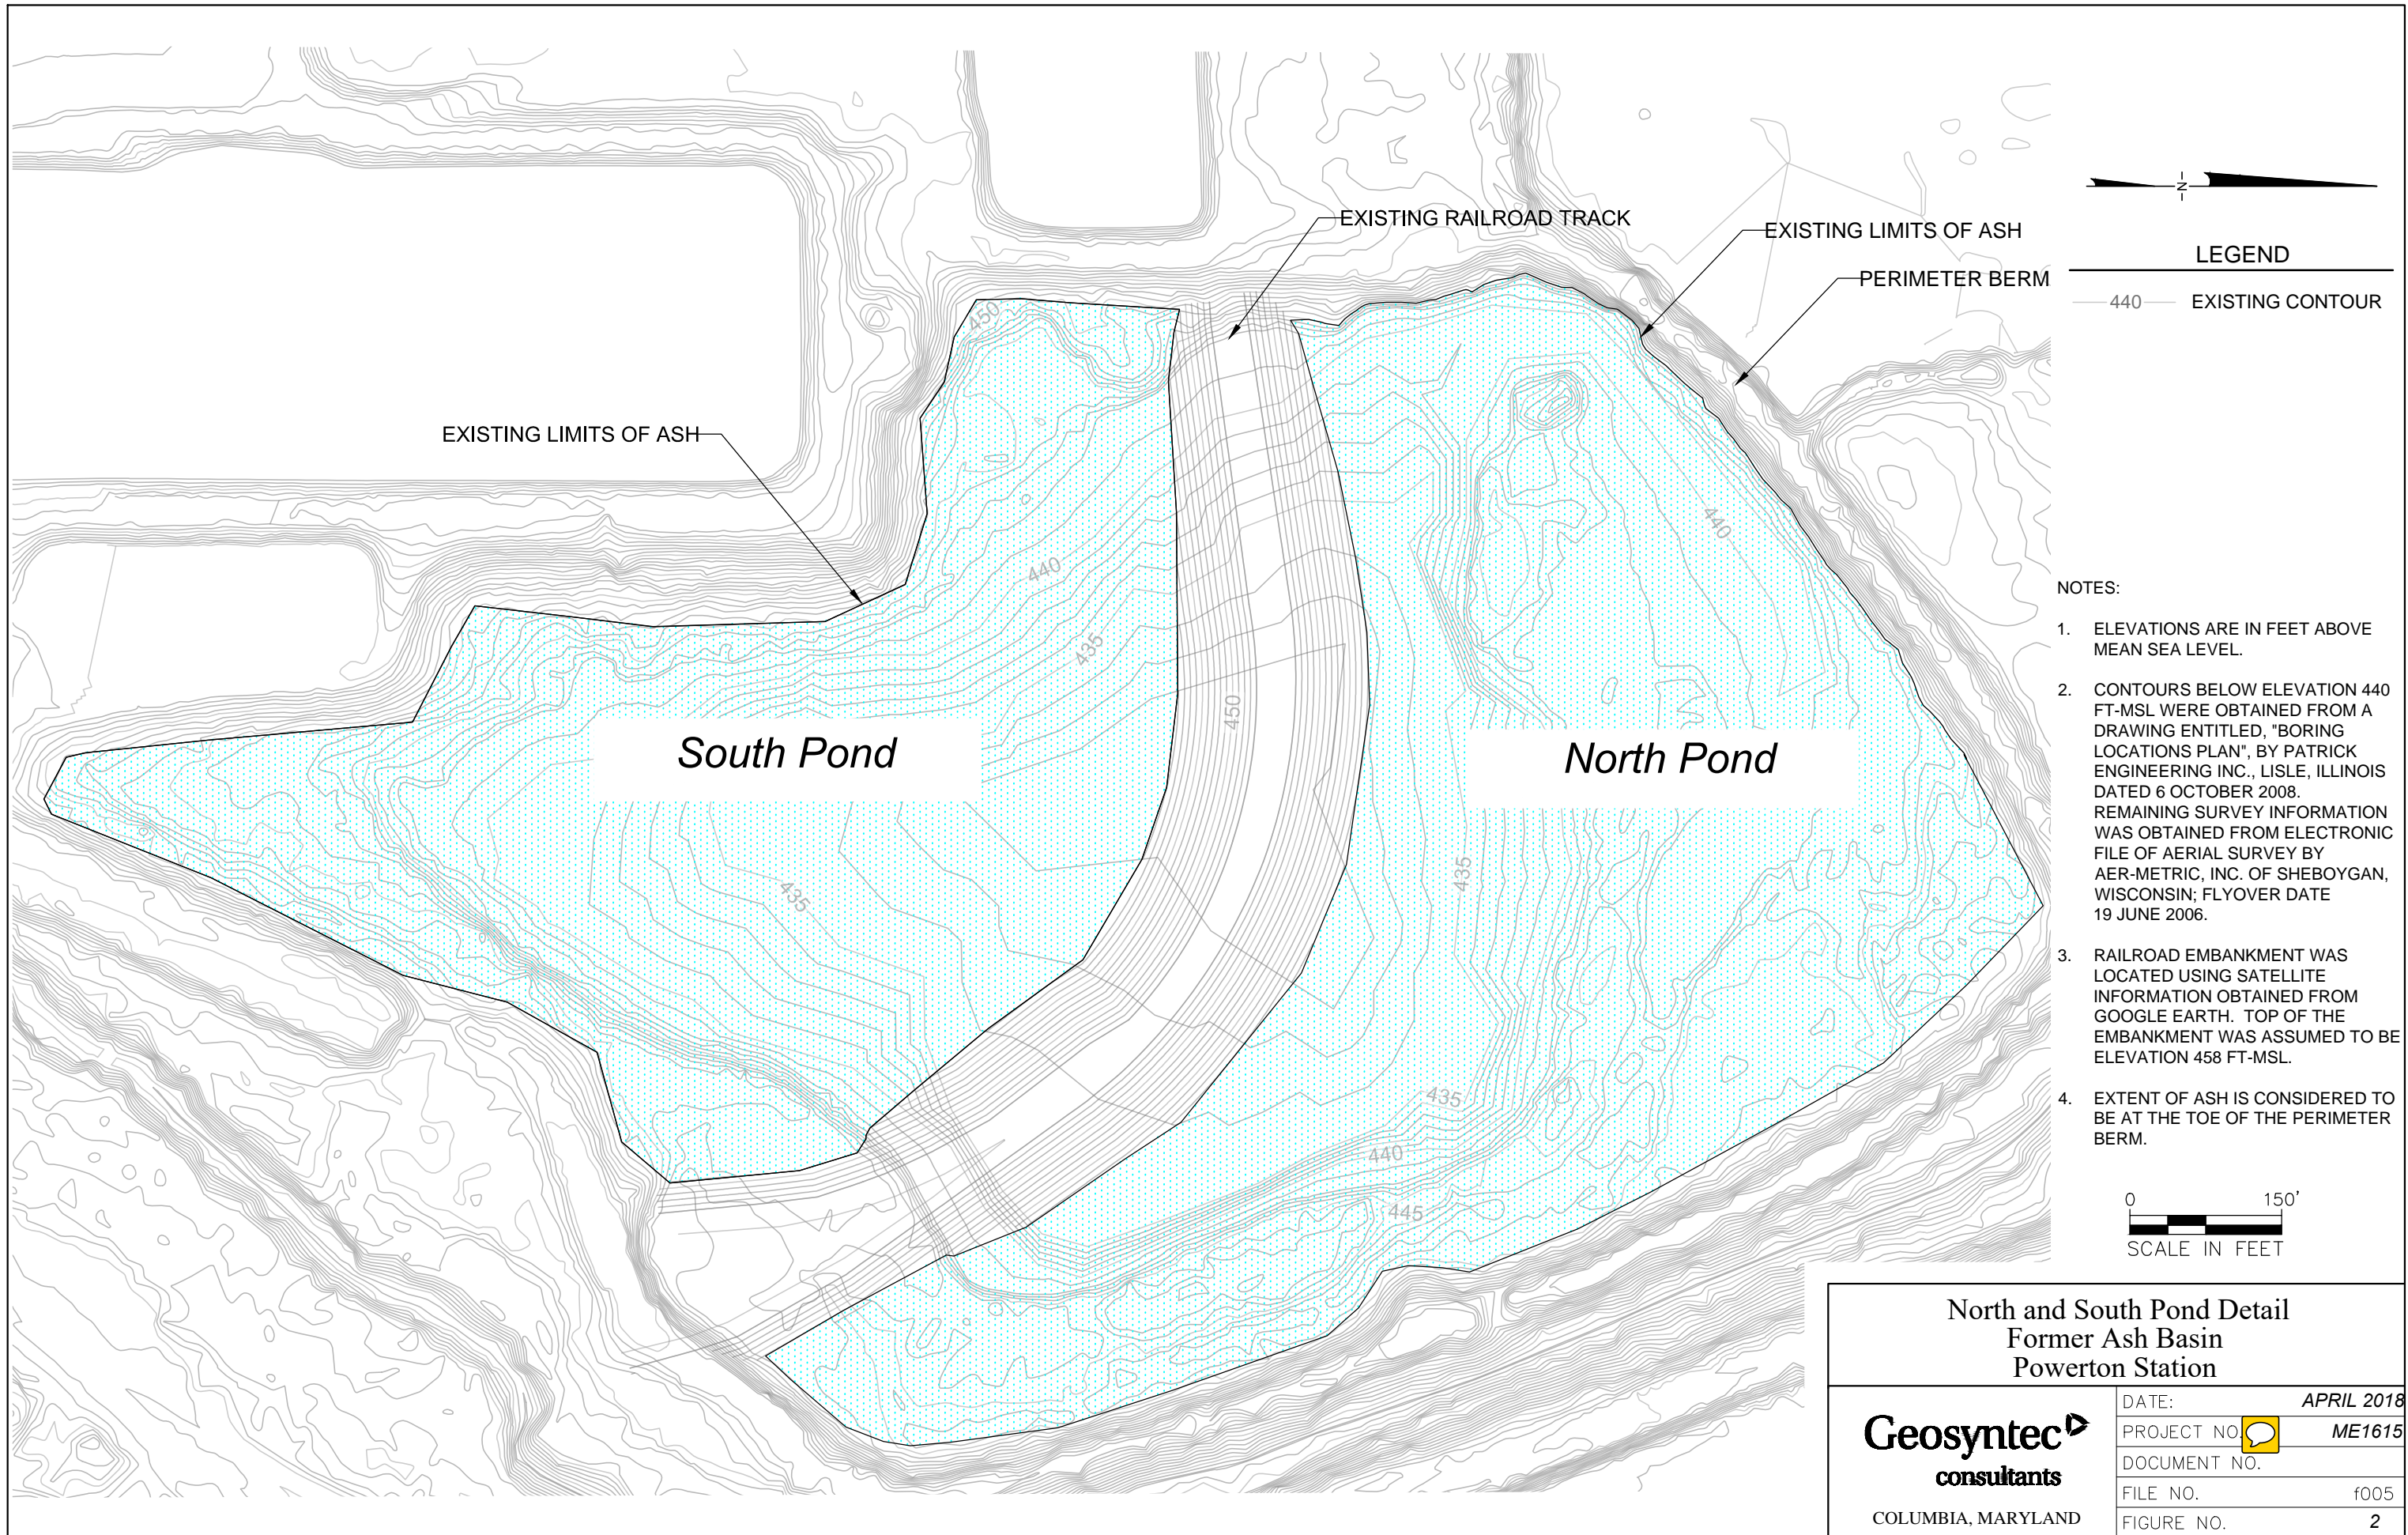
**North and South Pond Detail
Former Ash Basin
Powerton Station**

Located to the east of the existing Ash Surge Basin, the FAB is an inactive CCR surface impoundment which was historically used for bottom ash disposal. It is estimated that the FAB stopped receiving CCRs by the 1970s. Originally a single pond, in 2010 the FAB was bisected into two areas by construction of a railroad embankment. The two bisected ponds are now designated as the North Pond and South Pond (Figure 2). Due to the duration of inactive use, both areas contain heavy vegetation. The volumes of apparent CCR in the North Pond and South Pond are estimated to be less than 300,000 and 200,000 cubic yards, respectively.

The dike conditions are not highly controlled and inconsistent in height around the FAB. Documentation of as-built construction conditions for the FAB embankments was not available at the time of this report and no quantitative evaluation of the degree of compaction of the embankments was performed for the dikes in their current state. Therefore, it is unknown if the embankments are compacted to a density sufficient to withstand the range of loading conditions for the CCR unit.
