2016 ANNUAL ENGINEERING INSPECTION REPORT

PLUM POINT ENERGY STATION CLASS 3N LANDFILL

**PERMIT NO. 0303-S3N
AFIN: 47-00461**

JANUARY 18, 2017

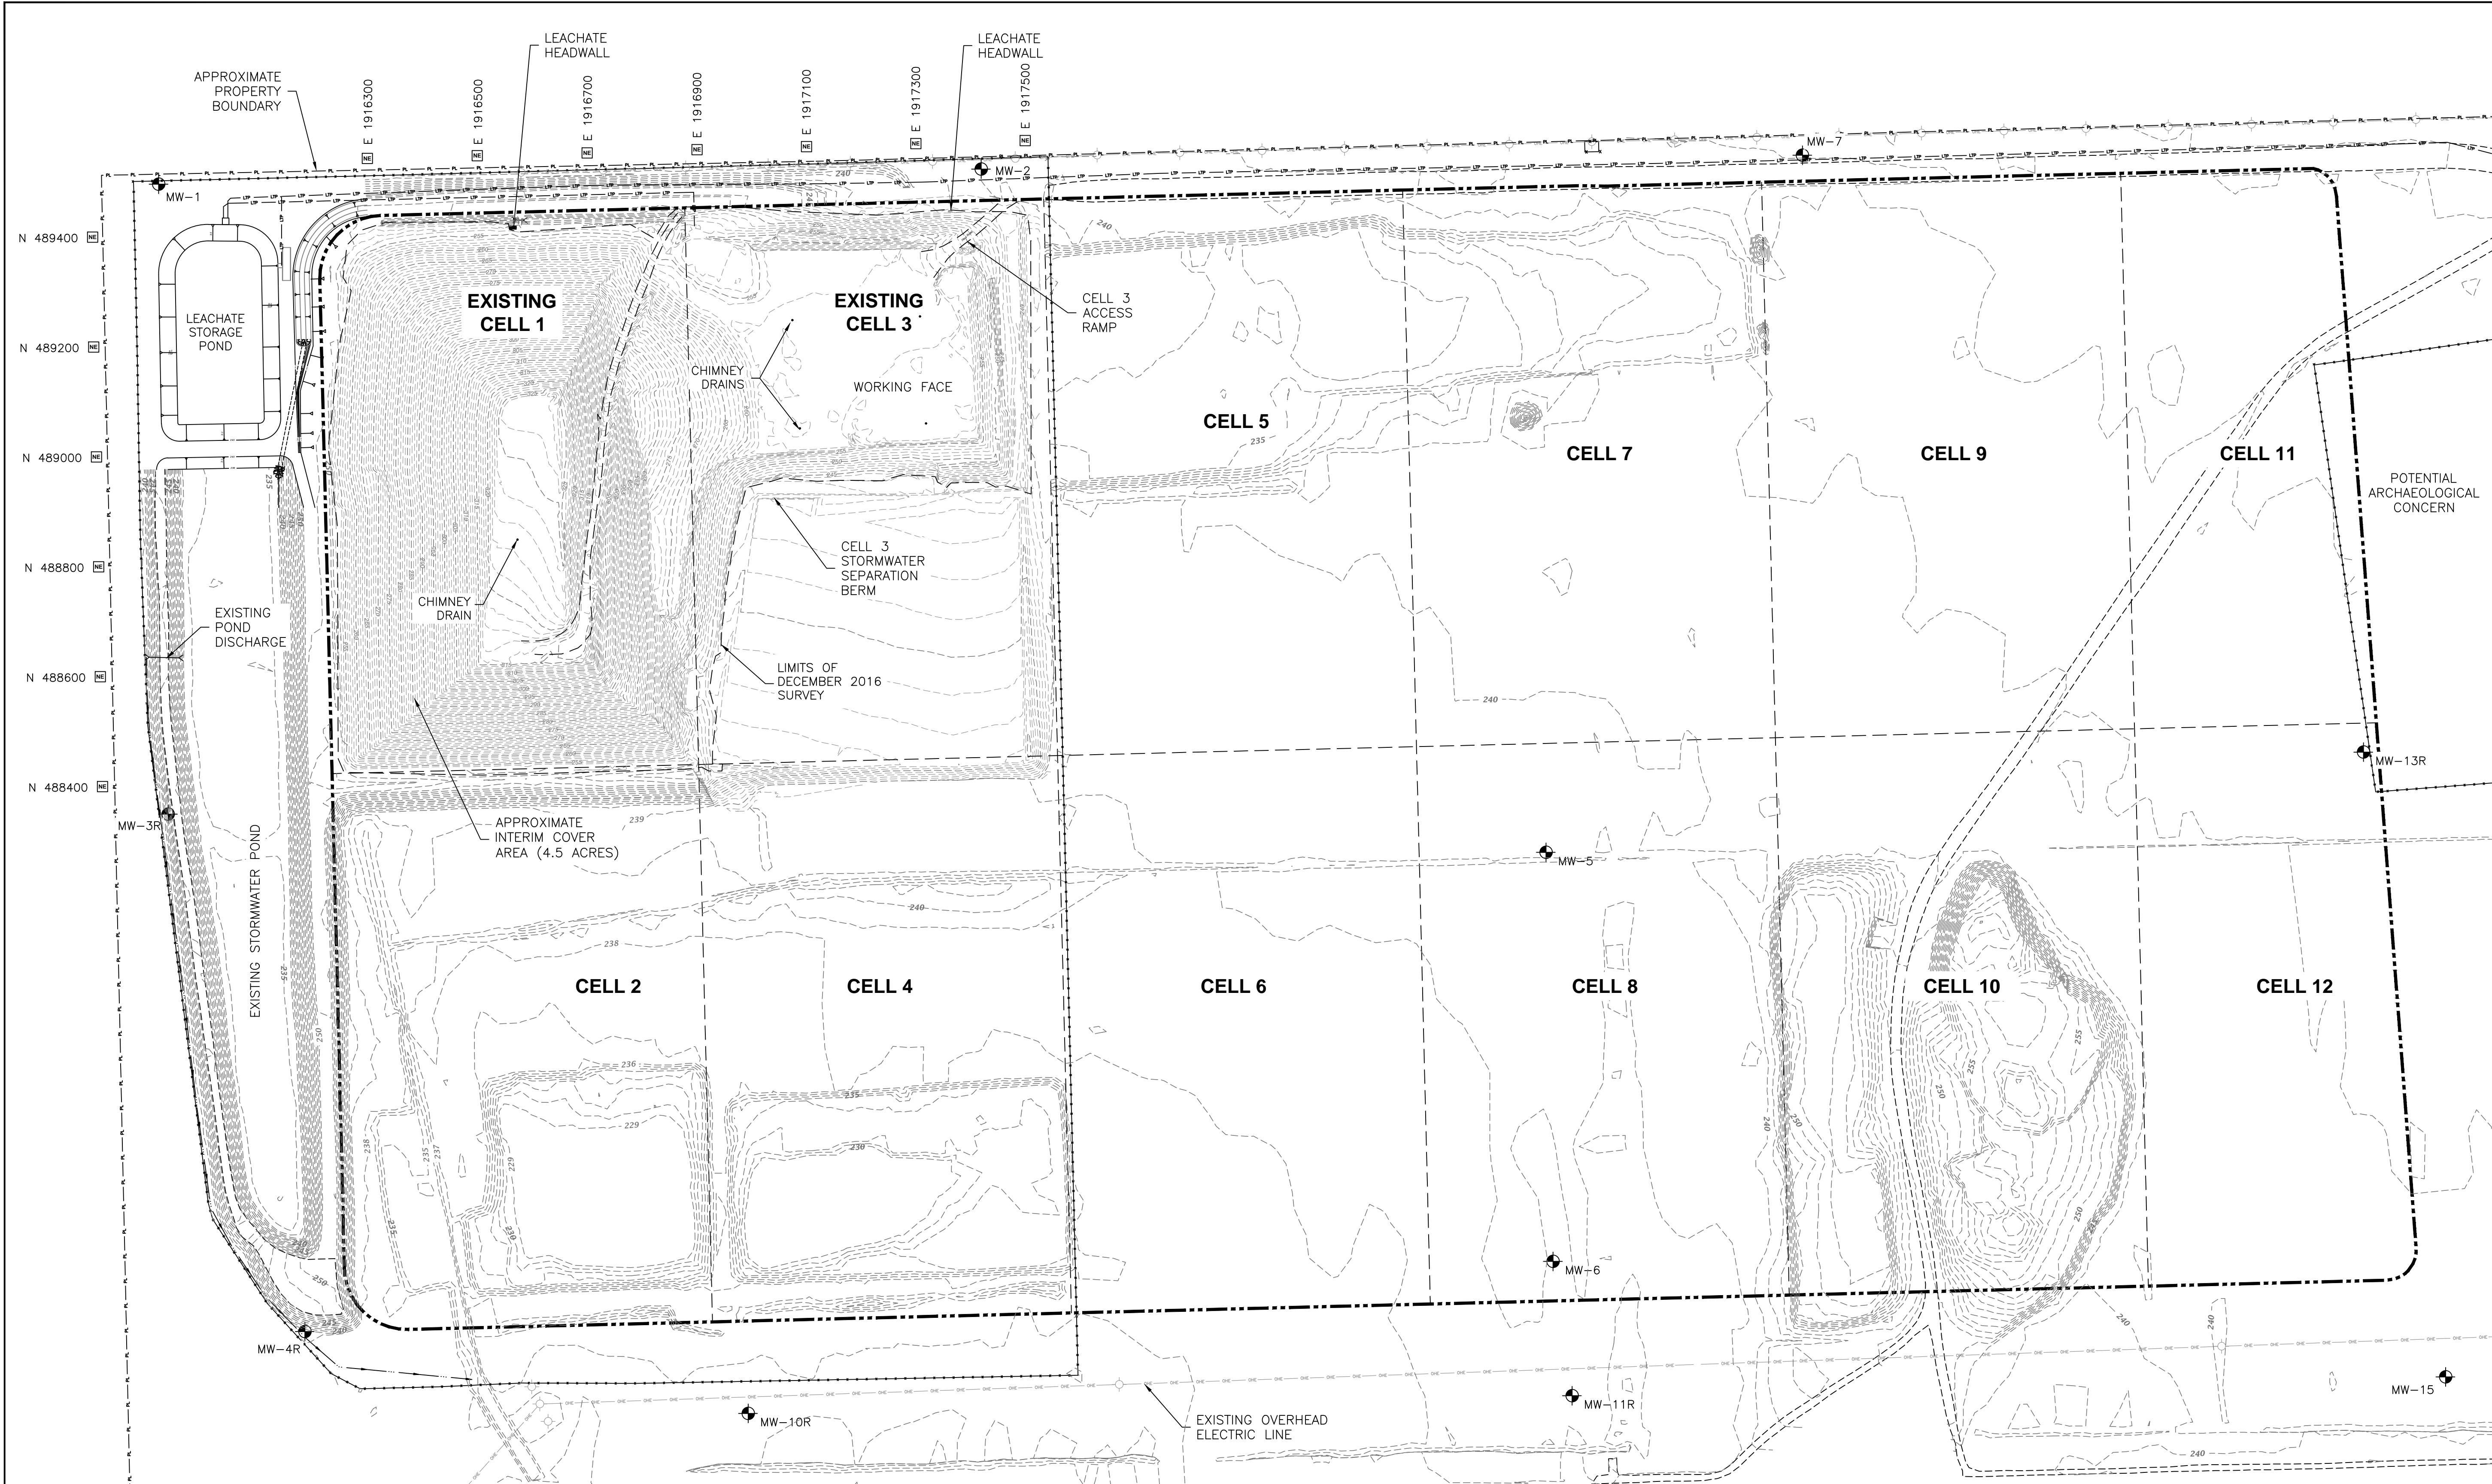
FIGURE 2
EXISTING CONDITIONS

No final cover system has been installed on Waste Cells 1 and 3. However, as shown on Figure 1, the west, north, and south slopes of Cell 1 have received interim soil cover.

Both active cells remain open. Interim cover soil has been placed, as noted, on the all of Cell 1 except for the east slope into Cell 3. Interim cover has also been installed on the north and east slopes of Cell 1, up to the current fill elevation.
