# **2018 ANNUAL ENGINEERING INSPECTION REPORT**

## **PLUM POINT ENERGY STATION CLASS 3N LANDFILL**

**PERMIT NO. 0303-S3N  
AFIN: 47-00461**

**JANUARY 18, 2019**

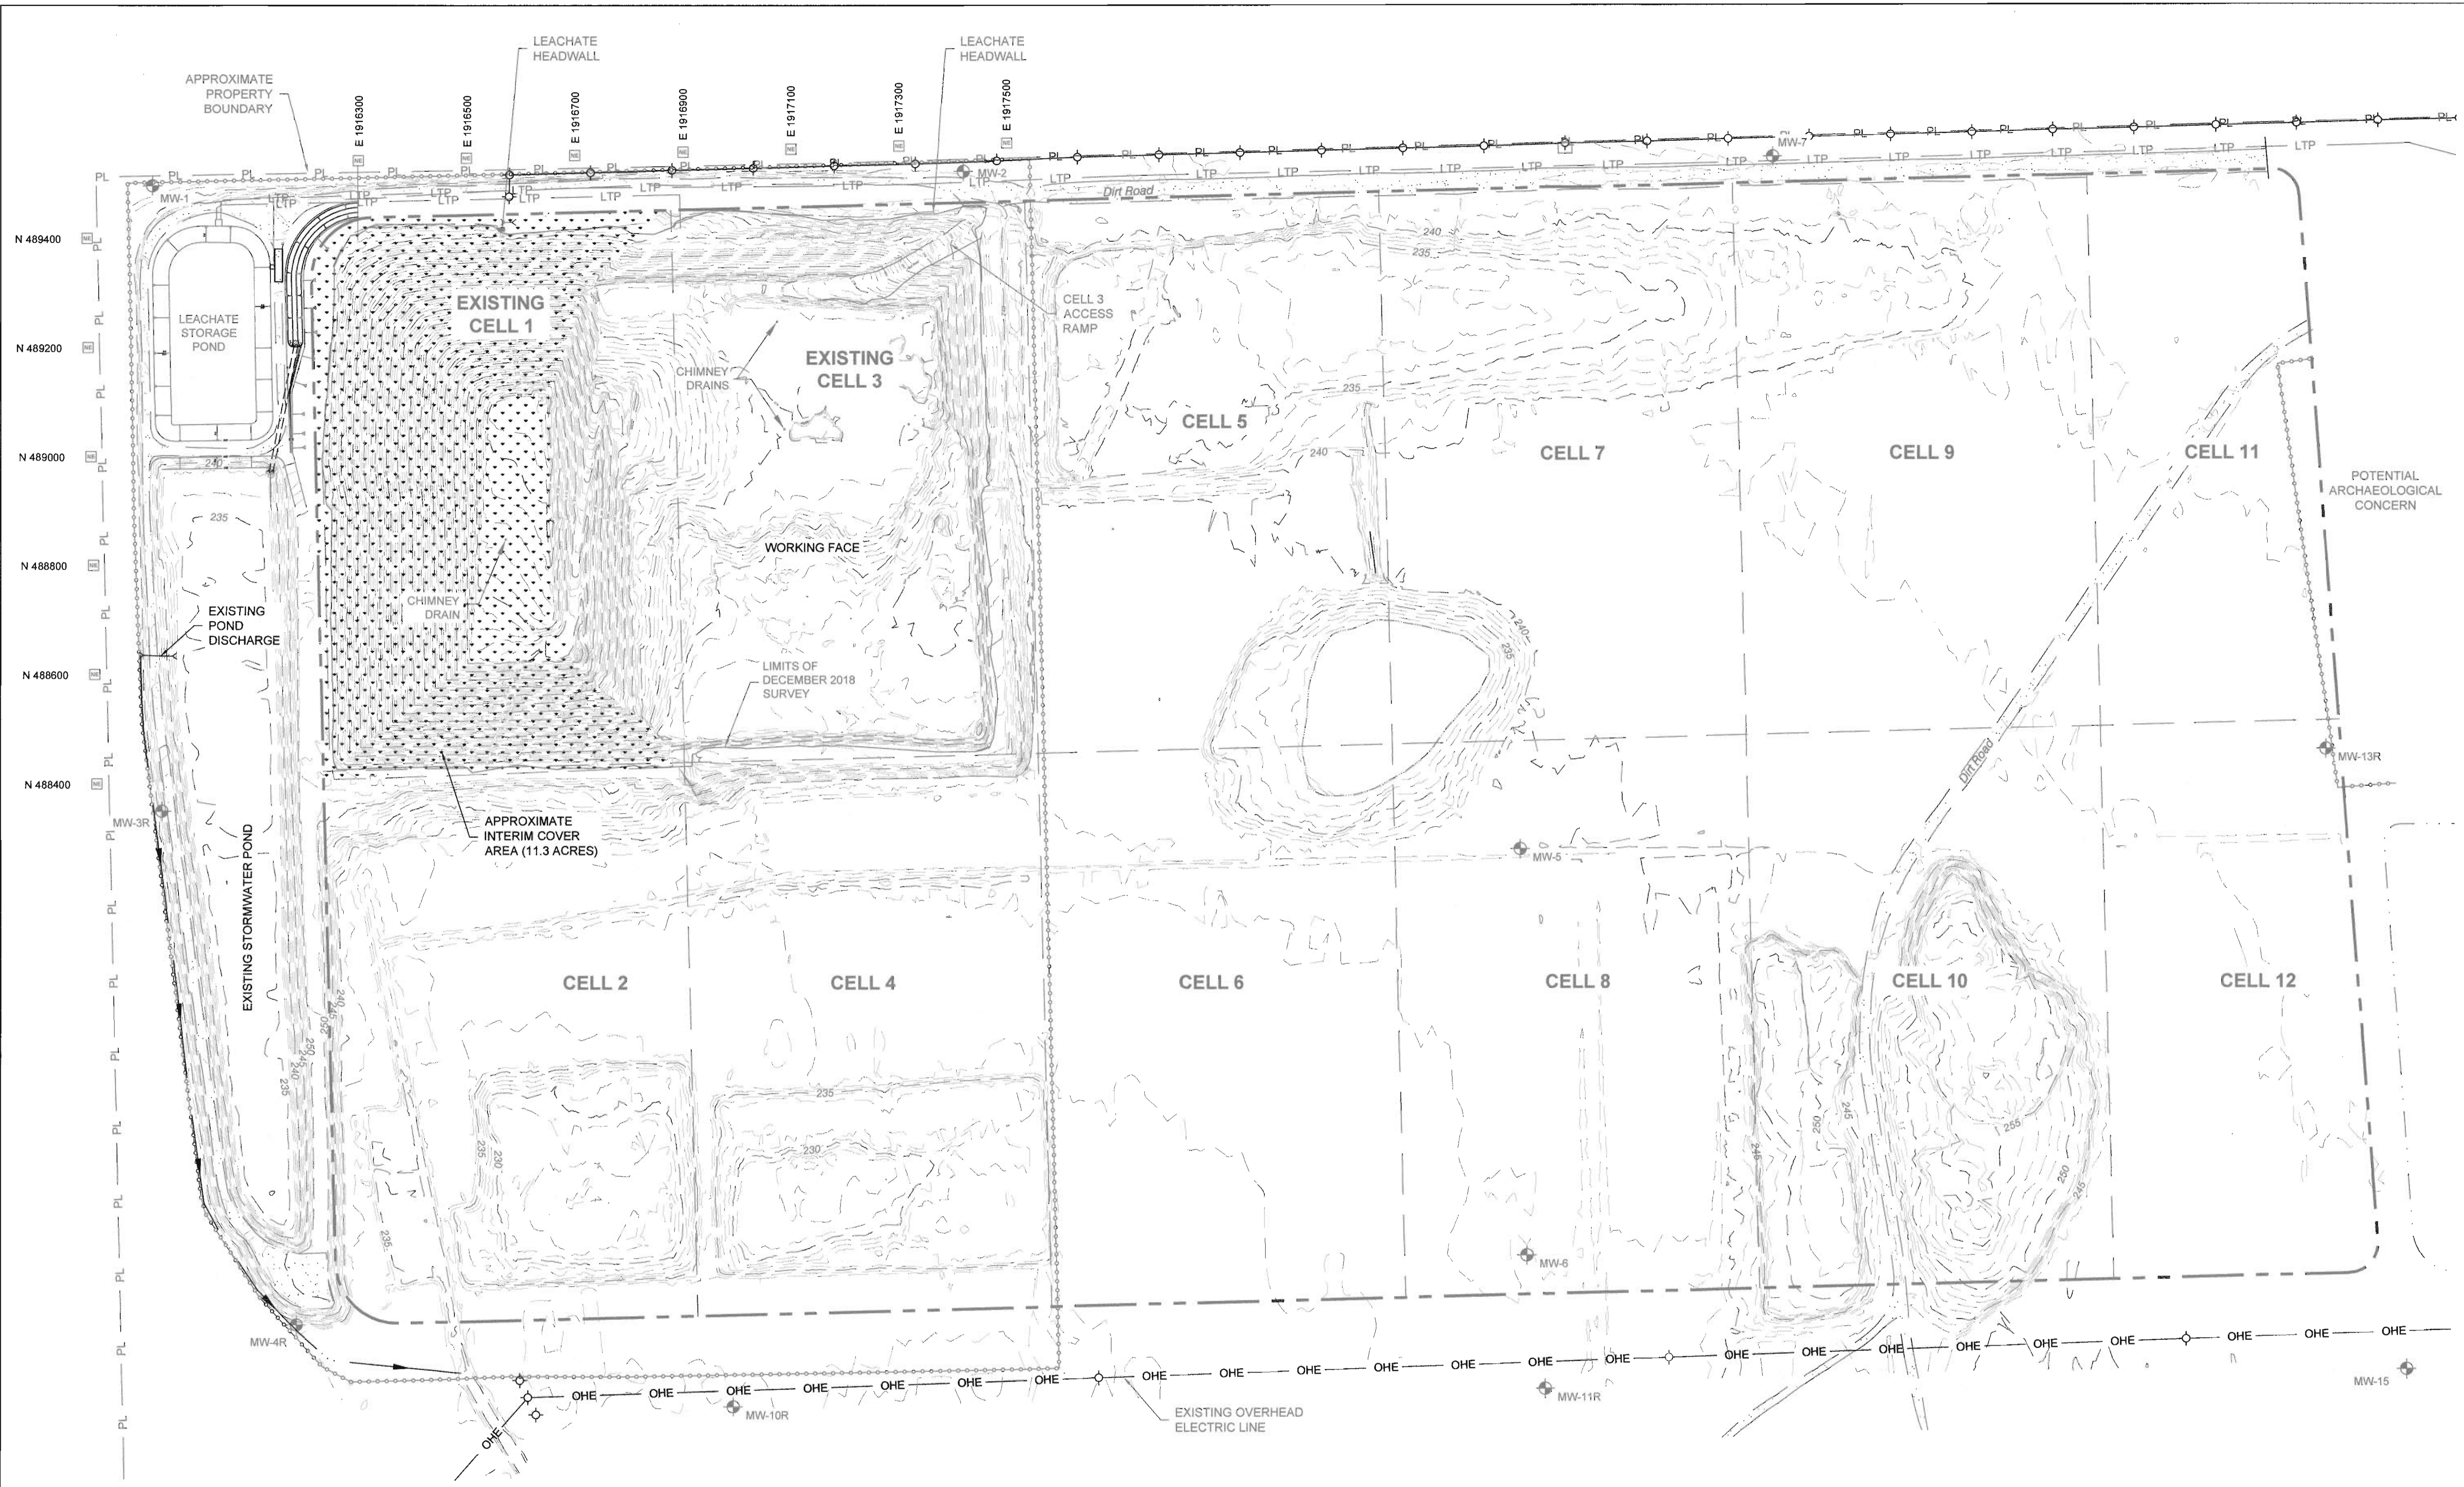
No final cover system has been installed on Waste Cells 1 and 3. However, as shown on Figure 1, the top and the west, north, and south slopes of Cell 1 have received interim soil cover.

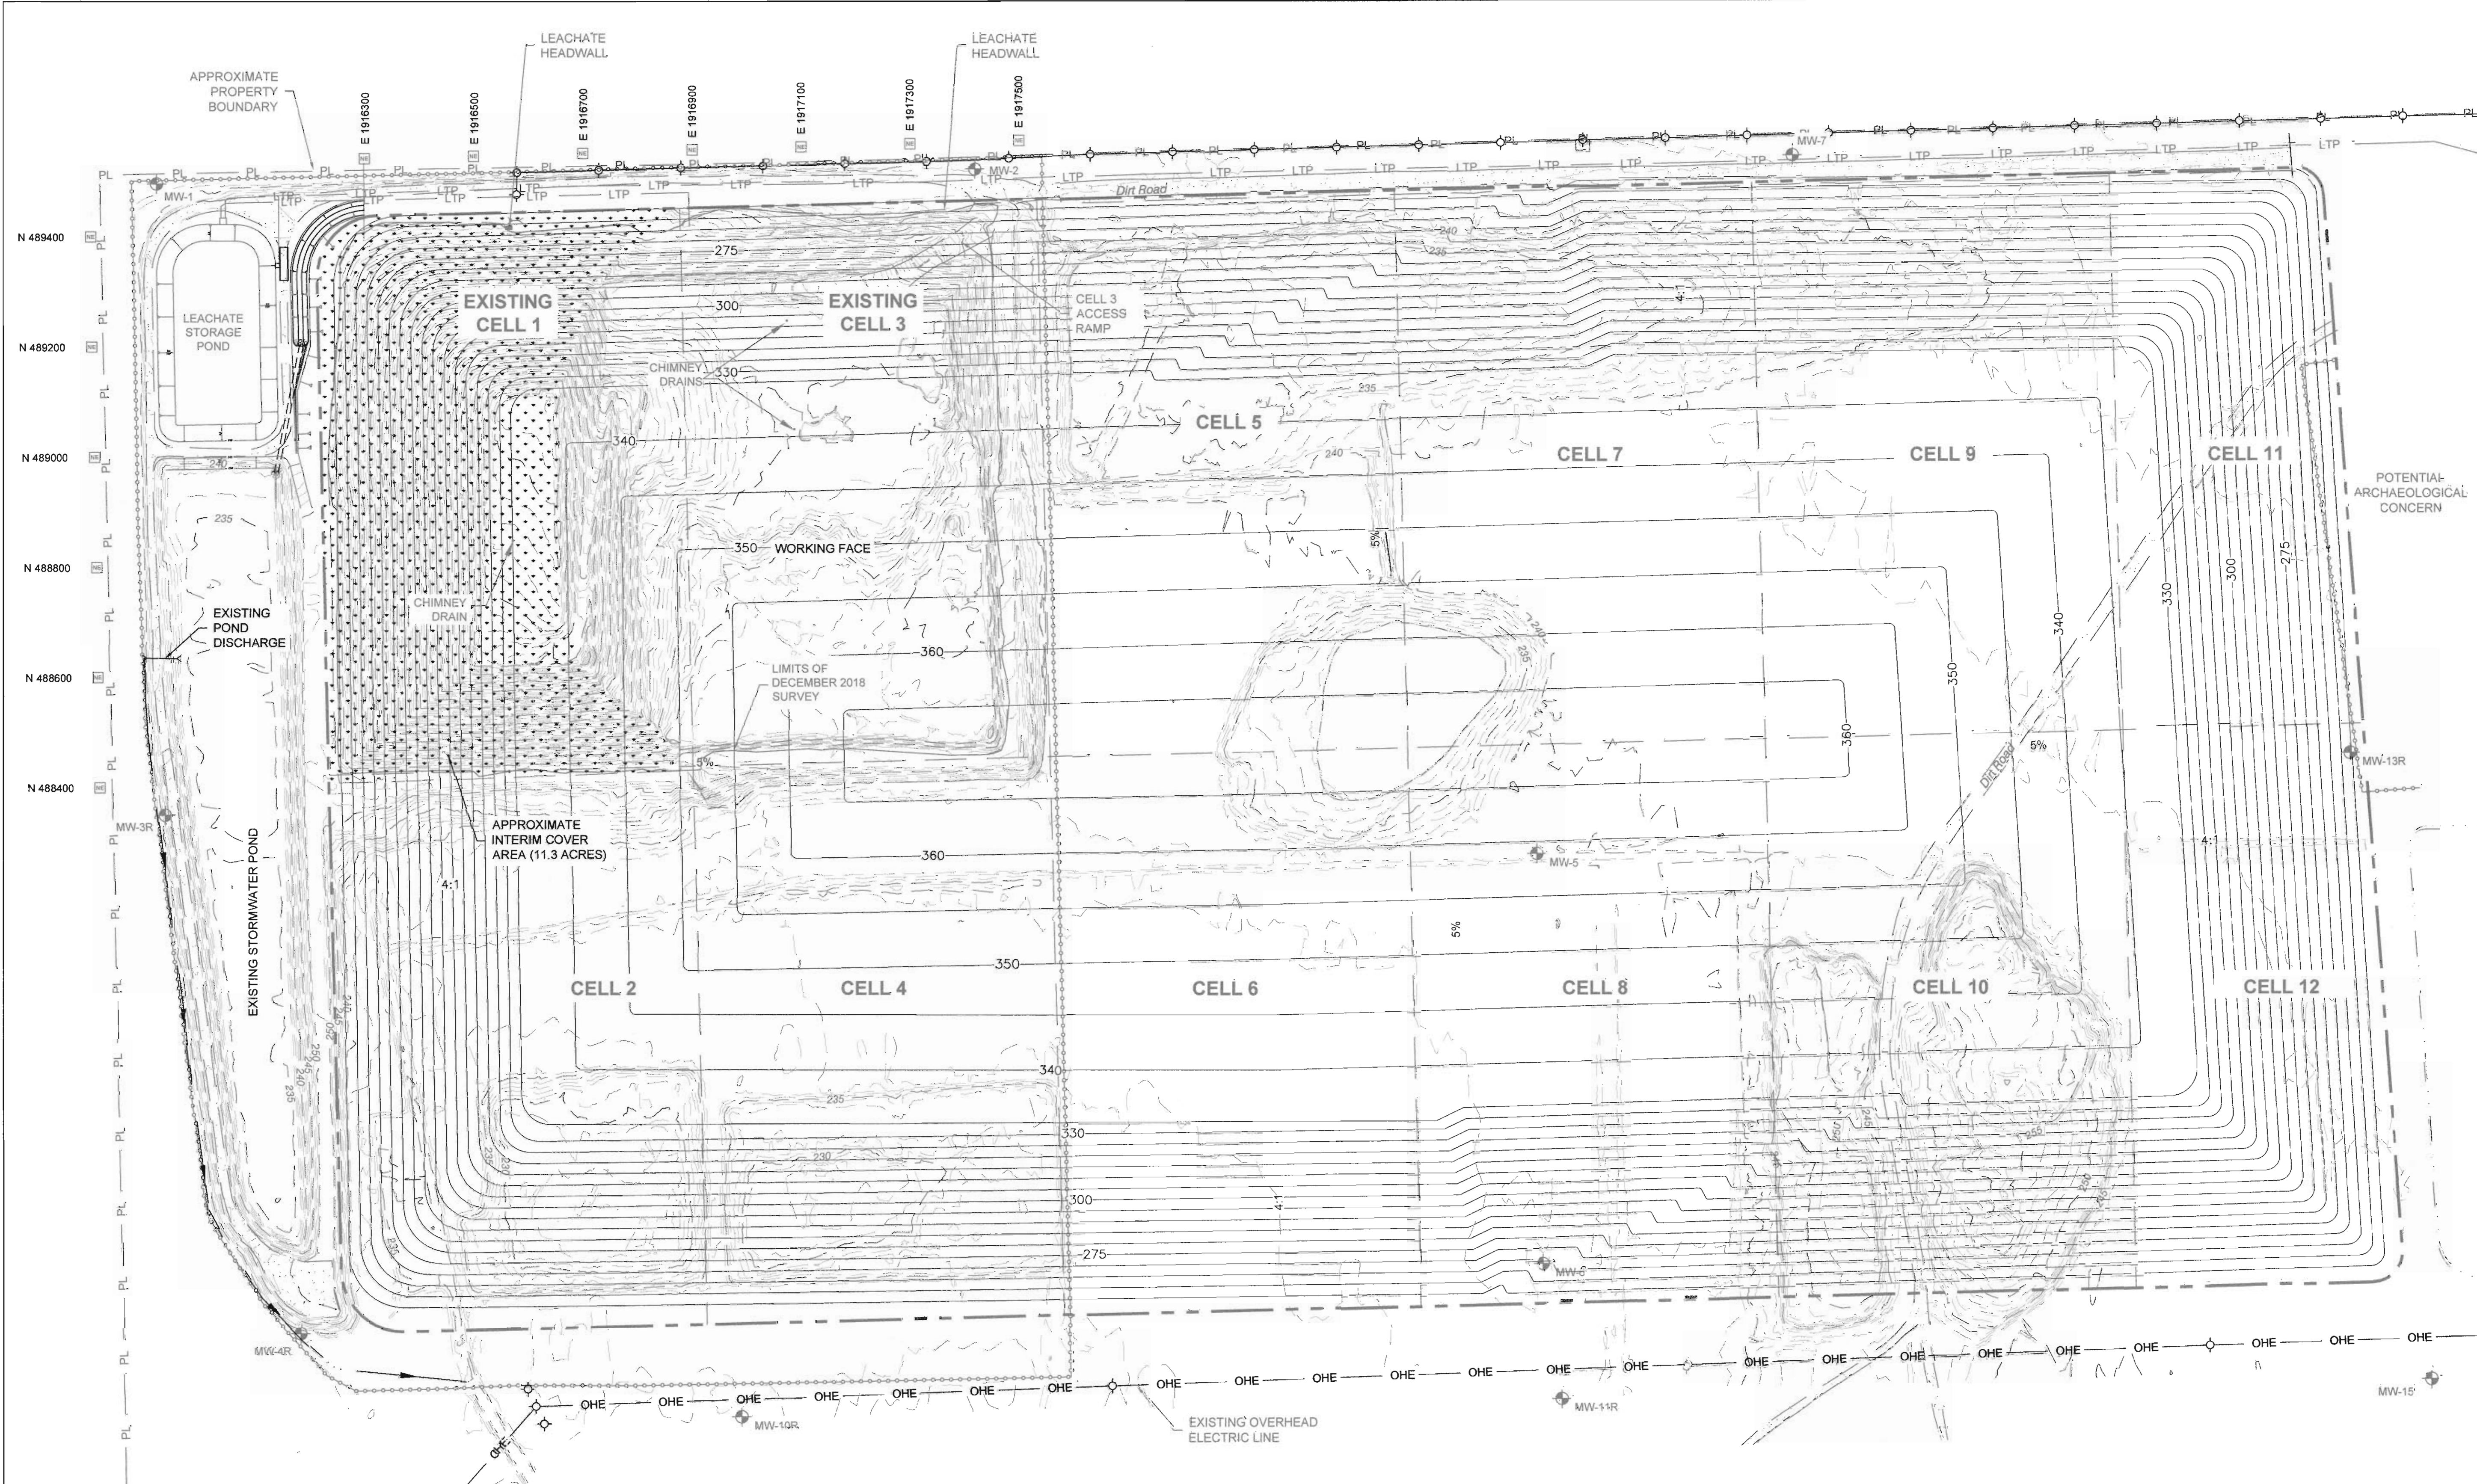
As noted, no final cover system has been installed on Waste Cells 1 and 3. Figure 3 presents contours for the currently permitted final cover system.
