# **2020 ANNUAL ENGINEERING INSPECTION REPORT**

## **PLUM POINT ENERGY STATION CLASS 3N LANDFILL**

**PERMIT NO. 0303-S3N  
AFIN: 47-00461**

**JANUARY 15, 2021**

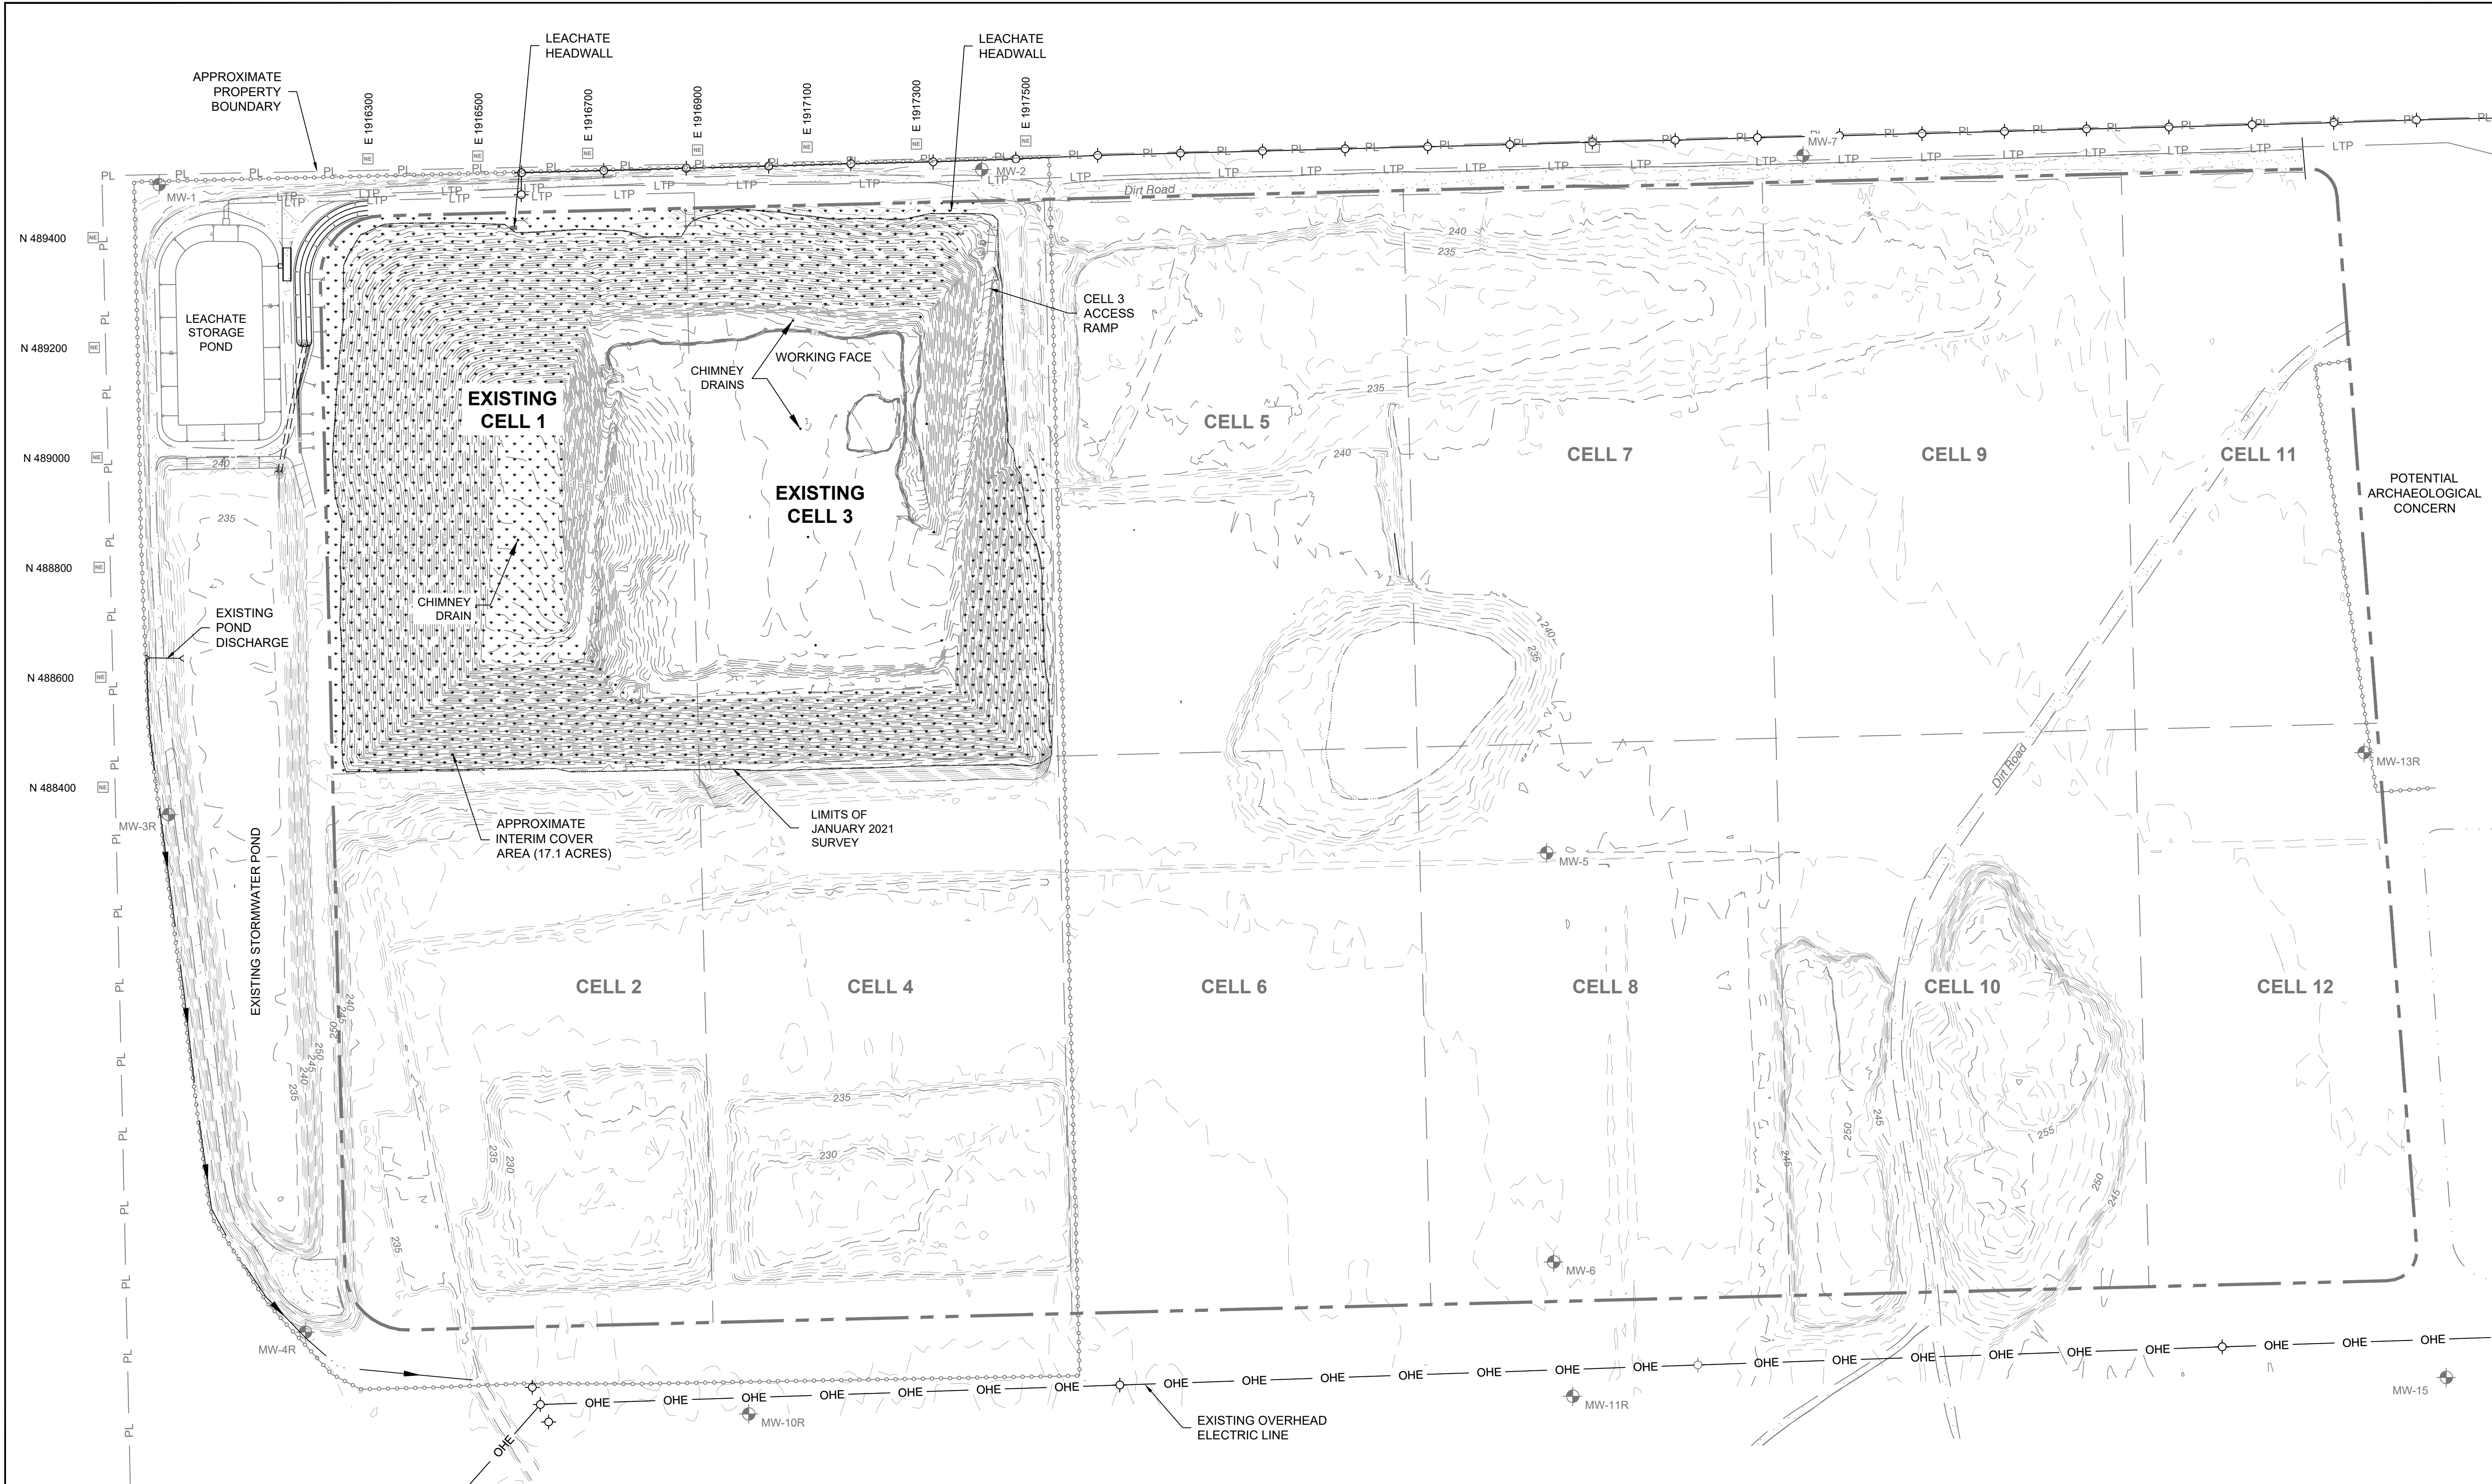
**FIGURE 2**  
**EXISTING CONDITIONS**

No final cover system has been installed on Waste Cells 1 and 3. However, as shown on Figure 1, the top and the west, north, and south slopes of Cell 1 have received interim soil cover. Interim cover, seed and mulch have also been installed on the north, east and south partial slopes of Cell 3 as they reach final waste grades.

Both active cells remain open. Interim cover soil has been placed, as noted, on all of Cell 1 except for the east slope into Cell 3 and on Cell 3 as noted above.

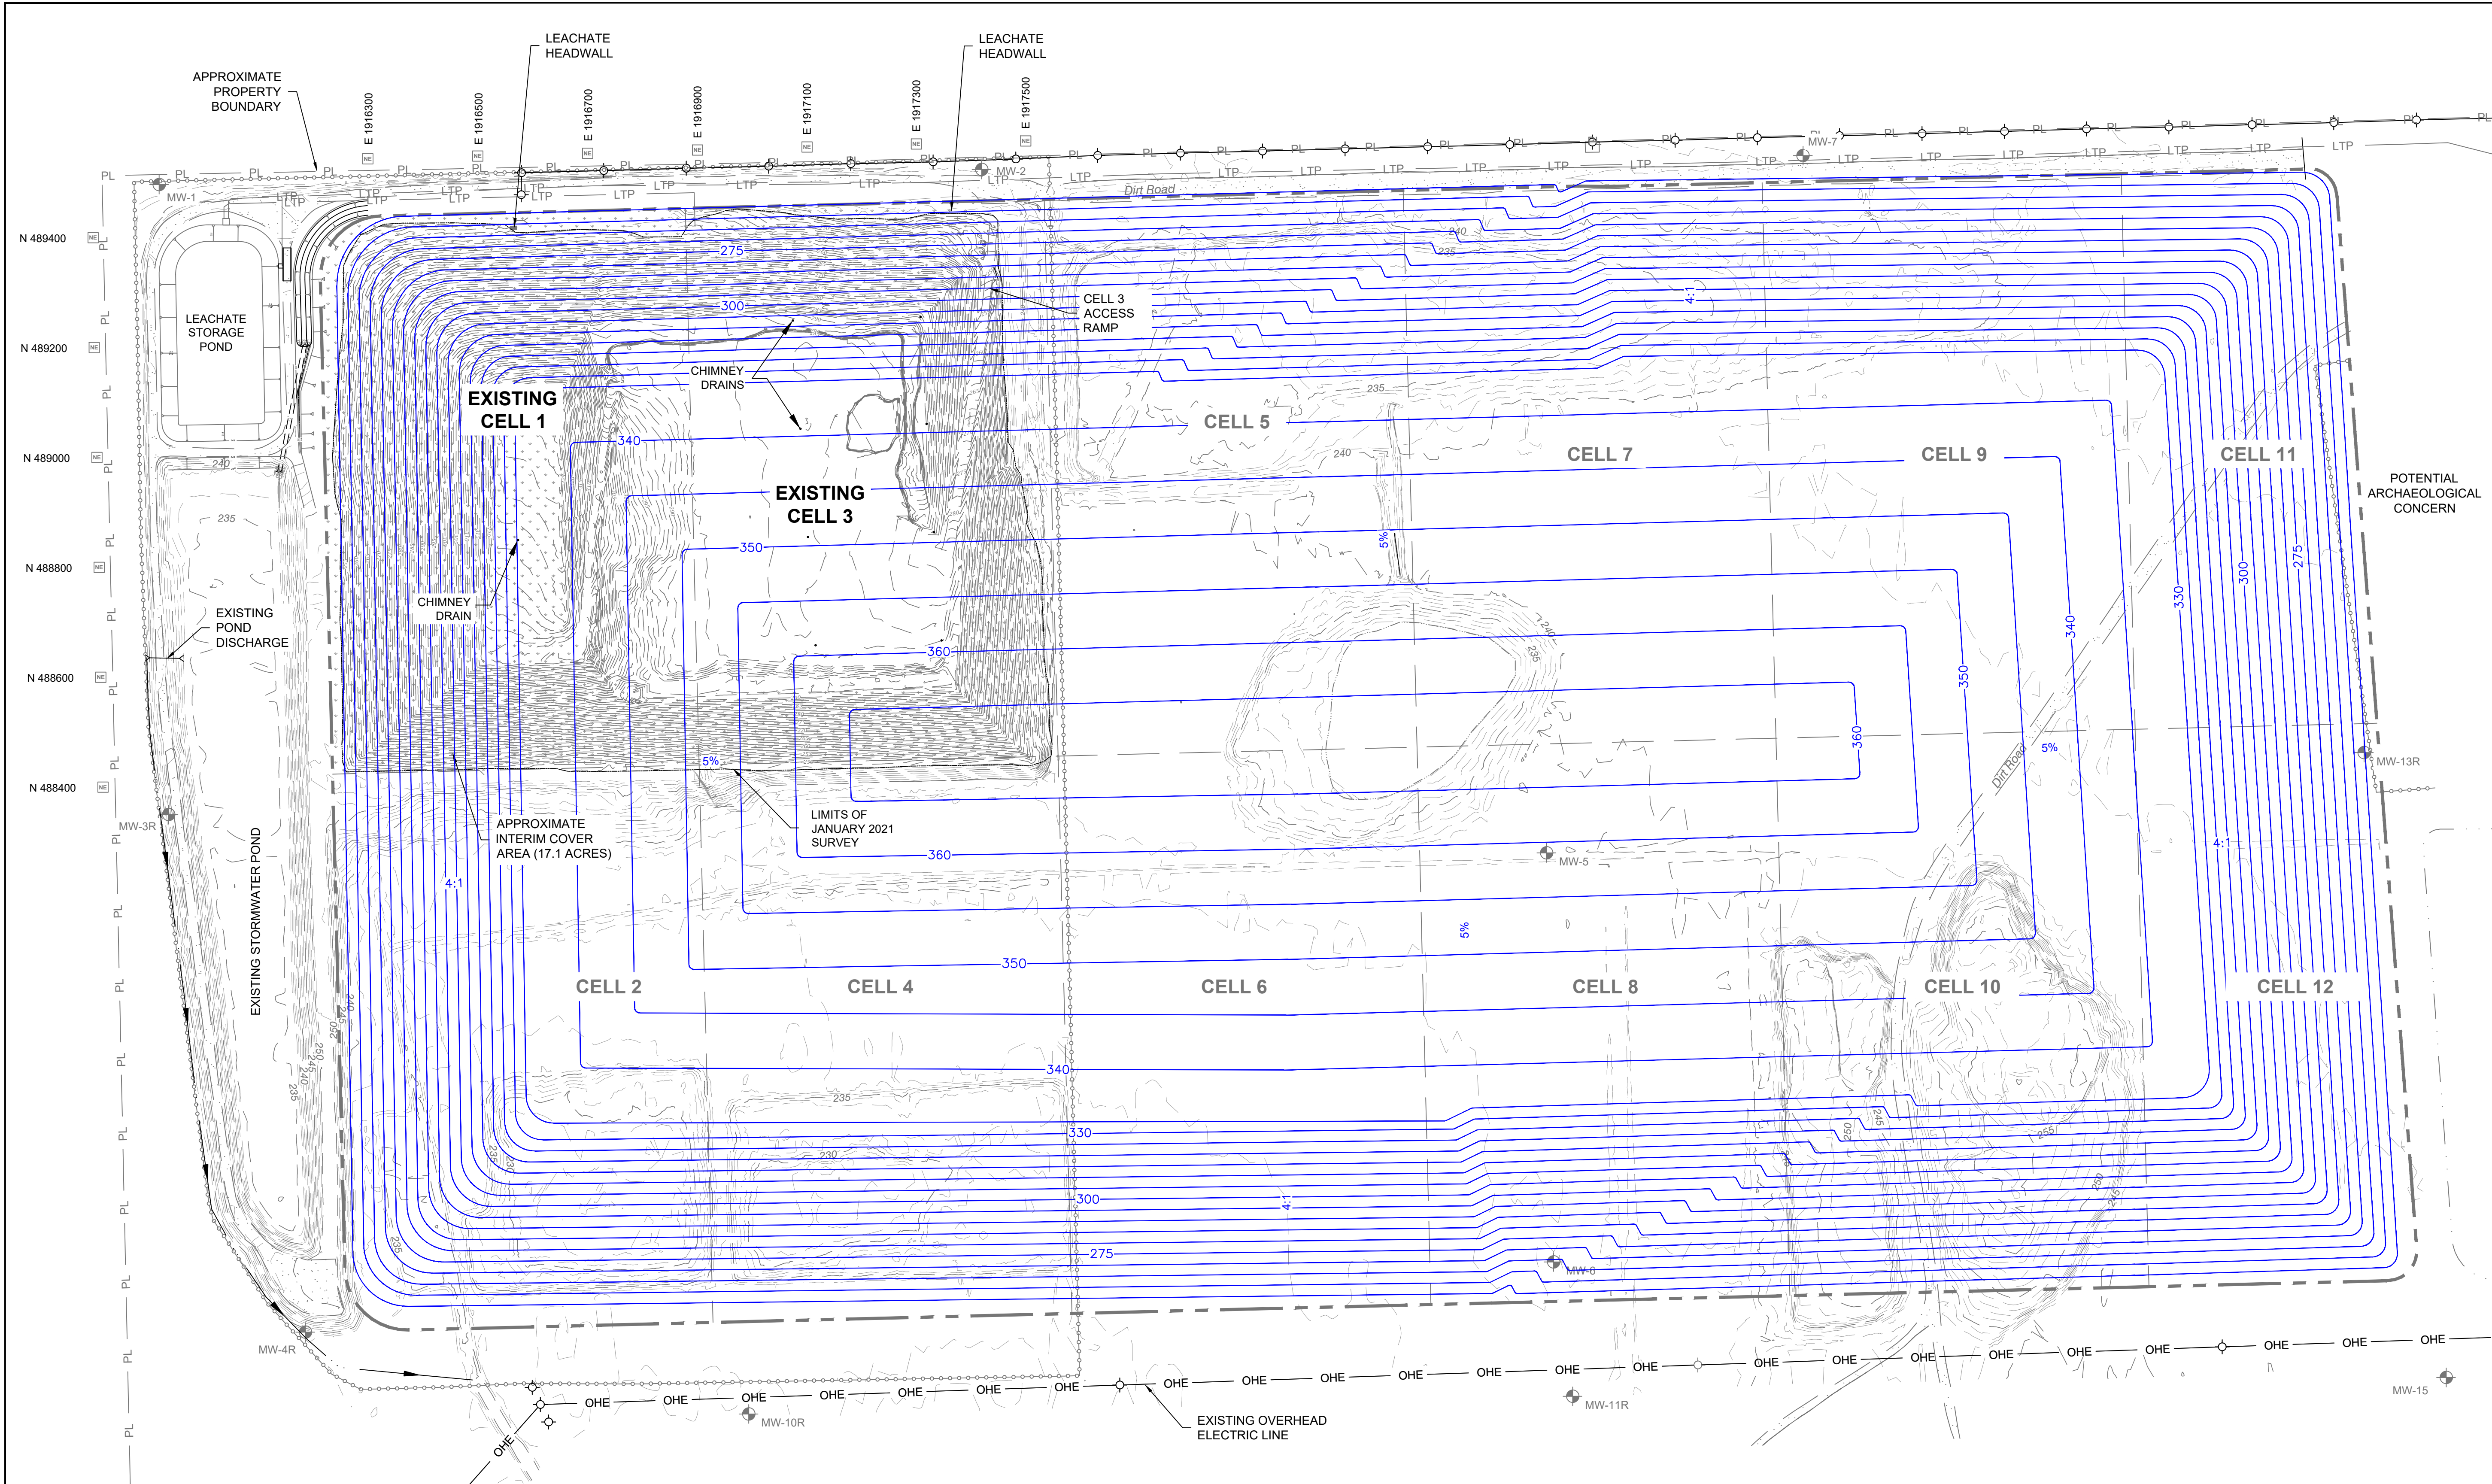
As noted, no final cover system has been installed on Waste Cells 1 and 3. Figure 3 presents contours for the currently permitted final cover system.
