**2023 ANNUAL ENGINEERING
INSPECTION REPORT**

**PLUM POINT ENERGY STATION
CLASS 3N LANDFILL**

**PERMIT NO. 0303-S3N-R1
AFIN: 47-00461**

JANUARY 19, 2024

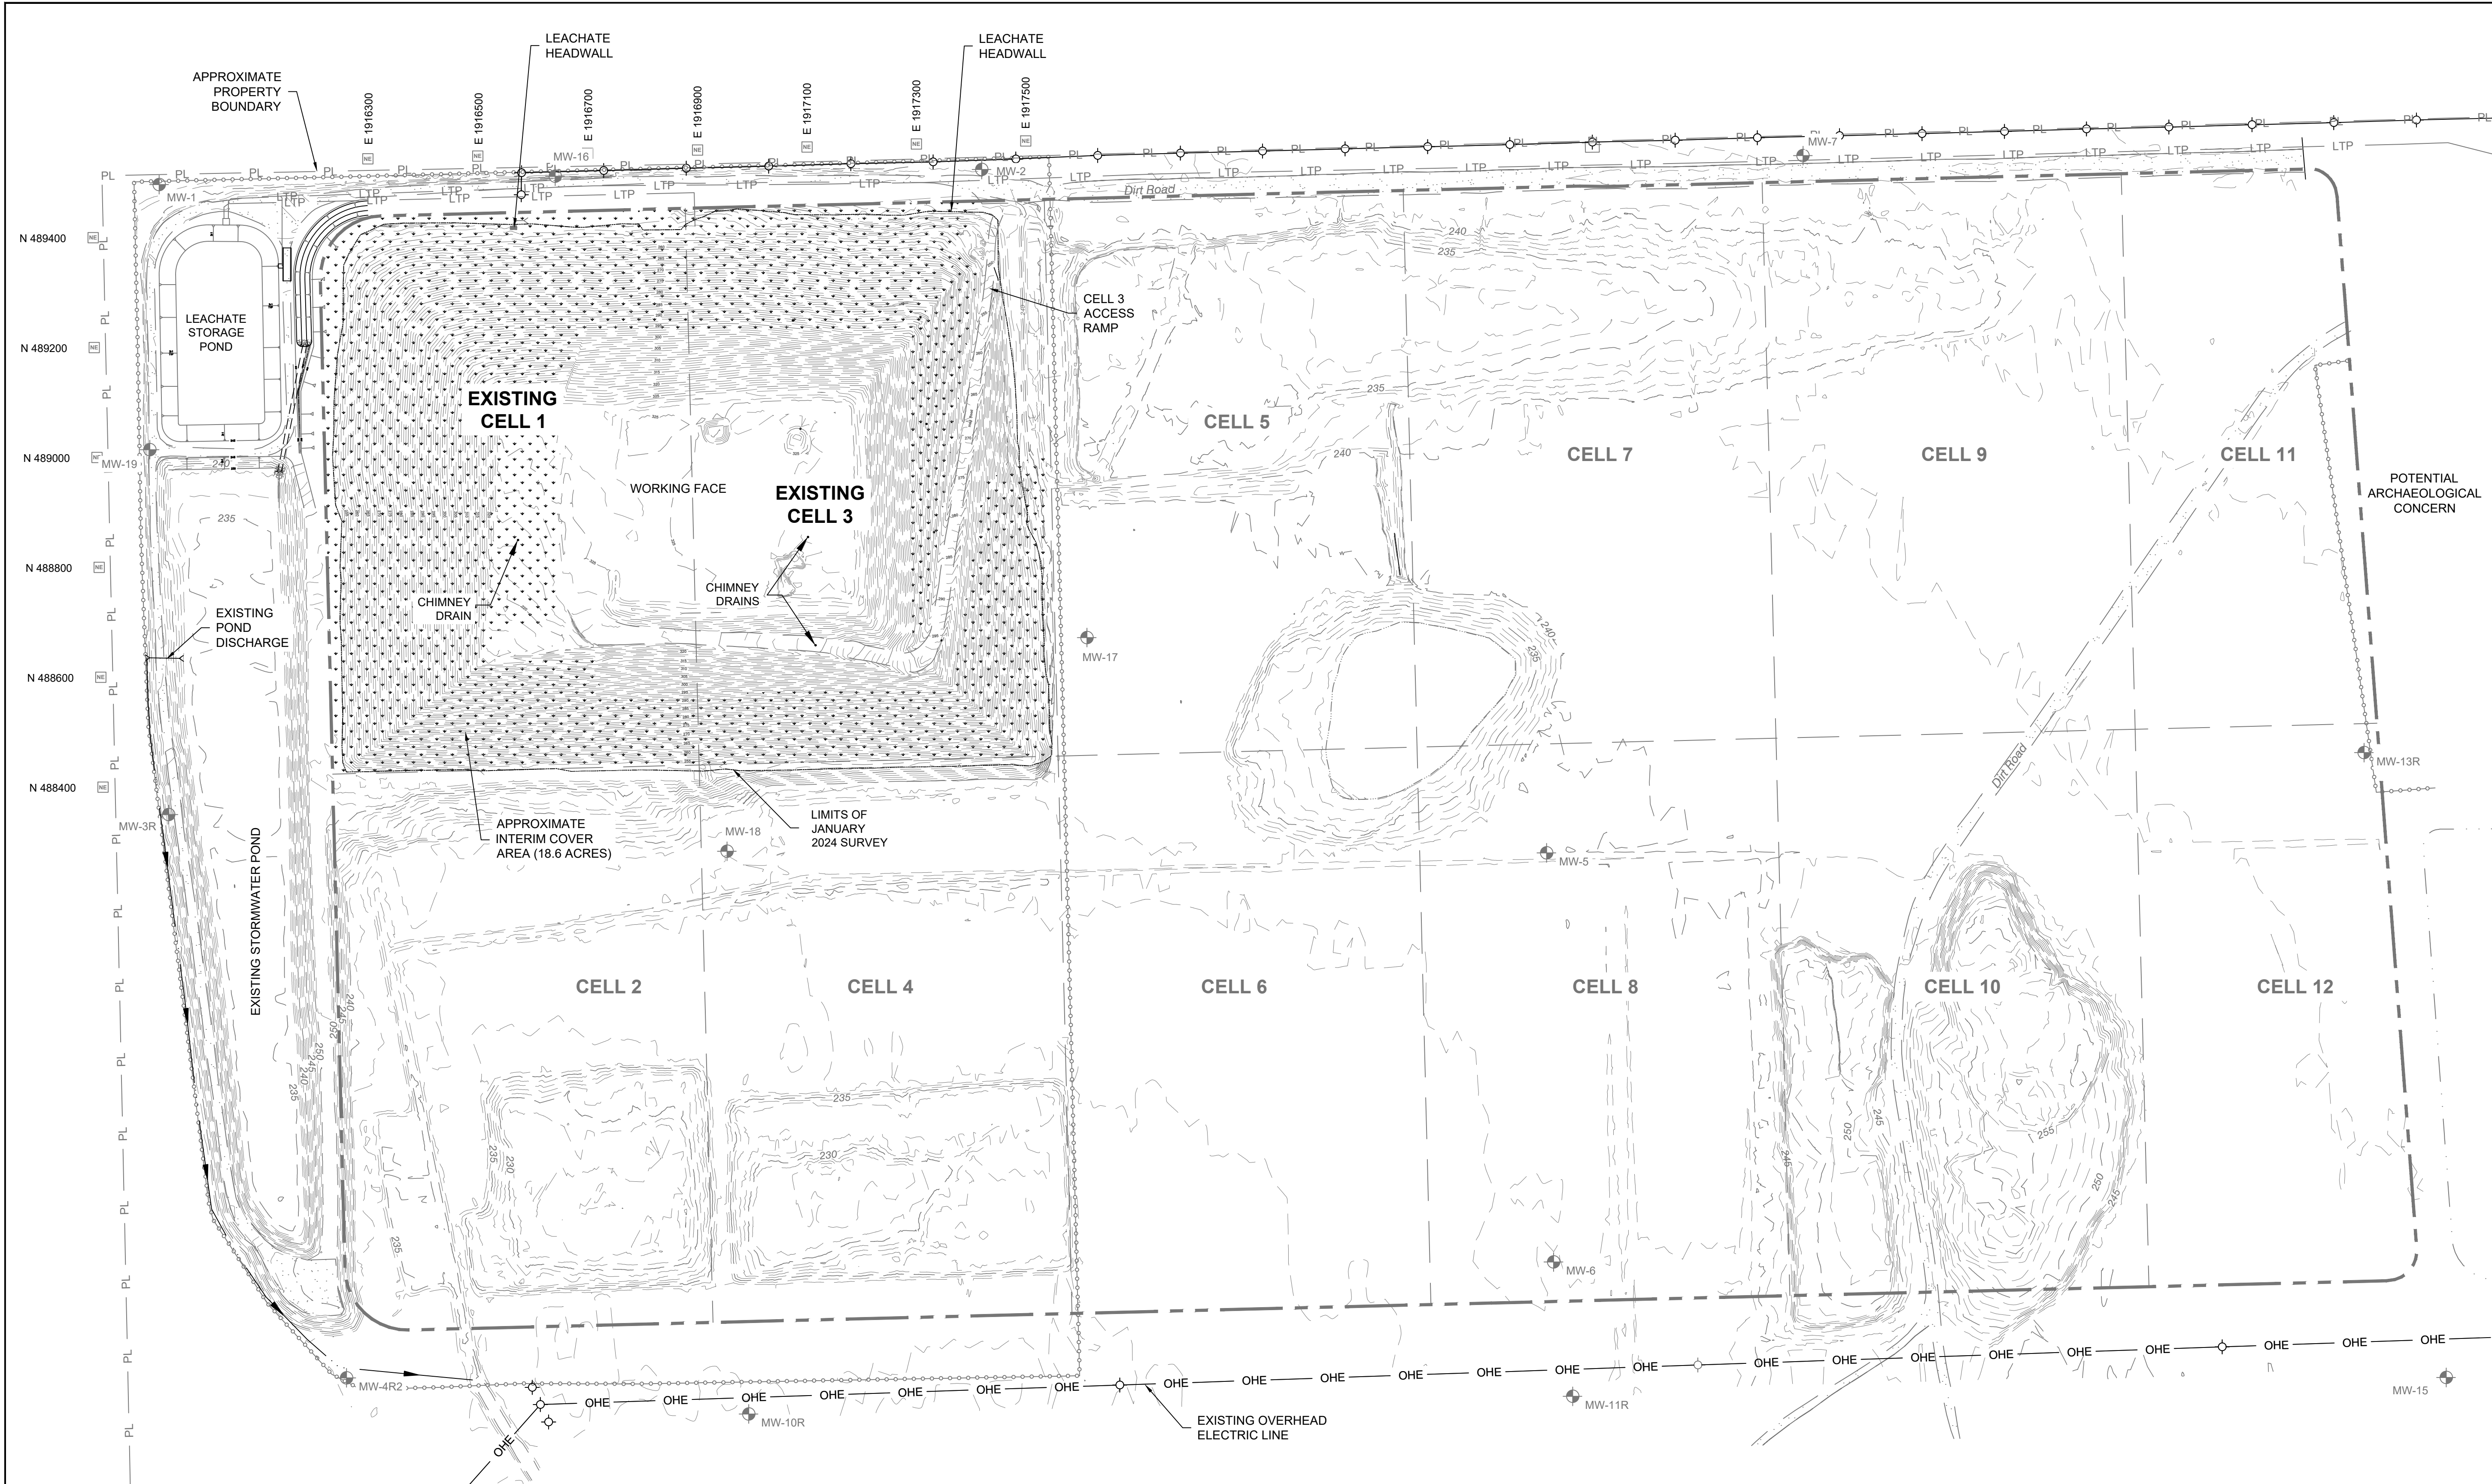
FIGURE 2
EXISTING CONDITIONS

No final cover system has been installed on Waste Cells 1 or 3. However, as shown on Figure 2, the side slopes of Cells 1 and 3 have received interim soil cover as they reach final waste grades.

Both active cells remain open. Interim cover soil has been placed on the completed slopes of Cells 1 and 3, as noted above.
