# **2015 ANNUAL ENGINEERING INSPECTION REPORT**

## **PLUM POINT ENERGY STATION CLASS 3N LANDFILL**

**PERMIT NO. 0303-S3N  
AFIN: 47-00461**

**JANUARY 15, 2016**

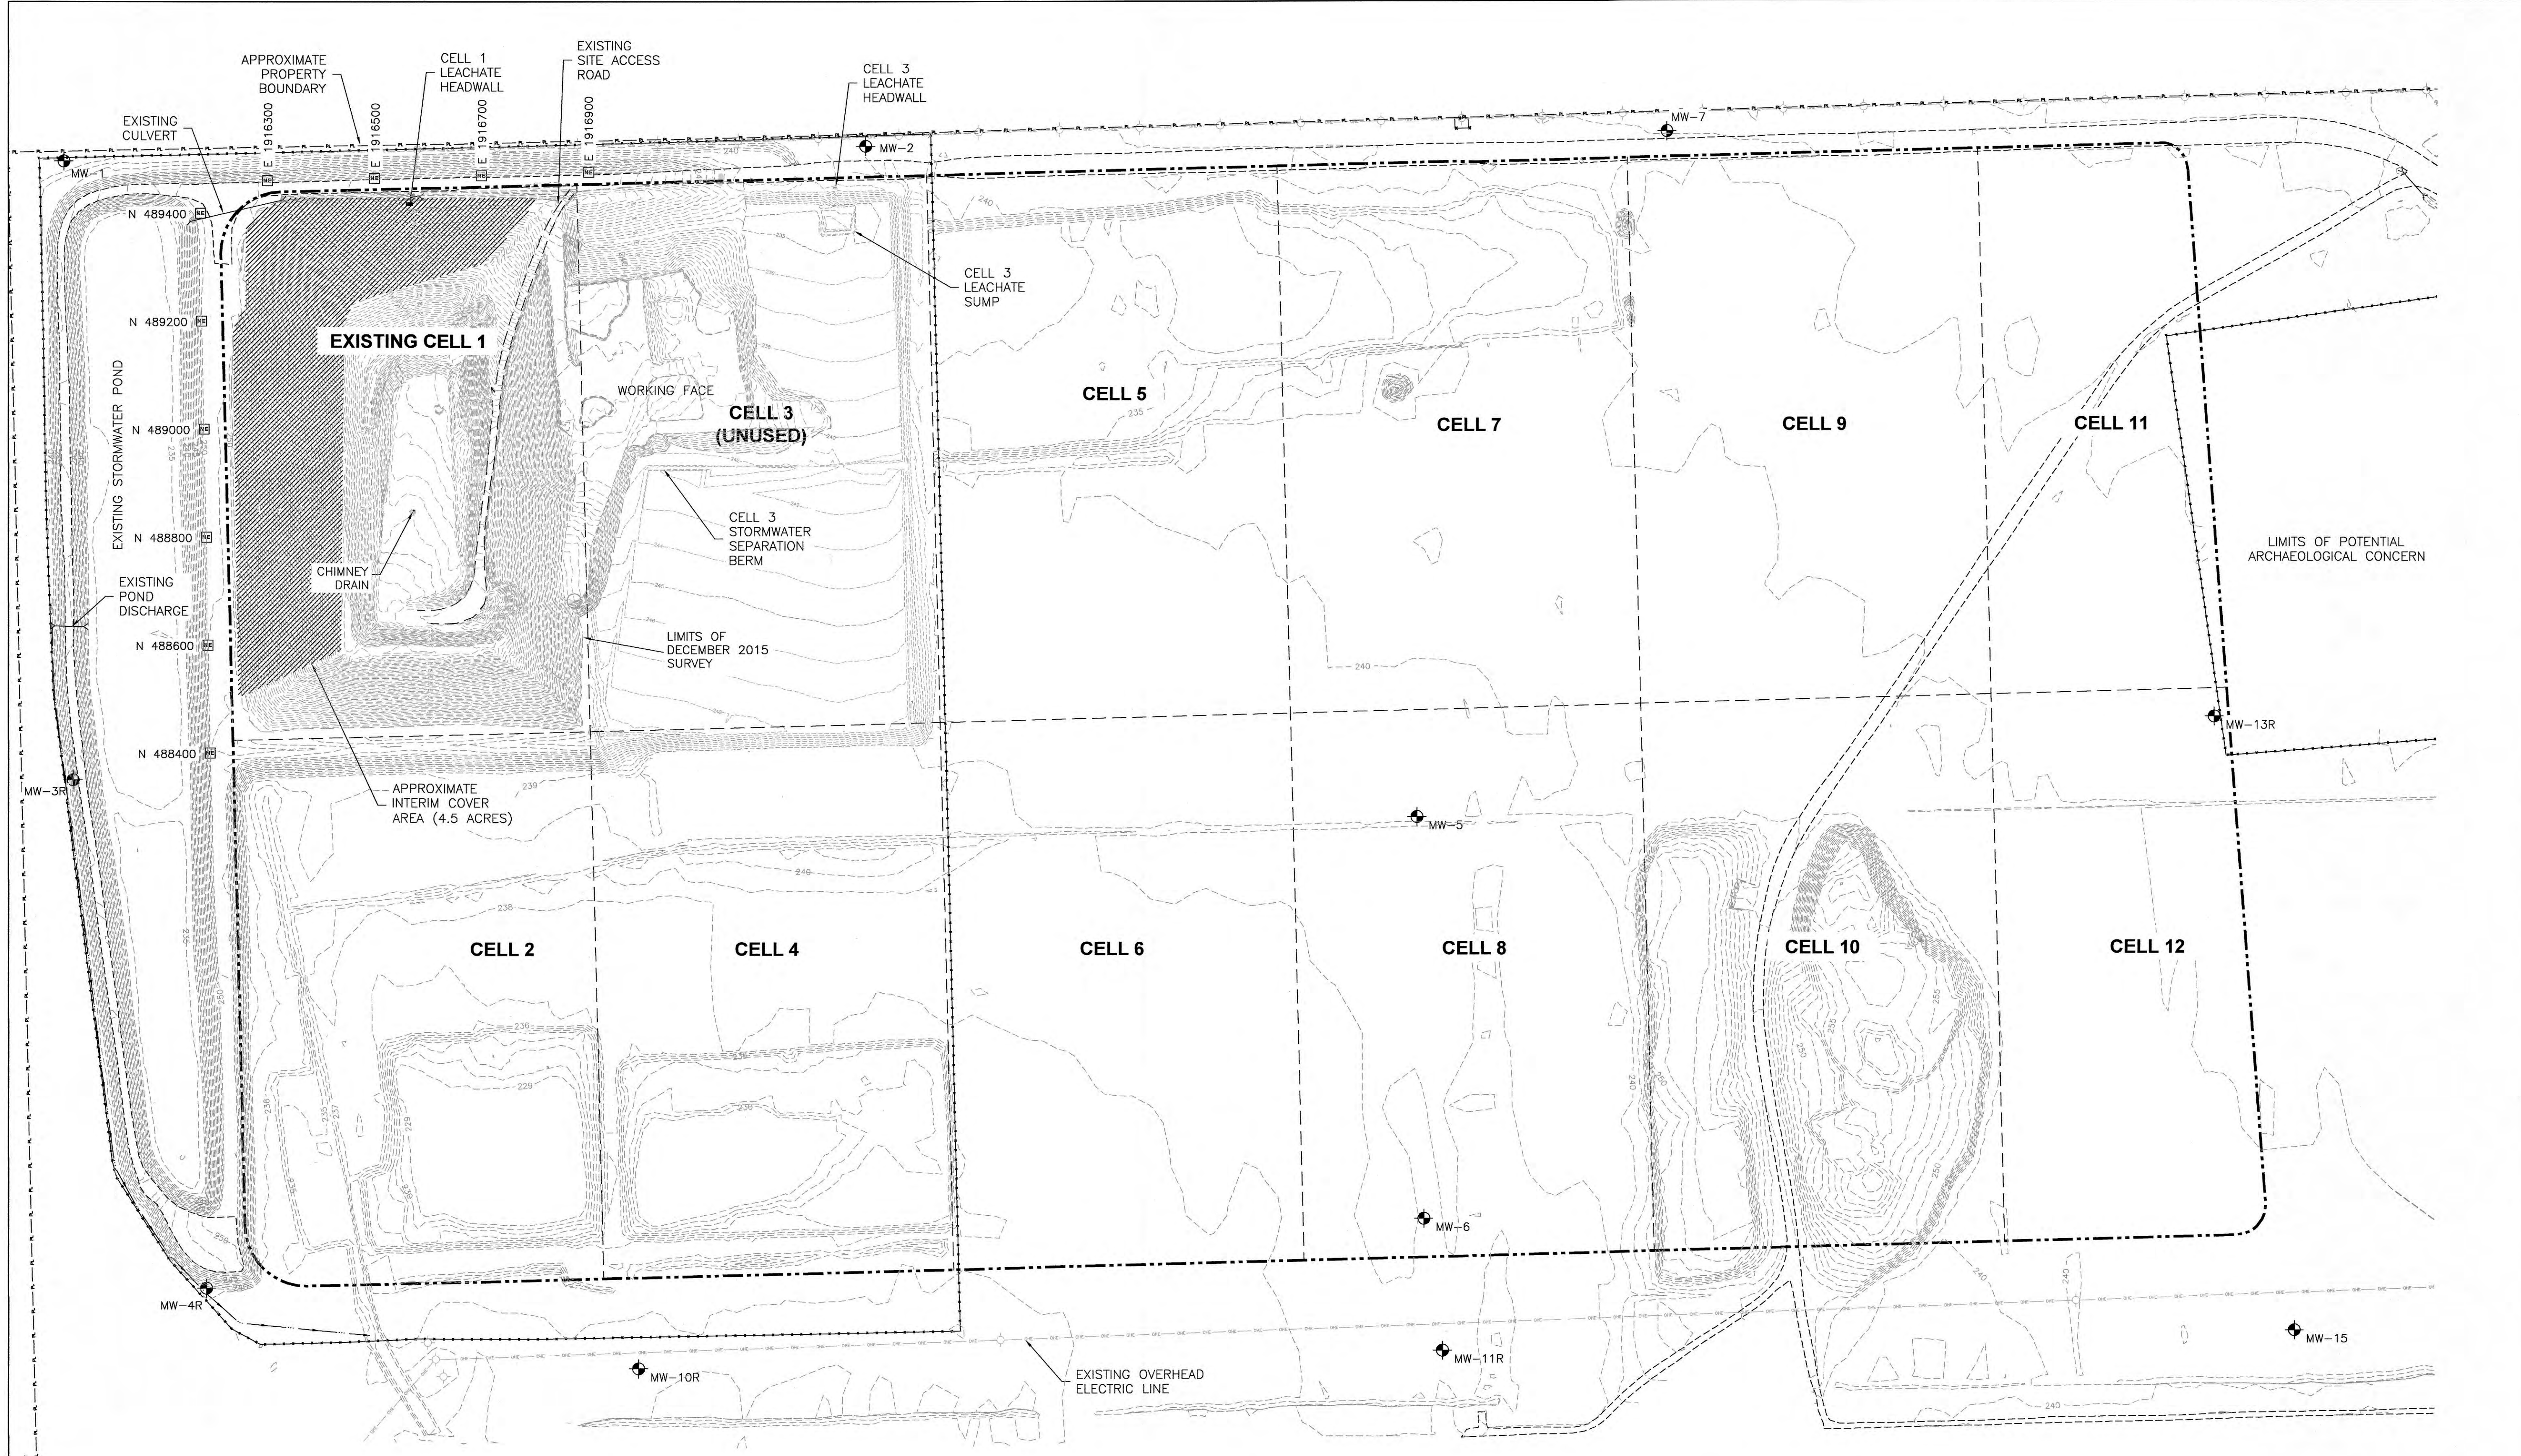
**FIGURE 2**  
**EXISTING CONDITIONS**

No final cover system has been installed on Waste Cells 1 and 3. However, as shown on Figure 1, the west, north, and south slopes of Cell 1 have received interim soil cover.

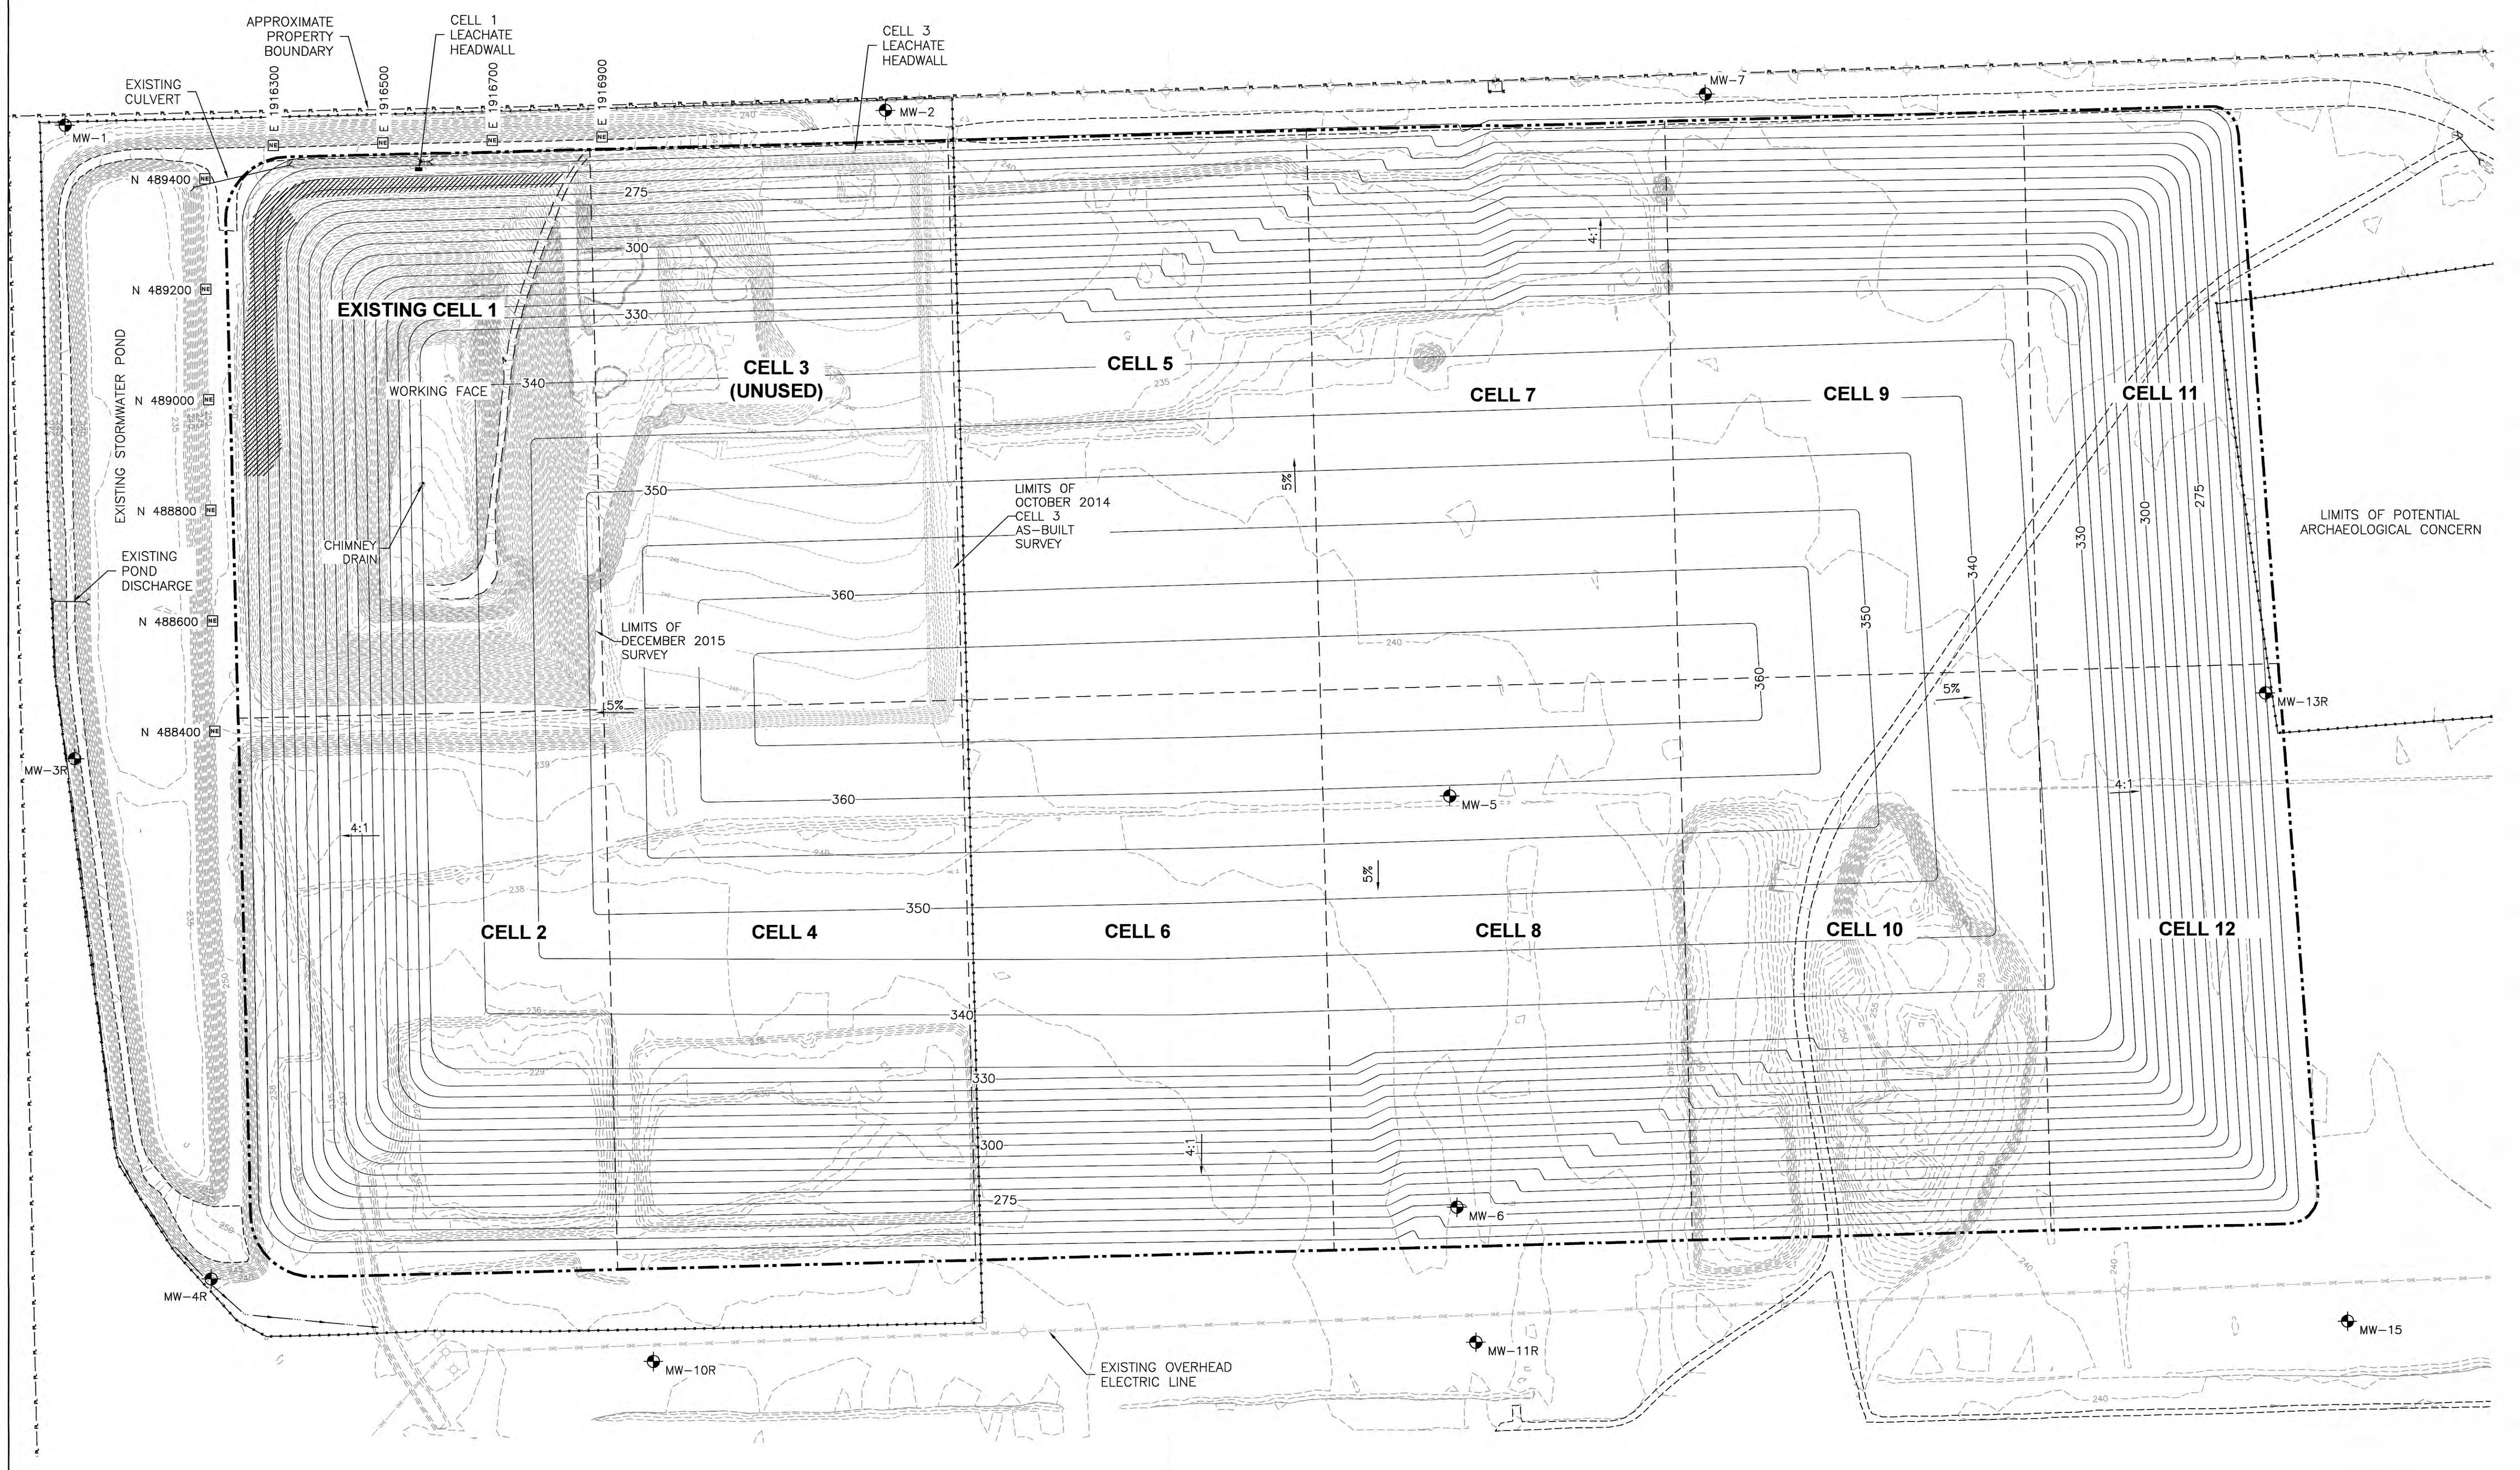
As noted, no final cover system has been installed on Waste Cells 1 and 3. Figure 3 presents contours for the currently permitted final cover system.
