2021 ANNUAL ENGINEERING INSPECTION REPORT

PLUM POINT ENERGY STATION CLASS 3N LANDFILL

**PERMIT NO. 0303-S3N
AFIN: 47-00461**

FTN No. R14590-2796-001

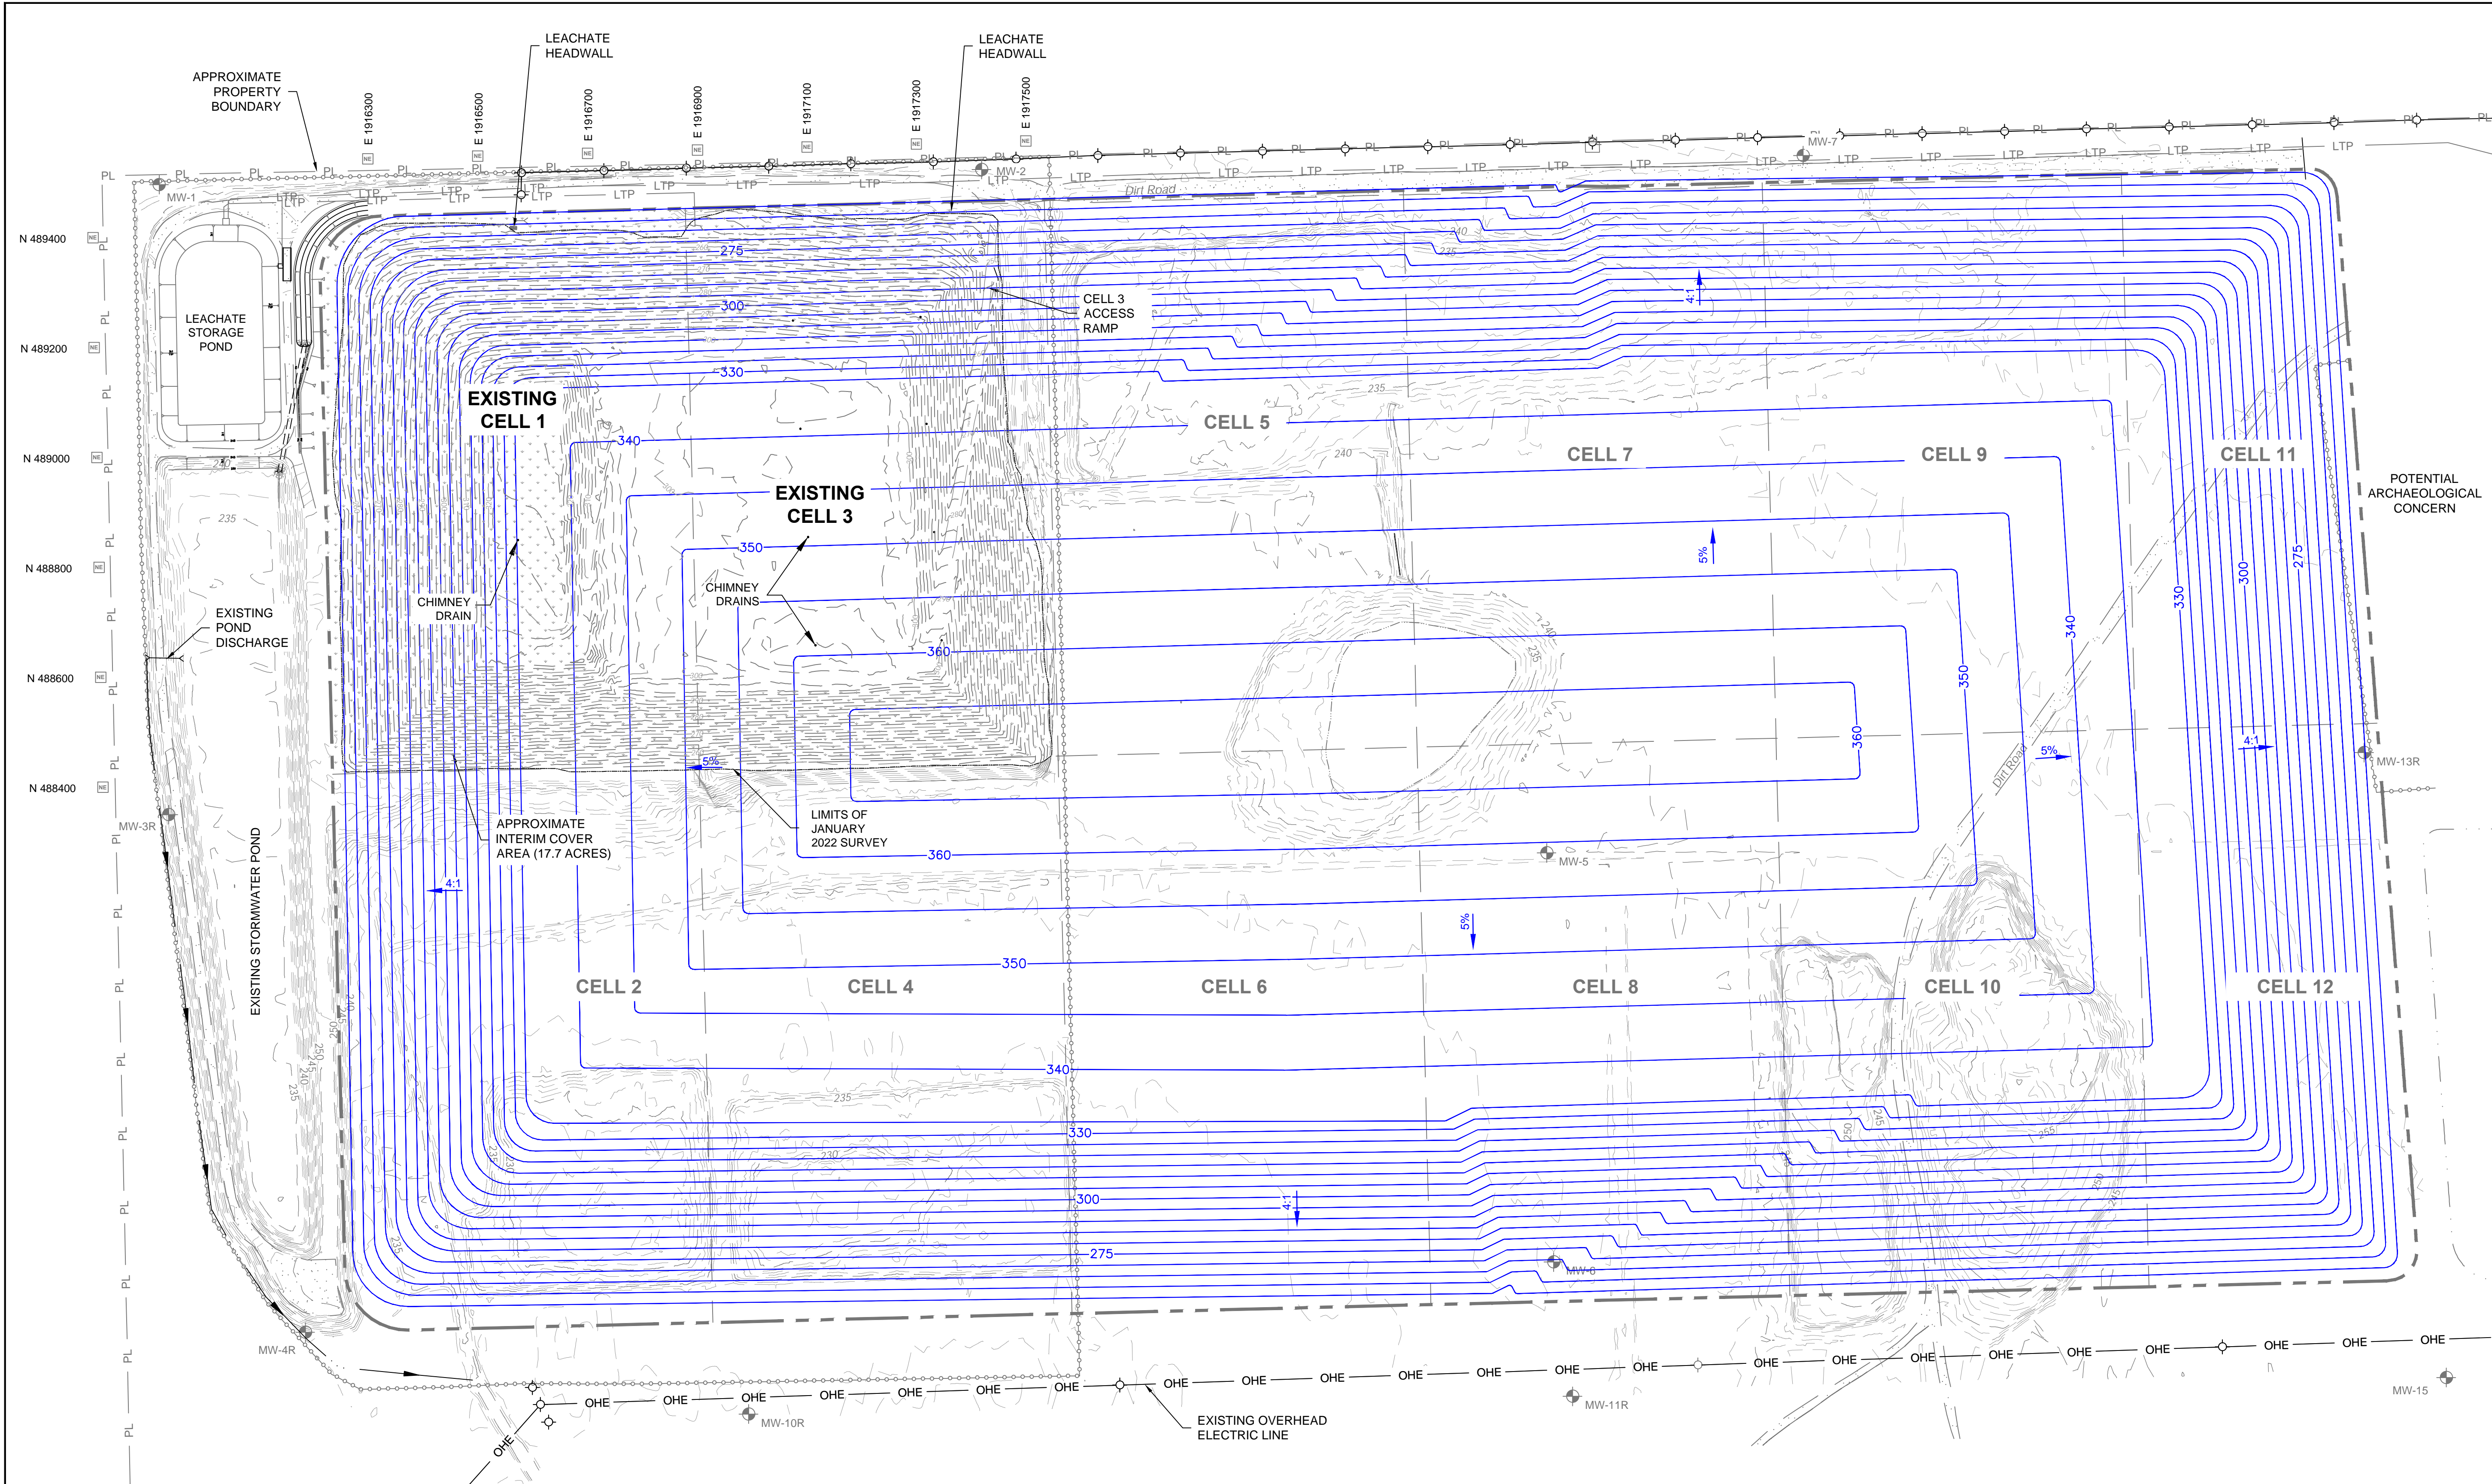
FIGURE 3
PERMITTED FINAL COVER

As noted, no final cover system has been installed on Waste Cells 1 and 3. Figure 3 presents contours for the currently permitted final cover system.
