**NRG TEXAS POWER LLC
W. A. PARISH GENERATING STATION, UNITS 5, 6, 7, & 8**

**ANNUAL INSPECTION OF CCR LANDFILL CELLS
SUPPORTING DOCUMENT**

S&L Project No.: 12661-073

Date: January 12, 2018

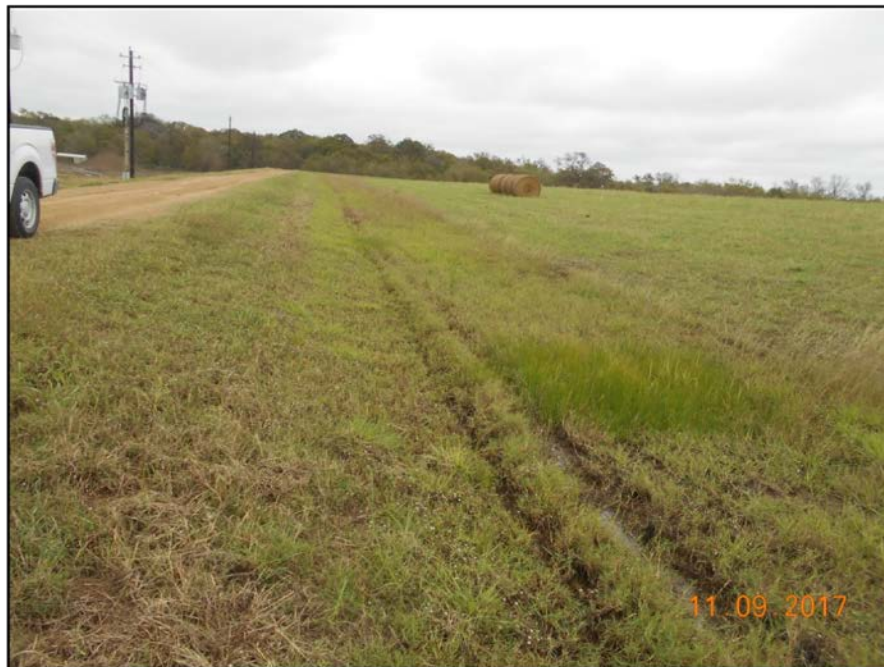
Photograph P-14 – Taken November 9, 2017 by David E. Nielson
Landfill Cell 2A: Looking east along the crest and outside slope of southern dike.

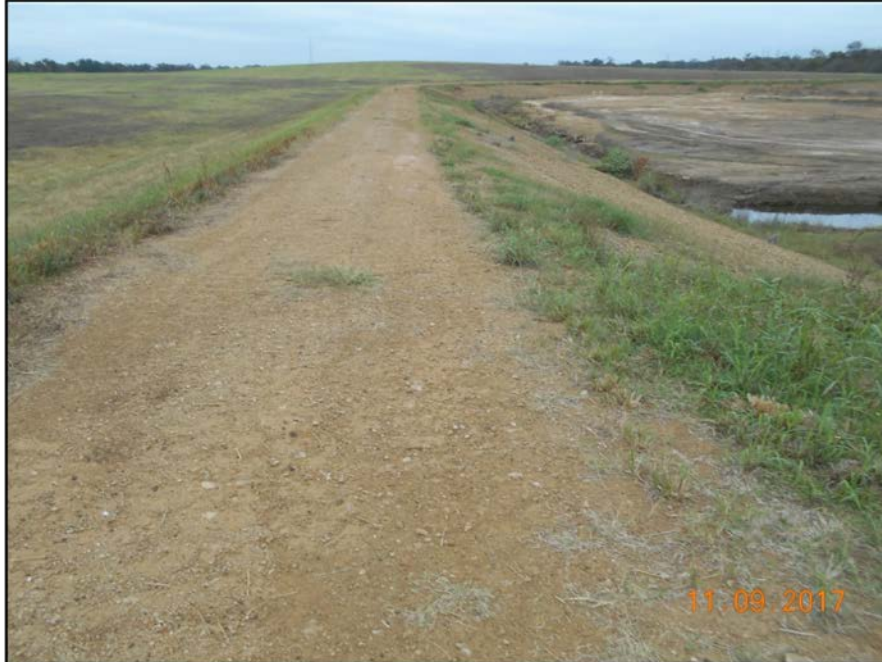
Photograph P-15 – Taken November 9, 2017 by David E. Nielson
Landfill Cell 2A: Looking north along the crest of the western berm.

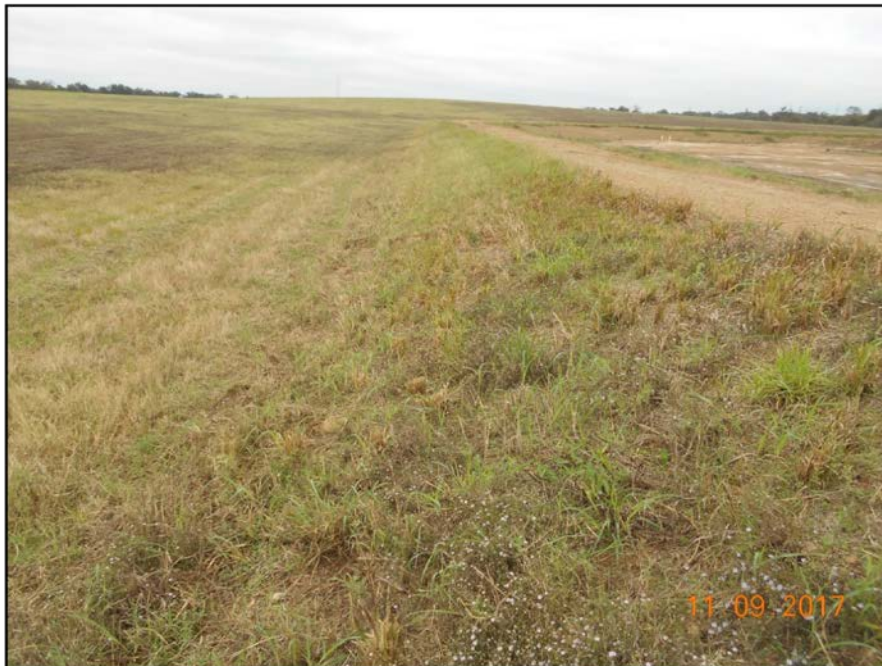
Photograph P-16 – Taken November 9, 2017 by David E. Nielson
Landfill Cell 2A: Looking north along the outside slope and crest of the western berm.

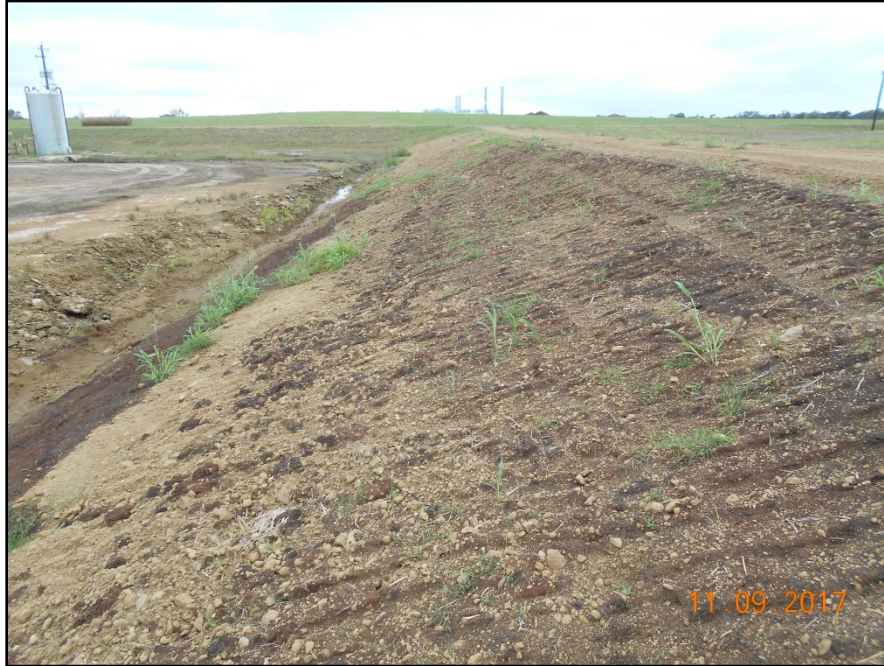
Photograph P-17 – Taken November 9, 2017 by David E. Nielson
Landfill Cell 2A: Looking south along the inside slope of western berm.

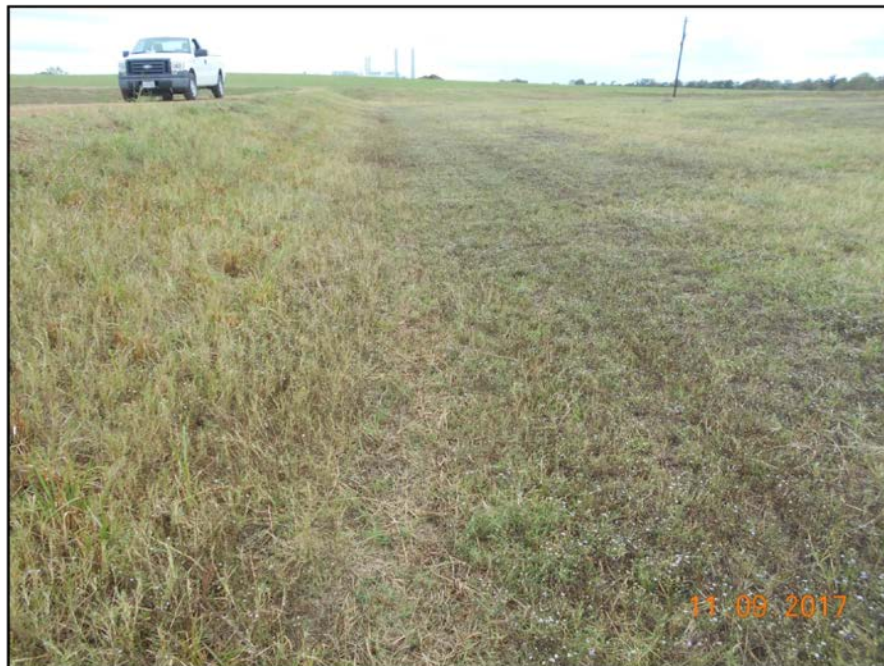
Photograph P-18 – Taken November 9, 2017 by David E. Nielson
Landfill Cell 2A: Looking south along the outside slope of the western berm.

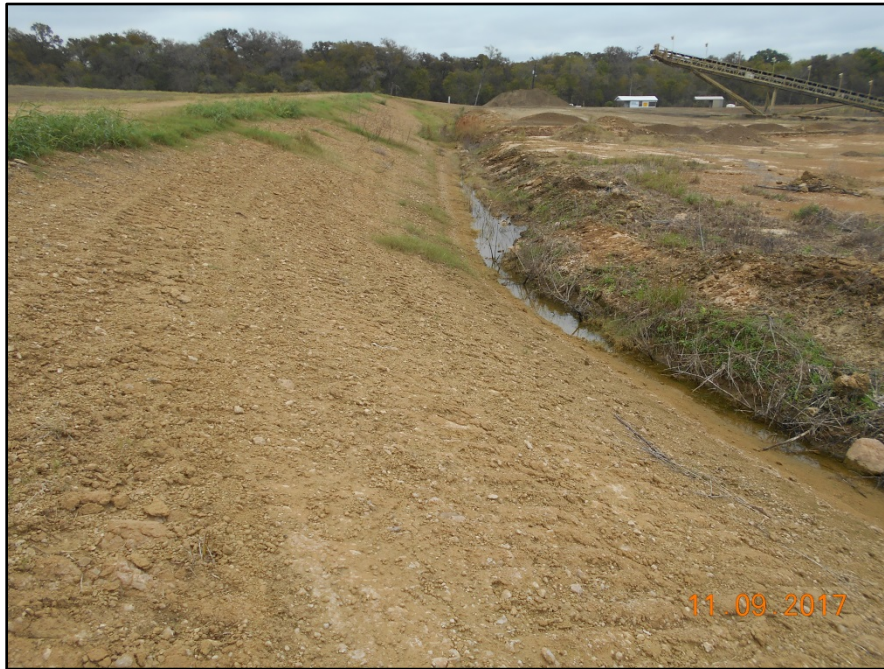
Photograph P-19 – Taken November 9, 2017 by David E. Nielson
Landfill Cell 2A: Looking east along the inside slope of northern berm.

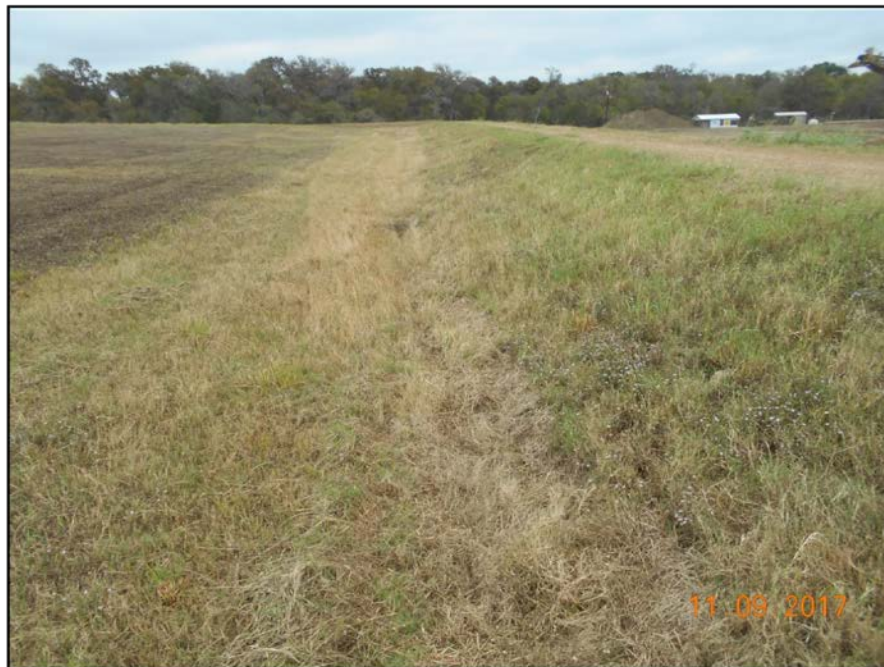
Photograph P-20 – Taken November 9, 2017 by David E. Nielson
Landfill Cell 2A: Looking east at outside slope of the northern berm.

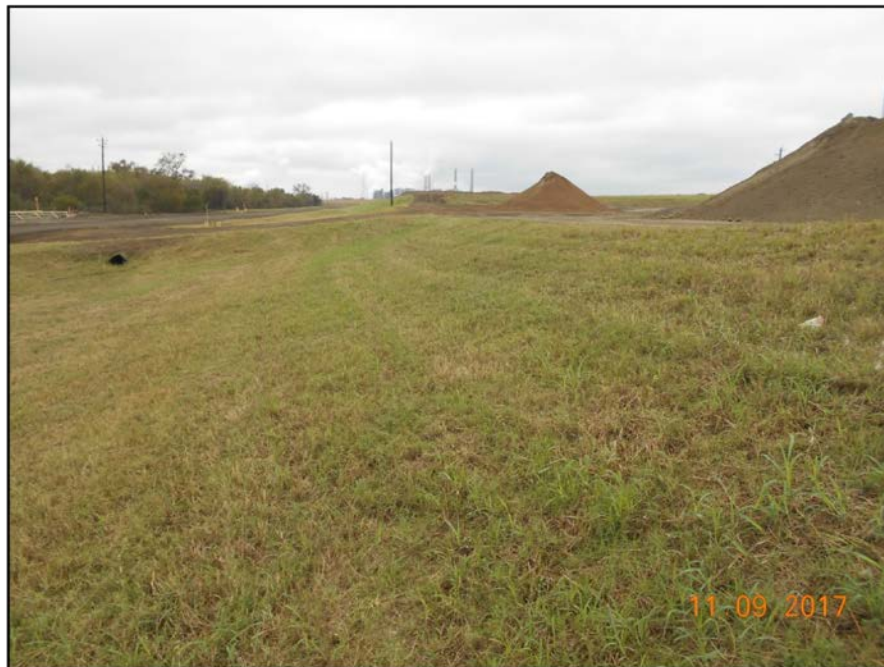
Photograph P-22 – Taken November 9, 2017 by David E. Nielson
Landfill Cell 2A: Looking south along the outside slope of the eastern berm.

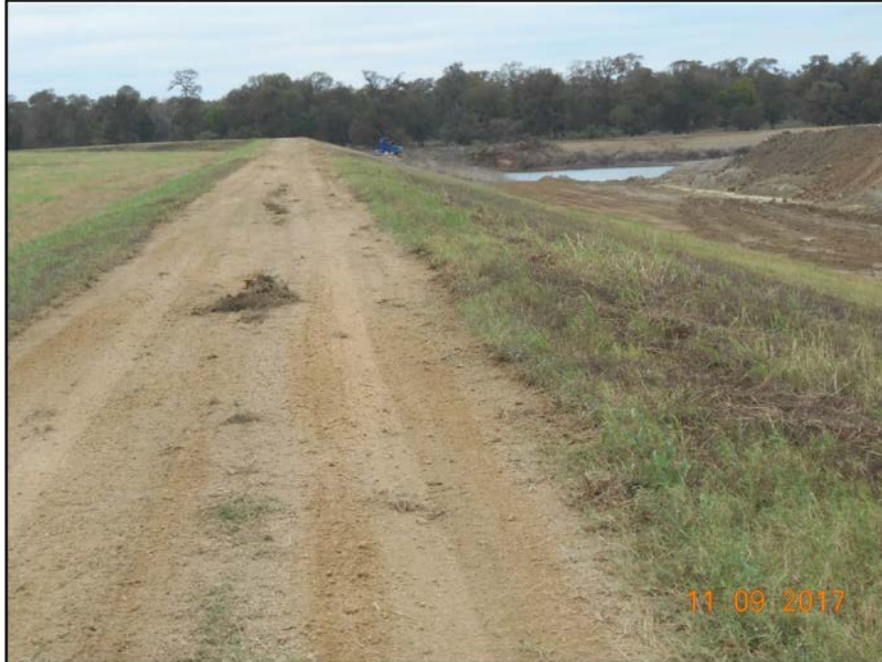
Photograph P-24 – Taken November 9, 2017 by David E. Nielson
Landfill Cell 1C: Looking west along the crest of the southern berm of the cell with a view of
the incised storm water pond.

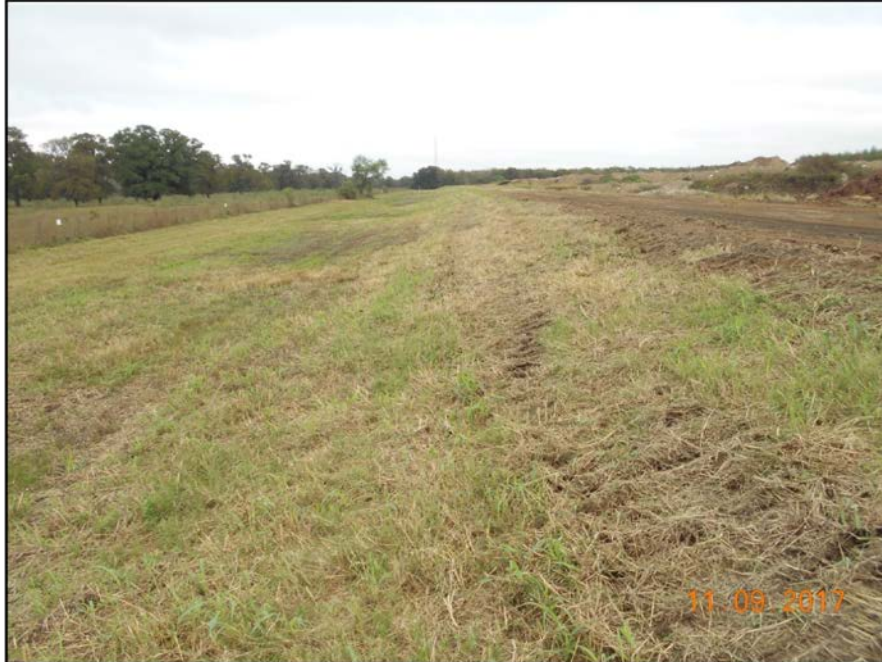
The outside slopes of the perimeter berms are shown in Photographs P-25, P-28, P-31, and P-33. These slopes typically exhibited good alignment and grades. No significant adverse conditions were identified for the outside slopes of the perimeter berm.

Photograph P-28 – Taken November 9, 2017 by David E. Nielson
Landfill Cell 1C: Looking north along outside slope of western berm of the landfill cell.

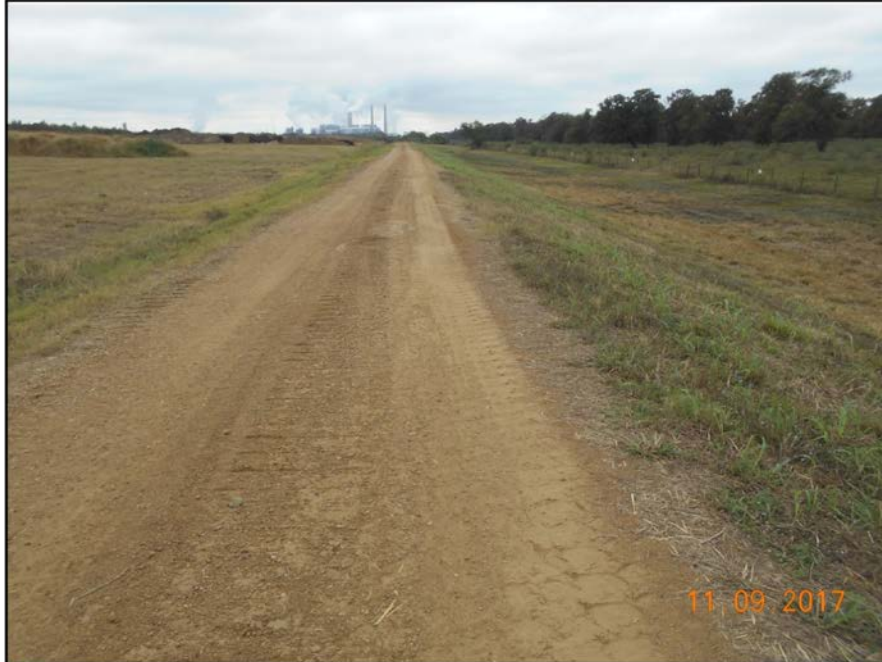
Photograph P-30 – Taken November 9, 2017 by David E. Nielson
Landfill Cell 1C: Looking south along the crest of the western berm.

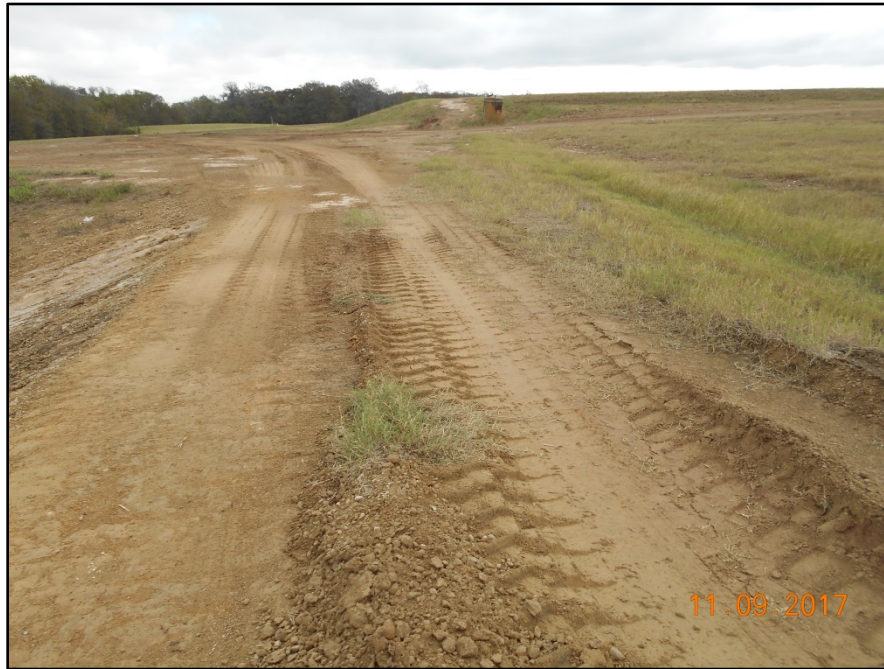
Photograph P-32 – Taken November 9, 2017 by David E. Nielson
Landfill Cell 1C: Looking east along the crest of slope of the northern berm.

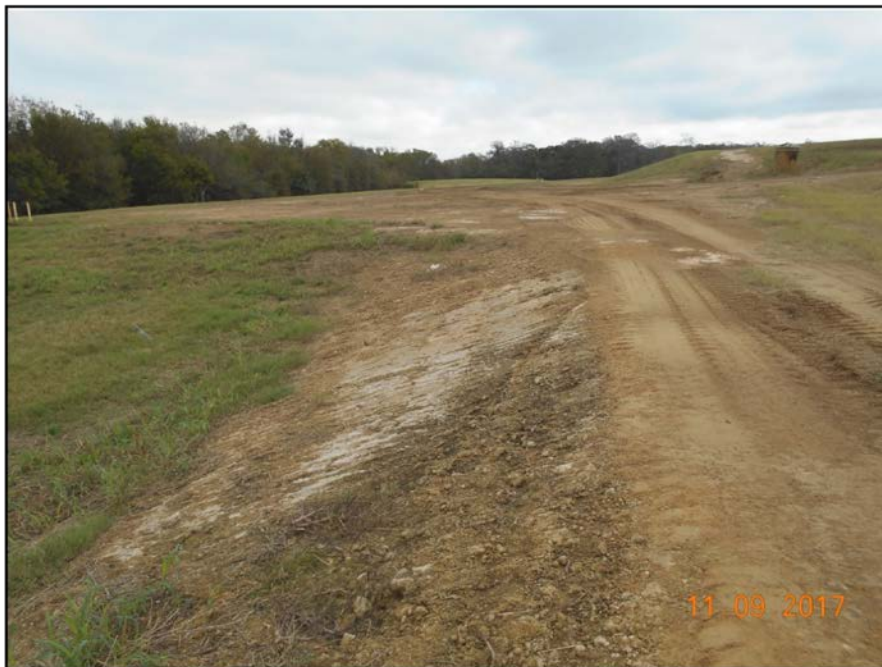
Photograph P-33 – Taken November 9, 2017 by David E. Nielson
Landfill Cell 1C: Looking east along the outside slope of the northern berm.

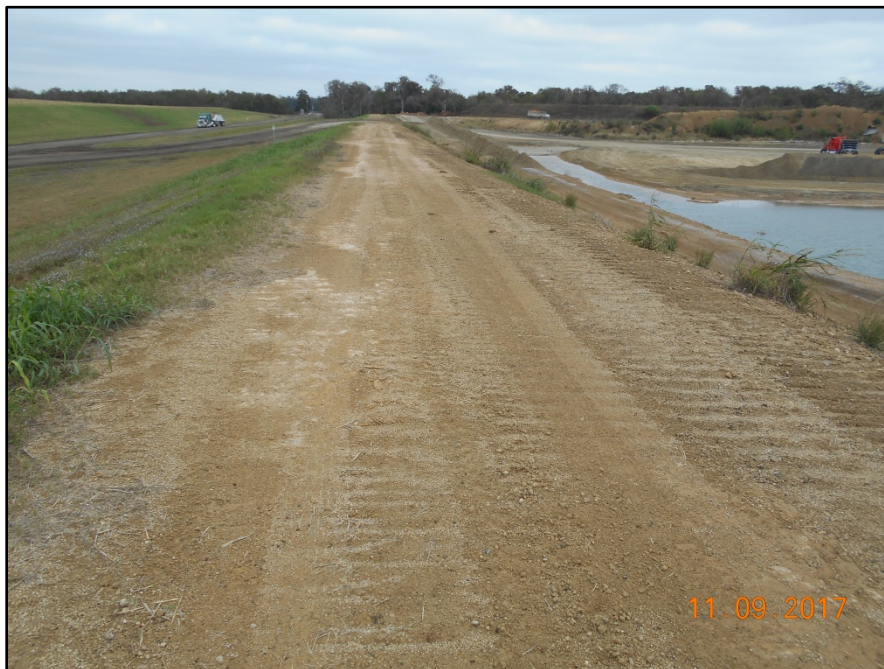
The crest of the berms and dikes around Cell 2B are generally free of rutting and misalignment as shown in Photographs P-36, P-38, P-41, and P-51. The berm crest and roadway surface are well maintained and considered to be in good to excellent condition.

Photograph P-36 – Taken November 9, 2017 by David E. Nielson
Landfill Cell 2B: Looking north along crest of western berm.

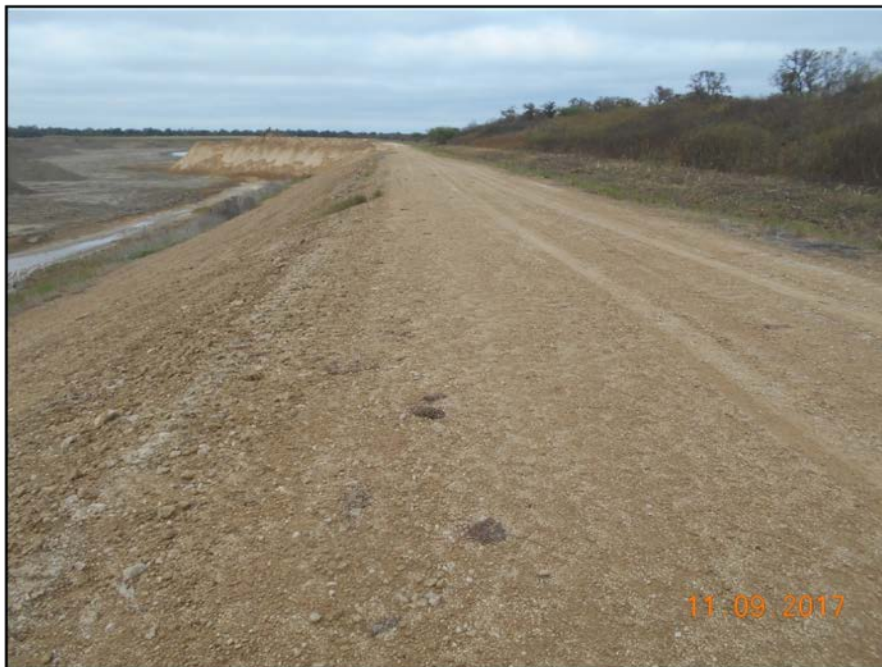
Photograph P-38 – Taken November 9, 2017 by David E. Nielson
Landfill Cell 2B: Looking west along the crest of the northern berm and the soil stockpile
(north of berm).

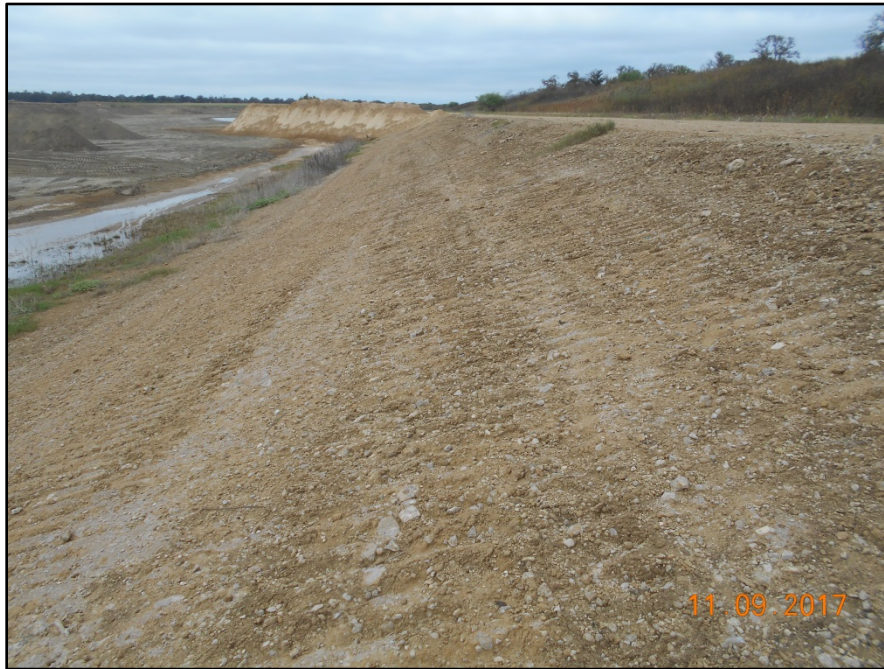
Photograph P-39 – Taken November 9, 2017 by David E. Nielson
Landfill Cell 2B: Looking west along the inside slope of the northern berm.

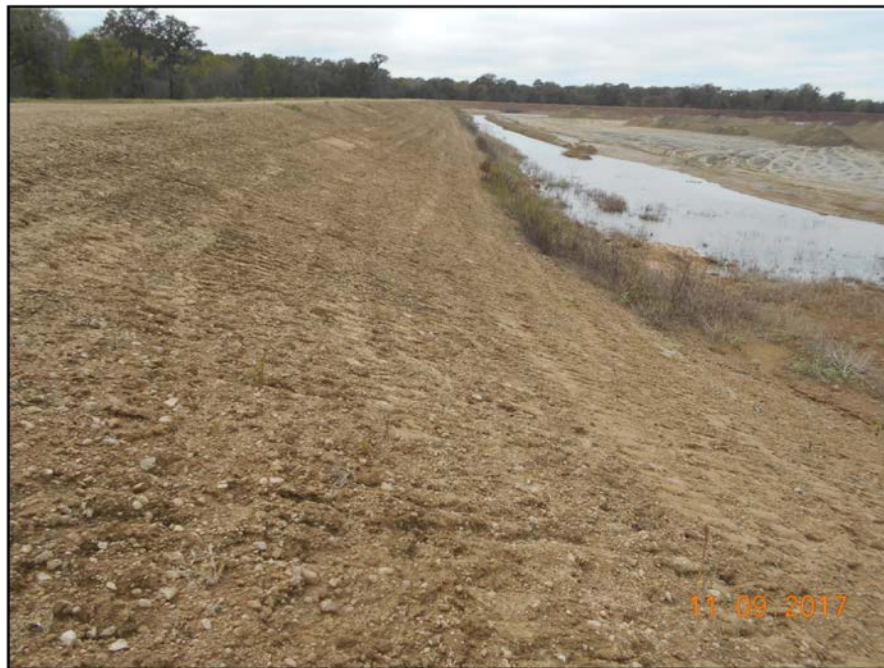
Photograph P-40 – Taken November 9, 2017 by David E. Nielson
Landfill Cell 2B: Looking south along the inside slope of the eastern berm.

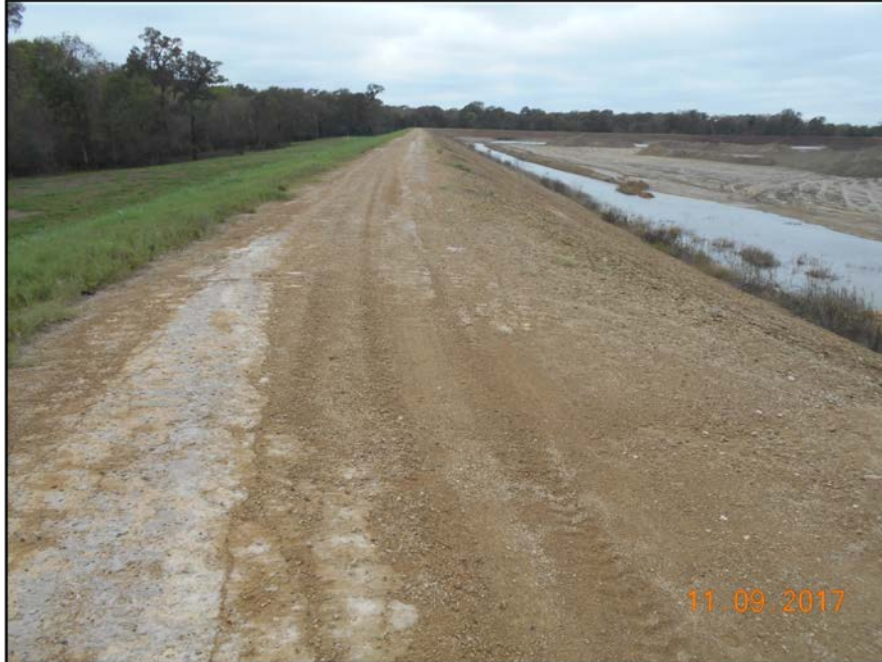
Photograph P-41 – Taken November 9, 2017 by David E. Nielson
Landfill Cell 2B: Looking south along the crest of the eastern berm.

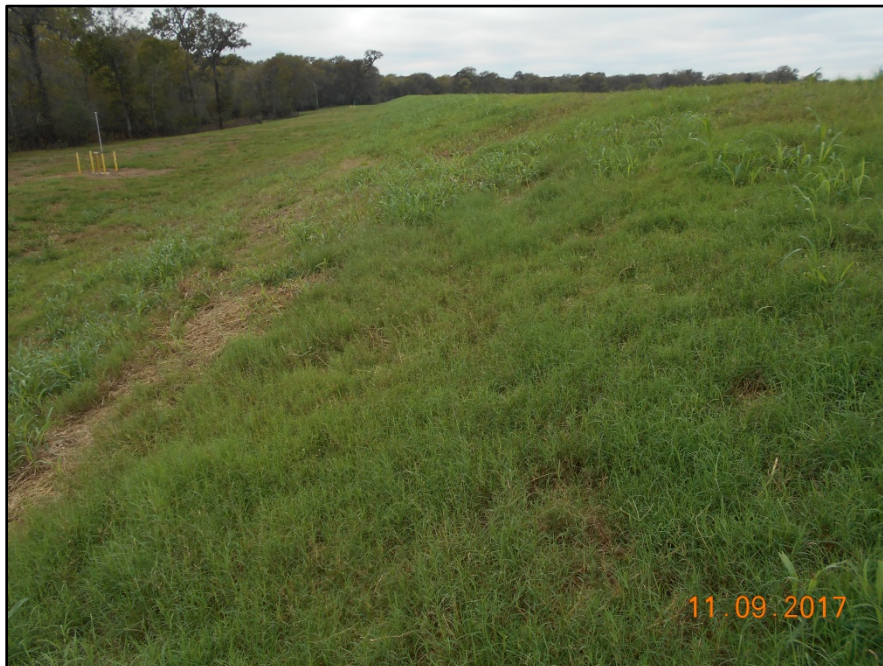
Photograph P-42 – Taken November 9, 2017 by David E. Nielson
Landfill Cell 2B: Looking south along the toe of the
outside slope of the eastern berm.

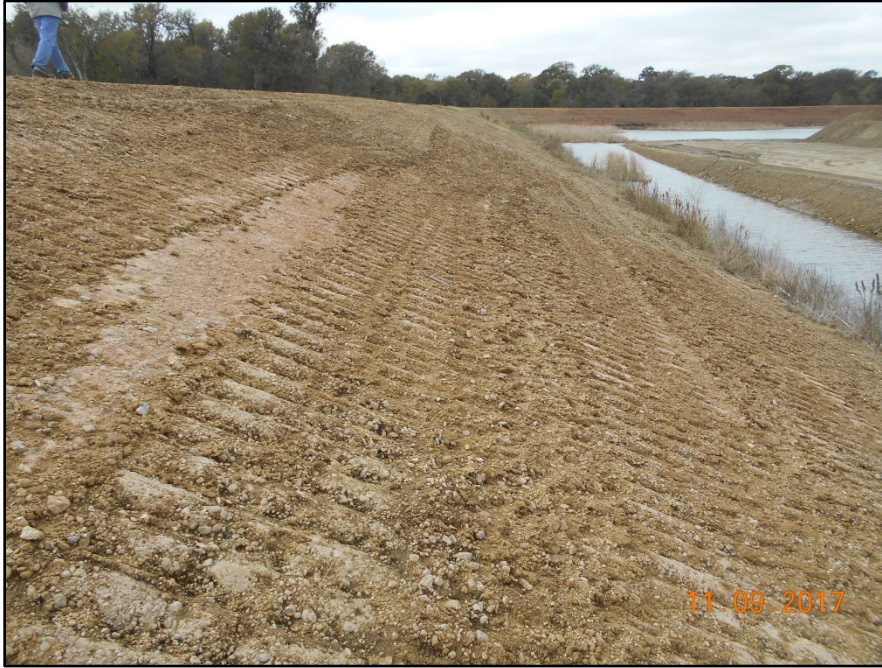
Photograph P-43 – Taken November 9, 2017 by David E. Nielson
Landfill Cell 2B: Looking south along the inside slope of the eastern landfill berm.

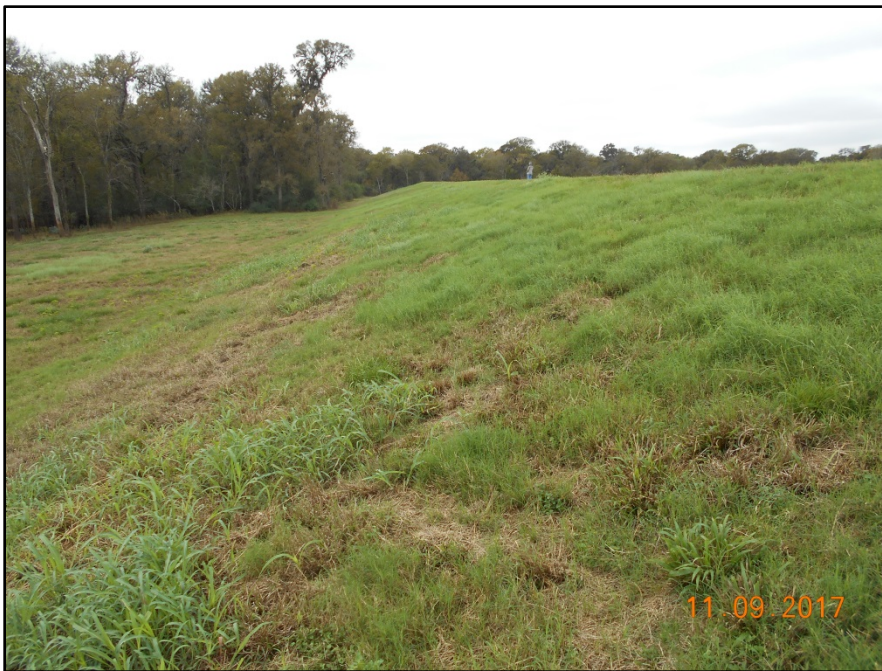
The outside slopes of the perimeter berms are shown in Photographs P-37, P-42, P-44, P-47, and P-52. These slopes typically exhibited good alignment, grades and vegetation. There were no observed indications of instability of the outside slopes of the perimeter berms and dikes.

Photograph P-44 – Taken November 9, 2017 by David E. Nielson
Landfill Cell 2B: Looking south along the
outside slope of the eastern berm.

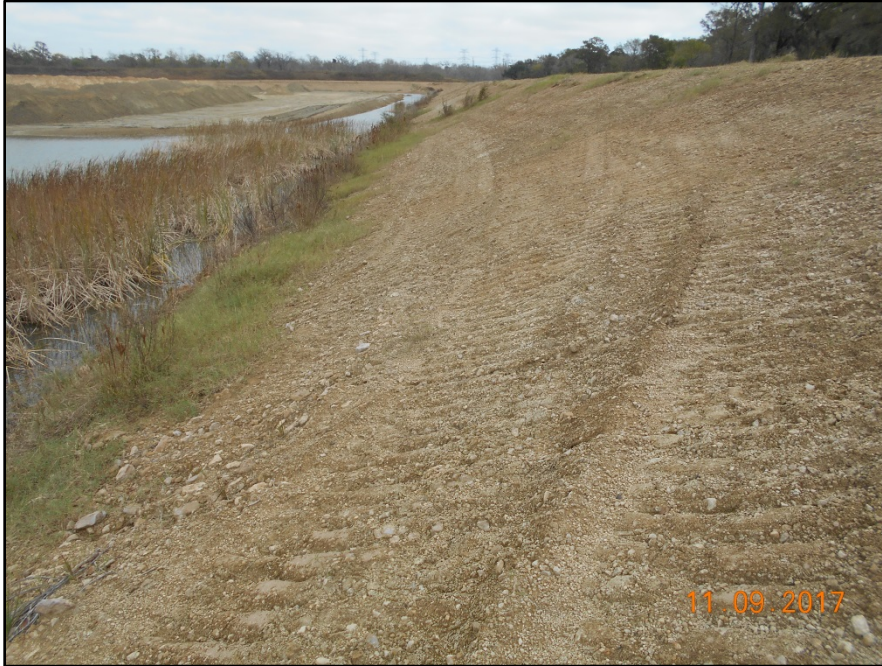
Photograph P-45 – Taken November 9, 2017 by David E. Nielson
Landfill Cell 2B: Looking north along the inside slope of the eastern berm.

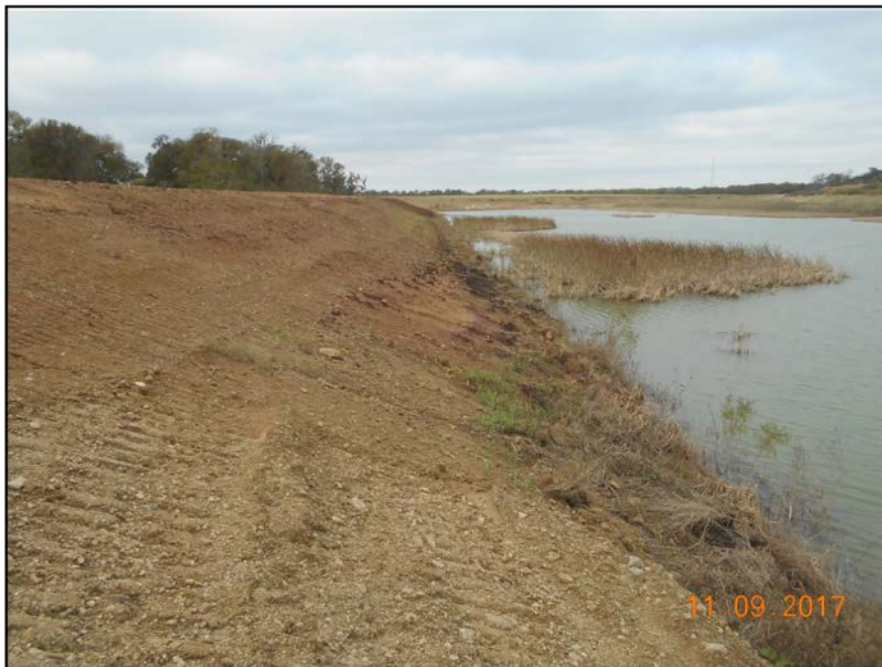
Photograph P-46– Taken November 9, 2017 by David E. Nielson
Landfill Cell 2B: Looking west along inside slope of southern berm.

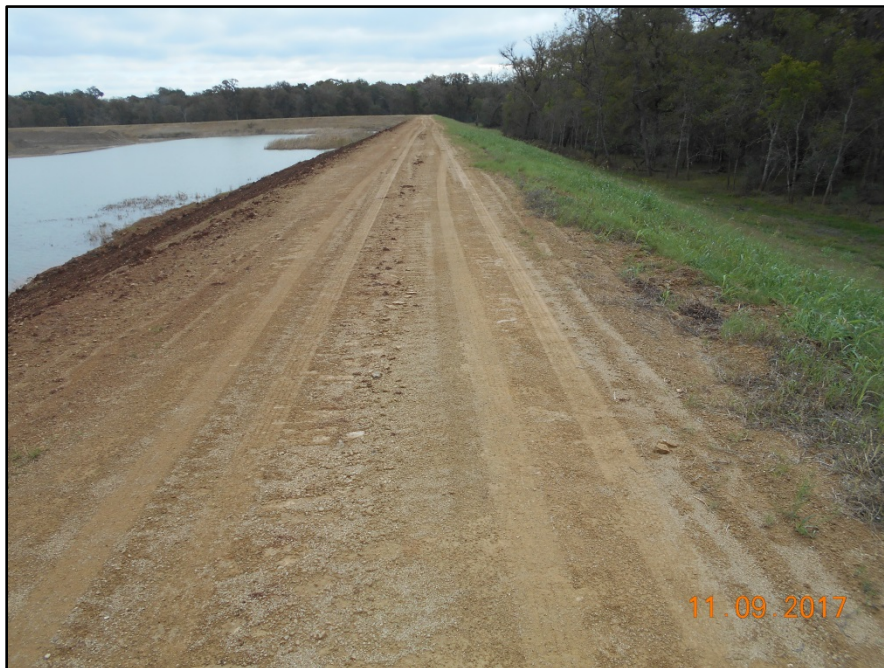
Photograph P-48 – Taken November 9, 2017 by David E. Nielson.
Landfill Cell 2B: Looking east along the crest of southern berm.

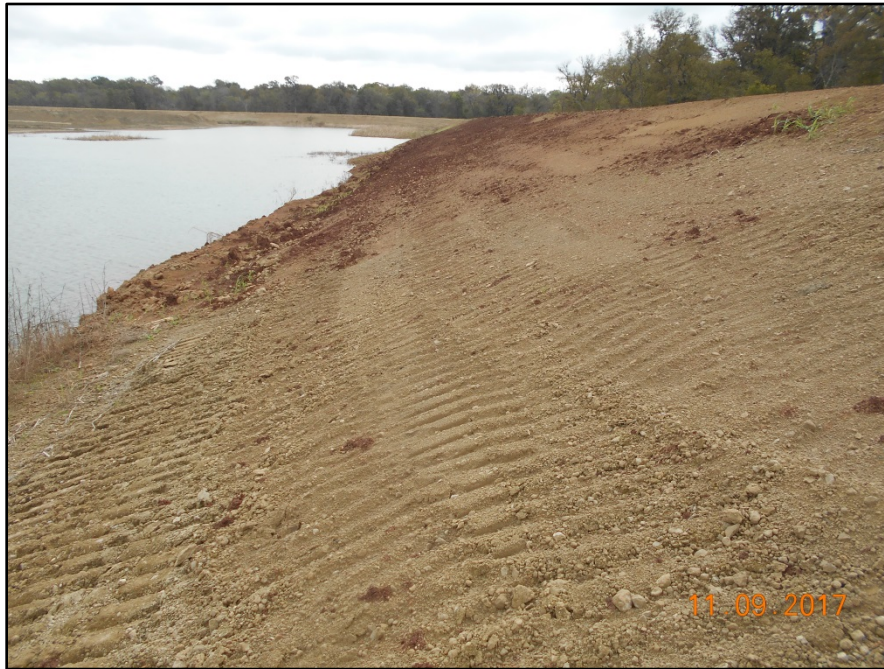
Photograph P-49 – Taken November 9, 2017 by David E. Nielson
Landfill Cell 2B: Looking east along inside slope of southern berm.

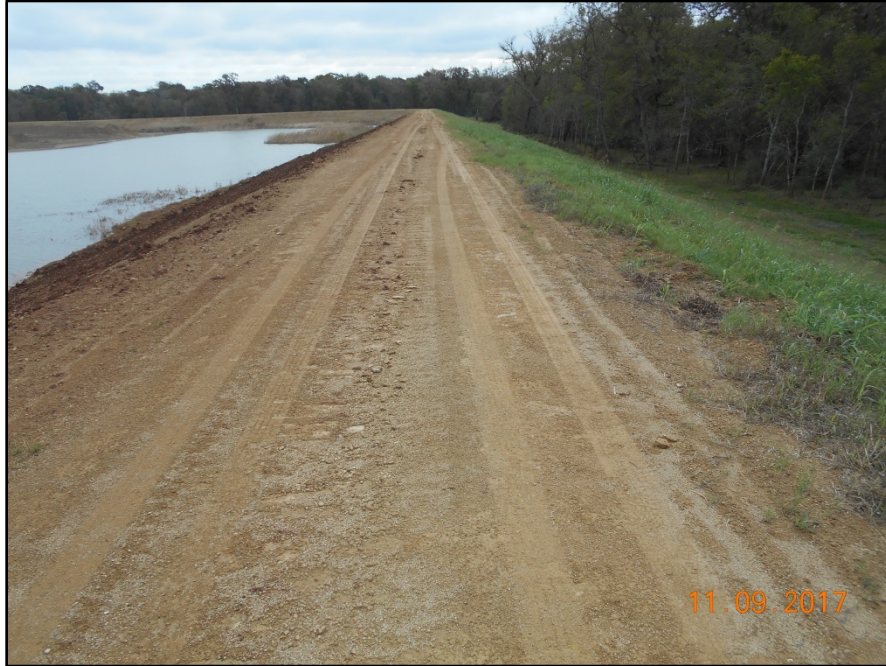
Photograph P-51 – Taken November 9, 2017 by David E. Nielson
Landfill Cell 2B: Looking east along crest of the southern berm.

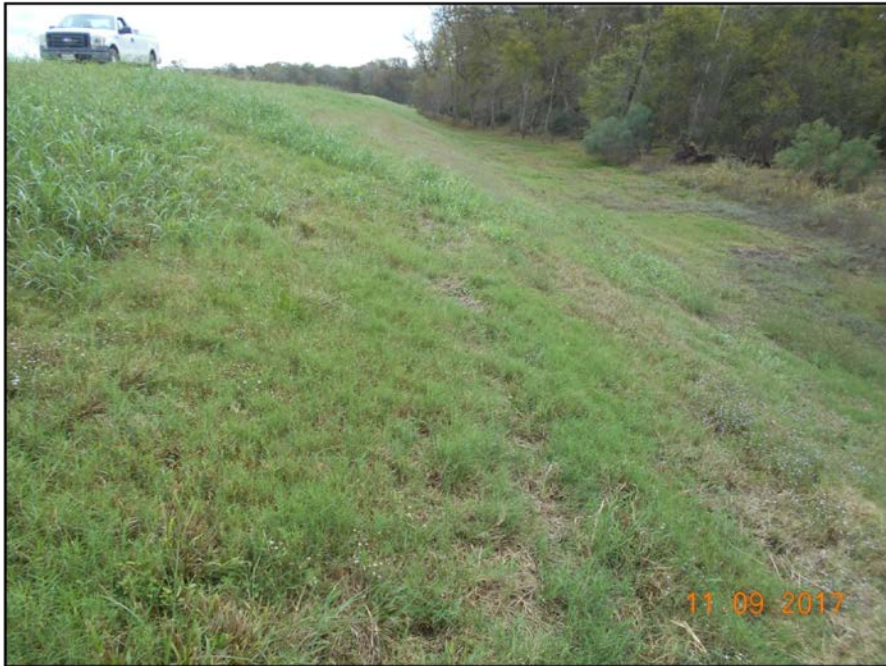
Photograph P-52 – Taken November 9, 2017 by David E. Nielson
Landfill Cell 2B: Looking east along outside slope of southern berm.
