**NRG TEXAS POWER, LLC
WA PARISH STATION, UNITS 5, 6, 7, & 8**

ANNUAL INSPECTION OF CCR IMPOUNDMENTS AND LANDFILL

S&L Report No.: SL-013202

Date: January 18, 2016

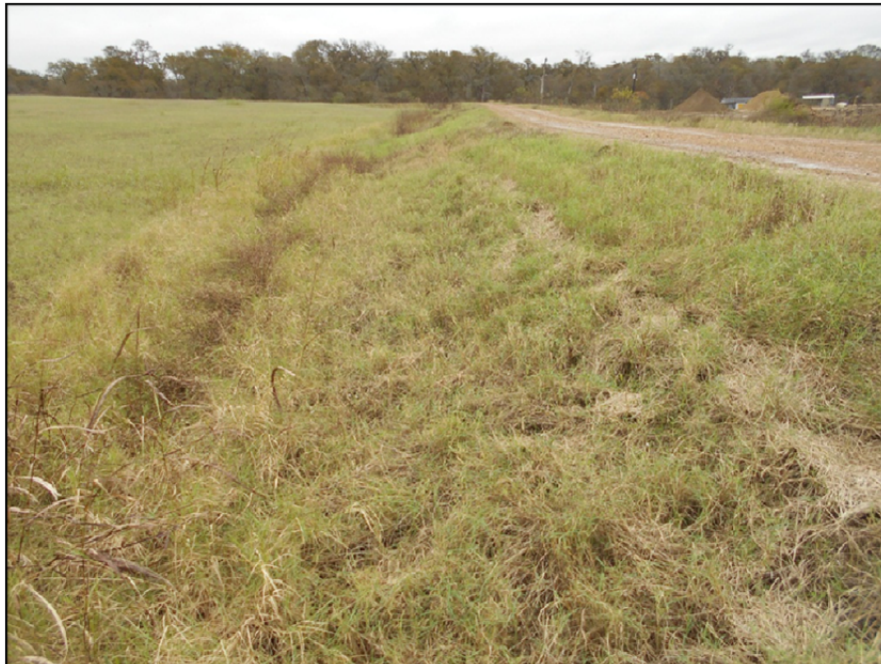
Photograph P-36 – Taken December 1, 2015 by David E. Nielson
Landfill Cell 2A: Looking east at outside slope of the northern berm.

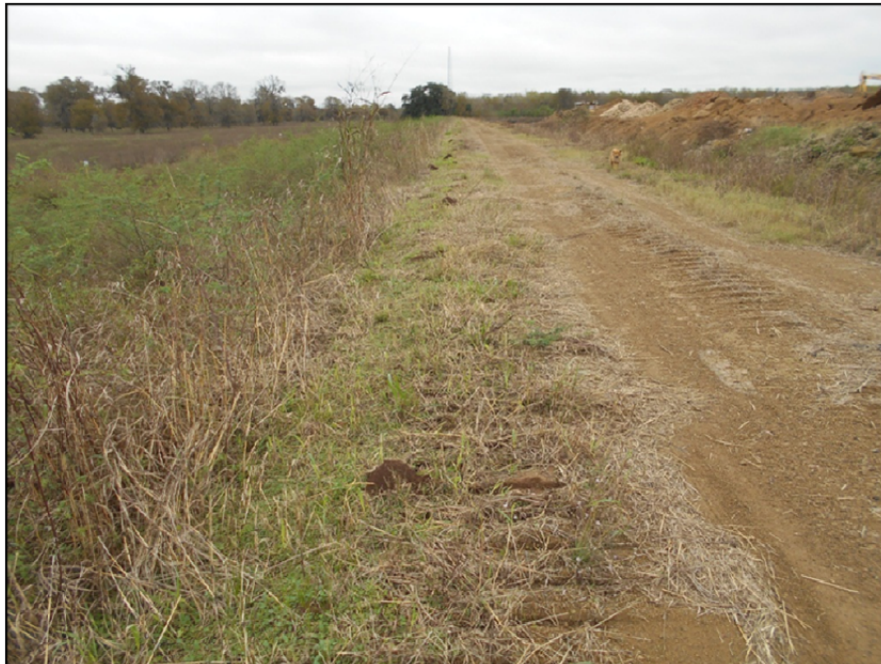
Photograph P-43 – Taken December 1, 2015 by David E. Nielson
Landfill Cell 1C: Looking north along the outside crest of the western berm.

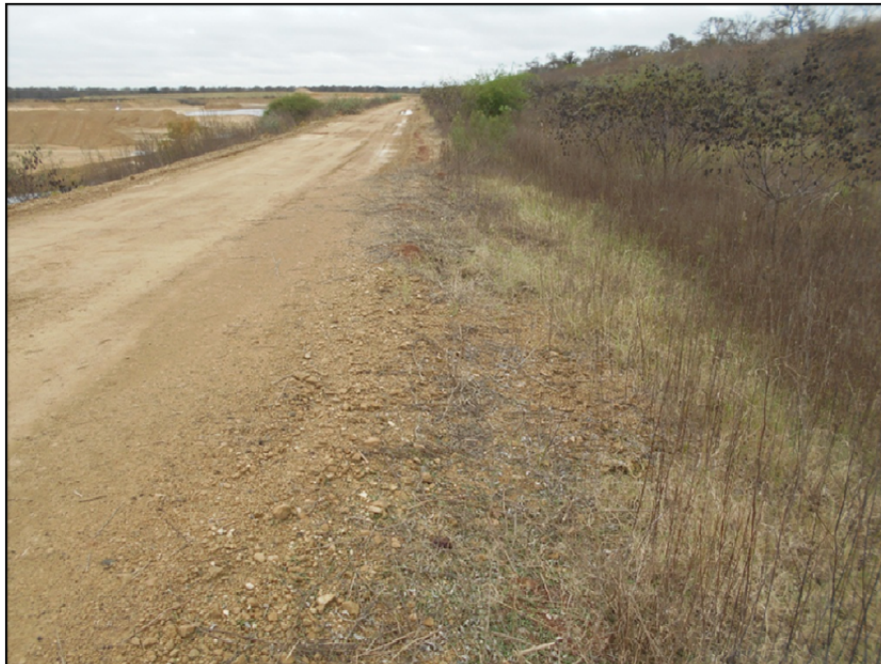
Photograph P-50 – Taken December 1, 2015 by David E. Nielson
Landfill Cell 2B: Looking west along the crest of the northern berm and the soil stockpile.

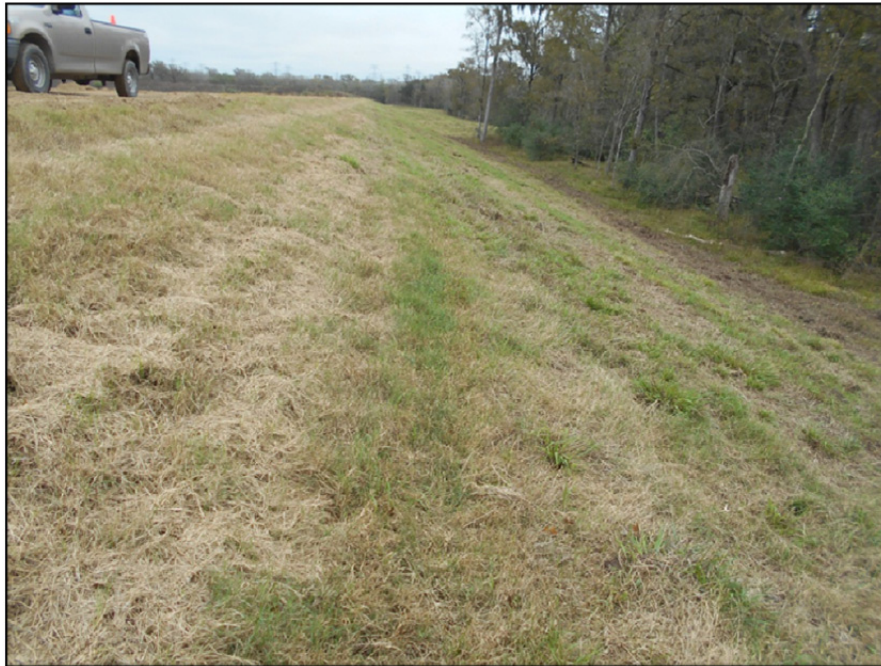
Photograph P-63 – Taken December 1, 2015 by David E. Nielson
Landfill Cell 2B: Looking north along the outside slope of the eastern berm. Note generally good vegetation cover, uniform slopes and absence of erosion.

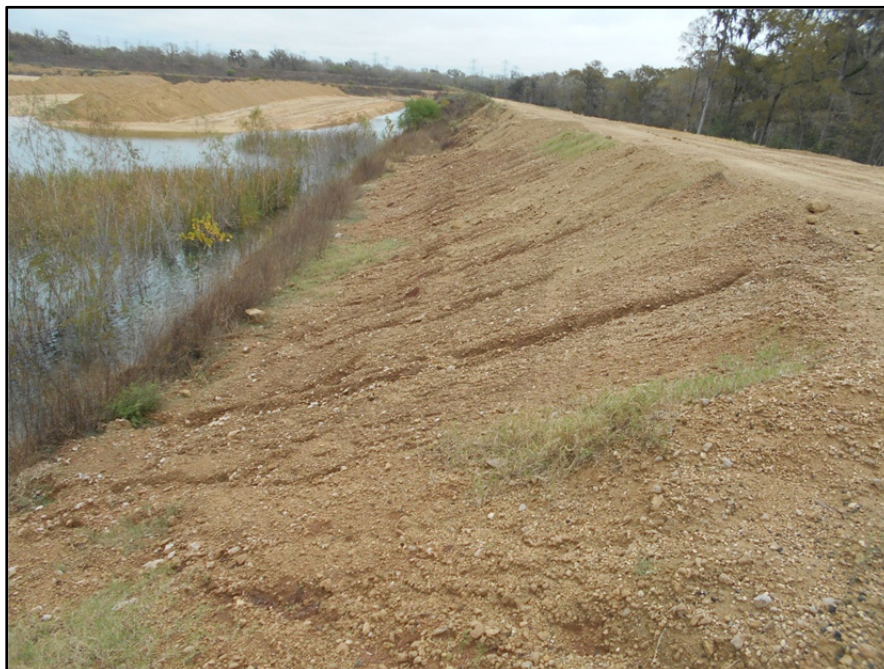
Photograph P-64 – Taken December 1, 2015 by David E. Nielson
Landfill Cell 2B: Looking north along the inside slope of the landfill berm.
Note ongoing erosion. Measures should be taken to mitigate erosion damage.

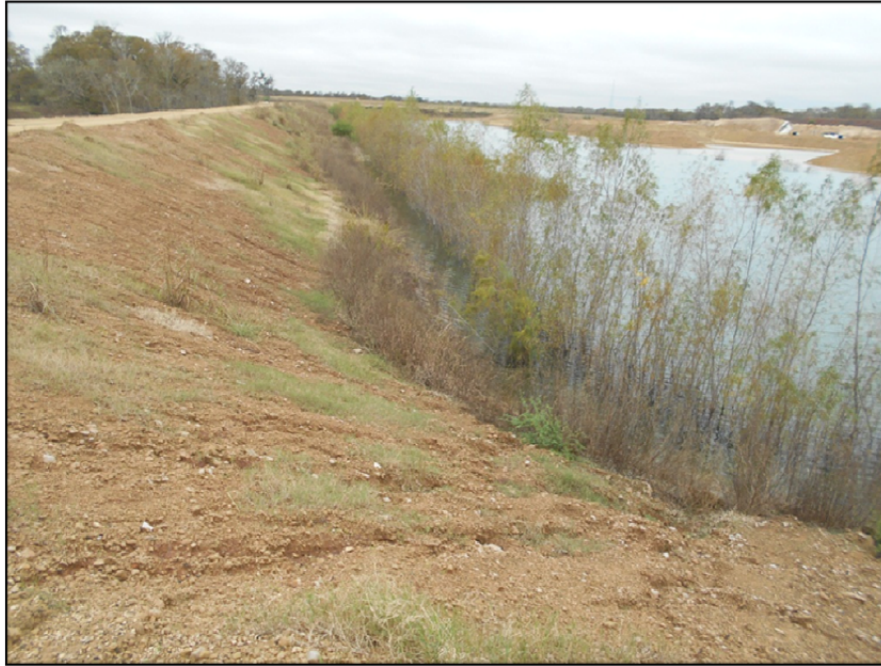
Photograph P-65 – Taken December 1, 2015 by David E. Nielson
Landfill Cell 2B: Looking west along inside slope of southern berm/dike.
Note sparse grass and small trees. Revegetation of slope is recommended.

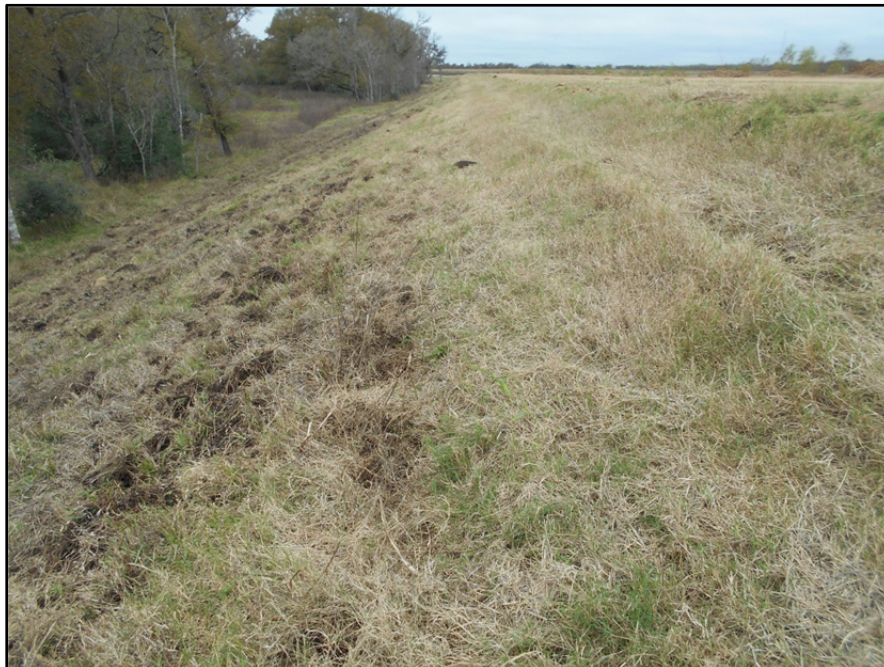
Photograph P-66 – Taken December 1, 2015 by David E. Nielson
Landfill Cell 2B: Looking west along outside slope of southern berm/dike.
Note ongoing feral hog damage to vegetation.

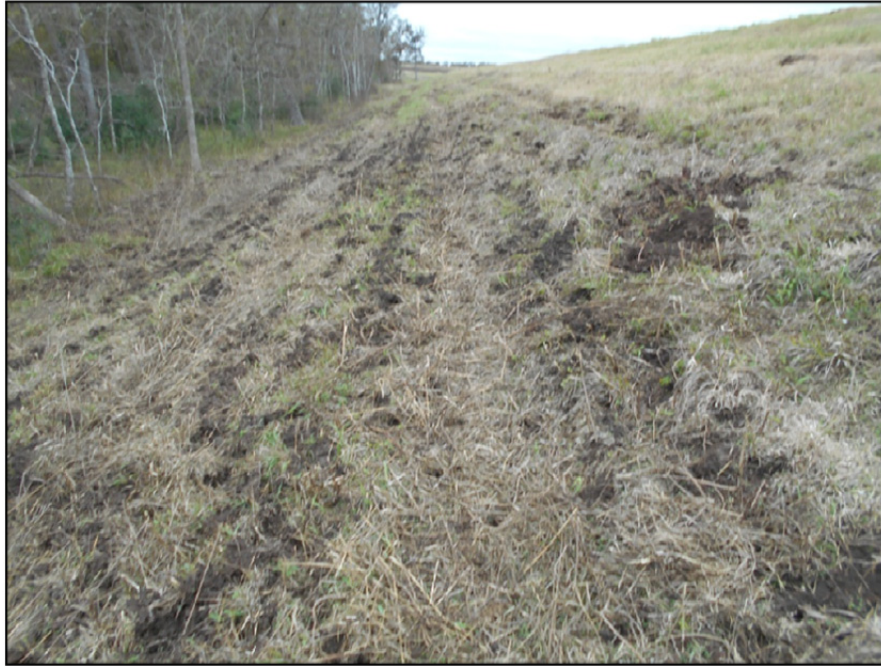
Photograph P-67 – Taken December 1, 2015 by David E. Nielson
Landfill Cell 2B: Looking west along outside slope of southern berm/dike.
Note significant damage to the vegetation by feral hogs.

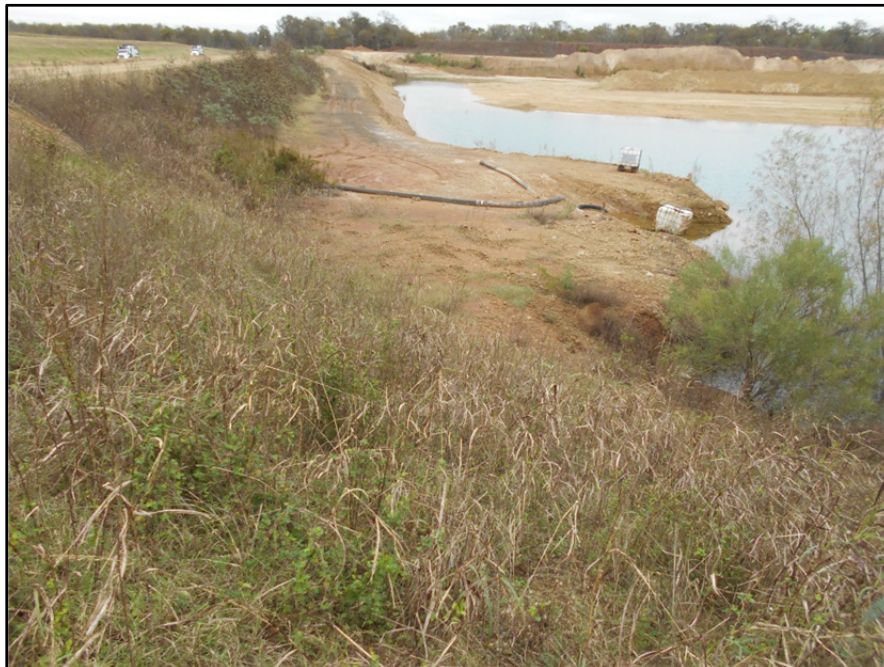
Photograph P-68 – Taken December 1, 2015 by David E. Nielson
Landfill Cell 2B: Looking north along the inside slope of the west berm/dike at the area where
a mobile pump is placed to remove stormwater collected in the cell.
Note the slope is somewhat steep in the area of the ramp.

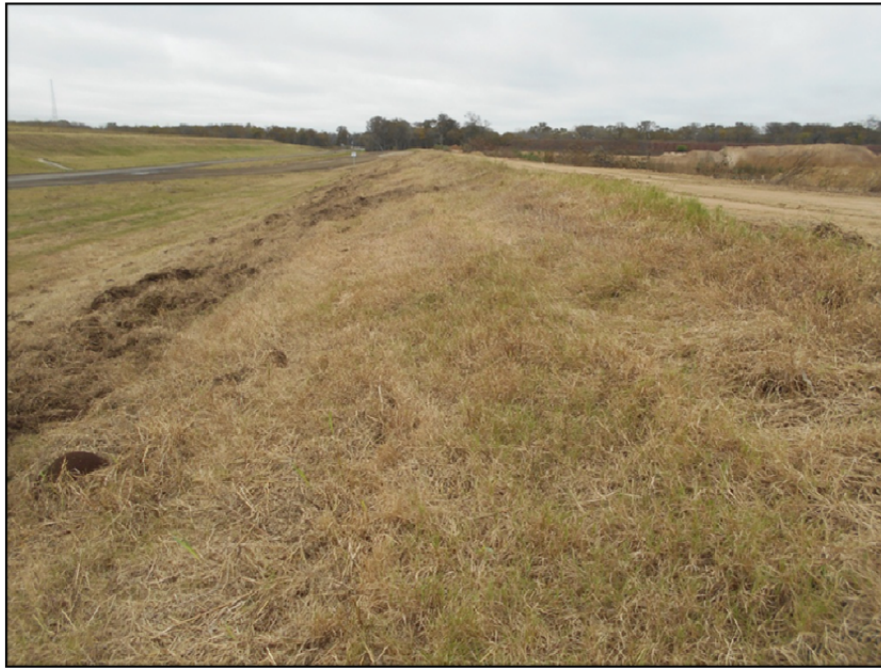
Photograph P-69 – Taken December 1, 2015 by David E. Nielson
Landfill Cell 2B: Looking north along the exterior slope of the western dike/berm.
Note uniformity of slope and generally good vegetation cover with
feral hog damage near toe of slope.

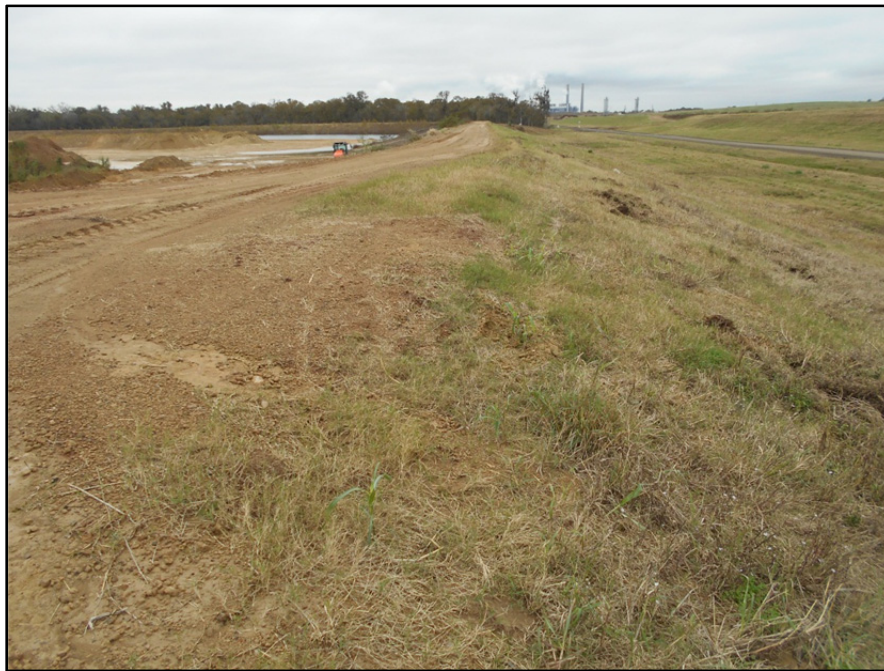
Photograph P-70 – Taken December 1, 2015 by David E. Nielson
Landfill Cell 2B: Looking south along crest and outside slope of western berm/dike.

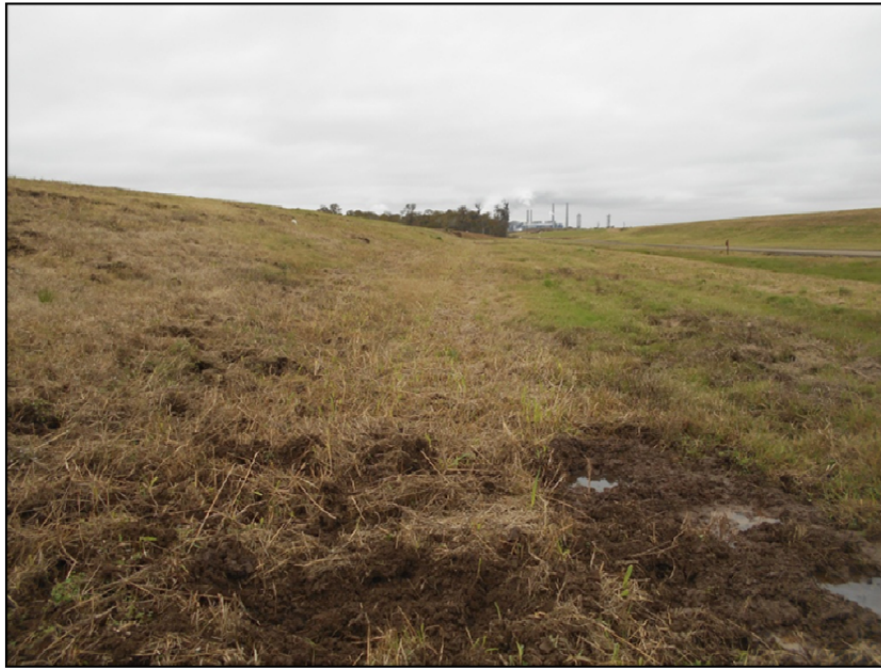
Photograph P-71 – Taken December 1, 2015 by David E. Nielson
Landfill Cell 2B: Looking south along toe of western slope with damaged vegetation in foreground. Standing water in some areas is from precipitation not from seepage.

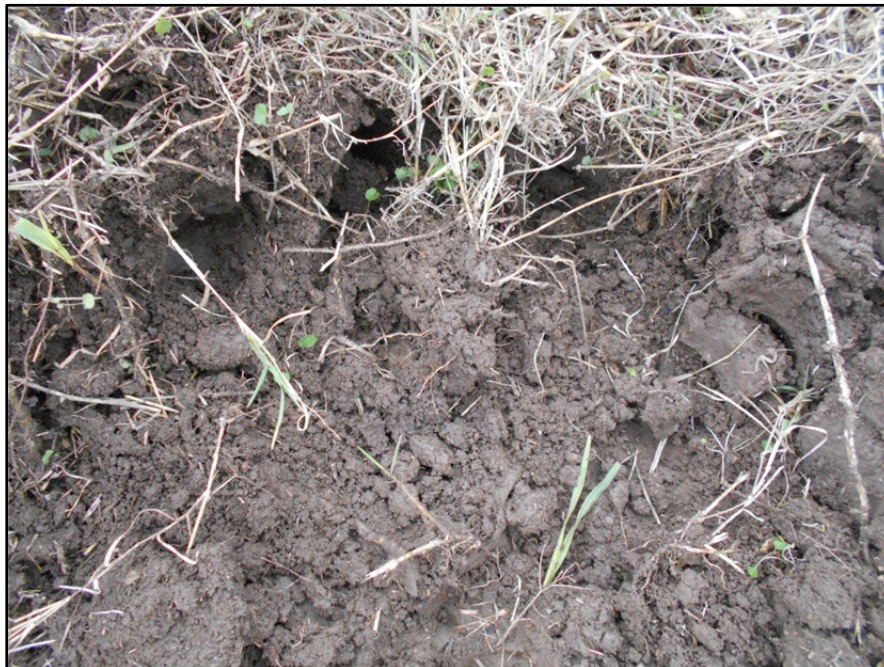
Photograph P-72 – Taken December 1, 2015 by David E. Nielson
Landfill Cell 2B: Looking at damage to vegetation shown in Photograph P-71, which was caused by feral hogs.
Note shallow depth of disturbance and likelihood of re-vegetation due to intact grass roots.
